NC DEPARTMENT OF TRANSPORTATION
 DIVISION OF HIGHWAYS
 BRIDGE MANAGEMENT UNIT

PRIORITY MAINTENANCE ISSUED

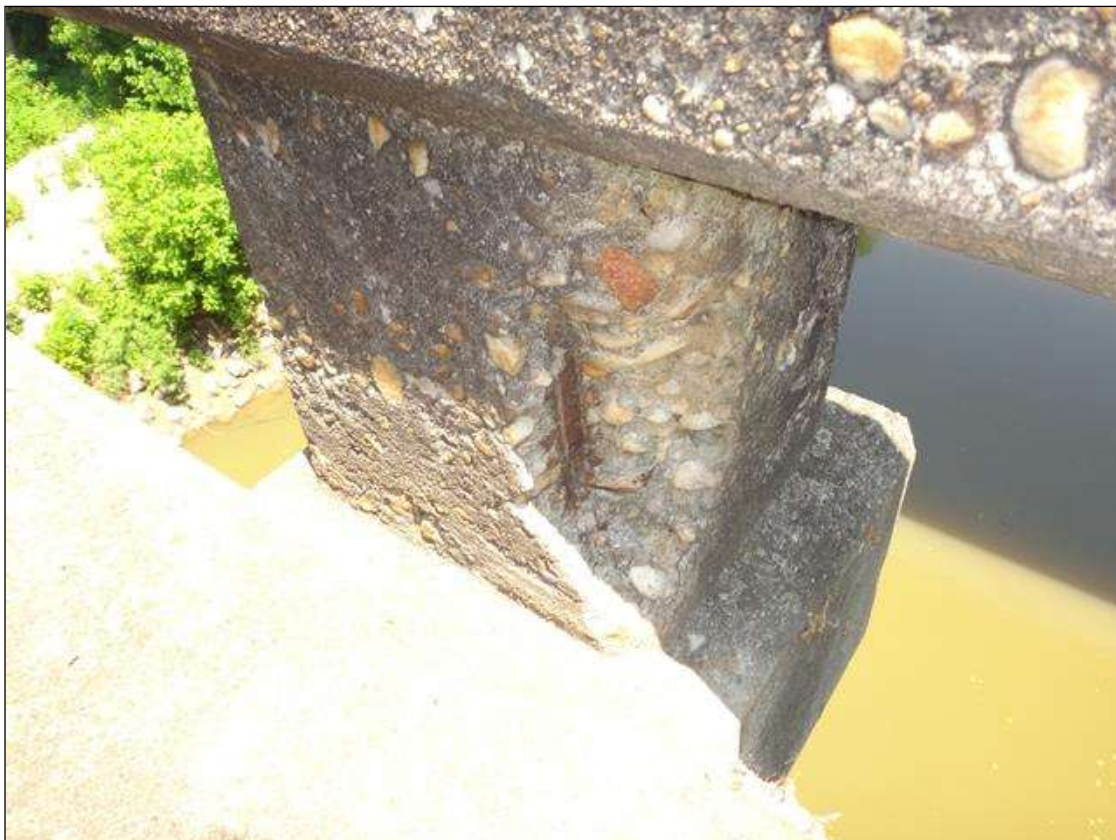
SPAN 9 NORTH RAIL POST AT 10FT FROM BENT 8, SPALL (8IN X 4IN X 1-1/2IN DEEP) WITH EXPOSED RUSTED REBAR

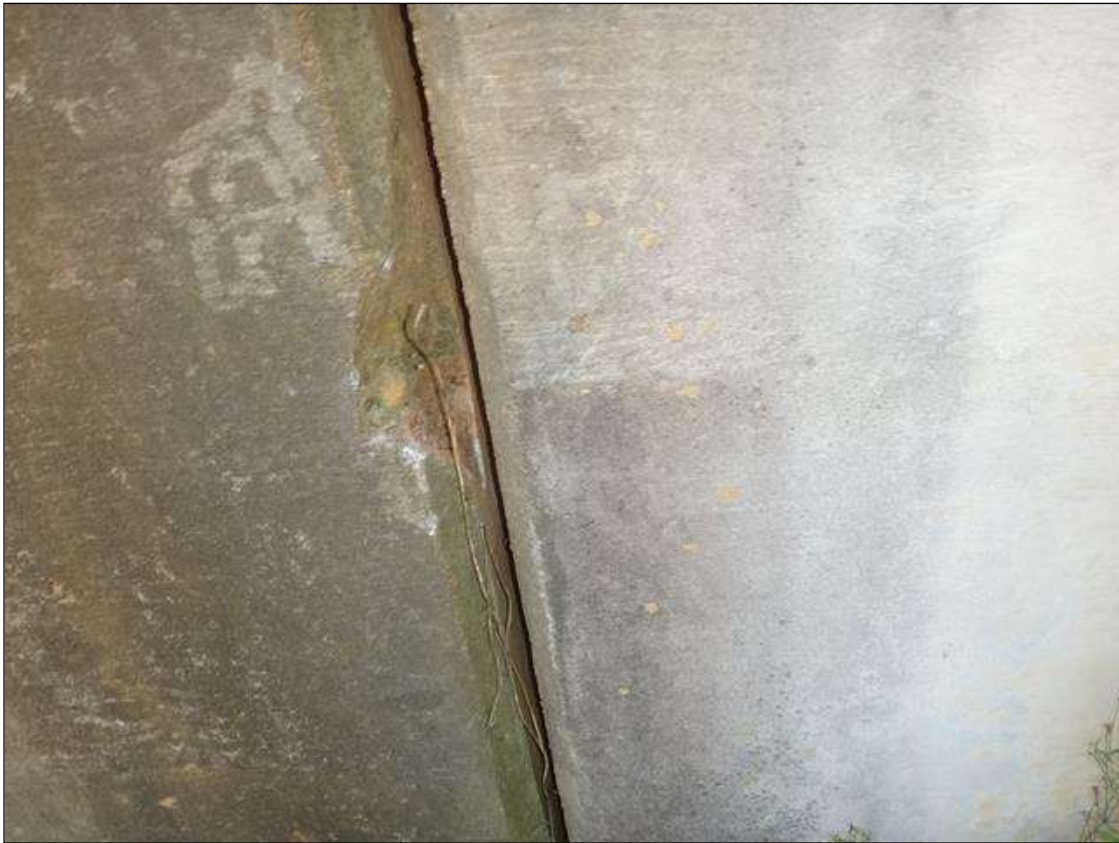
NORTHEAST EARWALL, POPOUT (6IN X 3IN X 1IN)

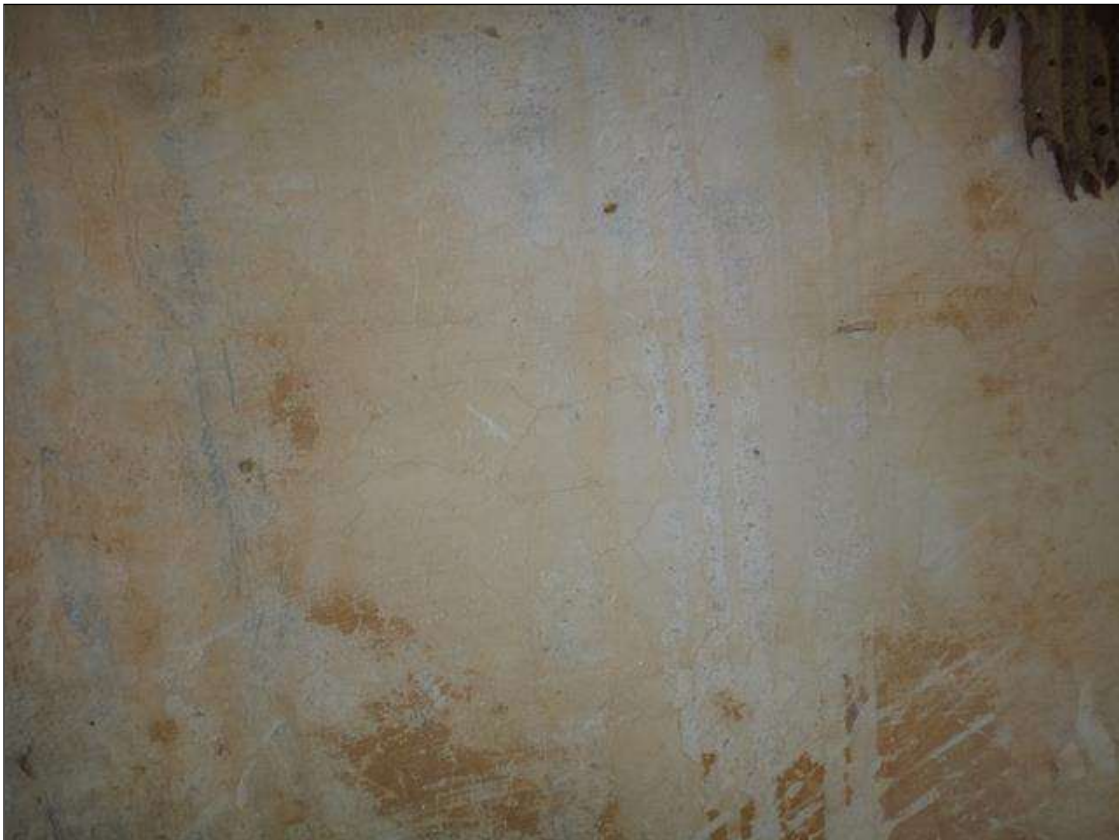
SPAN 10 BEAM 2 NORTH FACE AT END BENT 2, MAP CRACKING (3FT X 2FT X HAIRLINE)

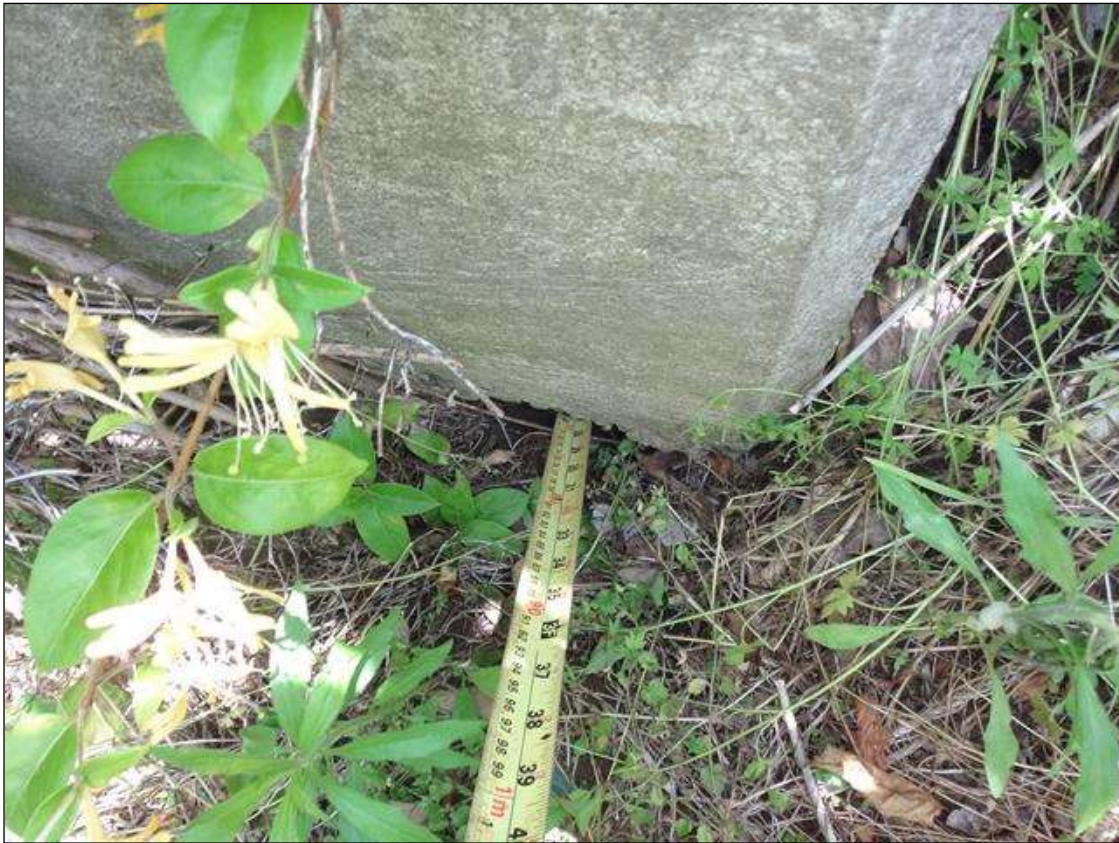
END BENT 2 CAP AT SOUTH END, EROSION WITH UNDERMINING (2FT X 1FT X 28IN)

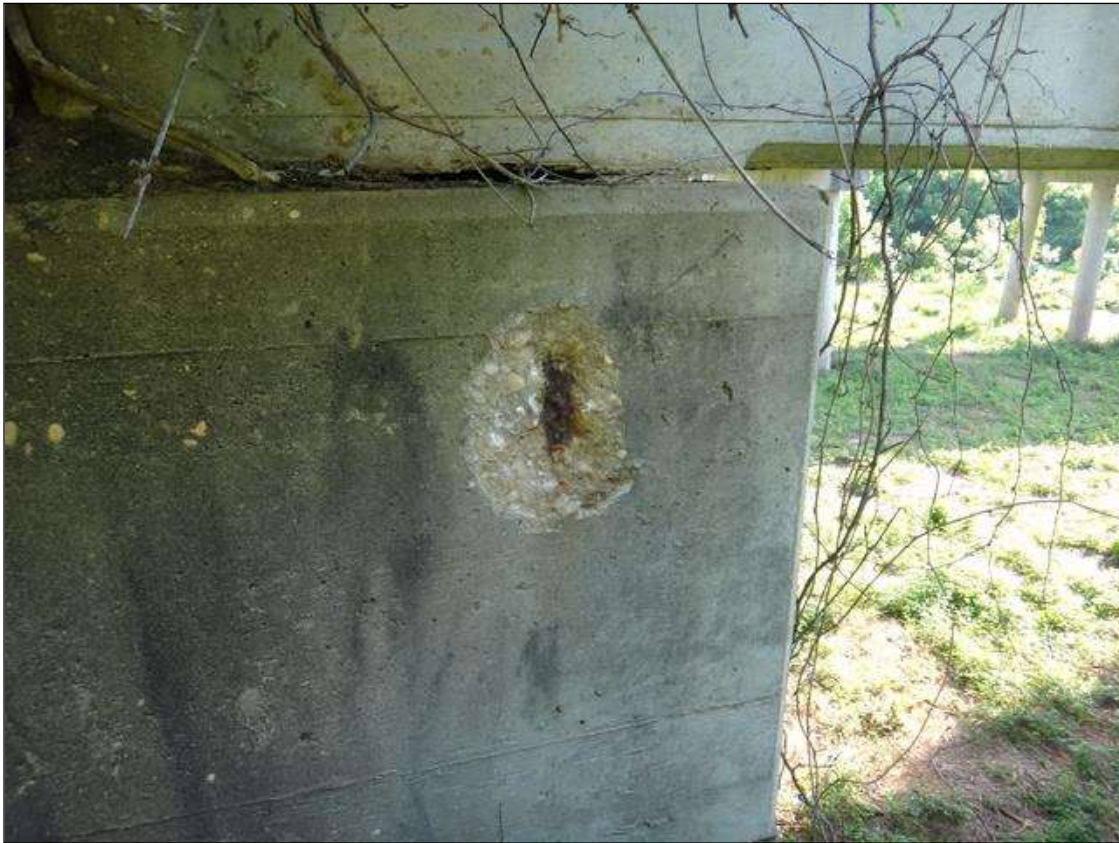
(PM) BENT 1 CAP SOUTH FACE, SPALL (12IN X 7IN X 1IN DEEP) WITH EXPOSED RUSTED REBAR

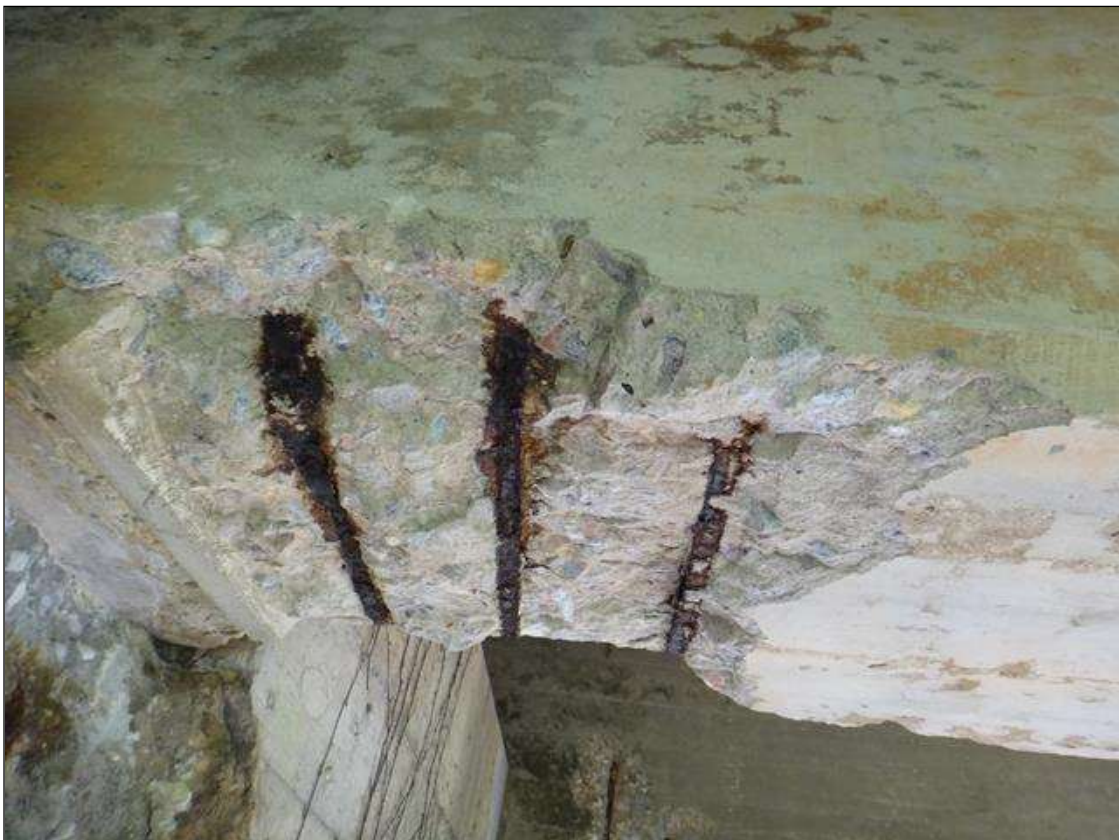
(PM) SPAN 2 BEAM 4 AT BENT 1, SPALL (2FT X 2FT X 2IN DEEP) WITH EXPOSED RUSTED REBAR AND SECTION LOSS ON REBAR

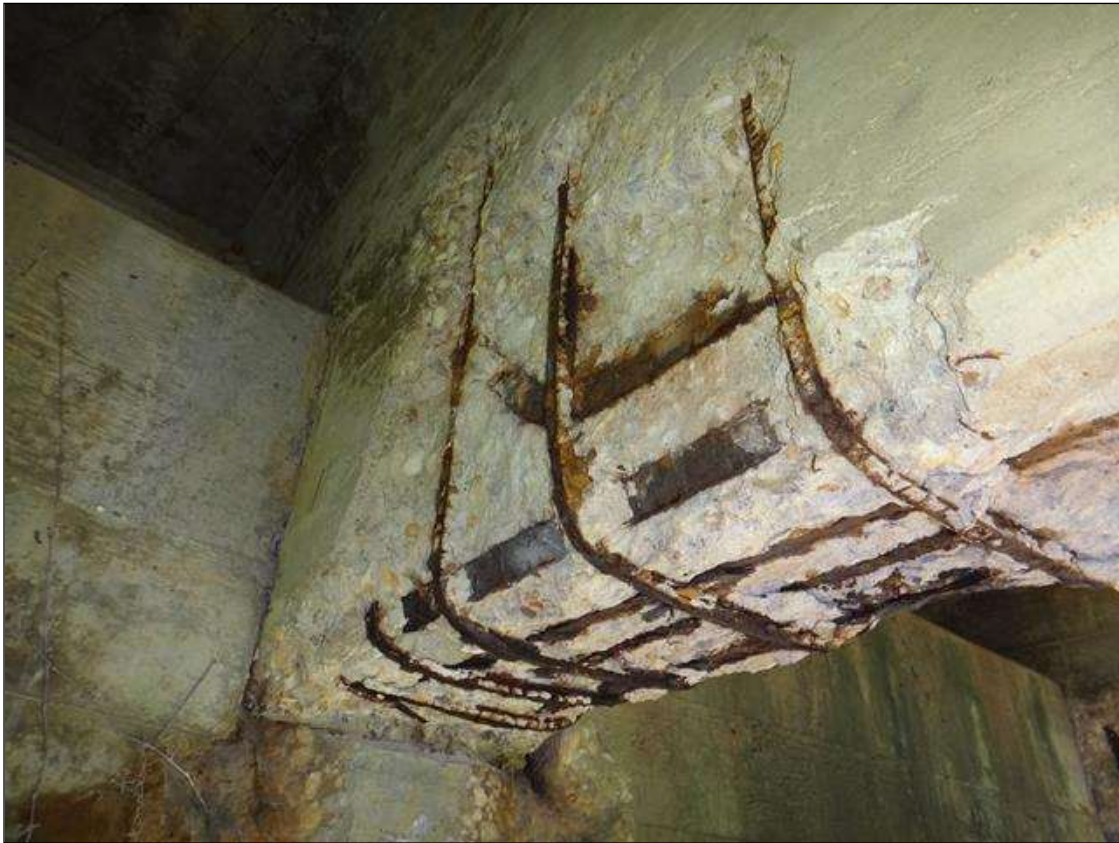
(PM) SPAN 2 BEAM 3 AT BENT 1, SPALL (33INX28INX2IN) WITH EXPOSED RUSTED REBAR, SECTION LOSS ON PRIMARY (NO MEASURABLE LOSS) AND SECONDARY (UP TO 50%)

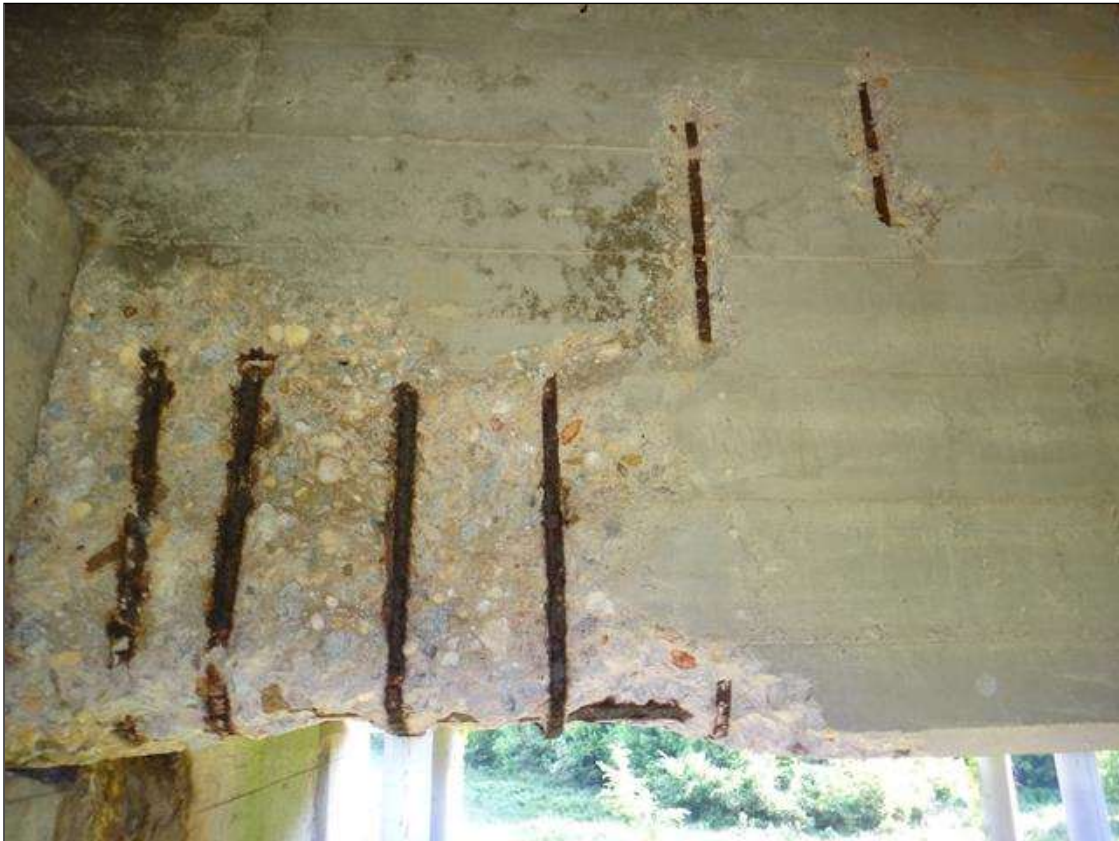
(PM) SPAN 2 BEAM 2 AT BENT 1, THREE (3) SPALLS (UP TO 36IN X 20IN X 2IN DEEP) WITH EXPOSED RUSTED REBAR, SECTION LOSS ON SECONDARY (UP TO 50%)

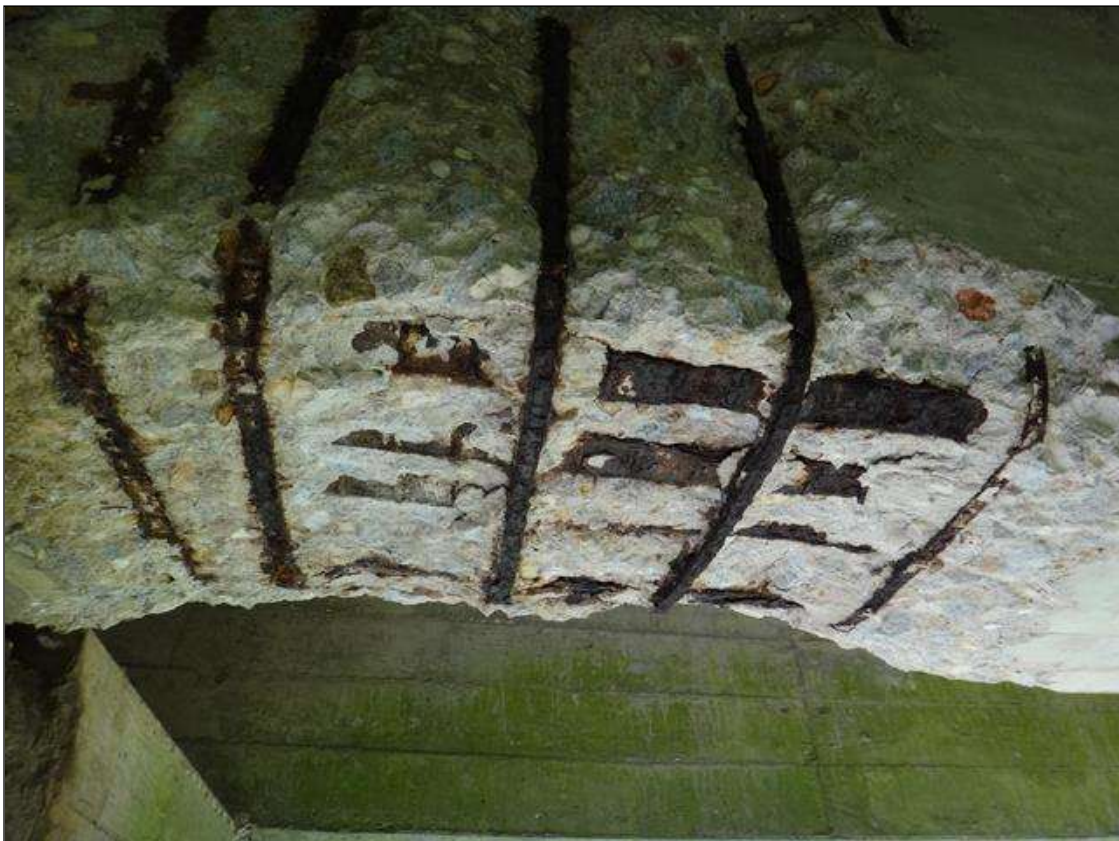
(PM) SPAN 2 BEAM 2 AT BENT 1, SPALL (48IN X 18IN X 2IN DEEP) WITH EXPOSED RUSTED REBAR

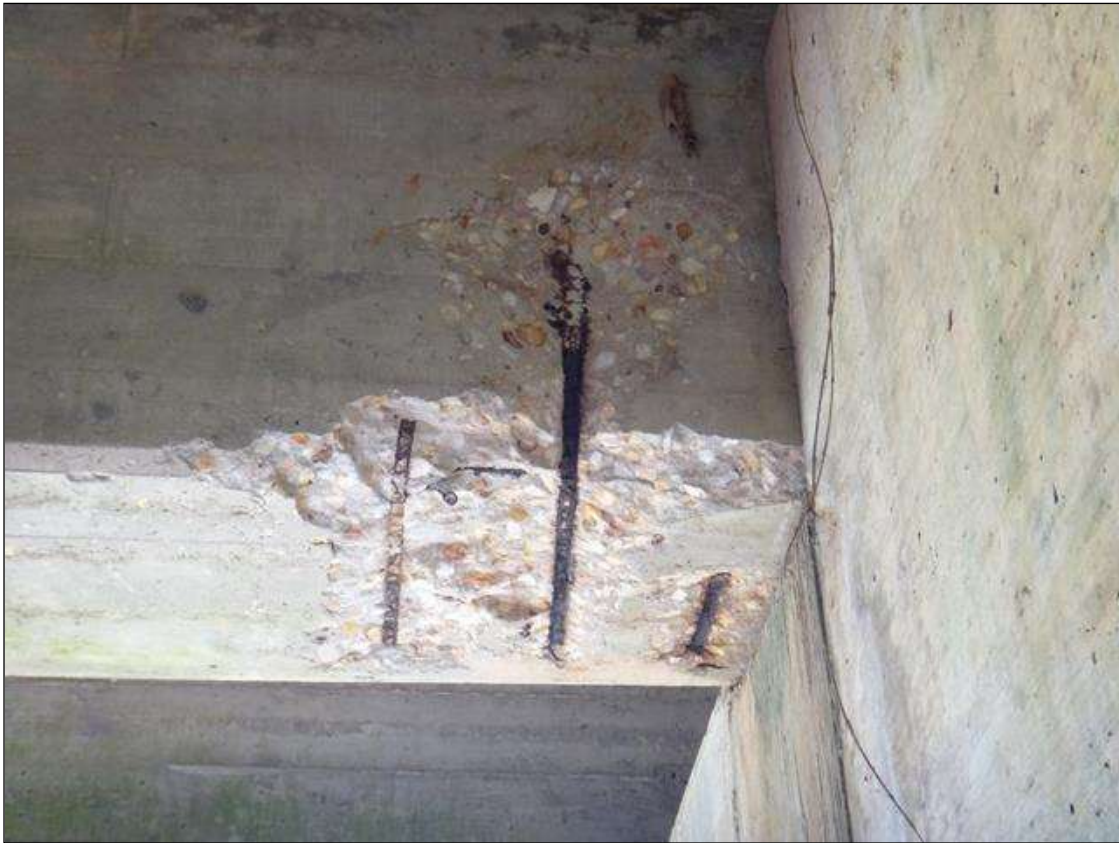
(PM) SPAN 1 BEAM 2 AT BENT 1, SPALL (24IN X 20IN X 2IN DEEP) WITH EXPOSED RUSTED REBAR, SECTION LOSS ON SECONDARY (UP TO 50%)

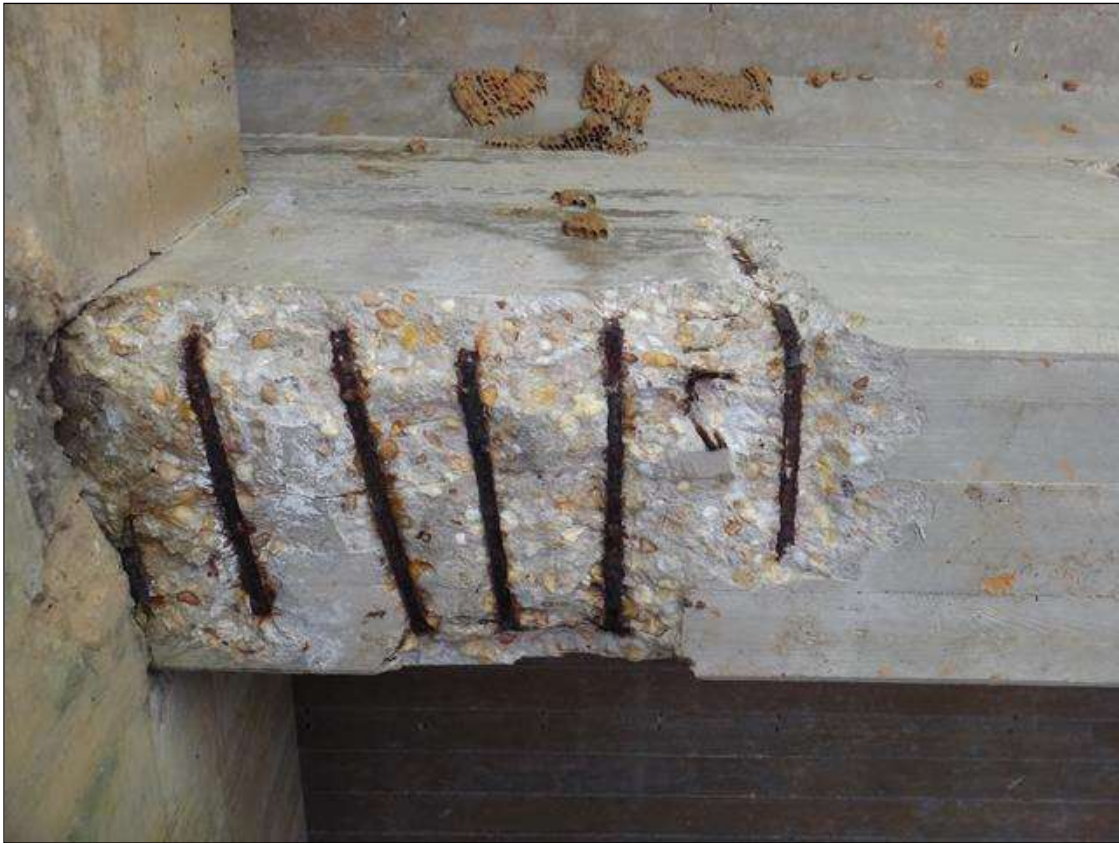
(PM) SPAN 1 BEAM 3 AT BENT 1, SPALL (30IN X 18IN X 2IN DEEP) WITH EXPOSED RUSTED REBAR, SECTION LOSS ON SECONDARY (UP TO 50%)

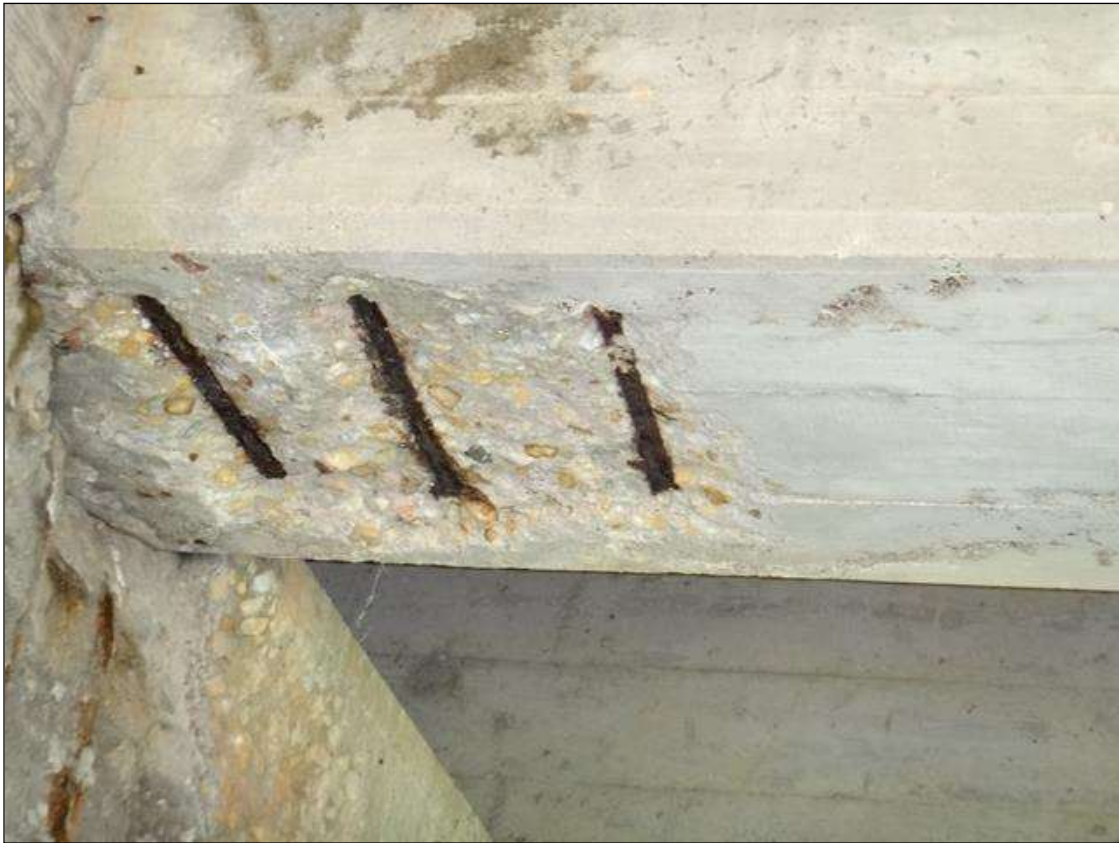
(PM) SPAN 1 BEAM 4 AT BENT 1, SPALL (18IN X 18IN X 2IN DEEP) WITH EXPOSED RUSTED REBAR, SECTION LOSS (NO MEASURABLE LOSS)

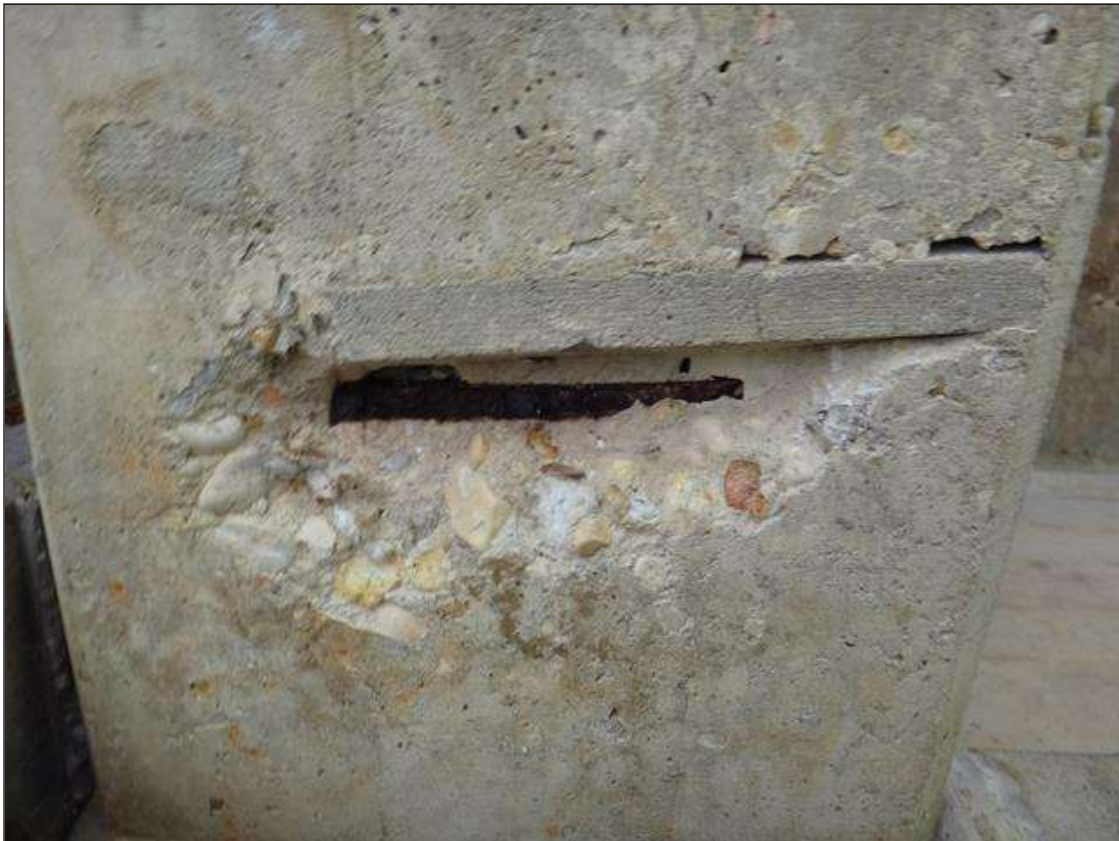
(PM) SPAN 2 BEAM 2 AT BENT 2, SPALL (14IN X 6IN X 2IN DEEP) WITH EXPOSED RUSTED REBAR

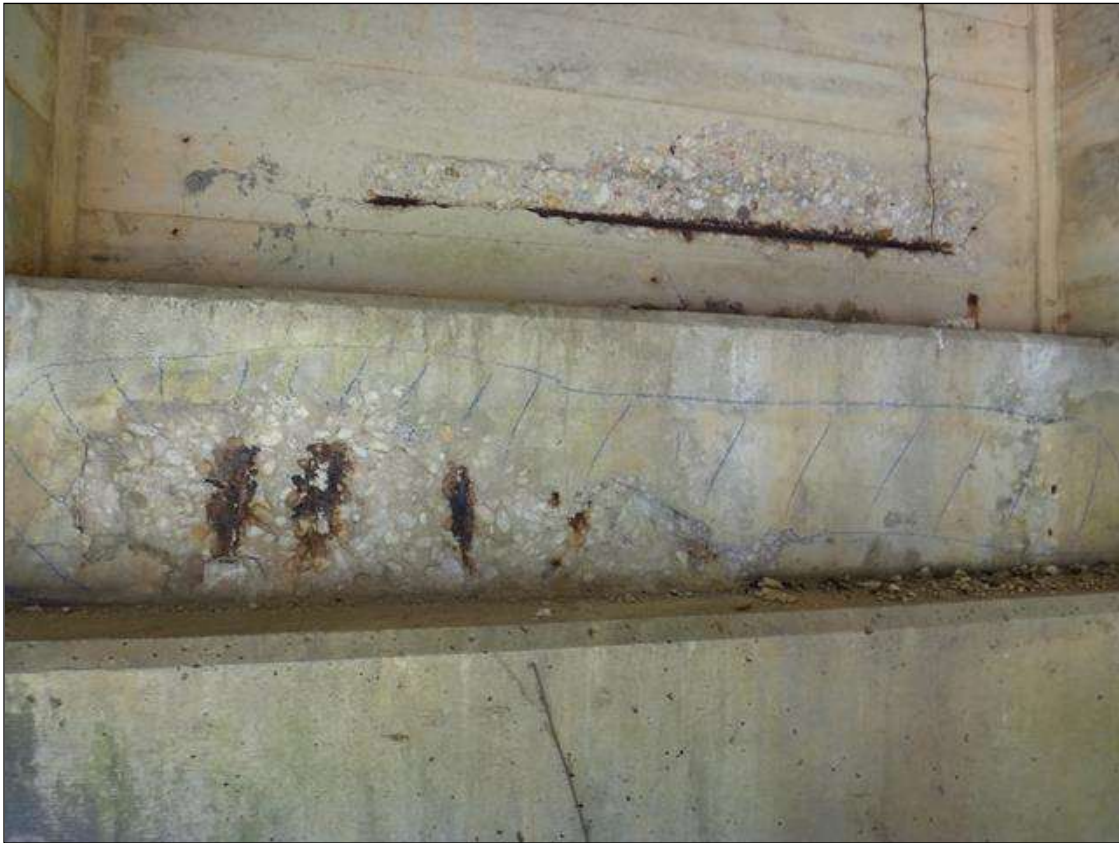
(PM) BENT 2 CAP WEST FACE AT BAY 2, SPALL (4FT X 12IN X 2IN) WITH EXPOSED RUSTED REBAR, SECTION LOSS (NO MEASURABLE LOSS), DELAMINATION (6-1/2FTX18IN)

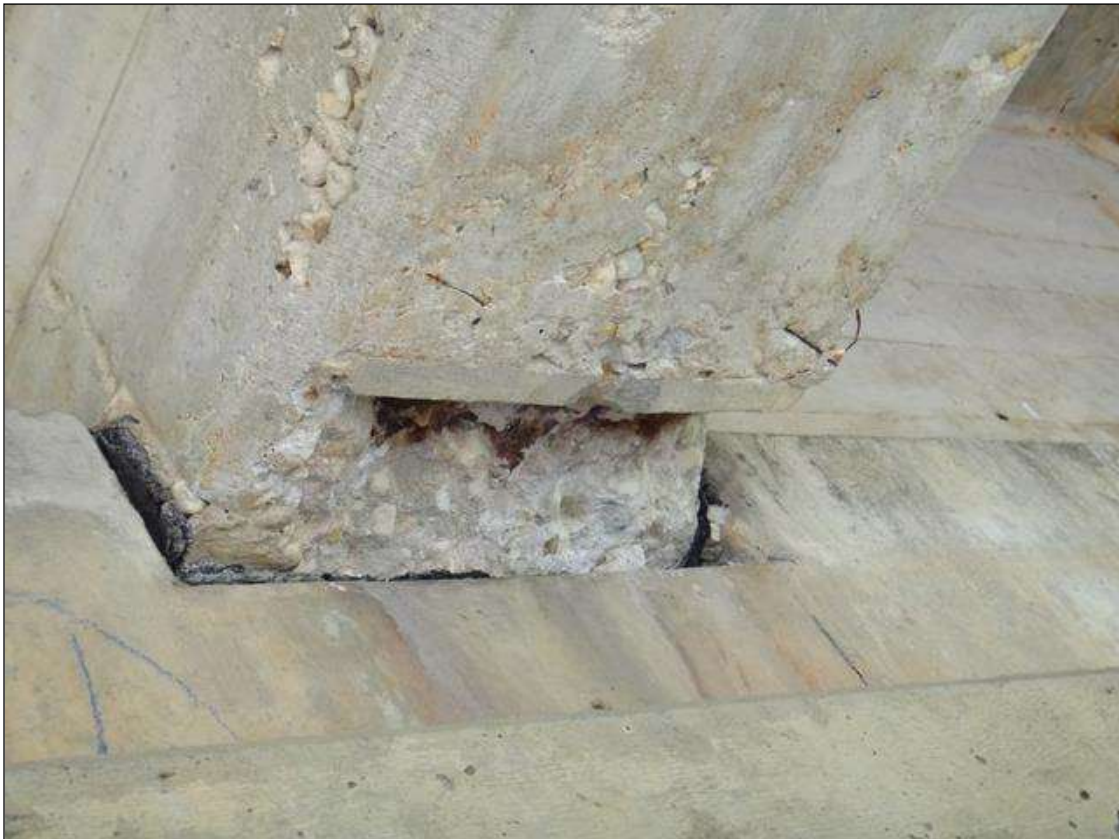
(PM) SPAN 2 BEAM 3 AT BENT 2, SPALL (18IN X 8IN X 3IN DEEP) WITH EXPOSED RUSTED REBAR

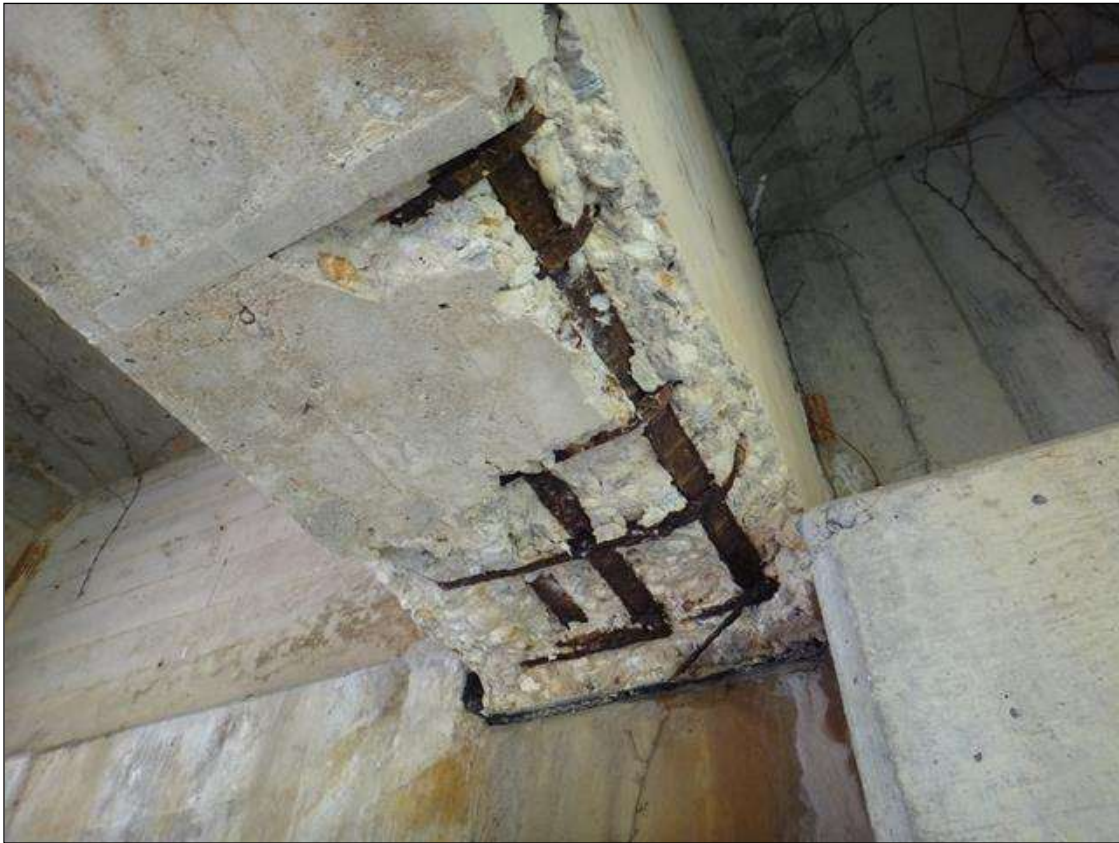
(PM) SPAN 2 BEAM 4 AT BENT 2, SPALL (30INX18INX4IN) WITH EXPOSED RUSTED REBAR, SECTION LOSS ON PRIMARY (NO MEASURABLE LOSS) AND SECONDARY (UP TO 100%)

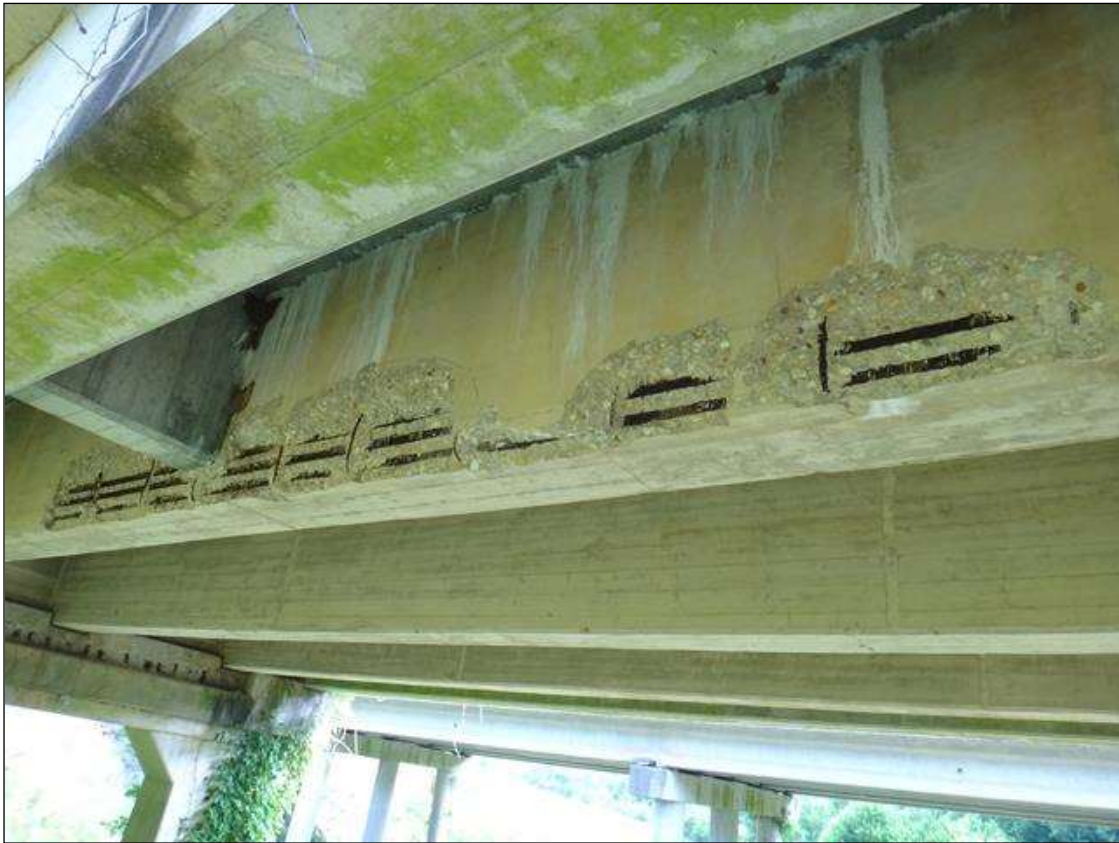
(PM) SPAN 3 BEAM 4 SOUTH FACE AT MIDSPAN, SPALL (18FT X 18IN X 2-1/2IN) WITH EXPOSED RUSTED REBAR, SECTION LOSS, DELAMINATION WITH TRANSVERSE CRACKS

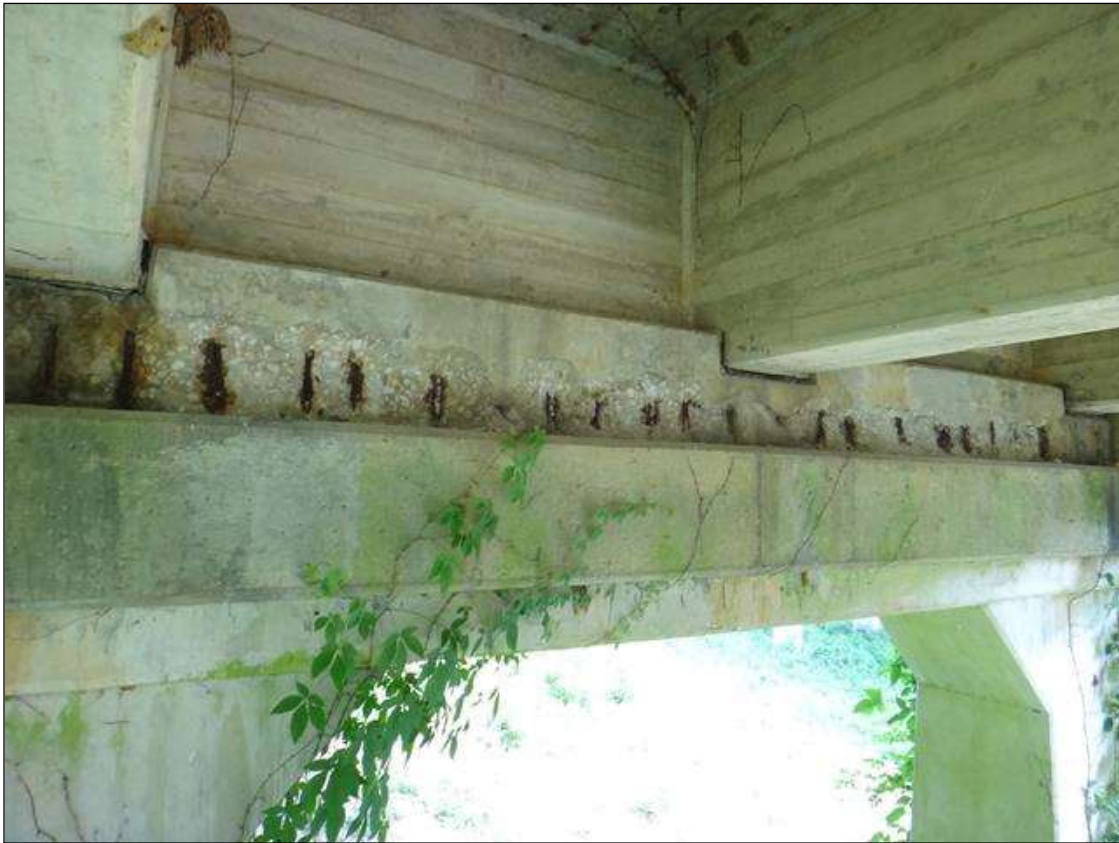
(PM) BENT 2 CAP EAST FACE, SPALL (17FT X 12IN X 2IN) WITH EXPOSED RUSTED REBAR, SECTION LOSS (NO MEASURABLE LOSS), DELAMINATION (FULL WIDTH X 15IN)

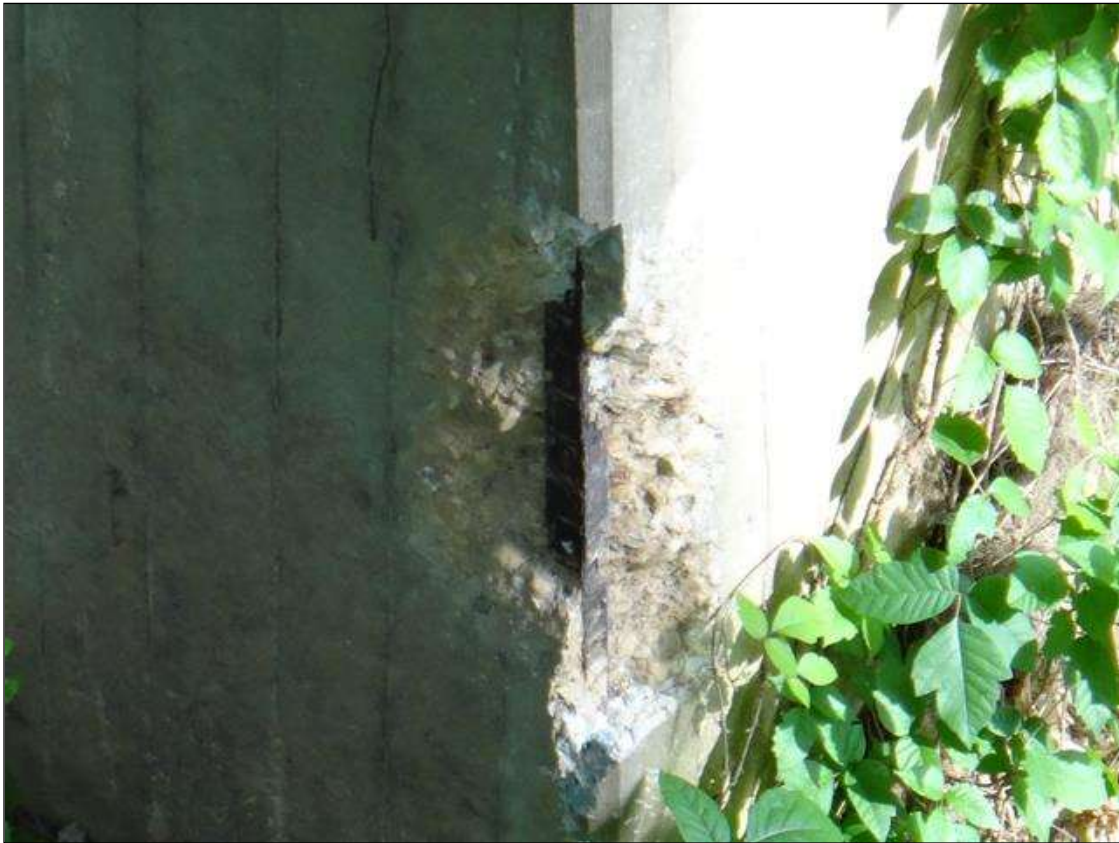
(PM) BENT 2 COLUMN 1 SOUTHEAST CORNER, SPALL (30IN X 12IN X 2IN DEEP) WITH EXPOSED RUSTED REBAR

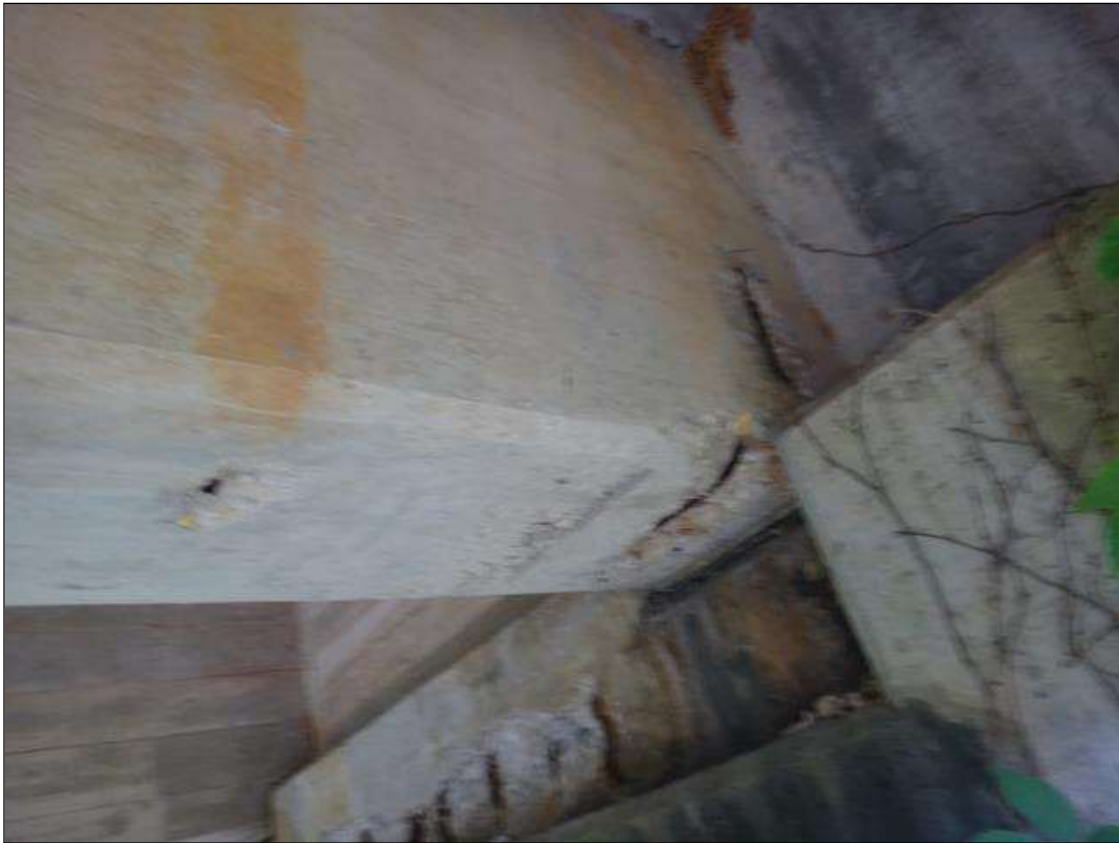
(PM) SPAN 3 BEAM 2 AT BENT 2, THREE (3) SPALLS (UP TO 16IN X 6IN X 2IN DEEP) WITH EXPOSED RUSTED REBAR

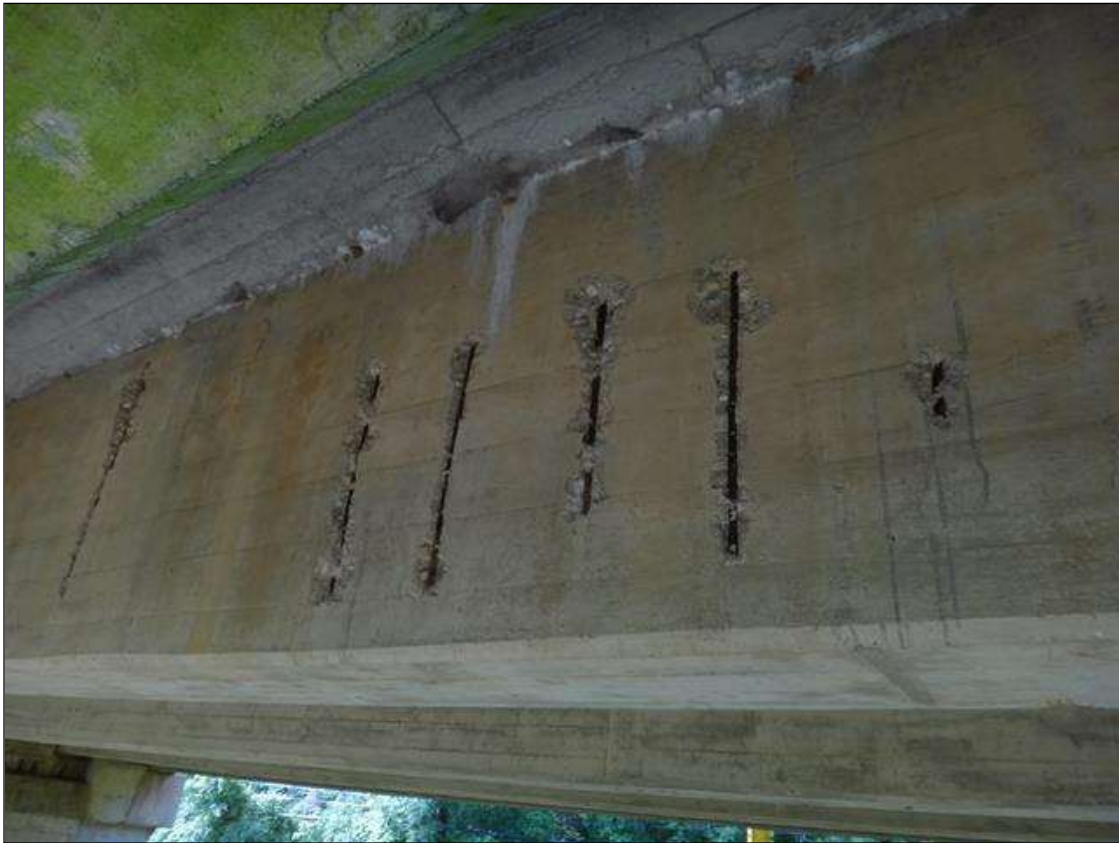
(PM) SPAN 3 BEAM 2 AT MIDSPAN, EIGHT (8) SPALLS AT STIRRUPS (UP TO 3FT X 5IN X 1IN DEEP) WITH EXPOSED RUSTED REBAR

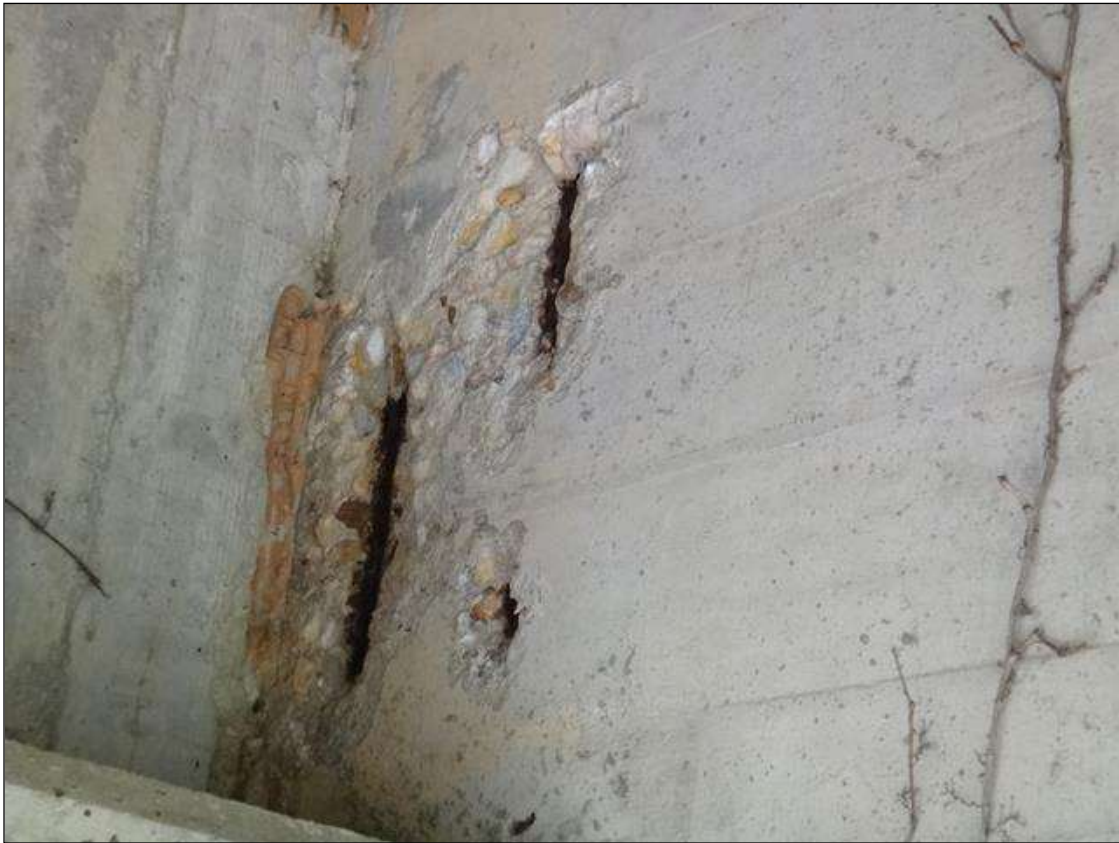
(PM) SPAN 3 BEAM 2 AT BENT 3, THREE (3) SPALLS (UP TO 18IN X 6IN X 1IN DEEP) WITH EXPOSED RUSTED REBAR

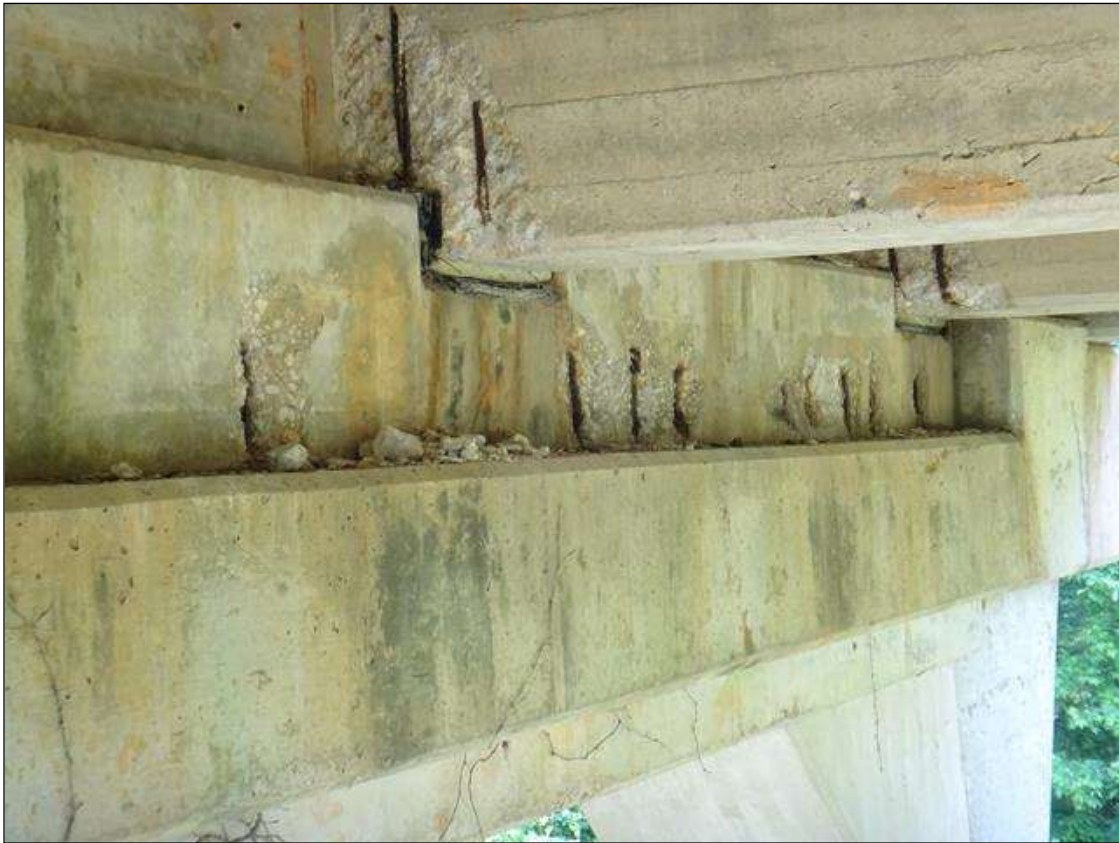
(PM) BENT 3 CAP WEST FACE, MULTIPLE SPALLS (UP TO 3FT X 10IN X 2IN DEEP) WITH EXPOSED RUSTED REBAR

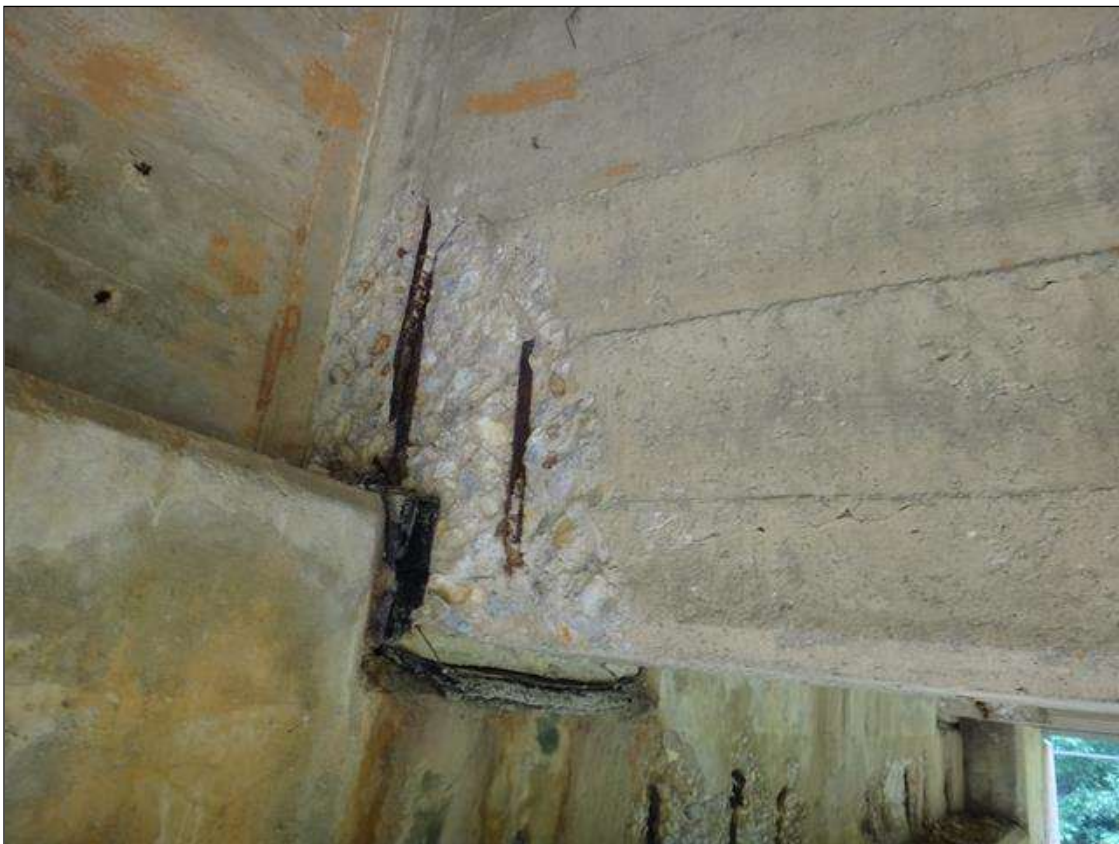
(PM) SPAN 3 BEAM 3 AT BENT 3, SPALL (16IN X 20IN X 2IN DEEP) WITH EXPOSED RUSTED REBAR, SECTION LOSS ON SECONDARY (50%)
