NC DEPARTMENT OF TRANSPORTATION
 DIVISION OF HIGHWAYS
 BRIDGE MANAGEMENT UNIT

PRIORITY MAINTENANCE ISSUED

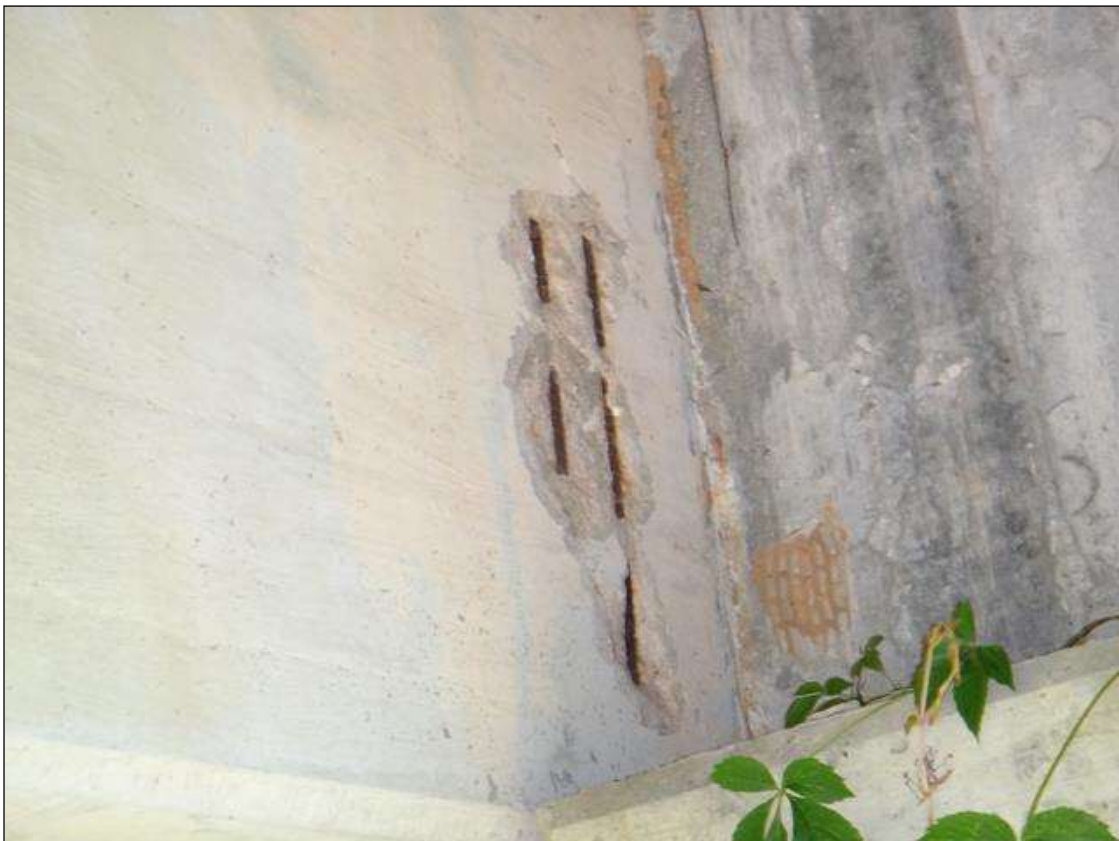
(PM) SPAN 4 BEAM 2 AT BENT 3, SPALL (18IN X 8IN X 1IN DEEP) WITH EXPOSED RUSTED REBAR

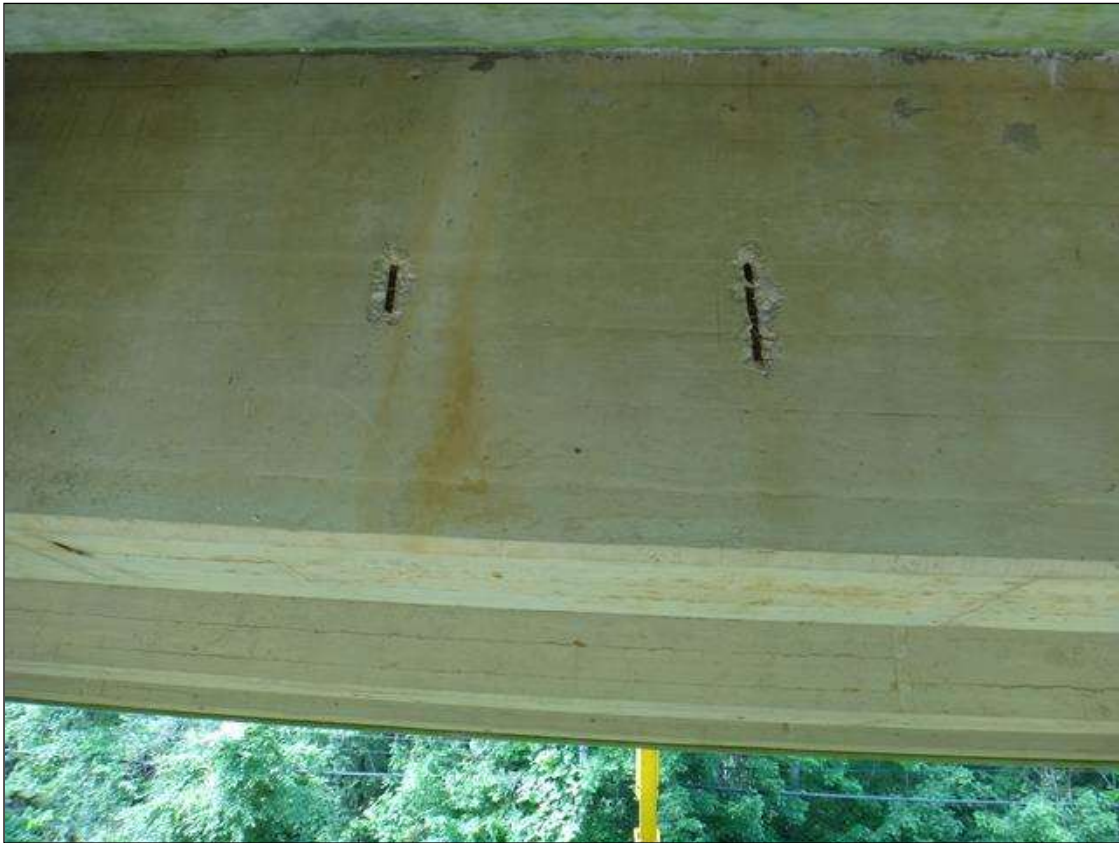
(PM) SPAN 4 BEAM 2 AT MIDSPAN, TWO (2) SPALLS (10IN X 3IN X 1IN DEEP) WITH EXPOSED RUSTED REBAR

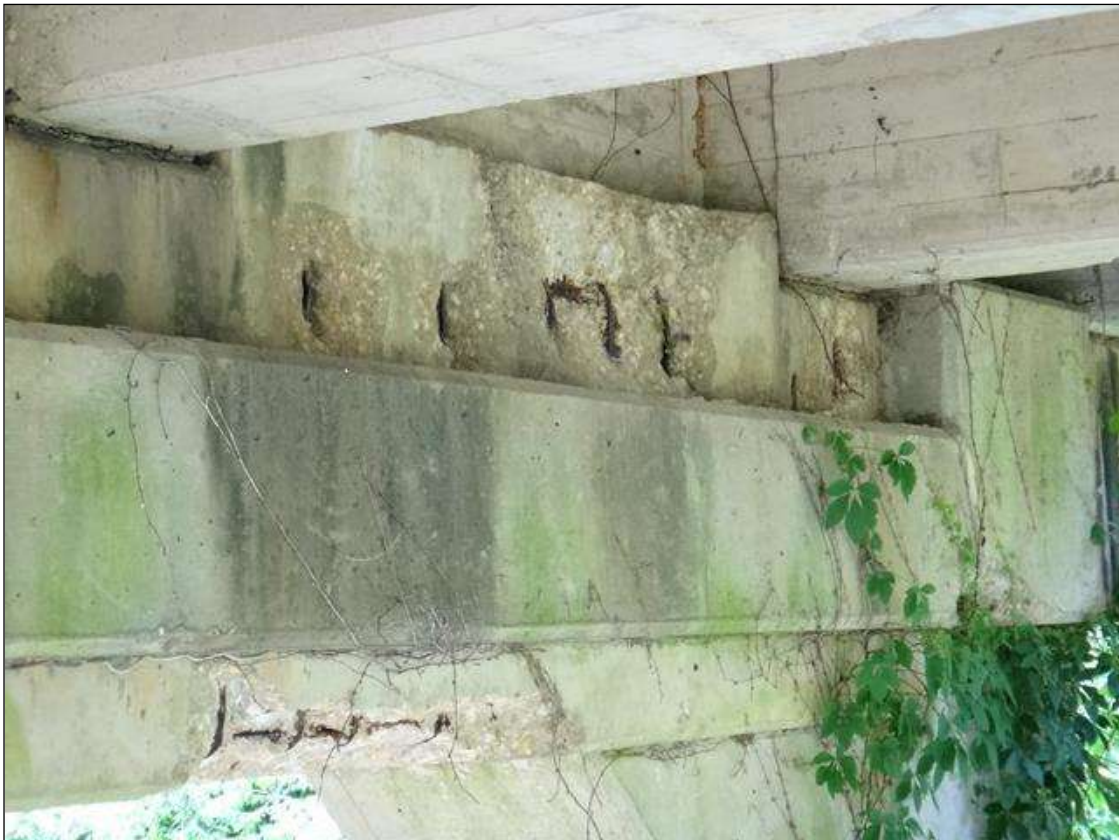
(PM) BENT 4 CAP WEST FACE, THREE (3) SPALLS (UP TO 4-1/2FT X 20IN X 3IN DEEP) WITH EXPOSED RUSTED REBAR, SECTION LOSS (NO MEASURABLE LOSS)

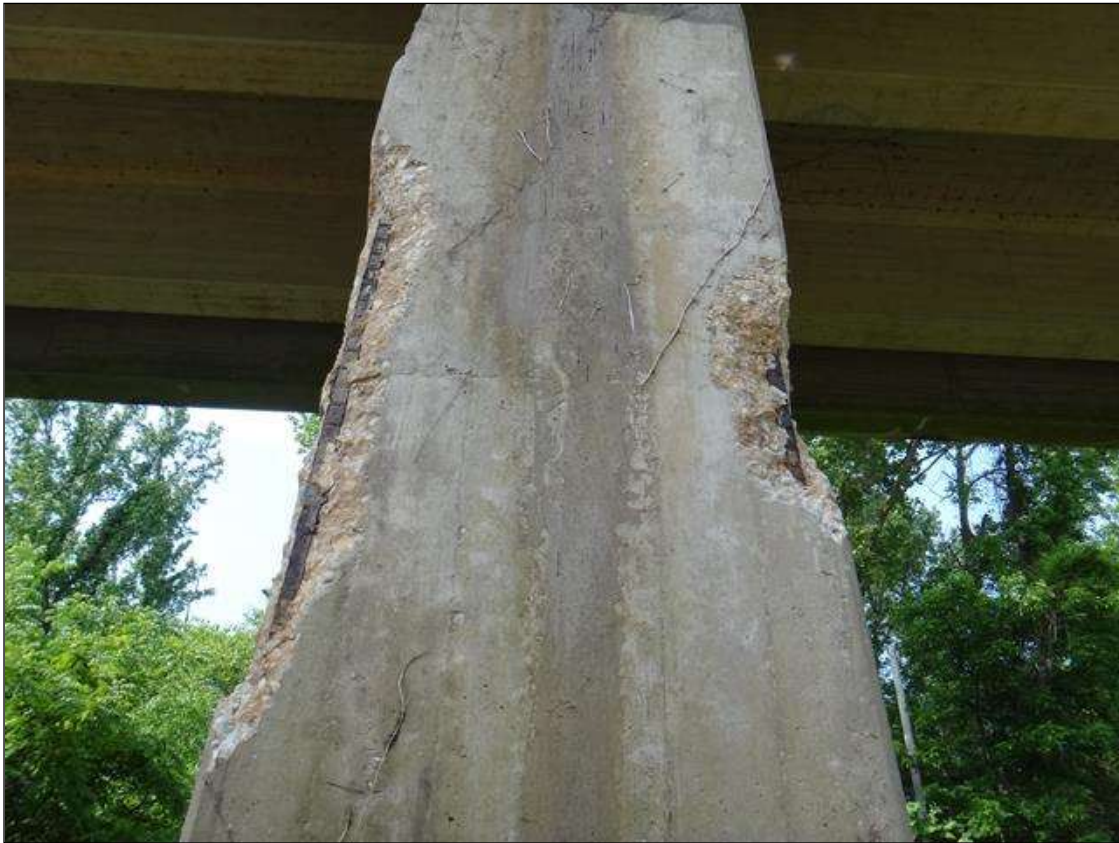
(PM) BENT 4 COLUMN 1 NORTH FACE, TWO (2) SPALLS (UP TO 5-1/2FT X 10IN X 3IN DEEP) WITH EXPOSED RUSTED REBAR, SECTION LOSS (NO MEASURABLE LOSS)

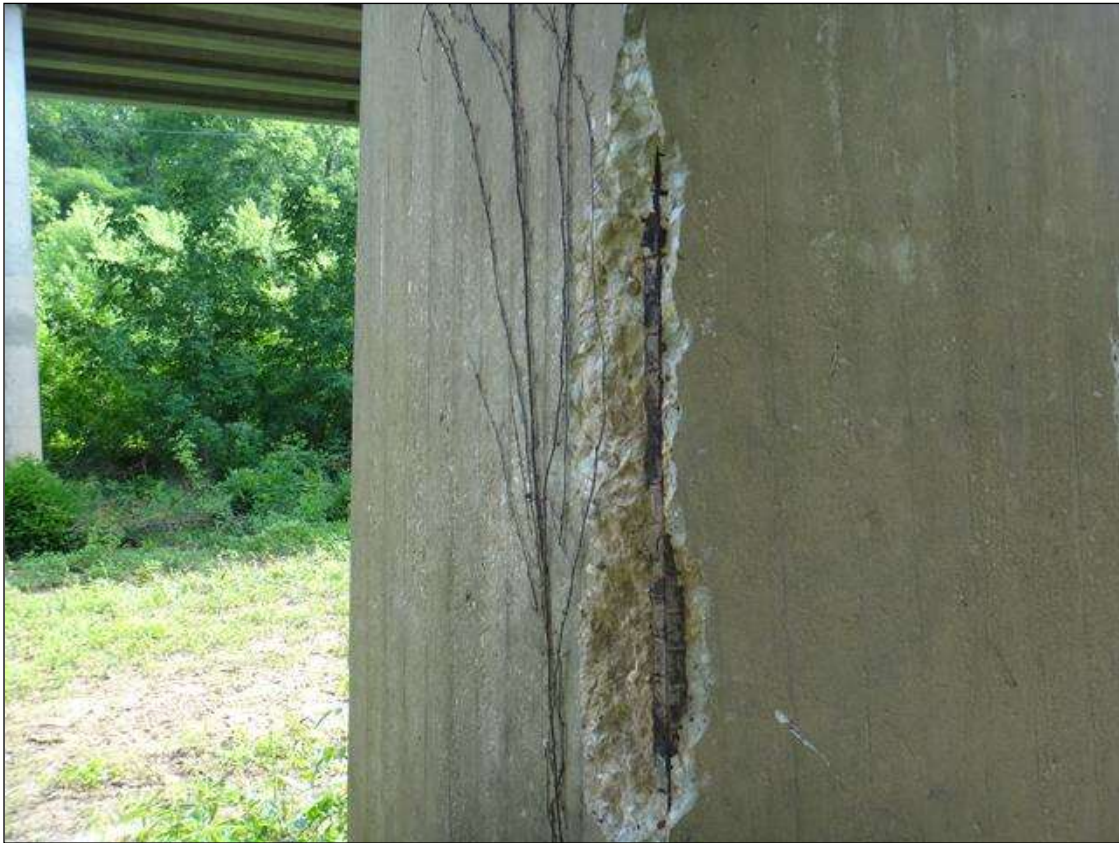
(PM) BENT 4 COLUMN 1 SOUTHWEST CORNER, SPALL (4FT X 8IN X 3IN DEEP) WITH EXPOSED RUSTED REBAR, SECTION LOSS (NO MEASURABLE LOSS)

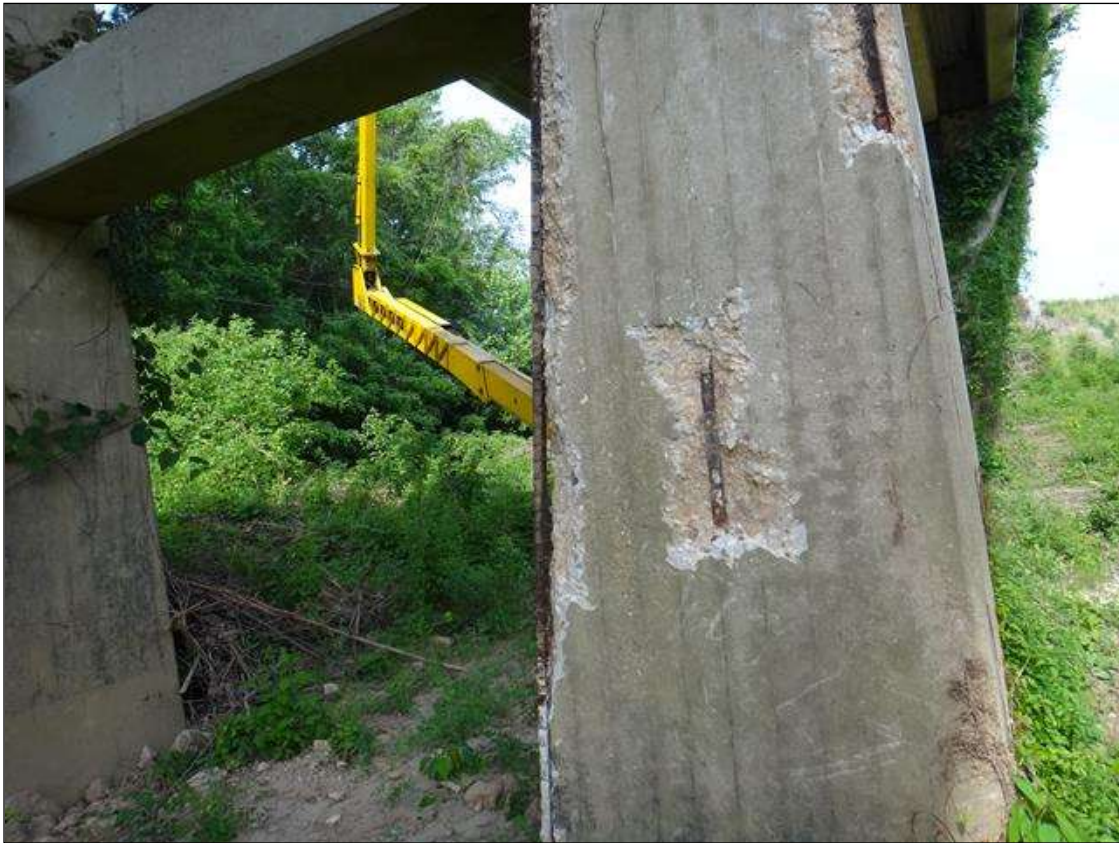
(PM) BENT 4 COLUMN 1 EAST FACE, THREE (3) SPALLS (UP TO 12FT X 14INX 4IN) WITH EXPOSED RUSTED REBAR, SECTION LOSS (NO MEASURABLE LOSS), DEBONDED REBAR

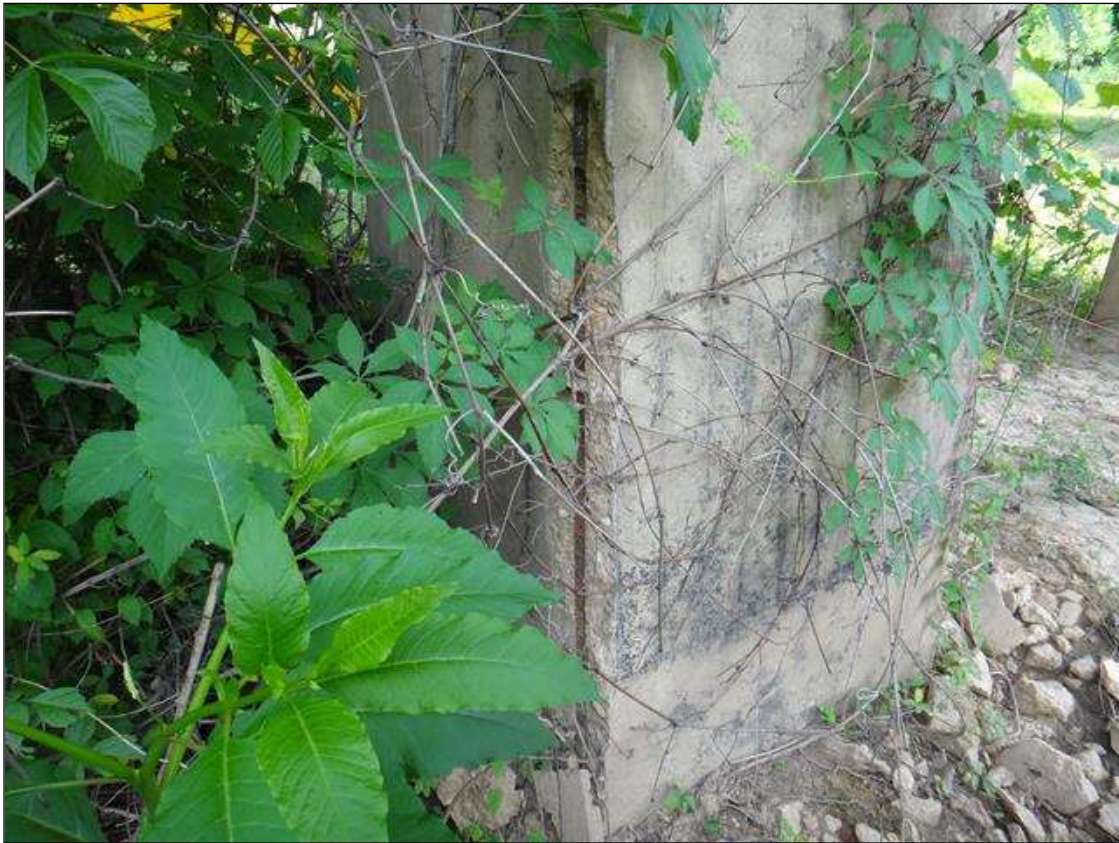
(PM) BENT 4 COLUMN 2 SOUTHEAST CORNER, SPALL (6FT X 8IN X 2IN DEEP) WITH EXPOSED RUSTED REBAR, SECTION LOSS (NO MEASURABLE LOSS)

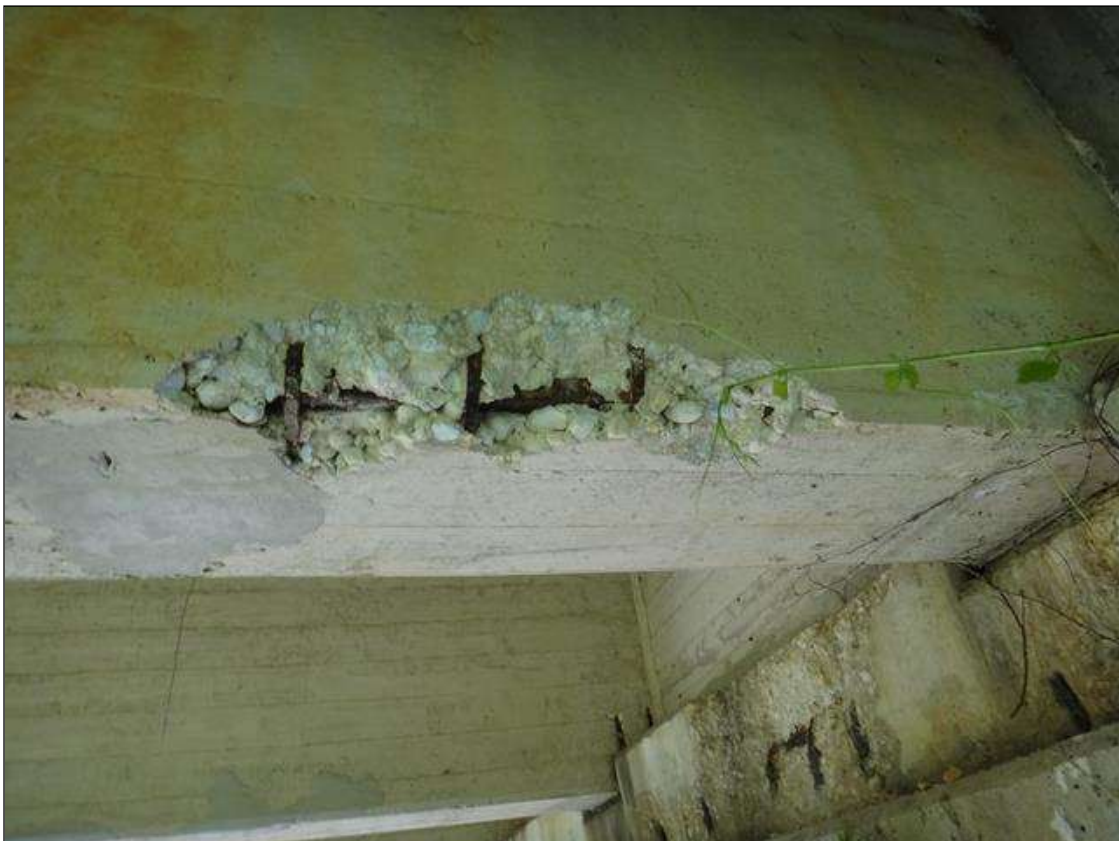
(PM) SPAN 4 BEAM 4 AT BENT 4, SPALL (2FT X 6IN X 4IN DEEP) WITH EXPOSED RUSTED REBAR

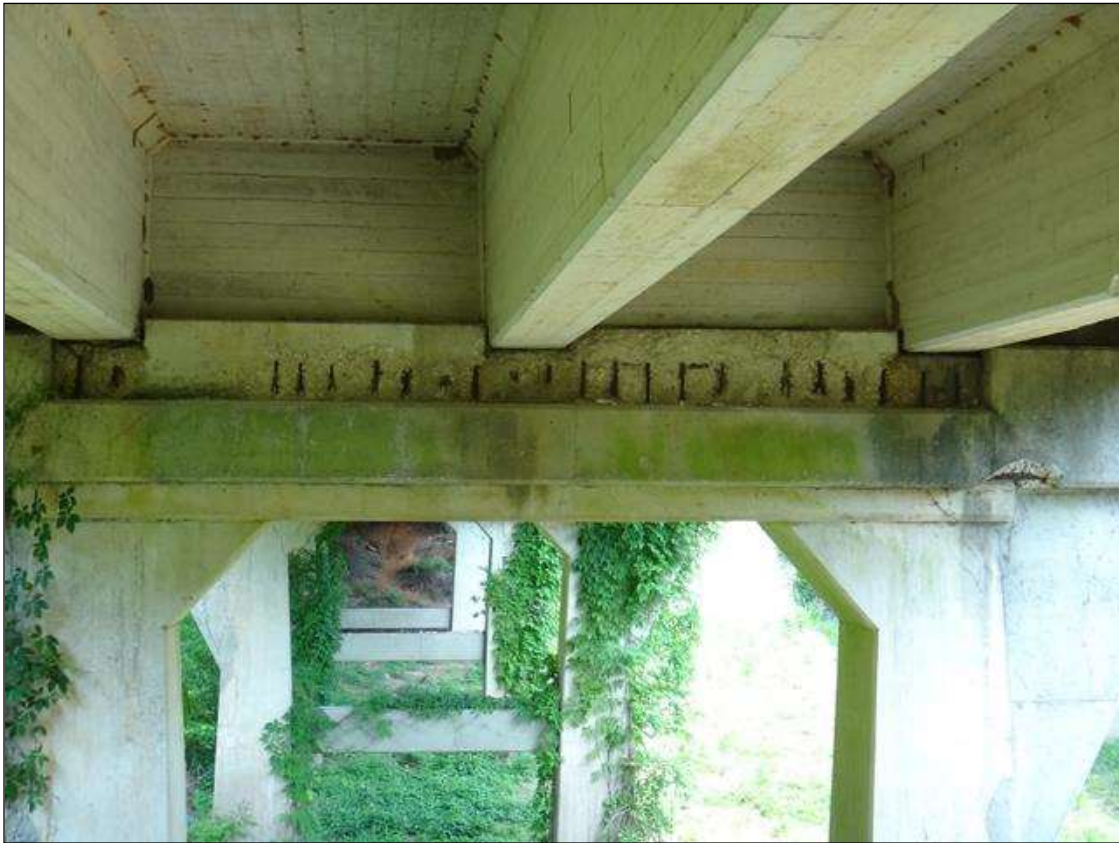
(PM) BENT 4 CAP EAST FACE, MULTIPLE SPALLS (UP TO 17FT X 20IN X 3IN DEEP) WITH EXPOSED RUSTED REBAR, SECTION LOSS (NO MEASURABLE LOSS)

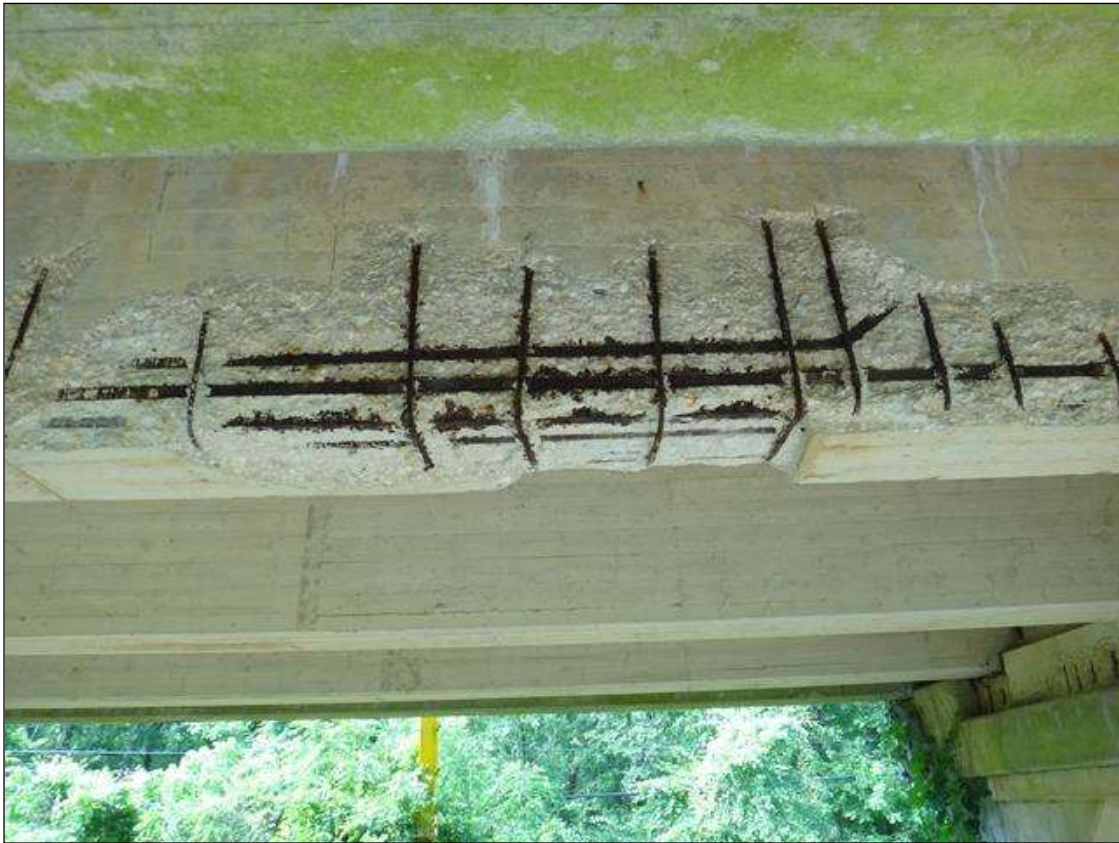
(PM) SPAN 5 BEAM 2 AT WEST HALF, SPALL (15FT X 2FT X 3IN DEEP) WITH EXPOSED RUSTED REBAR, SECTION LOSS (NO MEASURABLE LOSS), DEBONDED REBAR

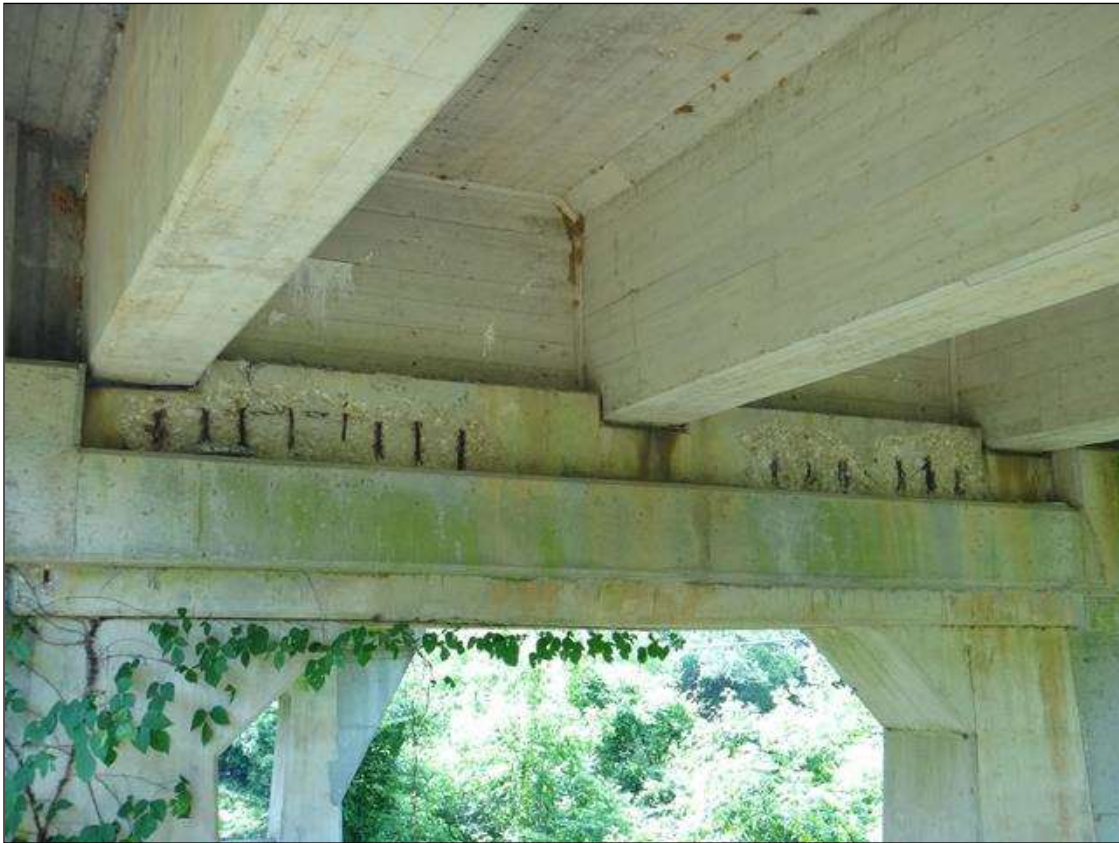
(PM) BENT 5 CAP WEST FACE, TWO (2) SPALLS (6FT X UP TO 20IN X 3IN DEEP) WITH EXPOSED RUSTED REBAR, SECTION LOSS (NO MEASURABLE LOSS)

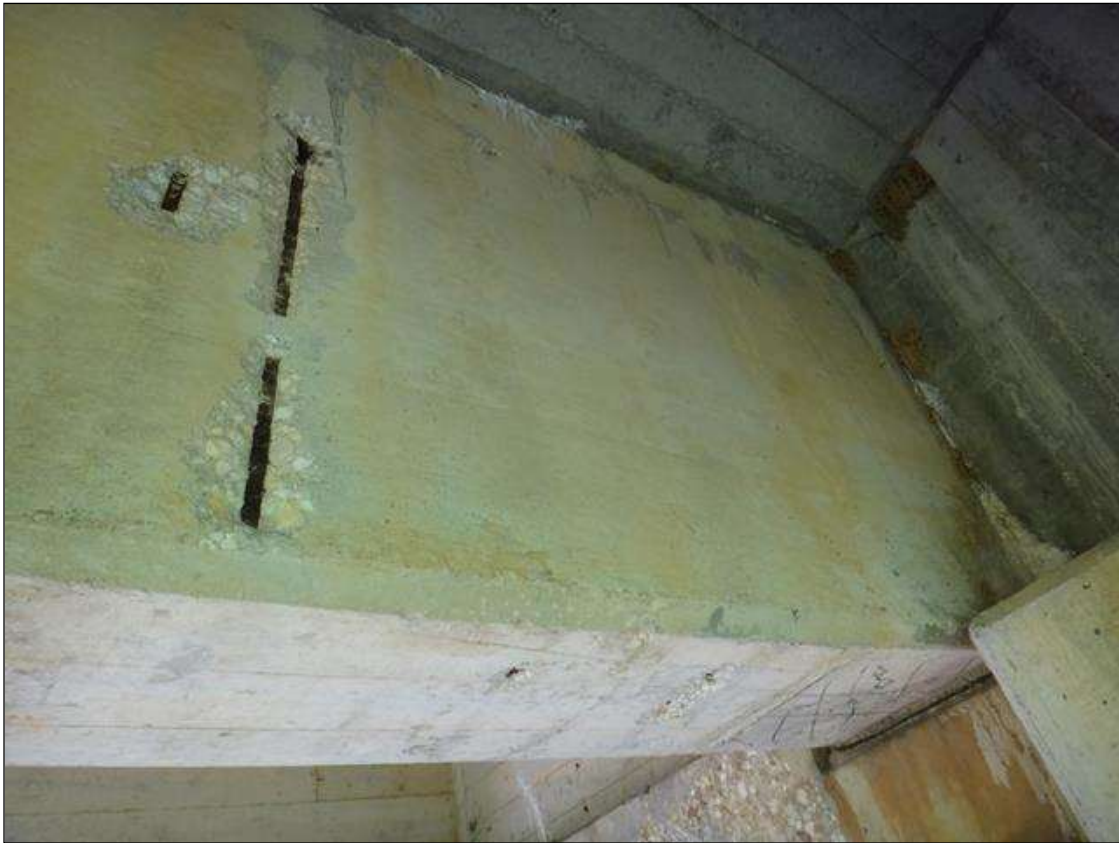
(PM) SPAN 5 BEAM 4 AT BENT 5, MULTIPLE SPALLS (UP TO 24IN X 4IN X 1IN DEEP) WITH EXPOSED RUSTED REBAR AND SECTION LOSS, DELAMINATION (18IN X 18IN)

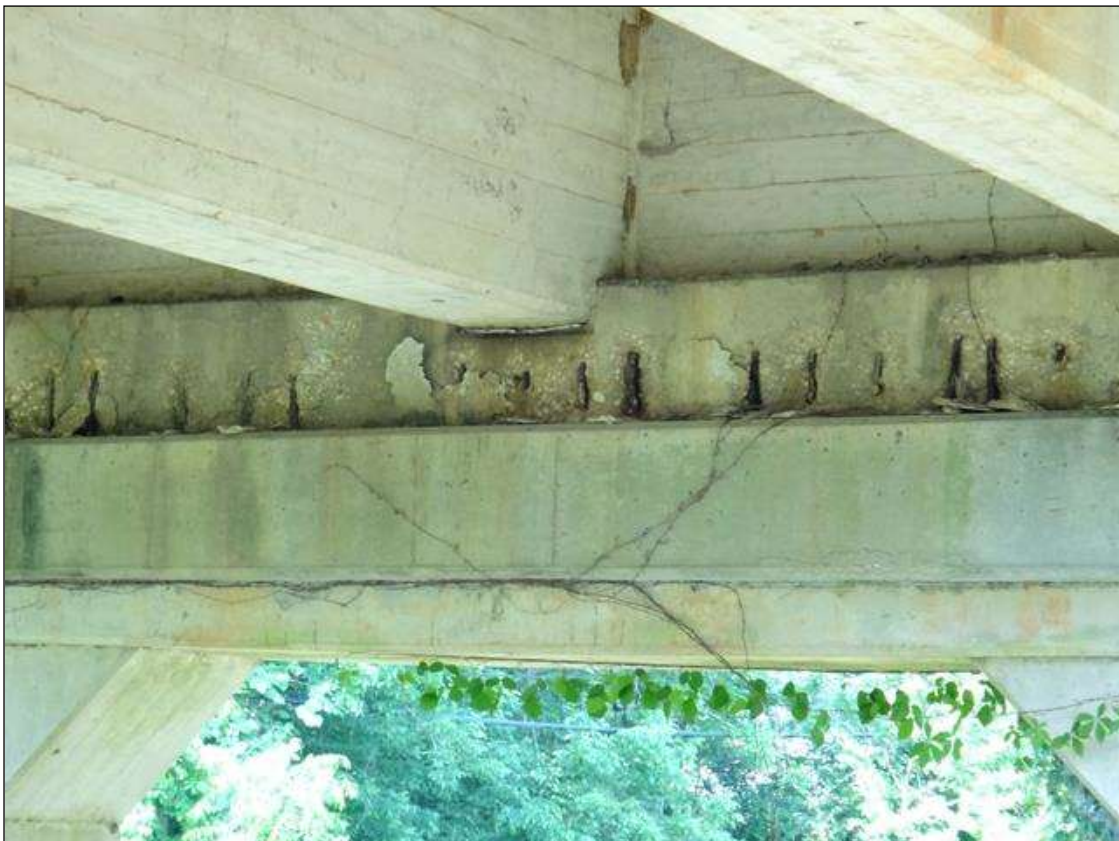
(PM) BEAM 5 CAP EAST FACE, MULTIPLE SPALLS (UP TO 20IN X 12IN)

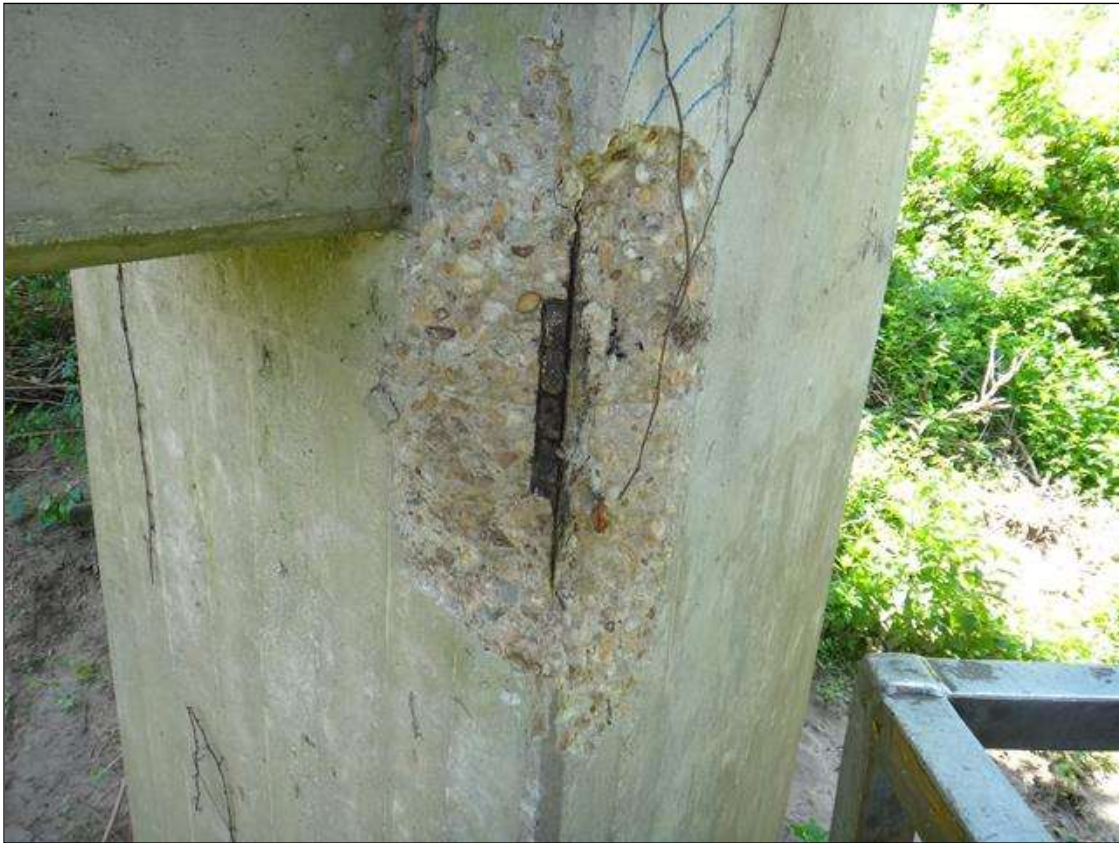
(PM) BENT 6 COLUMN 2 NORTHWEST CORNER, SPALL (2FT X 18IN X 3-1/2IN DEEP) WITH EXPOSED RUSTED REBAR, SECTION LOSS (NO MEASURABLE LOSS)

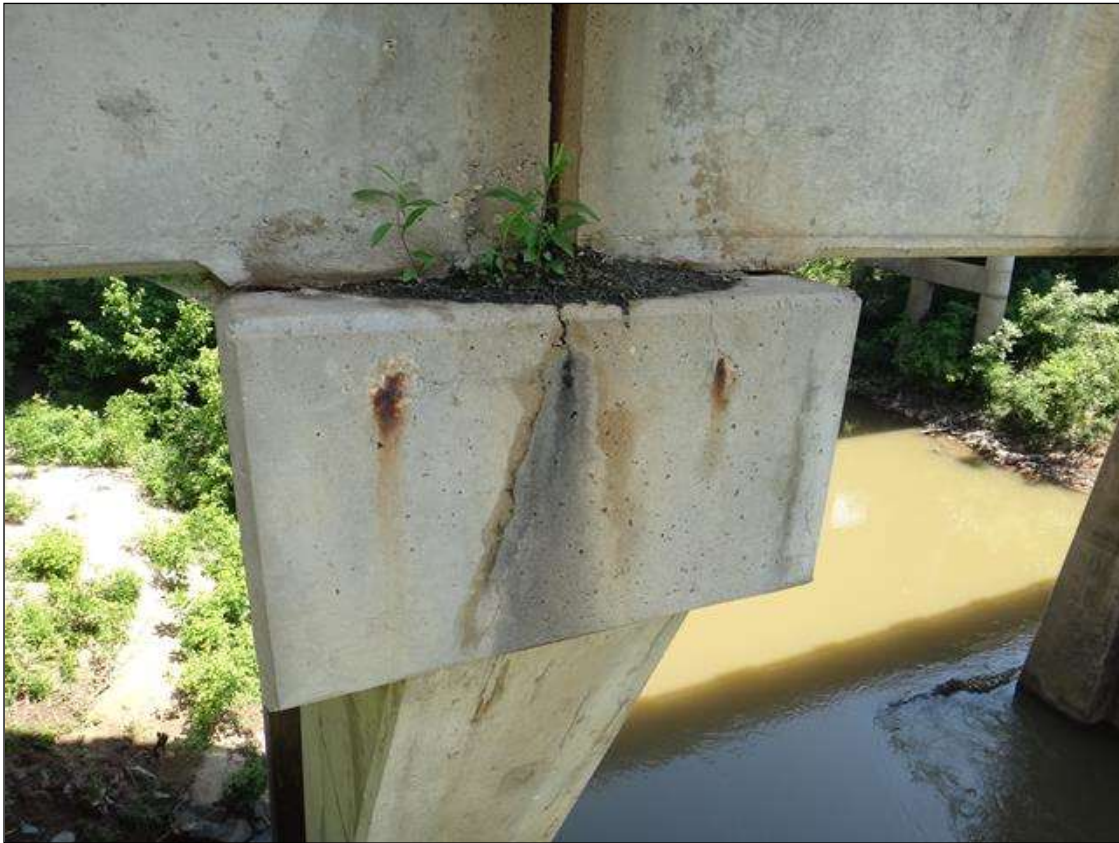
(PM) BENT 7 CAP AT SOUTH END, TWO (2) POPOUTS (3IN X 1/2IN) WITH EXPOSED RUSTED REBAR, THREE (3) VERTICAL CRACKS (FULL HEIGHT X HAIRLINE), AND DEBRIS

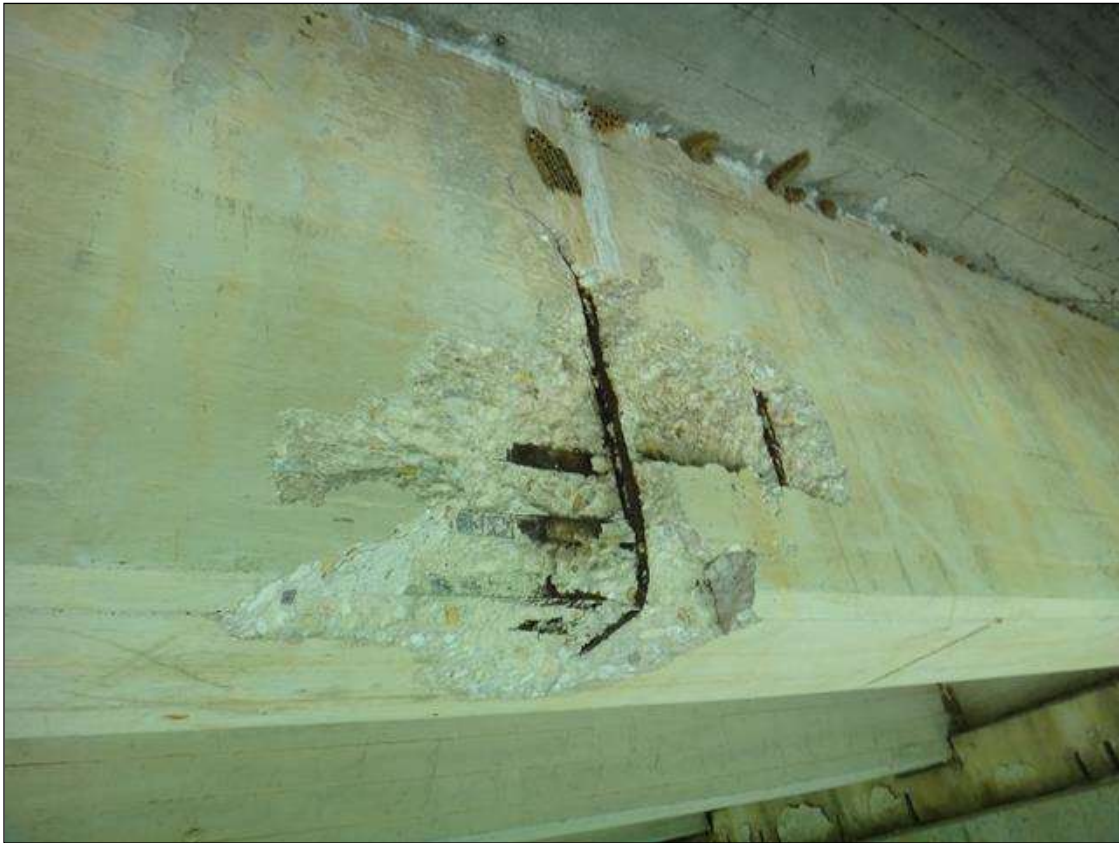
(PM) SPAN 7 BEAM 2 AT 12FT FROM BENT 6, SPALL (3FT X 3FT X 3IN DEEP) WITH EXPOSED RUSTED REBAR, SECTION LOSS (NO MEASURABLE LOSS)

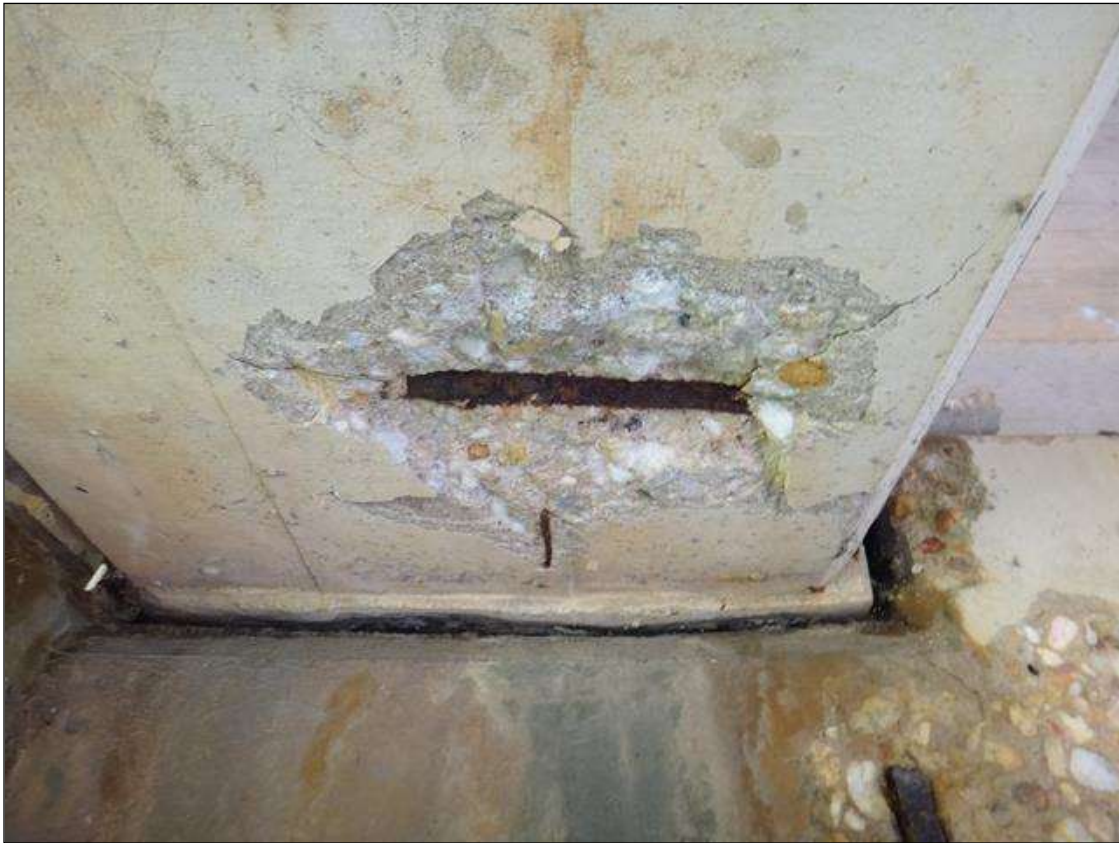
(PM) SPAN 7 BEAM 4 AT BENT 6, SPALL ON BOTTOM FACE (8IN X 6IN X 2IN DEEP) WITH EXPOSED RUSTED REBAR

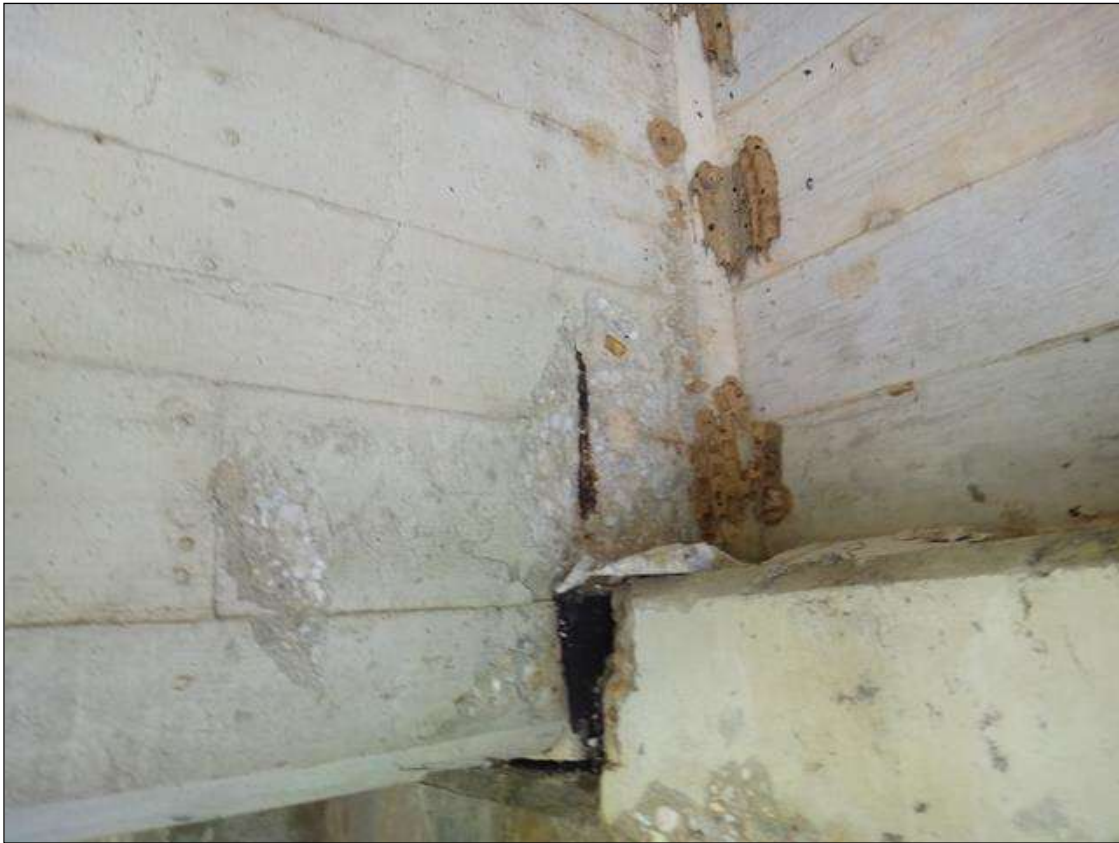
(PM) SPAN 7 BEAM 4 AT BENT 6, SPALL ON NORTH FACE (11IN X 6IN X 1IN DEEP) WITH EXPOSED RUSTED REBAR

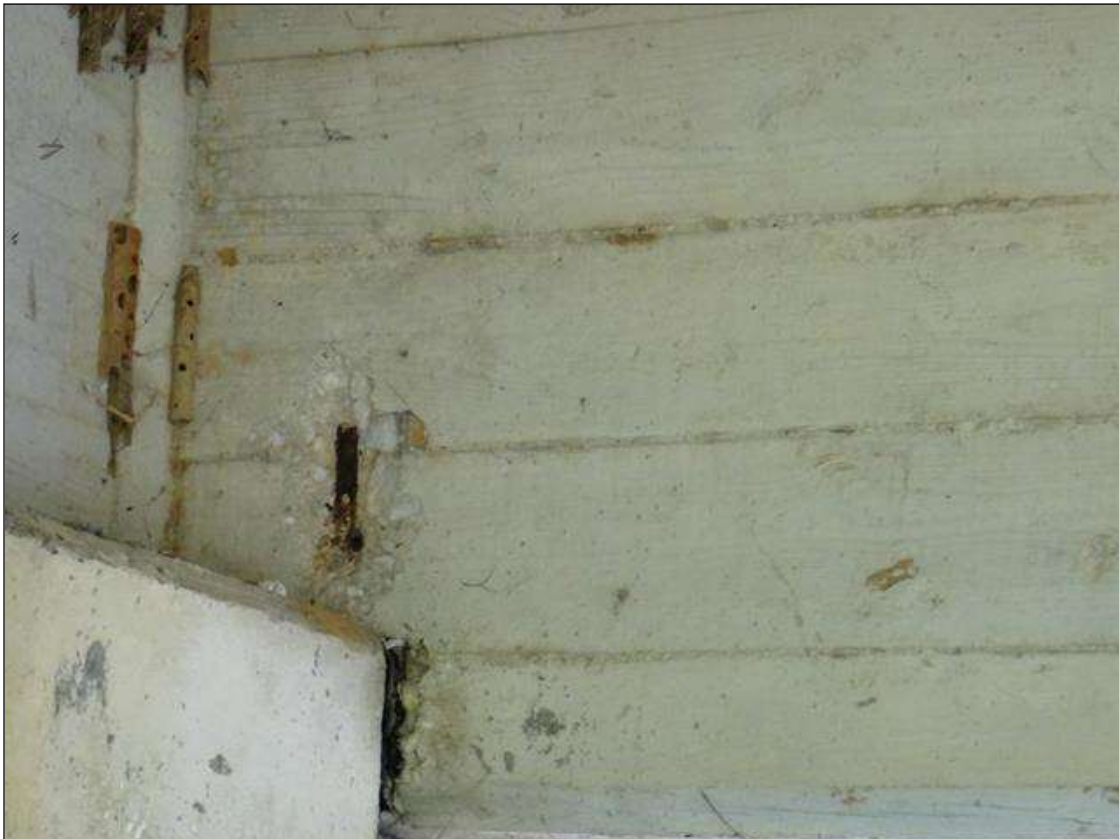
(PM) SPAN 7 BEAM 2 AT BENT 6, SPALL (6IN DIAMETER X 1IN DEEP) WITH EXPOSED RUSTED REBAR

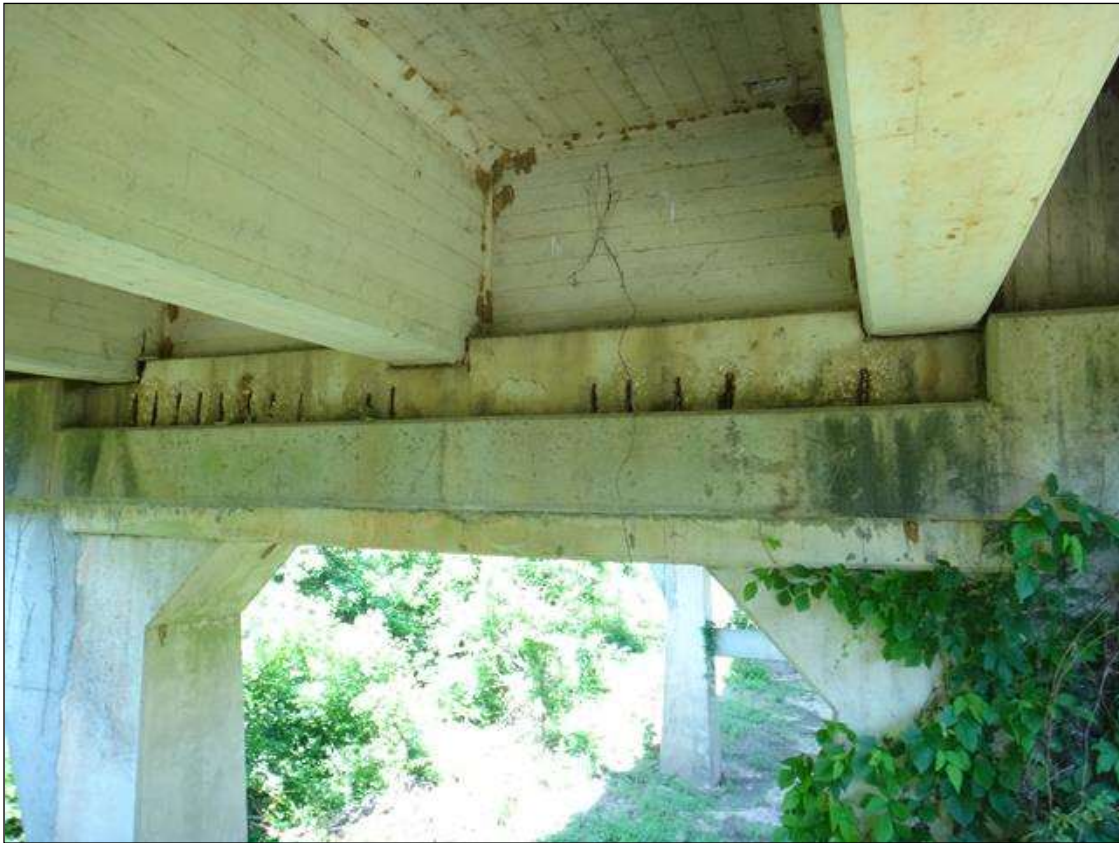
(PM) BENT 6 CAP EAST FACE, MULTIPLE SPALLS/DELAMINATIONS (UP TO 5-1/2FT X 16IN X 2IN) WITH EXPOSED RUSTED REBAR, SECTION LOSS (NO MEASURABLE LOSS)

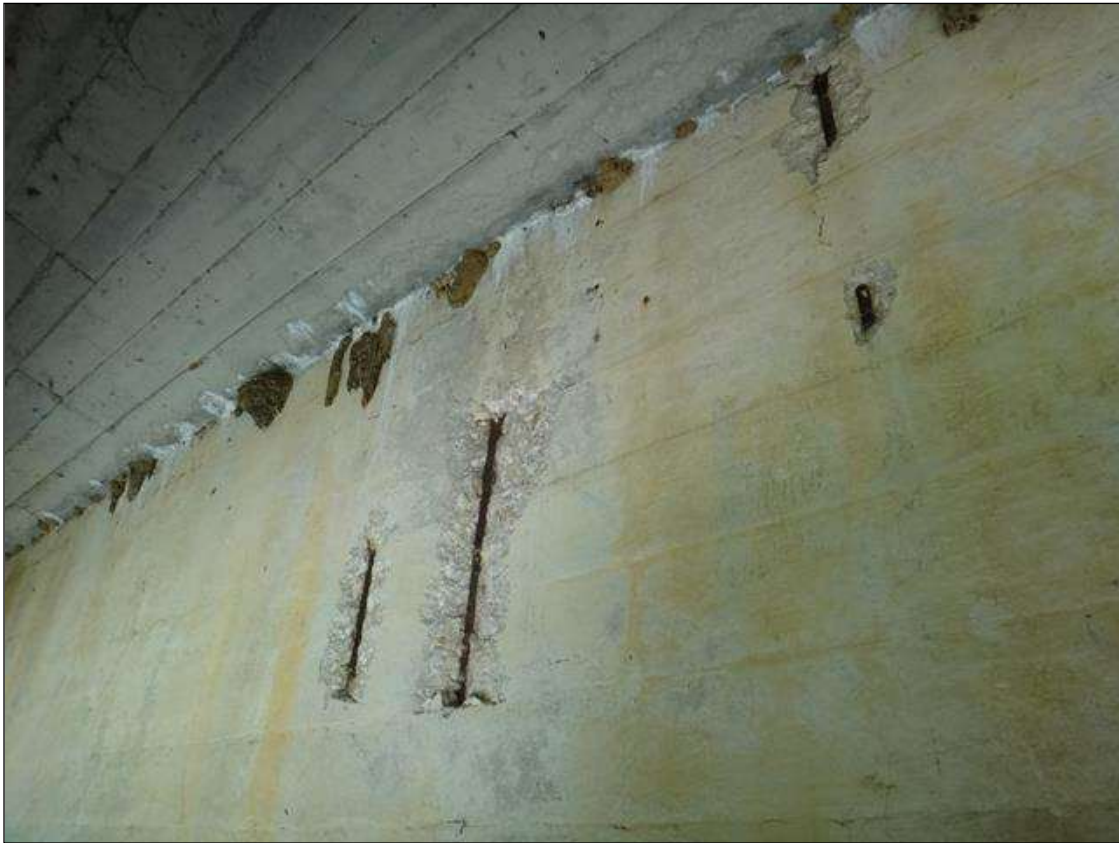
(PM) SPAN 7 BEAM 2 AT 12FT FROM BENT 6, MULTIPLE SPALLS (UP TO 18IN X 12IN X 1IN) WITH EXPOSED RUSTED REBAR AND SECTION LOSS, ADJACENT DELAMINATION

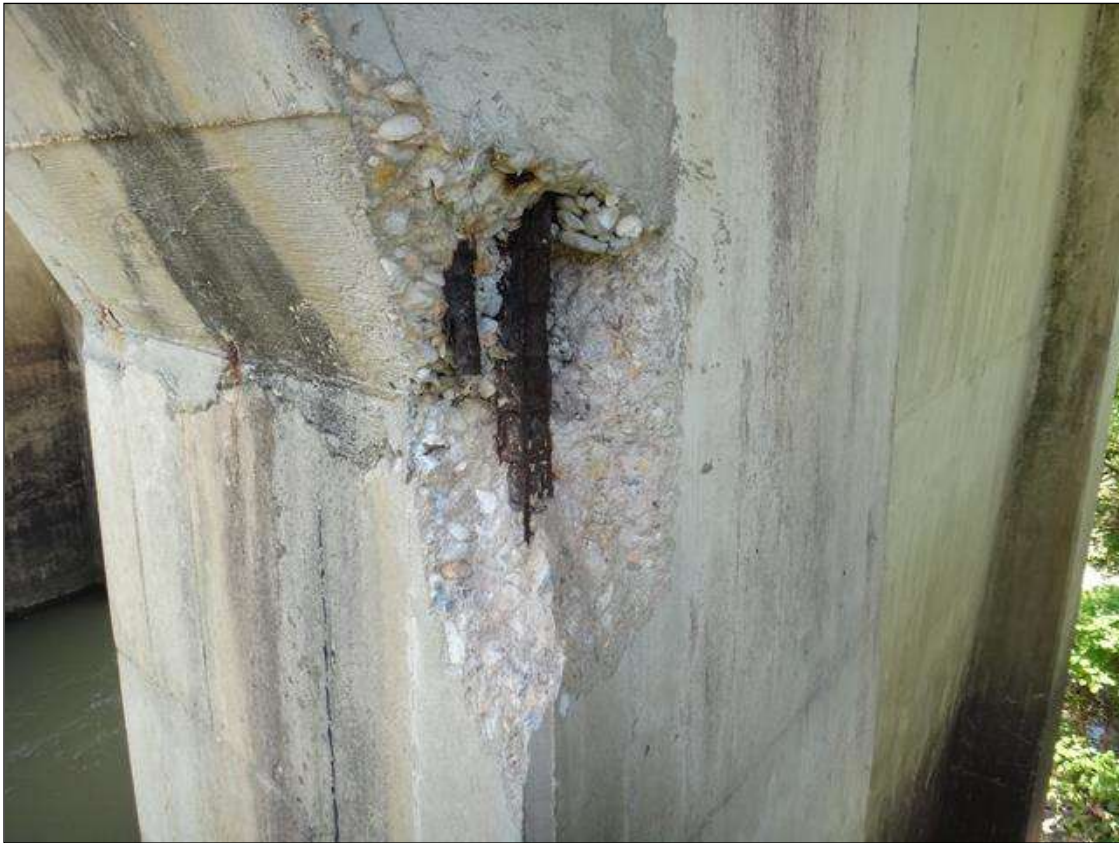
(PM) BENT 7 COLUMN 1 NORTHWEST CORNER AT HAUNCH, SPALL (24IN X 8IN X 4IN) WITH EXPOSED RUSTED REBAR, SECTION LOSS (NO MEASURABLE LOSS)

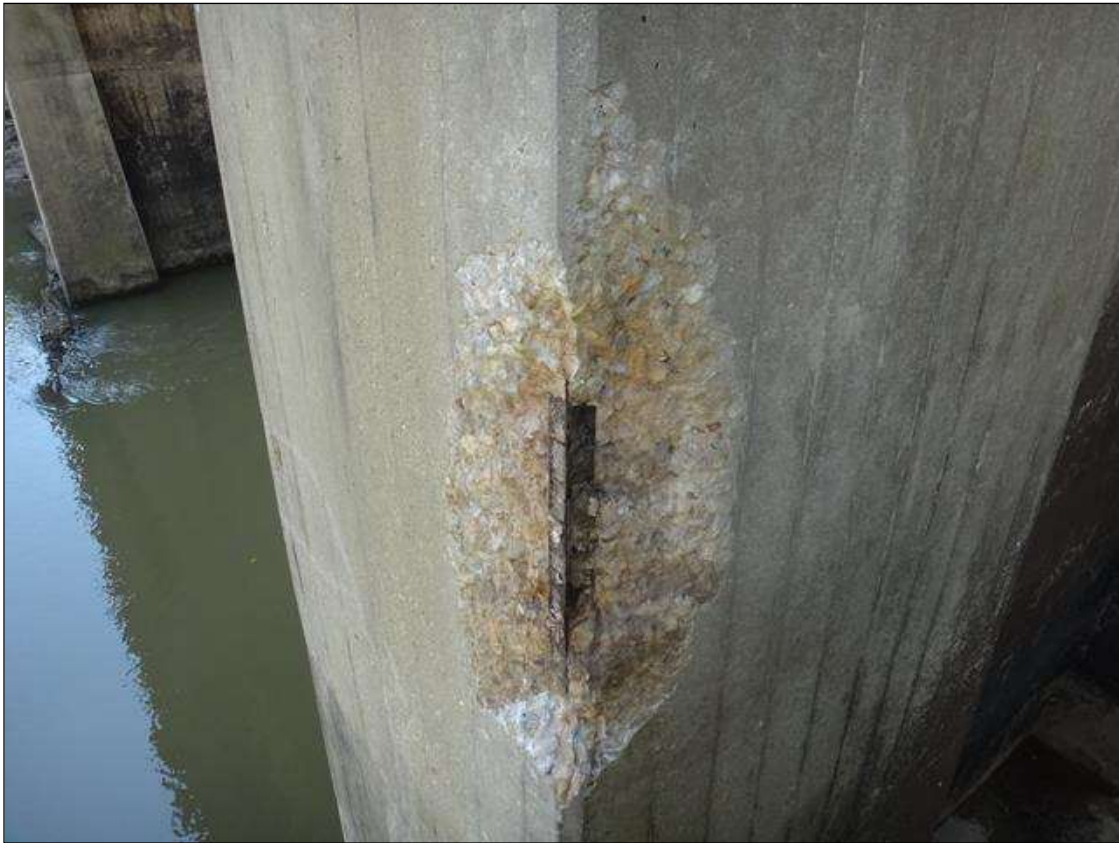
(PM) BENT 7 COLUMN 1 NORTHWEST CORNER AT 18FT FROM BOTTOM, SPALL (34IN X 9IN X 3IN DEEP) WITH EXPOSED RUSTED REBAR, SECTION LOSS (NO MEASURABLE LOSS)
