NC DEPARTMENT OF TRANSPORTATION
 DIVISION OF HIGHWAYS
 BRIDGE MANAGEMENT UNIT

PRIORITY MAINTENANCE ISSUED

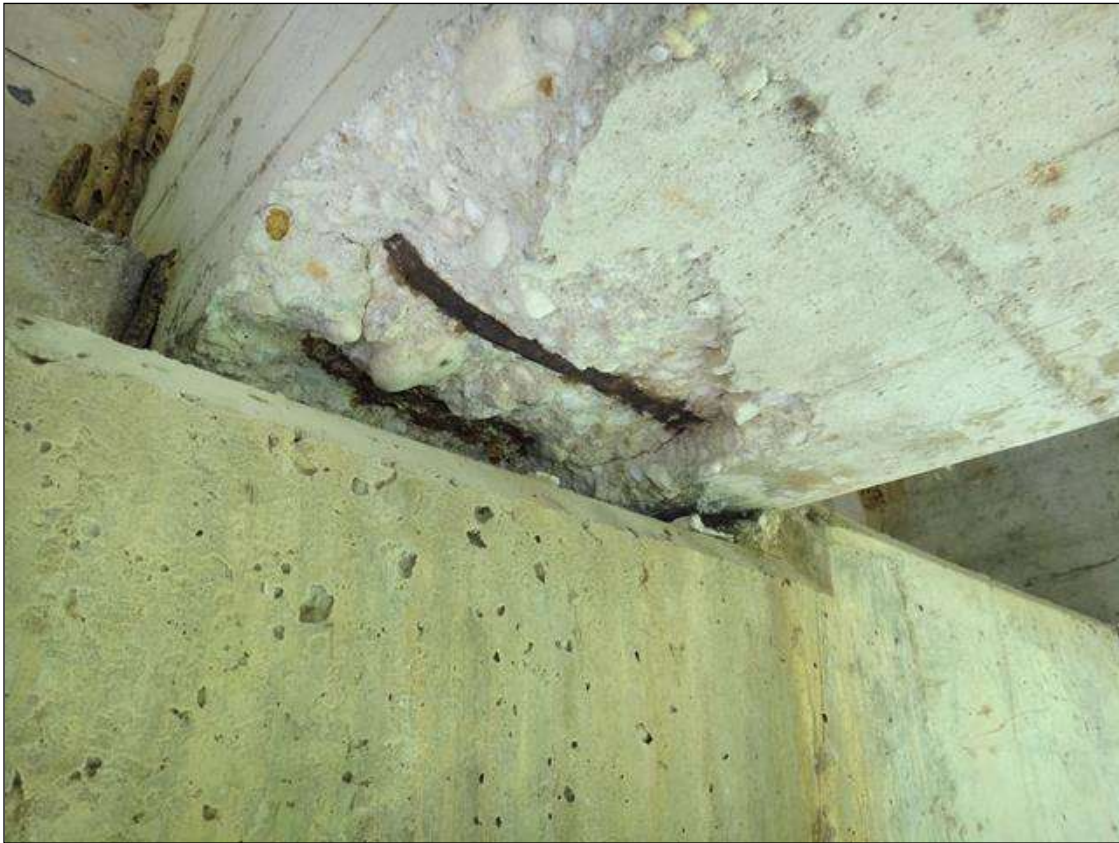
(PM) SPAN 7 BEAM 4 AT BENT 7, SPALL (16IN X 16IN X 2IN DEEP) WITH EXPOSED RUSTED REBAR AND ADJACENT DELAMINATION

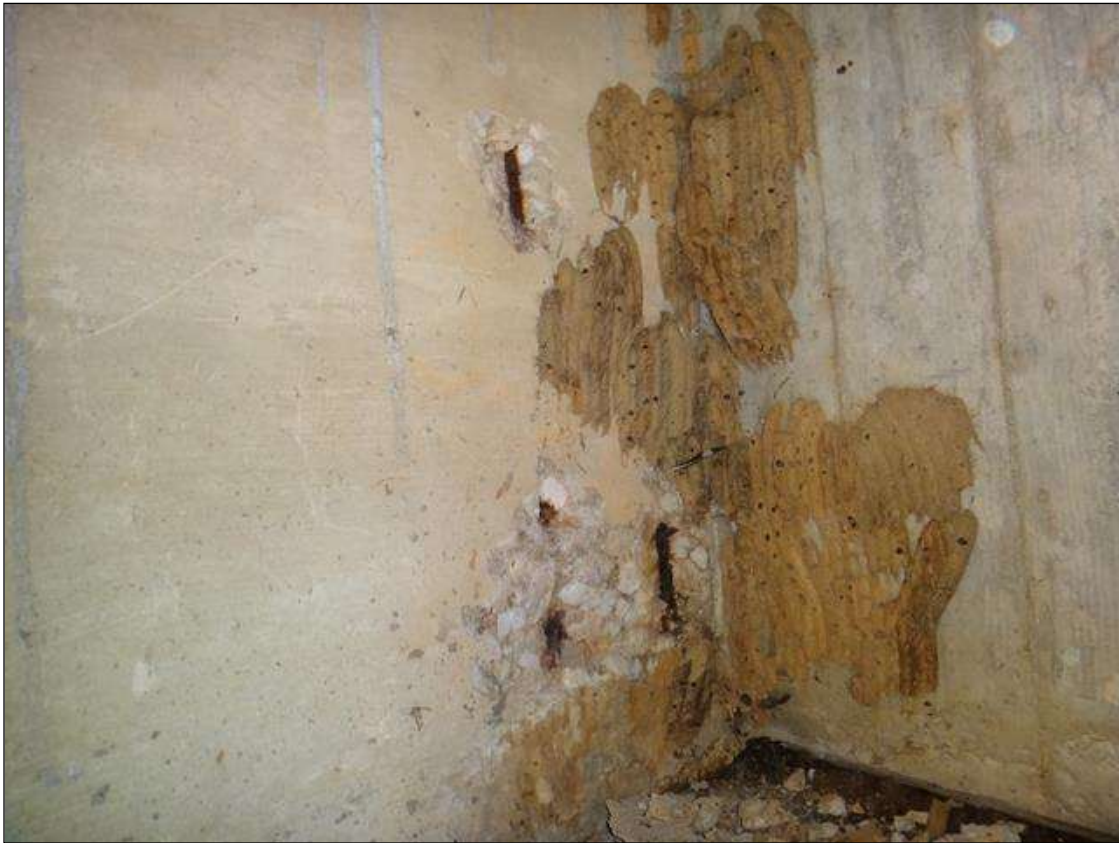
(PM) SPAN 8 BEAM 2 AT BENT 7, TWO (2) SPALLS (UP TO 12IN X 8IN X 1IN DEEP) WITH EXPOSED RUSTED REBAR

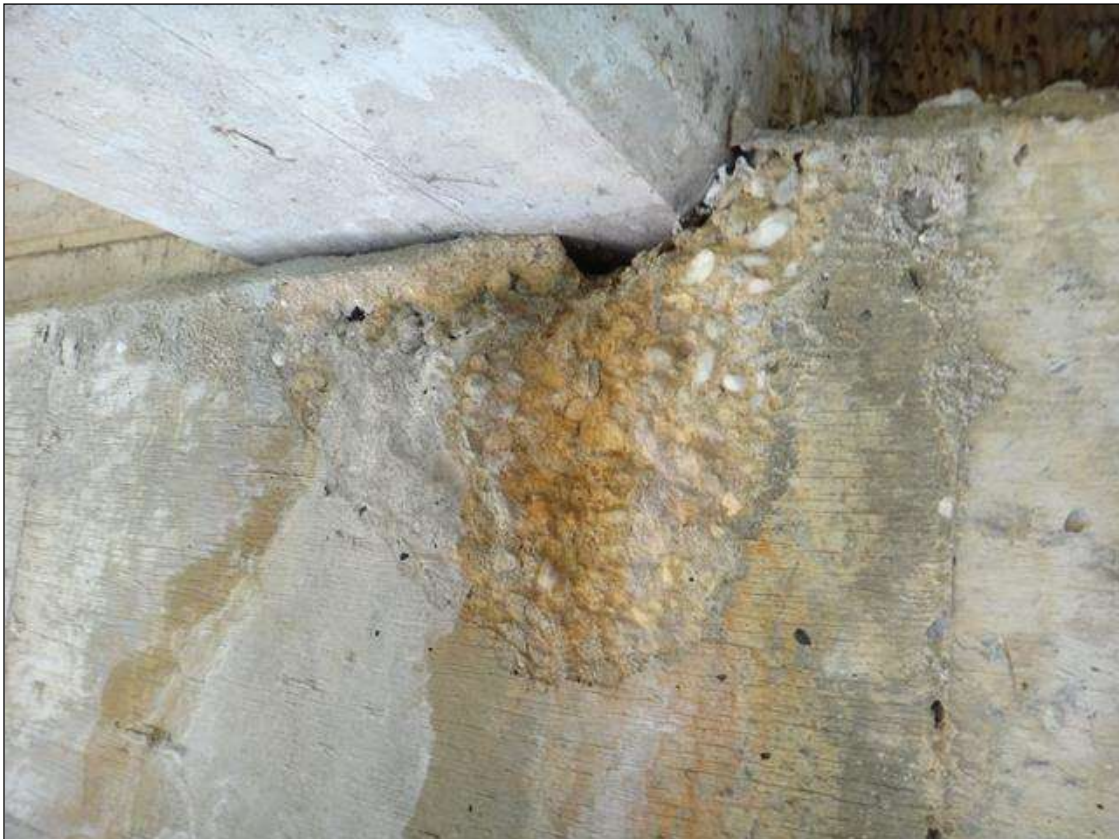
BENT 7 CAP EAST FACE BELOW BEAM 2, SPALL (16IN X 11IN X 2IN DEEP)

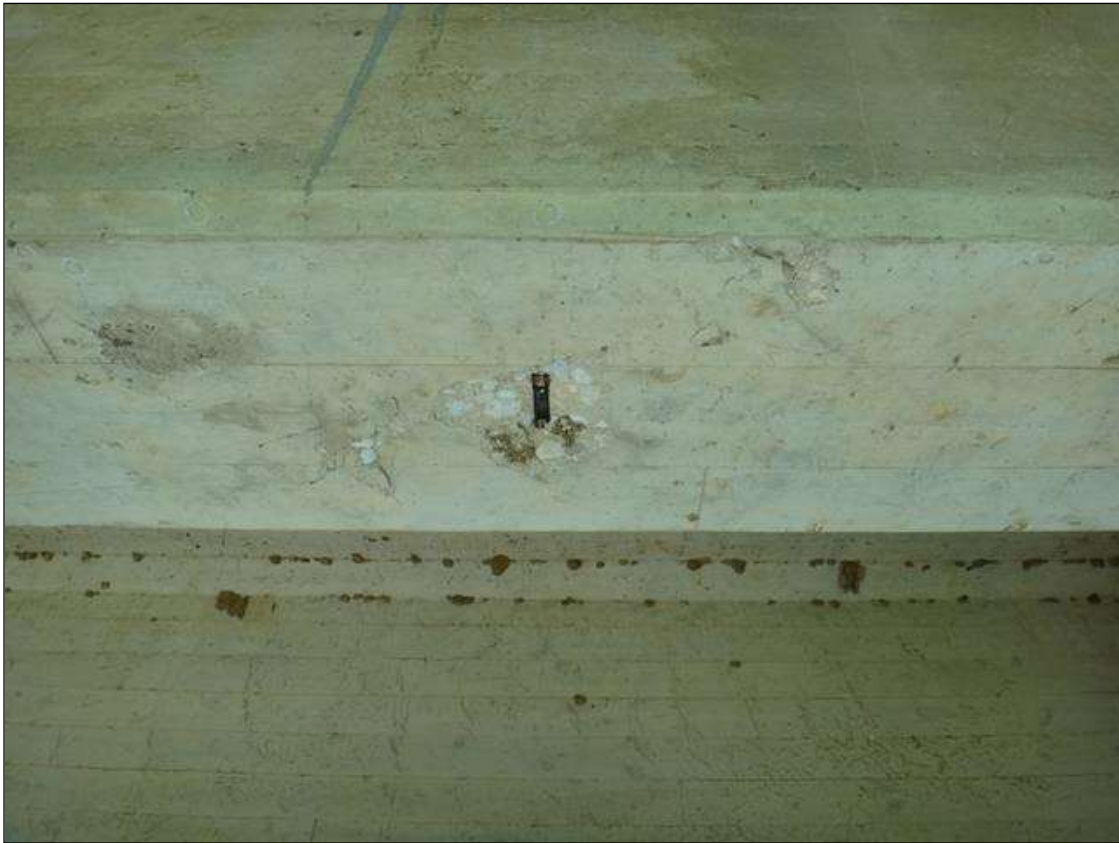
(PM) SPAN 8 BEAM 2 AT 8FT FROM BENT 7, SPALL (6IN DIAMETER X 1IN DEEP) WITH EXPOSED RUSTED REBAR AND ADJACENT DELAMINATION

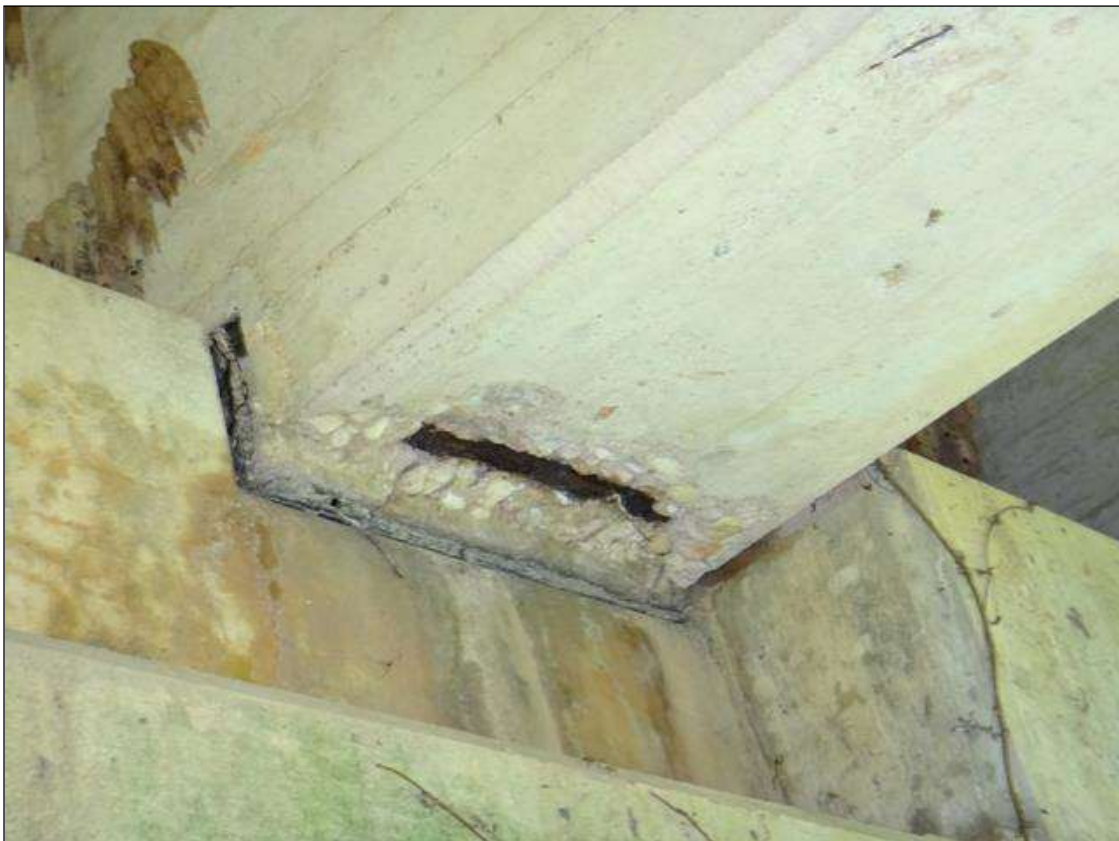
(PM) SPAN 10 BEAM 2 AT BENT 9, SPALL (18IN X 5IN X 2-1/2IN DEEP) WITH EXPOSED RUSTED REBAR

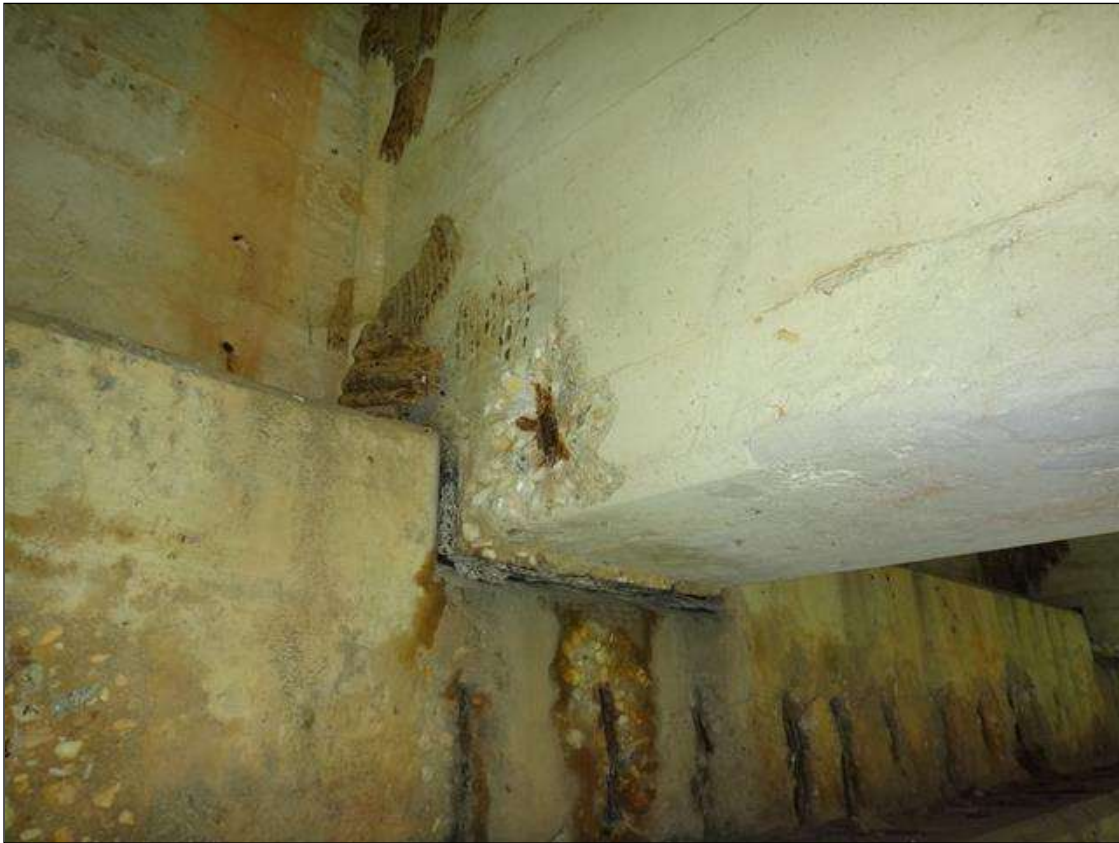
(PM) SPAN 10 BEAM 4 AT BENT 9, SPALL (6IN DIAMETER X 1-1/2IN DEEP) WITH EXPOSED RUSTED REBAR, SECTION LOSS (NO MEASURABLE LOSS)

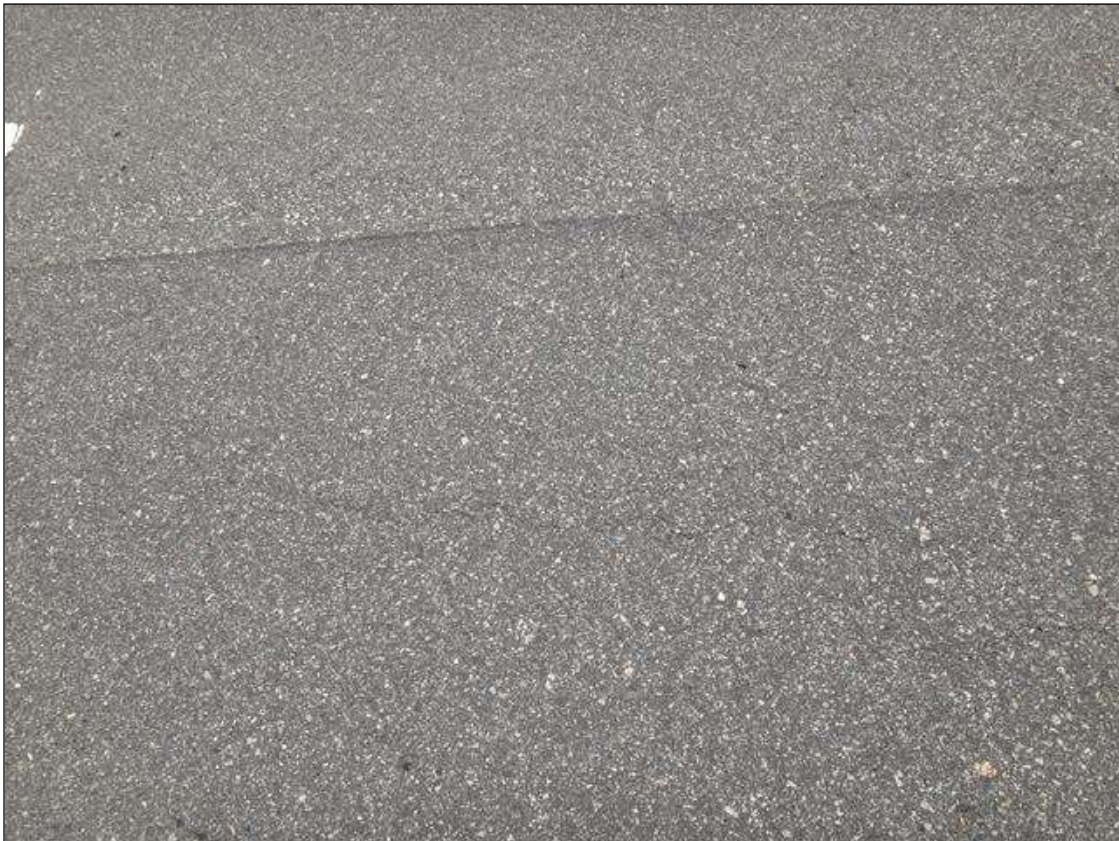
SPAN 10 ASPHALT WEARING SURFACE RIGHT LANE AT END BENT 2, LONGITUDINAL CRACK (8FT X 1/16IN)

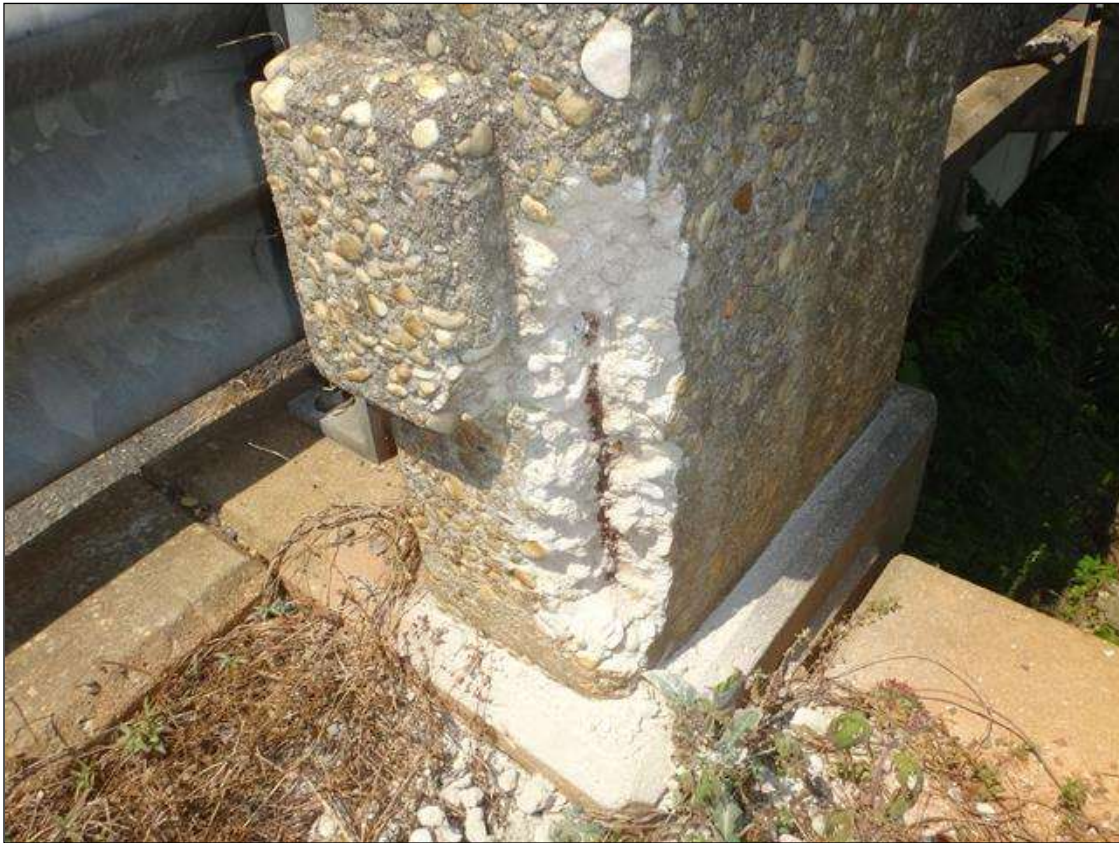
NORTH RAIL END POST AT END BENT 2, SPALL (18IN X 4IN X 2IN DEEP) WITH EXPOSED RUSTED REBAR

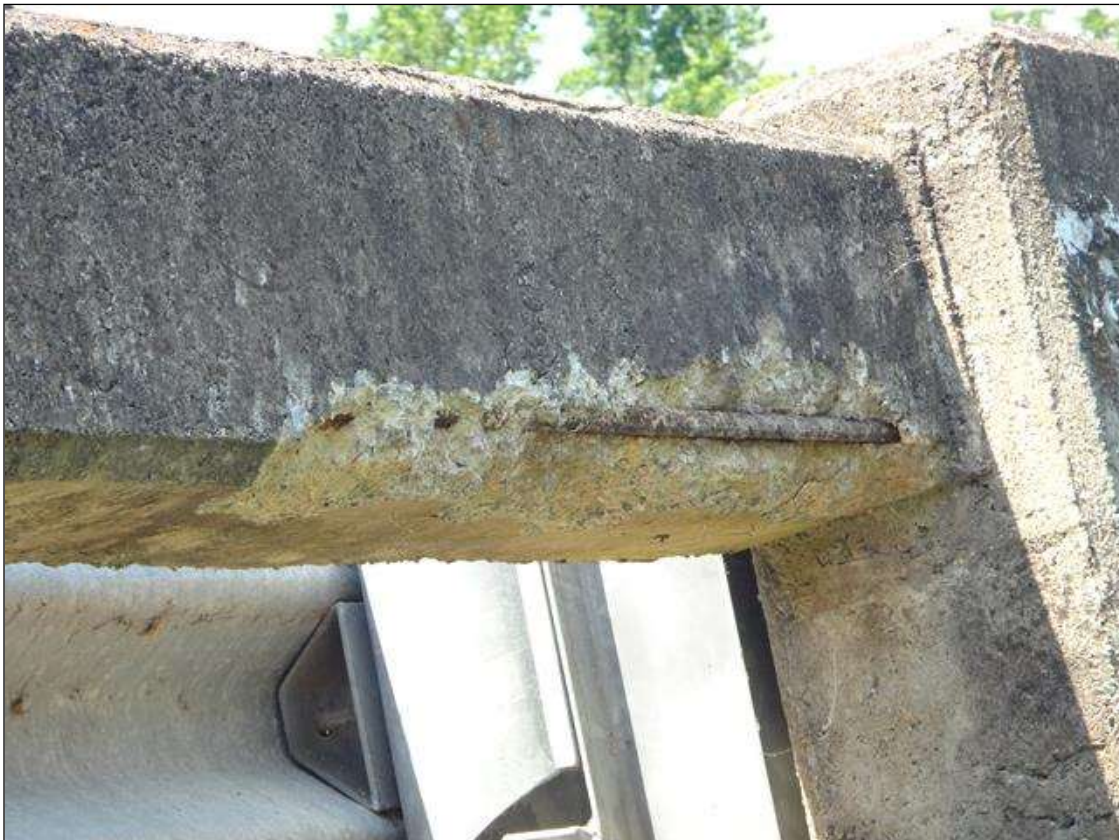
NORTH RAIL AT 16FT FROM END BENT 2, SPALL (3FT X 6IN X 2IN DEEP) WITH EXPOSED RUSTED REBAR

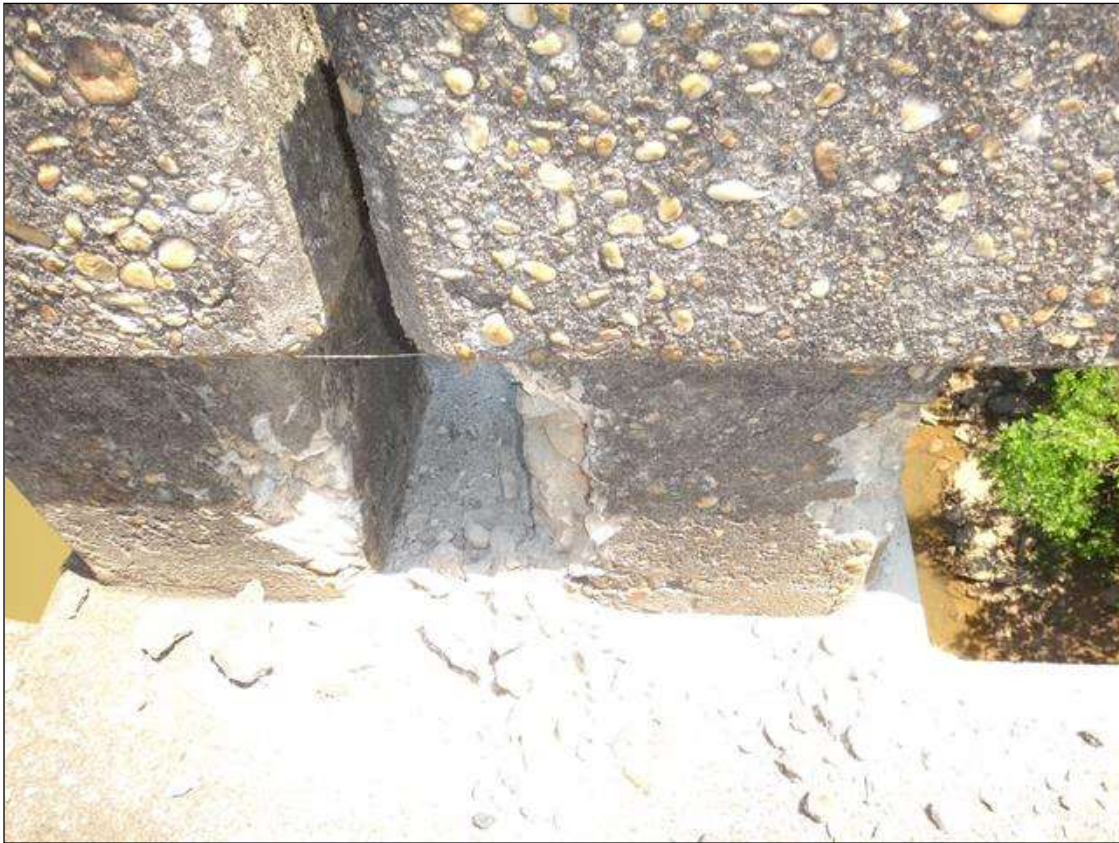
SPAN 9 NORTH RAIL POST NEAR MIDSPAN, THREE (3) SPALLS (UP TO 10IN X 5IN X 1-1/2IN DEEP) WITH EXPOSED RUSTED REBAR

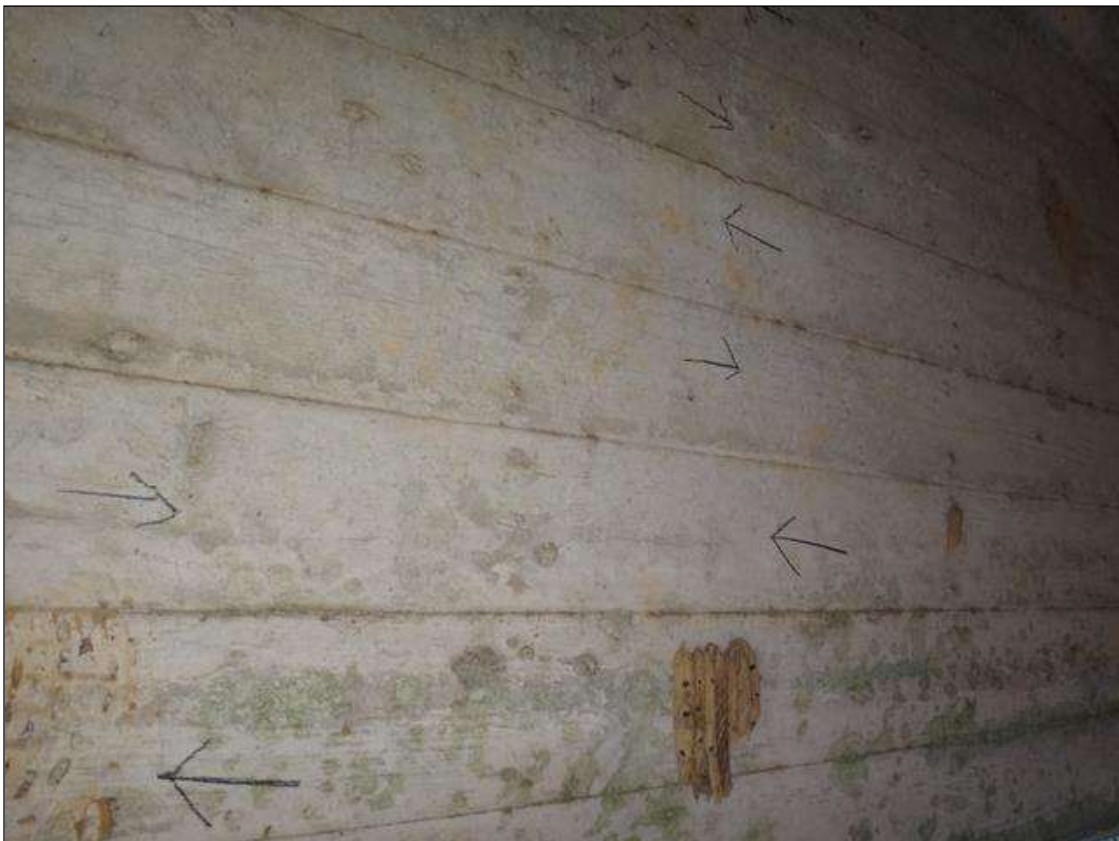
SPAN 10 BEAM 1 SOUTH FACE AT 10FT FROM END BENT 2, TWO (2) VERTICAL CRACKS (3FT X HAIRLINE)

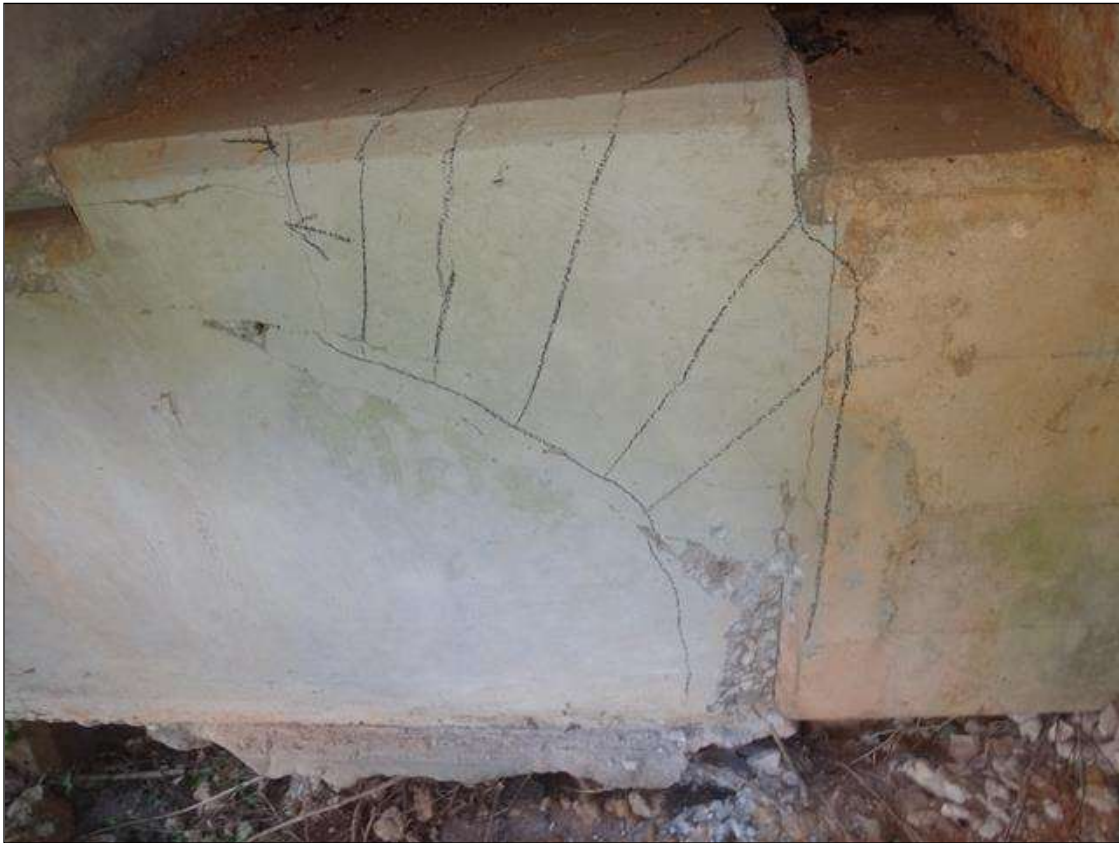
END BENT 2 BAY 1 WEST FACE AND TOP OF CAP, SPALL (15IN X 7IN X 1IN DEEP) WITH DELAMINATION (3FT X 2FT)

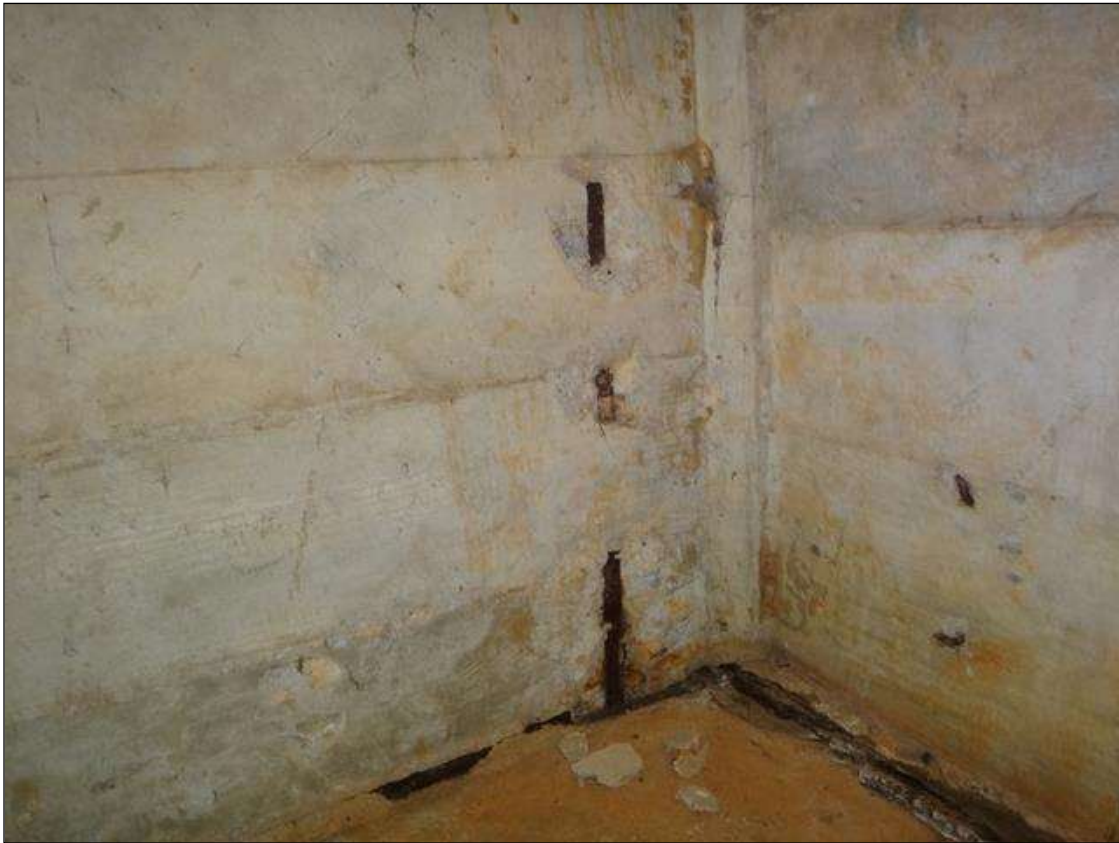
(PM) SPAN 10 BEAM 2 SOUTH FACE AT END BENT 2, THREE (3) SPALLS (UP TO 5IN X 3IN X 1IN DEEP) WITH EXPOSED RUSTED REBAR

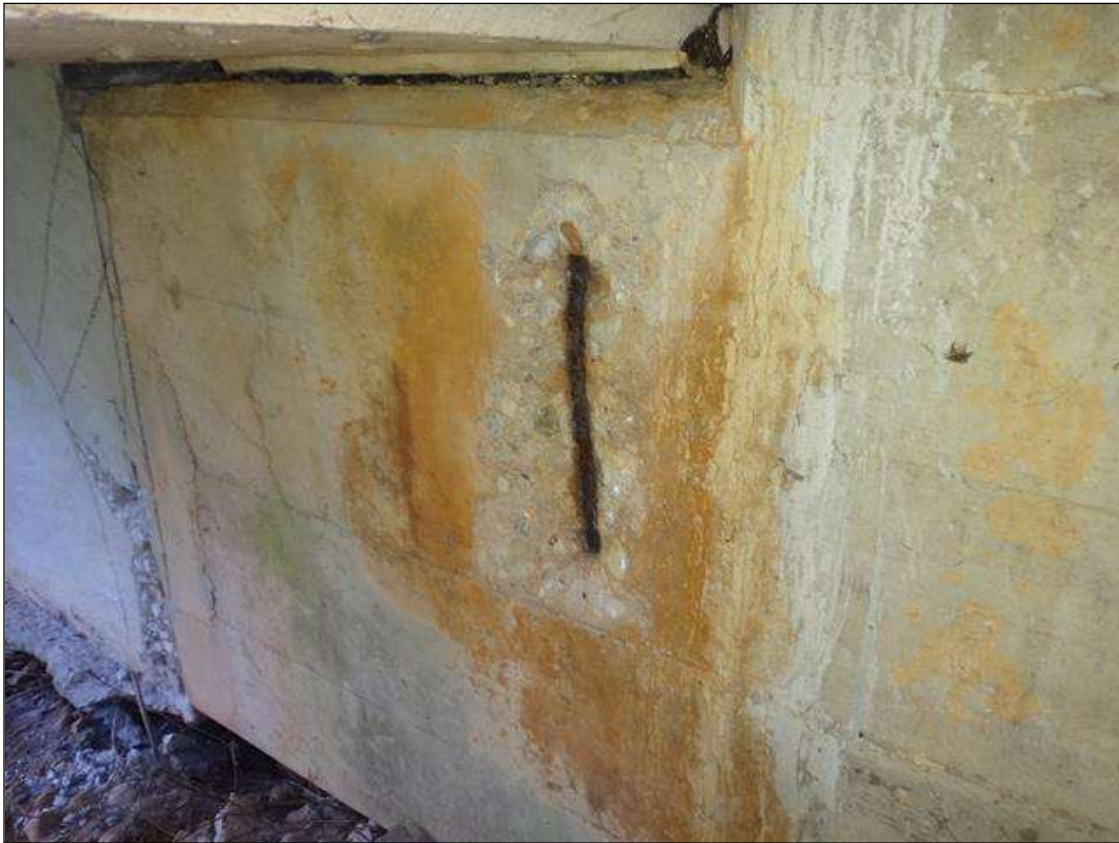
(PM) END BENT 2 CAP WEST FACE BELOW BEAM 2, SPALL (1FT X 6IN X 1IN DEEP) WITH EXPOSED RUSTED REBAR

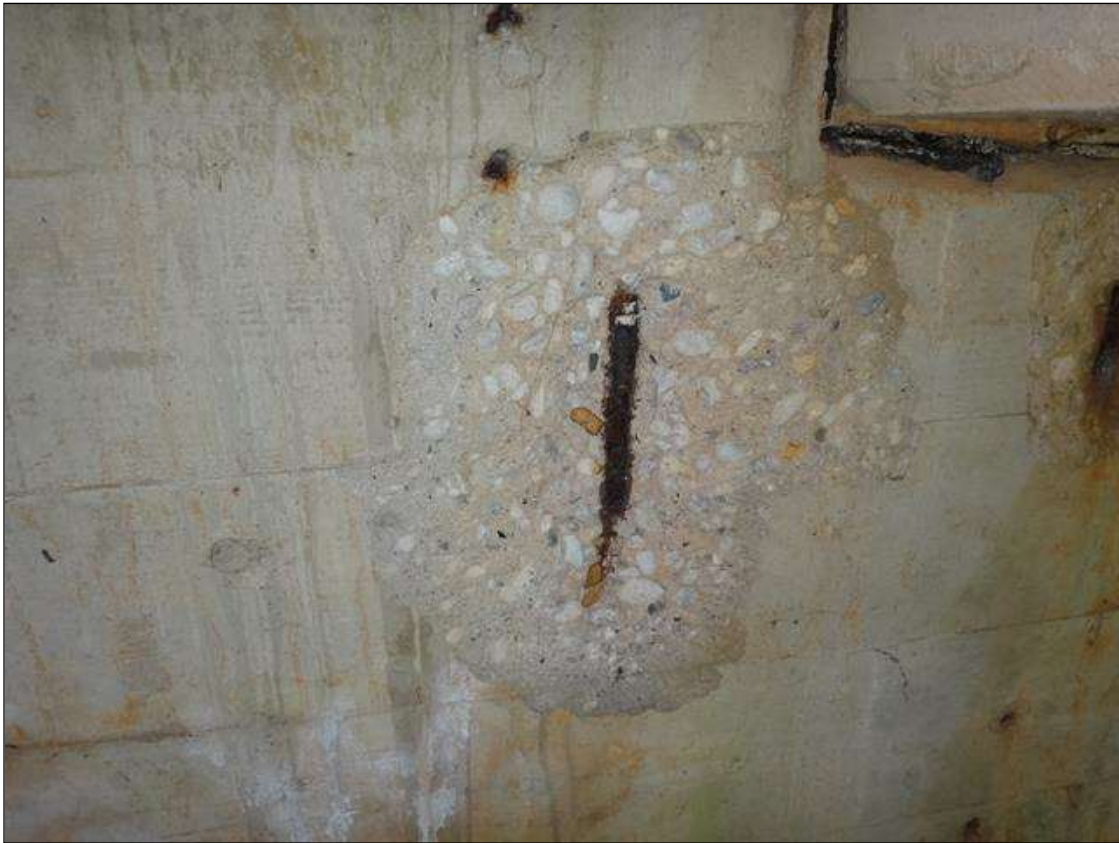
(PM) END BENT 2 CAP WEST FACE AT BEAM 3, SPALL (17IN X 15IN X 1IN DEEP) WITH EXPOSED RUSTED REBAR

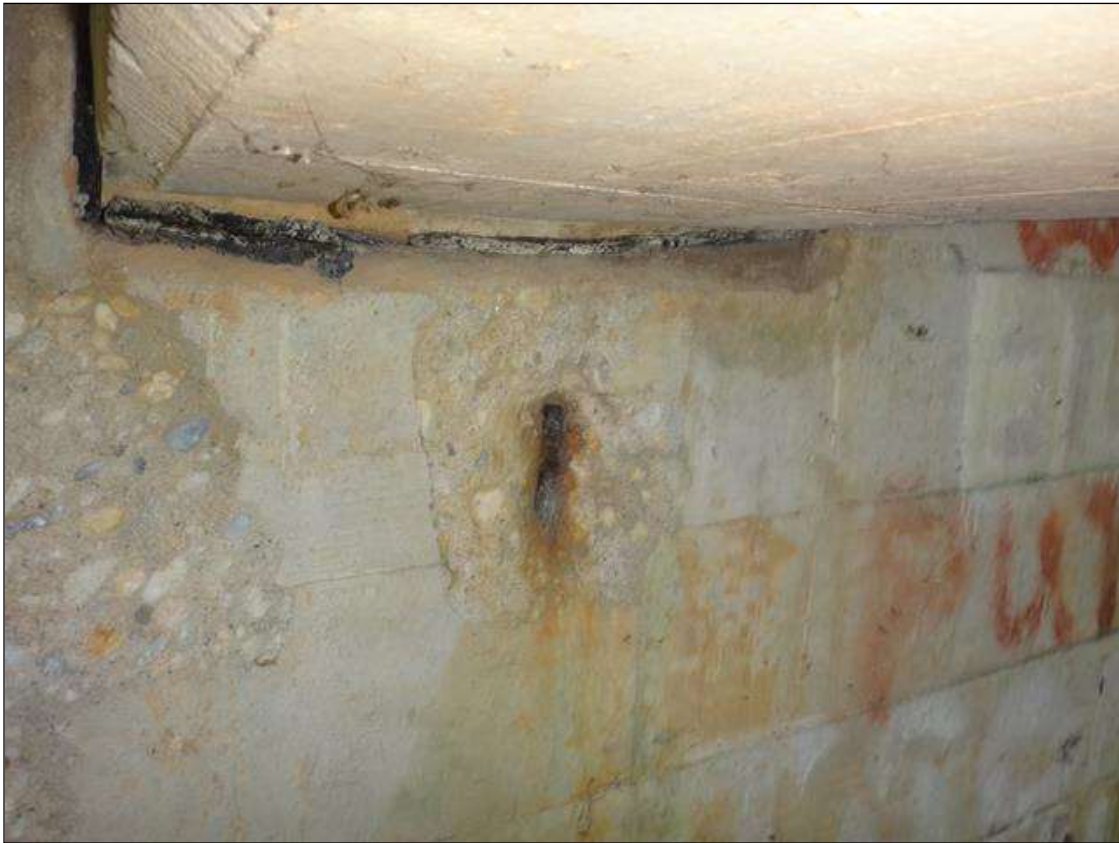
(PM) END BENT 2 CAP WEST FACE BELOW BEAM 3, SPALL (7IN DIAMETER X 1IN DEEP) WITH EXPOSED RUSTED REBAR

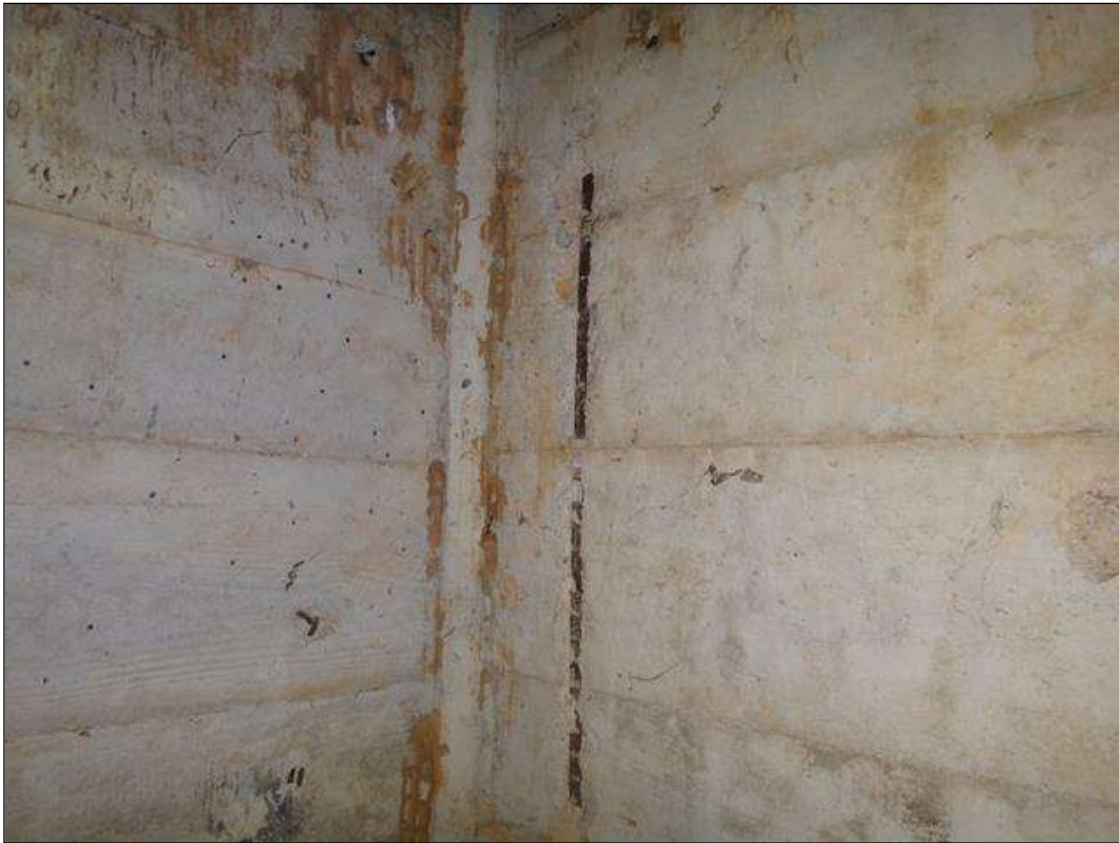
(PM) SPAN 10 BEAM 4 NORTH FACE AT END BENT 2, SPALL (2FT X 3IN X 1/2IN DEEP) WITH EXPOSED RUSTED REBAR

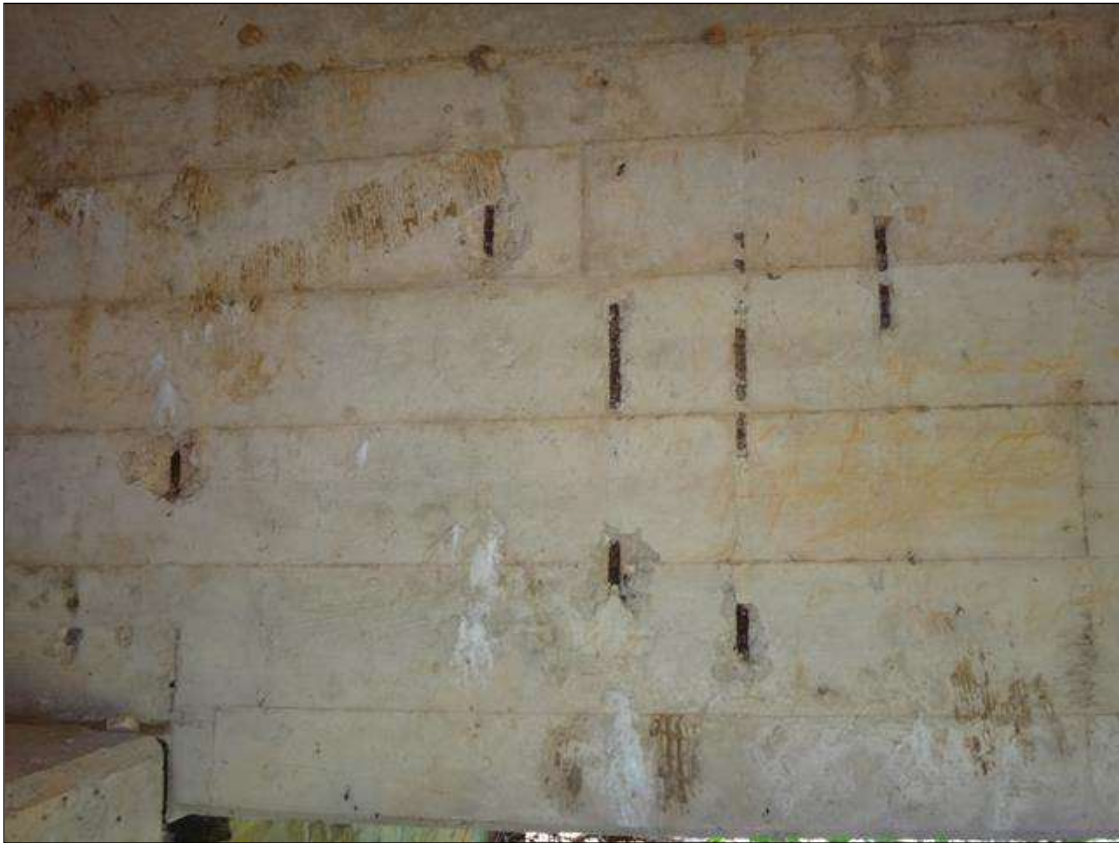
(PM) SPAN 10 BEAM 4 NORTH FACE AT 3FT FROM END BENT 2, SEVEN (7) SPALLS (UP TO 8IN X 3IN X 1/2IN DEEP) WITH EXPOSED RUSTED REBAR

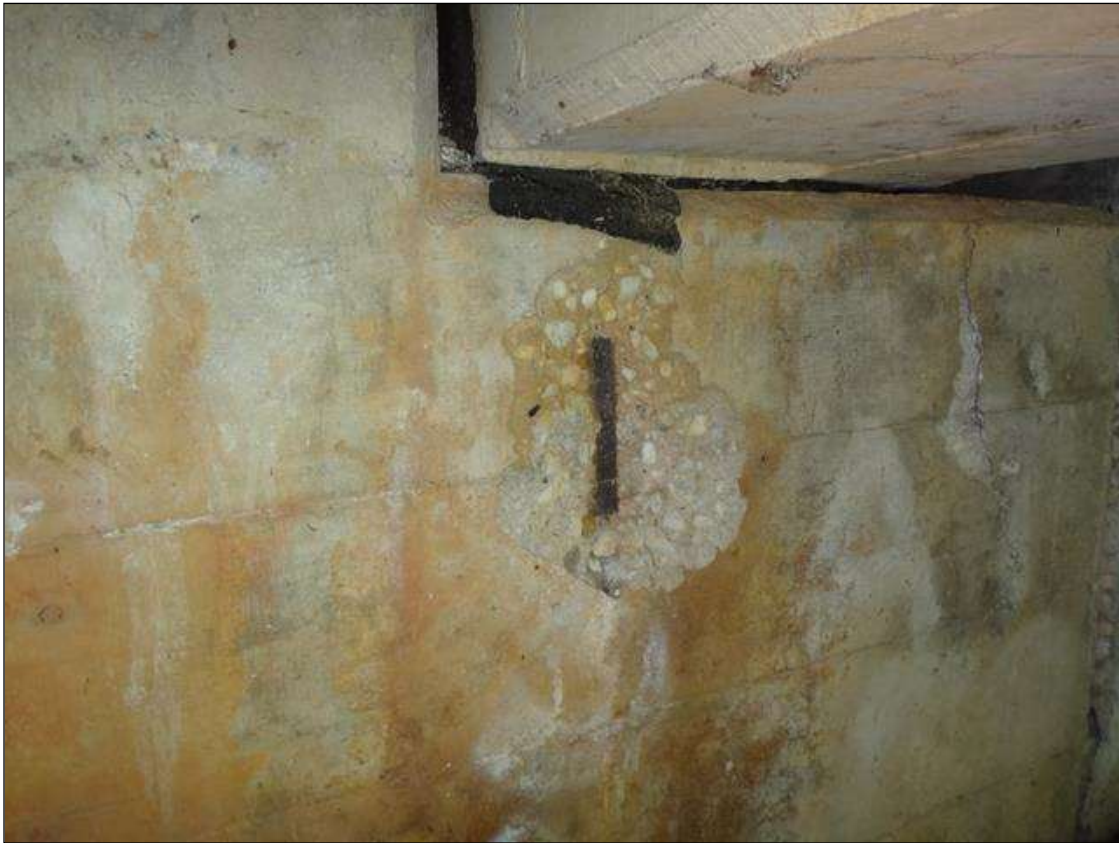
(PM) END BENT 2 CAP WEST FACE BELOW BEAM 4, SPALL (8IN X 6IN X 1IN DEEP) WITH EXPOSED RUSTED REBAR

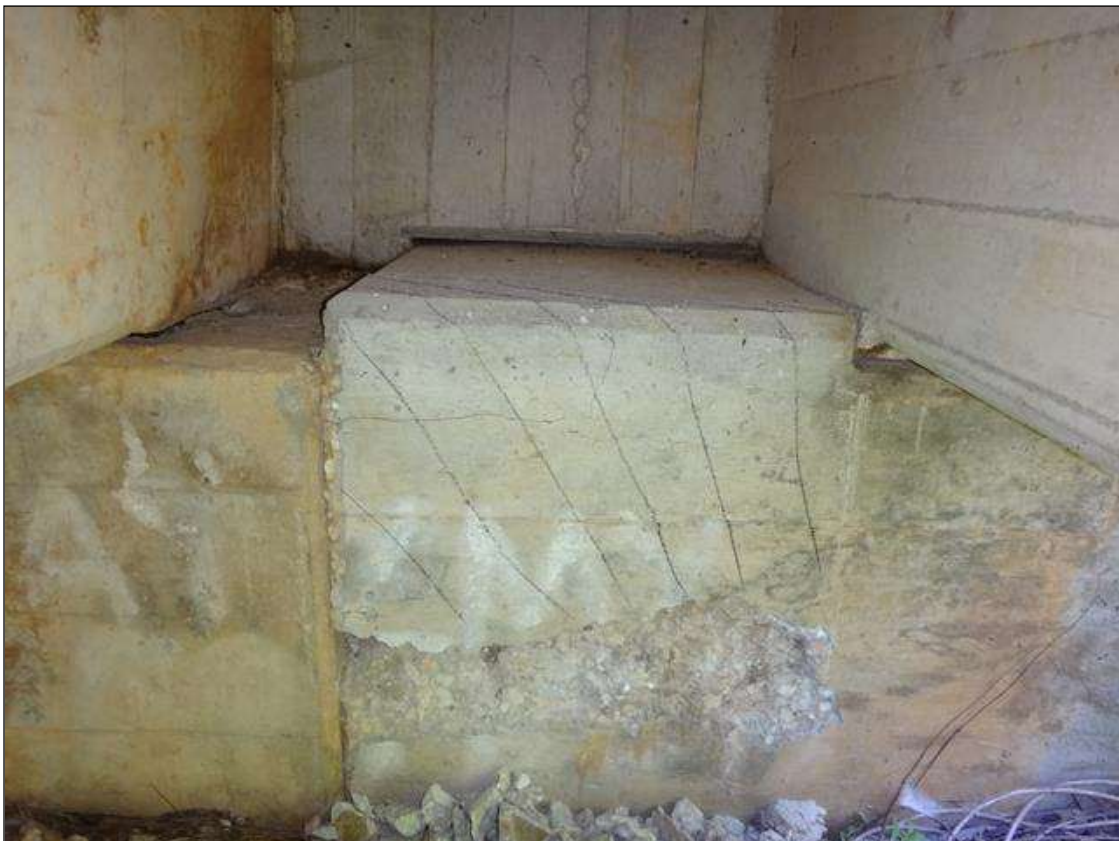
END BENT 2 BAY 4 CAP WEST AND TOP FACE, SPALL (3FT X 1FT X 3IN DEEP), DELAMINATION (3FT X 2FT)

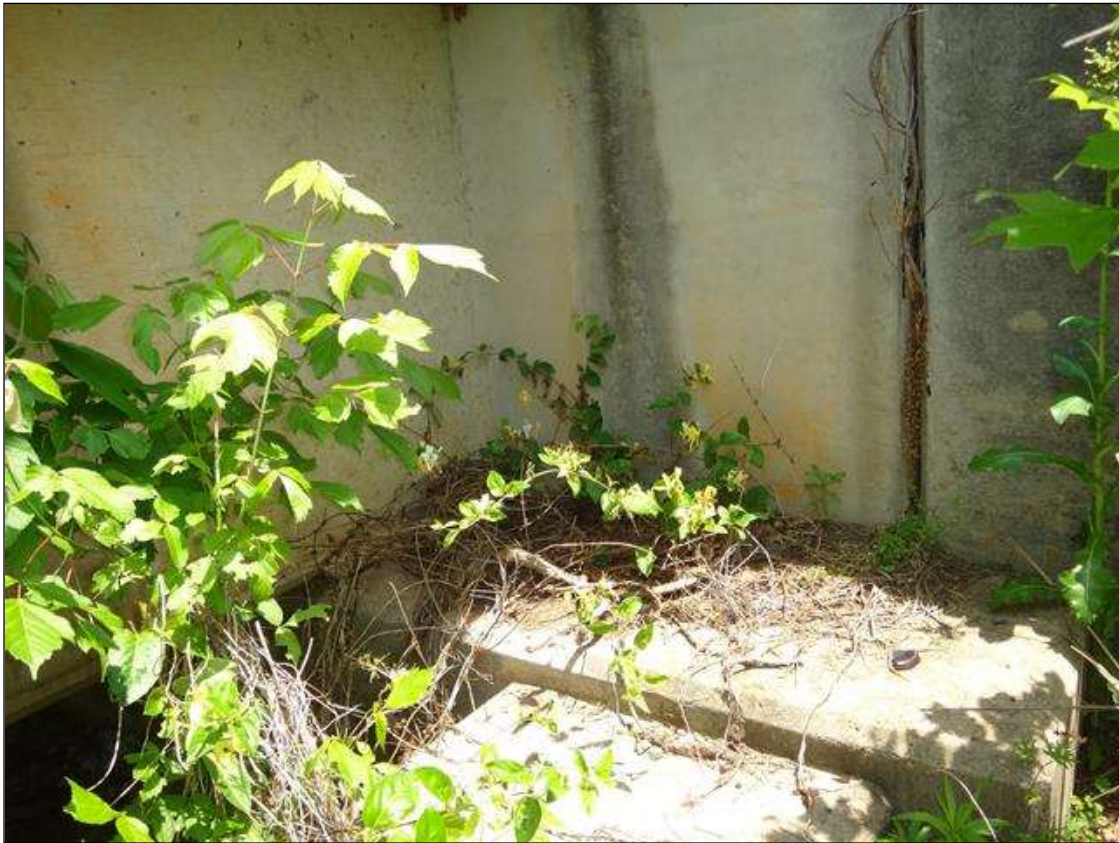
END BENT 2 CAP AT SOUTH END, DEBRIS ACCUMULATION WITH VEGETATION GROWTH (4FT X 2FT X 1FT)

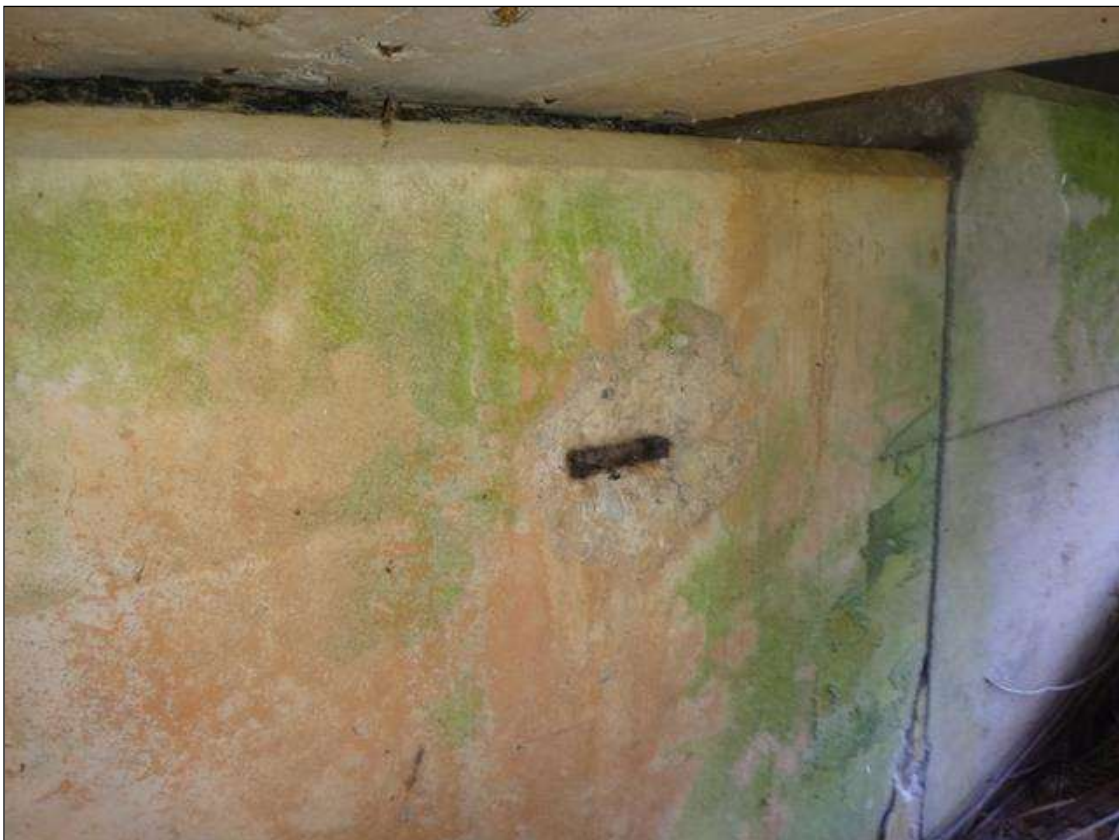
(PM) END BENT 1 CAP EAST FACE BELOW BEAM 2, SPALL (6IN X 4IN X 1/2IN DEEP) WITH EXPOSED RUSTED REBAR

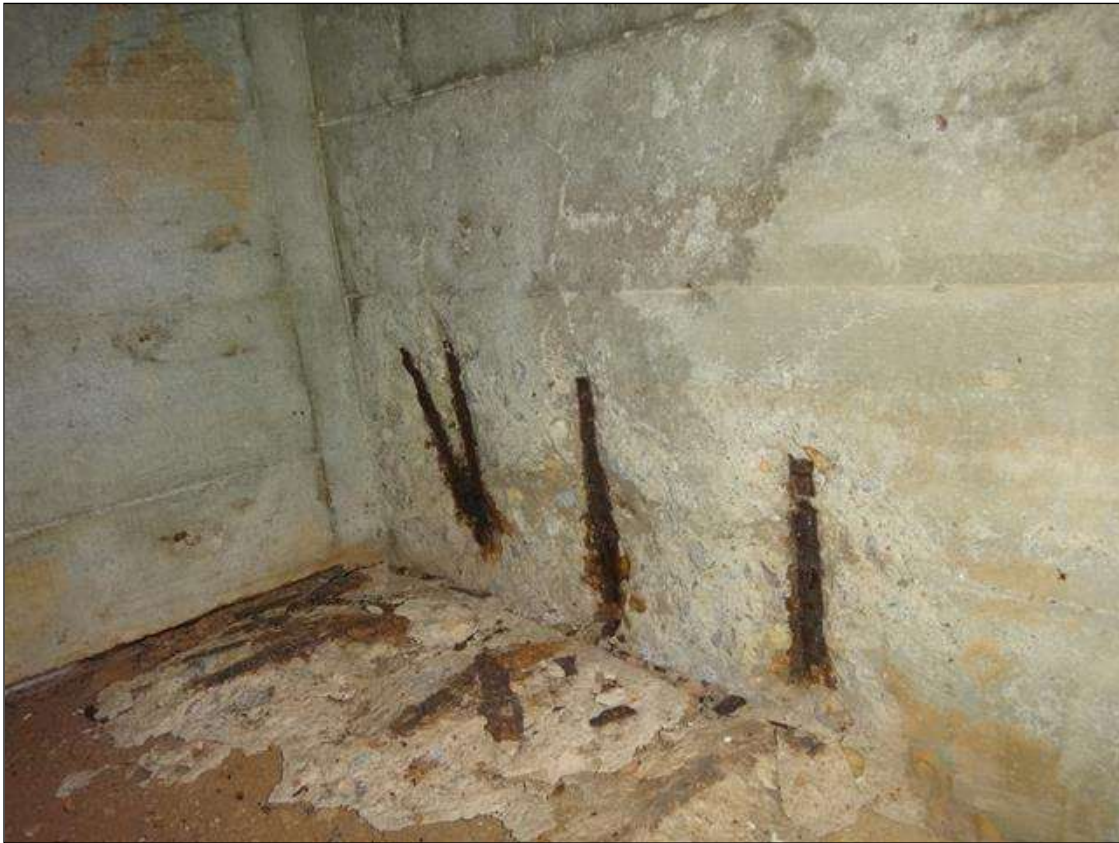
(PM) SPAN 1 BEAM 2 SOUTH FACE AT END BENT 1, THREE (3) SPALLS (UP TO 8IN X 6IN X 1IN DEEP) WITH EXPOSED RUSTED REBAR

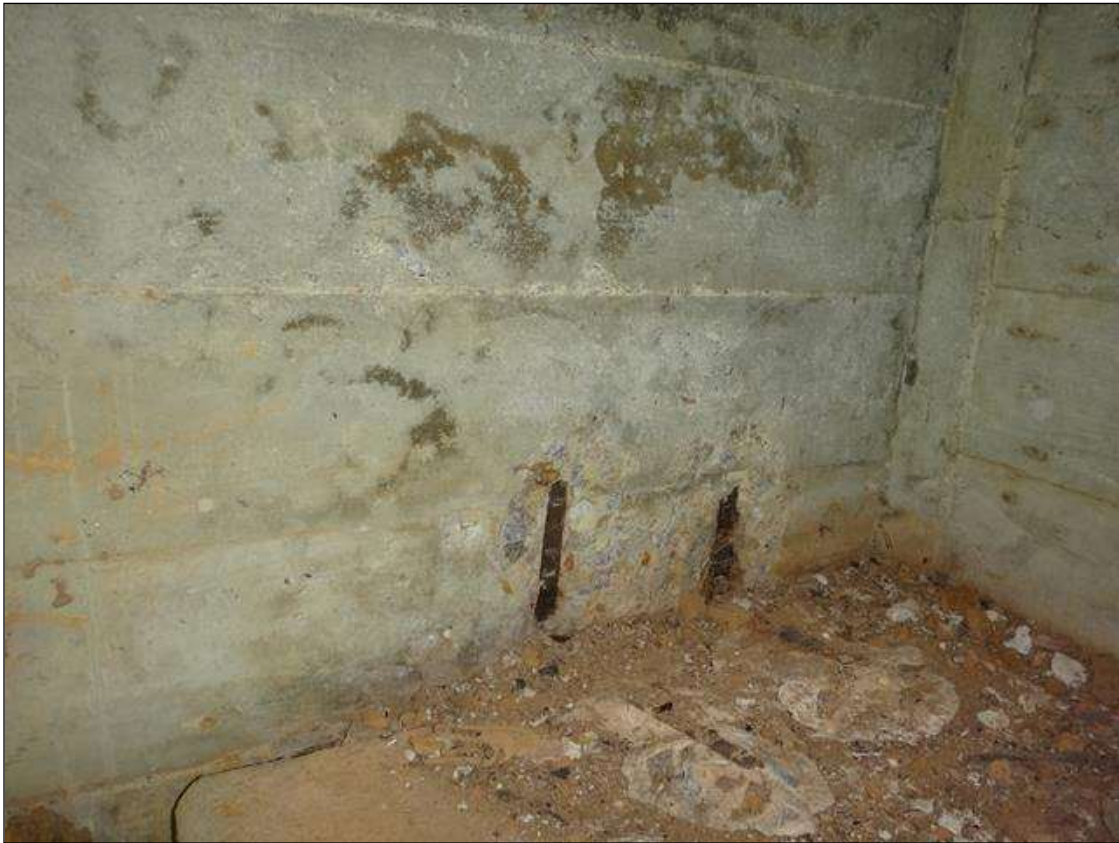
(PM) SPAN 1 BEAM 4 NORTH FACE AT END BENT 1, TWO (2) SPALLS (6IN X 4IN X 1IN DEEP) WITH EXPOSED RUSTED REBAR
