NC DEPARTMENT OF TRANSPORTATION
 DIVISION OF HIGHWAYS
 BRIDGE MANAGEMENT UNIT

PRIORITY MAINTENANCE ISSUED

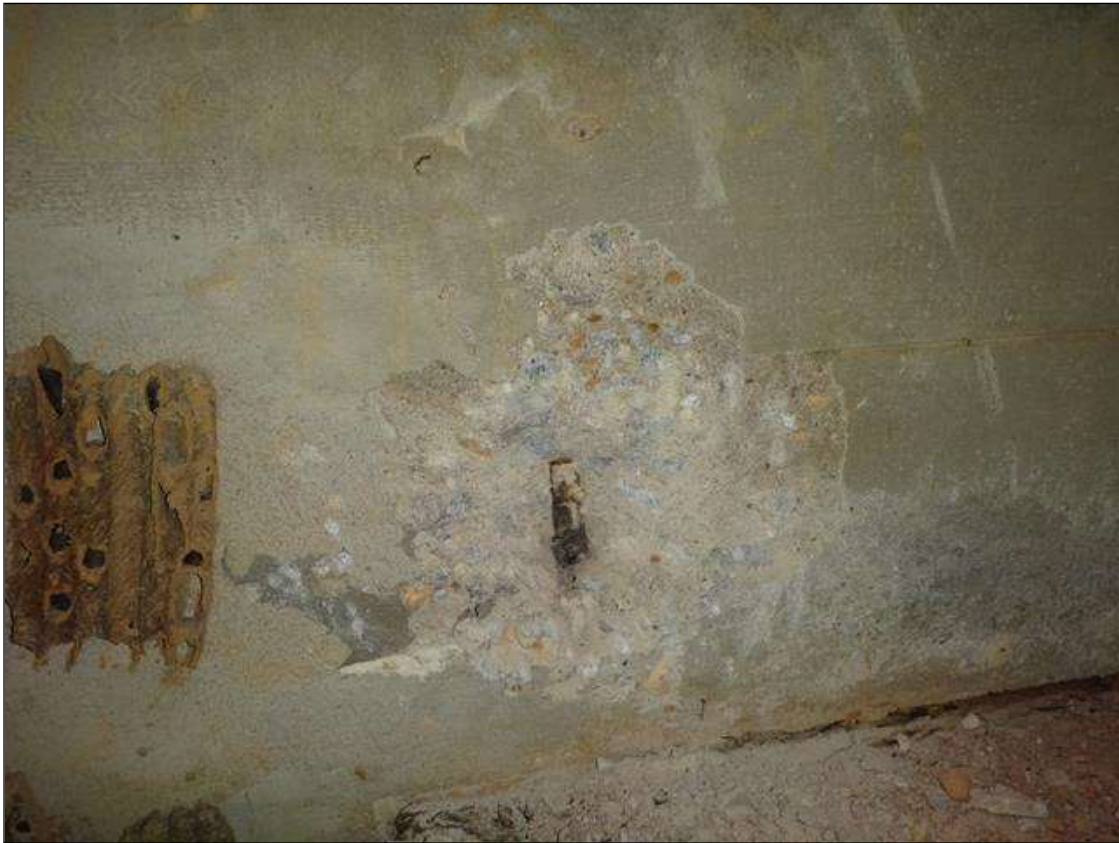
(PM) SPAN 1 BEAM 3 NORTH FACE AT END BENT 1, SPALL (10IN X 8IN X 2IN DEEP) WITH EXPOSED RUSTED REBAR

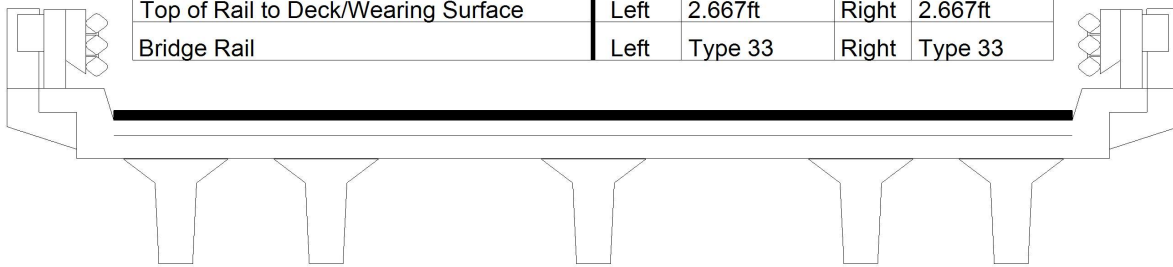
Measurements for Span #	1	ALL SPANS SIMILAR	
Deck Thickness	0.667ft	Left Overhang	3.167ft
Top of Rail to Bottom of Beam	6.917ft	Right Overhang	3.167ft

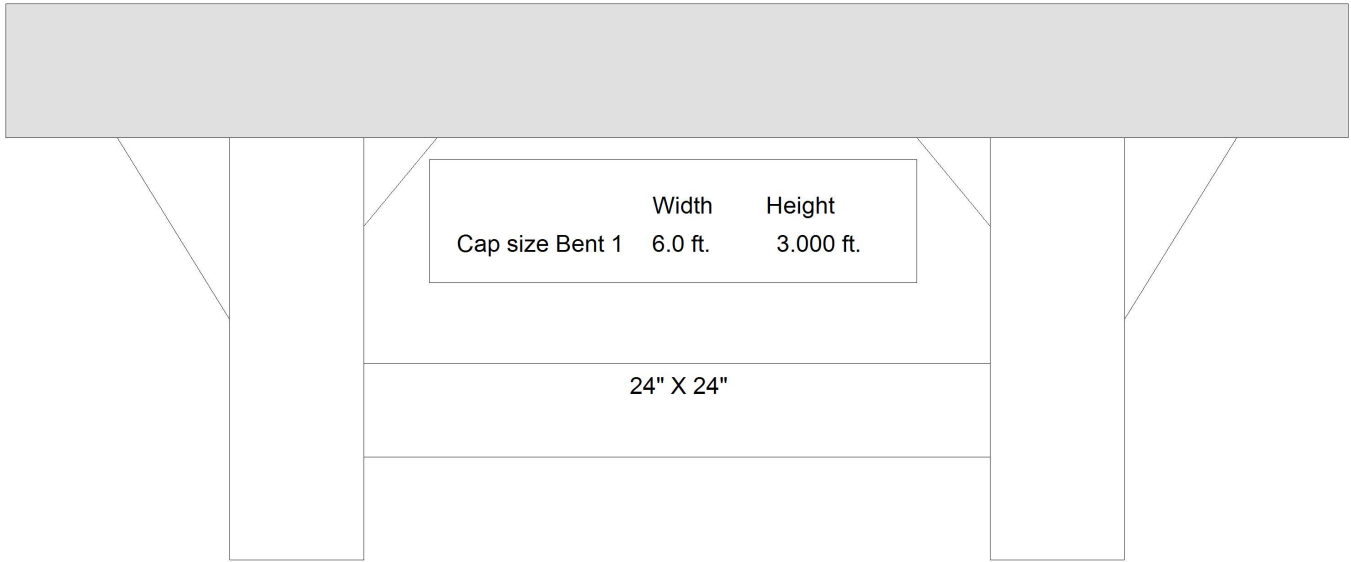
Cap Information			Material Cast-in-Place Concrete							
Length	Width	Height	Left Overhang	Right Overhang	Left Beam to End of Cap.	Right Beam to End of Cap.				
30.000 ft.	3.000 ft.	3.000 ft.	6.500 ft.	6.500 ft.	1.000 ft.	1.000 ft.				
Subcap Information			Material							
Length	Width	Height	Left Overhang	Right Overhang	Left Pile to Splice.					
Sill Information			Material							
Length	Width	Height								
Pile #	Material	Spacing	Width/Dia.	Height	Length	Orientation	Driven?	Replacement?	Removed?	Collar?
1	Concrete	17 ft.	3 ft.	3 ft.		Vertical	No	No	No	No
2	Concrete		3 ft.	3 ft.		Vertical	No	No	No	No
Bent/Abutment #: 1			Similar Bents: 2,3,4,5,6 & 9

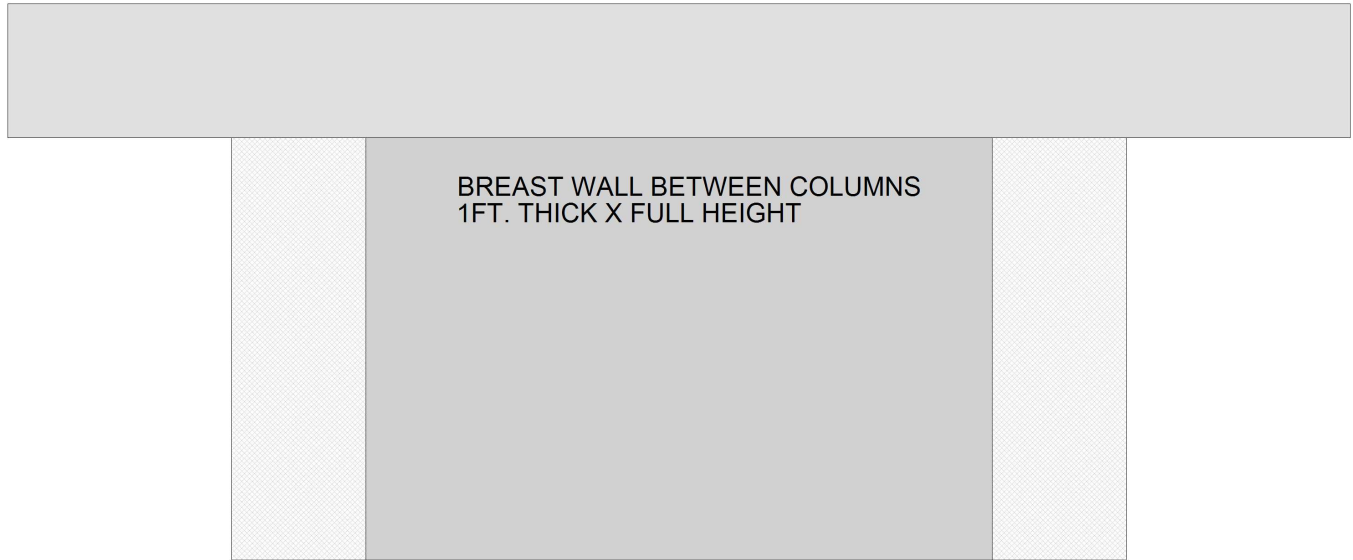
Cap Information			Material Cast-in-Place Concrete							
Length	Width	Height	Left Overhang	Right Overhang	Left Beam to End of Cap.	Right Beam to End of Cap.				
30.000 ft.	3.000 ft.	3.000 ft.	6.500 ft.	6.500 ft.	1.000 ft.	1.000 ft.				
Subcap Information			Material							
Length	Width	Height	Left Overhang	Right Overhang	Left Pile to Splice.					
Sill Information			Material							
Length	Width	Height								
Pile #	Material	Spacing	Width/Dia.	Height	Length	Orientation	Driven?	Replacement?	Removed?	Collar?
1	Concrete	17 ft.	3 ft.	3 ft.		Vertical	No	No	No	No
2	Concrete		3 ft.	3 ft.		Vertical	No	No	No	No
Bent/Abutment #: 7			Similar Bents: 8		VERIFIED BY: T. GRAHAM 5/20/2014

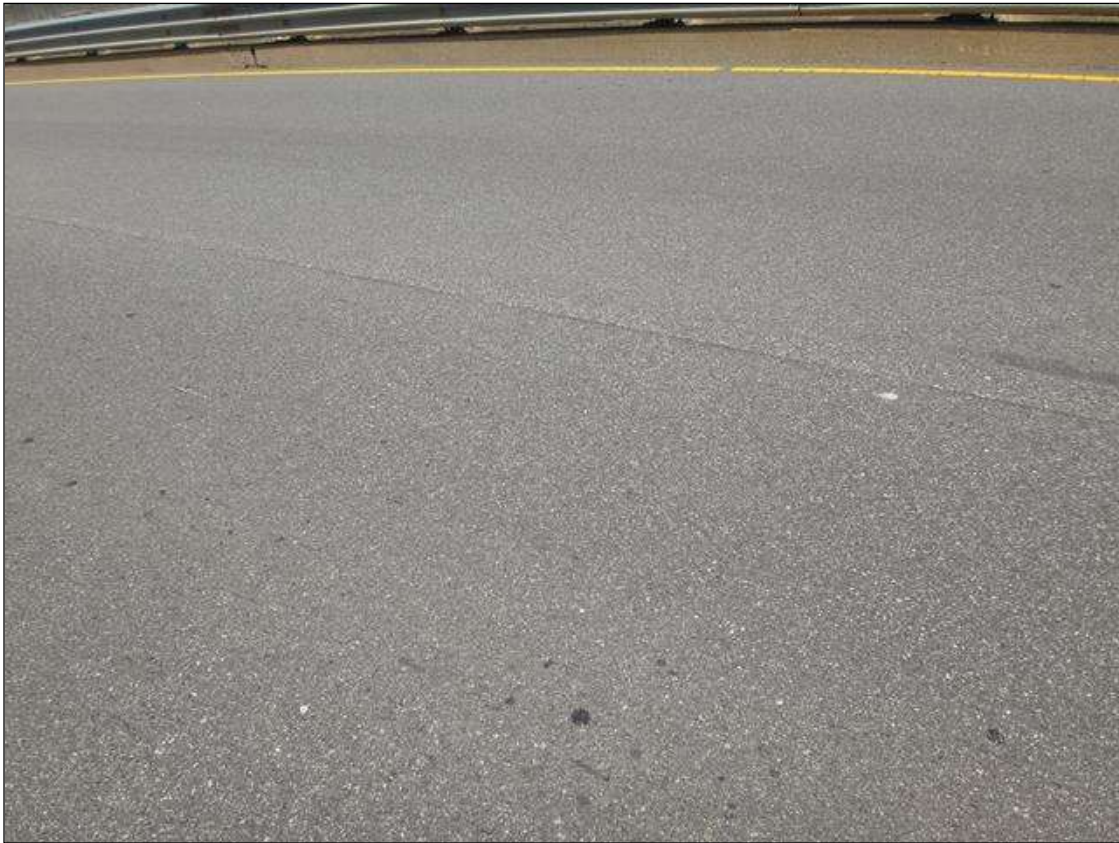
ASPHALT WEARING SURFACE AT SPAN 10
