NC DEPARTMENT OF TRANSPORTATION
 DIVISION OF HIGHWAYS
 STRUCTURE MANAGEMENT UNIT

ATTENTION: **PRIORITY ACTION REQUEST ISSUED; TEMPORARY SHORING**

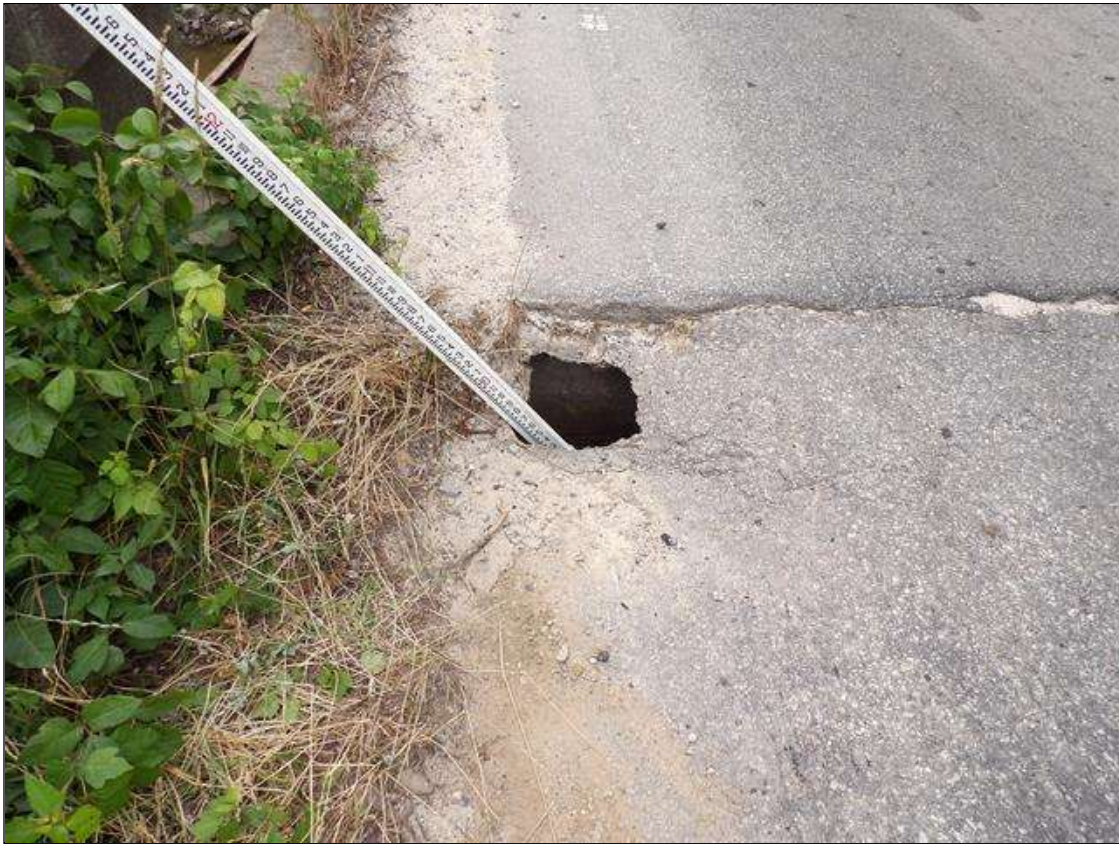
PAR--NORTH APPROACH NORTHBOUND LANE FULL DEPTH POT HOLE 1 FEET DIAMETER AT SHOULDER WITH VOID 5 FEET DEEP WHICH EXTENDS SEVERAL FEET BEHIND ABUTMENT 2. APPROACH PAVEMENT HAS SETTLED UPTO 4 INCHES

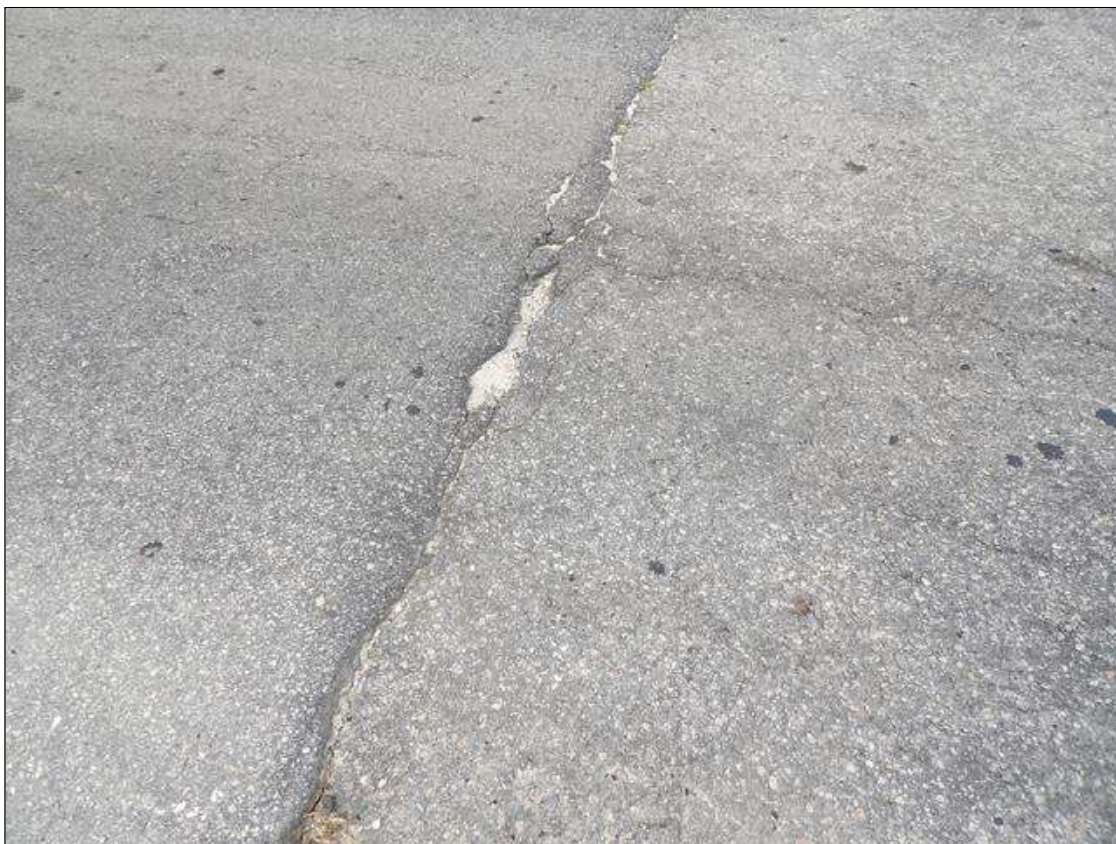
Span 2 Wearing Surface: ASPHALT WEARING SURFACE OVER END BENT 2 - SPALL UP TO 1 FOOT LONG. X 3 INCHES X 1 INCH NEAR CENTER INCHES NORTHBOUND TRAVEL LANE.

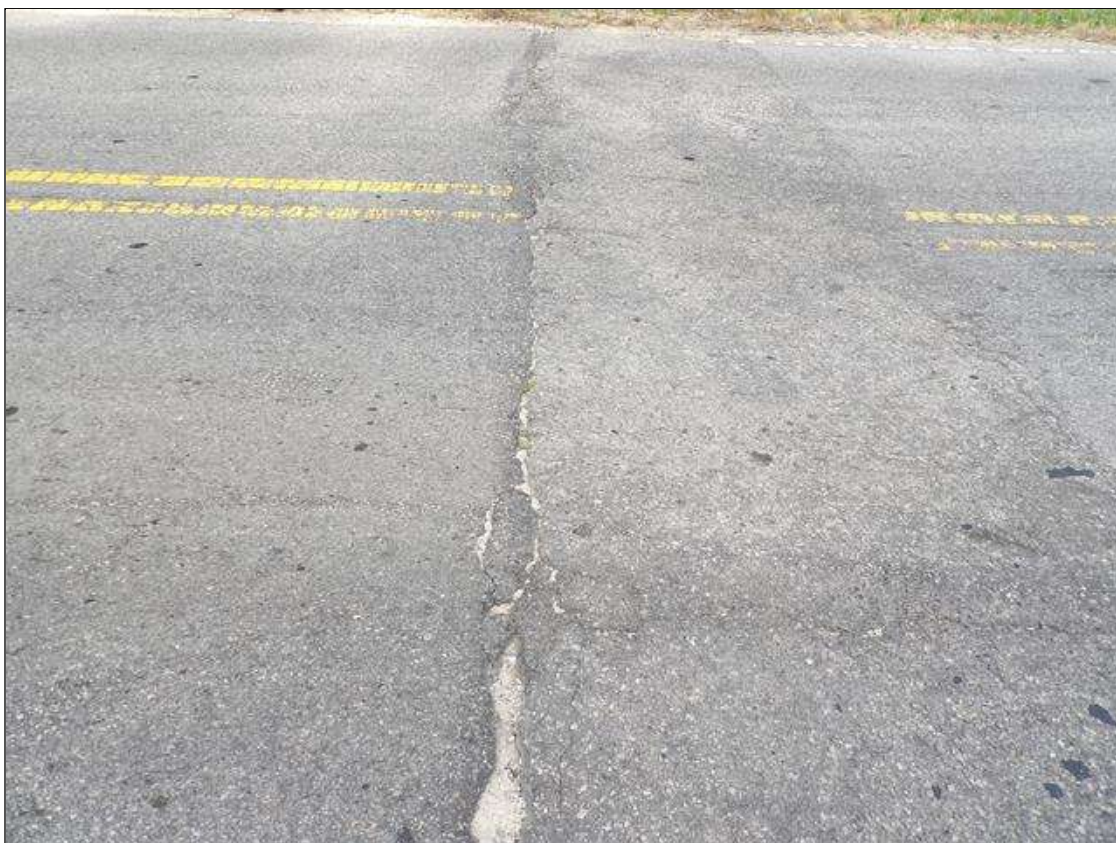
Span 2 Wearing Surface: ASPHALT WEARING SURFACE OVER END BENT 2 - TRANSVERSE CRACKING (UP TO 3/4 INCHES X FULL WIDE.)

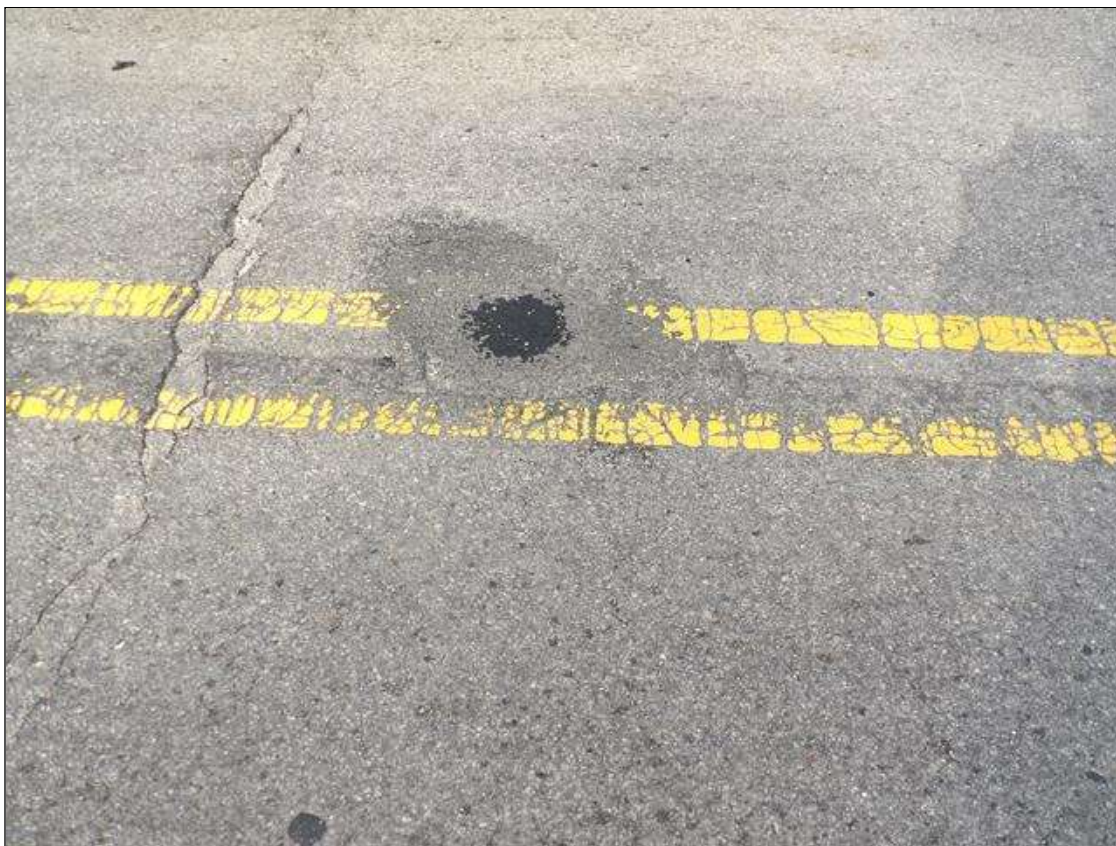
Span 2 Wearing Surface: SOUND PATCH, 1 FOOT X 1 FOOT AT NEAR END, CENTER OF ROADWAY

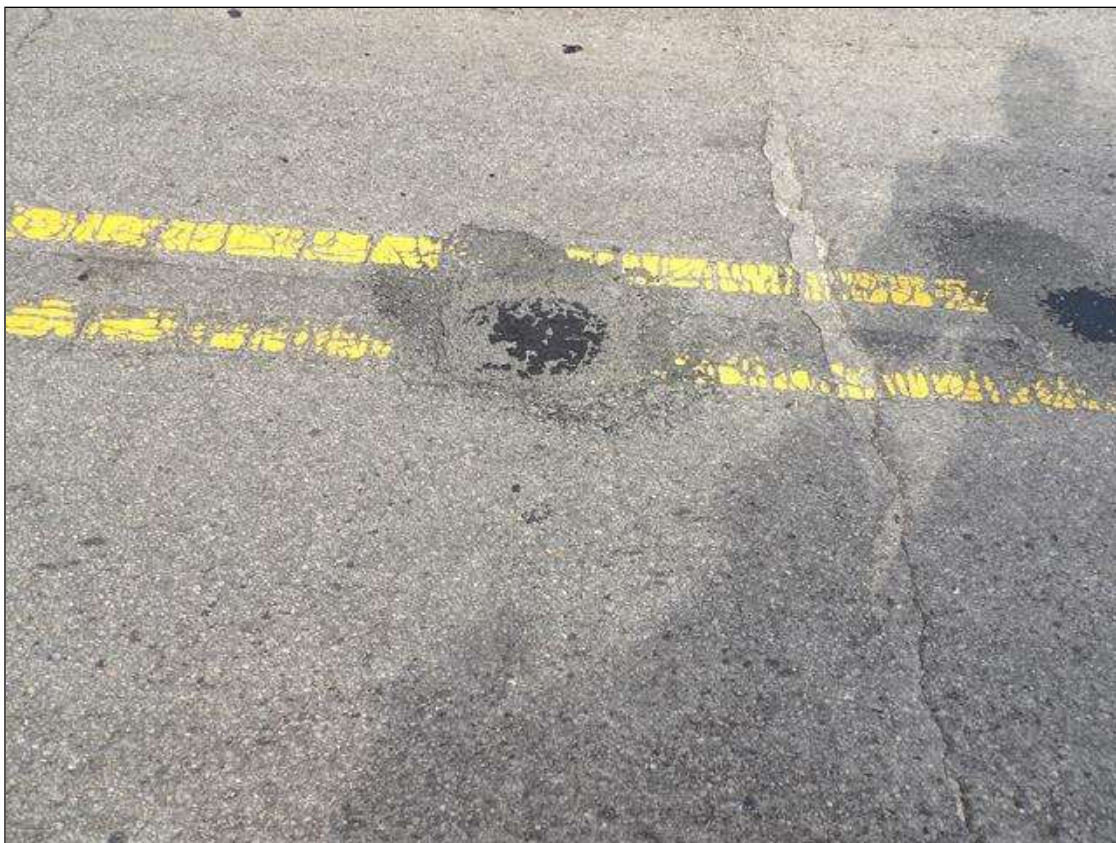
Span 1 Wearing Surface: SOUND PATCH, 1 FOOT X 1 FOOT AT FAR END, CENTER OF ROADWAY

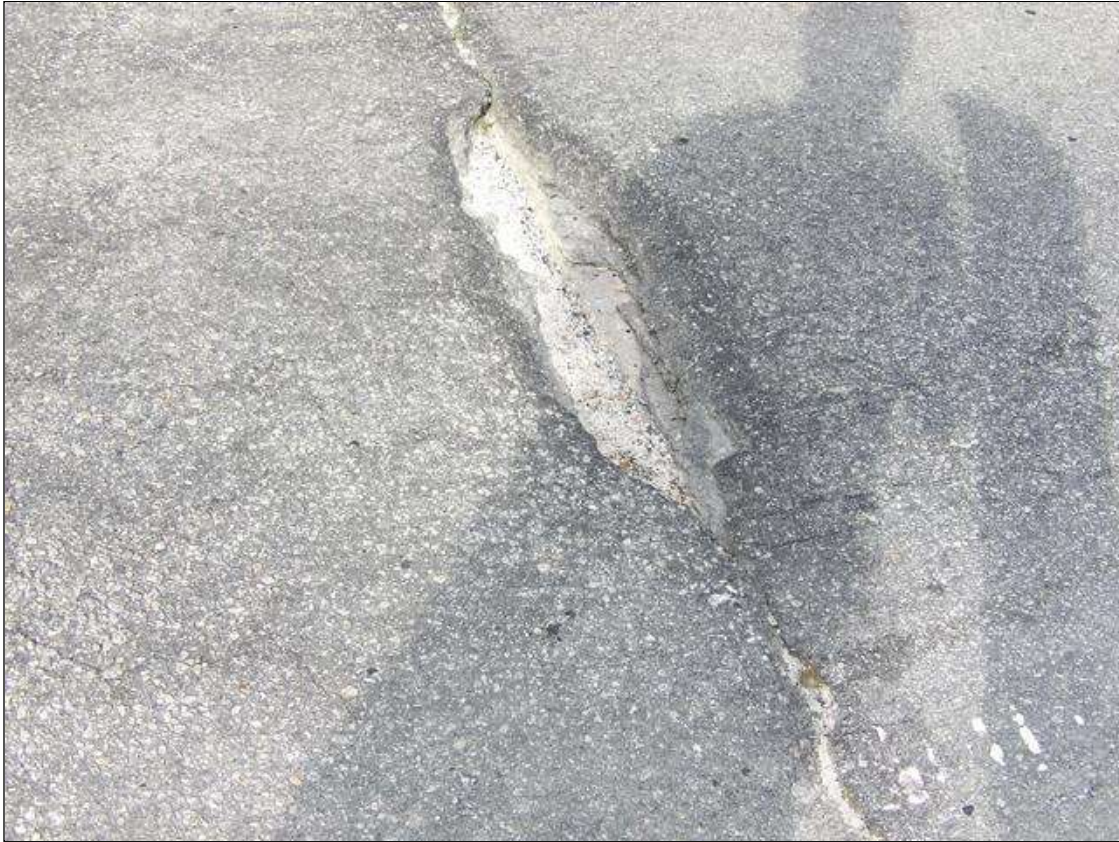
Span 1 Wearing Surface: PAR--SPALL/POTHOLE OVER ABUTMENT 1 2 FEET LONG. X 8 INCHES WIDE. X 3 INCHES DEEP NORTHBOUND TRAVEL LANE STARTING 2 FEET FROM RIGHT SHOULDER.

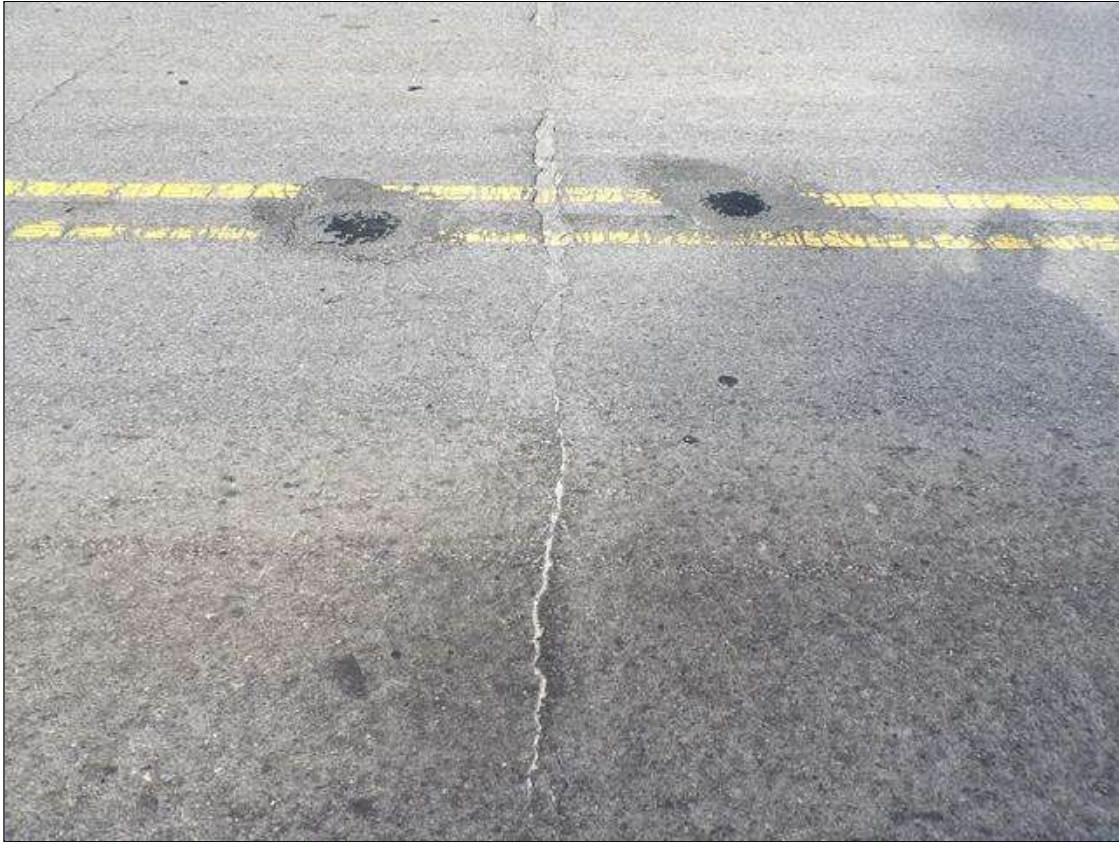
Span 1 Wearing Surface: ASPHALT WEARING SURFACE OVER END BENT 1 - TRANSVERSE CRACKING UP TO 1 INCH X FULL WIDE. THROUGHOUT, AND ASPHALT WEARING SURFACE OVER BENT 1 & CRUTCH BENTS - TRANSVERSE CRACKING UP TO 1/2 INCHES X FULL WIDTH WITH BROKEN ASPHALT WEARING SURFACE NEAR CENTER LINE 2.5 FEET WIDE X 3 INCHES LONG. BENT 1 SHOWN

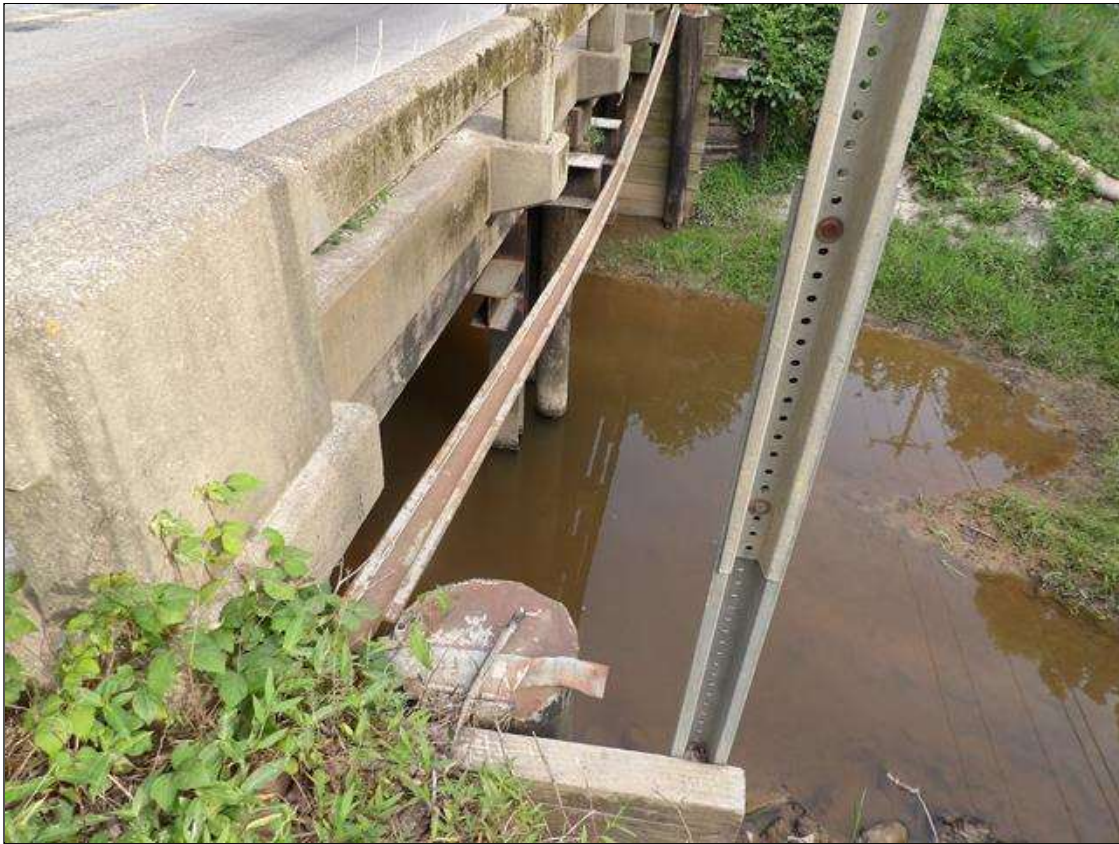
Abandoned/sagging utility pipe right side of bridge

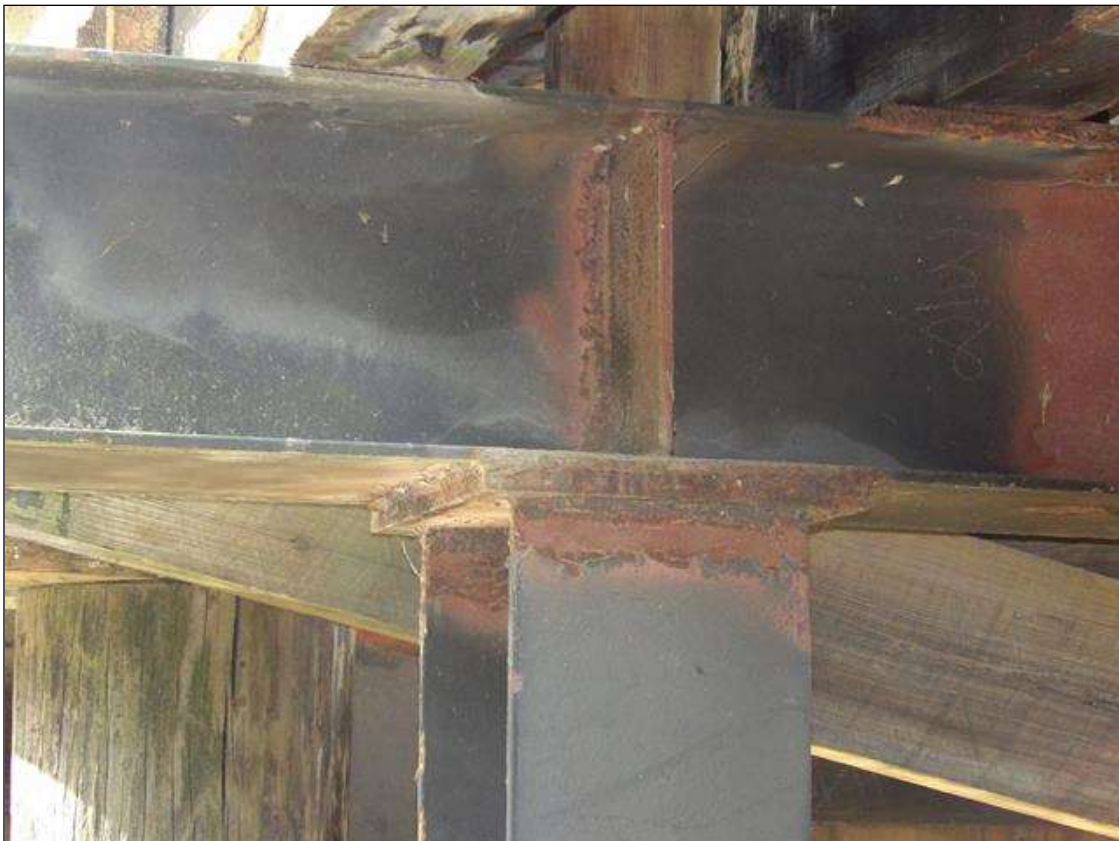
Typical surface corrosion on crutch bents

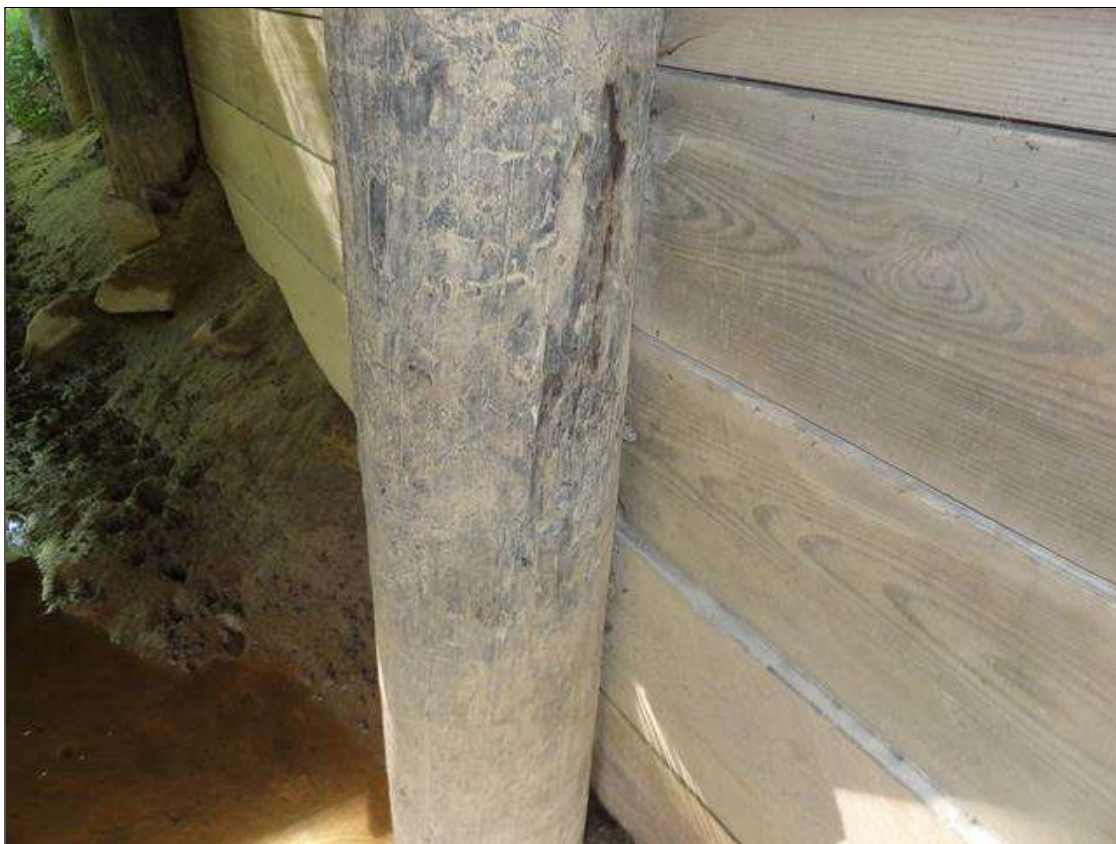
End Bent 2 Pile 3: DECAY 16 INCHES HEIGHT. X 6 INCHES WIDE X 1/2 INCHES DEEP TO EAST FACE, 2 FEET FROM BOTTOM

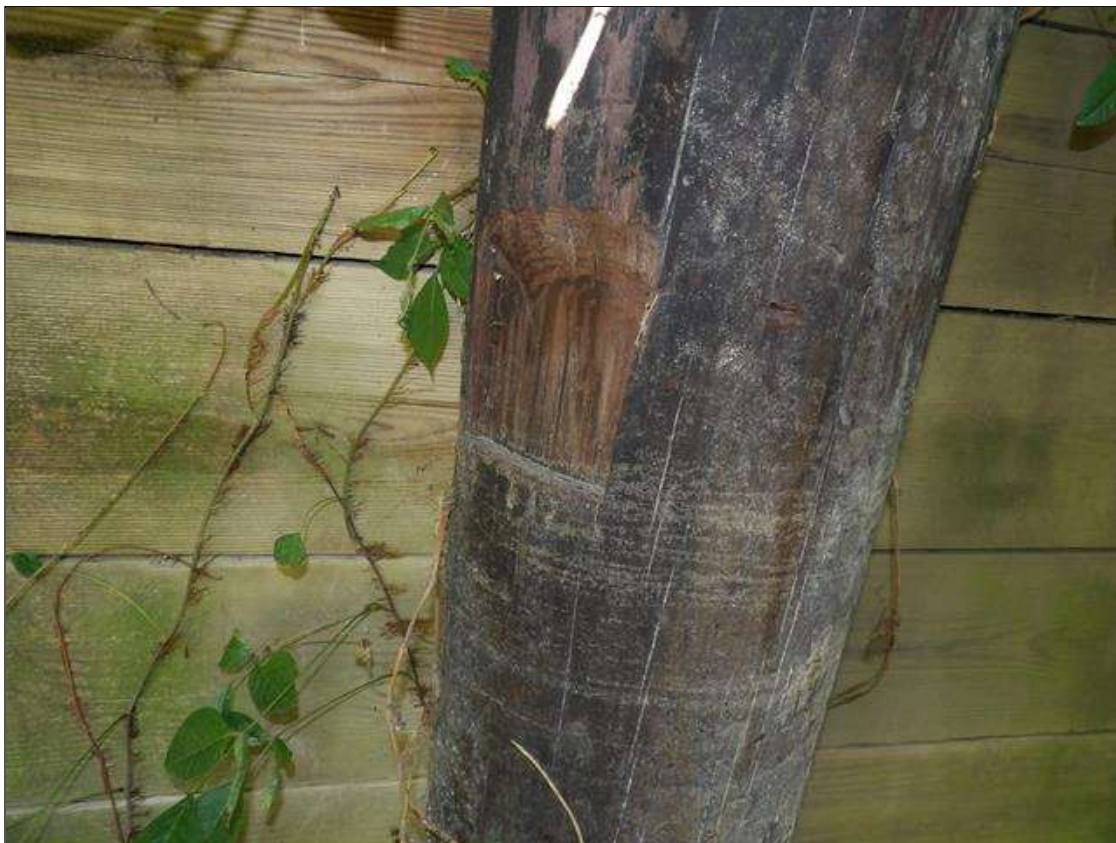
End Bent 2 Pile 1: SECTION LOSS 6 INCHES X 6 INCHES X 1 INCH TO WEST FACE, 2 FEET FROM TOP

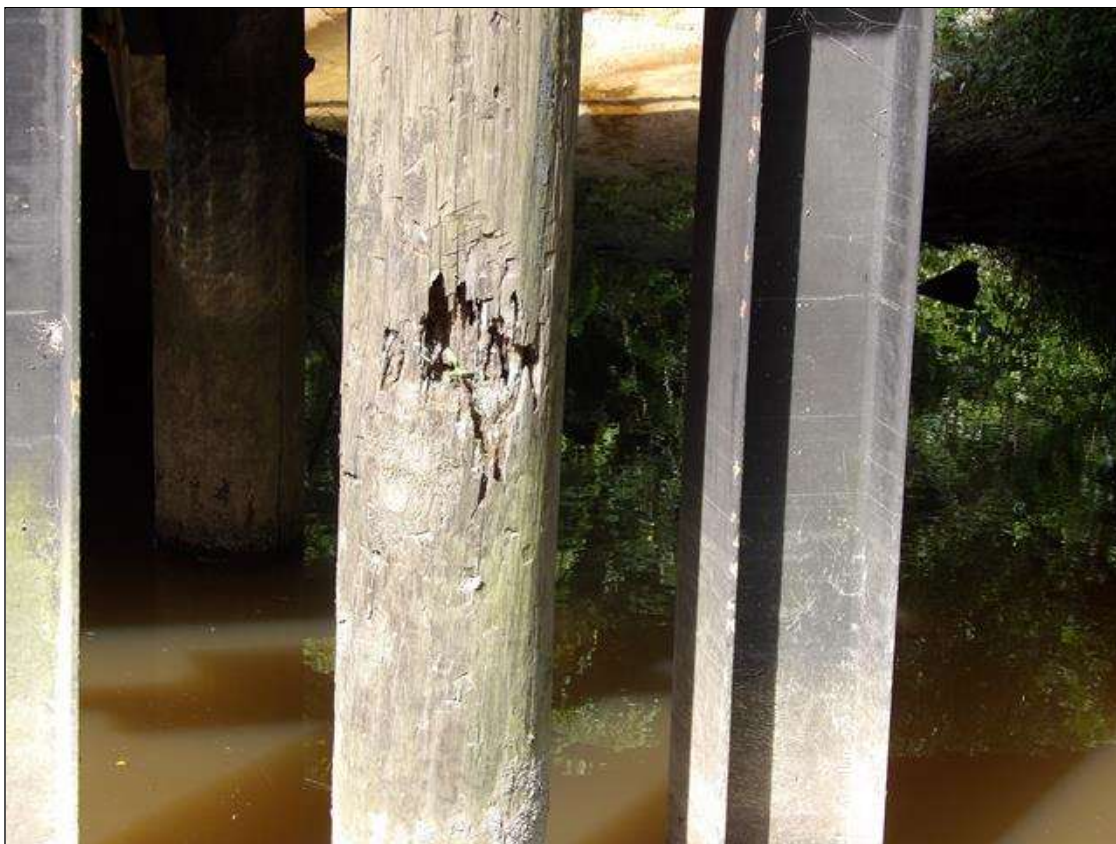
Bent 1 Pile 4: 10" X 8" X 1 1/2" DEEP AREA OF DECAY WEST FACE MID HEIGHT

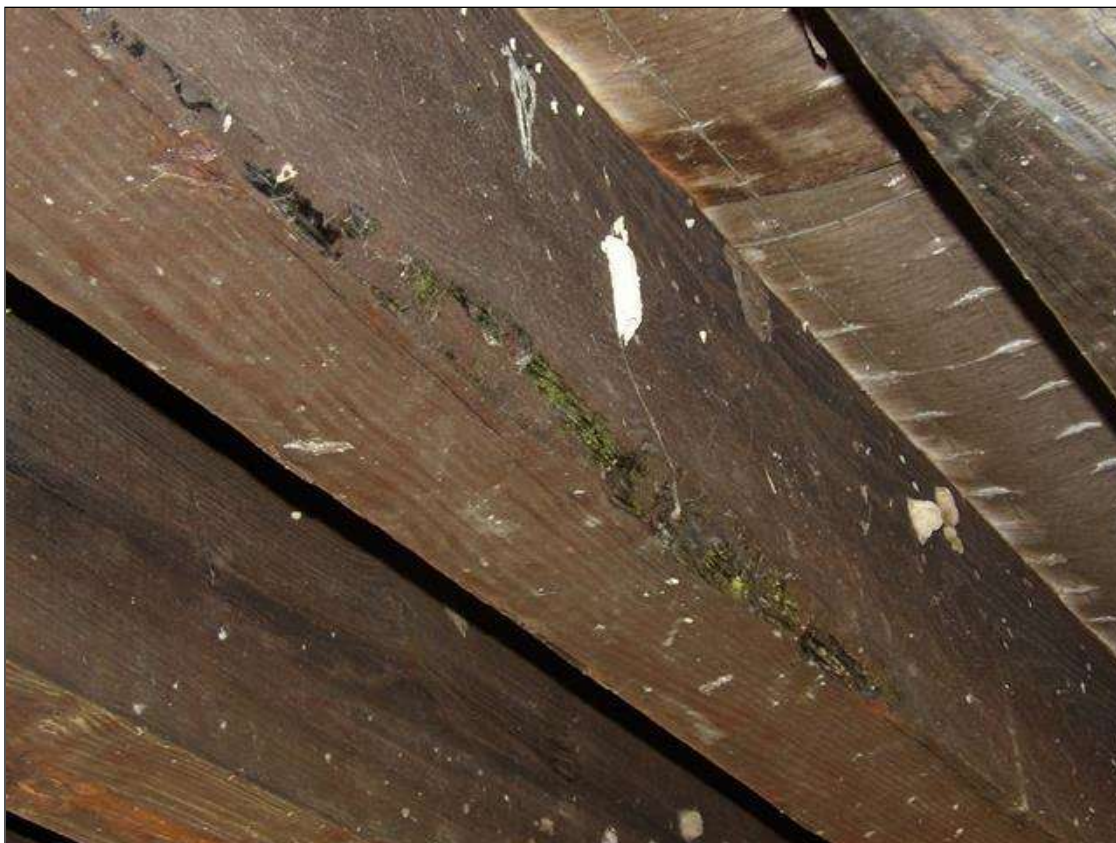
Span 1 Beam 5: SHAKE 30 INCHES LONG. X 2 INCHES WIDE X 1 INCH DEEP TO BOTTOM EAST FACE AT MID-SPAN

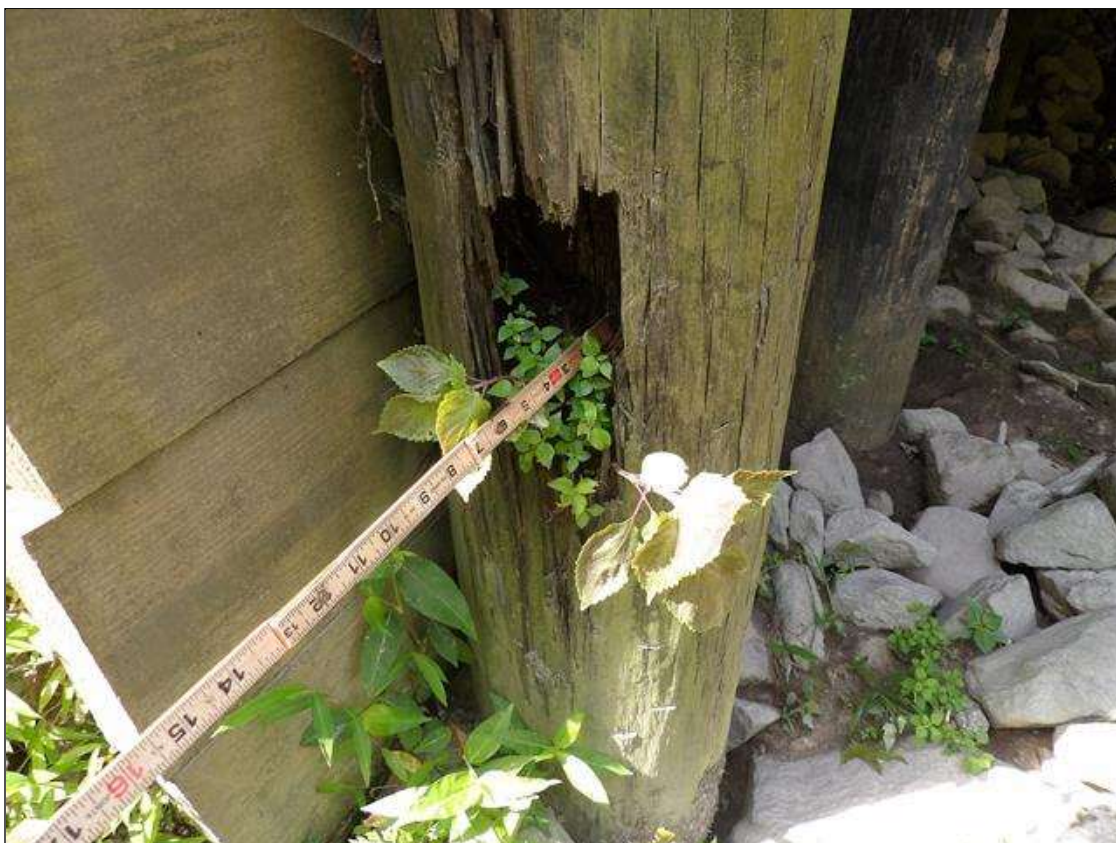
End Bent 1 Abutment: PAR--EAST SIDE ABUTMENT SUPPORT PILE - DECAY 12 INCHES HEIGHT. X 4 INCHES WIDE X 4 INCHES DEEP TO RIGHT SIDE, 2 FEET FROM BOTTOM.

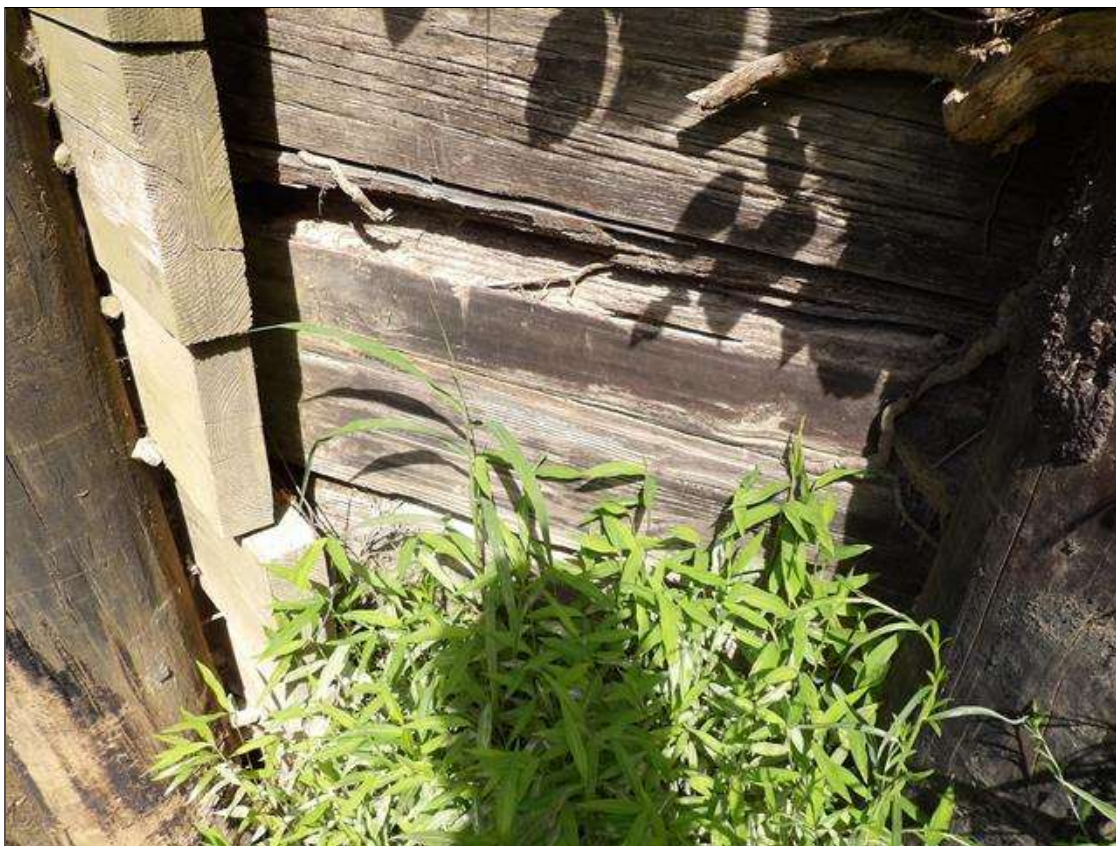
Northeast wingwall 4' x 4" x 1 1/2" deep area of decay near bottom

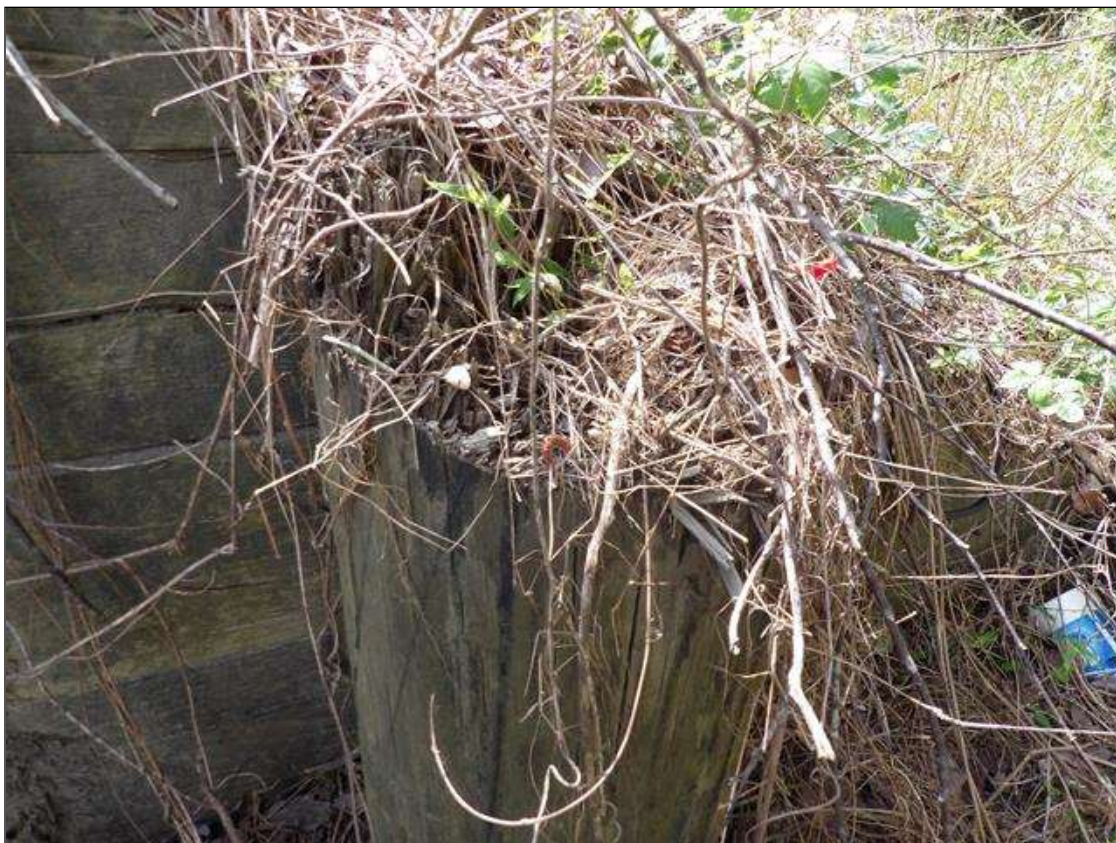
PAR--Southwest wingwall top 1' deep x full circumference area of decay to top holdback pile with 40% average remaining

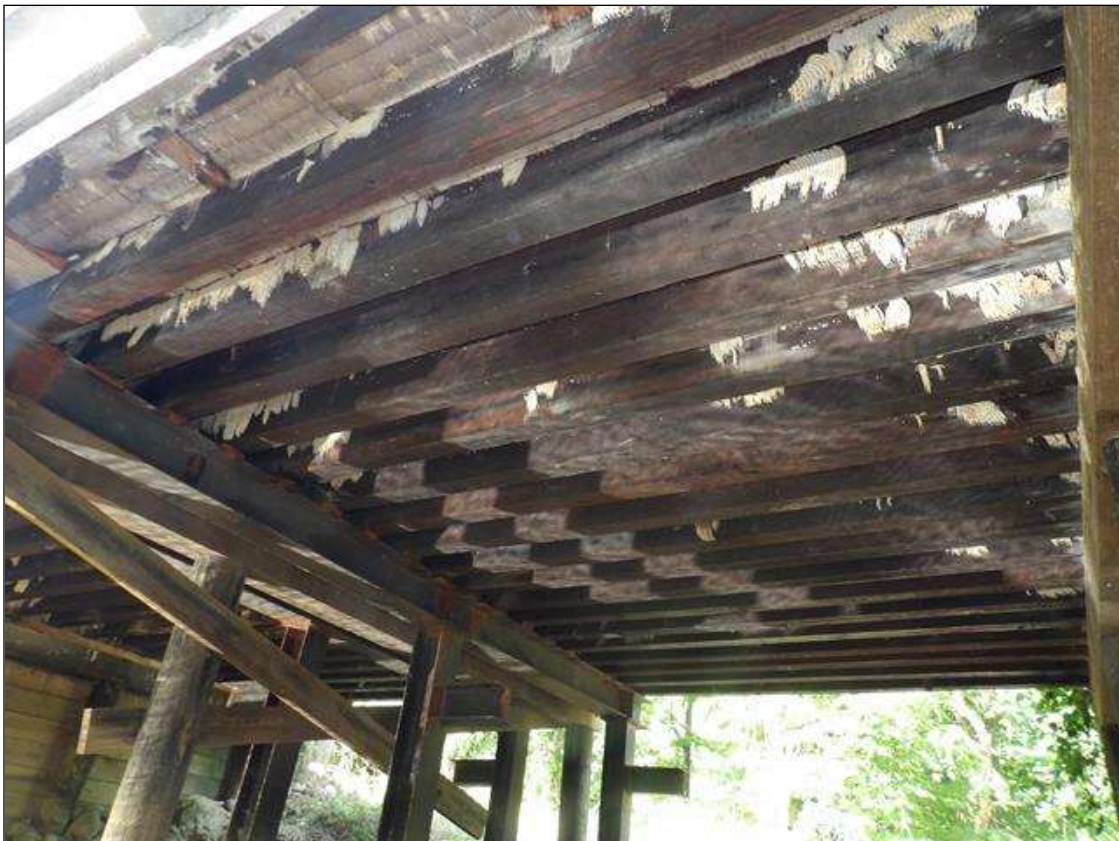
Superstructure underside span 2 shown, span 1 similar

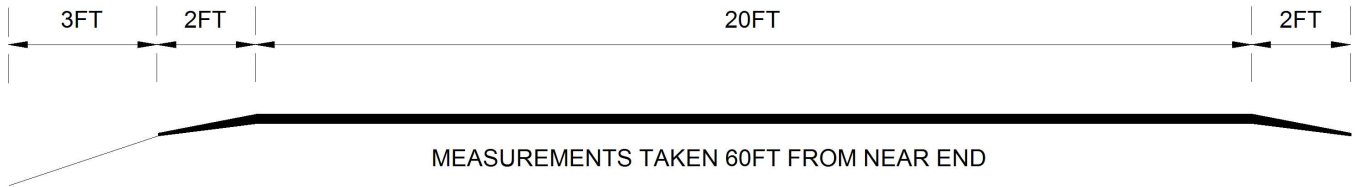
Roadway	20ft Wide	2 Paved Lanes	Looking North
Left Shoulder	5ft Wide	2ft Paved	3ft Unpaved
Right Shoulder	2ft Wide	2ft Paved	
Left Guardrail			
Right Guardrail

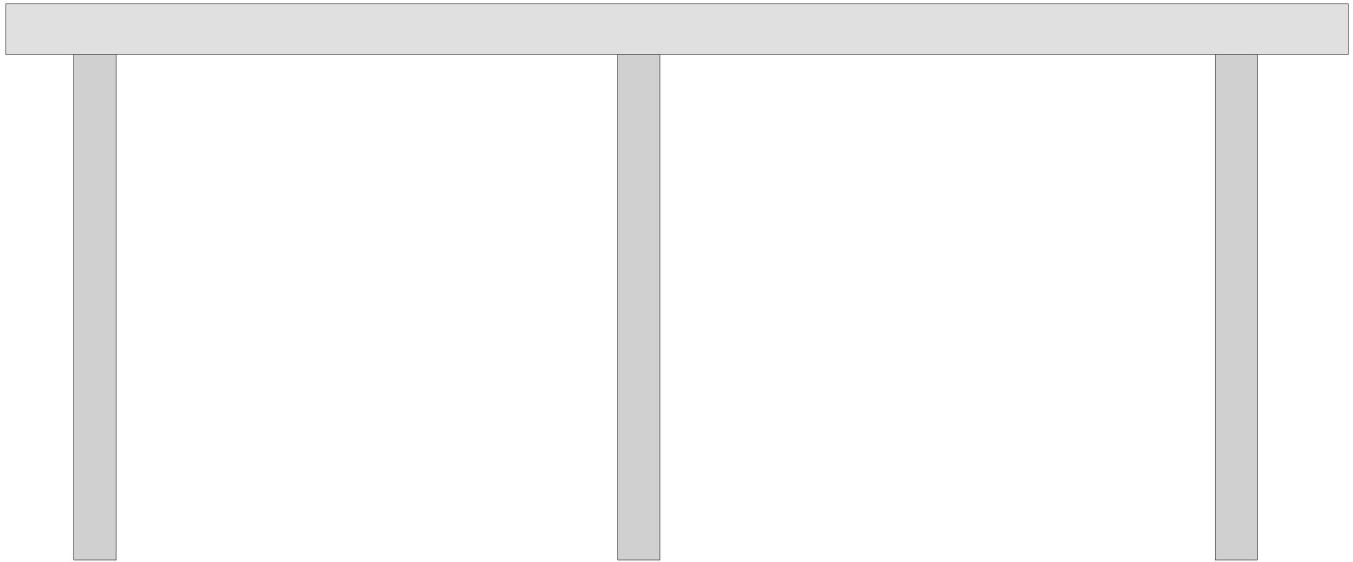
Cap Information			Material Steel							
Length	Width	Height	Left Overhang	Right Overhang	Left Beam to End of Cap.	Right Beam to End of Cap.				
26.04 ft.	1.000 ft.	1.000 ft.	1.750 ft.	1.850 ft.	0.750 ft.	1.333 ft.				
Subcap Information			Material							
Length	Width	Height	Left Overhang	Right Overhang	Left Pile to Splice.					
Sill Information			Material							
Length	Width	Height								
Pile #	Material	Spacing	Width/Dia.	Height	Length	Orientation	Driven?	Replacement?	Removed?	Collar?
1	Steel	10.7 ft.	0.833 ft.	0.833 ft.	30.00 ft.	Vertical	Yes	No	No	No
2	Steel	11.75 ft.	0.833 ft.	0.833 ft.	30.00 ft.	Vertical	Yes	No	No	No
3	Steel		0.833 ft.	0.833 ft.	30.00 ft.	Vertical	Yes	No	No	No
<p style="font-size: 1.2em; margin: 0;">MEAS. VERIFIED 6/7/2022...RFW</p>

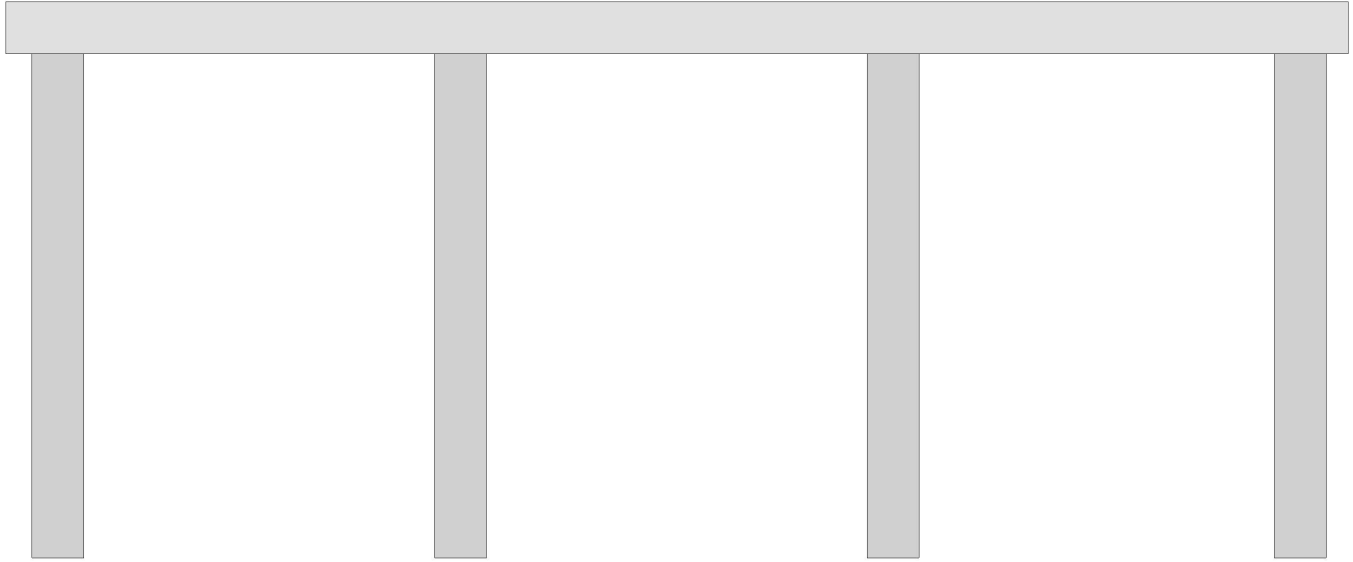
Cap Information			Material Timber							
Length	Width	Height	Left Overhang	Right Overhang	Left Beam to End of Cap.	Right Beam to End of Cap.				
25.840 ft.	.958 ft.	1.000 ft.	1.000 ft.	.920 ft.	.750 ft.	.750 ft.				
Subcap Information			Material							
Length	Width	Height	Left Overhang	Right Overhang	Left Pile to Splice.					
Sill Information			Material							
Length	Width	Height								
Pile #	Material	Spacing	Width/Dia.	Height	Length	Orientation	Driven?	Replacement?	Removed?	Collar?
1	Timber	7.75 ft.	1 ft.			Vertical	Yes	No	No	No
2	Timber	8.33 ft.	1 ft.			Vertical	Yes	No	No	No
3	Timber	7.84 ft.	1 ft.			Vertical	Yes	No	No	No
4	Timber		1 ft.			Vertical	Yes	No	No	No
<p>MEAS. VERIFIED 6/7/2022...RFW</p>										
Bent/Abutment #: 1			Similar Bents:

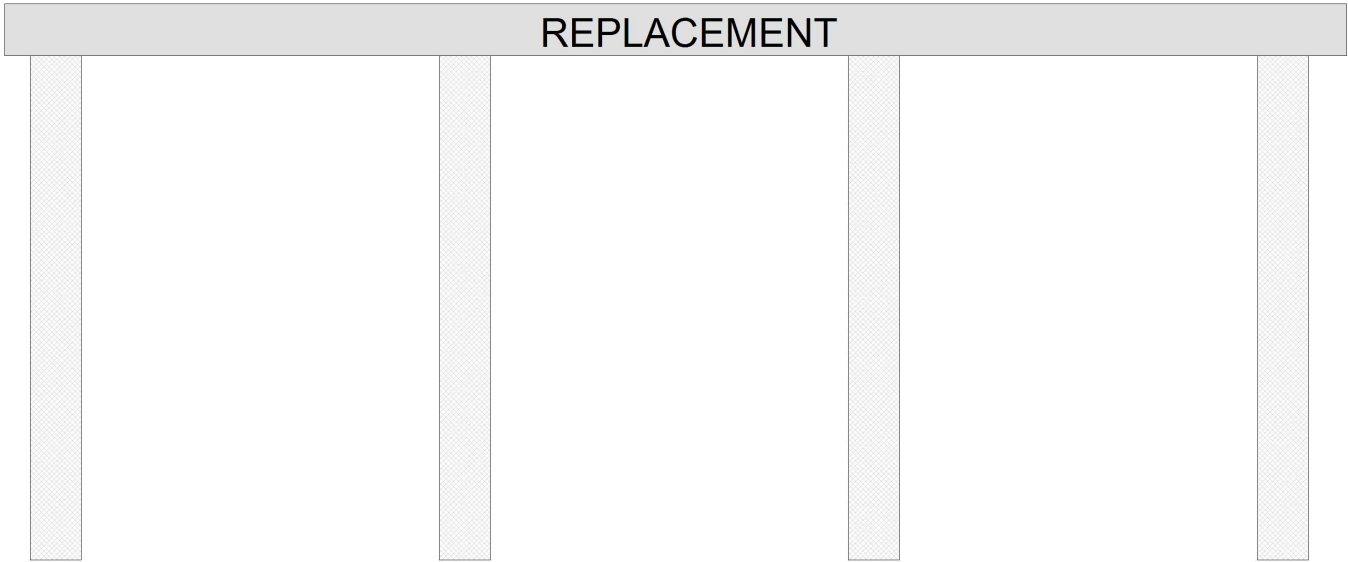
Cap Information			Material Timber							
Length	Width	Height	Left Overhang	Right Overhang	Left Beam to End of Cap.	Right Beam to End of Cap.				
26.250 ft.	.979 ft.	1.021 ft.	1.000 ft.	1.250 ft.	.830 ft.	.920 ft.				
Subcap Information			Material							
Length	Width	Height	Left Overhang	Right Overhang	Left Pile to Splice.					
Sill Information			Material							
Length	Width	Height								
Pile #	Material	Spacing	Width/Dia.	Height	Length	Orientation	Driven?	Replacement?	Removed?	Collar?
1	Timber	8 ft.	1 ft.			Vertical	Yes	No	No	No
2	Timber	8 ft.	1 ft.			Vertical	Yes	No	No	No
3	Timber	8 ft.	1 ft.			Vertical	Yes	No	No	No
4	Timber		1 ft.			Vertical	Yes	No	No	No
<p>MEAS. VERIFIED 6/7/2022...RFW</p>										
Bent/Abutment #: 2			Similar Bents:

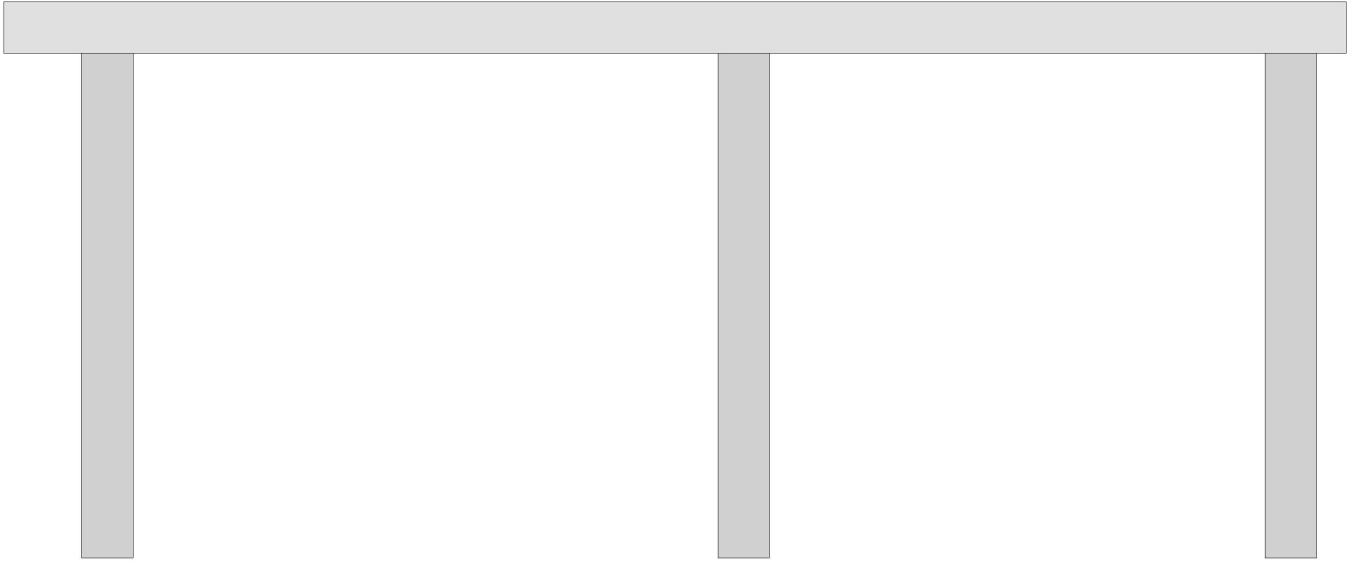
Cap Information			Material Steel							
Length	Width	Height	Left Overhang	Right Overhang	Left Beam to End of Cap.	Right Beam to End of Cap.				
26.000 ft.	1.000 ft.	1.000 ft.	1.5 ft.	1.6 ft.	3.000 ft.	3.000 ft.				
Subcap Information			Material							
Length	Width	Height	Left Overhang	Right Overhang	Left Pile to Splice.					
Sill Information			Material							
Length	Width	Height								
Pile #	Material	Spacing	Width/Dia.	Height	Length	Orientation	Driven?	Replacement?	Removed?	Collar?
1	Steel	10.60 ft.	1 ft.	1 ft.	30 ft.	Vertical	Yes	No	No	No
2	Steel	12.33 ft.	1 ft.	1 ft.	30 ft.	Vertical	Yes	No	No	No
3	Steel		1 ft.	1 ft.	30 ft.	Vertical	Yes	No	No	No
<p style="font-size: 1.2em; margin: 0;">MEAS. VERIFIED 6/7/2022...RFW</p>										
Bent/Abutment #: 2			Similar Bents:
