NC DEPARTMENT OF TRANSPORTATION  
 DIVISION OF HIGHWAYS  
 STRUCTURE MANAGEMENT UNIT

ATTENTION: **PAR'S SUBMITTED (IMPACT DAMAGE TO GURADRAIL, POT HOLE IN WEARING SURFACE AND SCOUR AT BENTS 1 & 2)**

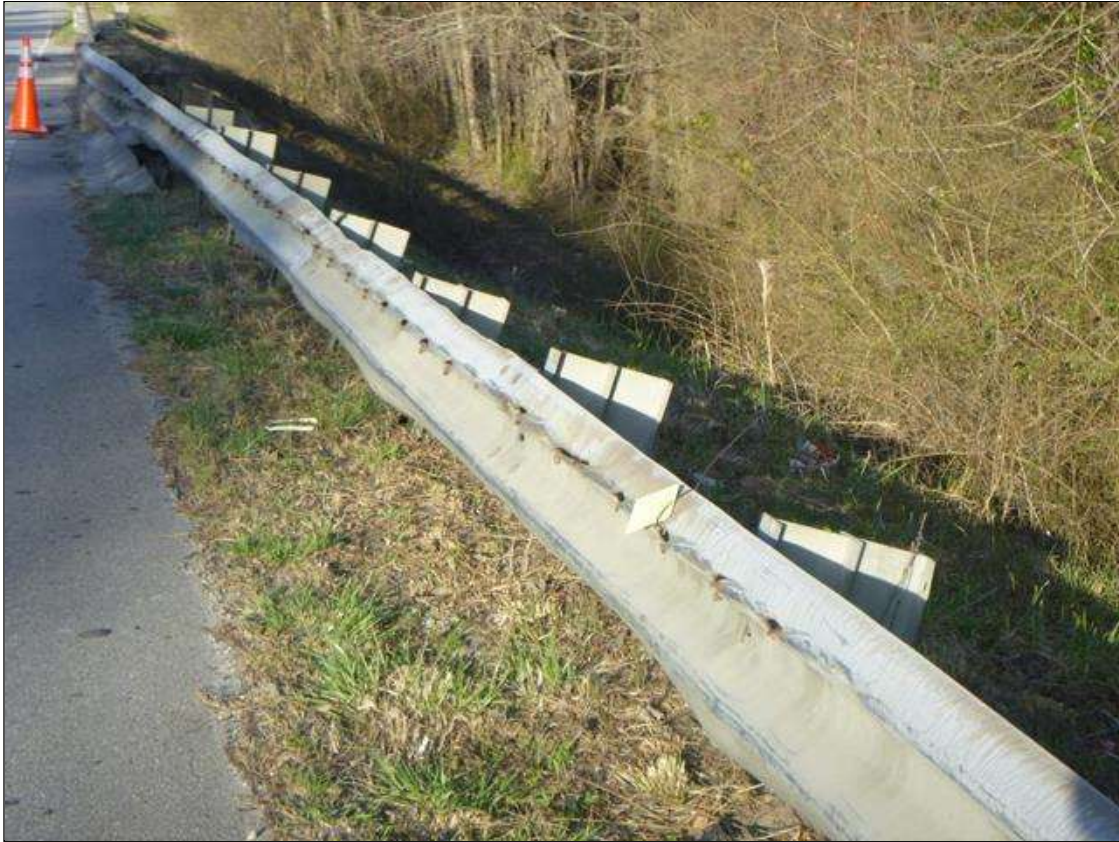
General Comments and Misc. Items: (PAR) 40' OF IMPACT DAMAGE, UP TO 1' DEFLECTION, GAUGES IN SOUTHEAST GUARDRAIL WITH 1 POST TO RAIL BOLT MISSING, 15' SOUTH OF BRIDGE.

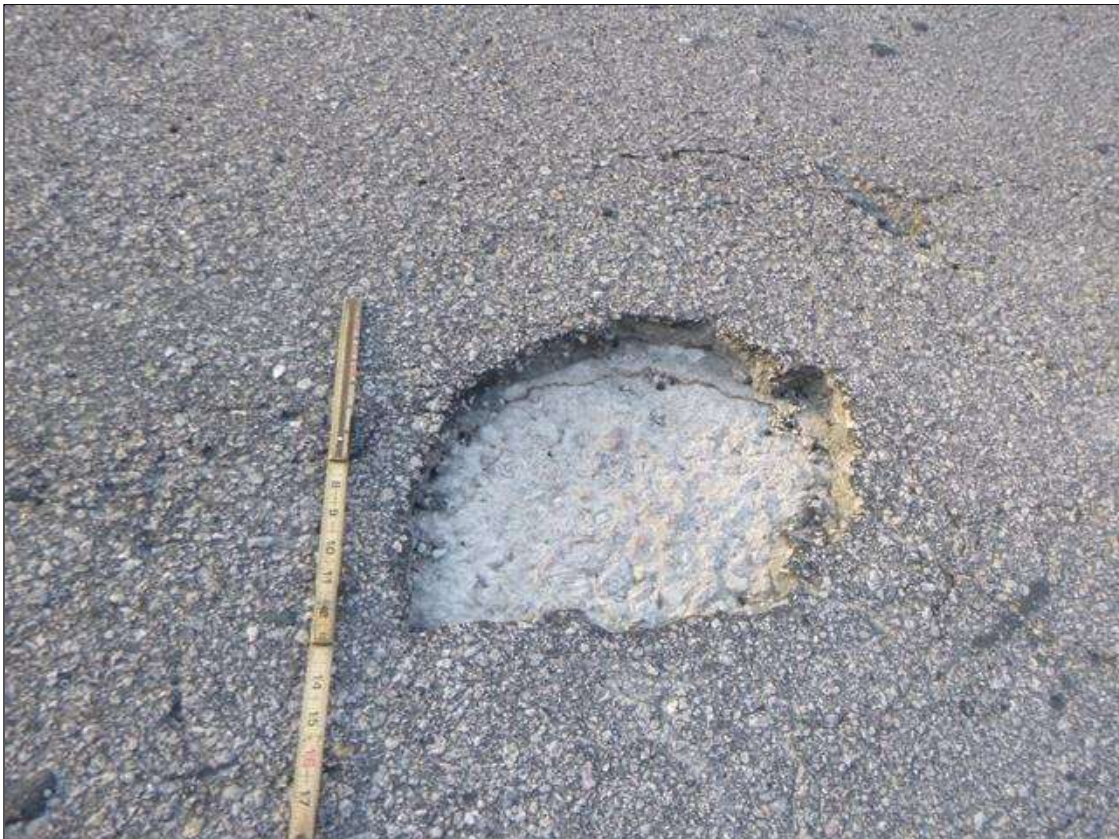
Span 1 Wearing Surface: (PAR) 17" X UP TO 12" X FULL DEPTH POT HOLE, 3' FROM ABUTMENT 1 AND 5' FROM EAST BRIDGE RAIL.

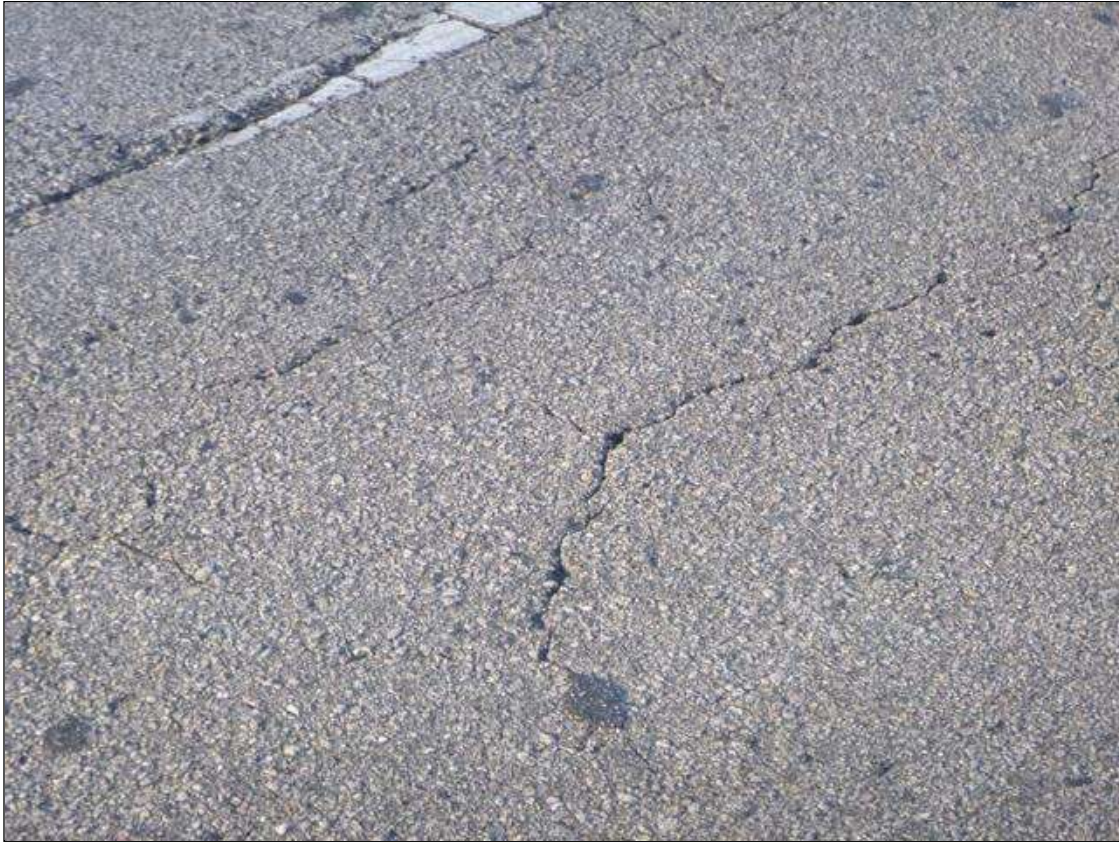
Span 1 Wearing Surface: SCATTERED HAIRLINE TO 1/8" WIDE MAP CRACKING IN ASPHALT WEARING SURFACE

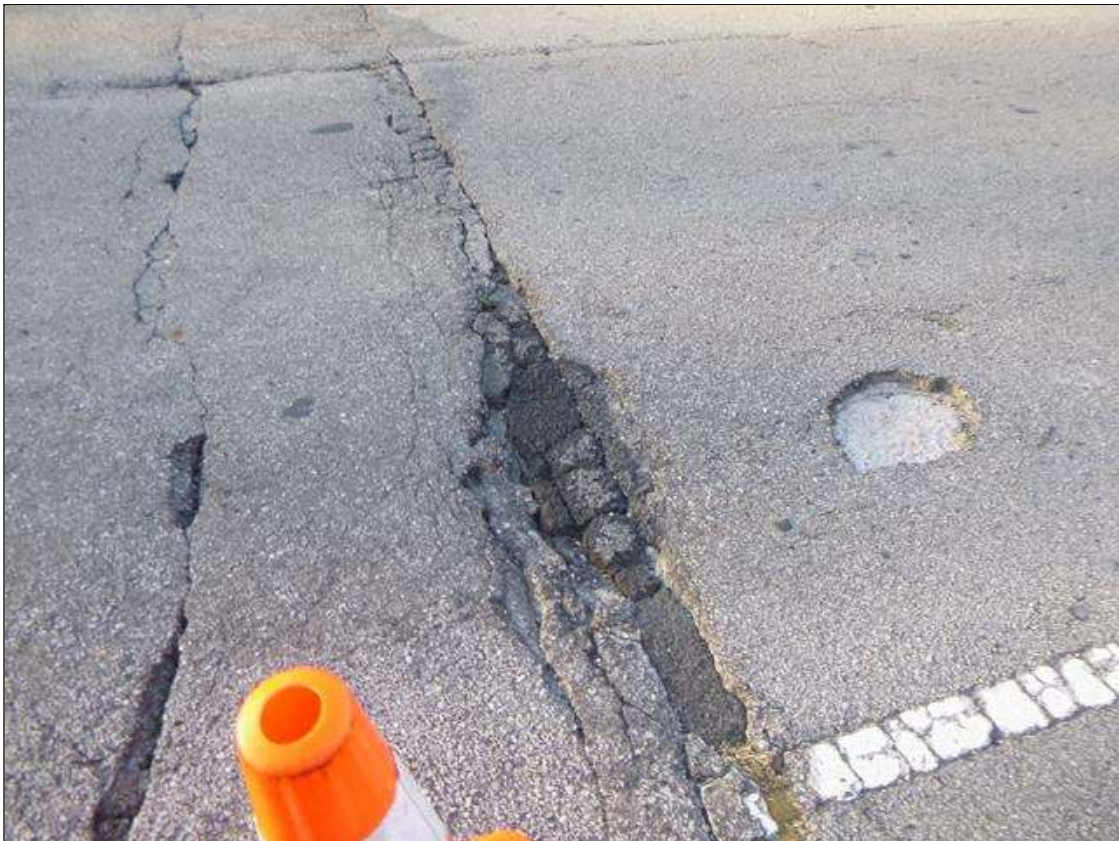
Span 1 Wearing Surface: UP TO 1/2" TRANSVERSE CRACKING AND 4' X UP TO 1' X 2" CRACKED PATCHED AREA IN EAST LANE IN ASPHALT WEARING SURFACE OVER ABUTMENT 1.

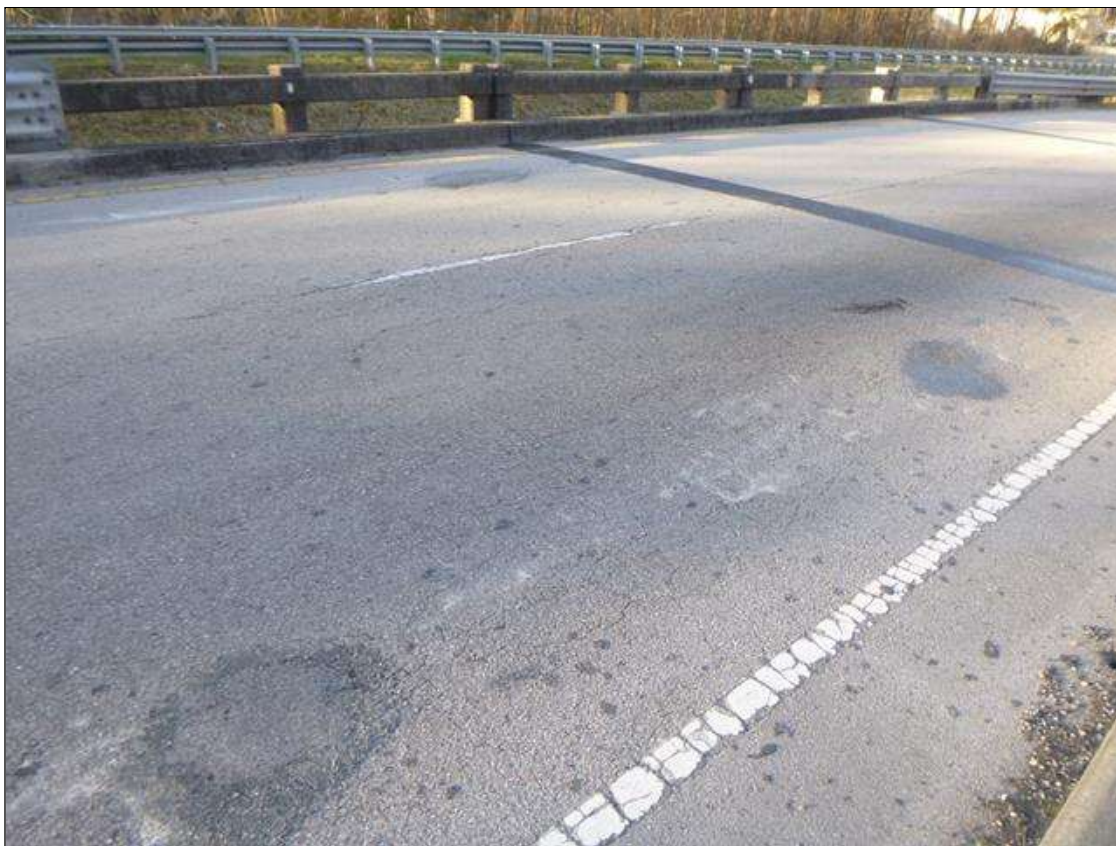
Span 1 Wearing Surface: 3- UP TO 3' X 1.5 SOUND PATCH IN ASPHALT WEARING SURFACE AT RANDOM THROUGHOUT.

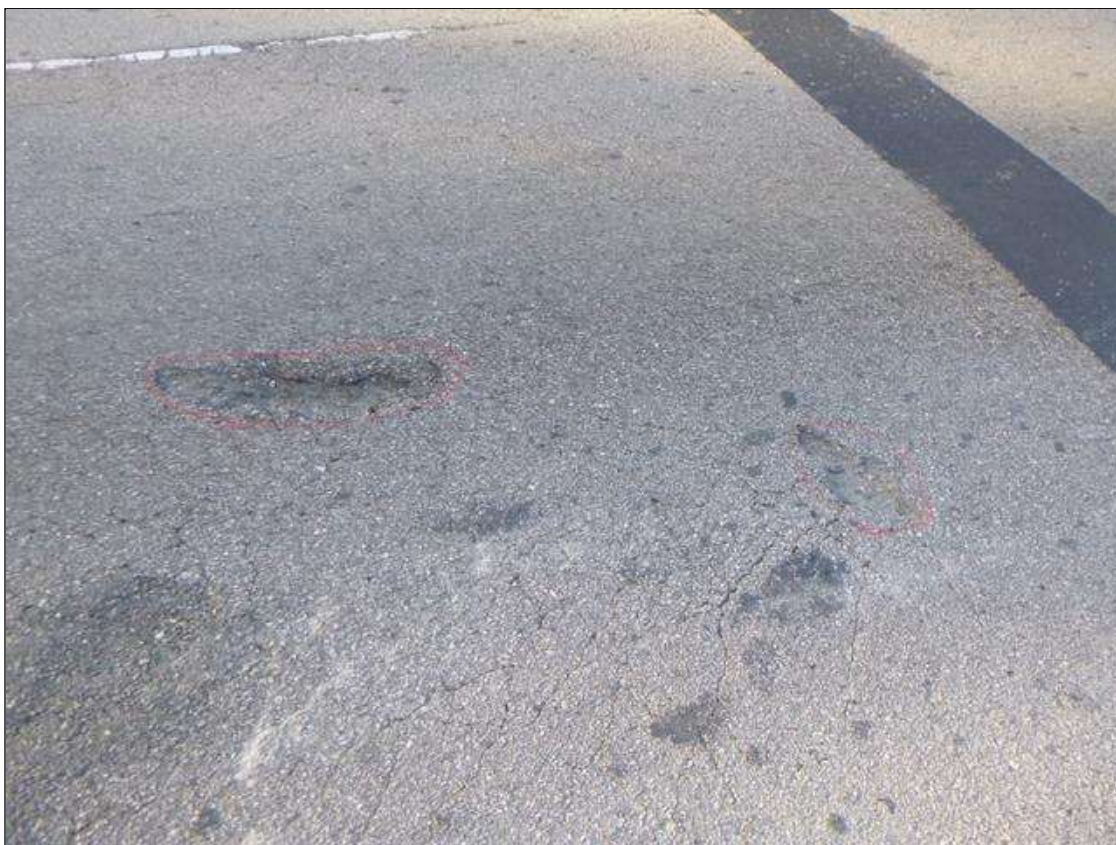
Span 1 Wearing Surface: 2- UP TO 20" X 6" X 1" POTHOLES, NEAR BENT 1 IN EAST LAST.

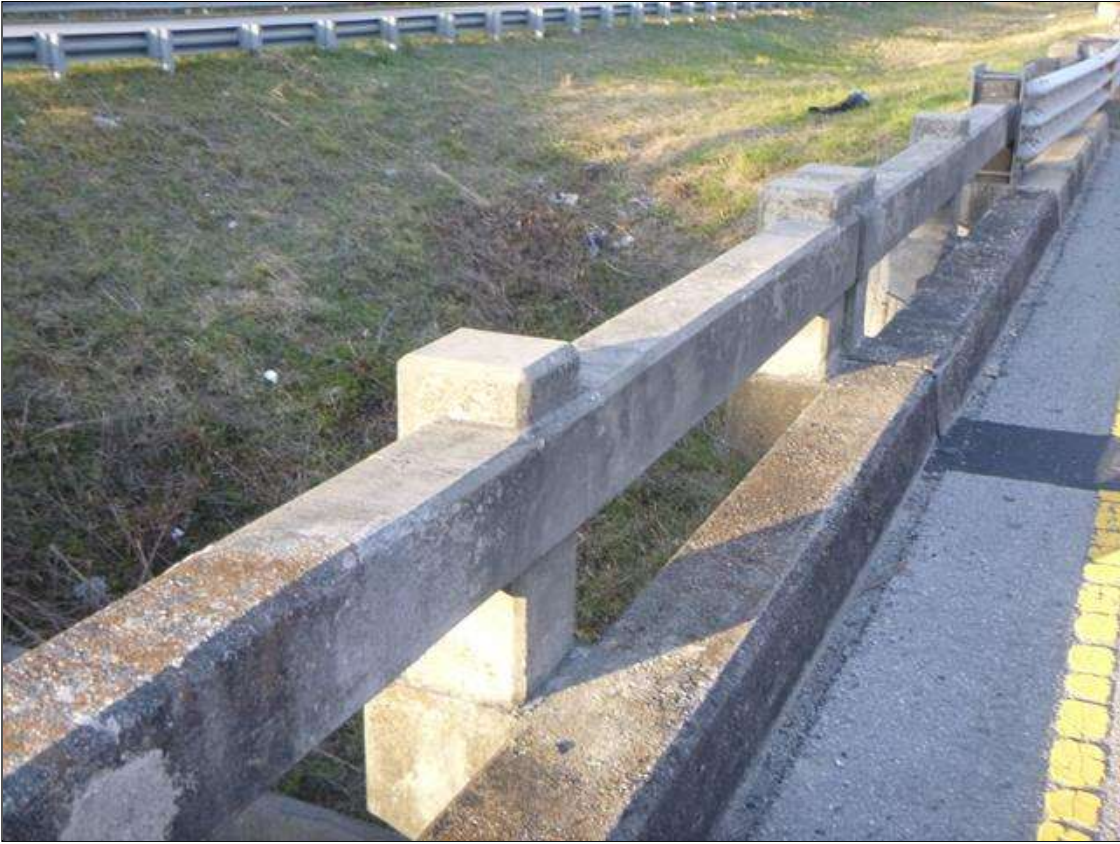
Span 2 Left Bridge Rail: PATCHED AREA IN LEFT RAIL, SPAN 2 (14' LONG)

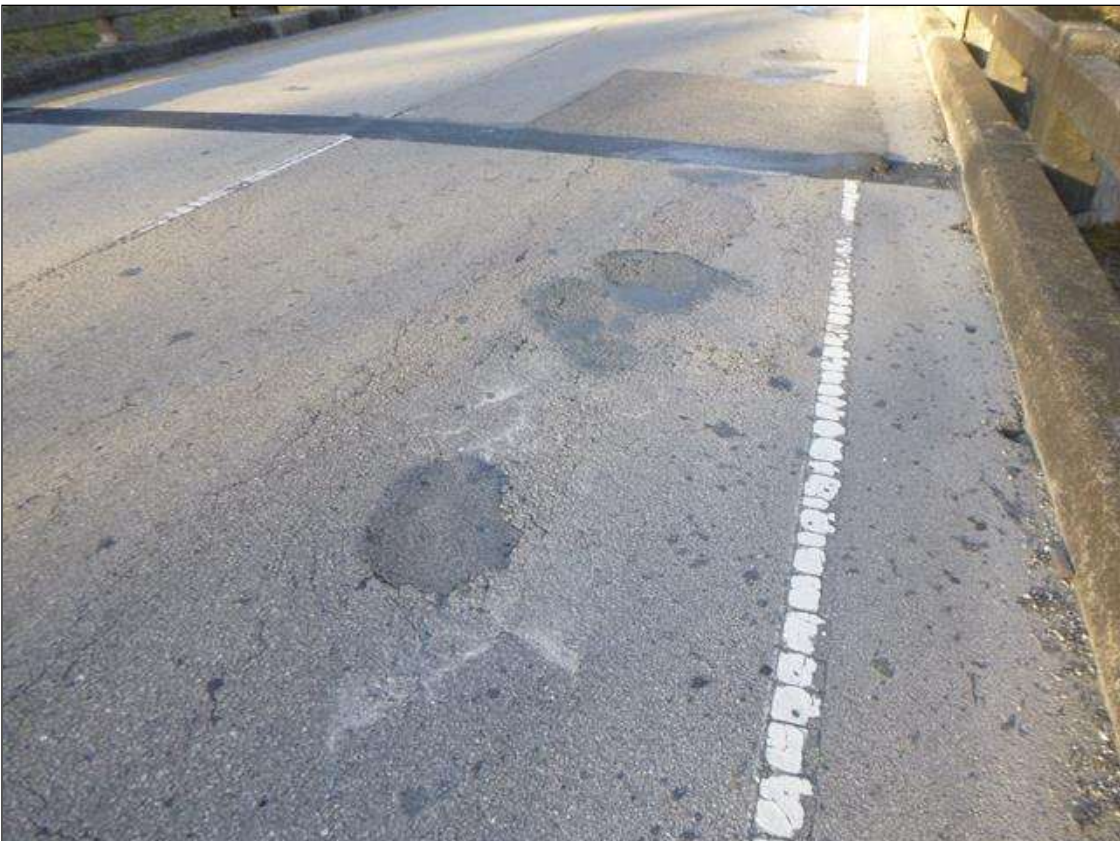
Span 2 Wearing Surface: A FEW SOUND PATCHED AREAS IN ASPHALT WEARING SURFACE LANE #2 RIGHT WHEEL PATH (10' FROM NORTH END) (UP TO 1.5' LONG X 2' WIDE)

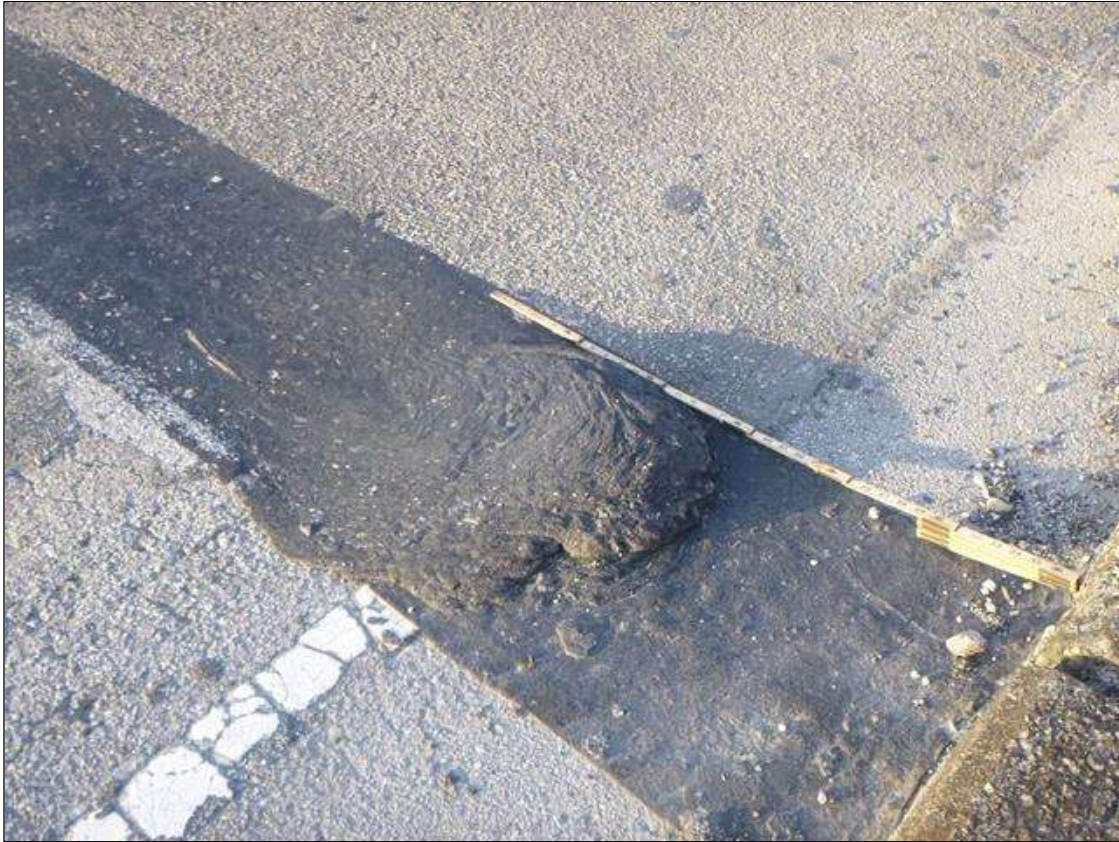
Span 2 Wearing Surface: UP TO 20" DIAMETER X 2" BUILDUP ON ASPHALT WEARING SURFACE OVER BENT 2, 2' FROM EAST BRIDGE RAIL.

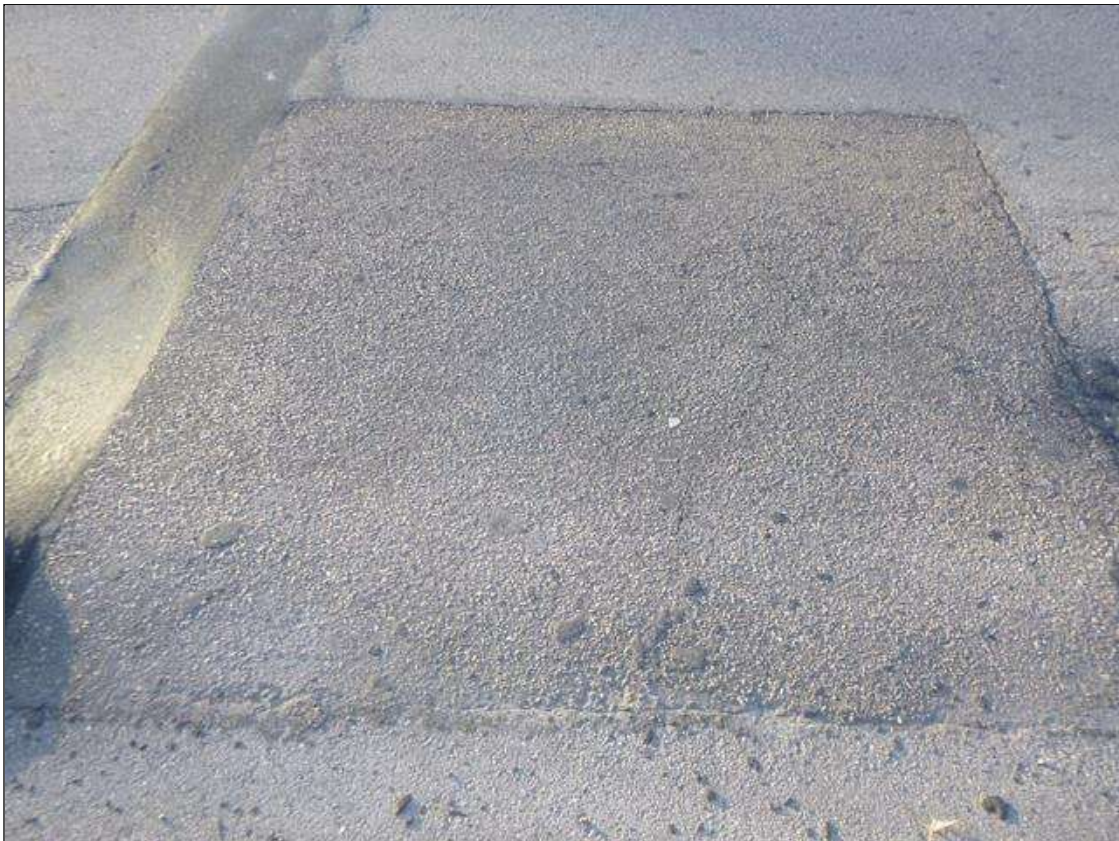
Span 3 Wearing Surface: 9' X 8' CRACKED PATCHED AREA WITH UP TO 1/4" CRACKING IN RIGHT LANE STARTING AT PIER 2

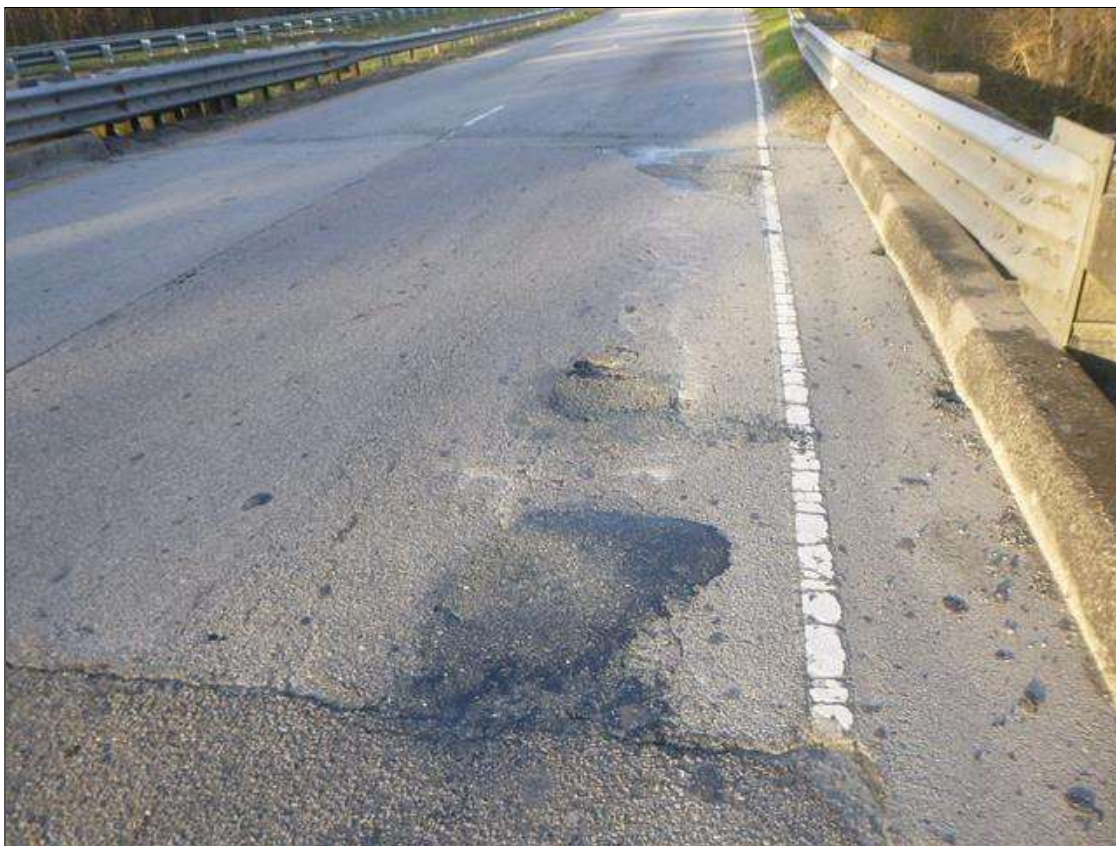
Span 3 Wearing Surface: 4 SOUND PATCHED AREAS IN RIGHT TRAVEL LANE UP TO 2.5' X 1.5'

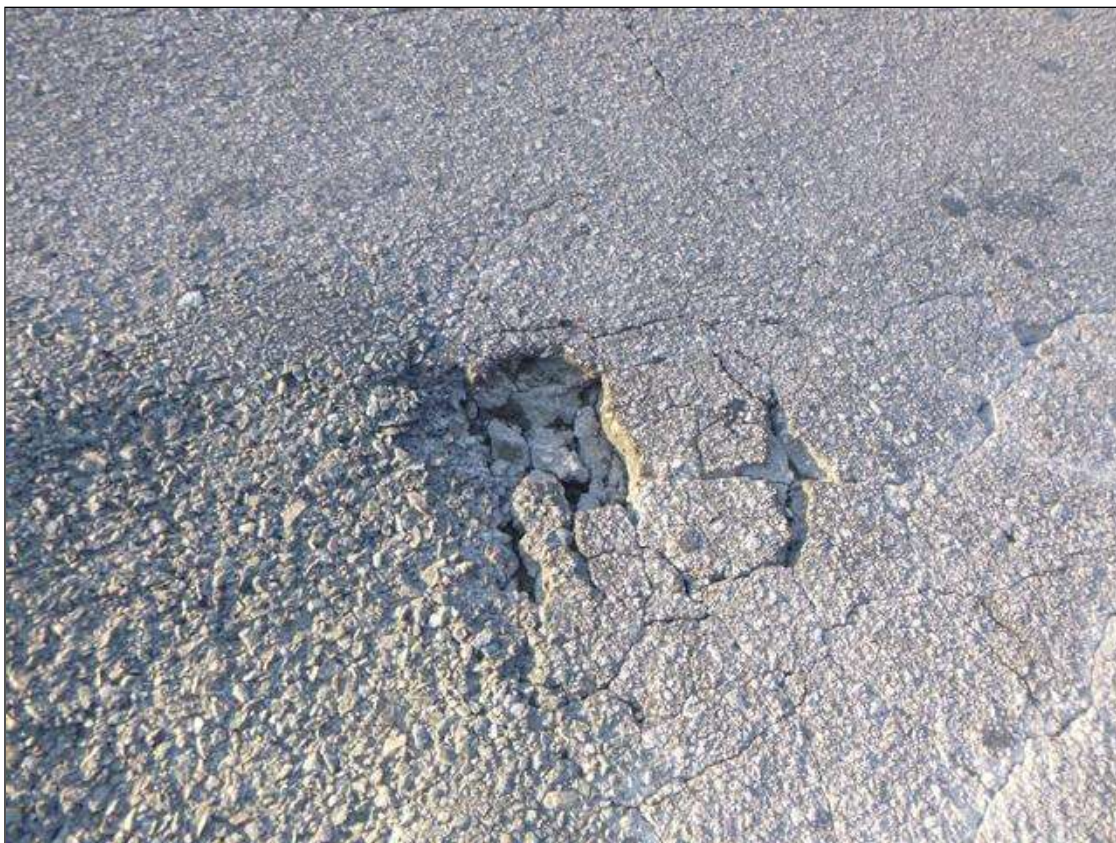
Span 3 Wearing Surface: 7" X 5" X 1" POTHOLE 5' FROM EAST BRIDGE RAIL AT MIDSPAN.

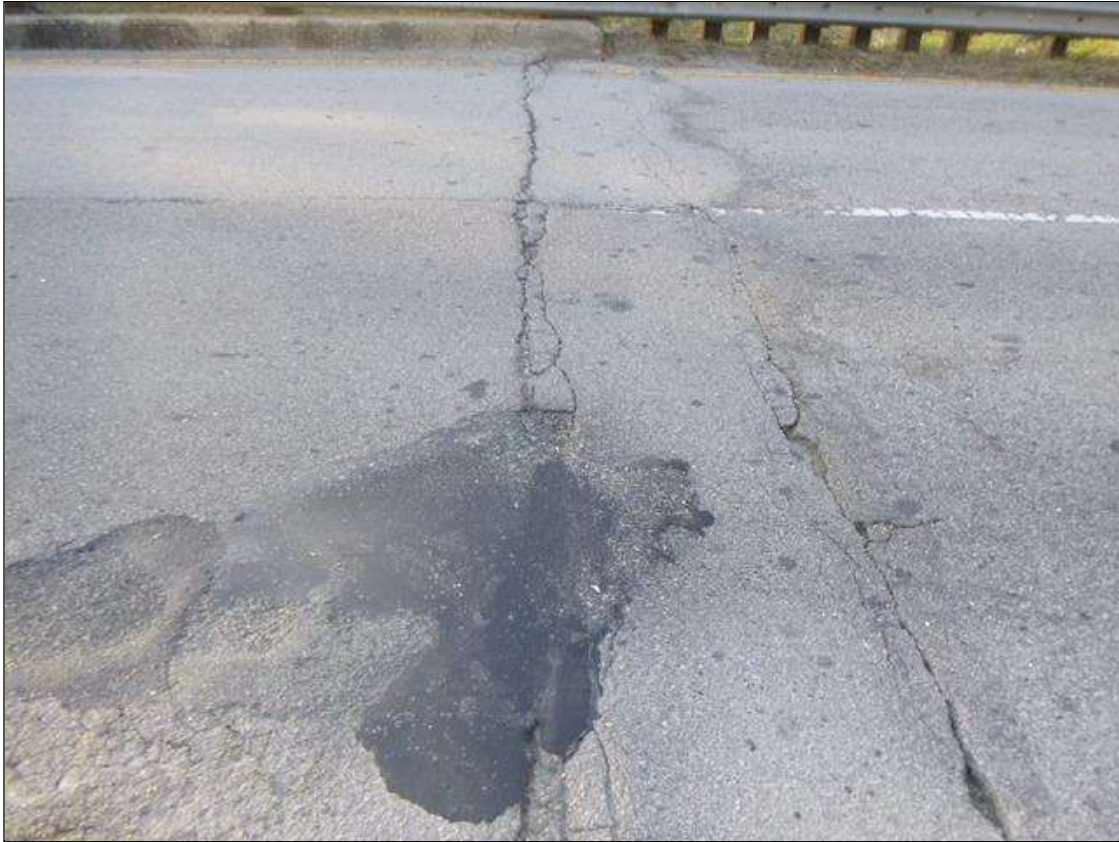
Span 3 Wearing Surface: TRANSVERSE CRACKING IN ASPHALT WEARING SURFACE OVER ABUTMENT 2 (UP TO 1/2" WIDE)

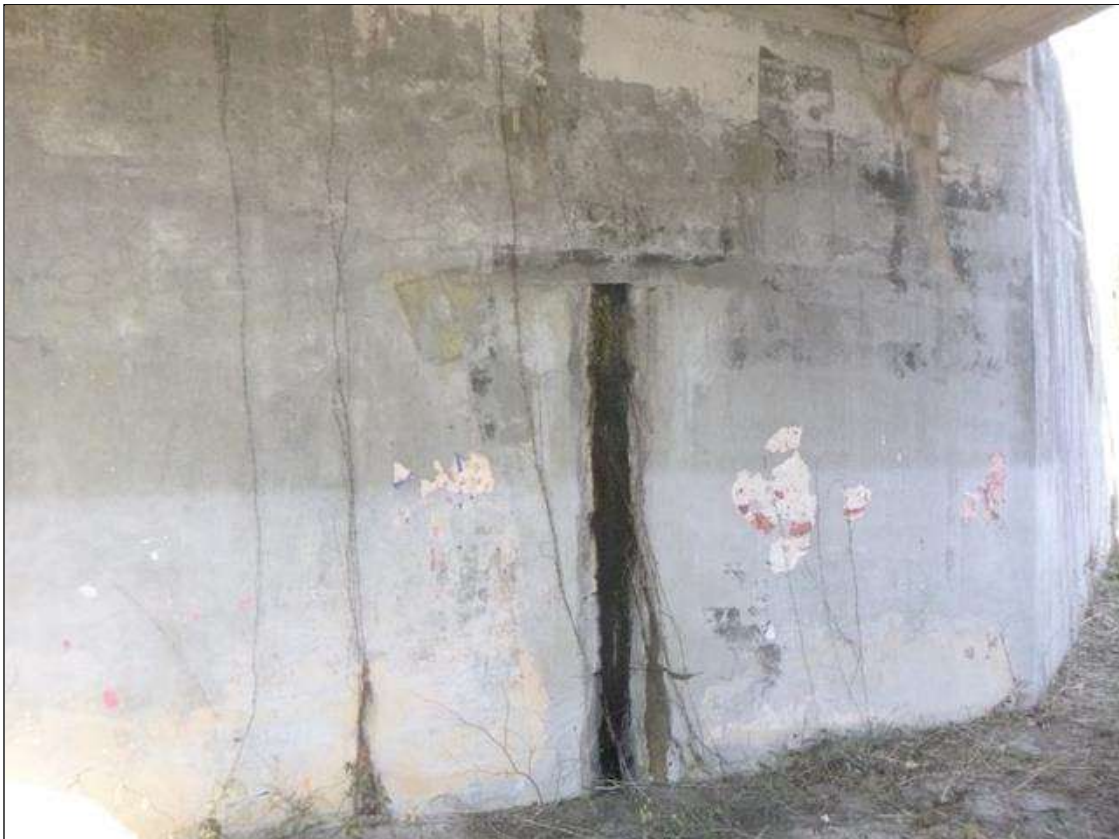
Abutment 2 Abutment: DIAGONAL / HORIZONTAL / VERTICAL CRACKING UP TO 1/32" WIDE ALONG THE ABUTMENT 2 BREASTWALL AT LOWER PORTION WITH RUST LEAKAGE.

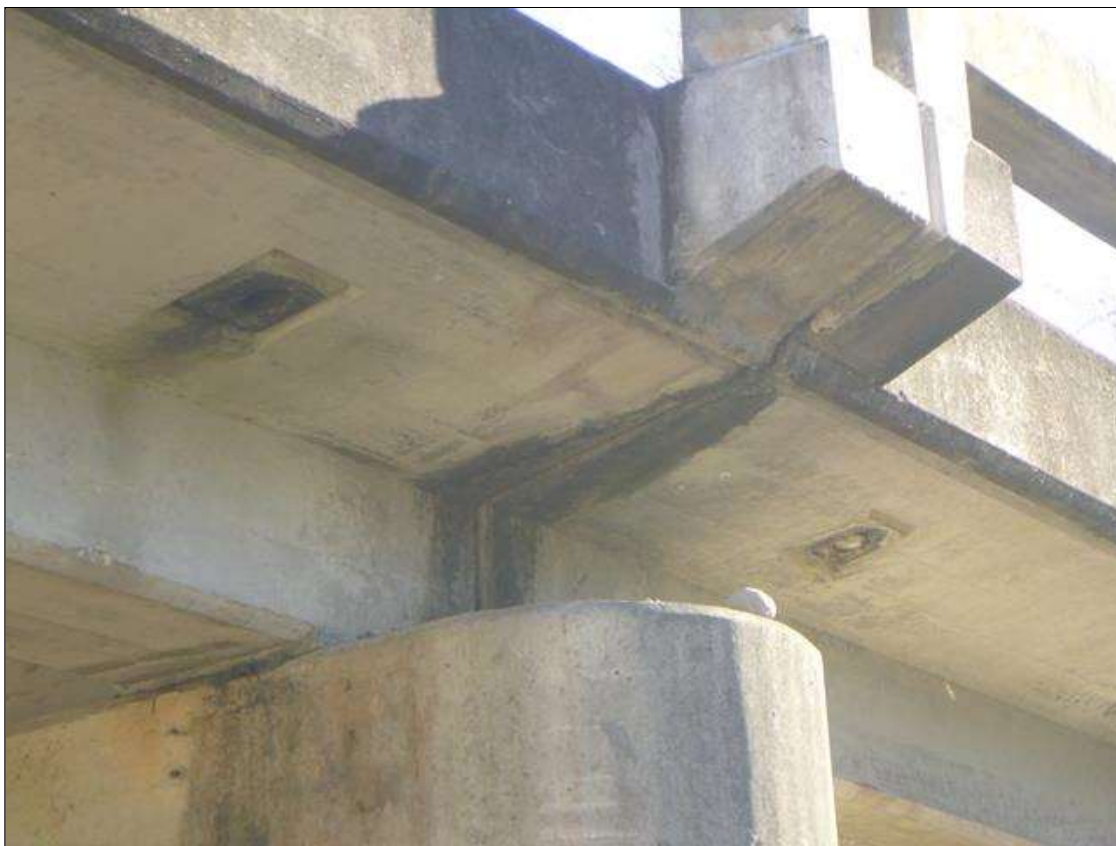
Span 3 Deck: SOUND PATCHED AREA WEST OVERHANG IN SPAN 3 BENT 2 (6" DIAMETER)

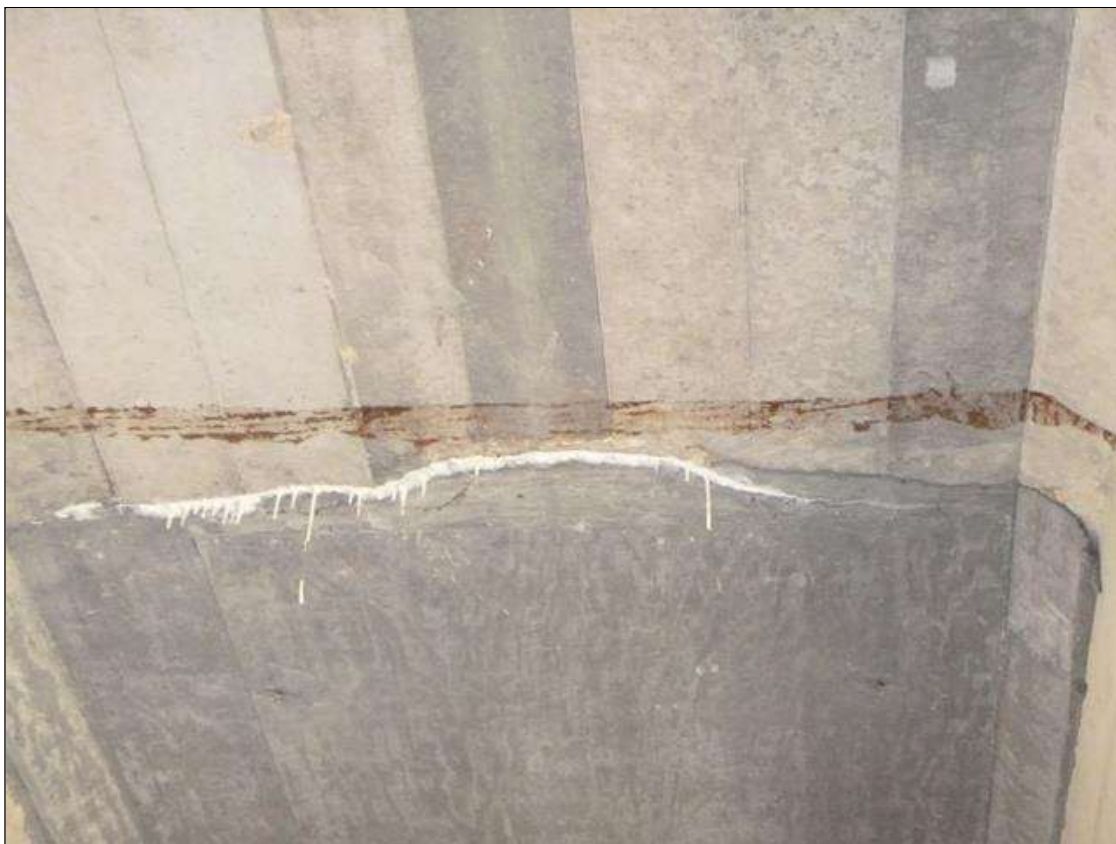
Span 3 Deck: HAIRLINE TRANSVERSE CRACK WITH EFFLORESCENCE BUILDUP IN SPAN 3 DECK UNDERSIDE IN BAY 3 AT END OF PATCHED AREA

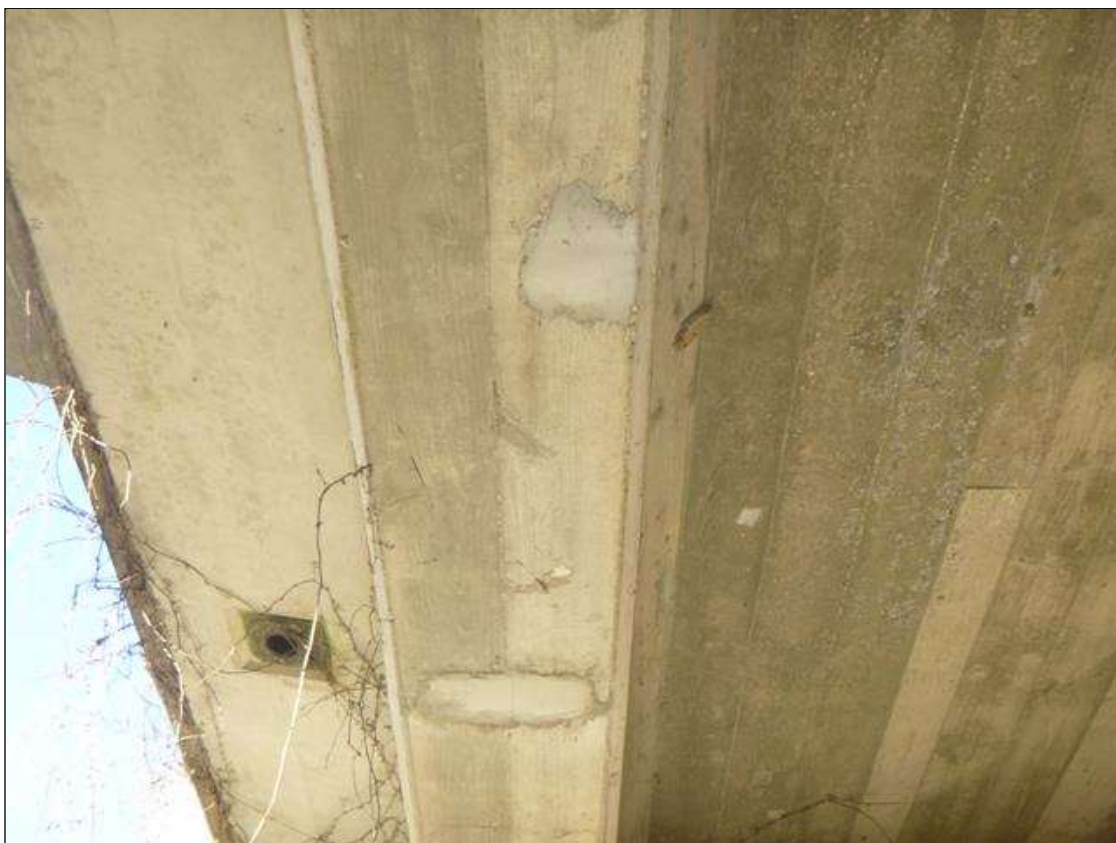
Span 3 Beam 1: 2- UP TO 9" X 6" CRACKED PATCHED AREA WITH UP TO 1/32" CRACKING ON UNDERSIDE OF BEAM 6' FROM ABUTMENT 2

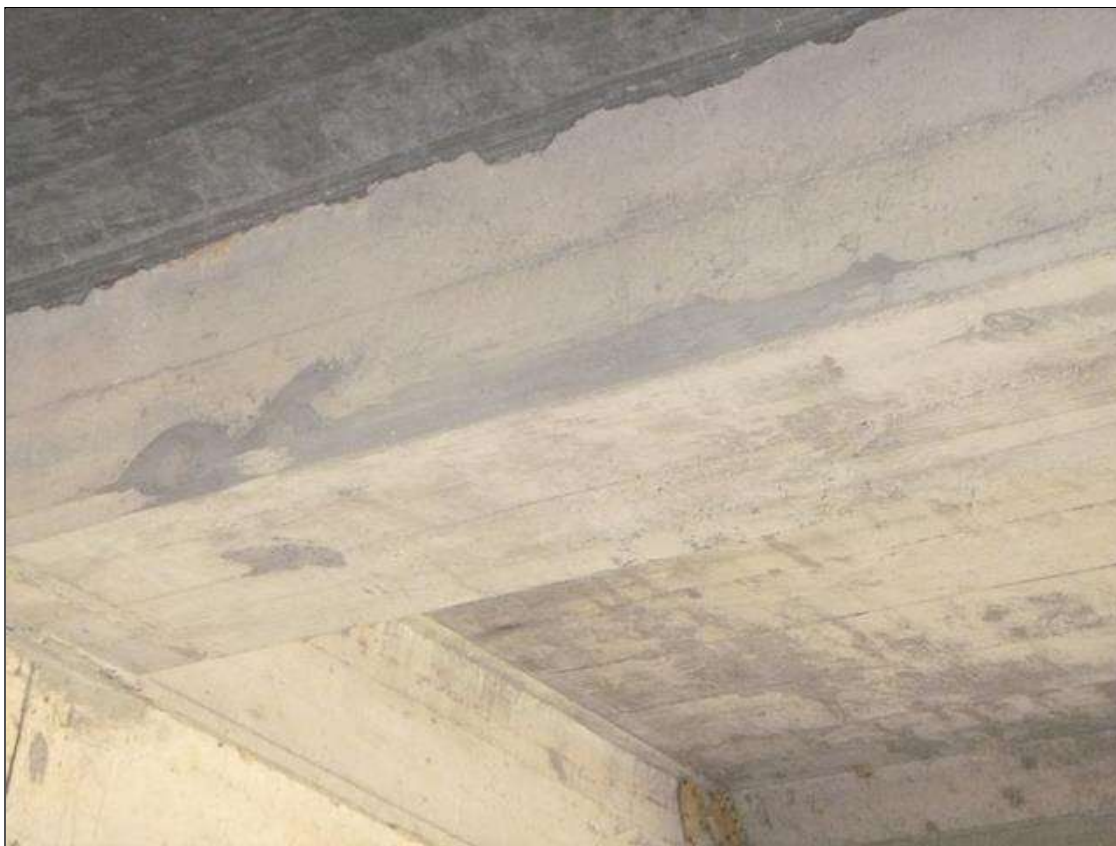
Span 3 Beam 3: GIRDER 3 IN SPAN 3 AT PIER 2 BAY 3 SIDE LONGITUDINAL CRACKING 3' LONG THAT HAS BEEN PATCHED AND IS SOUND

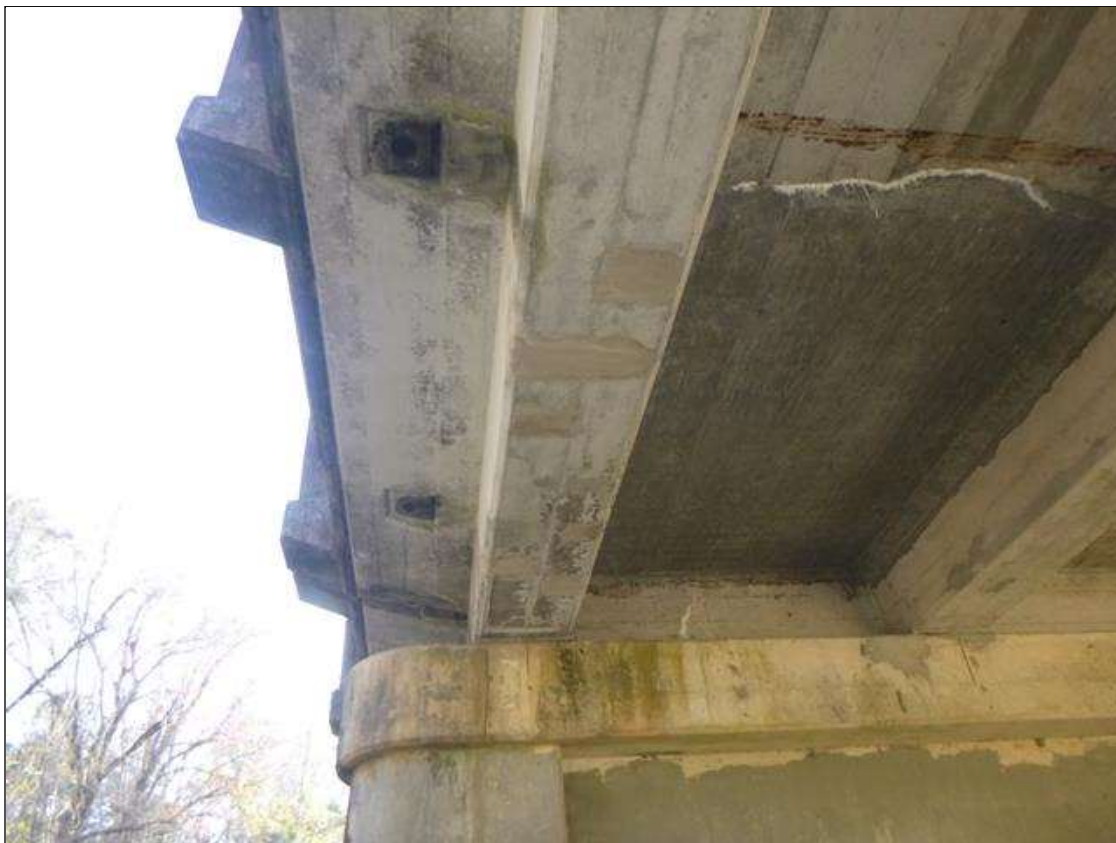
Span 3 Beam 4: SEVERAL SOUND PATCHED AREAS IN GIRDER 4 UNDERSIDE IN SPAN 3 STARTING AT PIER 2 (UP TO FULL WIDTH X 5" WIDE)

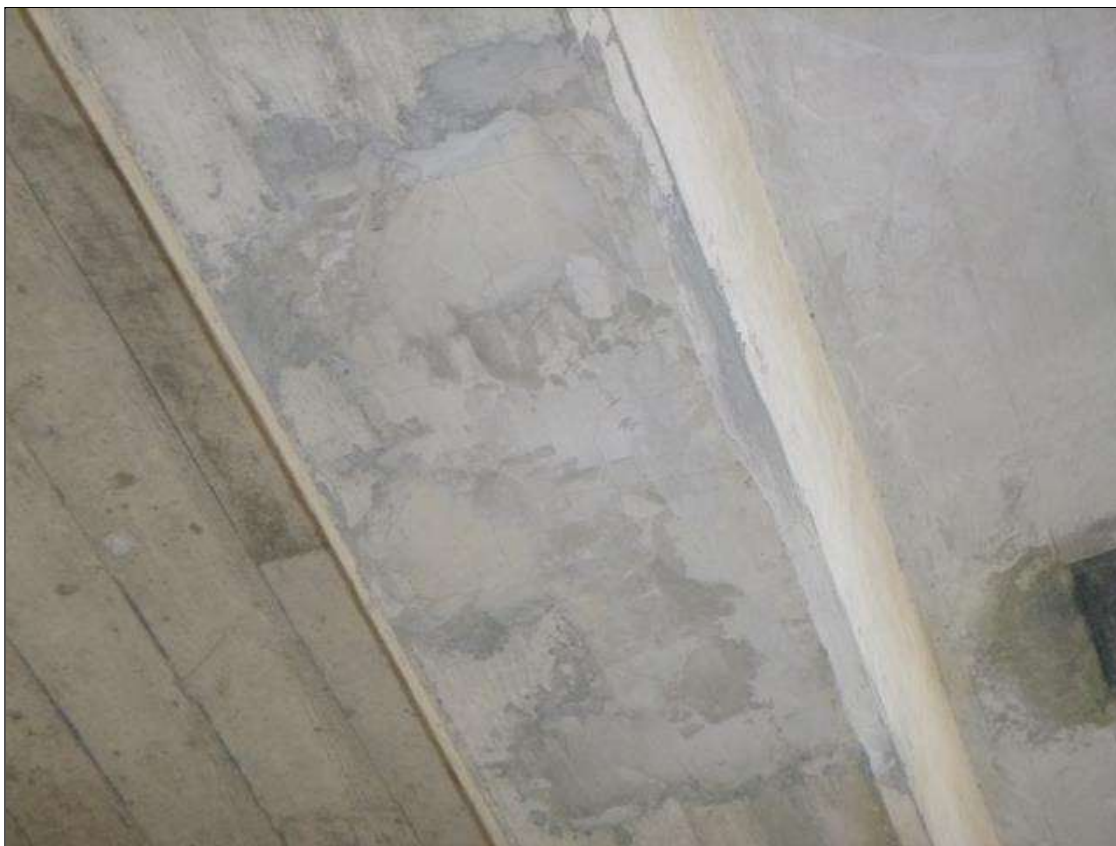
Span 3 Beam 4: CRACKED PATCHED AREA WITH UP TO 1/32" CRACKING IN GIRDER 4 UNDERSIDE IN SPAN 3, 5' FROM ABUTMENT 2 (2.5' LONG X 1.5' WIDE)

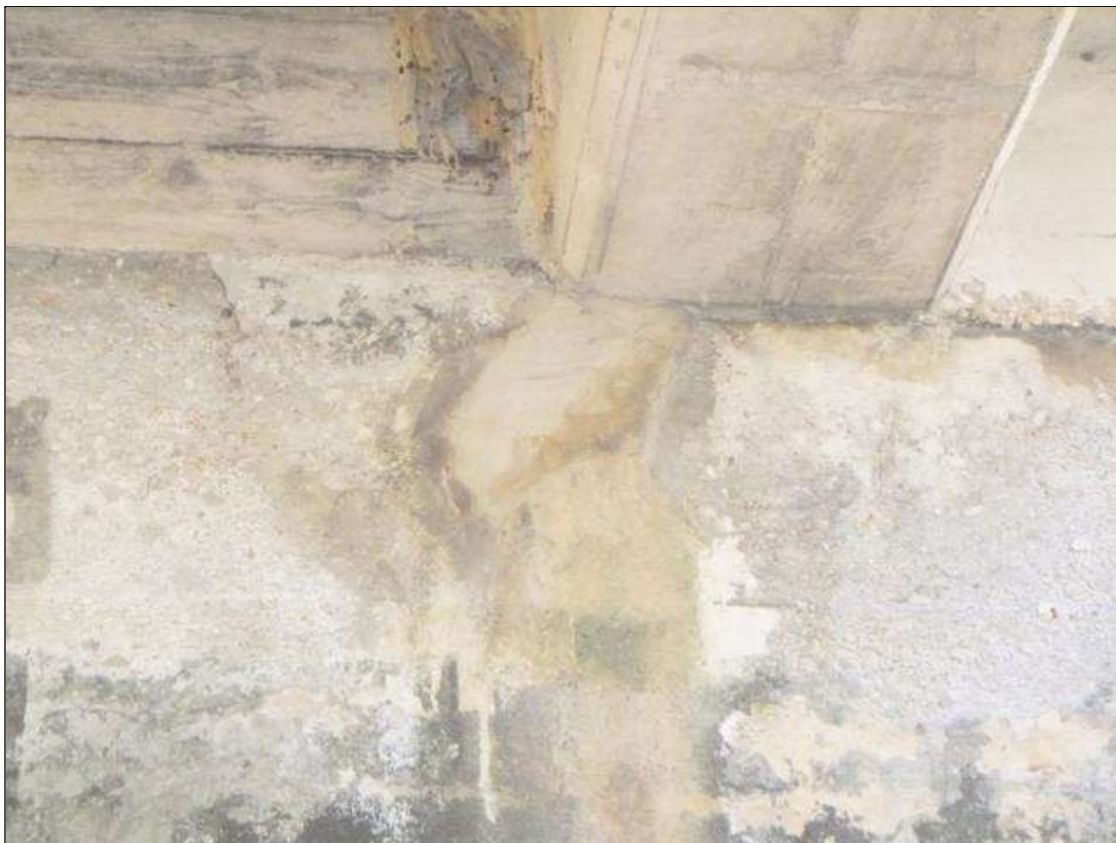
Abutment 2 Abutment: 1' X 1' CRACKED PATCHED AREA WITH UP TO 1/32" CRACKING WITH EFFLORESCENCE UNDER GIRDER 4.

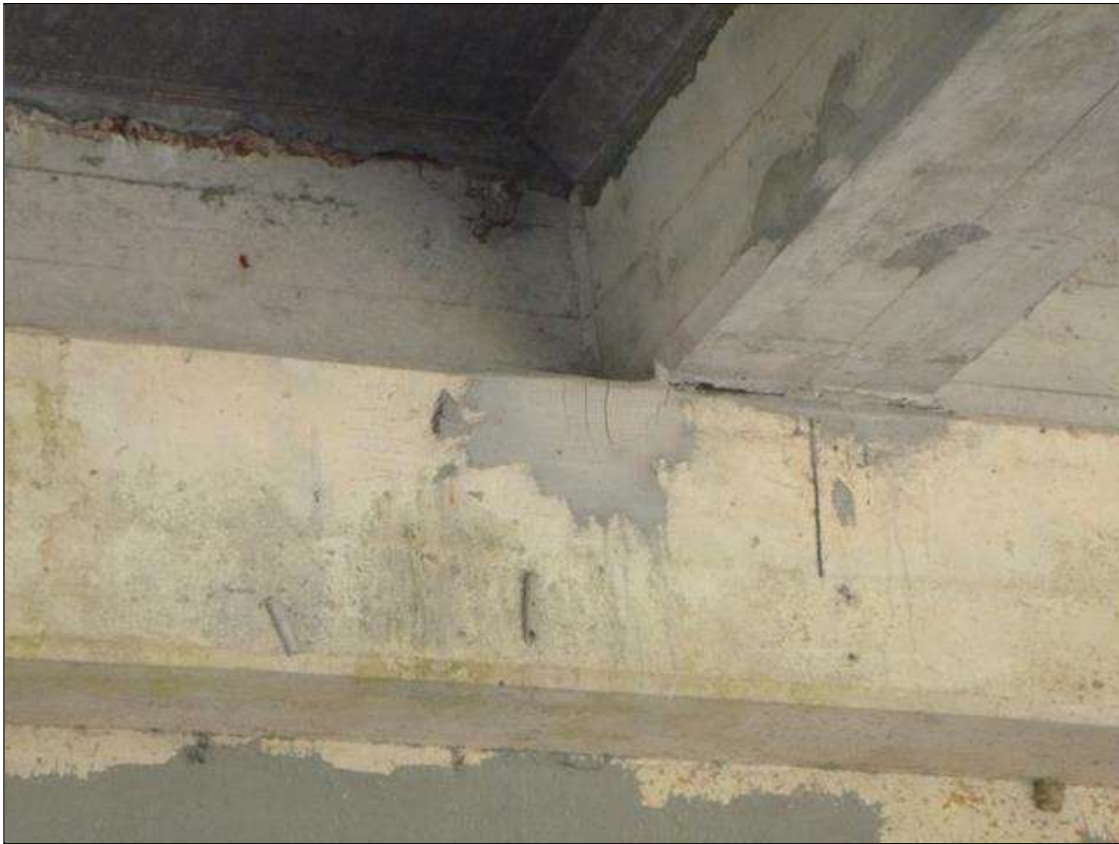
Bent 2 Cap 1: CRACKED PATCHED AREA WITH UP TO 1/16" CRACKING IN PIER 2 CAP SPAN 3 SIDE UNDER BAY 3, 9" LONG X 9" HIGH)

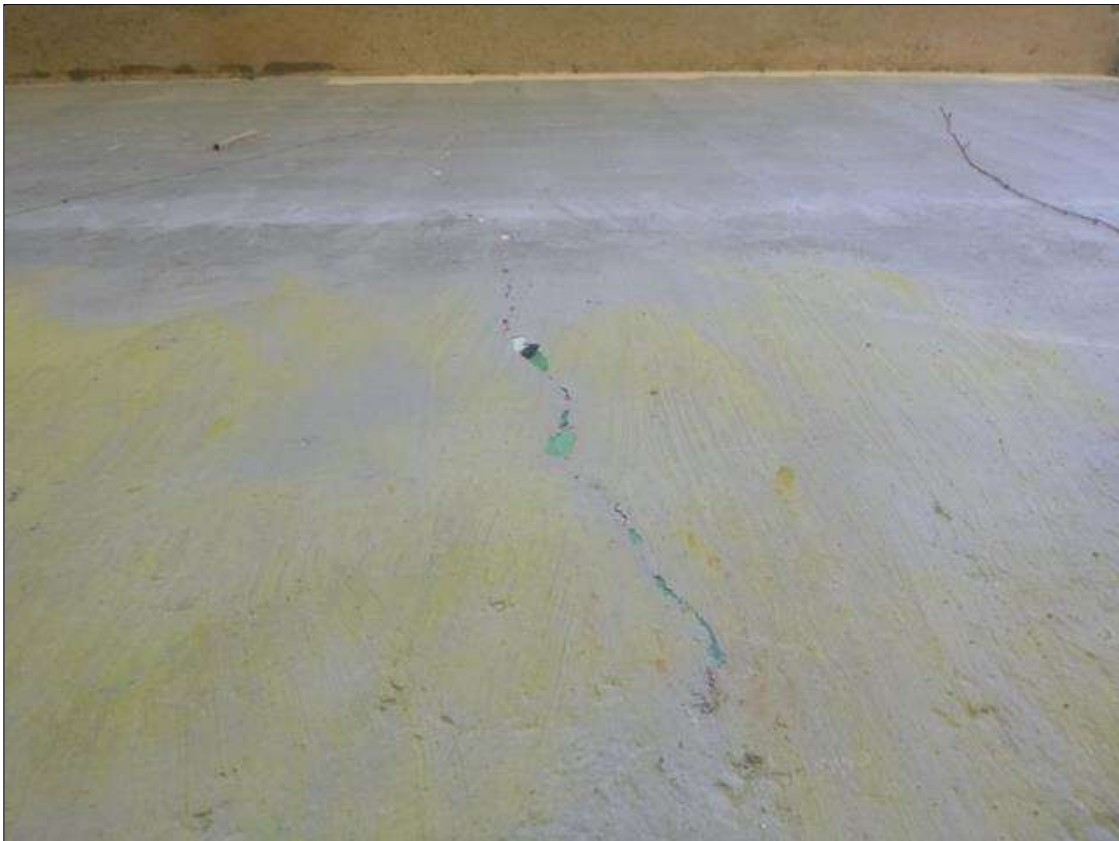
Bent 2 Pier 2: FULL HEIGHT VERTICAL HAIRLINE CRACKS ON NORTH AND SOUTH FACES UNDER BEAM 2 AND
