NC DEPARTMENT OF TRANSPORTATION  
 DIVISION OF HIGHWAYS  
 STRUCTURE MANAGEMENT UNIT

ATTENTION: **PAR'S SUBMITTED (IMPACT DAMAGE TO GURADRAIL, POT HOLE IN WEARING SURFACE AND SCOUR AT BENTS 1 & 2)**

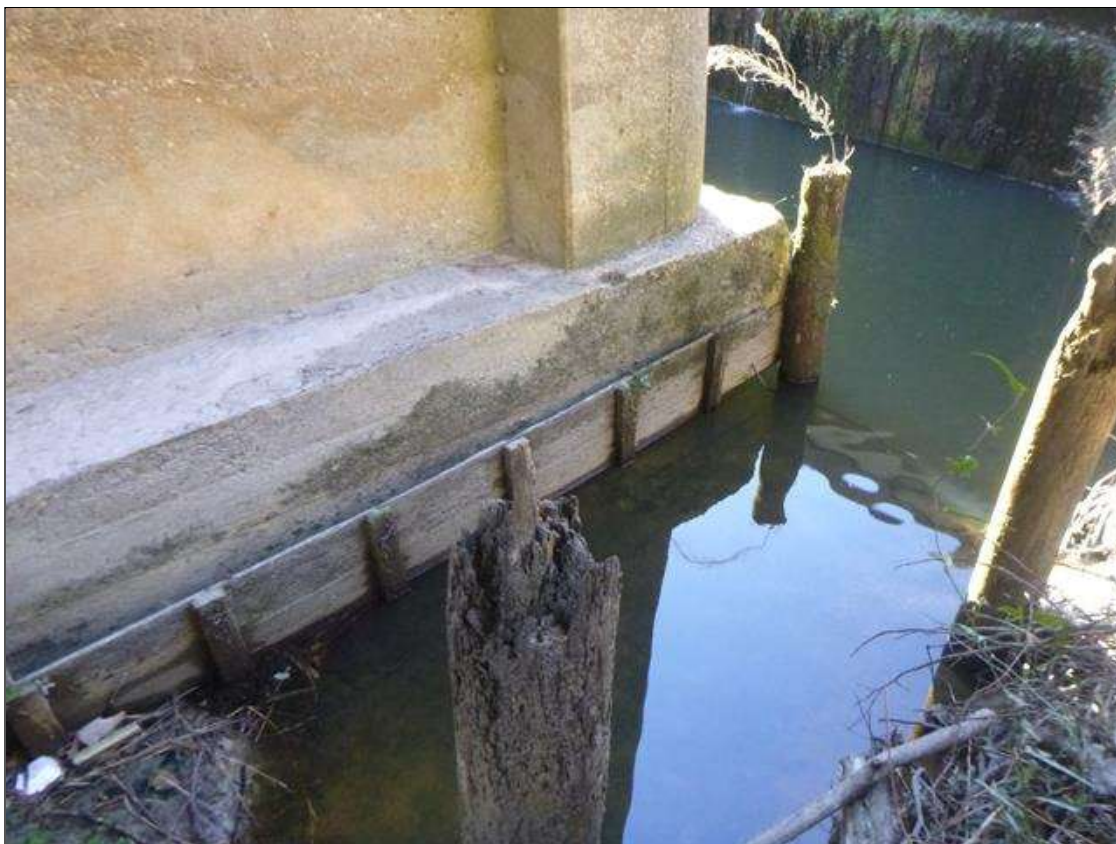
Bent 2 Footing: (PAR) SCOUR AROUND FOOTING FULL LENGTH EXPOSING FOOTING WITH 1' OF UNDERMINING FULL WIDTH AT UPSTREAM END

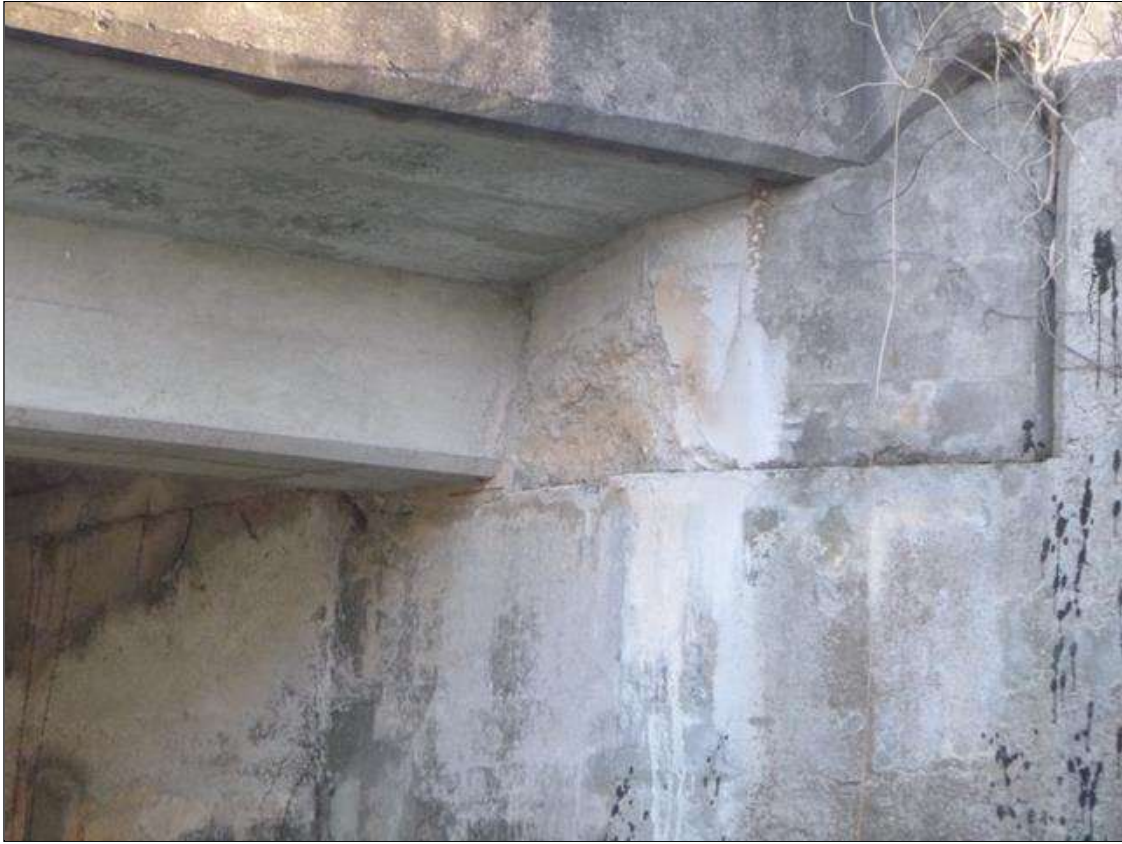
Abutment 1 Abutment: 2' X UP TO 14" X 5" SPALL UNDER WEST OVERHANG ADJACENT TO BEAM 1.

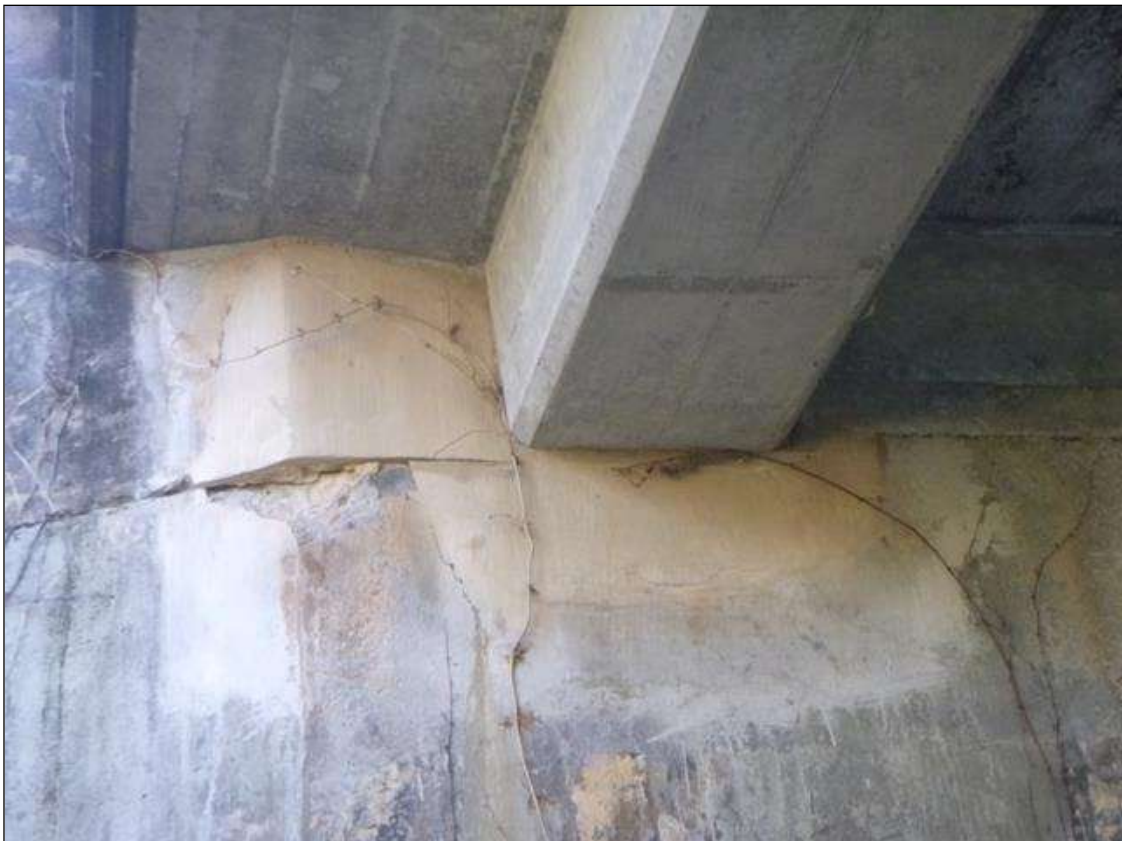
Abutment 1 Abutment: 3' WIDE X 1' HIGH SOUND PATCH AT TOP AT BEAM 4

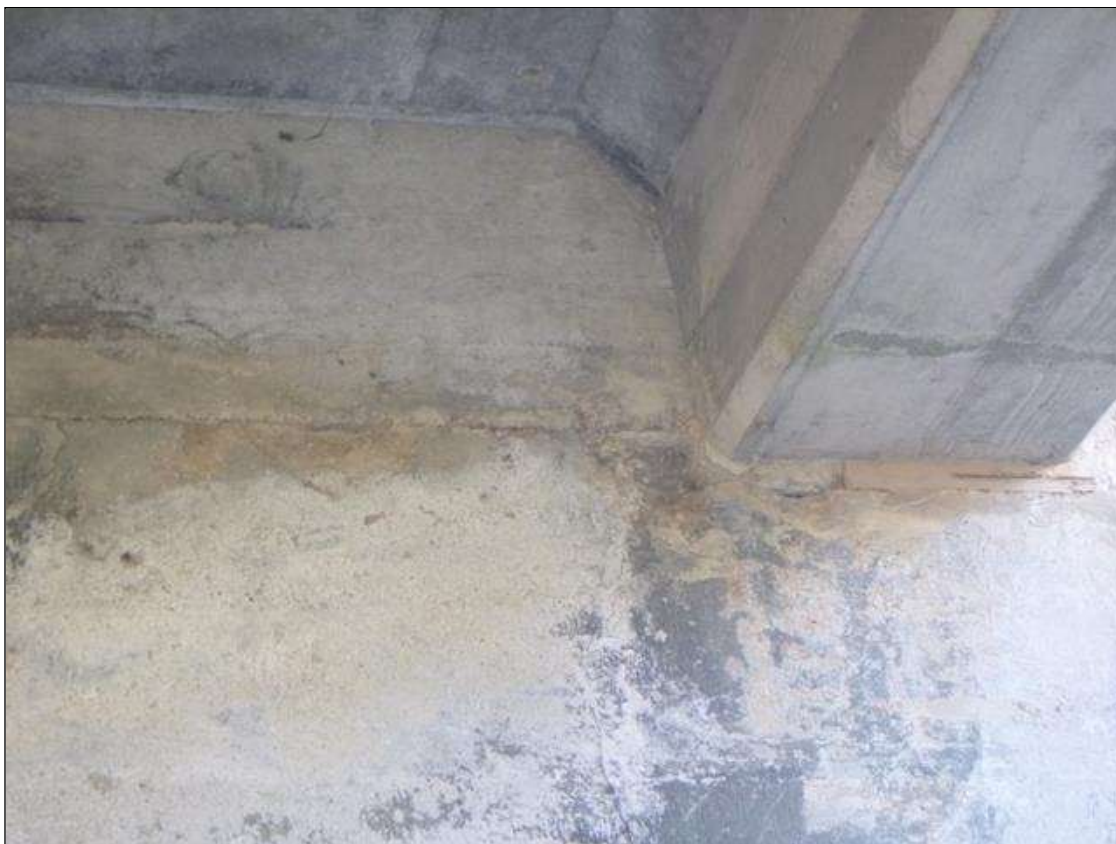
Abutment 1 Abutment: 2 SMALL SPALLS UP TO 6" X 4" X 1" DEEP AT TOP UNDER BAY 1

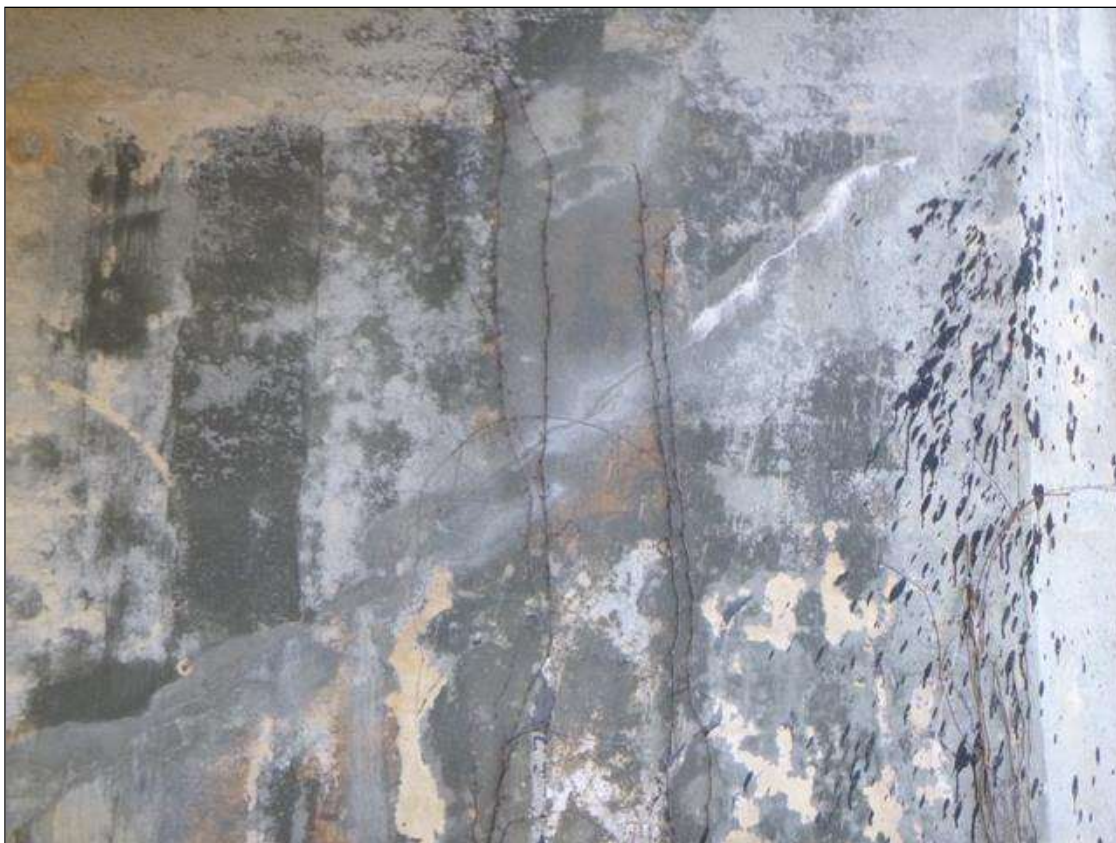
Abutment 1 Abutment: HORIZONTAL/DIAGONAL CRACKING WITH EFFLORESCENCE ALONG THE ABUTMENT 1 BREASTWALL (25' LONG X UP TO 1/8" WIDE)

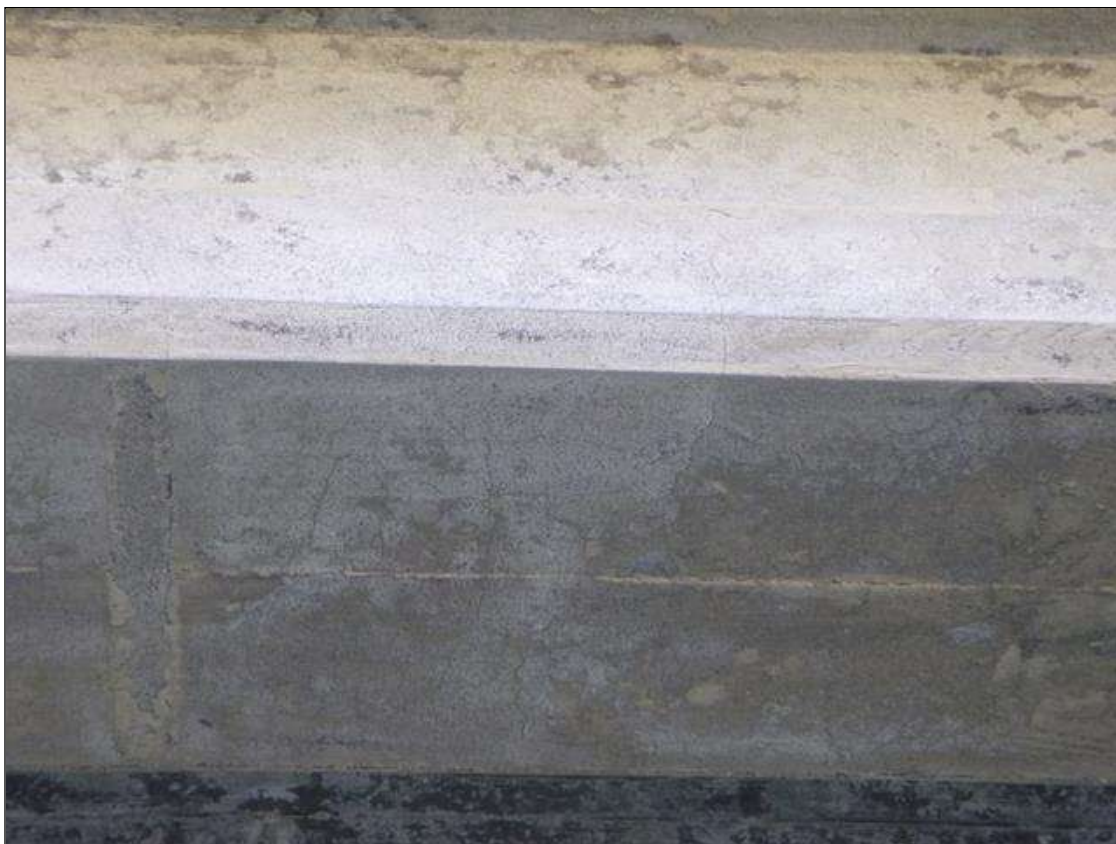
Span 1 Beam 4: 5' OF HAIRLINE TRANSVERSE / MAP CRACKING RIGHT OF MID SPAN TOWARDS PIER 1

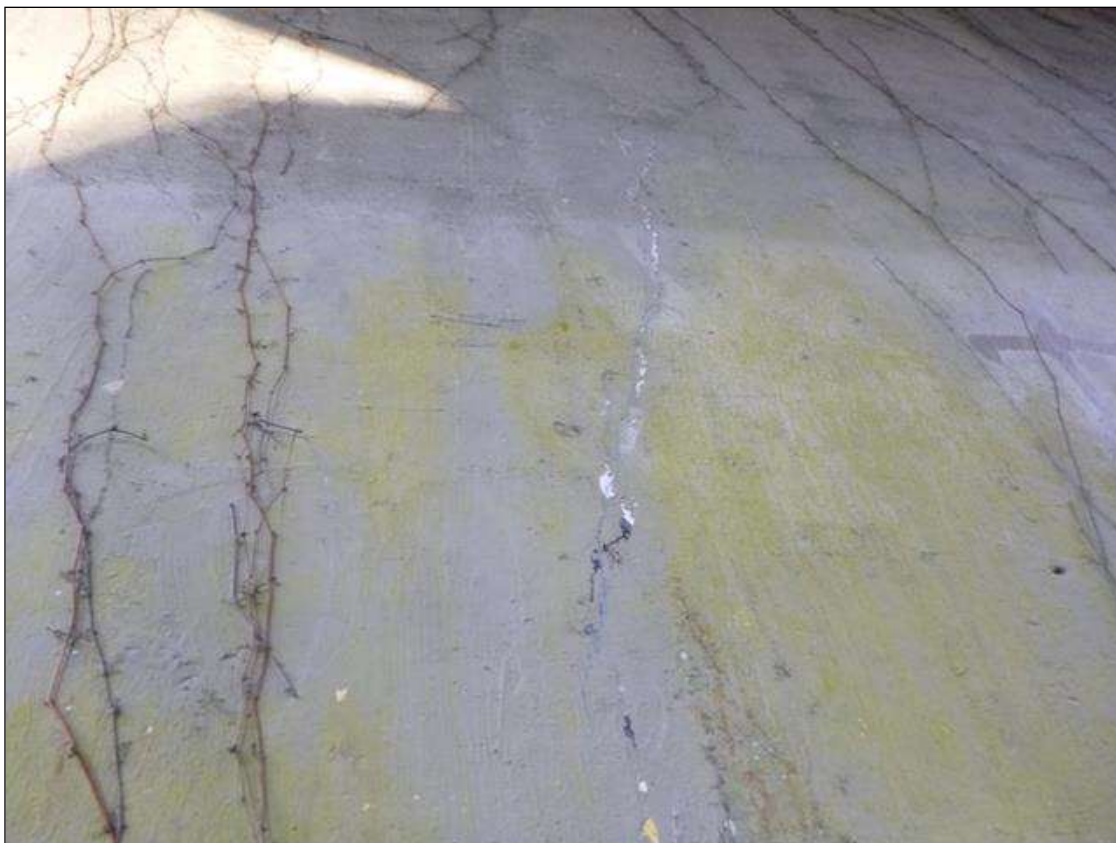
Bent 1 Pier 1: HAIRLINE VERTICAL CRACKING FULL HEIGHT AT CENTER POINT IN WALL ON SOUTH AND NORTH FACES

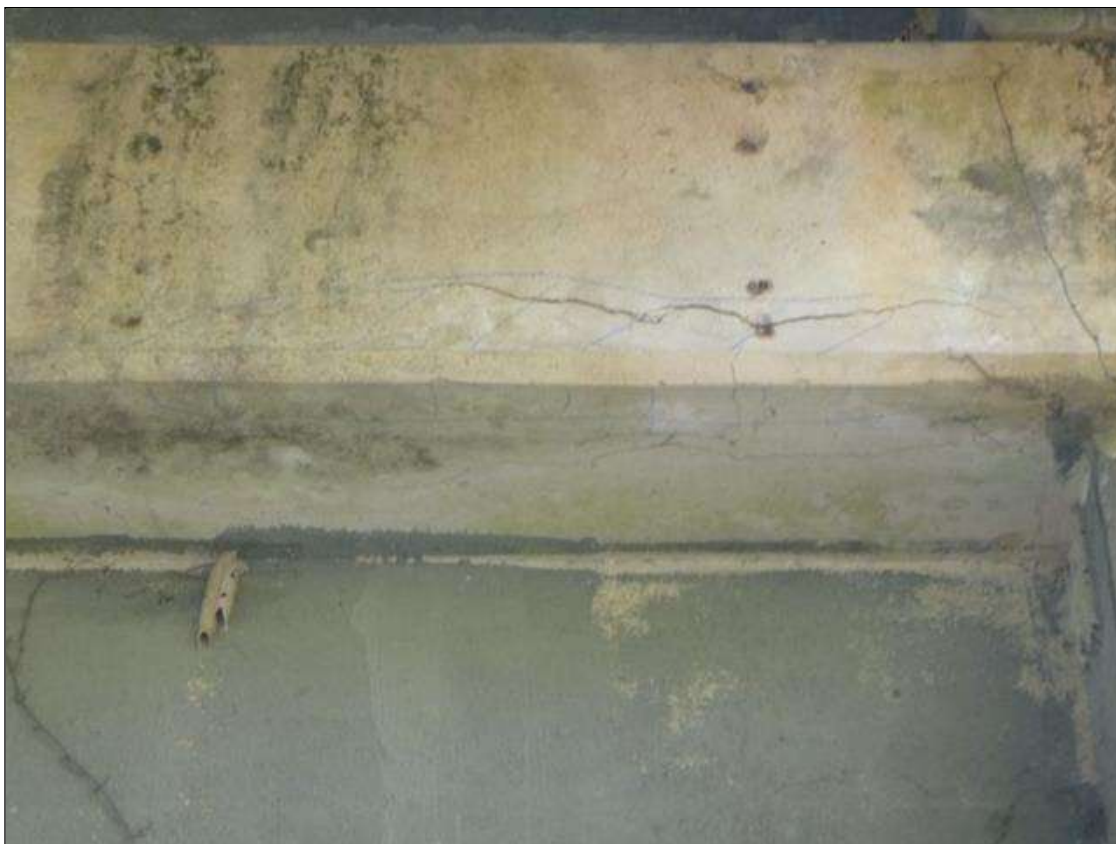
Bent 1 Cap 1: UP TO 1/8" HORIZONTAL CRACK AND DELAMINATED AREA IN PIER 1 CAP SOUTH SIDE UNDER BAY 3 (2' LONG X 4" HIGH)

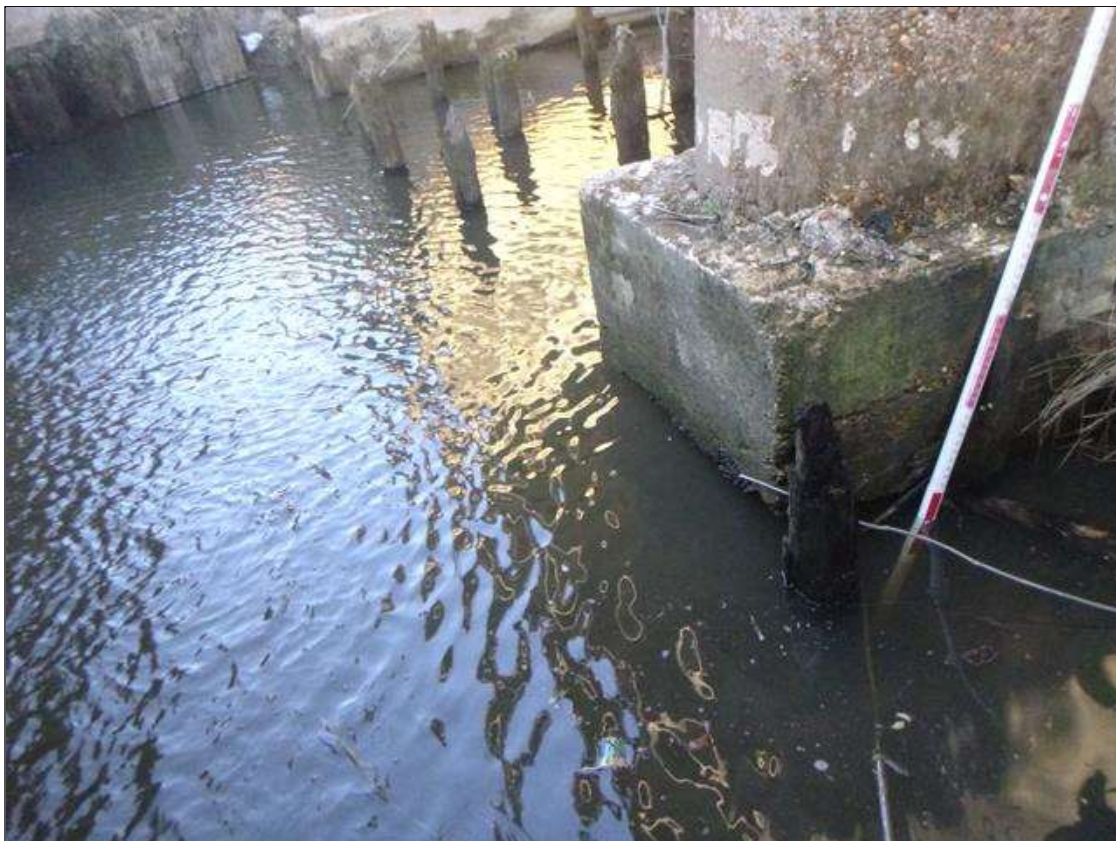
Bent 1 Footing: (PAR) SCOUR AROUND FOOTING ENTIRE LENGTH EXPOSING FOOTING WITH 6" OF UNDERMINING FULL WIDTH AT UPSTREAM END.

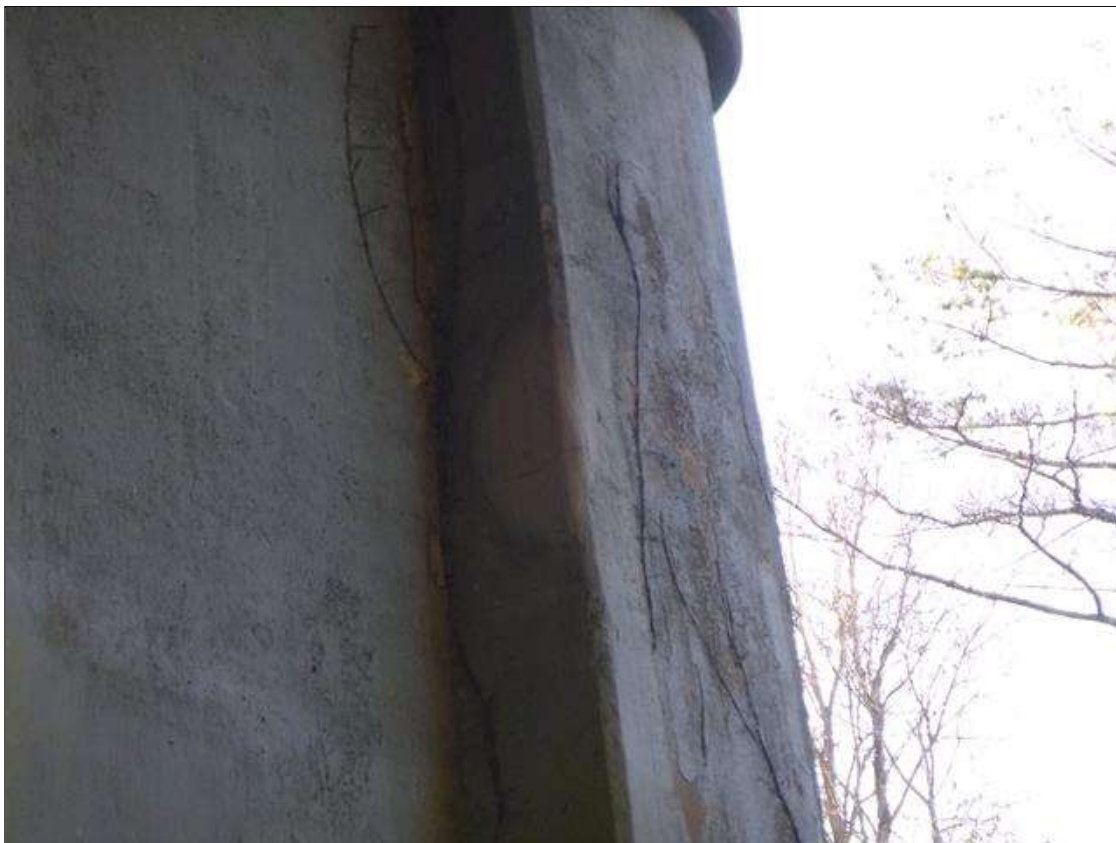
Bent 1 Pier 1: 15" X 9" CRACKED PATCHED AREA WITH UP TO 1/32" CEACKING IN NOSE PORTION NORTH FACE AT WEST END 5' FROM CAP

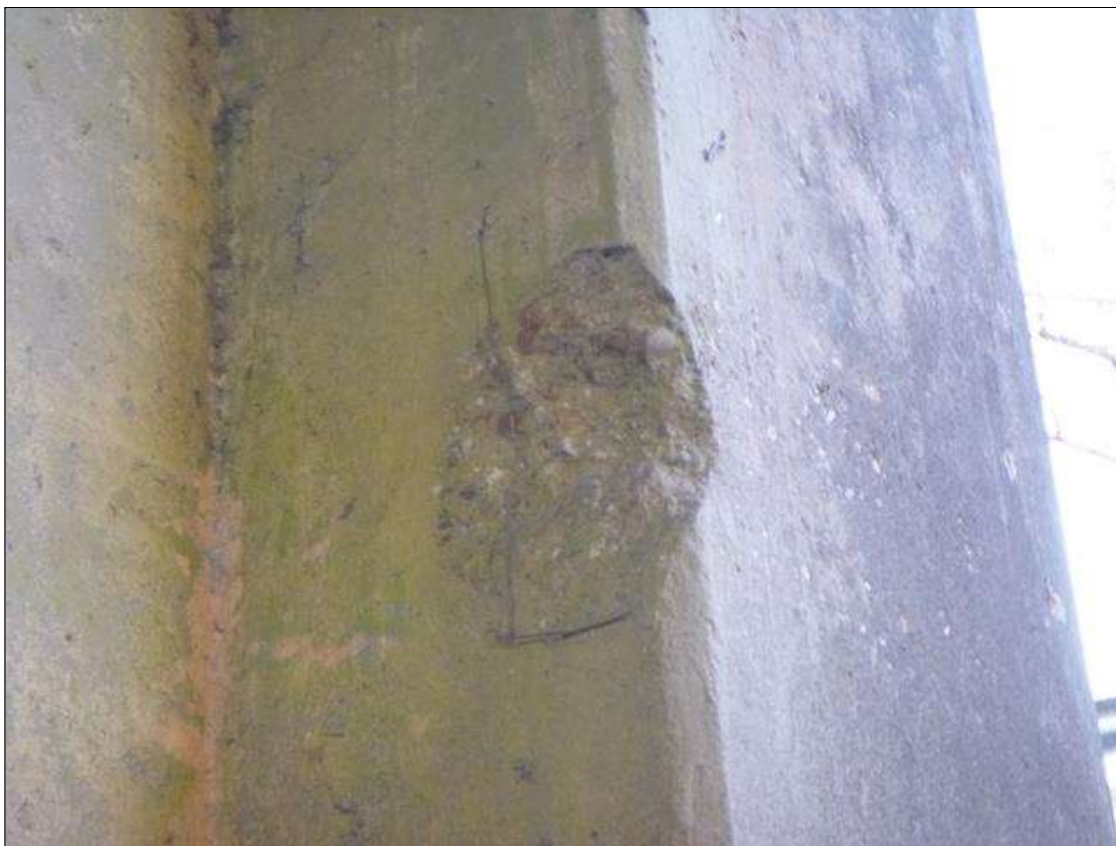
Bent 1 Pier 1: 9" DIAMETER X 1" DEEP SPALL IN NOSE PORTION NORTH FACE AT WEST END

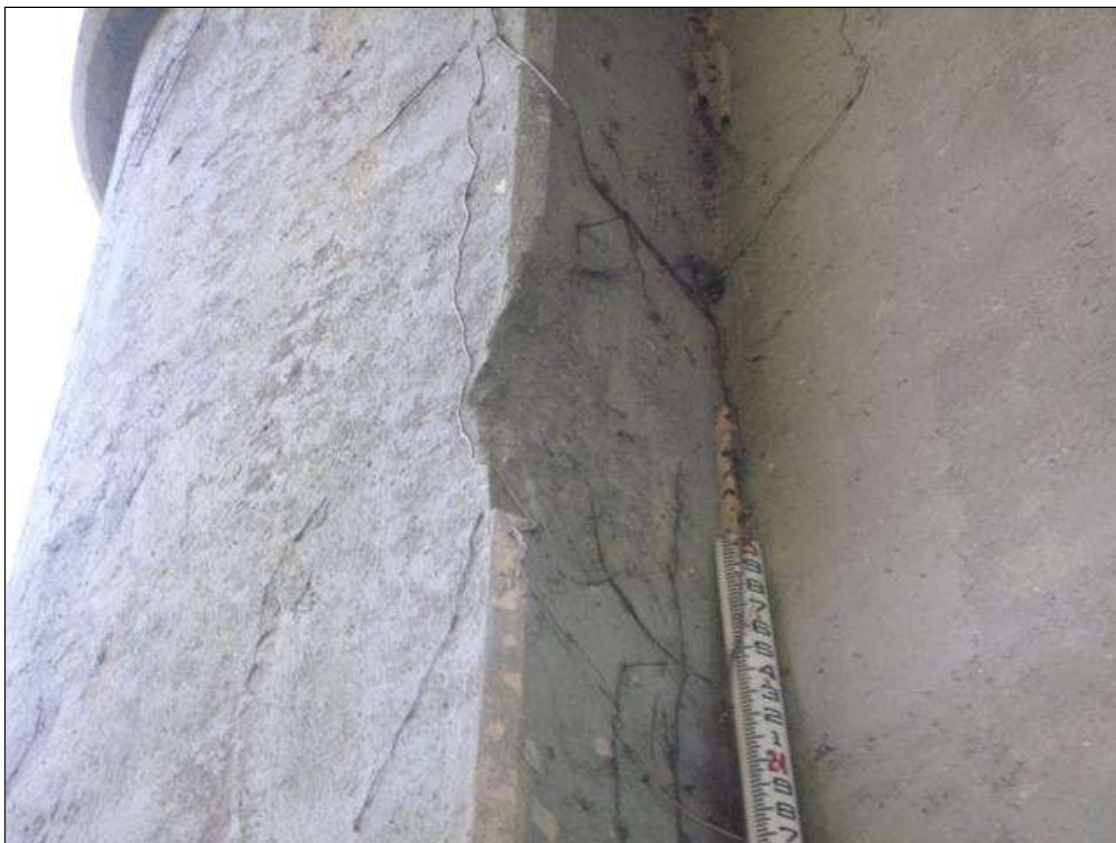
Bent 1 Pier 1: 16" X 9" X 1" DEEP SPALL IN NOSE PORTION NORTH FACE AT EAST END

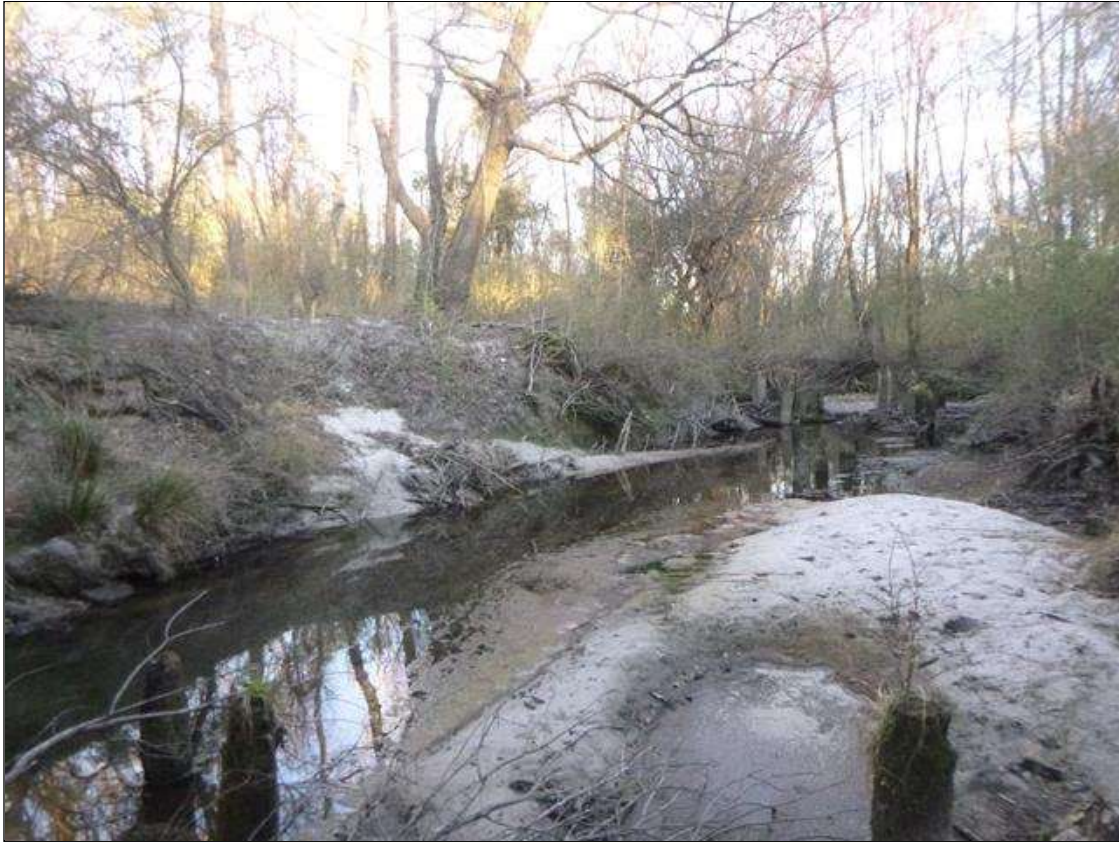
**WATERWAY ADEQUACY: BANK EROSION ON BOTH EMBANKMENTS AT DOWNSTREAM SIDE OF BRIDGE DUE TO HIGH WATER EVENTS WITH FALLEN TREES ALONG BOTH BANKS**

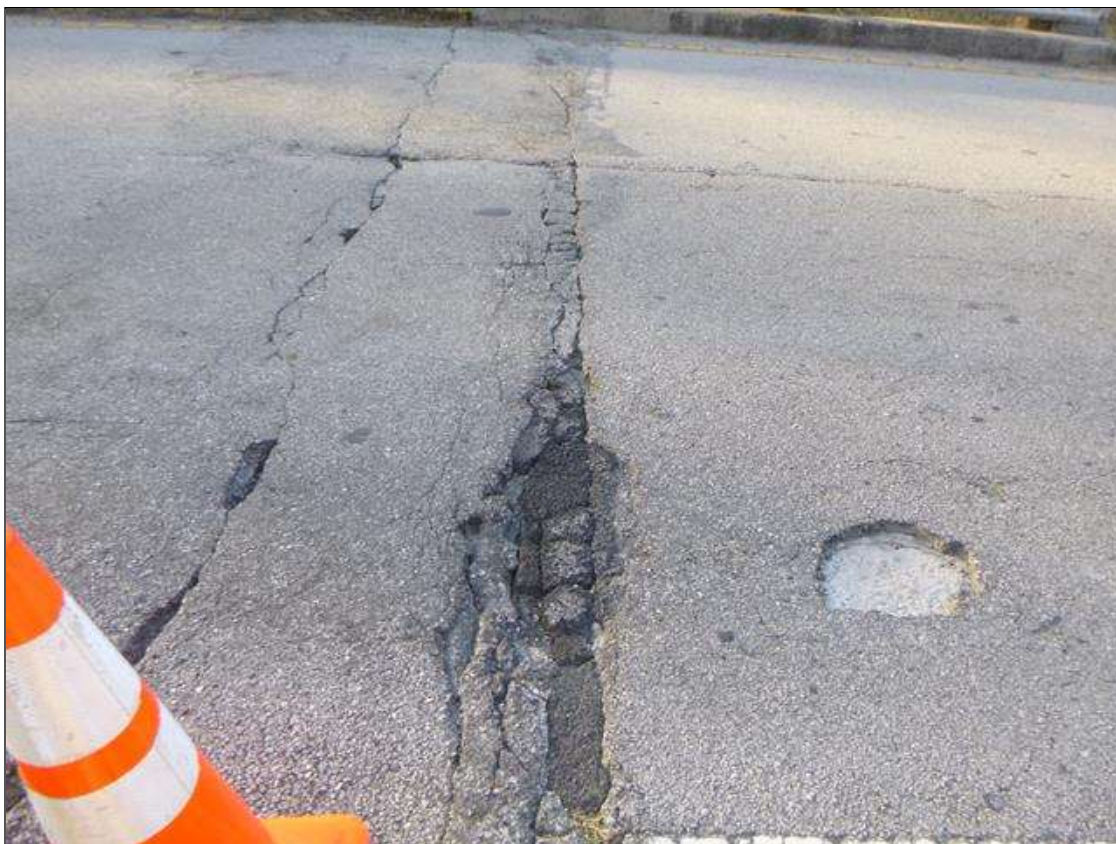
ASPHALT WEARING SURFACE OVER END BENT 1 LOOKING WEST

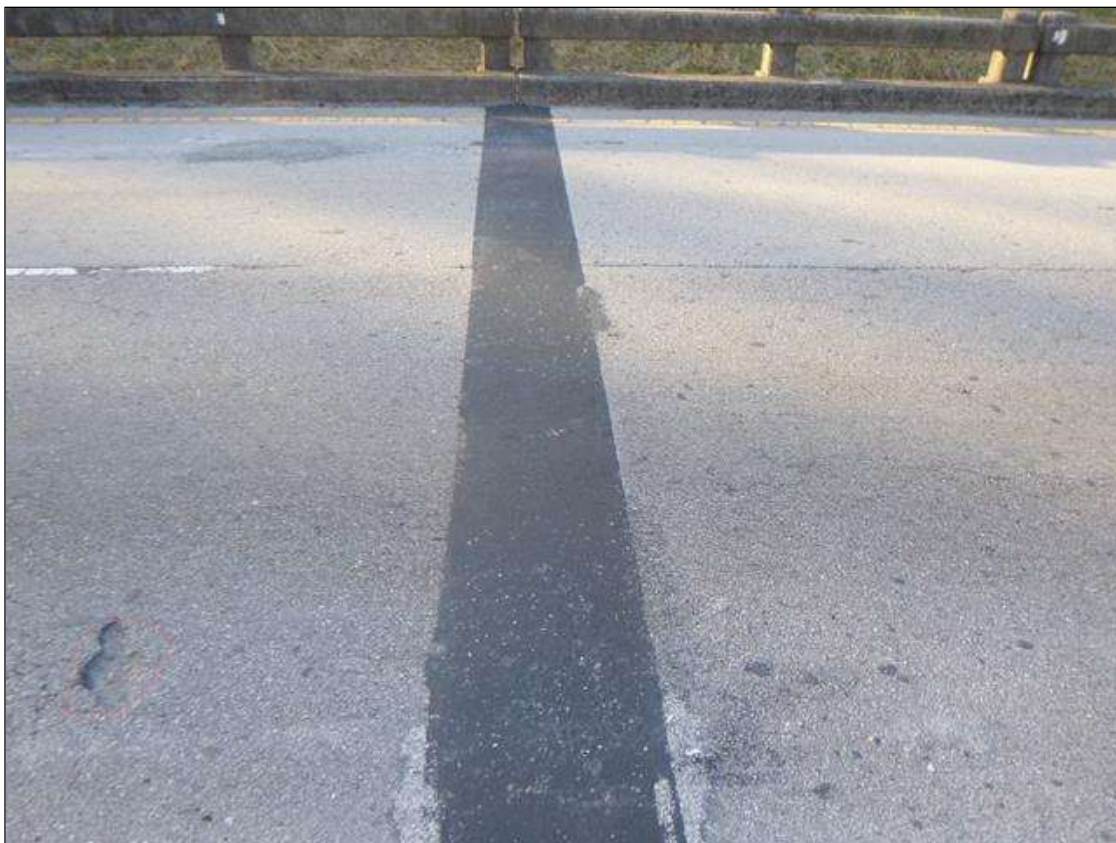
ASPHALT WEARING SURFACE OVER BENT 1 LOOKING WEST

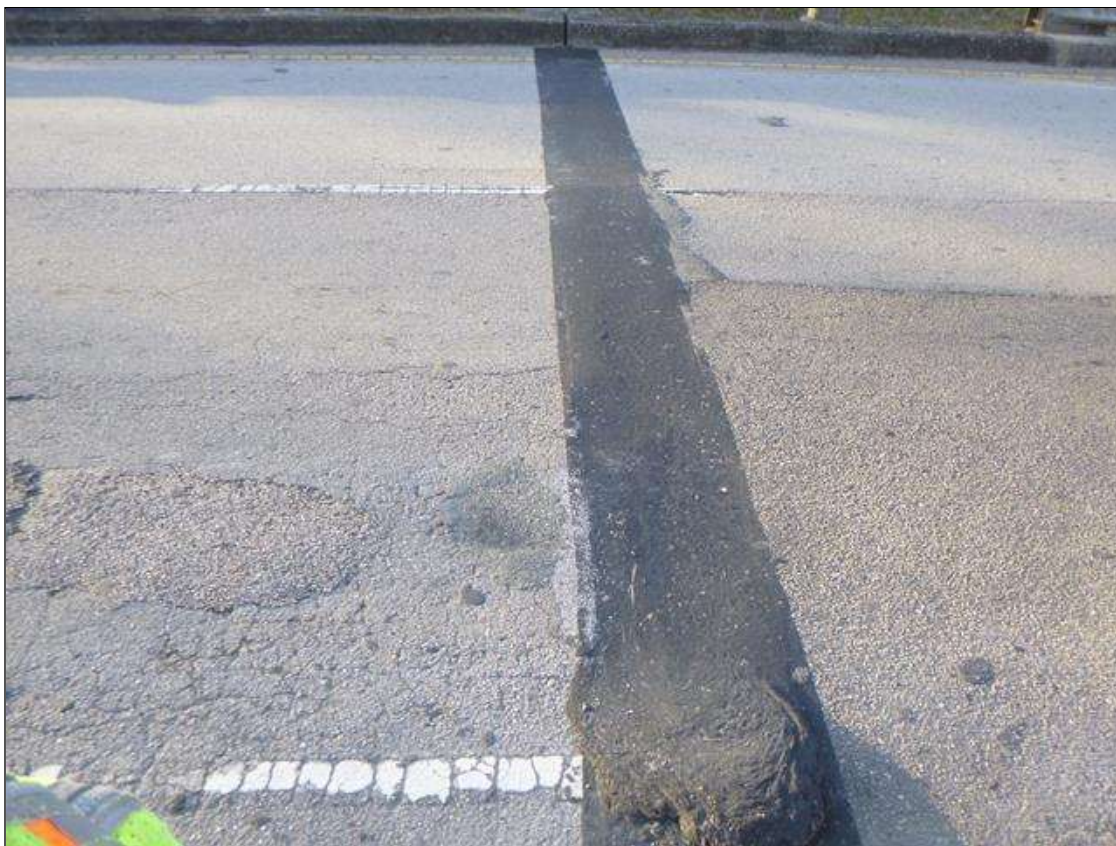
ASPHALT WEARING SURFACE OVER BENT 2 LOOKING WEST

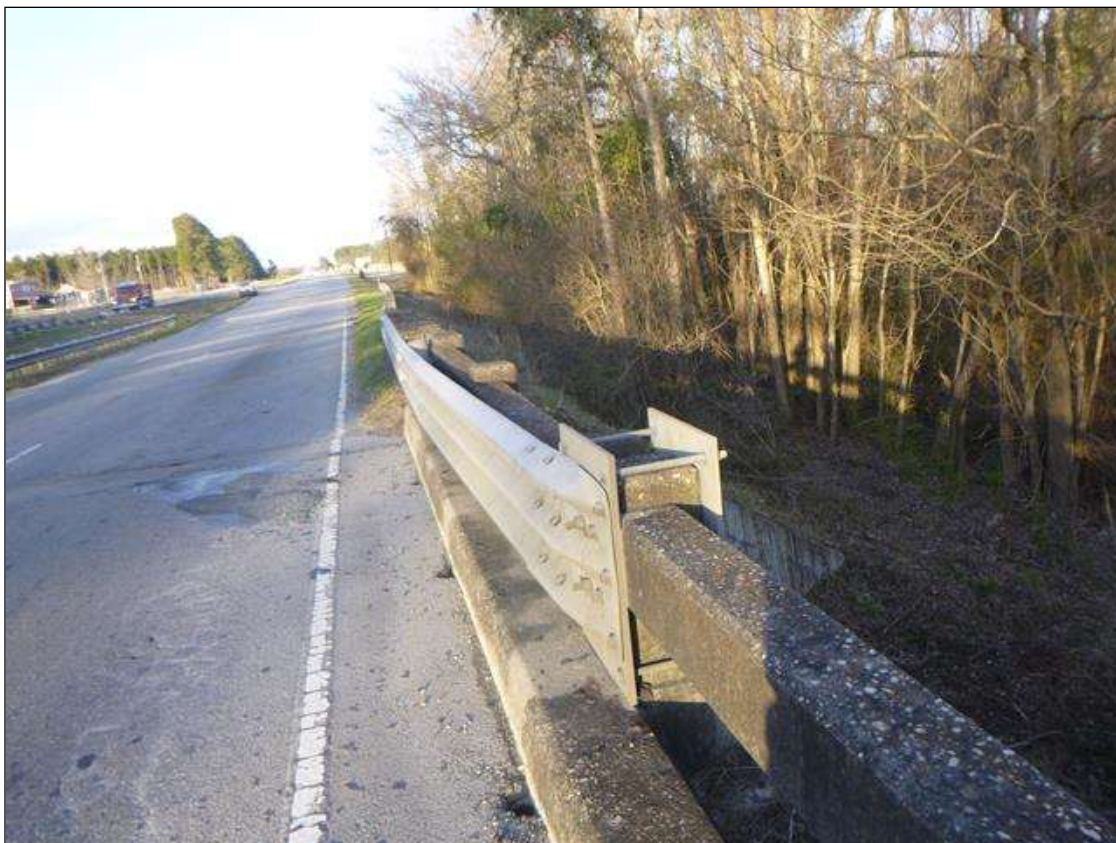
NORTHEAST GUARDRAIL ATTACHMENT (OTHERS SIMILAR)

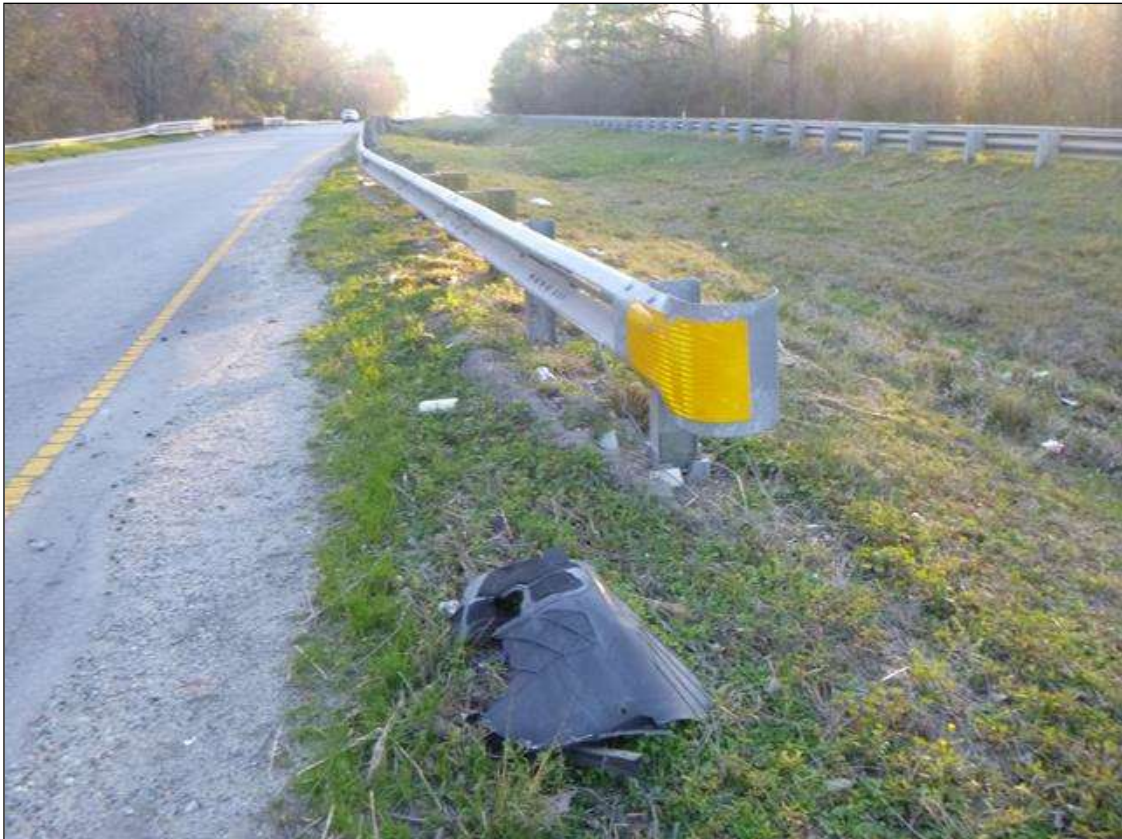
NORTHWEST GUARDRAIL TERMINAL, NORTHEAST SIMILAR
