INSPECTED BY

H.W. HICKS, JR.

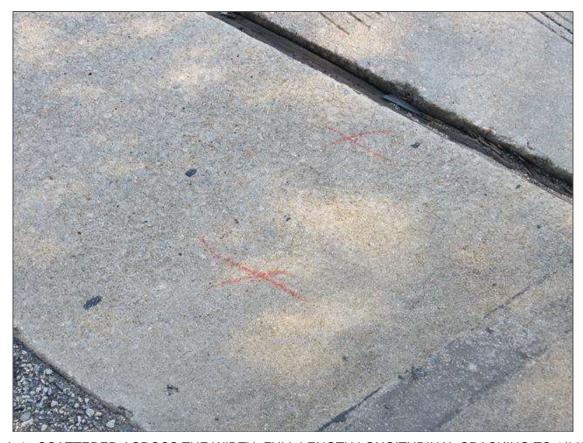
Approach 1 : SCATTERED ACROSS THE WIDTH, FULL LENGTH LONGITUDINAL CRACKING TO 1/32" WIDE

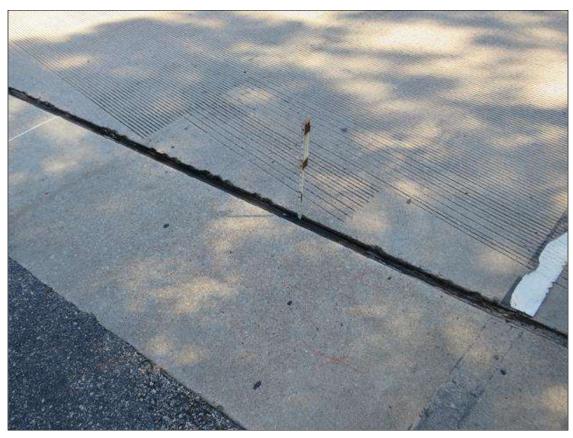
Span 1 Expansion Joint: 50% ADHESION LOSS OF DECK JOINT. JOINT LEAKING AT BAYS 8, 9, 12, 13 AT END BENT 1.

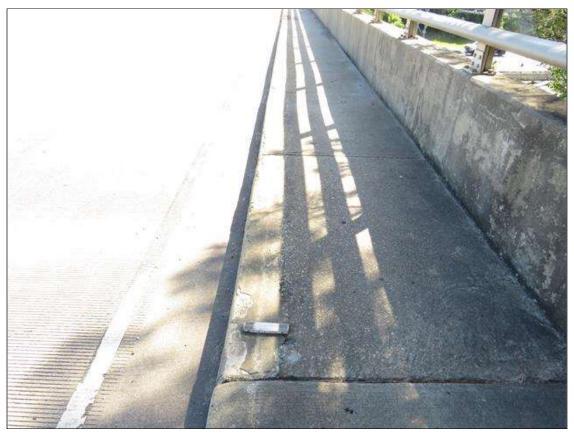
Span 1 Right Bridge Rail: SCATTERED SCALING UP TO 1/8" DEEP ALONG FACE OF CURB AT NEAR END.

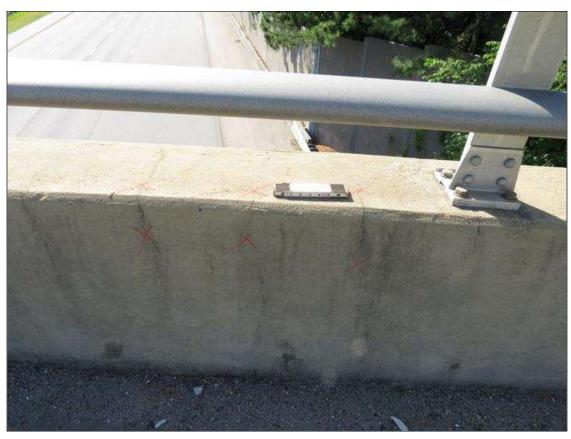
Span 1 Right Bridge Rail: FULL HEIGHT VERTICAL HAIRLINE CRACKING IN RIGHT BRIDGE RAILING IN NEGATIVE MOMENT REGION

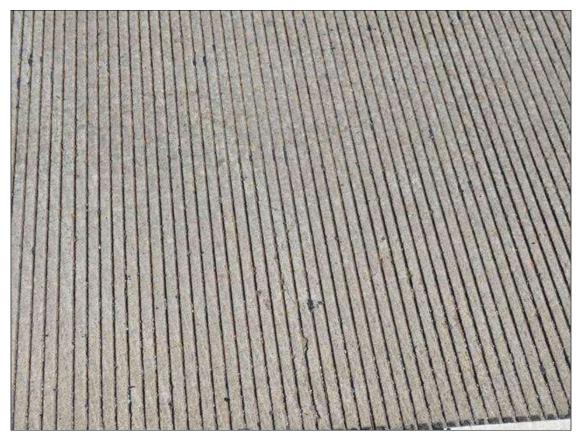
Span 1 Deck: TOP OF THE DECK AT THE SOUTH END, SCATTERED ACROSS THE WIDTH, LONGITUDINAL CRACKING TO 1/64" WIDE EMANATES FROM THE JOINT HEADER, AND TRANSVERSE CRACKING TO 1/64" WIDE SCATTERED THROUGHOUT; UNDERSIDE OF THE OVERHANGS, SCATTERED HAIRLINE TRANSVERSE CRACKING WITH SOME EFFLORESCENCE

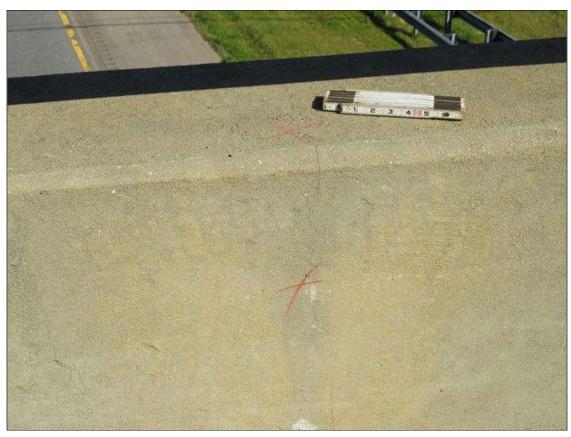
Span 1 Left Bridge Rail: PARTIAL DEPTH VERTICAL HAIRLINE TO OPEN (1/32") CRACKING IN BRIDGE RAILING. FULL HEIGHT VERTICAL HAIRLINE CRACKS WITH LIGHT EFFLORESCENCE IN NEGATIVE MOMENT REGION, 4 TOTAL

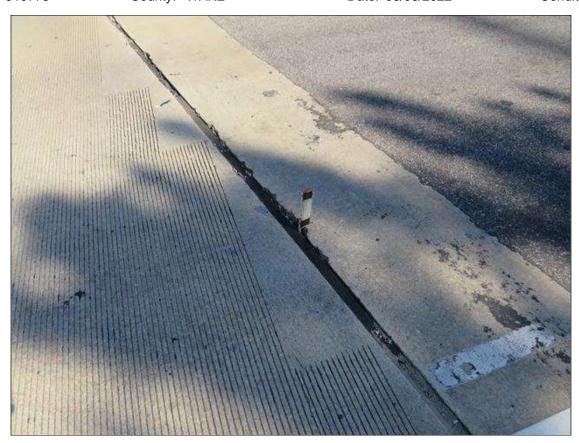
Span 2 Expansion Joint: SEAL ADHESION FAILURE, SCATTERED LEAKING THROUGHOUT END BENT 2 JOINT.

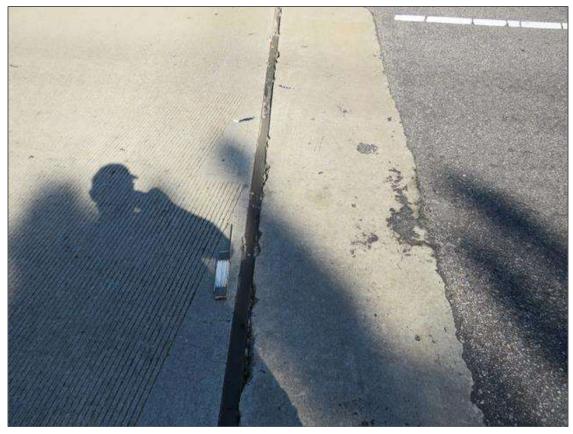
Span 2 Expansion Joint: ADJACENT DECK HEADERS, SCATTERED ALONG THE LENGTH, EDGE CHIPPING [UP TO 1" WIDE X 1" DEEP] ALONG END BENT 2 JOINT.

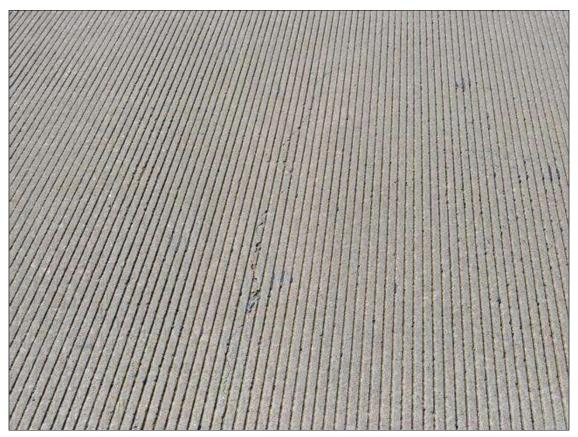
Span 2 Deck: TOP OF THE DECK AT THE SOUTH END, SCATTERED ACROSS THE WIDTH, LONGITUDINAL CRACKING TO 1/64" WIDE EMANATES FROM THE JOINT HEADER, AND TRANSVERSE CRACKING TO 1/64" WIDE SCATTERED THROUGHOUT; UNDERSIDE OF THE OVERHANGS, SCATTERED HAIRLINE TRANSVERSE CRACKING WITH SOME EFFLORESCENCE

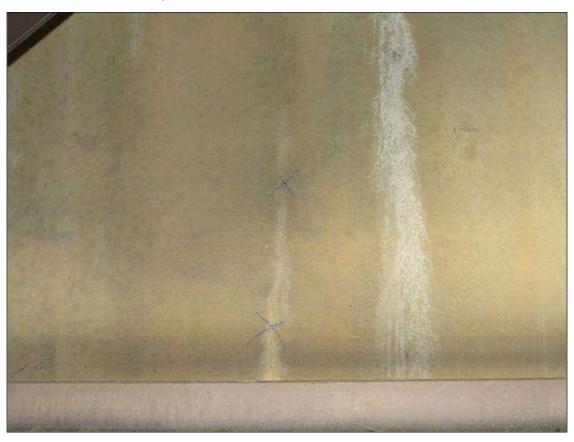
End Bent 1 Abutment: VERTICAL HAIRLINE TO 1/64" WIDE CRACK, FULL HEIGHT IN BAY 3, 9, 10 11 & 12. LONGITUDINAL HAIRLINE CRACK TO 1/64" WIDE IN TOP OF BACKWALL (12 TOTAL)

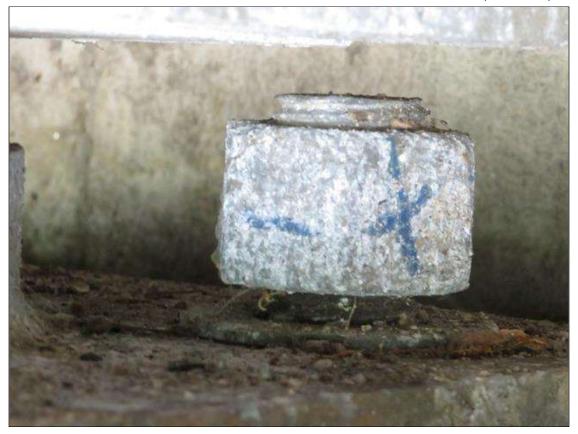
Span 1 Beam 5 - Near Bearing: (1) OF (4) SPAN 1 BEAM 5 NEAR ANCHOR NUTS LOOSE [REAR]

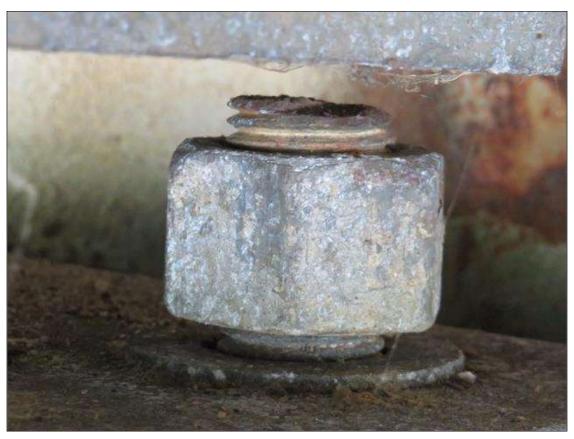
Span 1 Beam 10 - Near Bearing: SPAN 1 BEAM 10 (1) OF (4) ANCHOR NUTS LOOSE [REAR]

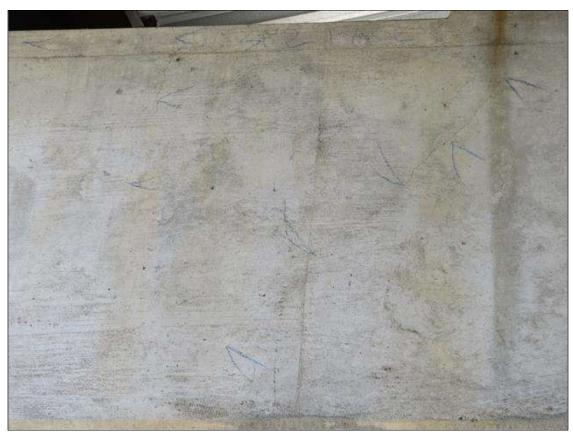
Bent 1 Cap 1: CRACKING ON BOTH FACES OVER COLUMN 1 & 6, HAIRLINE to 1/64" WIDE CRACKS ARE DIAGONAL AND VERTICAL, RUNNING FROM TOP EDGE DOWN TOWARDS BOTTOM EDGE. MINOR HAIRLINE CRACK AT BOTTOM OF CAP BETWEEN COLUMNS 5 & 6

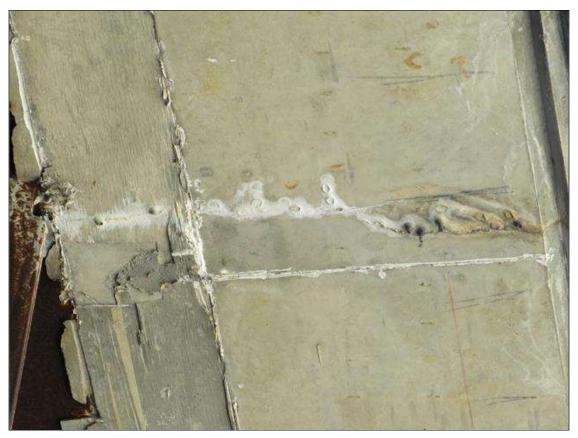
Span 1 Deck: TOP OF THE DECK AT THE SOUTH END, SCATTERED ACROSS THE WIDTH, LONGITUDINAL CRACKING TO 1/64" WIDE EMANATES FROM THE JOINT HEADER, AND TRANSVERSE CRACKING TO 1/64" WIDE SCATTERED THROUGHOUT; UNDERSIDE OF THE OVERHANGS, SCATTERED HAIRLINE TRANSVERSE CRACKING WITH SOME EFFLORESCENCE

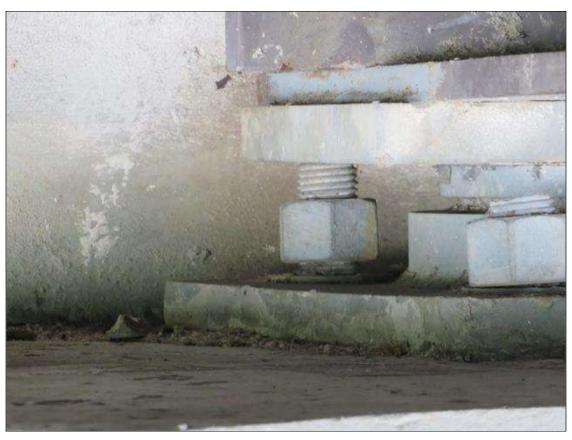
Span 1 Beam 3 - Far Bearing: SPAN 1 BEAM 3 FAR BEARING(1) OF (4) CONNECTION NUTS LOOSE [REAR]

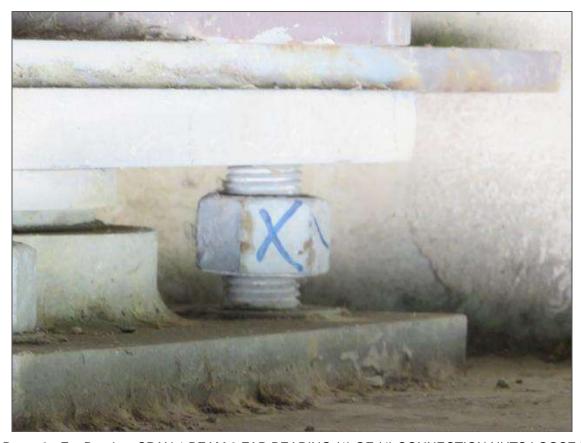
Span 1 Beam 9 - Far Bearing: SPAN 1 BEAM 9 FAR BEARING (1) OF (4) CONNECTION NUTS LOOSE [REAR]

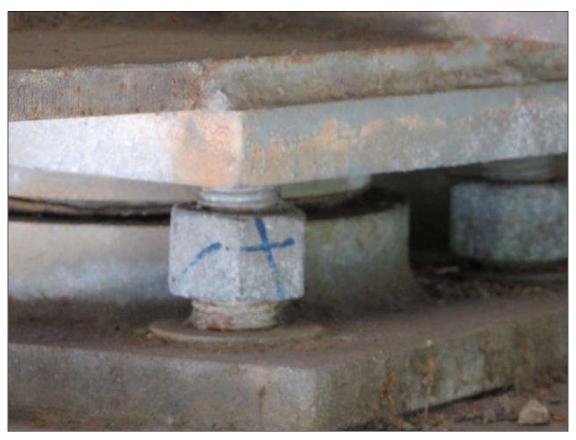
Span 1 Beam 13 - Far Bearing: SPAN 1 BEAM 13 FAR BEARING (1) OF (4) CONNECTION NUTS LOOSE [NEAR]

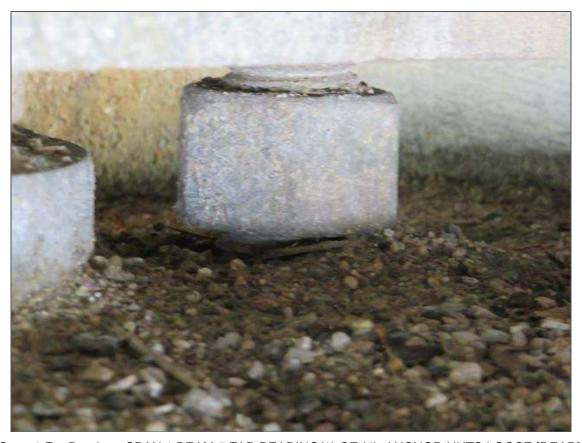
Span 1 Far Bearing: SPAN 1 BEAM 5 FAR BEARING(1) OF (4) ANCHOR NUTS LOOSE [REAR]

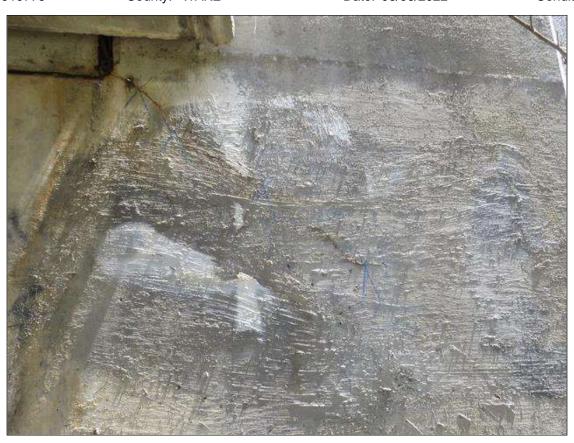
End Bent 2 Abutment: 2 DIAGONAL HAIRLINE CRACKS (2' EACH) AT LEFT AND RIGHT SIDE ABUTMENT EXTENSIONS, FULL HEIGHT VERTICAL AND DIAGONAL HAIRLINE CRACKS

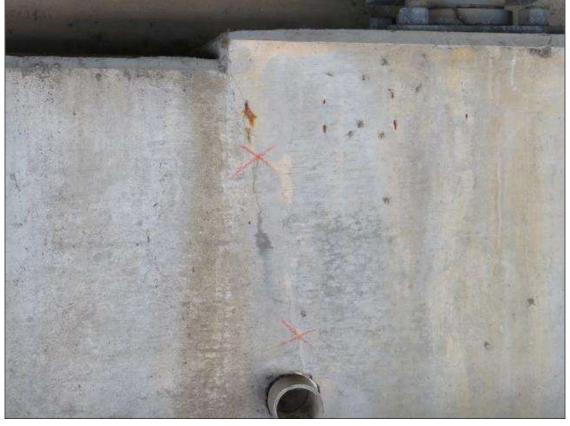
End Bent 2 CAP: (10) SCATTERED VERTICAL HAIRLINE CRACKS UP TO 1' HIGH.
