NC DEPARTMENT OF TRANSPORTATION
 DIVISION OF HIGHWAYS
 STRUCTURE MANAGEMENT UNIT

ATTENTION: **NON-NBIS; PAR: DELIENATOR, DECK, END BENTS, RAIL**

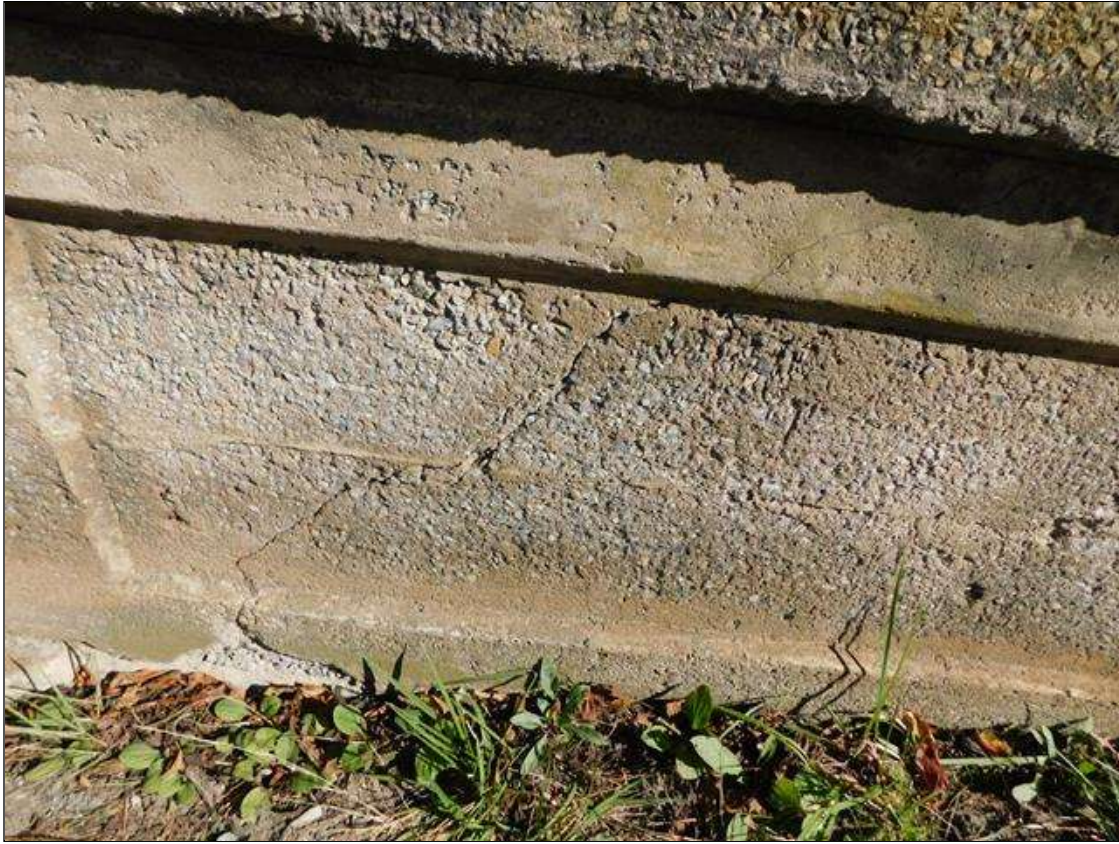
Span 1 Right Bridge Rail: 0.125" WIDE DIAGONAL CRACK BEGINNING AT 5.5' FROM THE FAR END AT THE TOP OF THE RAIL AND RUNNING BACK TOWARDS THE FAR END. SPALL AT FAR END OF RAIL HAS BEEN PATCHED AS REPAIR TO PREVIOUS PAR.

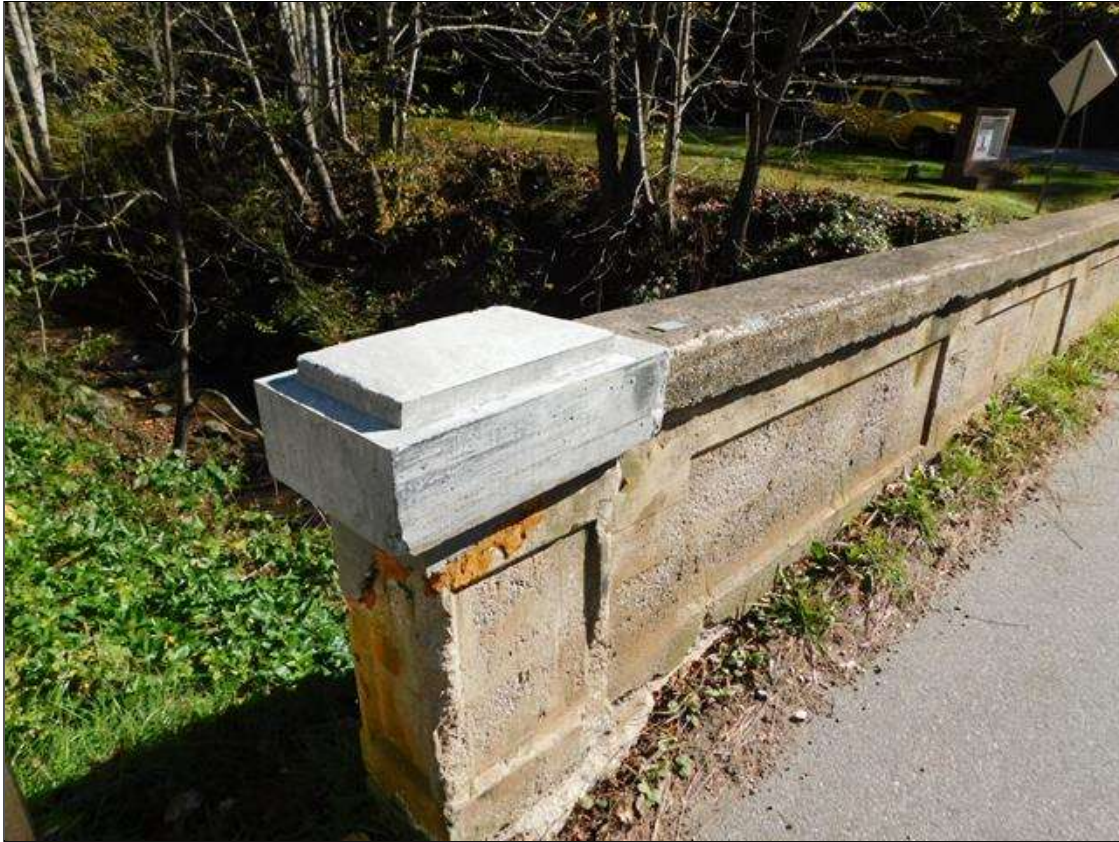
Span 1 Right Bridge Rail: 0.125" WIDE DIAGONAL CRACK BEGINNING AT 5.5' FROM THE FAR END AT THE TOP OF THE RAIL AND RUNNING BACK TOWARDS THE FAR END. SPALL AT FAR END OF RAIL HAS BEEN PATCHED AS REPAIR TO PREVIOUS PAR.

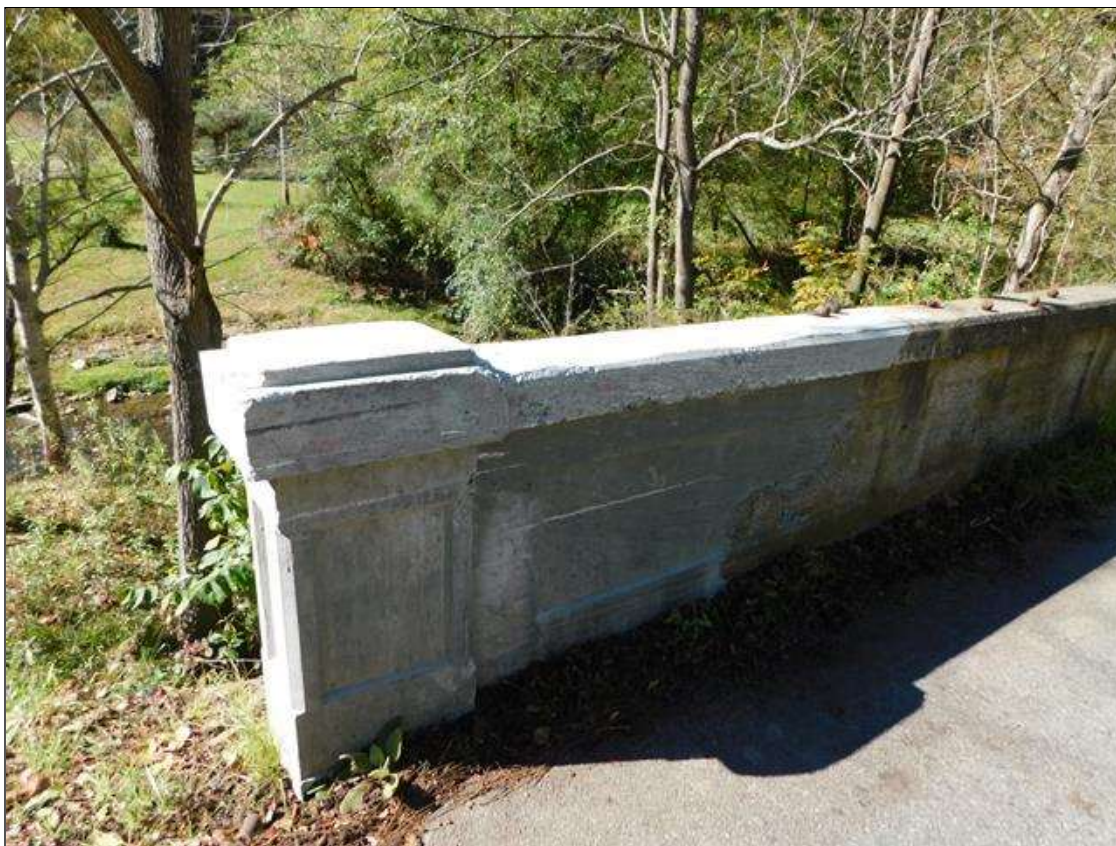
Span 1 Left Bridge Rail: NEAR END OF THE LEFT RAIL HAS BEEN RE-POURED FOR 8' LONG AS REPAIRS TO PREVIOUS PAR.

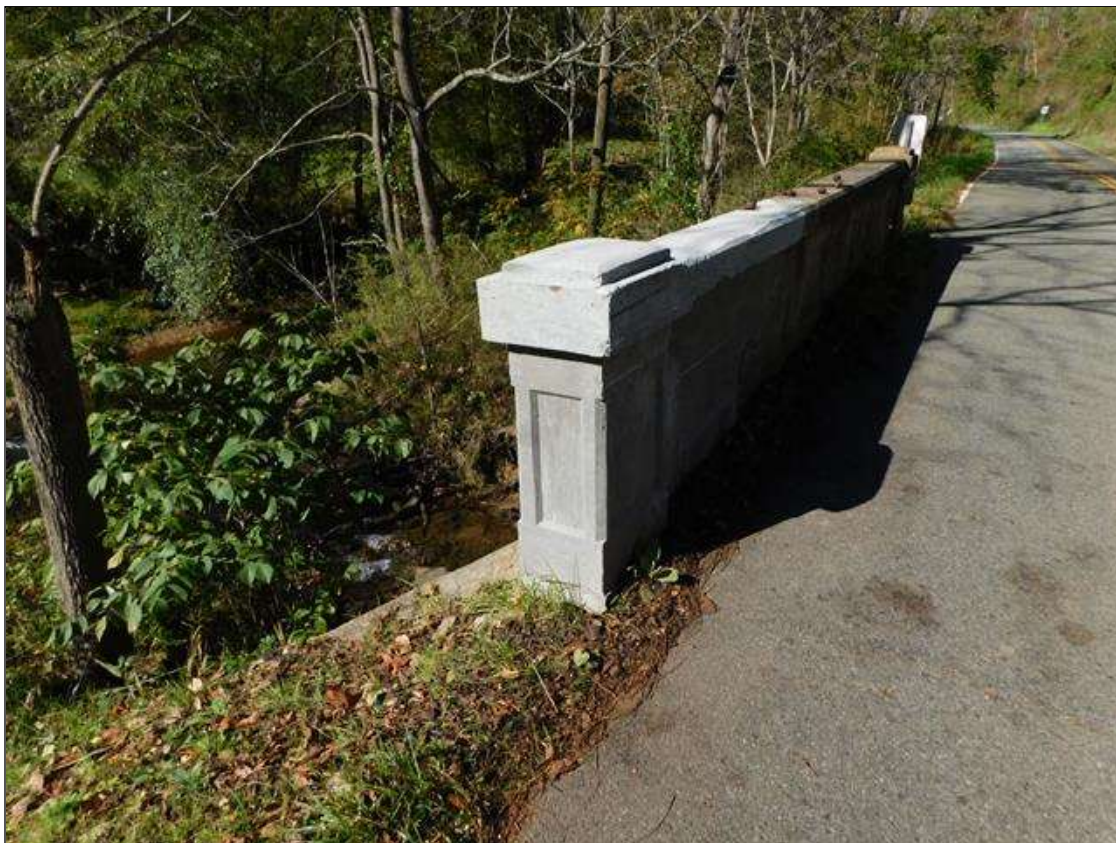
DELINEATOR AT SOUTH WEST CORNER MISSING. (PAR)

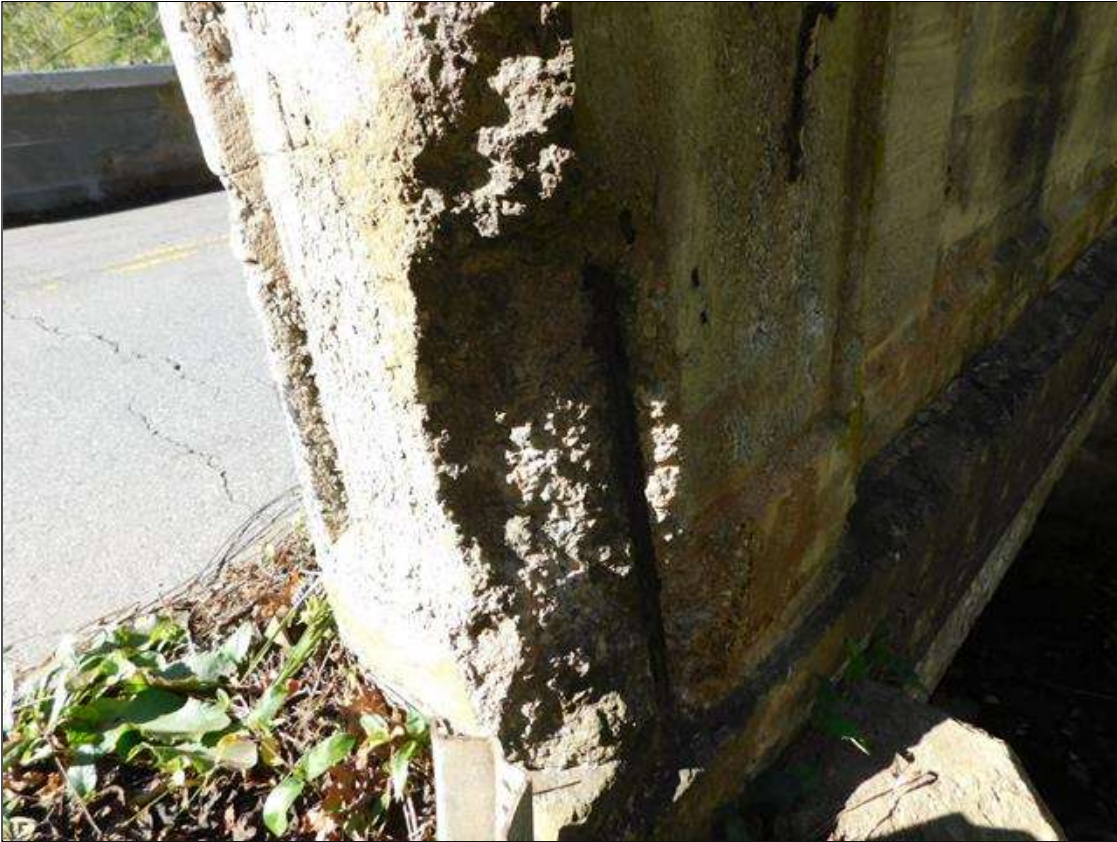
Span 1 Right Bridge Rail: 9" WIDE X 1.5' HIGH X 4" DEEP SPALL IN NEAR END WITH ONE VERTICAL BAR EXPOSED AND CORRODING. (PAR)

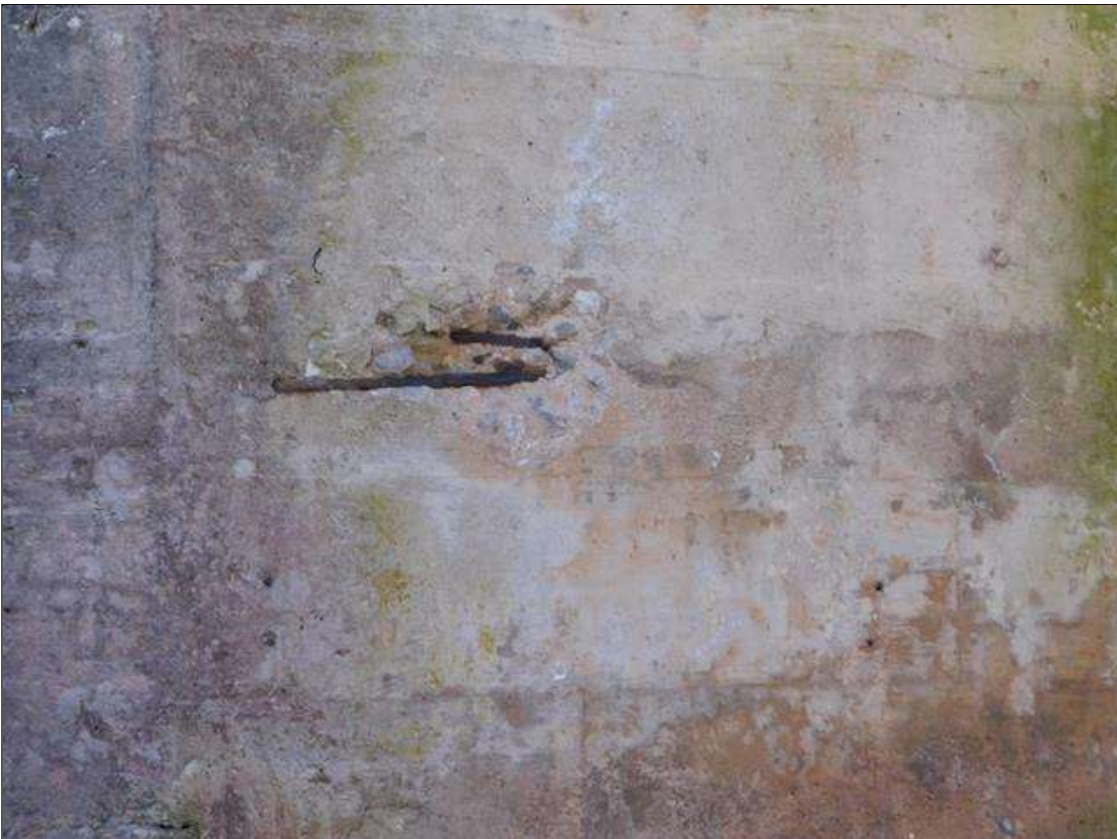
End Bent 1 Abutment: 1' WIDE X 9" HIGH X 2" DEEP DELAMINATION WITH EXPOSED AND CORRODING REINFORCING STEEL AT THE RIGHT SIDE OF THE END BENT, 5' UP FROM THE GROUND. (PAR)

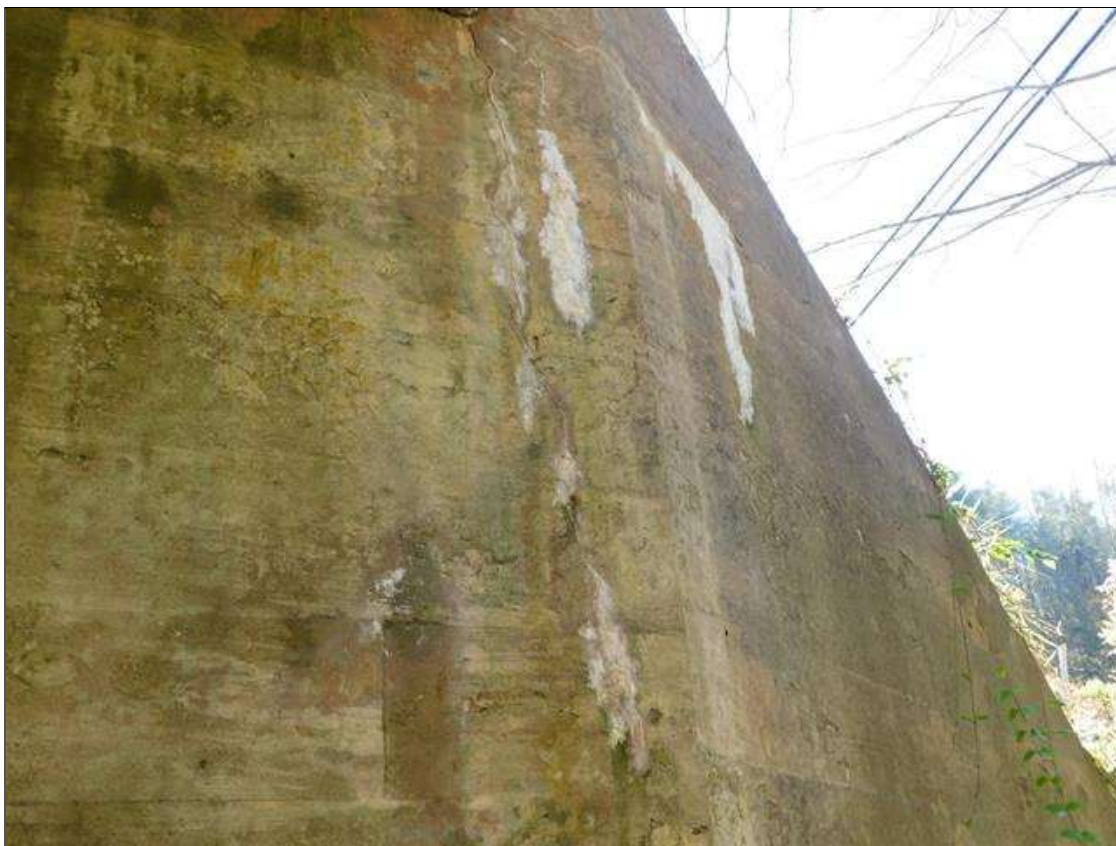
End Bent 1 Abutment: DIAGONAL CRACKS WITH EFFLORESCENCE IN LEFT END NEAR BREAKBACK.

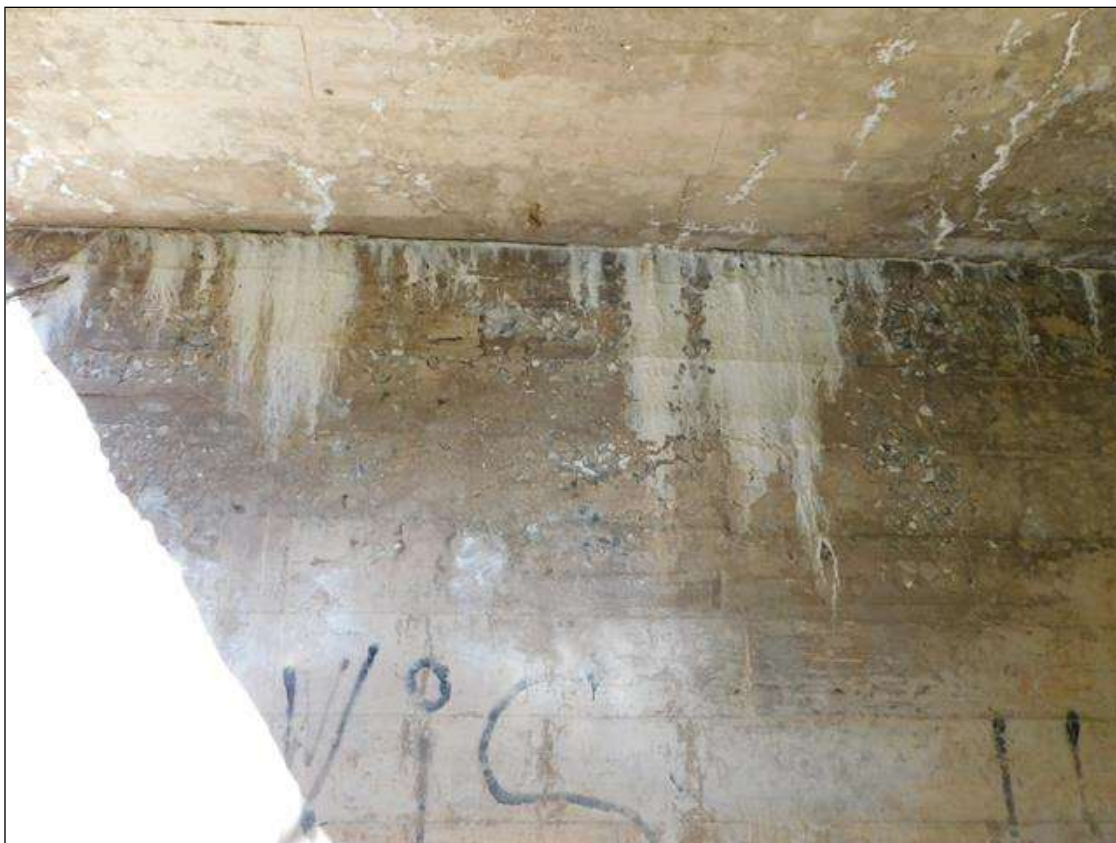
End Bent 1 Abutment: EFFLORESCENCE BUILDUP EMANATING FROM BRIDGE SEAT.

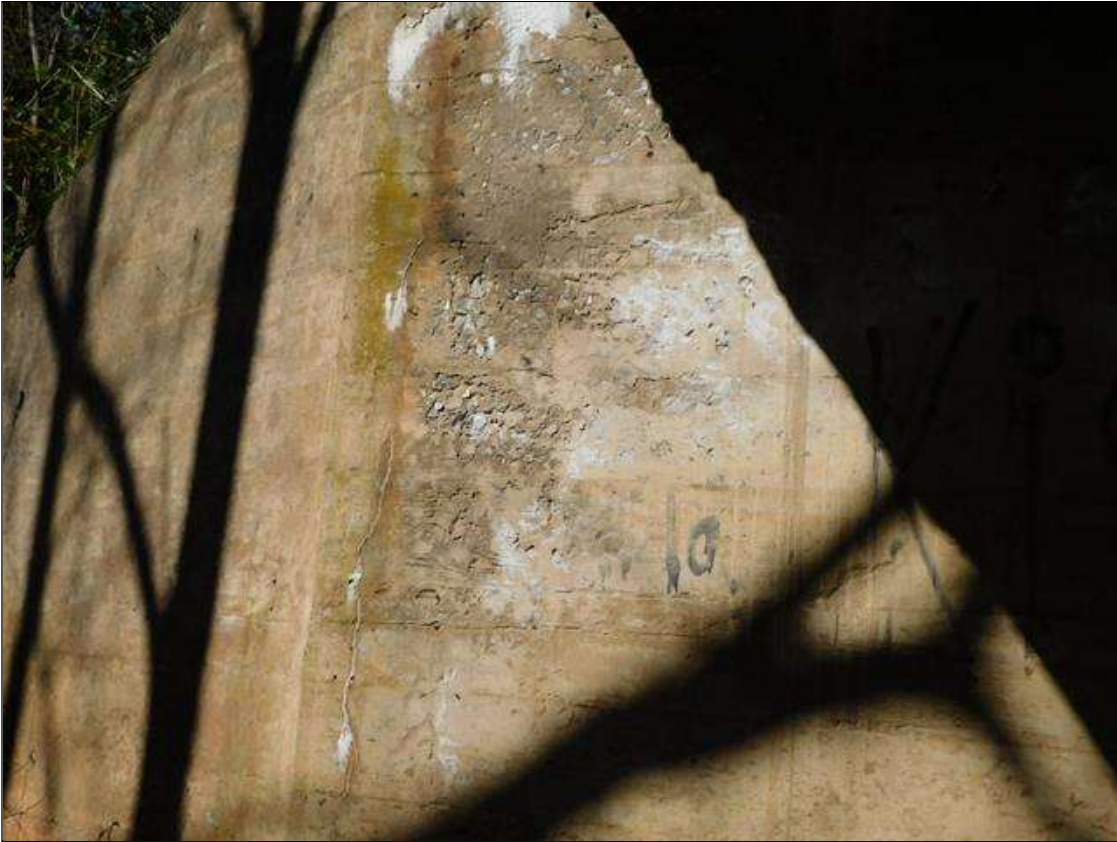
End Bent 2 Abutment: HEAVY EFFLORESCENCE BUILDUP ALONG THE BRIDGE SEAT AND RANDOM HAIRLINE CRACKS WITH EFFLORESCENCE STAINING

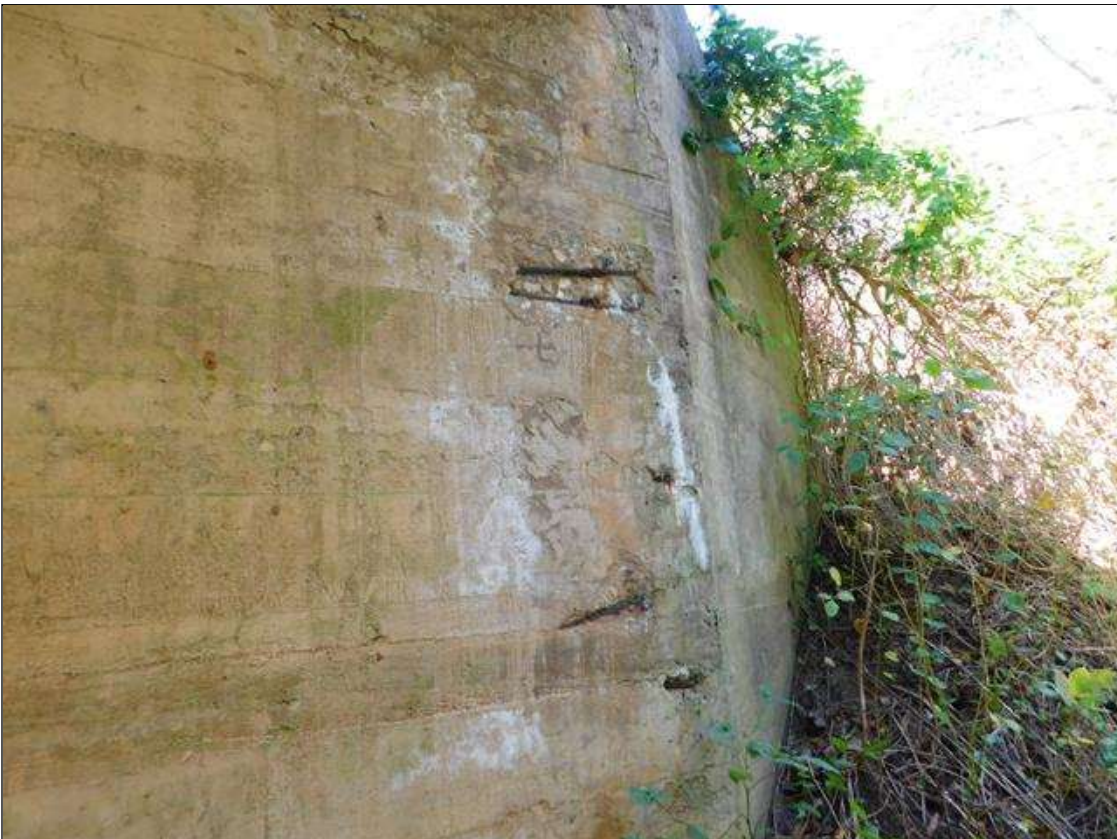
End Bent 2 Abutment: MULTIPLE SPALLS UP TO 2' WIDE X 6" HIGH ALONG THE RIGHT SIDE OF THE END BENT WITH REINFORCING STEEL EXPOSED AND CORRODING. (PAR)

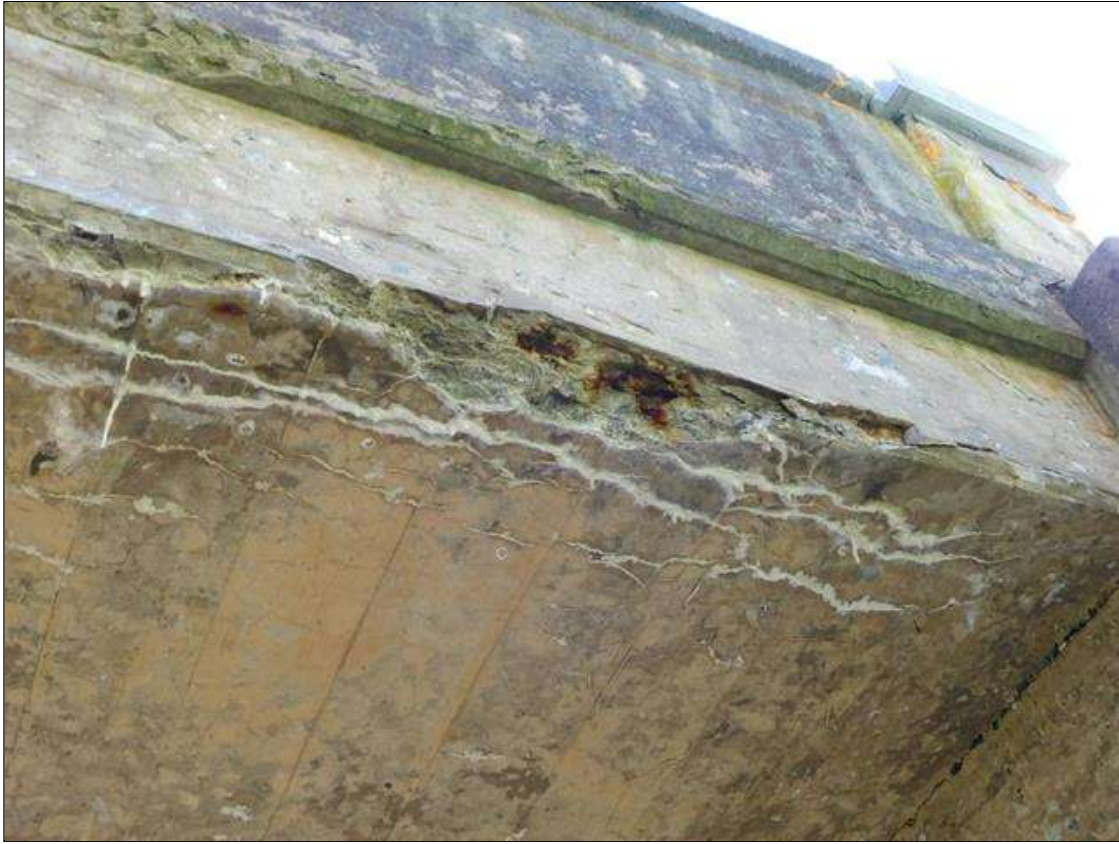
Span 1 Deck: 12' LONG X 1.5' WIDE X 4" DEEP DELAMINATION ALONG THE RIGHT SIDE OF THE SLAB BEGINNING 5' FROM THE NEAR END WITH HEAVY EFFLORESCENCE BUILDUP AND ONE LONGITUDINAL STEEL BAR EXPOSED. STEEL IS CORRODING WITH 0.0625" PITTING AND SCALE. (PAR)

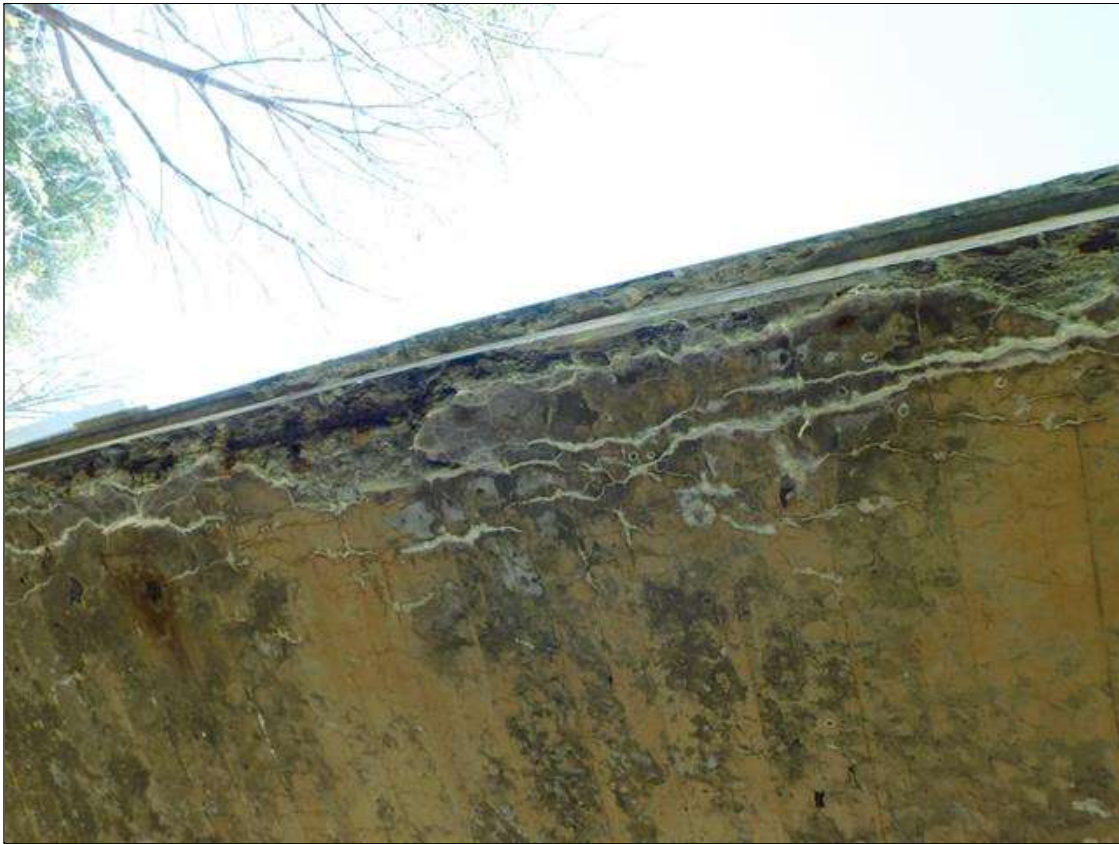
Span 1 Deck: 12' LONG X 1.5' WIDE X 4" DEEP DELAMINATION ALONG THE RIGHT SIDE OF THE SLAB BEGINNING 5' FROM THE NEAR END WITH HEAVY EFFLORESCENCE BUILDUP AND ONE LONGITUDINAL STEEL BAR EXPOSED. STEEL IS CORRODING WITH 0.0625" PITTING AND SCALE. (PAR)

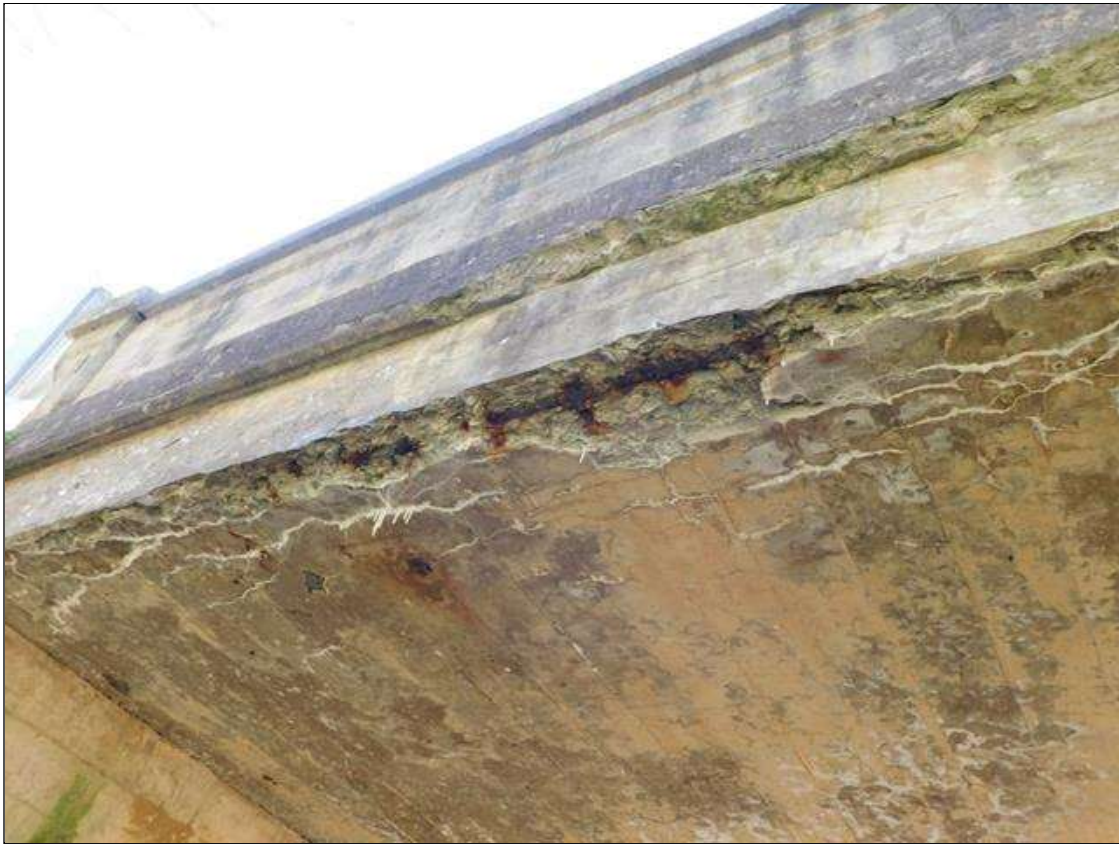
Span 1 Deck: 12' LONG X 1.5' WIDE X 4" DEEP DELAMINATION ALONG THE RIGHT SIDE OF THE SLAB BEGINNING 5' FROM THE NEAR END WITH HEAVY EFFLORESCENCE BUILDUP AND ONE LONGITUDINAL STEEL BAR EXPOSED. STEEL IS CORRODING WITH 0.0625" PITTING AND SCALE. (PAR)

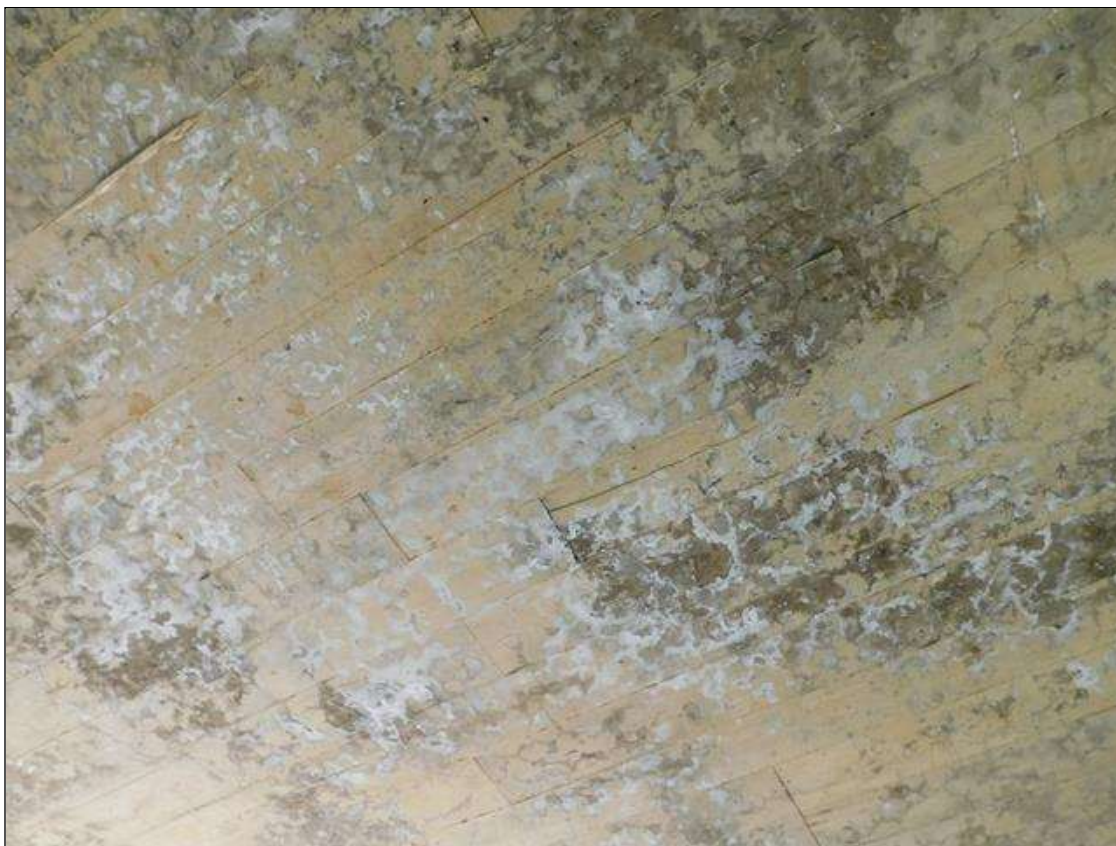
Span 1 Deck: HAIRLINE MAP CRACKS SCATTERED THROUGHOUT THE UNDERSIDE OF THE SLAB.

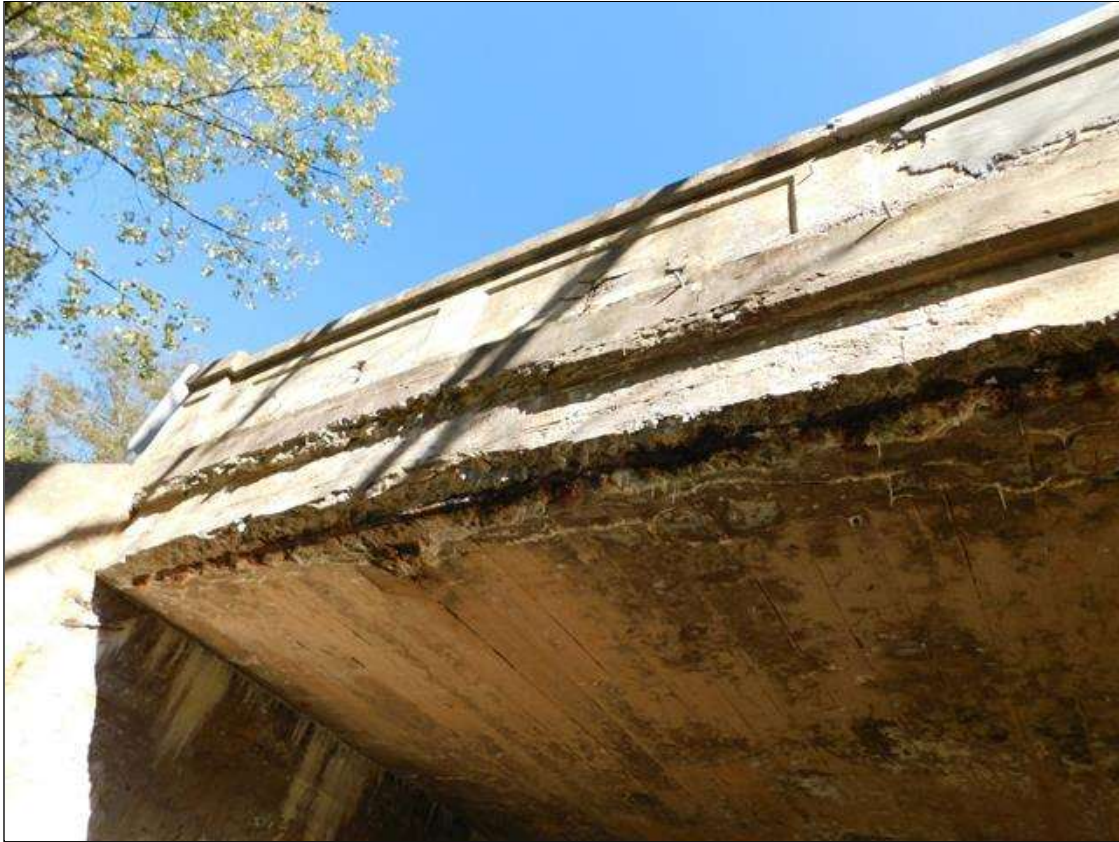
Span 1 Deck: 1.5' WIDE X FULL LENGTH X 6" DEEP DELAMINATION ALONG THE LEFT SIDE OF THE SLAB WITH HEAVY EFFLORESCENCE BUILDUP AND ONE EXPOSED LONGITUDINAL STEEL BAR. STEEL IS CORRODING WITH 0.0625" PITTING AND SCALE LOSS. (PAR)

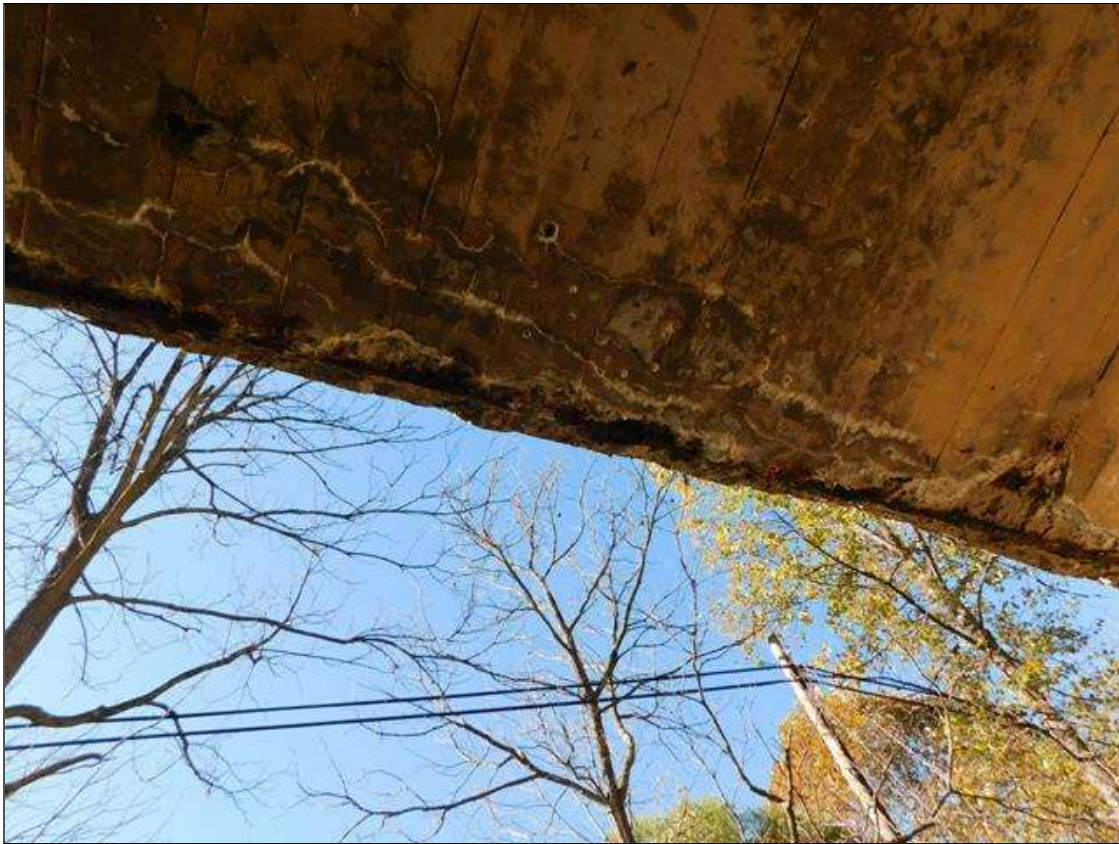
Span 1 Deck: 1.5' WIDE X FULL LENGTH X 6" DEEP DELAMINATION ALONG THE LEFT SIDE OF THE SLAB WITH HEAVY EFFLORESCENCE BUILDUP AND ONE EXPOSED LONGITUDINAL STEEL BAR. STEEL IS CORRODING WITH 0.0625" PITTING AND SCALE LOSS. (PAR)

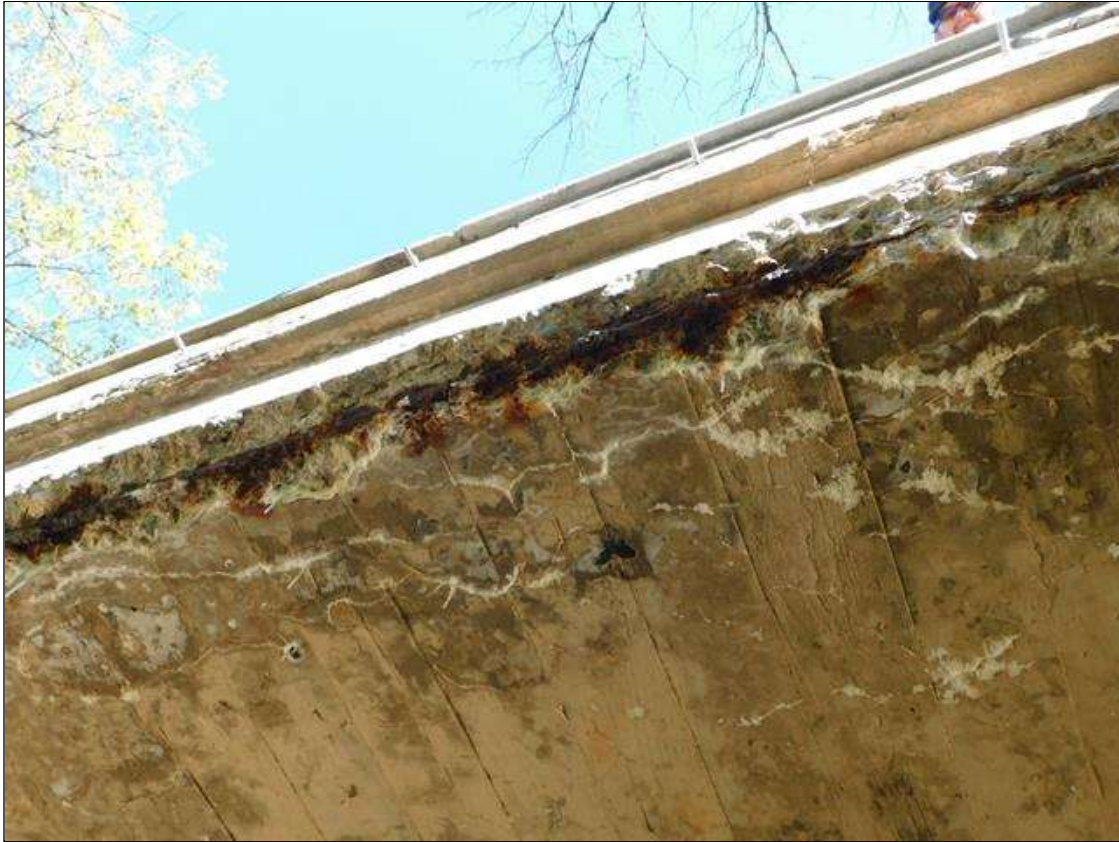
Span 1 Deck: 1.5' WIDE X FULL LENGTH X 6" DEEP DELAMINATION ALONG THE LEFT SIDE OF THE SLAB WITH HEAVY EFFLORESCENCE BUILDUP AND ONE EXPOSED LONGITUDINAL STEEL BAR. STEEL IS CORRODING WITH 0.0625" PITTING AND SCALE LOSS. (PAR)

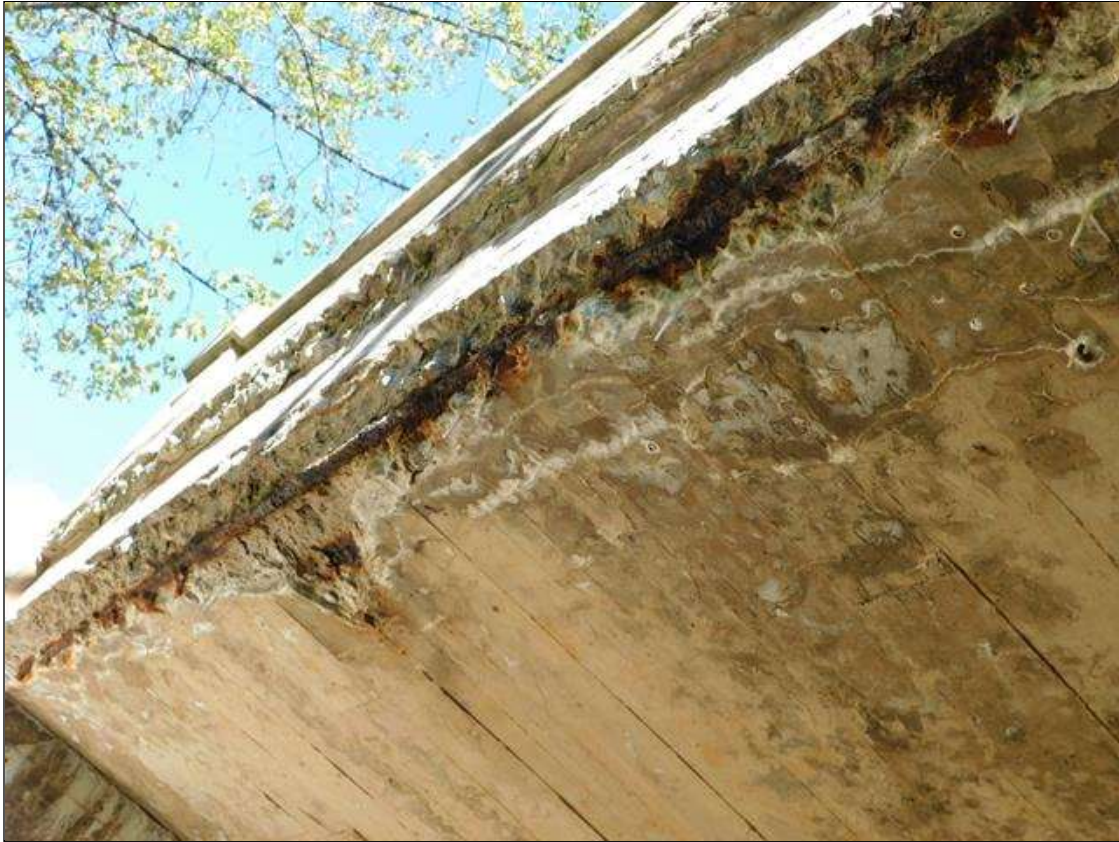
Span 1 Deck: 1.5' WIDE X FULL LENGTH X 6" DEEP DELAMINATION ALONG THE LEFT SIDE OF THE SLAB WITH HEAVY EFFLORESCENCE BUILDUP AND ONE EXPOSED LONGITUDINAL STEEL BAR. STEEL IS CORRODING WITH 0.0625" PITTING AND SCALE LOSS. (PAR)

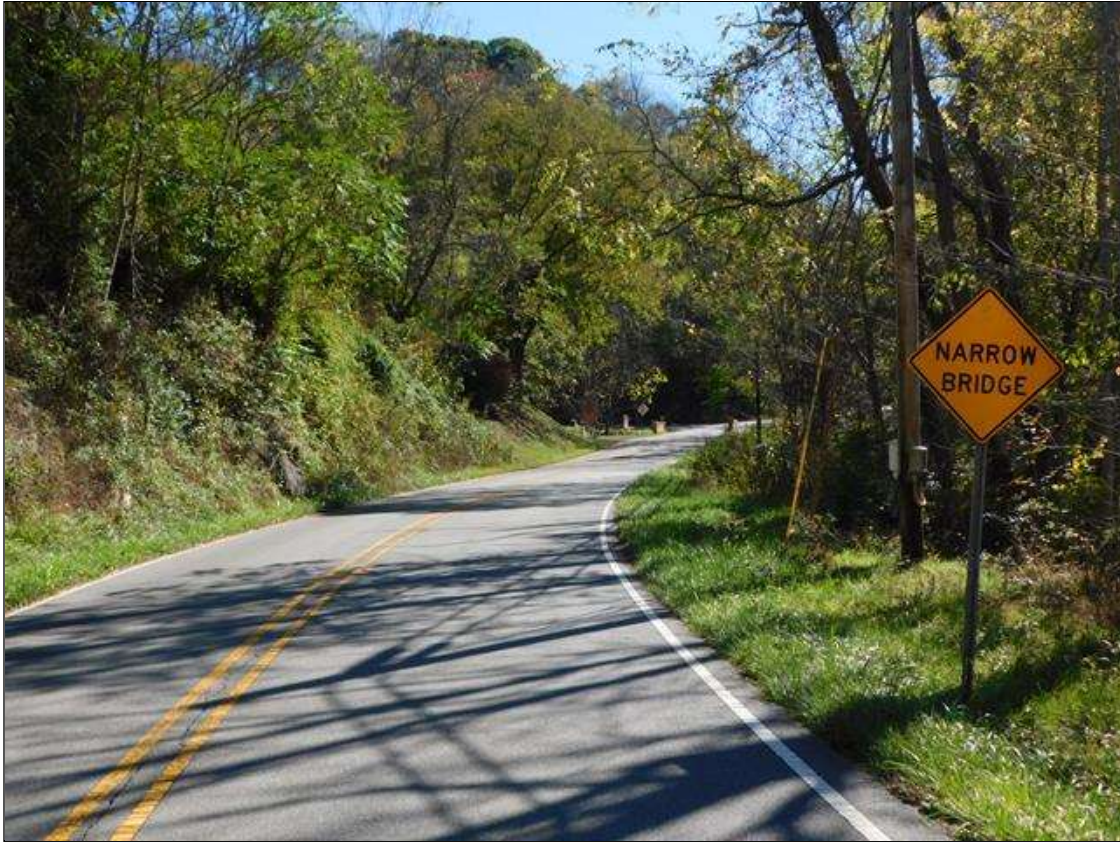
NORTH APPROACH NARROW BRIDGE SIGN
