NC DEPARTMENT OF TRANSPORTATION
 DIVISION OF HIGHWAYS
 STRUCTURE MANAGEMENT UNIT

ATTENTION: **PM ISSUED FOR CAPS, GIRDERS AND COL.**

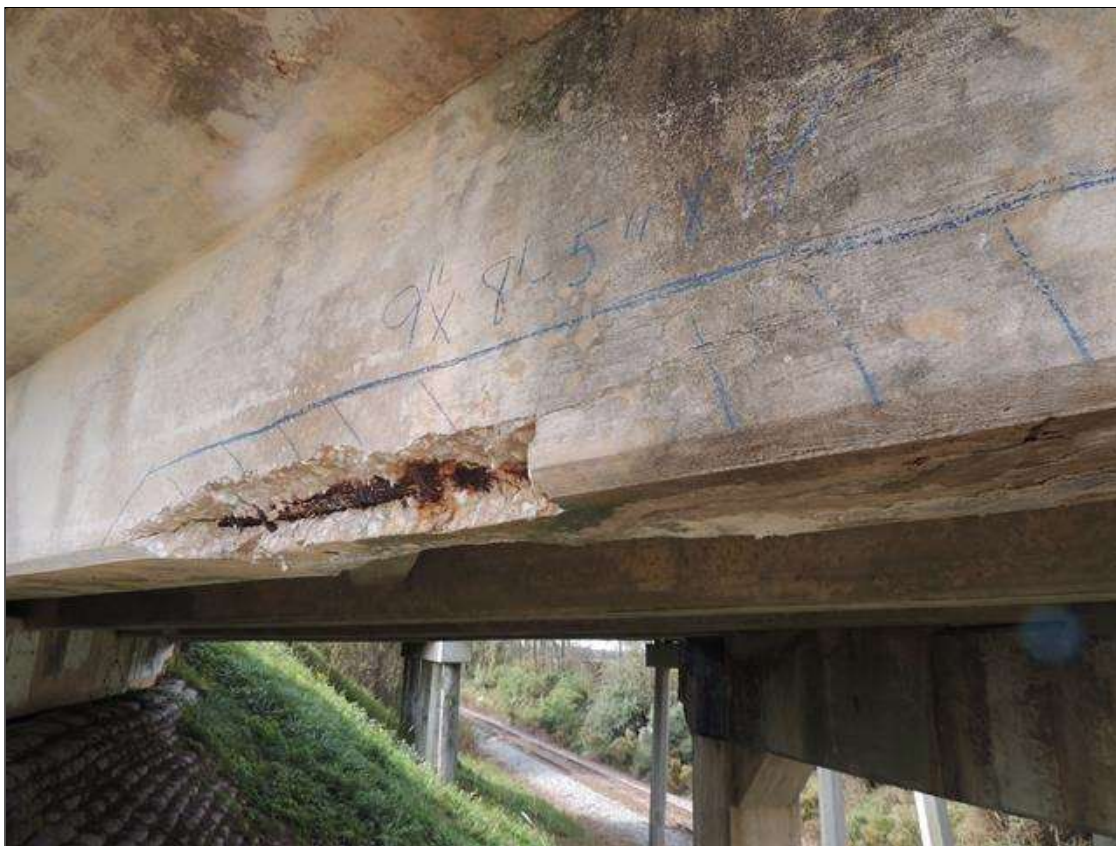
Span 1 Beam 4: 9 Feet of Delamination/Spall/Patched Area: Spall greater than 1 in. deep or greater than 6 in. diameter. Patched area that is unsound or showing distress. Does not warrant structural review.
SPAN 1 G4 CRACKED AND DELAMINATED SPALL AREA AT MID SPAN ALONG LEFT AND RIGHT SIDE AND UNDER BOTTOM 9" UP FACE 8' 5" LONG 18" WIDE.

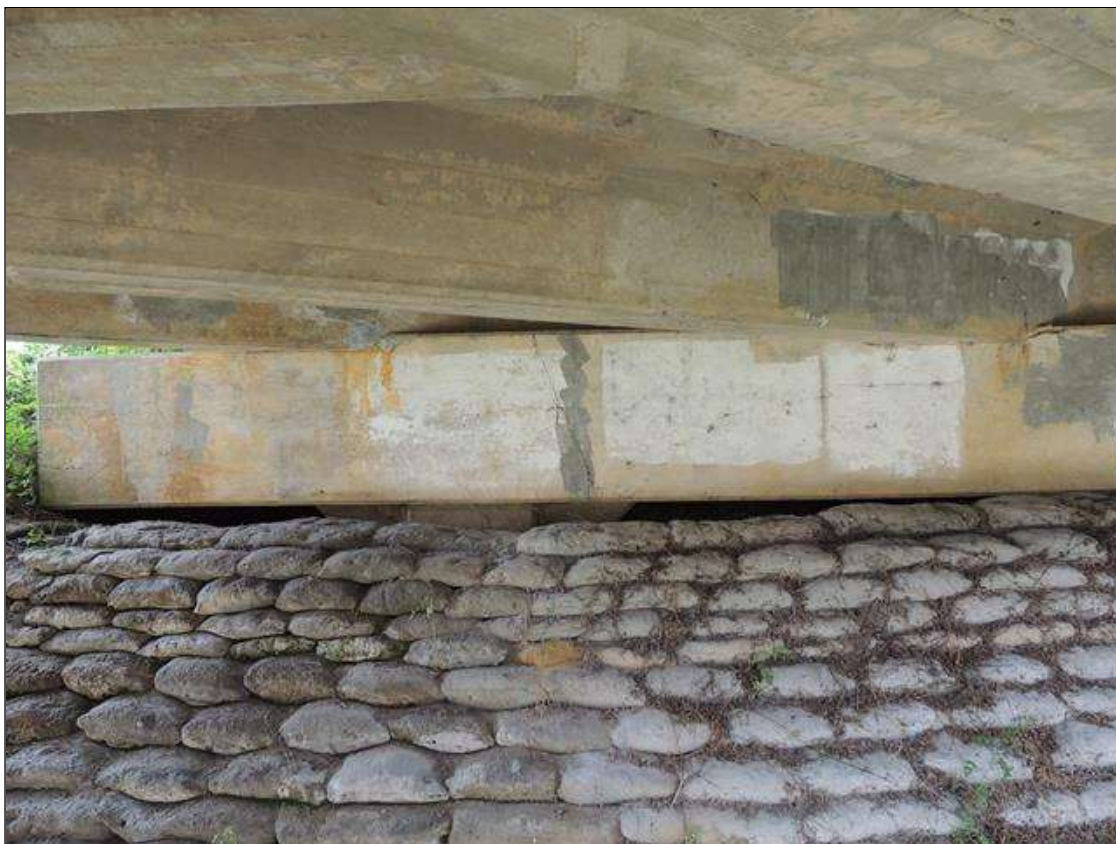
Bent 1 Cap : 45 Feet of Cracking (RC and Other): Width 0.012-0.05 in. or spacing of 1.0-3.0 ft.
END BENT 1 HAS SCATTERED MAP CRACKING WITH HORIZ CRACKS FROM LEFT TO RIGHT END.

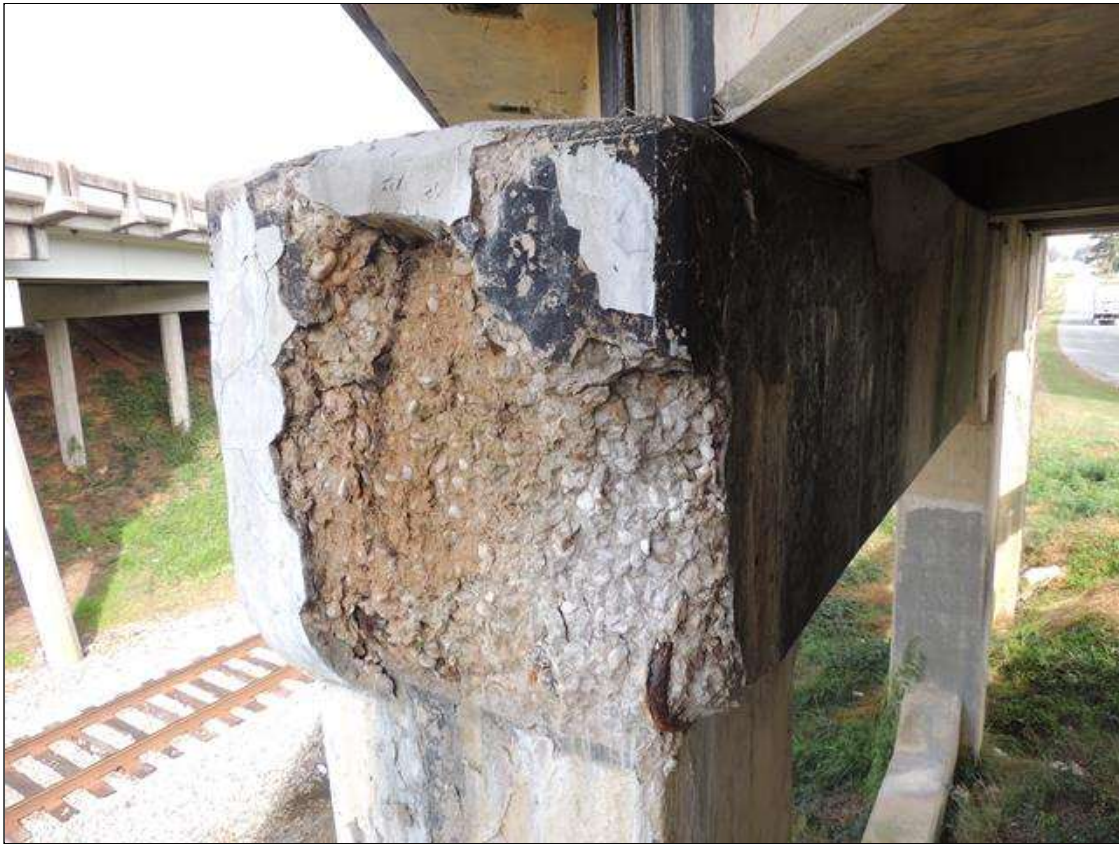
Bent 1 Cap : 4 Feet of Delamination/Spall/Patched Area: The condition warrants structural review to determine the effect on strength and serviceability of the element or the bridge; OR a structural review has been completed and the defects impact strength or serviceability of the element or bridge

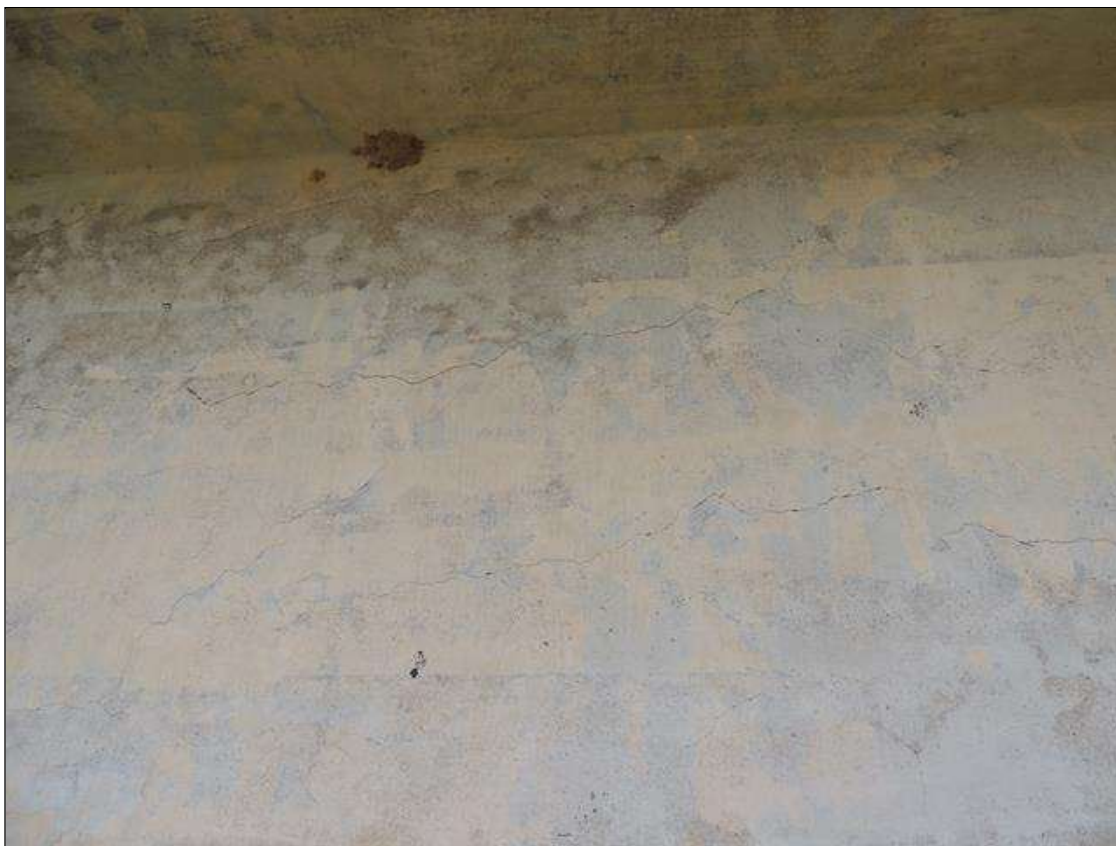
Span 1 Beam 1: 8 Feet of Cracking (RC and Other): Width 0.012-0.05 in. or spacing of 1.0-3.0 ft.
SPAN 1 LEFT SIDE OF G1 NEAR BENT 1 SCATTERED MAP CRACKING IN FACE OF GIRDER.

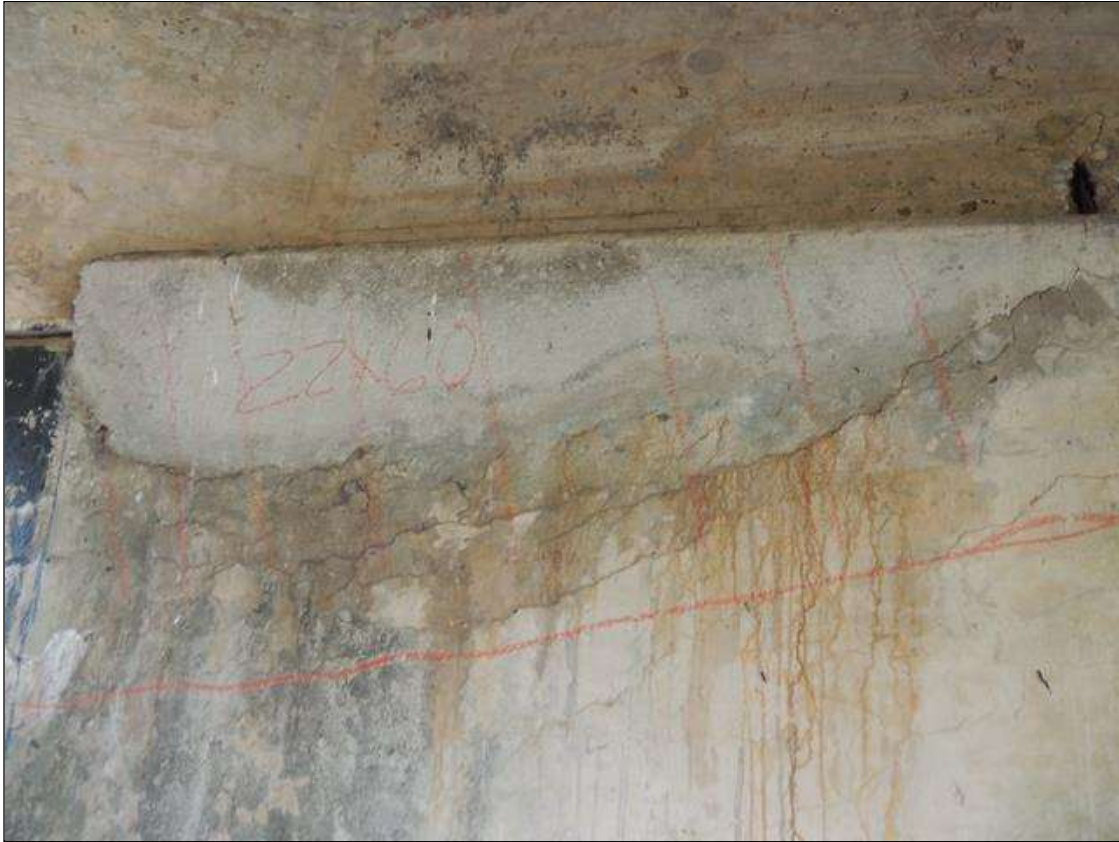
Bent 1 Cap : 5 Feet of Delamination/Spall/Patched Area: Delaminated. Spall 1 inch or less deep or 6 inches or less in diameter. Patched area that is sound
BENT 1 SOUTH FACE OF CAP RIGHT SIDE OF G1 CRACKED AND PATCHED AREA IS DELAMINATED TOP DOWN 22" 5' LONG.

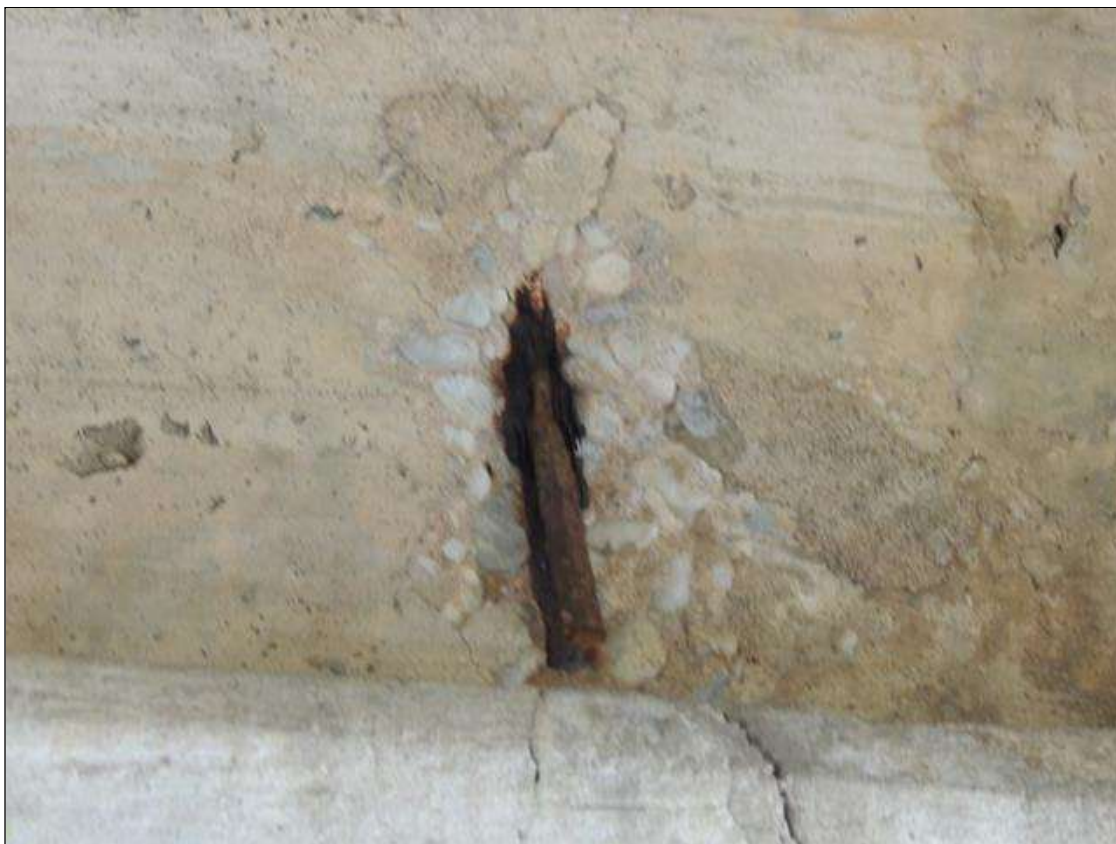
END DIAPHRAGM OVER BENT 1 IN BAY 1 6" X 8" X 3/4" VERTICAL REBAR EXPOSED.

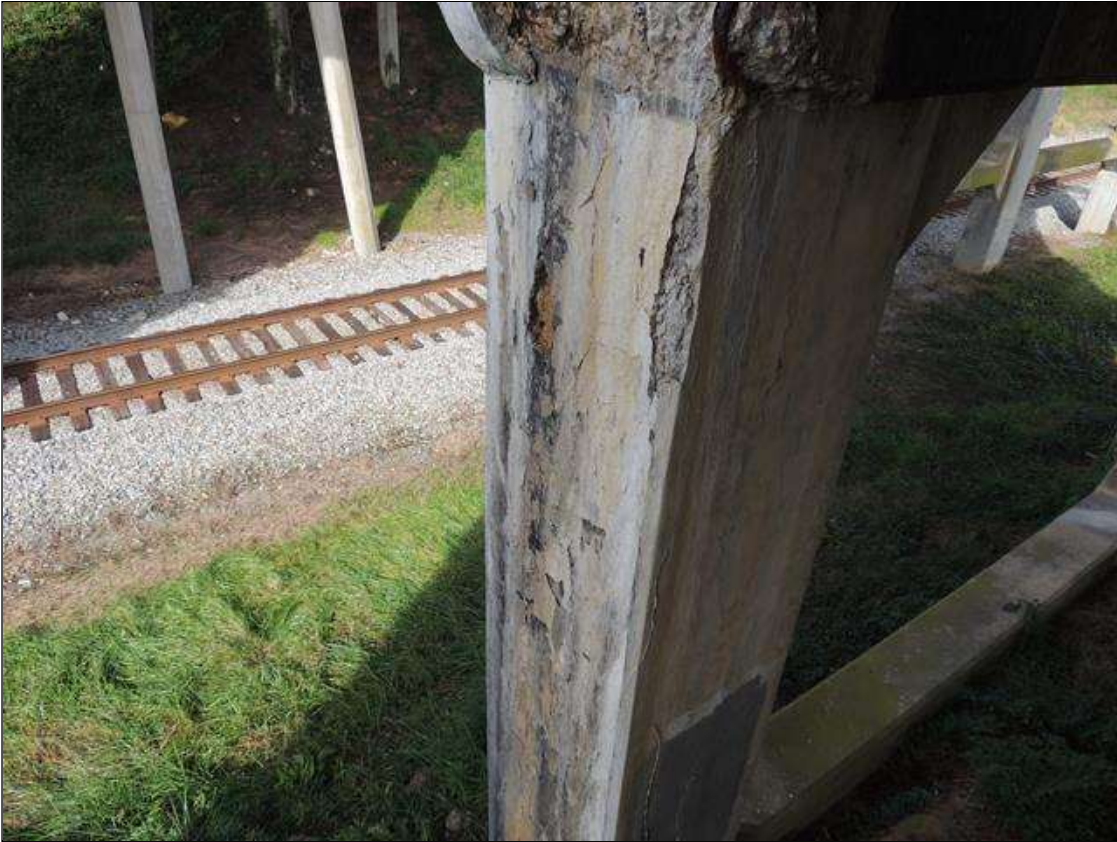
Bent 1 Pile 1: 1 Each of Delamination/Spall/Patched Area: Spall greater than 1 in. deep or greater than 6 in. diameter. Patched area that is unsound or showing distress. Does not warrant structural review.
BENT 1 COL 1 WEST FACE END BENT 1 CRACKED SPALL DELAMINATED AND DETERIORATED 31" WIDE FROM TOP TO GROUND LINE 13' WITH HEAVY EFFLO EXPOSED. ALSO CRACKED AND DELAMINATED ON NORTH FACE AND SOUTH FACE 10".

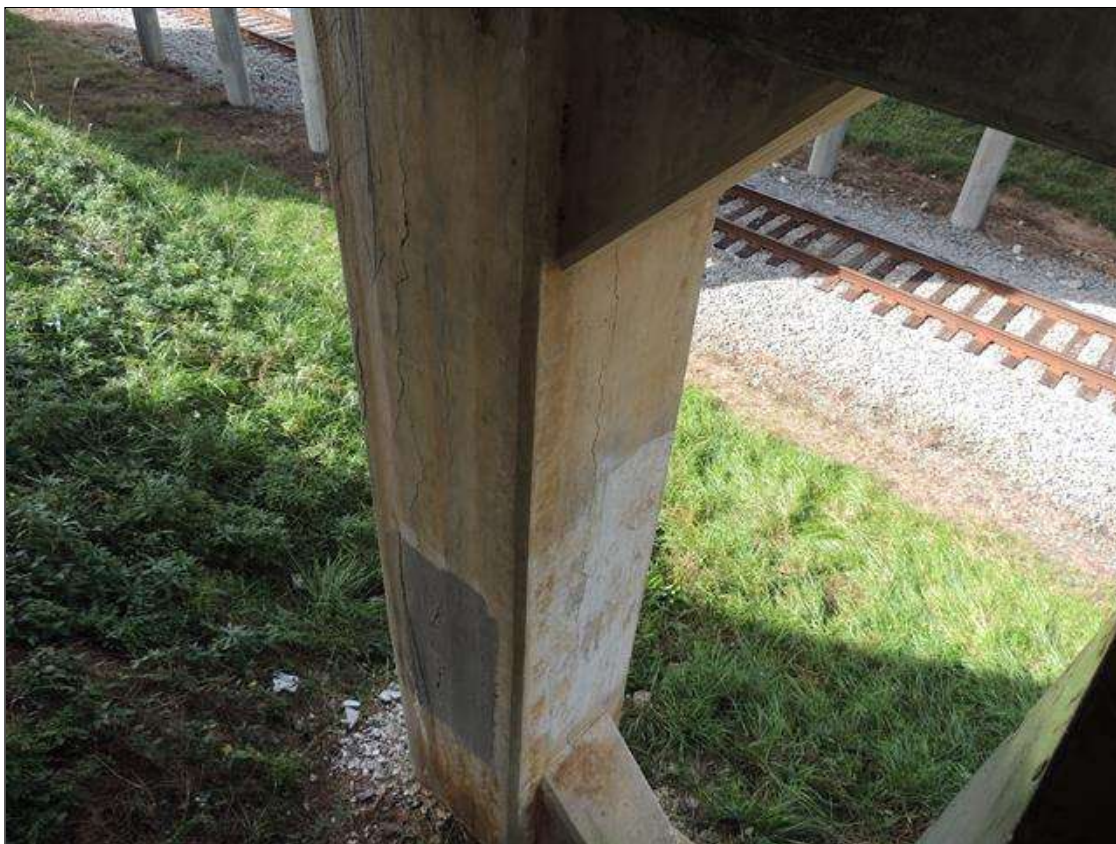
Bent 1 Pile 1: 0 Each of Cracking (RC and Other): Width 0.012-0.05 in. or spacing or 1.0-3.0 ft.
BENT 1 COL 1 SOUTH AND EAST FACE OF COL HEAVY VERTICAL AND MAP CRACKING AND NORTH FACE IS
SIMILAR.

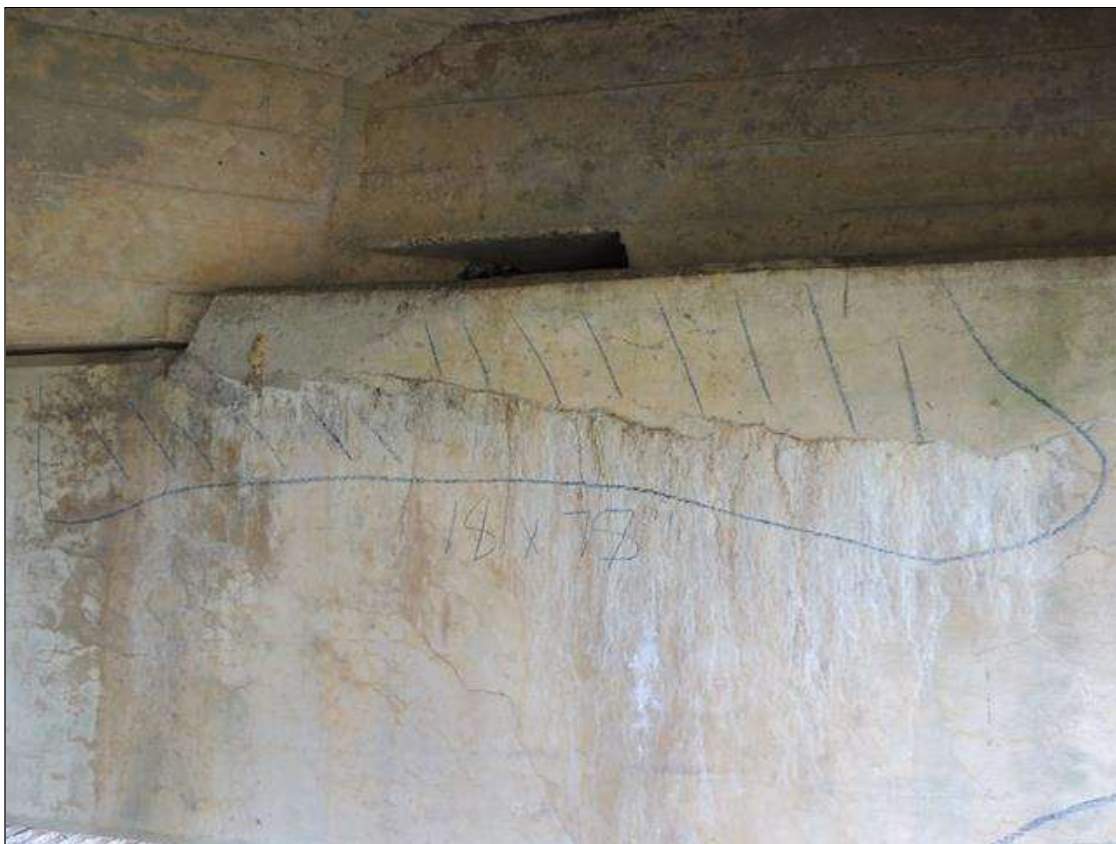
Bent 1 Cap : 7 Feet of Delamination/Spall/Patched Area: Delaminated. Spall 1 inch or less deep or 6 inches or less in diameter. Patched area that is sound
BENT 1 SOUTH FACE OF CAP CRACKED PATCHED AND DELAMINATED AREA WITH HEAVY EFFLO FROM G2 OVER TO COL 2 18" DOWN FACE 78" LONG.

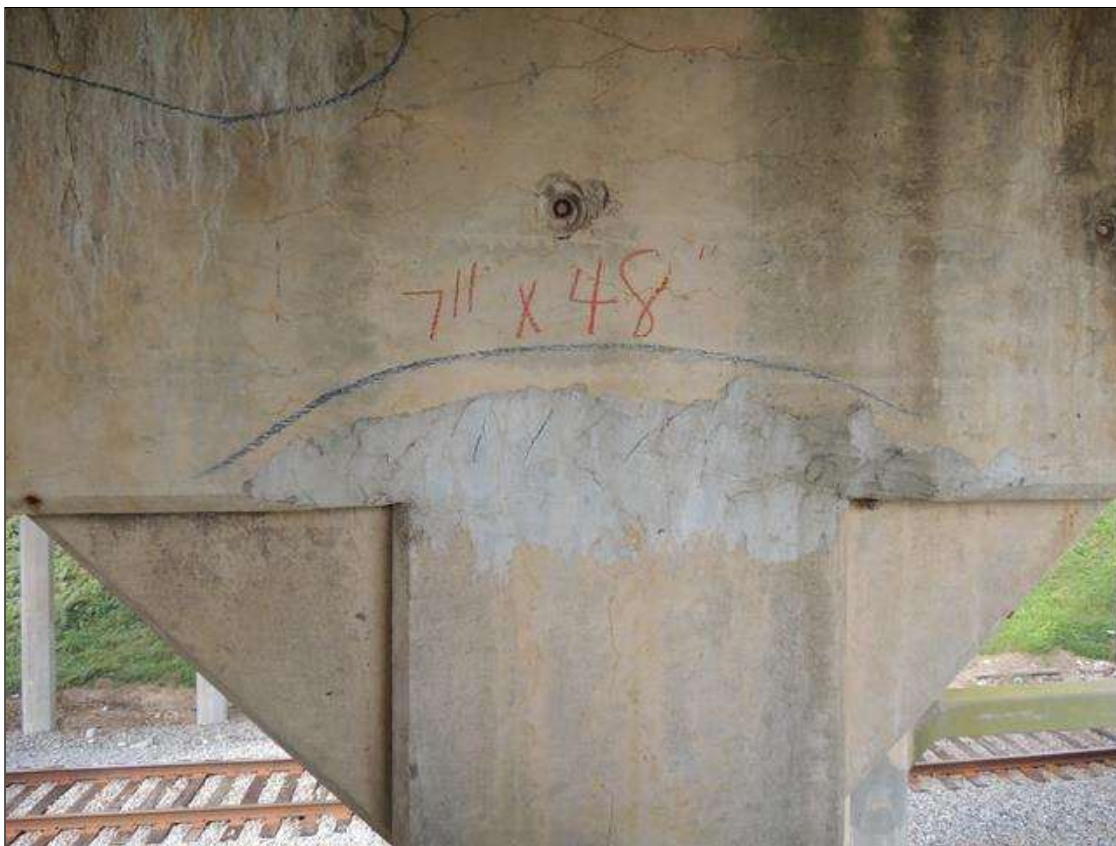
Bent 1 Cap : 4 Feet of Delamination/Spall/Patched Area: Delaminated. Spall 1 inch or less deep or 6 inches or less in diameter. Patched area that is sound
BENT 1 SOUTH FACE OF CAP PATCHED AREA ALONG THE BOTTOM EDGE AT COL 2 7" UP FACE AND 40" LONG.

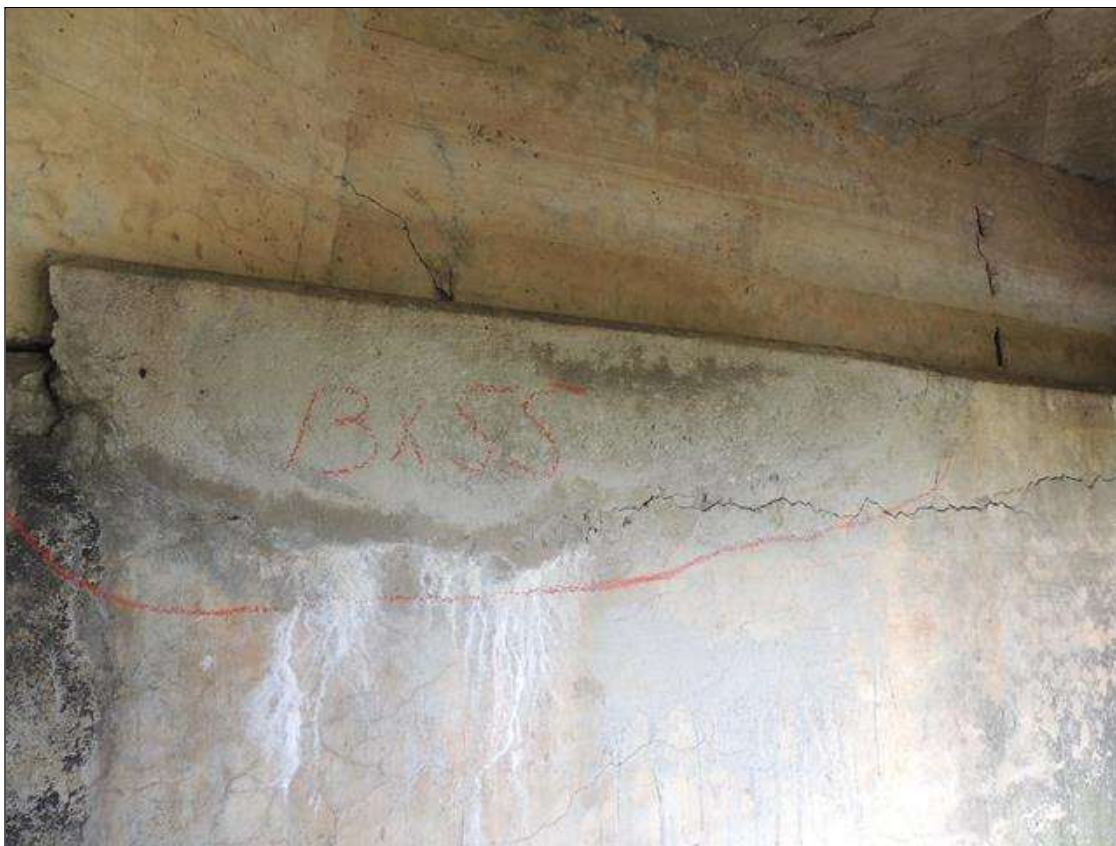
Bent 1 Cap : 5 Feet of Delamination/Spall/Patched Area: Delaminated. Spall 1 inch or less deep or 6 inches or less in diameter. Patched area that is sound
BENT 1 SOUTH FACE OF CAP HAS A PATCHED AREA ALONG TOP FACE RIGHT SIDE OF G3 13" DOWN FACE AND 55 " LONG.

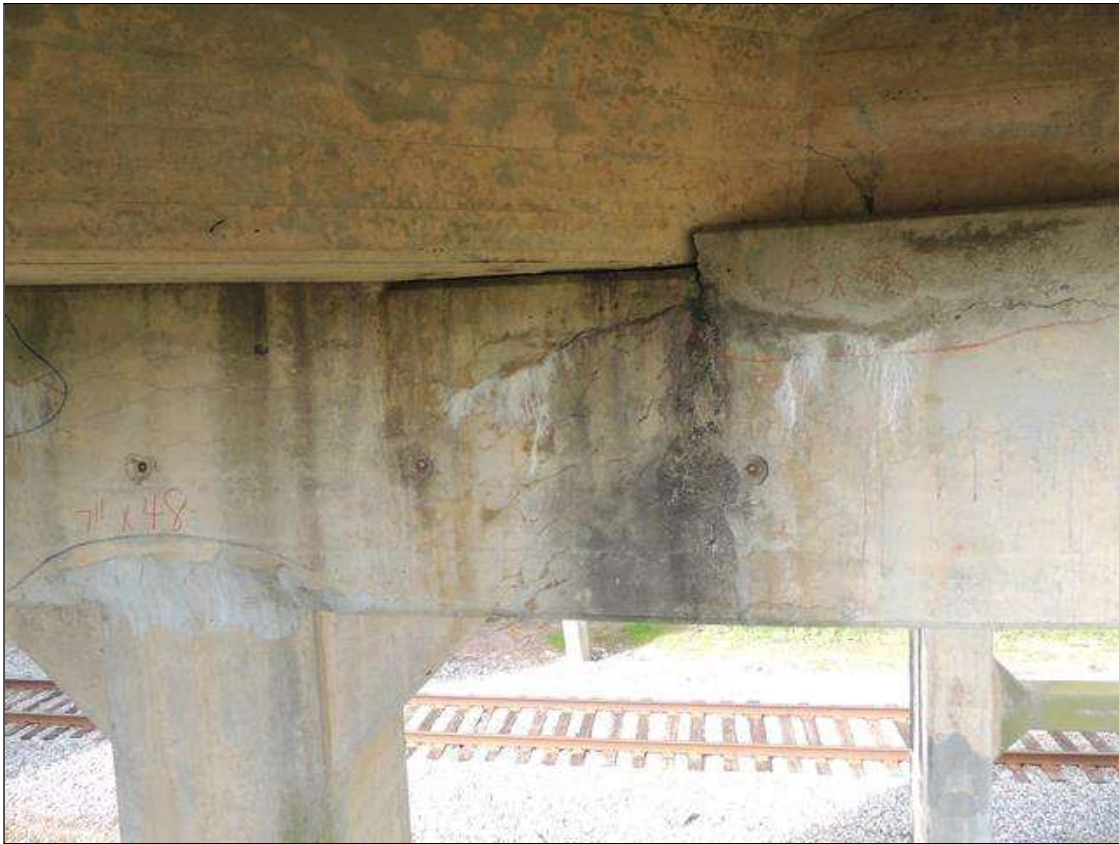
Bent 1 Cap : 0 Feet of Cracking (RC and Other): Width greater than 0.05 in. or spacing of less than 1 ft.
BENT 1 SOUTH FACE OF CAP HAS SCATTERED MAP CRACKING AND HORIZ CRACKS FROM LEFT TO RIGHT
END WITH EFFLO STAINS LEACHING.

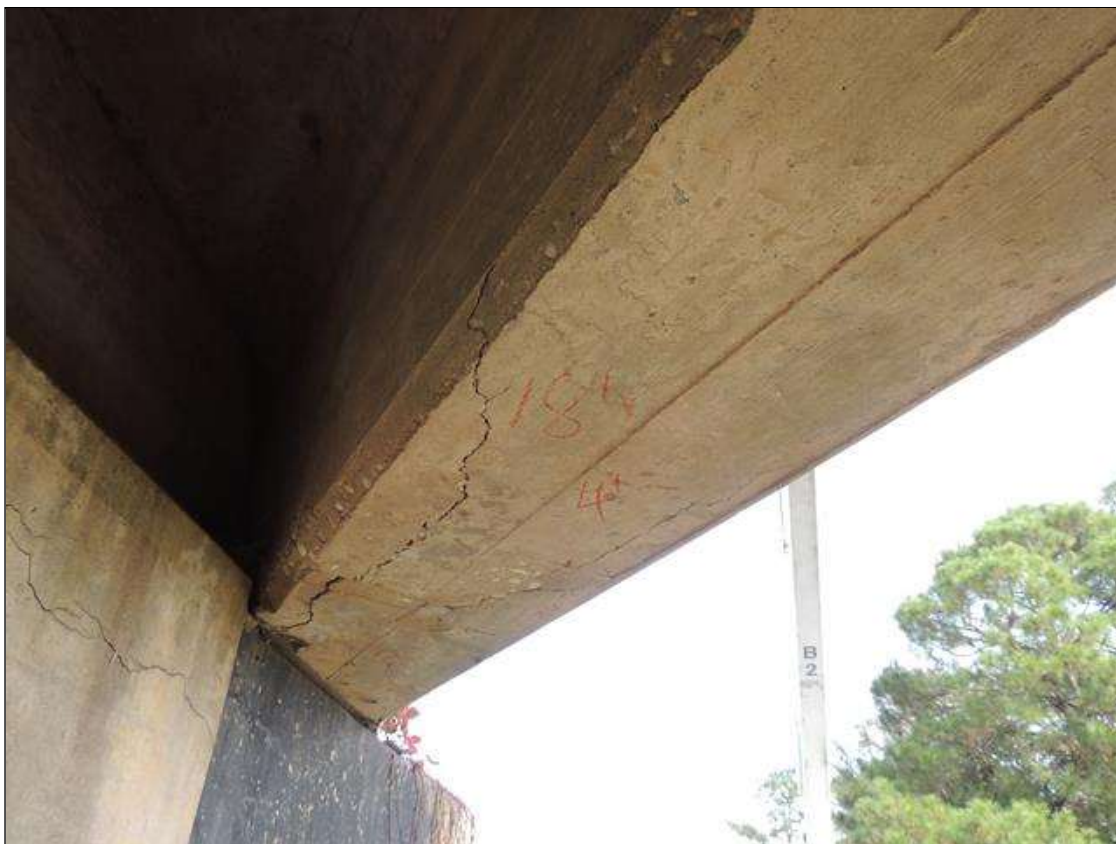
Span 1 Beam 4: 4 Feet of Delamination/Spall/Patched Area: Delaminated. Spall 1 in. or less deep or 6 in. or less in diameter. Patched area that is sound.
SPAN 1 LEFT AND RIGHT SIDE AND BOTTOM OF G4 AT BENT 1 IS CRACKED AND DELAMINATED 6" UP EACH FACE 18" WIDE UNDER BOTTOM 4' LONG.

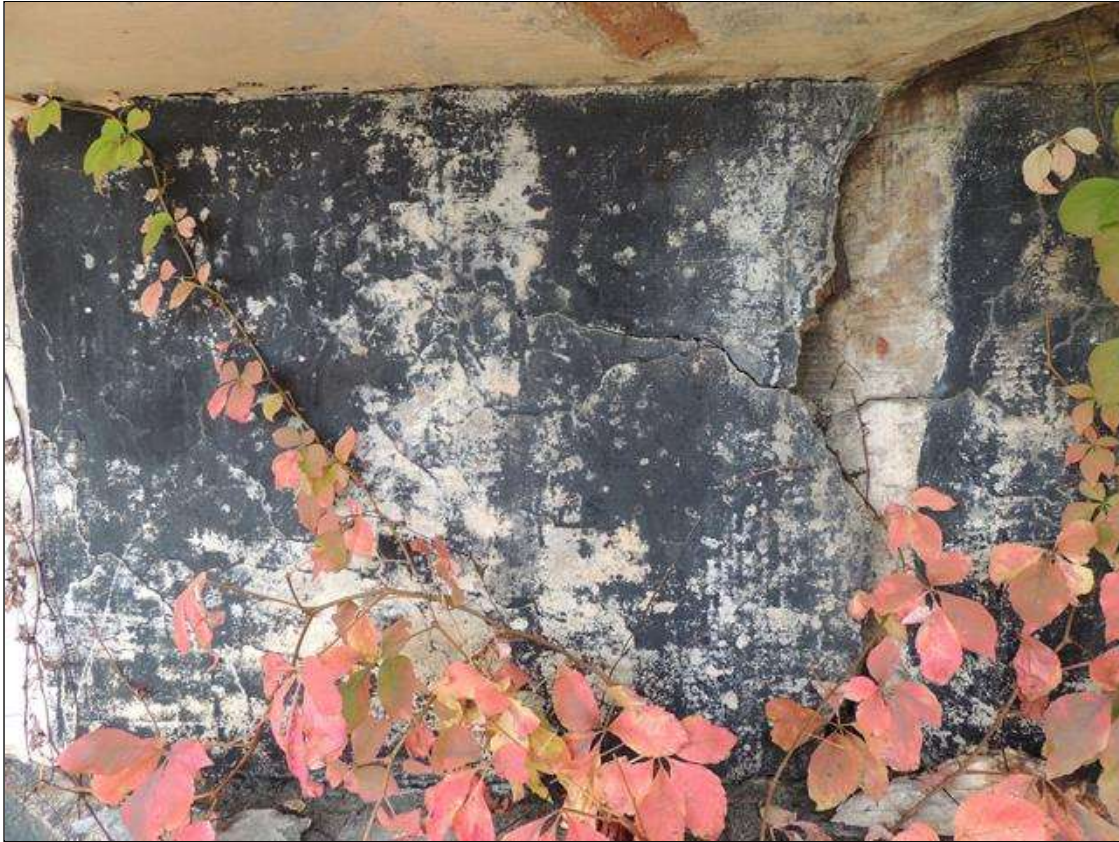
Span 1 Beam 4: 2 Feet of Delamination/Spall/Patched Area: Delaminated. Spall 1 in. or less deep or 6 in. or less in diameter. Patched area that is sound.
SPAN 1 RIGHT SIDE OF G4 CRACKED SPALL DELAMINATED AREA FROM THE END BACK 20" TOP DOWN 24" 3" DEEP.

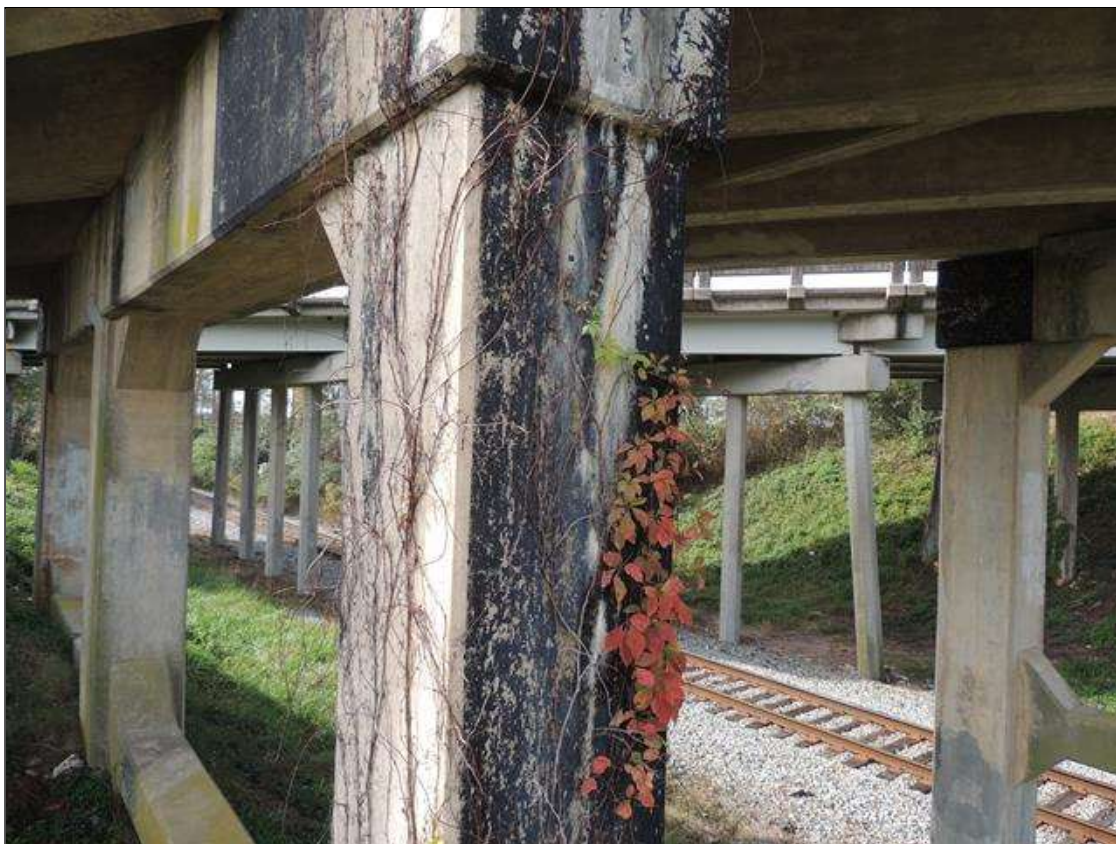
Bent 1 Pile 3: 1 Each of Delamination/Spall/Patched Area: Delaminated. Spall 1 in. or less deep or 6 in. or less in diameter. Patched area that is sound.
BENT 1 EAST FACE OF COL 3 CRACKED AND DELAMINATED WITH EFFLO STAINS TO- DOWN 12'

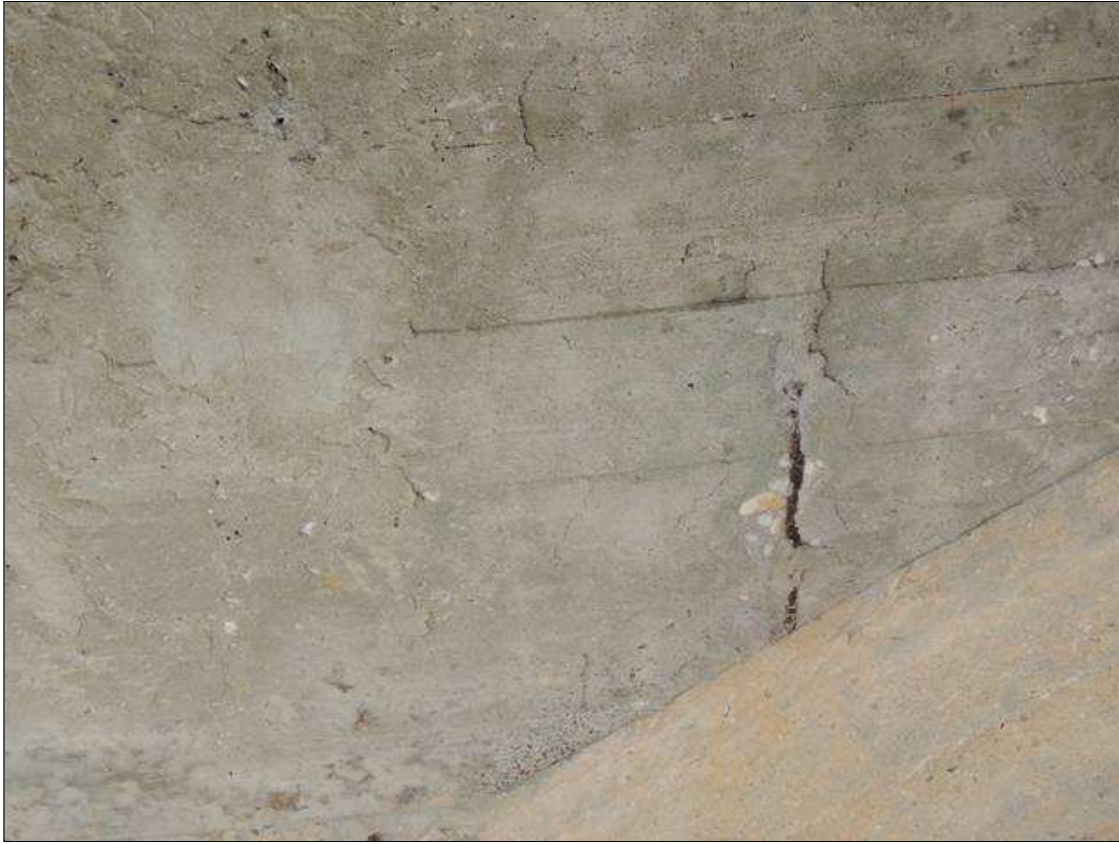
Span 2 Deck: 4 Square Feet of Delamination/Spall: Delaminated. Spall 1 in. or less deep or 6 in. or less in diameter.
SPAN 2 BOTTOM OF DECK OF BAY 3 OVER BENT 1 CAP CRACKED AND DELAMINATED AREA WITH REBAR EXPOSED.

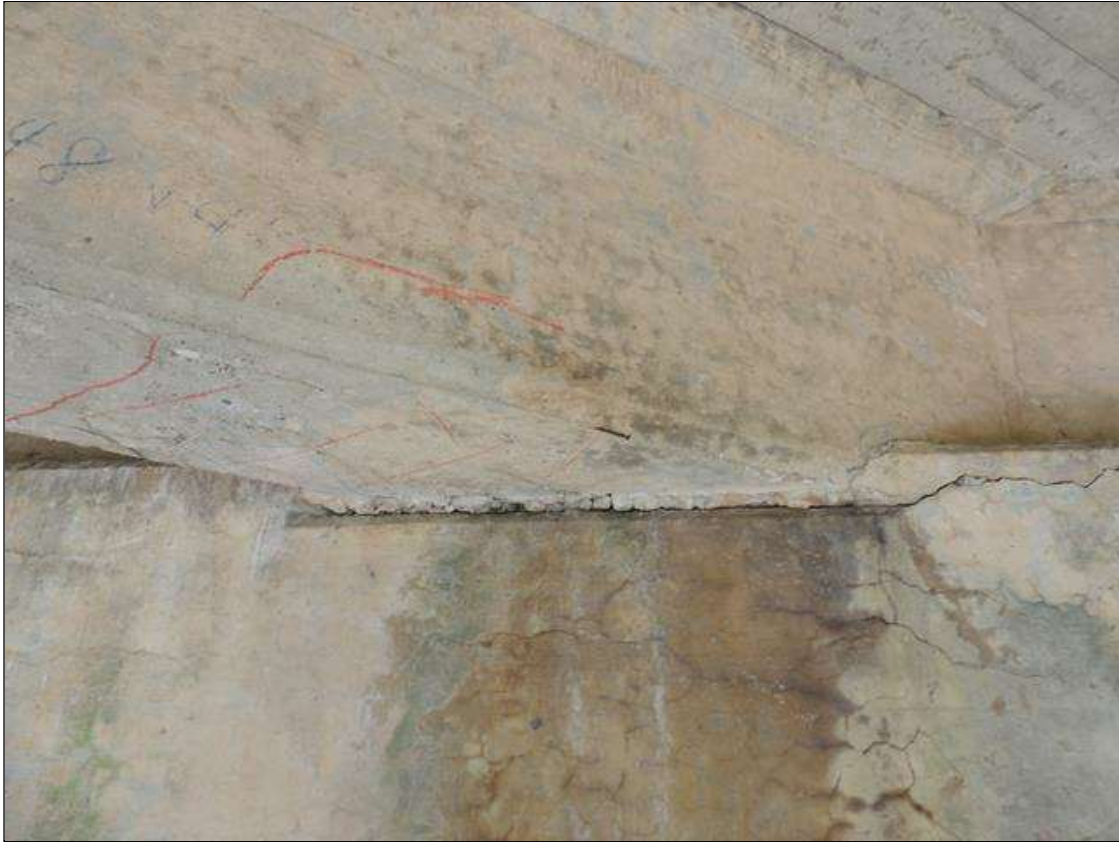
Span 2 Beam 3: 4 Feet of Delamination/Spall/Patched Area: Delaminated. Spall 1 in. or less deep or 6 in. or less in diameter. Patched area that is sound.
SPAN 2 LEFT AND RIGHT SIDE OF G3 AND BOTTOM CRACKED AND DELAMINATED FROM END OF GIRDER OVER BENT 1 OUT 4' 18" UNDER BOTTOM AND 4" UP THE FACE.

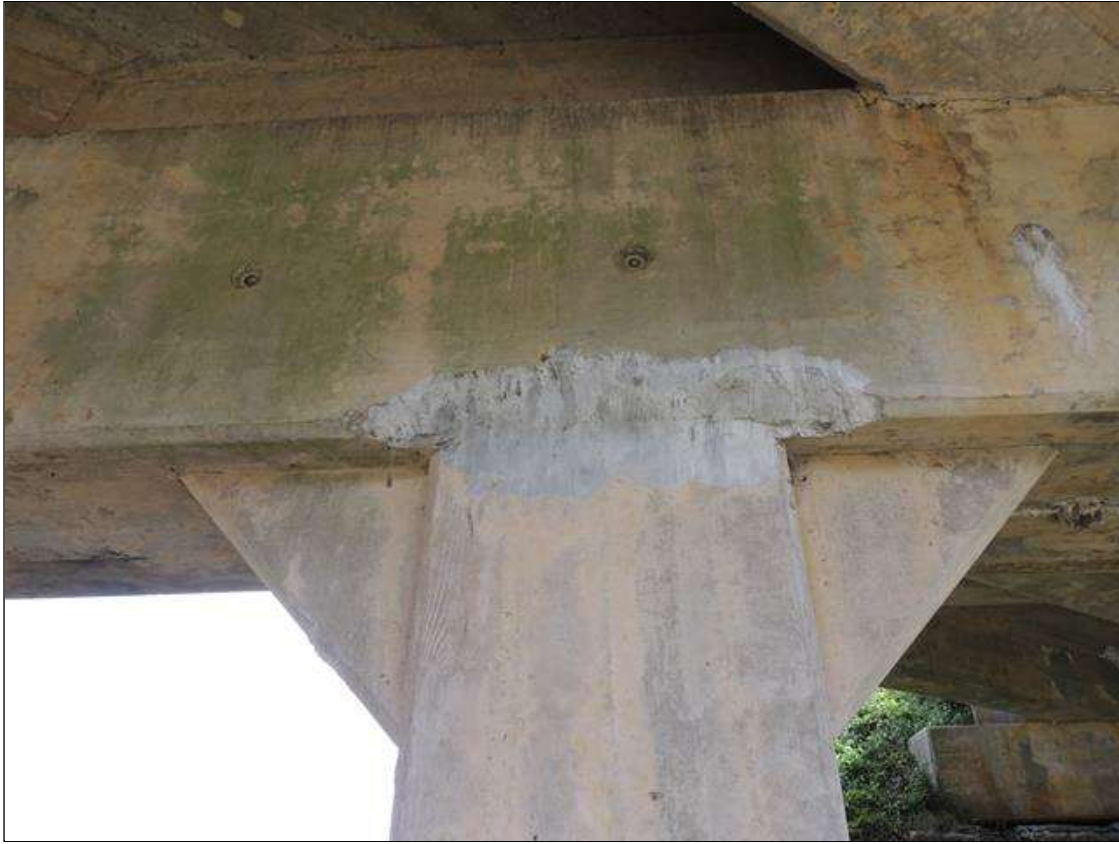
Bent 1 Cap : 0 Feet of Delamination/Spall/Patched Area: Delaminated. Spall 1 inch or less deep or 6 inches or less in diameter. Patched area that is sound
BENT 1 NORTH FACE OF CAP PATCHED AREA ALONG BOTTOM EDGE AT COL 2 5" UP FACE 45" LONG.

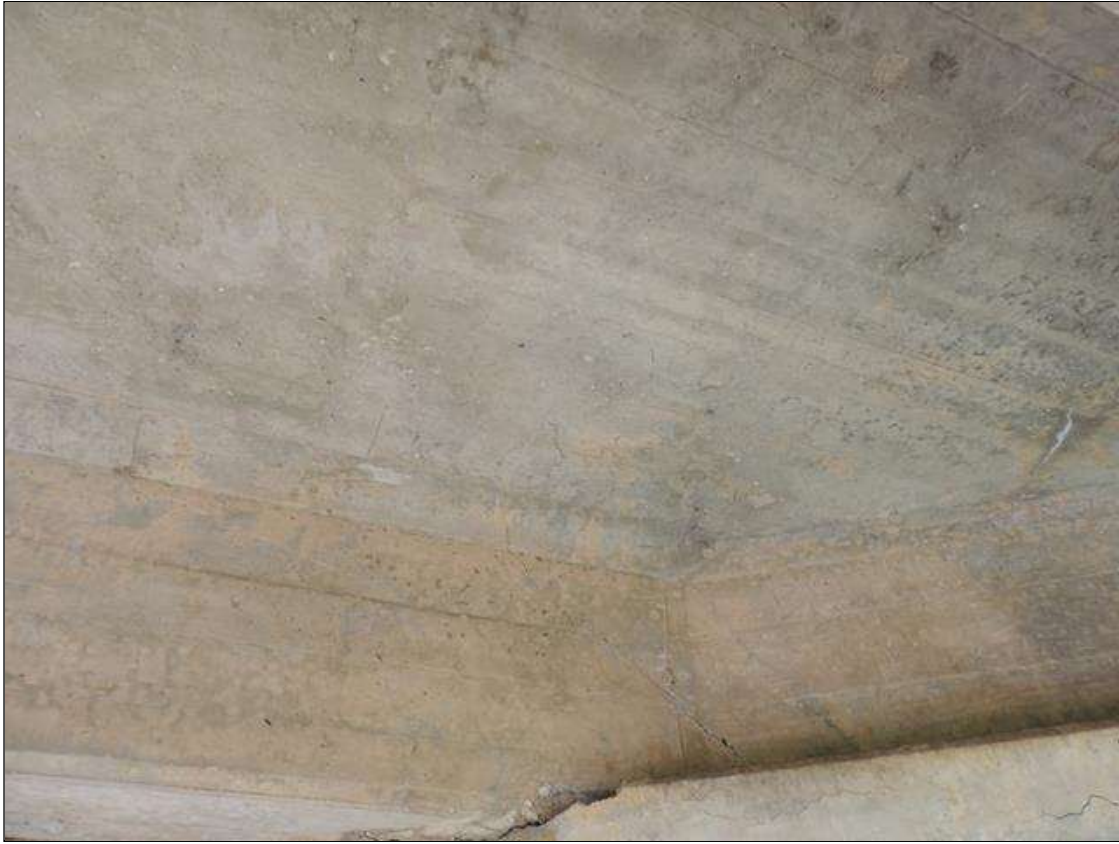
Span 2 Deck: 40 Square Feet of Delamination/Spall: Delaminated. Spall 1 in. or less deep or 6 in. or less in diameter.
SPAN 2 BOTTOM OF DECK IN BAY 1 CRACKED AND DELAMINATED FROM BENT OUT 10' 4' WIDE.

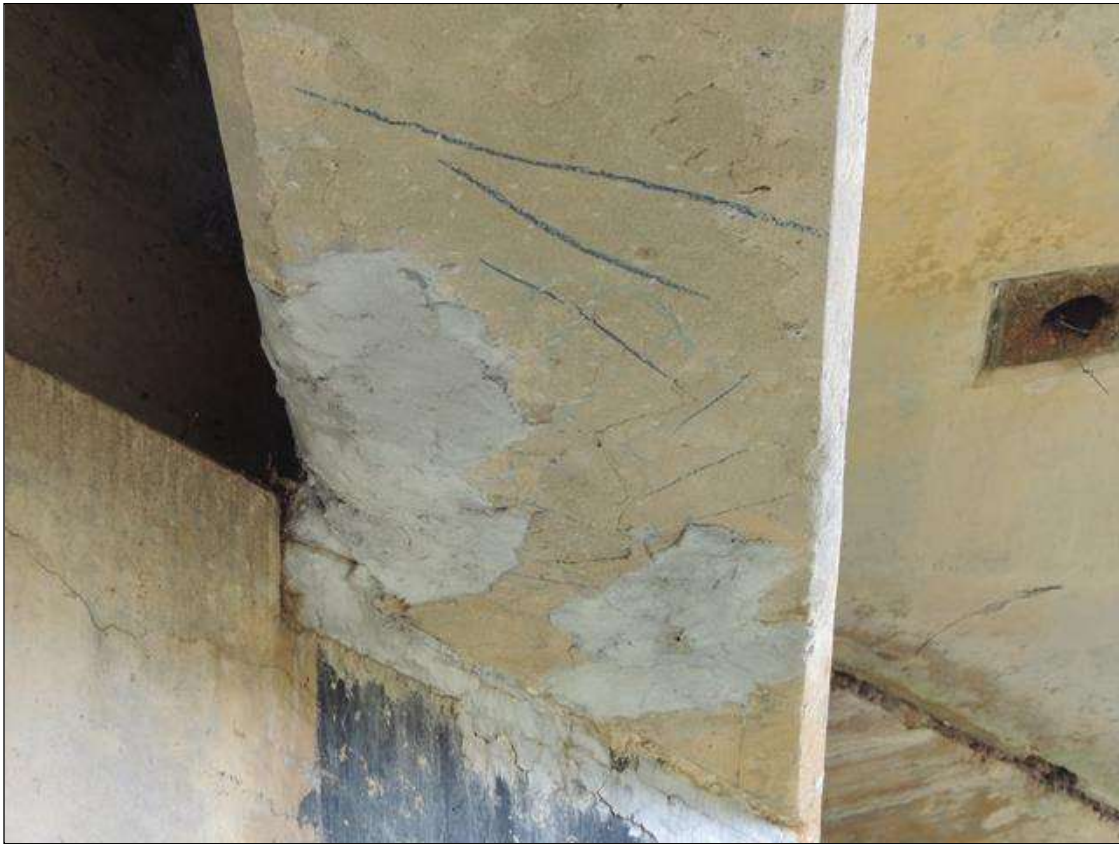
Span 2 Beam 1: 4 Feet of Delamination/Spall/Patched Area: Delaminated. Spall 1 in. or less deep or 6 in. or less in diameter. Patched area that is sound.
SPAN 2 LEFT AND RIGHT SIDE AND BOTTOM OF G1 CRACKED AND DELAMINATED AREAS 18" WIDE FROM BENT 1 CAP OUT 4' AND 4" UP FACE.

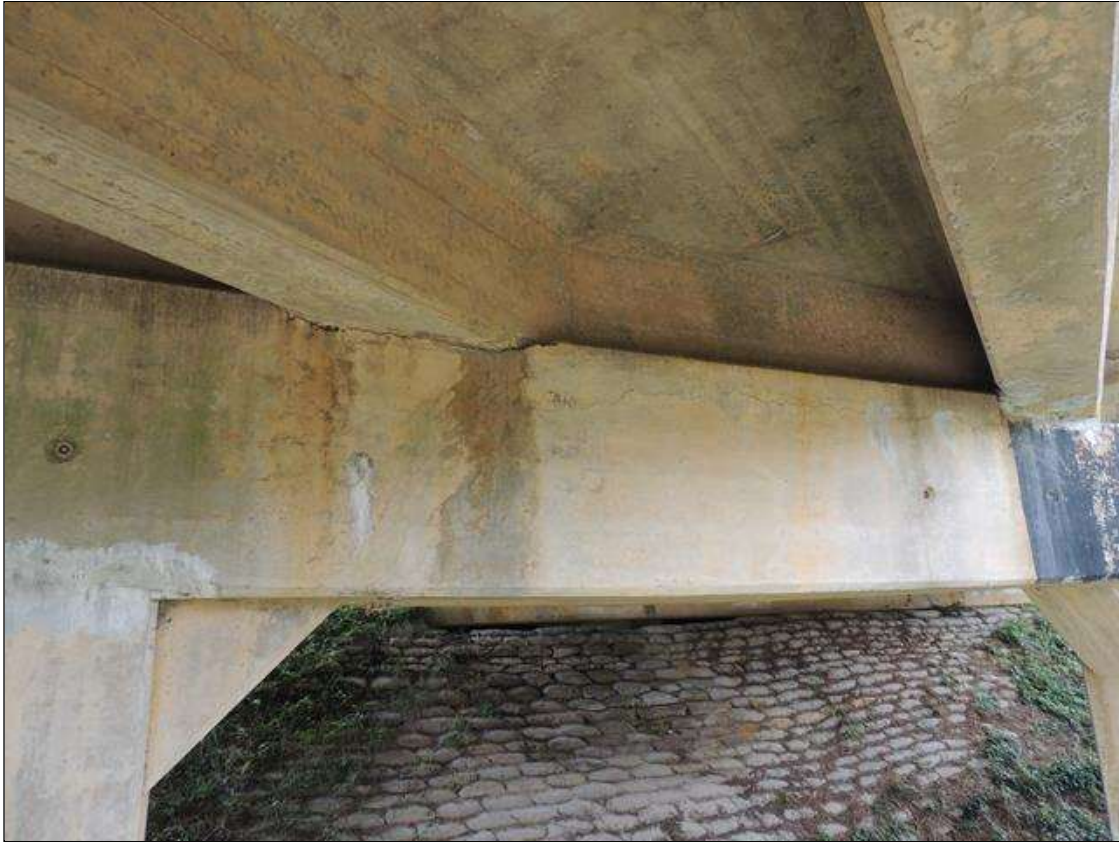
Bent 1 Cap : 0 Feet of Cracking (RC and Other): Width 0.012-0.05 in. or spacing of 1.0-3.0 ft.
BENT 1 NORTH FACE OF CAP SCATTERED MAP CRACKING AND HORIZ CRACKS FROM LEFT TO RIGHT END.

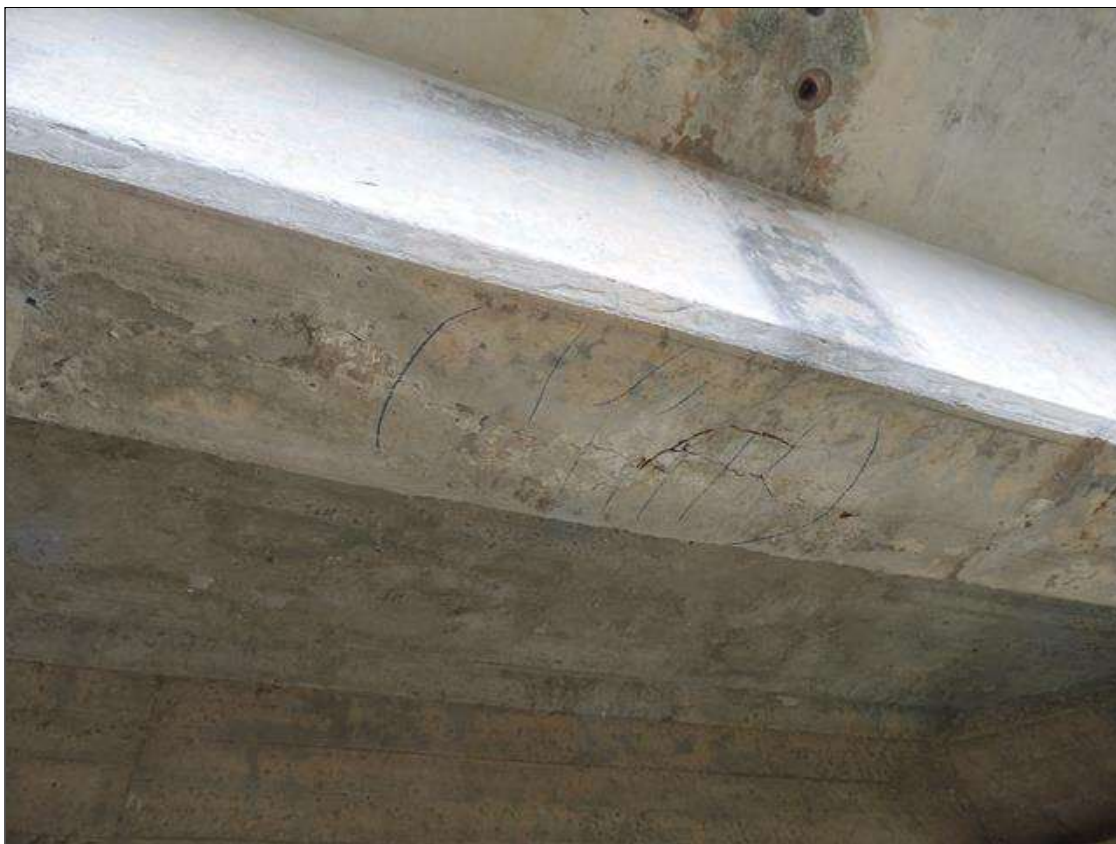
Span 2 Beam 1: 3 Feet of Delamination/Spall/Patched Area: Delaminated. Spall 1 in. or less deep or 6 in. or less in diameter. Patched area that is sound.
SPAN 2 G1 CRACKED AND DELAMINATED AREA NEAR MID SPAN 18" UNDER BOTTOM 5" UP RIGHT FACE 32" LONG.
