NC DEPARTMENT OF TRANSPORTATION
 DIVISION OF HIGHWAYS
 STRUCTURE MANAGEMENT UNIT

ATTENTION: **PM ISSUED FOR CAPS, GIRDERS AND COL.**

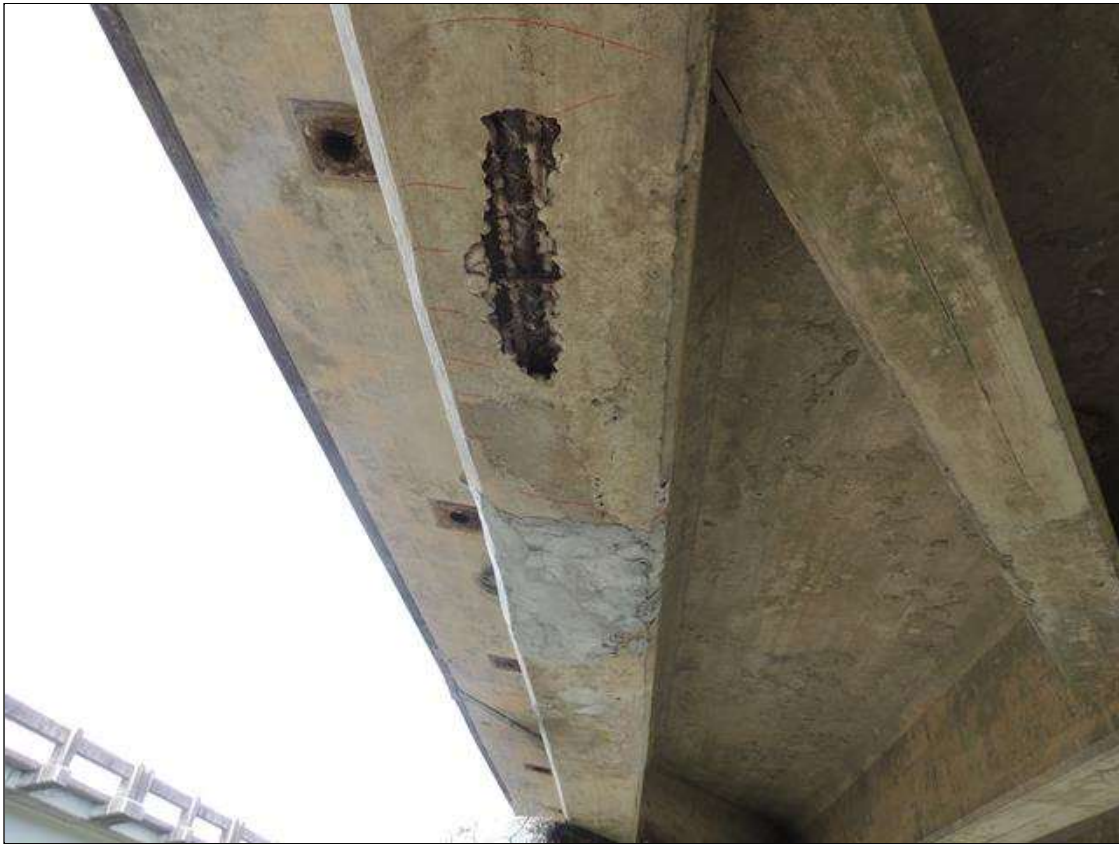
Span 2 Beam 1: 13 Feet of Delamination/Spall/Patched Area: The condition warrants a structural review to determine the effect on strength or serviceability of the element or bridge; OR a structural review has been completed and the defects impact strength or serviceability of the element or bridge.

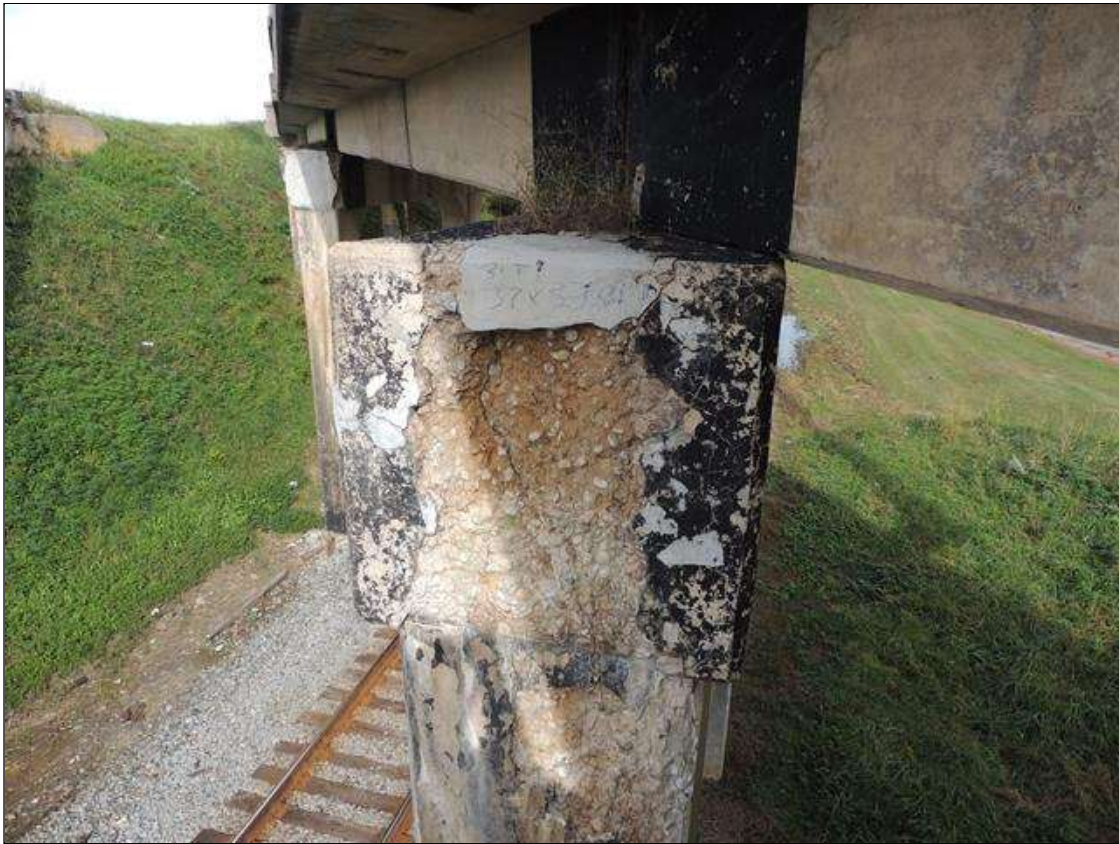
Bent 2 Cap : 6 Feet of Delamination/Spall/Patched Area: The condition warrants structural review to determine the effect on strength and serviceability of the element or the bridge; OR a structural review has been completed and the defects impact strength or serviceability of the element or bridge

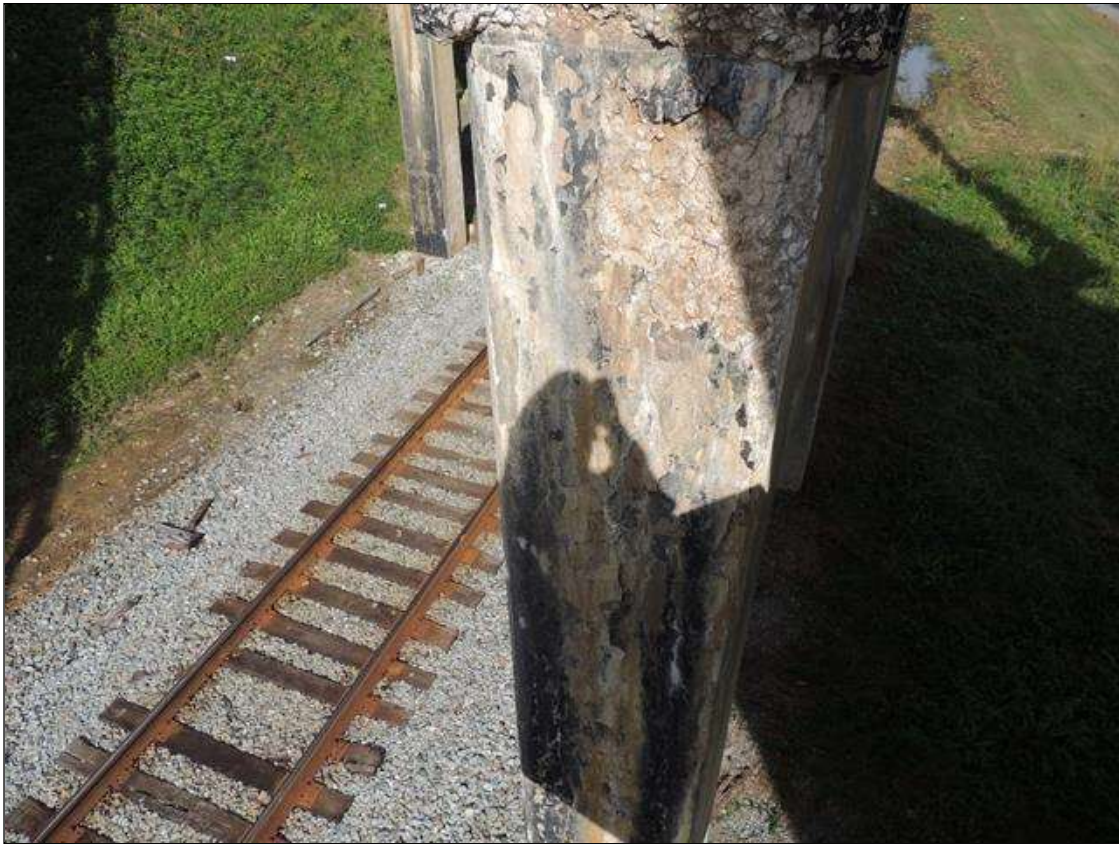
Bent 2 Pile 1: 1 Each of Delamination/Spall/Patched Area: The condition warrants a structural review to determine the effect on strength or serviceability of the element or bridge; OR a structural review has been completed and the defects impact strength or serviceability of the element or bridge.

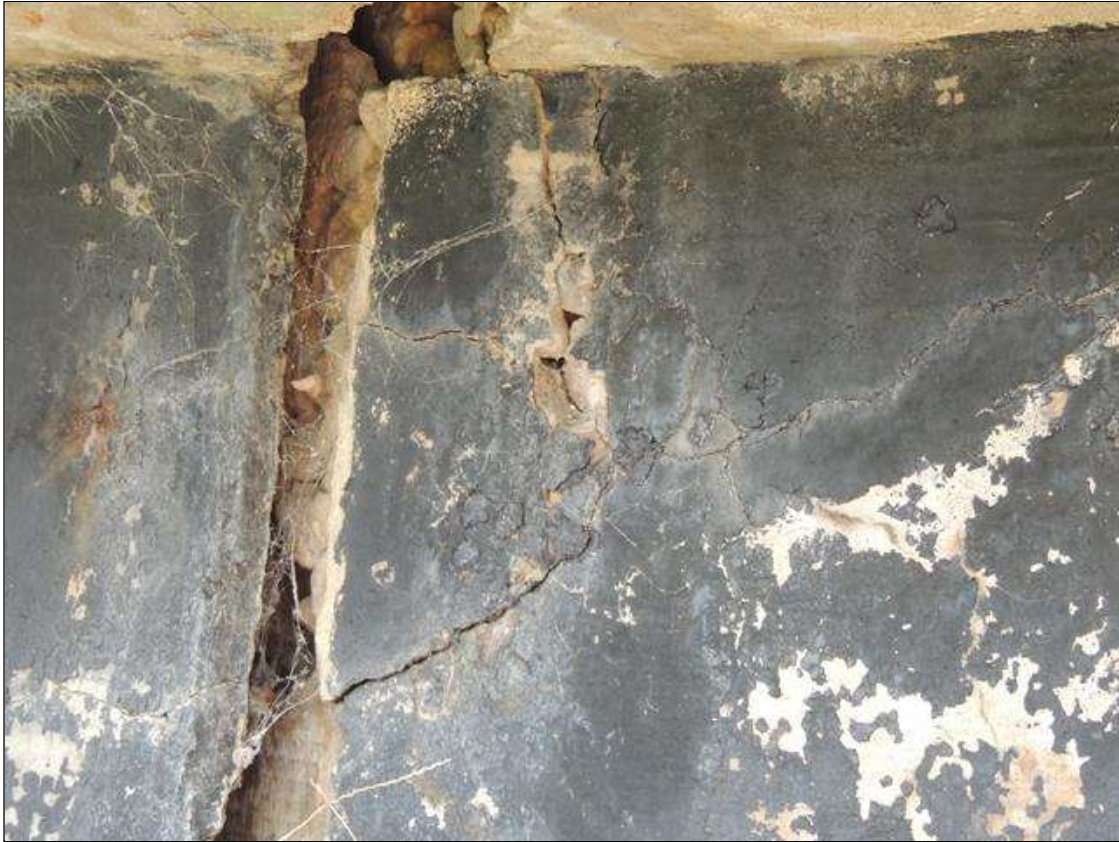
Span 2 Beam 1: 1 Feet of Delamination/Spall/Patched Area: Delaminated. Spall 1 in. or less deep or 6 in. or less in diameter. Patched area that is sound.
SPAN 2 LEFT SIDE OF G1 OVER BENT 2 7" X 7" CRACK AREA OVER TOP OF GIRDER.

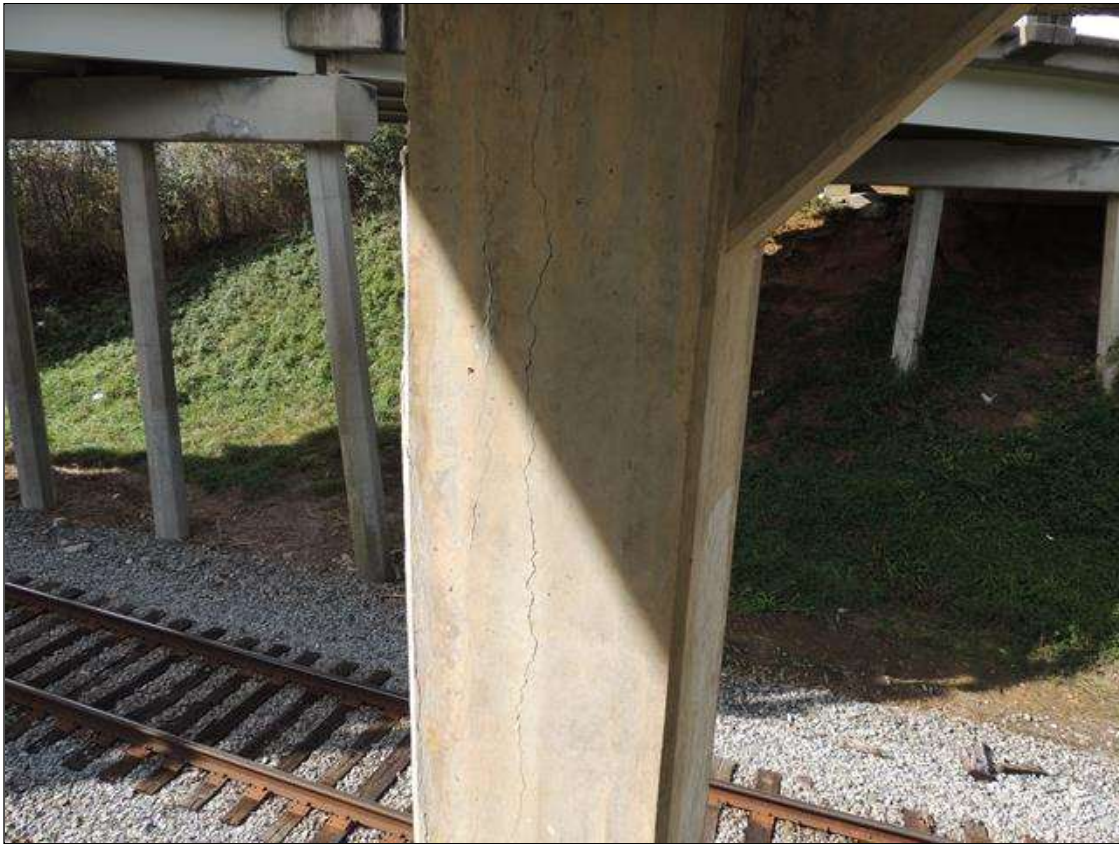
Bent 2 Pile 1: 0 Each of Cracking (RC and Other): Width 0.012-0.05 in. or spacing or 1.0-3.0 ft.
BENT 2 COL 1 SOUTH FACE OF CAP VERTICAL AND MAP CRACKING FROM TOP TO BOTTOM AND ALL
OTHER FACES ARE SIMILAR.

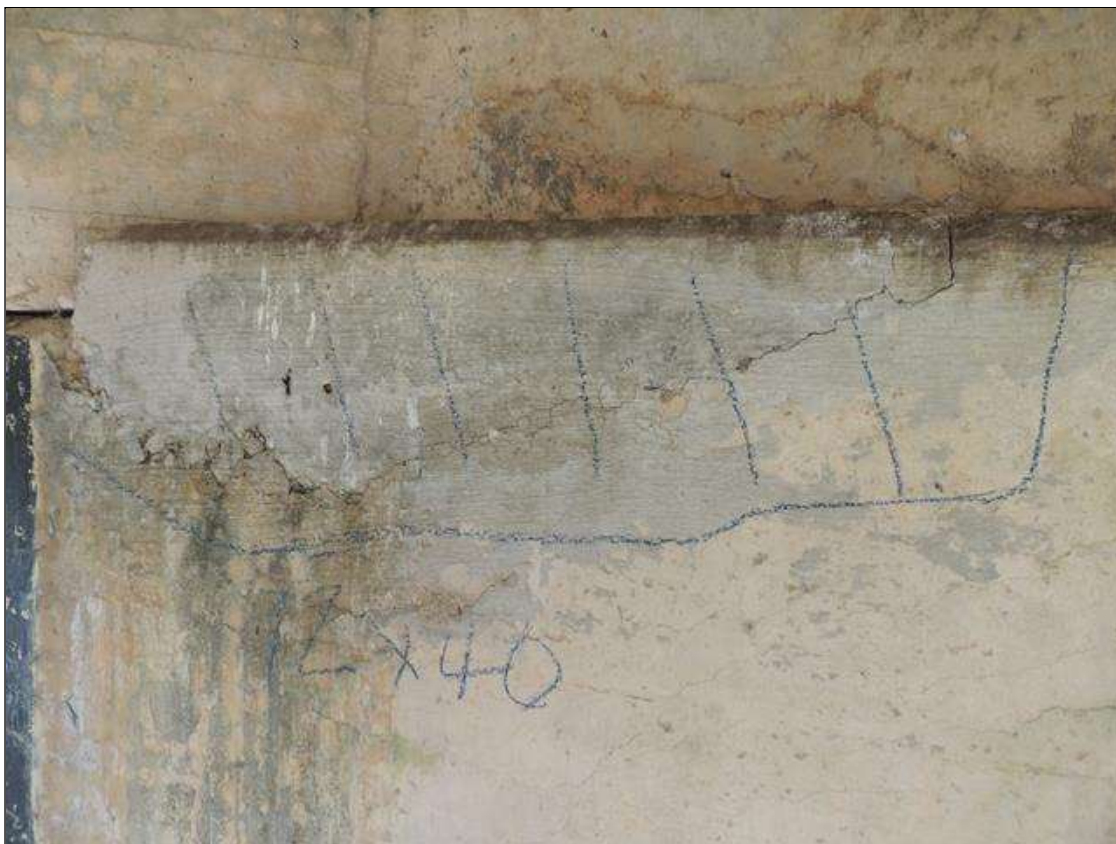
Bent 2 Cap : 4 Feet of Delamination/Spall/Patched Area: Delaminated. Spall 1 inch or less deep or 6 inches or less in diameter. Patched area that is sound
BENT 2 SOUTH FACE OF CAP PATCHED AREA RIGHT SIDE OF G1 CRACKED AND DELAMINATED TOP DOWN 12" AND 40" LONG.

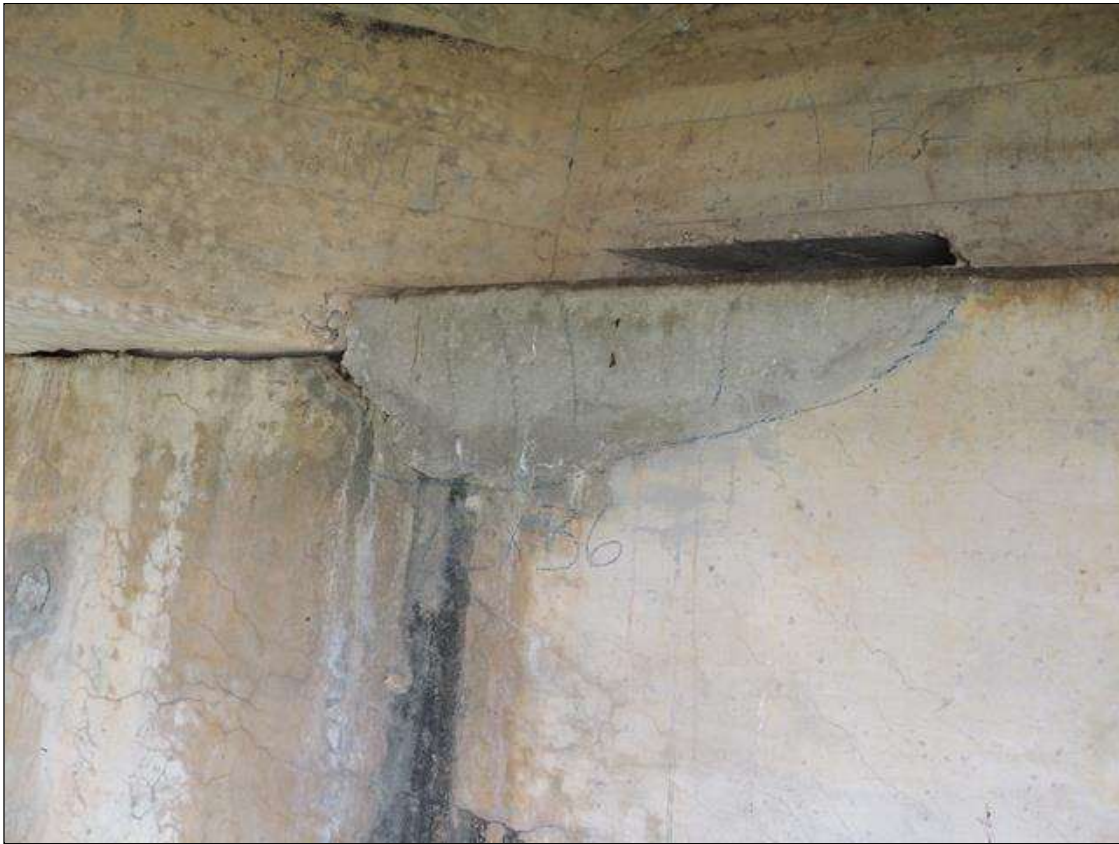
Bent 2 Cap : 3 Feet of Delamination/Spall/Patched Area: Delaminated. Spall 1 inch or less deep or 6 inches or less in diameter. Patched area that is sound
BENT 2 SOUTH FACE OF CAP CRACKED AND DELAMINATED AND PATCHED AREA RIGHT SIDE OF G2 12" X 36".

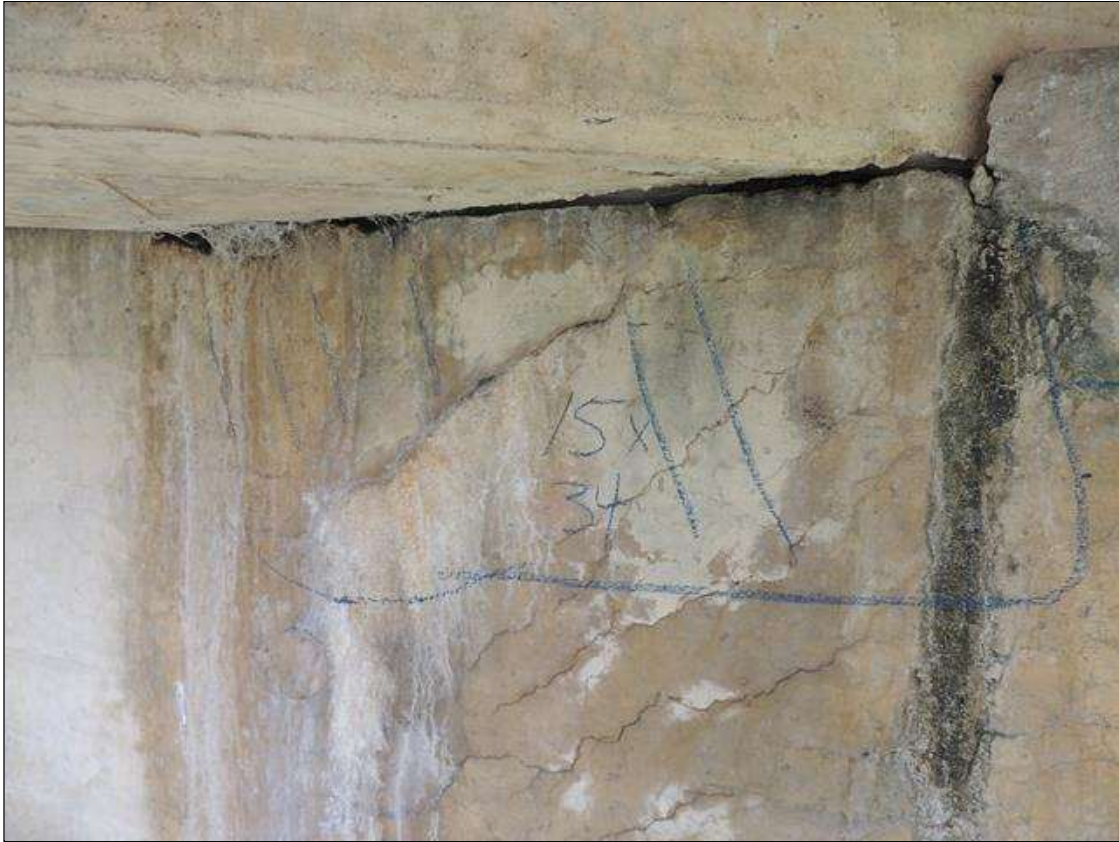
Bent 2 Cap : 3 Feet of Delamination/Spall/Patched Area: Delaminated. Spall 1 inch or less deep or 6 inches or less in diameter. Patched area that is sound
BENT 2 SOUTH FACE OF CAP CRACKED AND DELAMINATED AREA WITH HEAVY EFFLO UNDER G3.

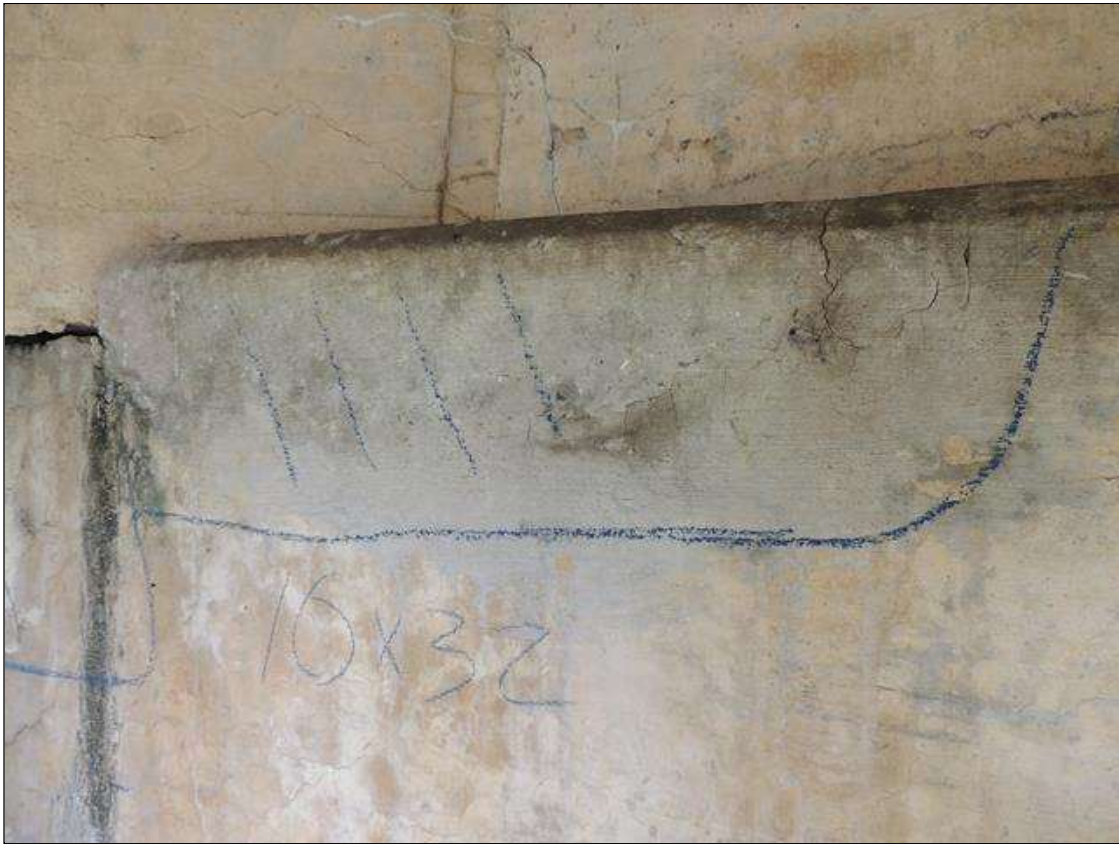
Bent 2 Cap : 3 Feet of Delamination/Spall/Patched Area: Delaminated. Spall 1 inch or less deep or 6 inches or less in diameter. Patched area that is sound
BENT 2 SOUTH FACE OF CAP CRACKED AND DELAMINATED AND PATCHED AREA RIGHT SIDE OF G3 10" DOWN FACE AND 32" LONG.

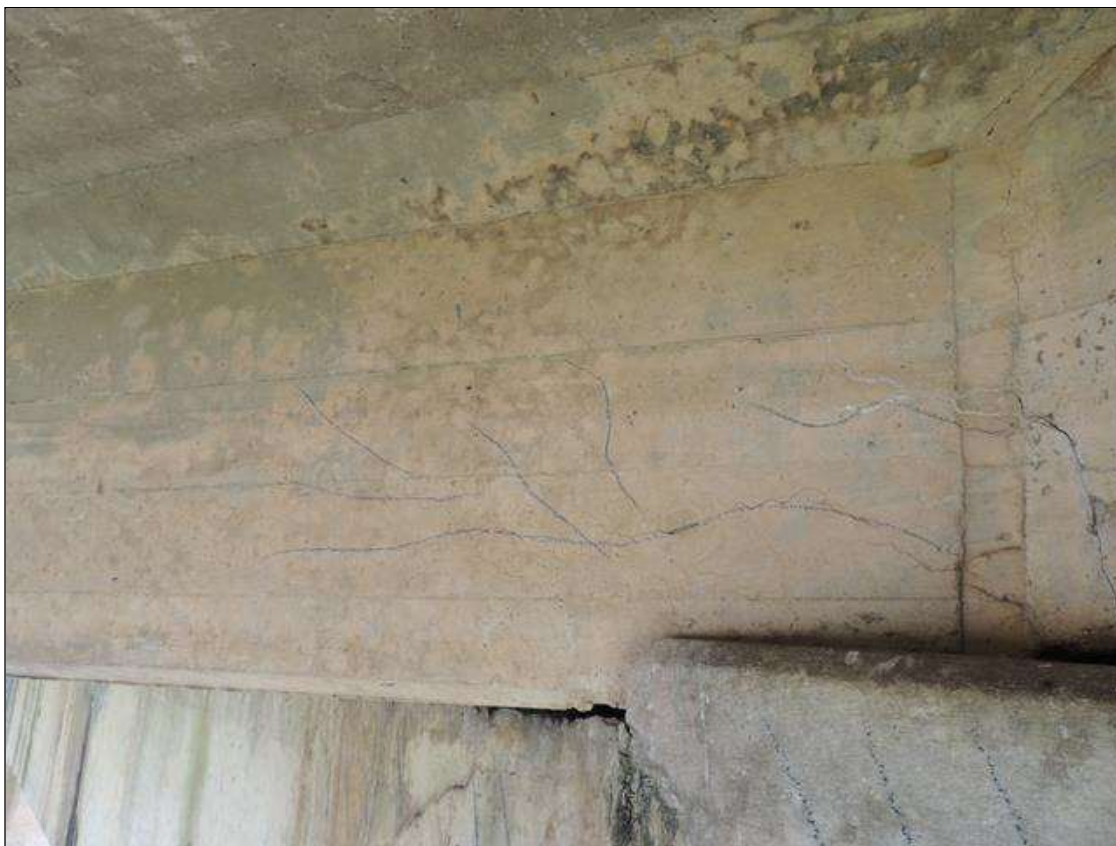
Span 2 Beam 3: 5 Feet of Cracking (RC and Other): Width 0.012-0.05 in. or spacing of 1.0-3.0 ft.
SPAN 2 RIGHT SIDE OF G3 SCATTERED MAP CRACKING AT BENT 2.

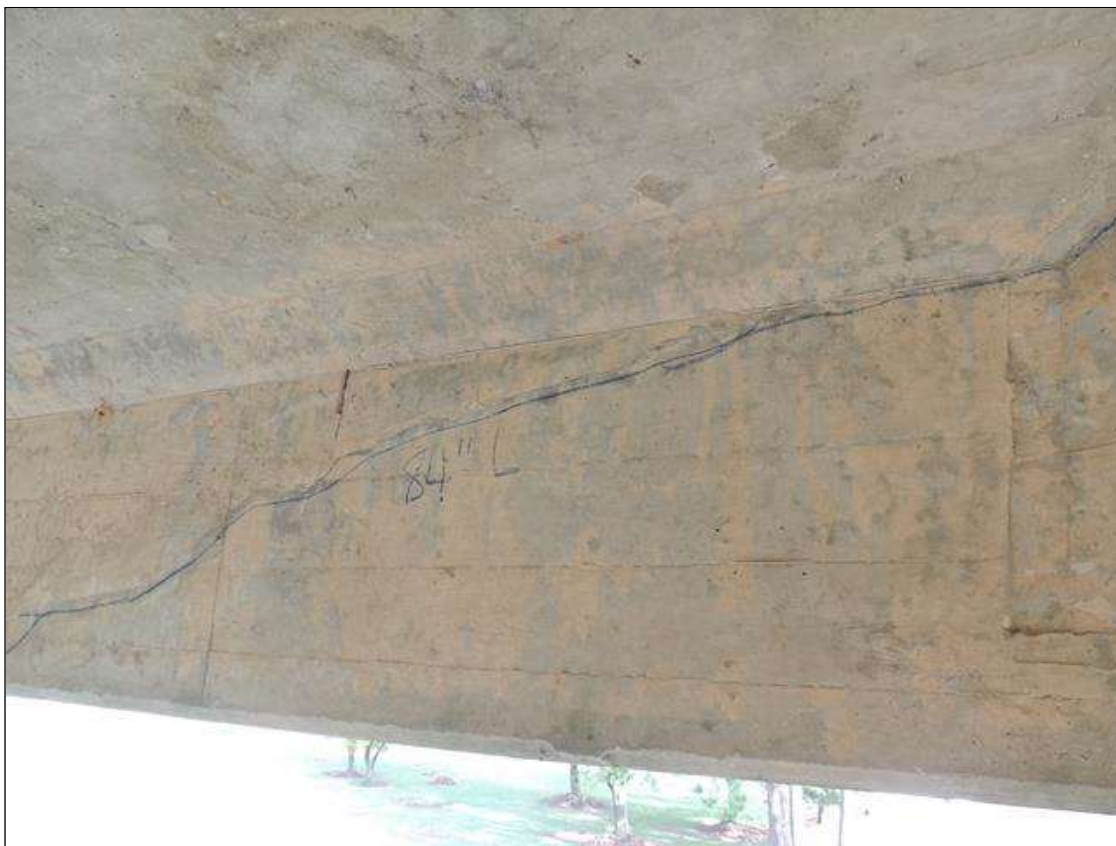
Span 2 Beam 4: 7 Feet of Cracking (RC and Other): Width 0.012-0.05 in. or spacing of 1.0-3.0 ft.
SPAN 2 LEFT SIDE OF G4 HAS A DIAG CRACK COMING OFF THE INTERIOR DIAPHRAGM 7' LONG FROM TOP TO BOTTOM.

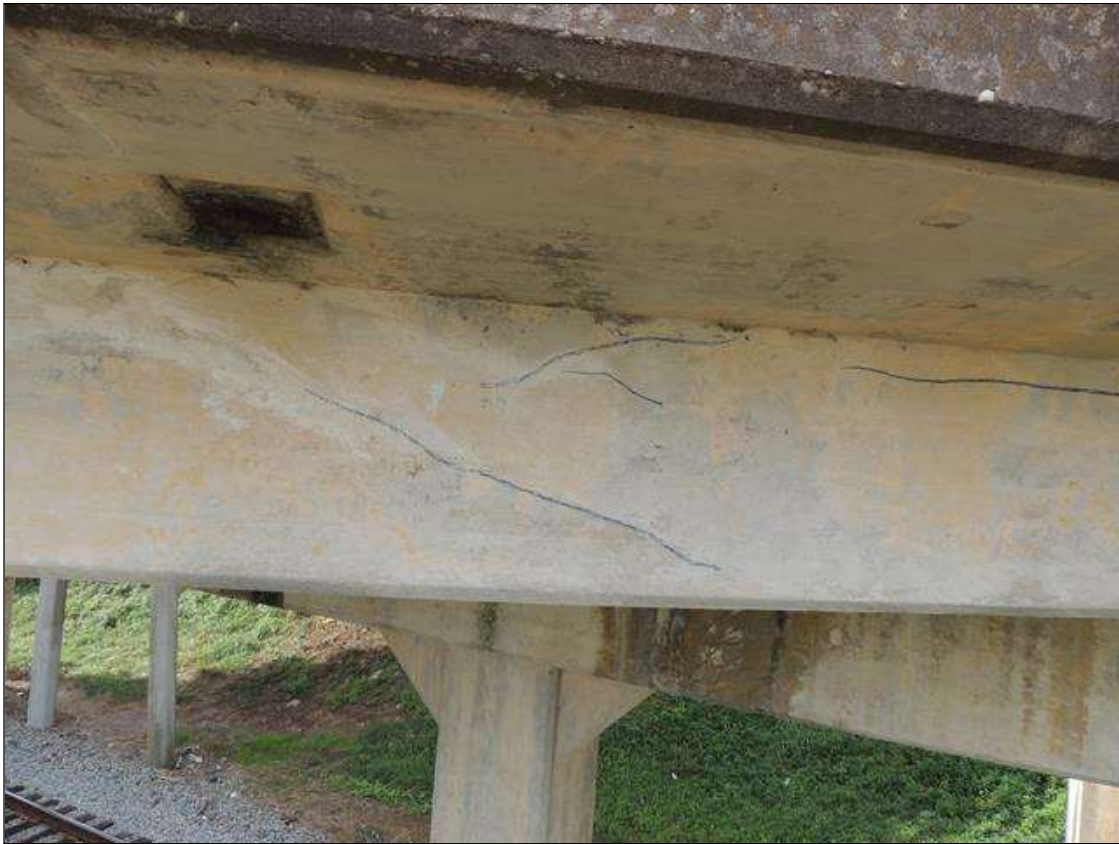
Span 2 Beam 4: 20 Feet of Cracking (RC and Other); Width 0.012-0.05 in. or spacing of 1.0-3.0 ft.
SPAN 2 RIGHT SIDE OF G4 SCATTERED LONGITUDINAL CRACKS AND MAP CRACKING.

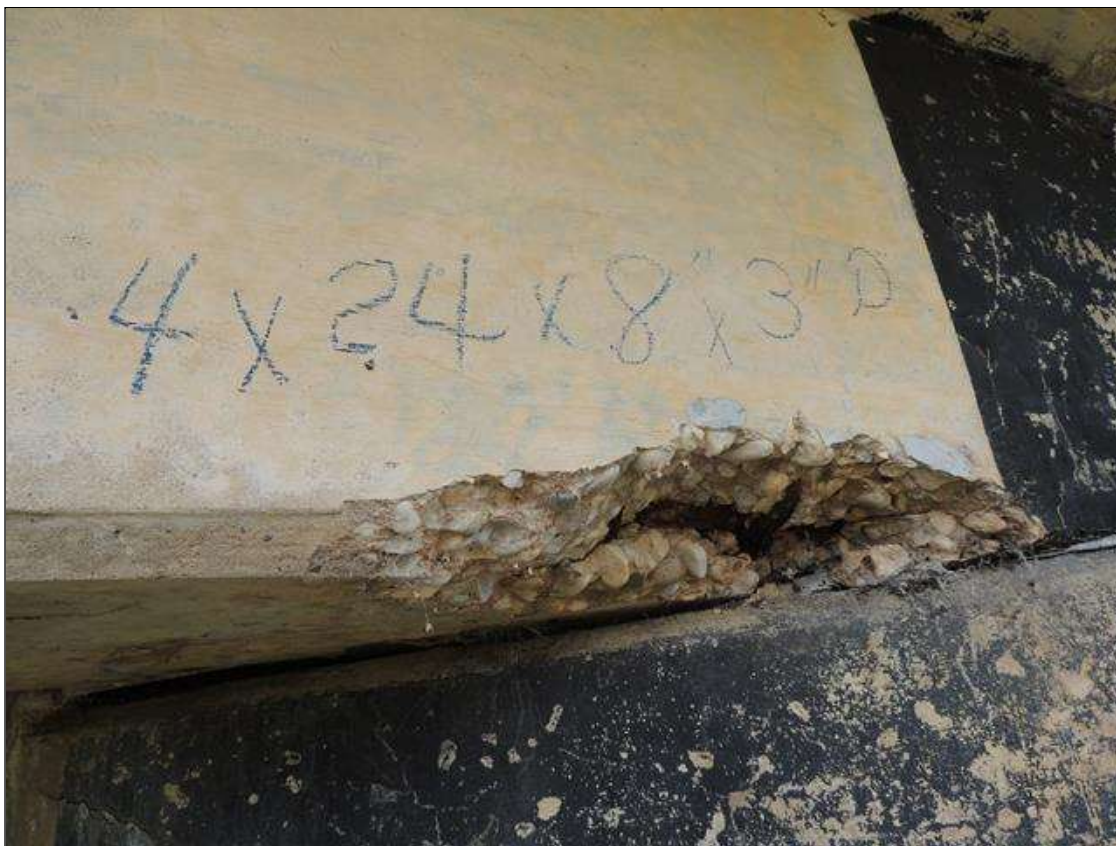
Span 2 Beam 4: 2 Feet of Delamination/Spall/Patched Area: Spall greater than 1 in. deep or greater than 6 in. diameter. Patched area that is unsound or showing distress. Does not warrant structural review.
BENT 2 RIGHT BOTTOM SIDE OF G4 AT BENT 2 SPALL AND DELAMINATED EXPOSED REBAR STIRRUPS EXPOSED.

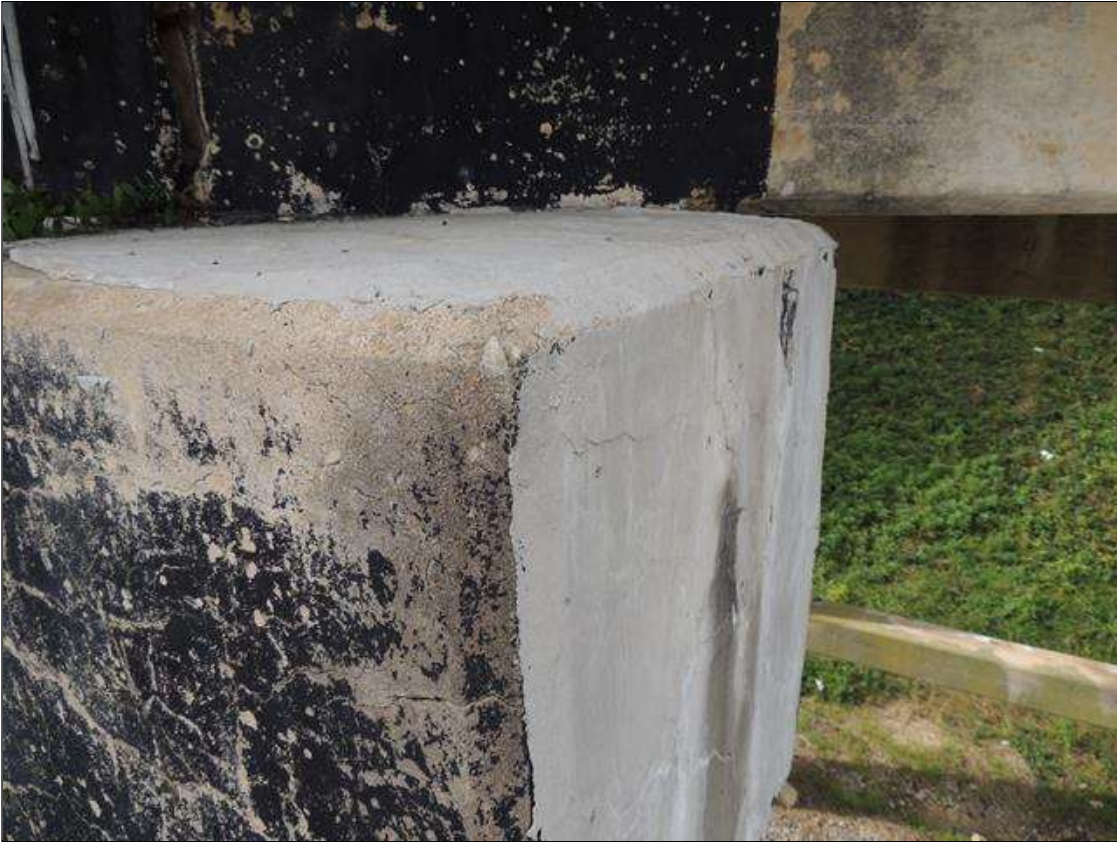
BENT 2 TOP OF CAP AND RIGHT END OF CAP HAS CONCRETE SMOOTH ON TOP AND END AND IS MAP CRACKED ON SOUTH RIGHT END AND NORTH FACES.

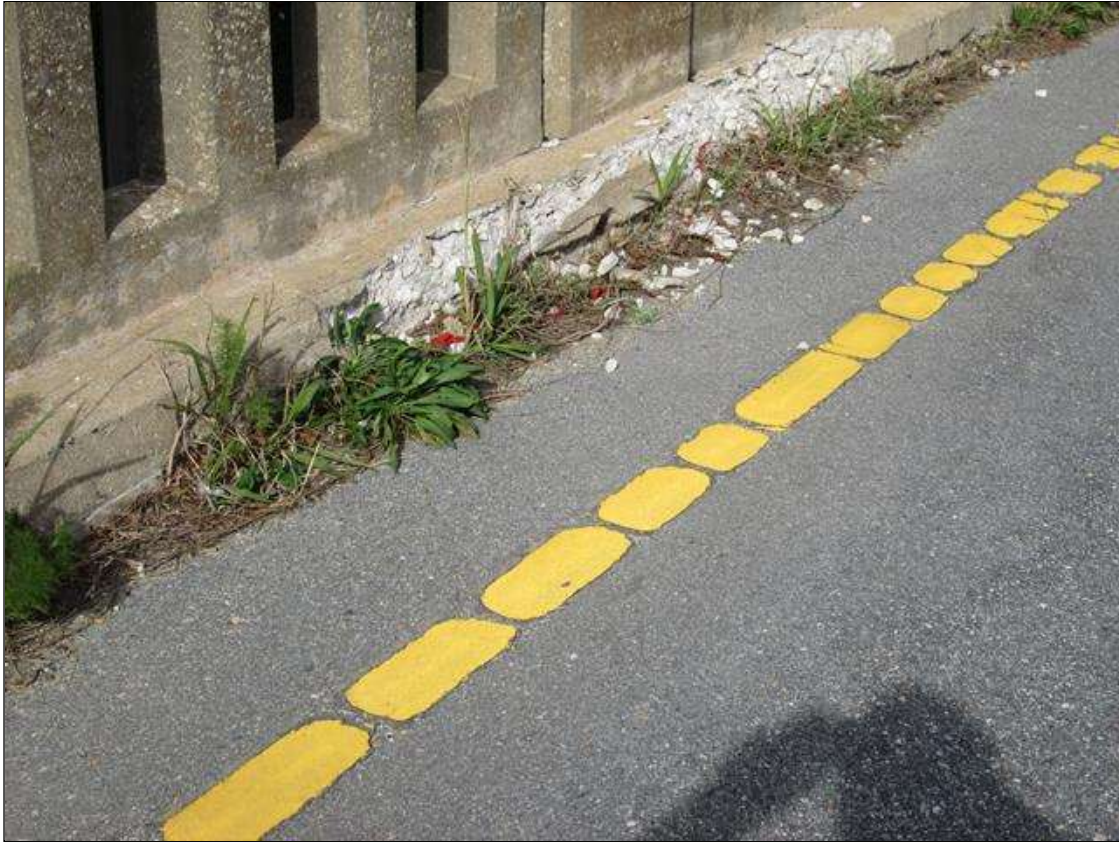
Span 1 Right Bridge Rail: 10 Feet of Delamination/Spall/Patched Area: Delaminated. Spall 1 in. or less deep or 6 in. or less in diameter. Patched area that is sound. LEFT CURB 10' FROM END BENT 1 IS SPALLED , CRACKED AND DELAMINATED. AREA IS 10' LONG 10" HIGH AND 8" BACK ON TOP

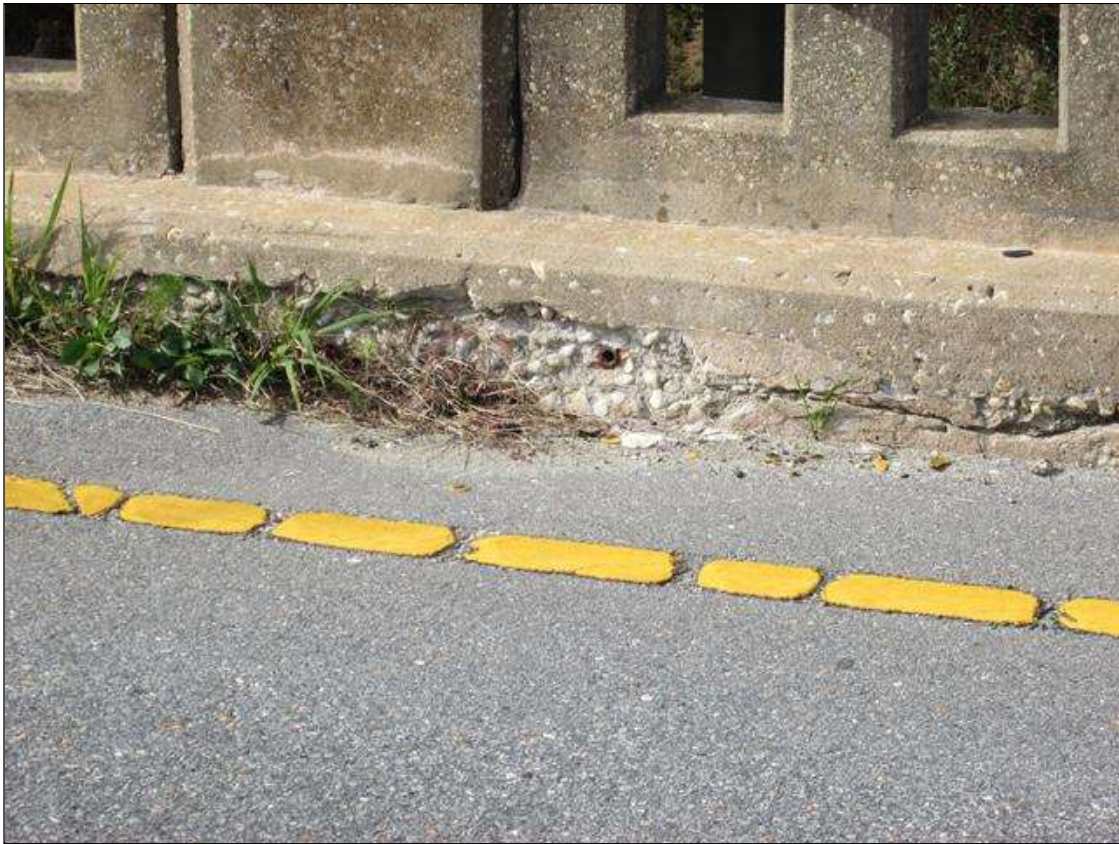
Span 1 Left Bridge Rail: 4 Feet of Delamination/Spall/Patched Area: Delaminated. Spall 1 in. or less deep or 6 in. or less in diameter. Patched area that is sound. LEFT CURB @ MID SPAN FACE IS CRACKED , SPALLED AND DELAMINATED. AREA IS 4' LONG 6" HIGH 1" DEEP.

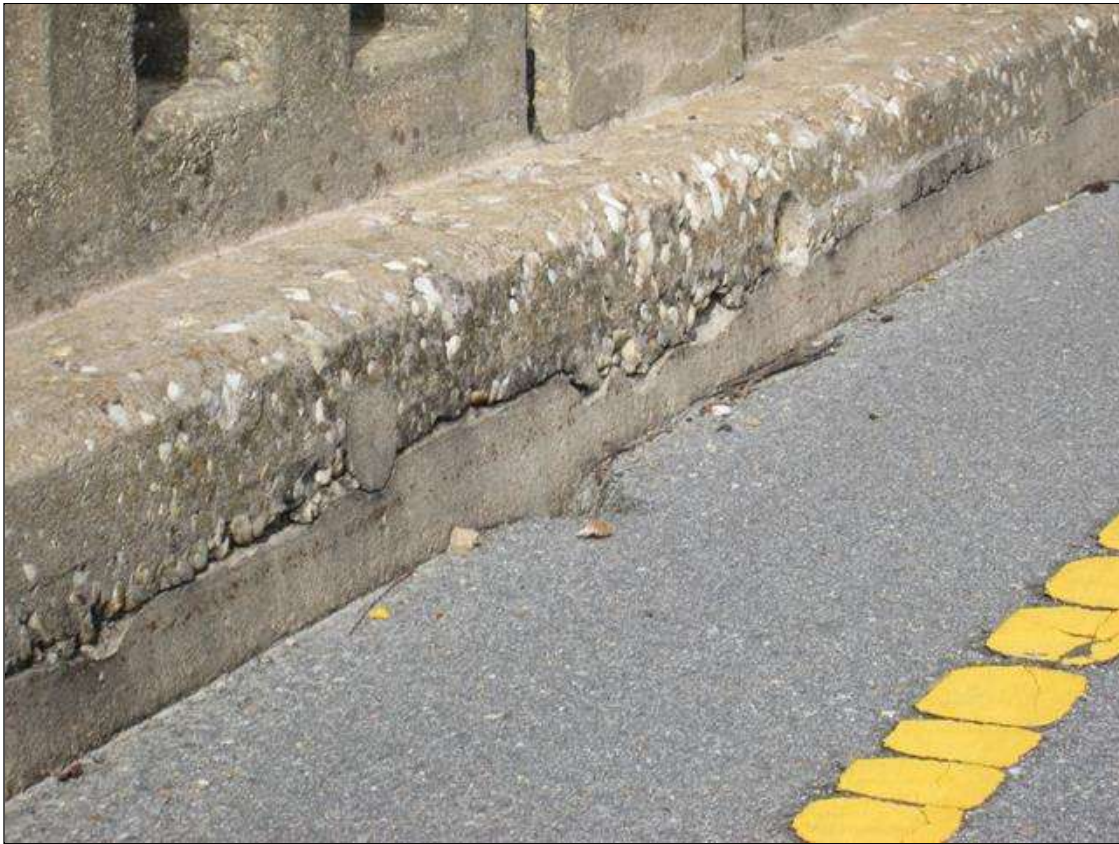
Span 2 Left Bridge Rail: 41 Feet of Cracking (RC and Other): Width 0.012-0.05 in. or spacing of 1.0-3.0 ft. LEFT CURB FACE IS CRACKED FULL LENGTH.

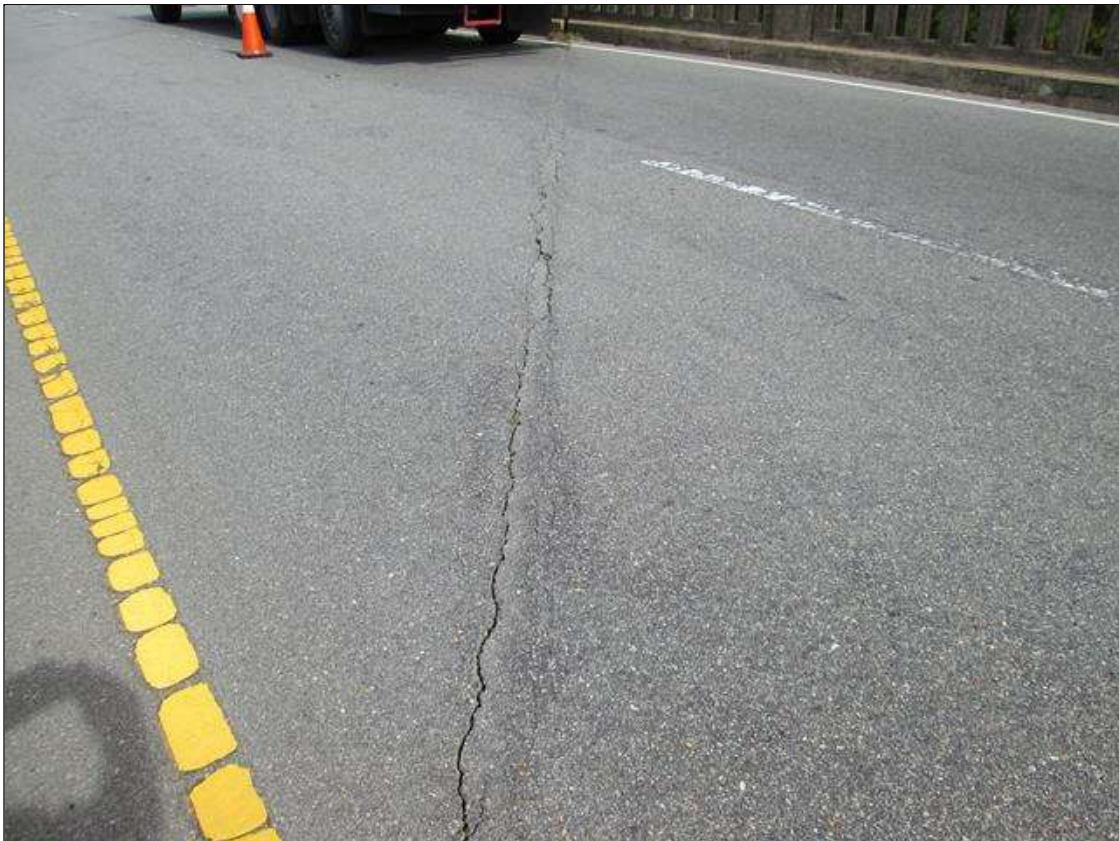
Expansion Joint 2 : 42 Feet of Seal Cracking: Surface crack. ASPHALT OVER BENT 1 JOINT IS CRACKED.

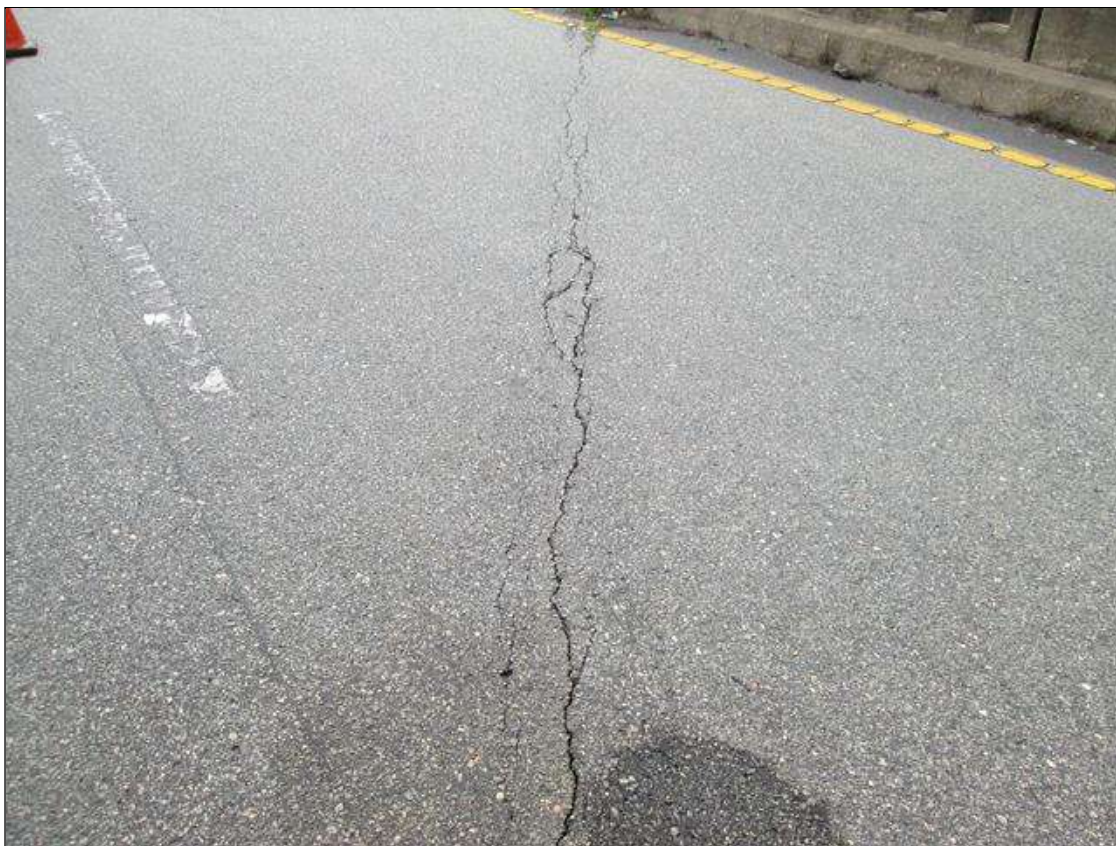
Expansion Joint 3 : 42 Feet of Seal Cracking: Surface crack. ASPHALT OVER BENT 2 IS CRACKED.

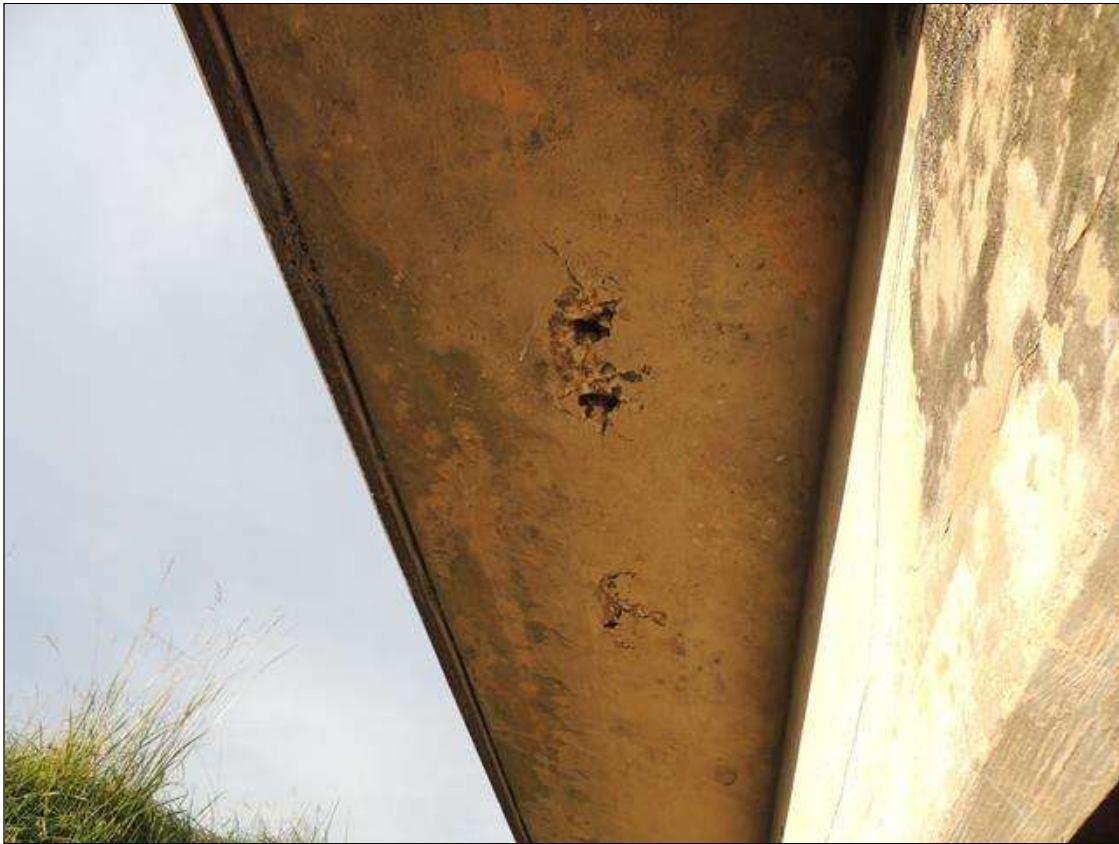
Span 5 Deck: 2 Square Feet of Delamination/Spall: Delaminated. Spall 1 in. or less deep or 6 in. or less in diameter. THE LEFT OVERHANG BOTTOM OF DECK HAS TWO AREAS SPALLED AND DELAMINATED 15' FROM END BENT 2. ONE AREA IS 6" X 10" AND 7" X 12".

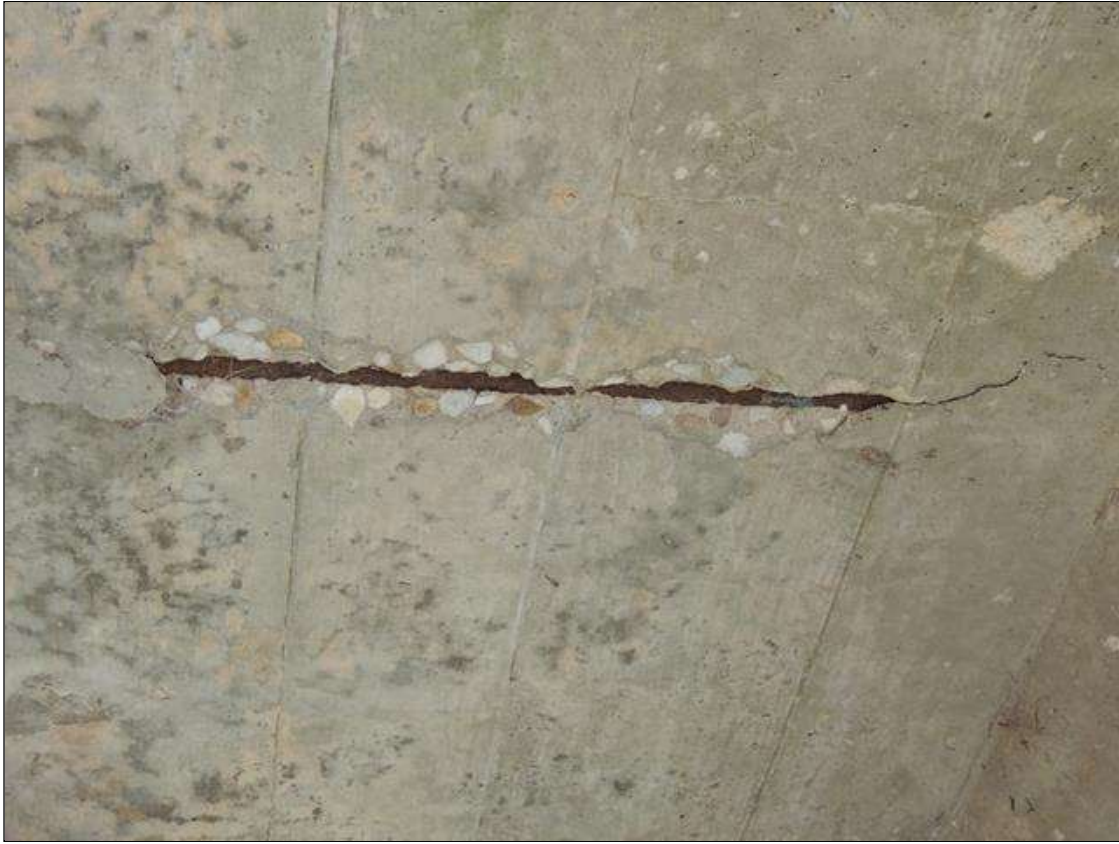
Span 4 Deck: 3 Square Feet of Delamination/Spall: Delaminated. Spall 1 in. or less deep or 6 in. or less in diameter.
BOTTOM OF DECK BAY 2 NEAR BENT 4 HAS SURFACE SPALL AREA 4" WIDE X 24" LONG.

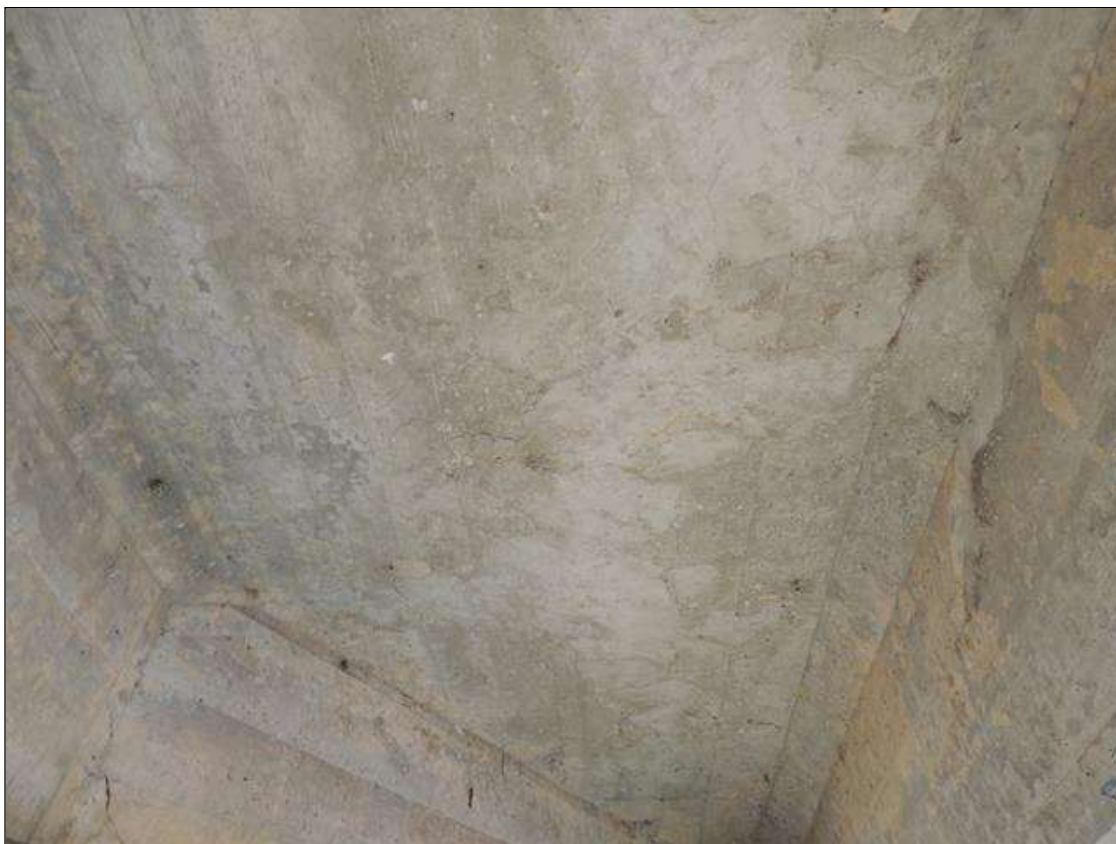
Span 4 Deck: 200 Square Feet of Delamination/Spall: Delaminated. Spall 1 in. or less deep or 6 in. or less in diameter. BOTTOM OF DECK IN BAY 3 HAS A SMALL PATCHED AREA WITH SOME DELAMINATION. BAYS 1 & 2 HAVE SIMILAR AREAS.

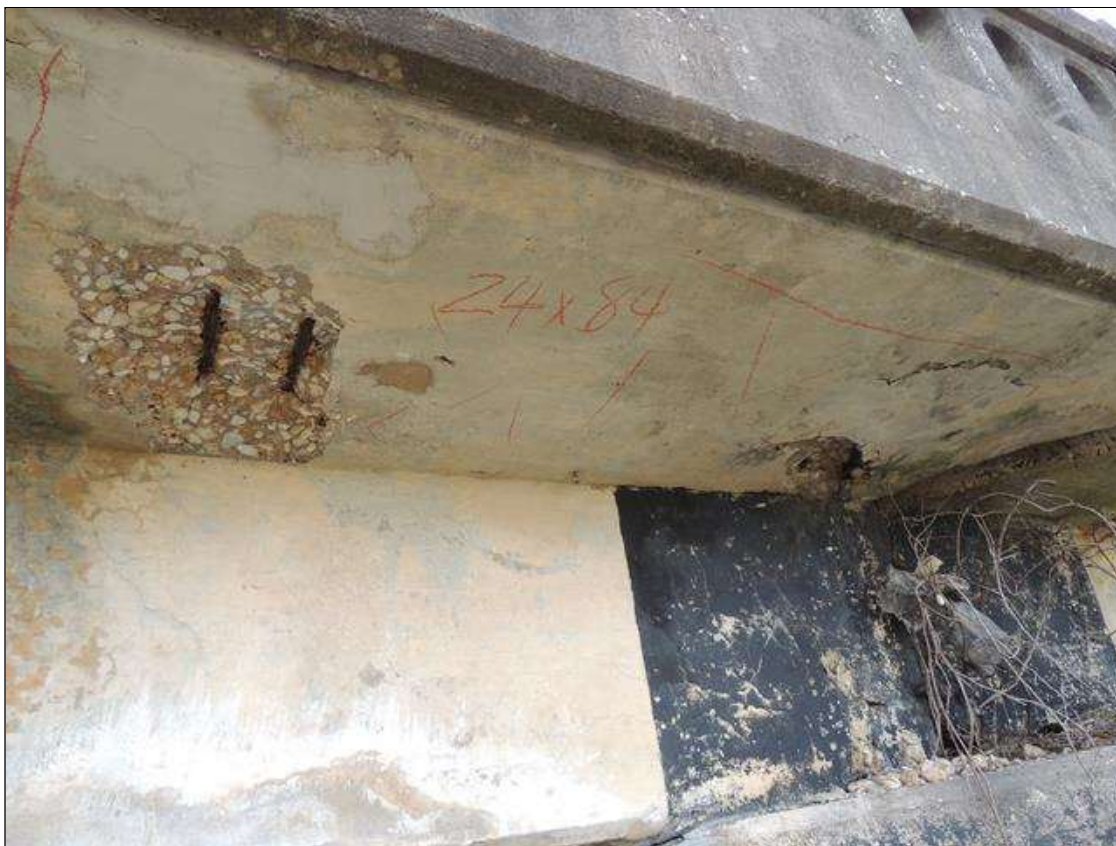
Span 4 Deck: 14 Square Feet of Exposed Rebar: Present without measurable section loss. BOTTOM OF DECK RIGHT OVER HANG HAS 2 SPALL AND DELAMINATED AREAS WITH REBAR EXPOSED NEAR BENT 4. AREAS ARE 16" X 20" X 2" & 23" X 26" X 2".
