NC DEPARTMENT OF TRANSPORTATION
 DIVISION OF HIGHWAYS
 STRUCTURE MANAGEMENT UNIT

ATTENTION: **PM ISSUED FOR CAPS, GIRDERS AND COL.**

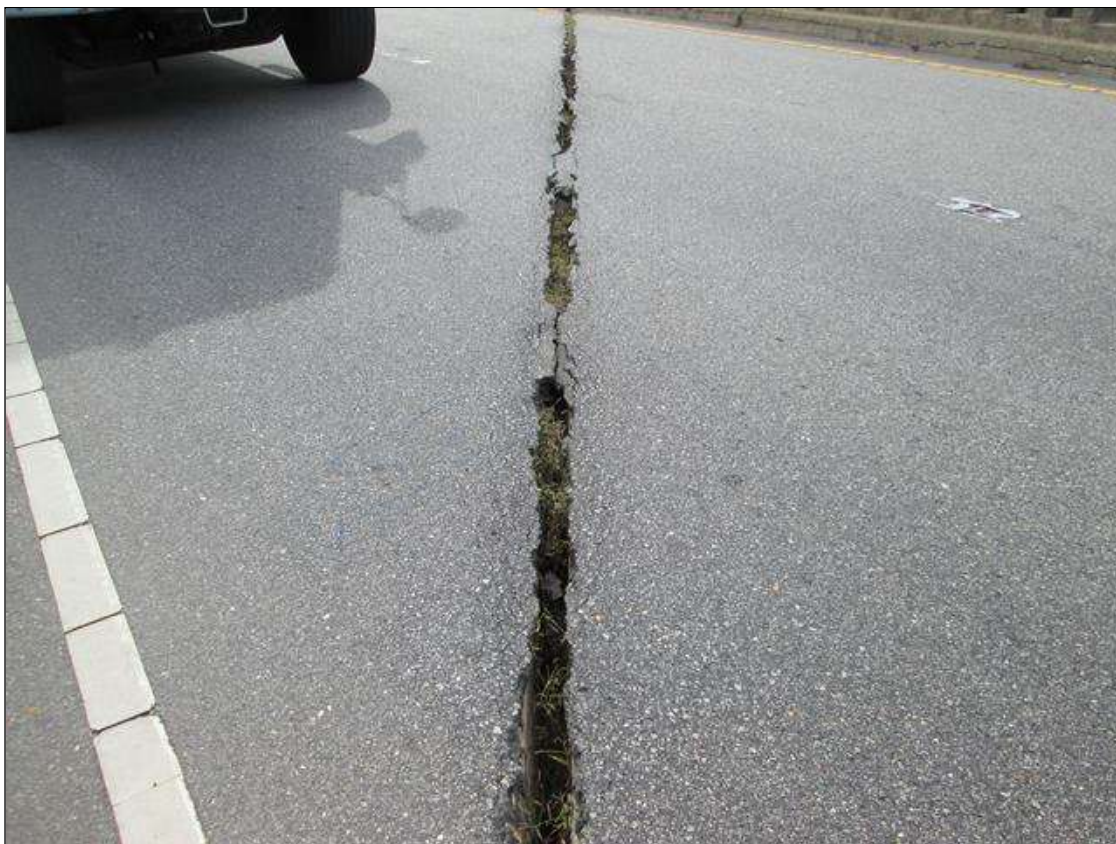
Expansion Joint 4 : 35 Feet of Leakage: Moderate. More than a drip and less than free flow of water. 35' OF JOINT MATERIAL AND ASPHALT MISSING OVER BENT 3.

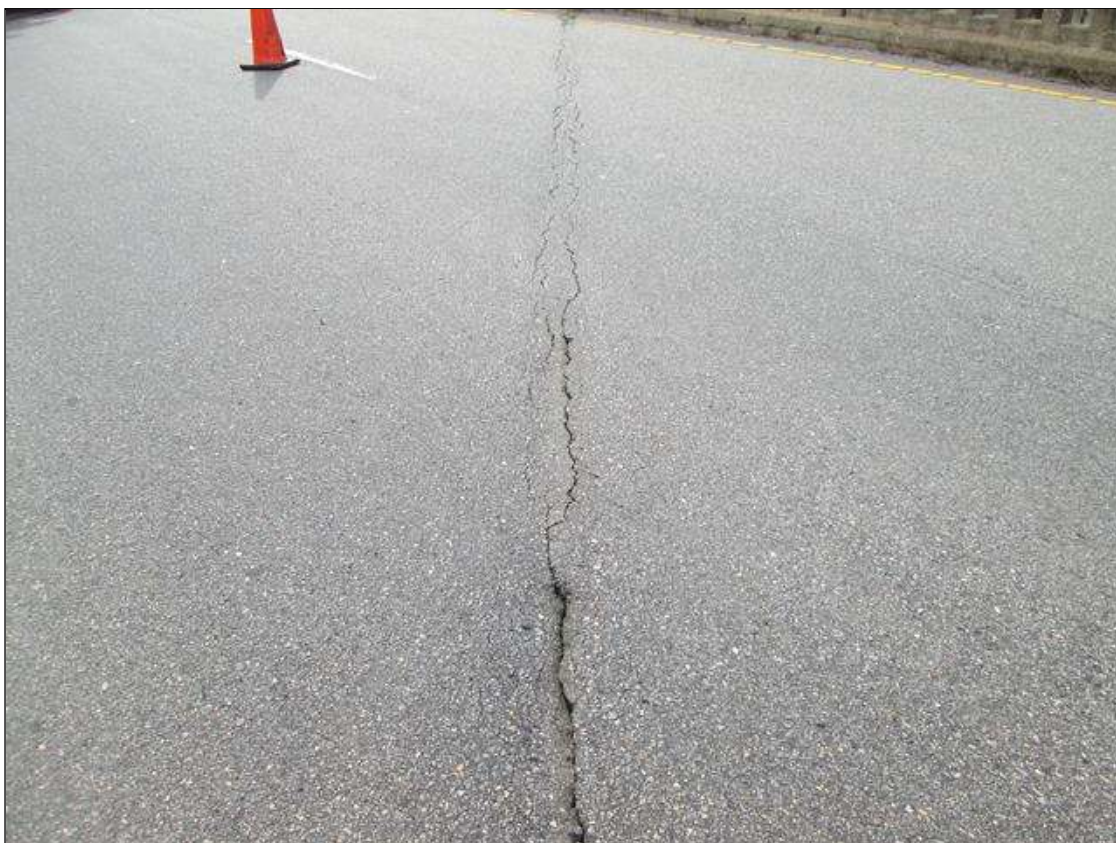
Expansion Joint 5 : 32 Feet of Seal Cracking: Surface crack. ASPHALT OVER BENT 4 IS CRACKED IN BOTH LANES FROM LEFT CURB OUT 32'.

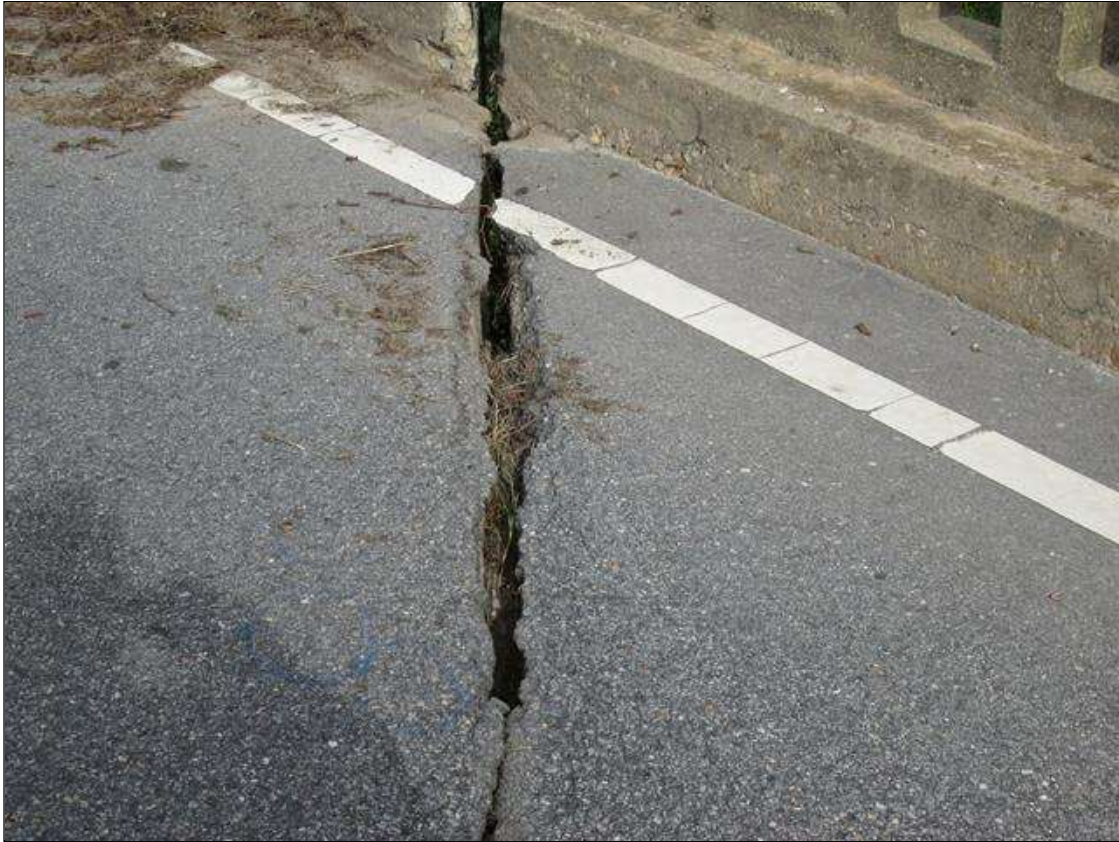
Expansion Joint 5 : 8 Feet of Leakage: Moderate. More than a drip and less than free flow of water. JOINT MATERIAL IS MISSING IN RIGHT LANE FROM RIGHT CURB OUT 8'. THIS AREA HAS SOME DEBRIS.

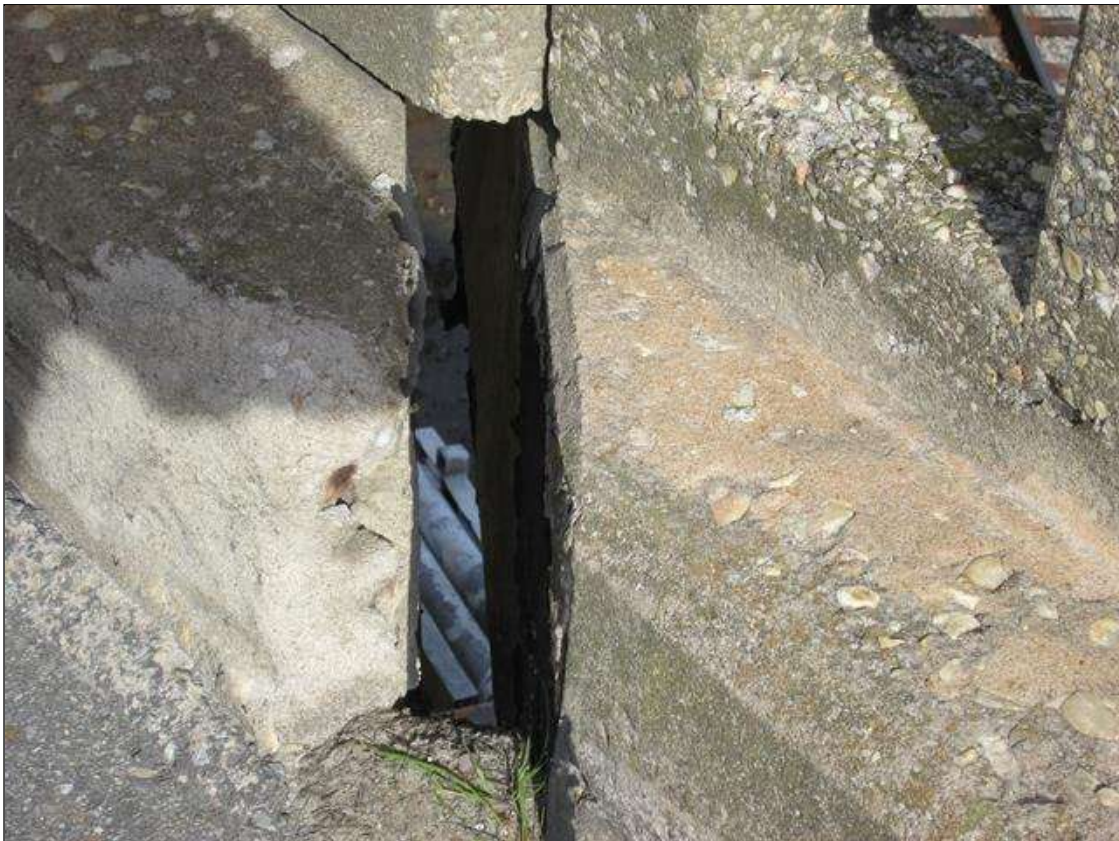
Expansion Joint 4 : 0 Feet of Leakage: Free flow of water through the joint. JOINT MATERIAL MISSING IN RIGHT CURB AREA OVER BENT 3. OPENING IS 2 1/2" WIDE SPANS ARE MISSALINGED

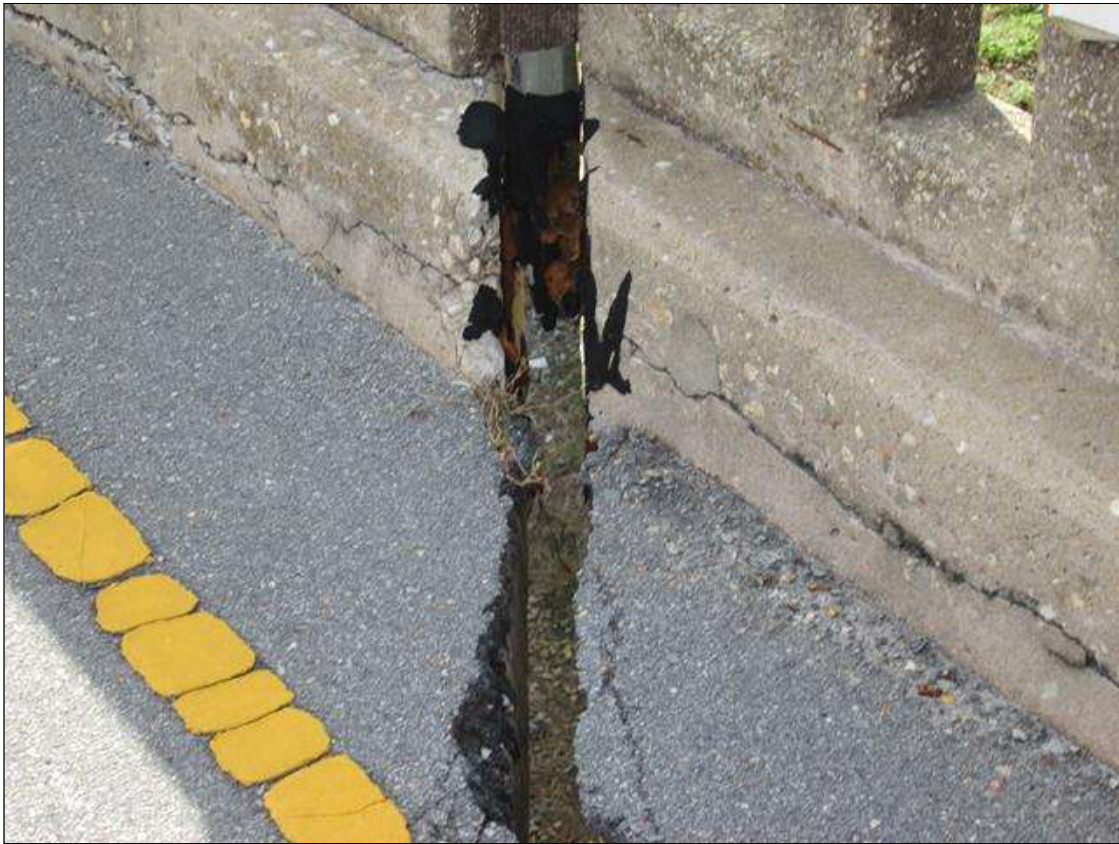
Expansion Joint 4 : 0 Feet of Leakage: Free flow of water through the joint. JOINT MATERIAL IS MISSING IN THE LEFT CURB AREA. THE OPENING IS 3" AND THE SPANS ARE MISALIGNED.

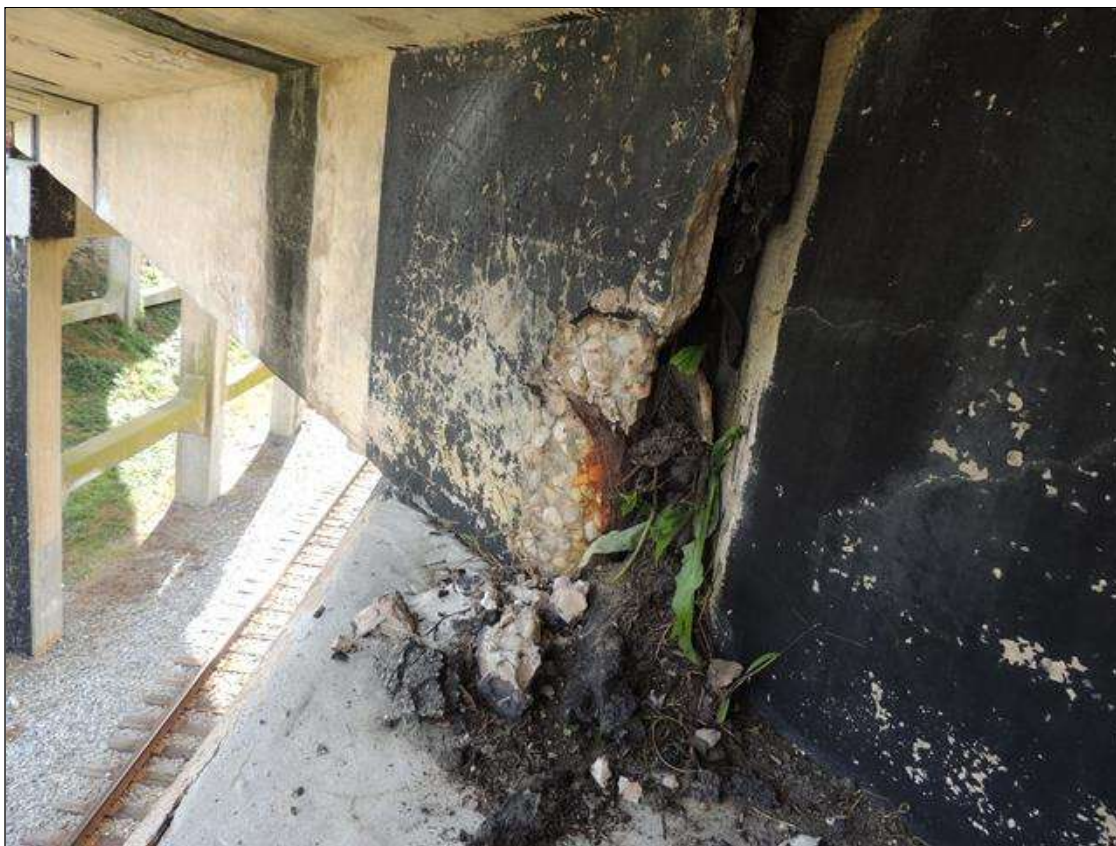
Span 3 Beam 4: 1 Feet of Delamination/Spall/Patched Area: Spall greater than 1 in. deep or greater than 6 in. diameter. RIGHT SIDE G 4 HAS A SPALLED AND DELAMINATED AREA OVER BENT 3 9" X 24" WITH LARGE REBAR EXPOSED.

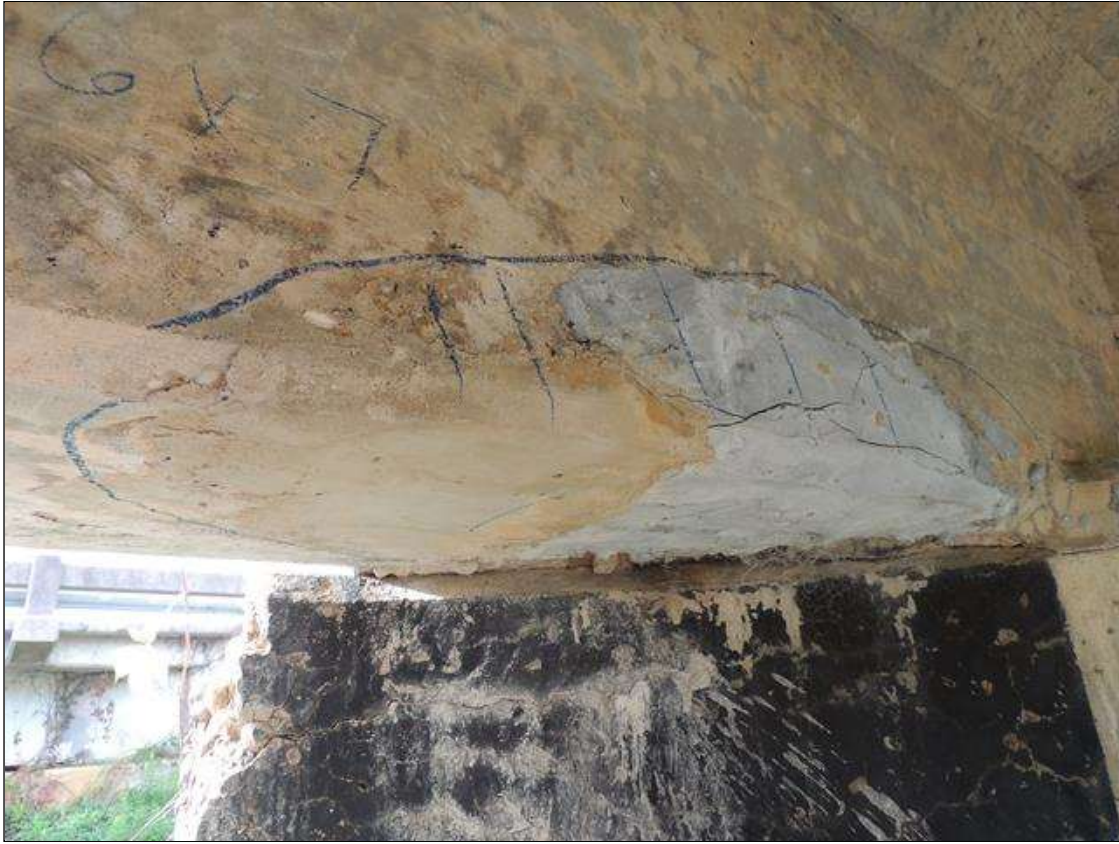
Span 4 Beam 1: 3 Feet of Delamination/Spall/Patched Area: Delaminated. Spall 1 in. or less deep or 6 in. or less in diameter. RIGHT SIDE AND BOTTOM OF G1 AT BENT 4 PATCHED AREA IS DELAMINATED 16" UNDER BOTTOM 3' LONG & 7" UP FACE.

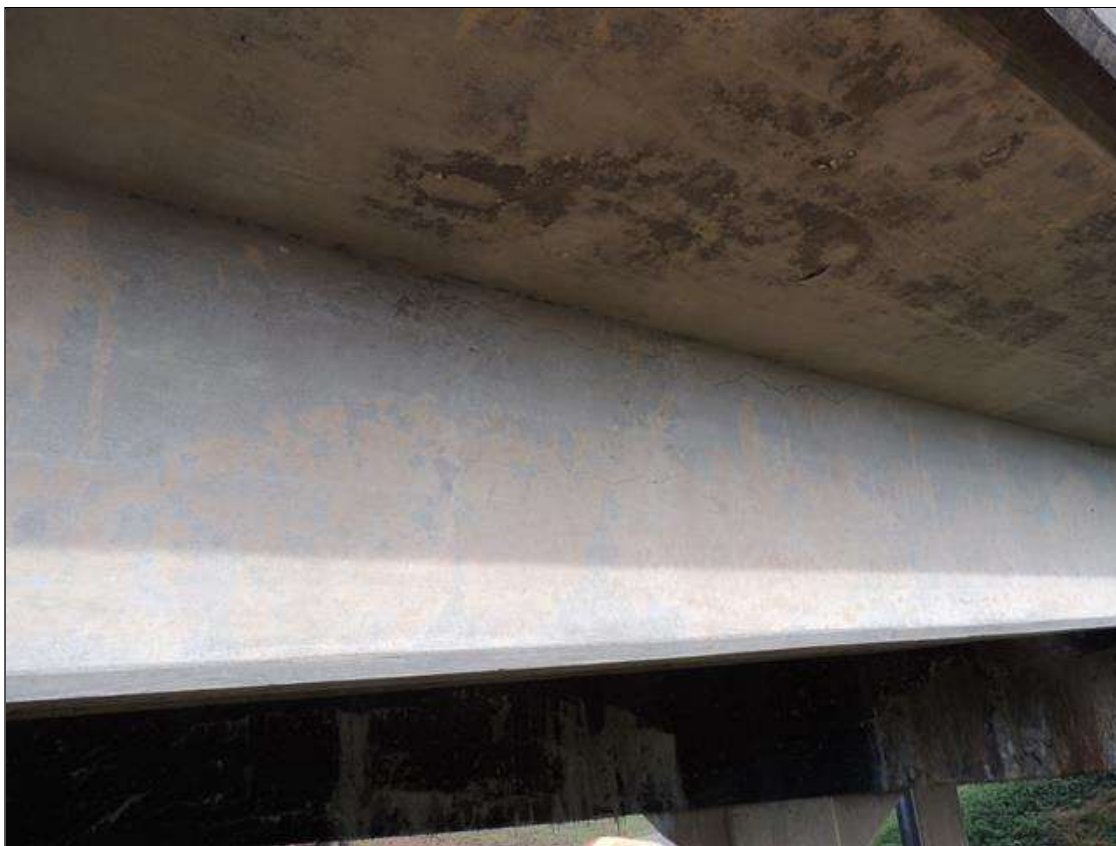
Span 4 Beam 1: 30 Feet of Cracking (RC and Other): Width 0.012-0.05 in. or spacing of 1.0-3.0 ft. LEFT SIDE OF G 1
SCATTERED MAP CRACKING FROM BENT 3 TO BENT 4.

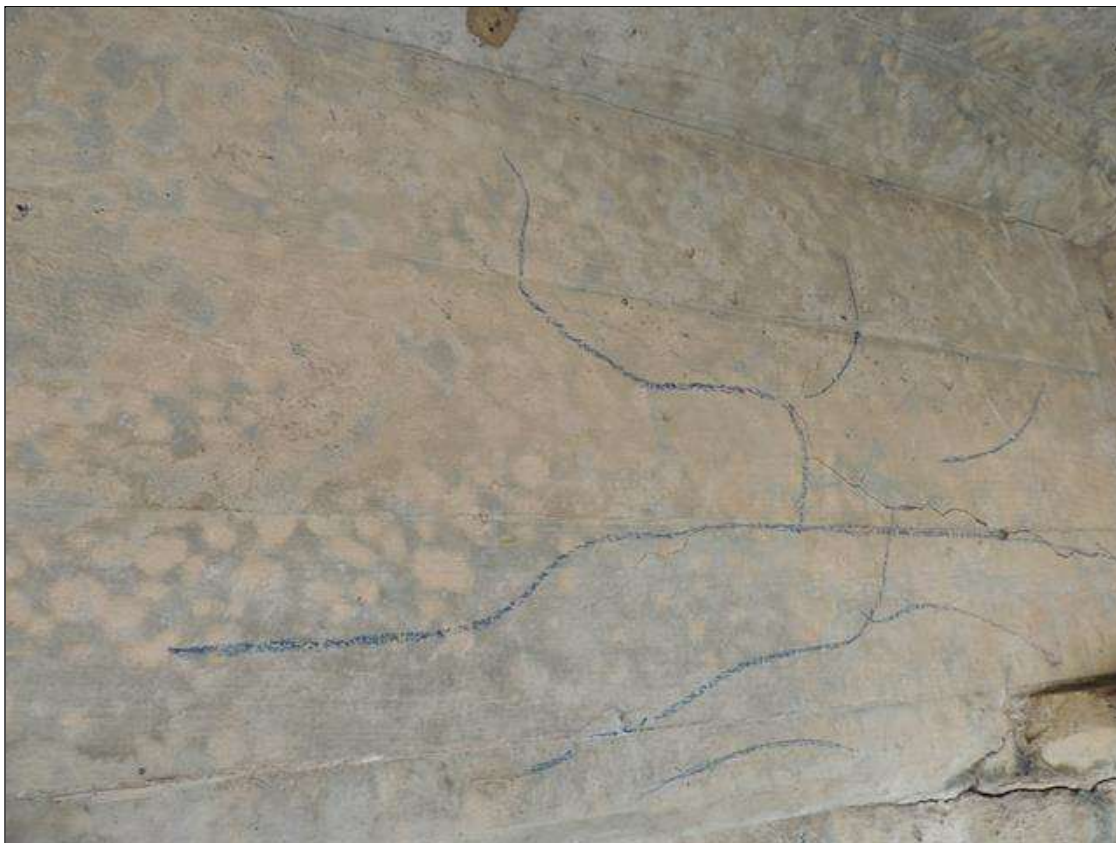
Span 4 Beam 2: 7 Feet of Cracking (RC and Other): Width 0.012-0.05 in. or spacing of 1.0-3.0 ft. RIGHT SIDE OF G 2
HAS SCATTERED MAP CRACKING AT BENT 4

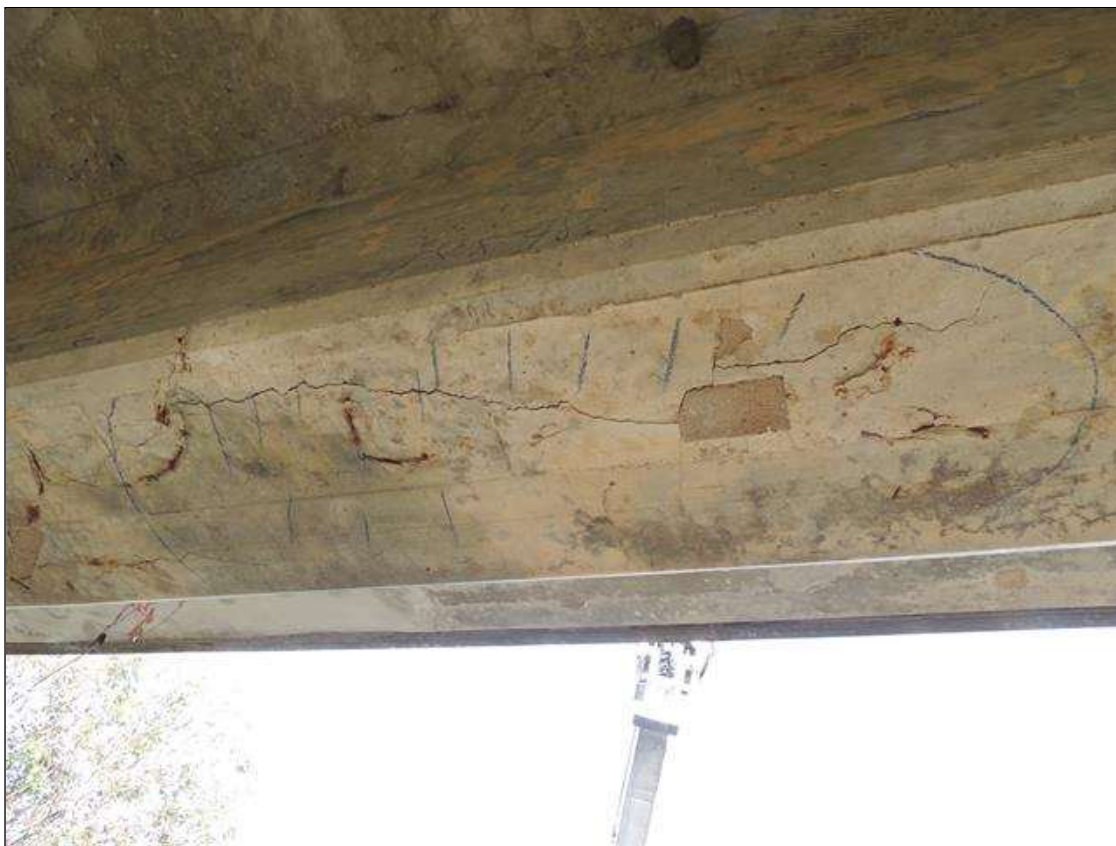
Span 4 Beam 4: 4 Feet of Delamination/Spall/Patched Area: Delaminated. Spall 1 in. or less deep or 6 in. or less in diameter. BOTTOM OF G 4 IS CRACKED & DELAMINATED 7' FROM BENT 4 18" UNDER BOTTOM 4' LONG.

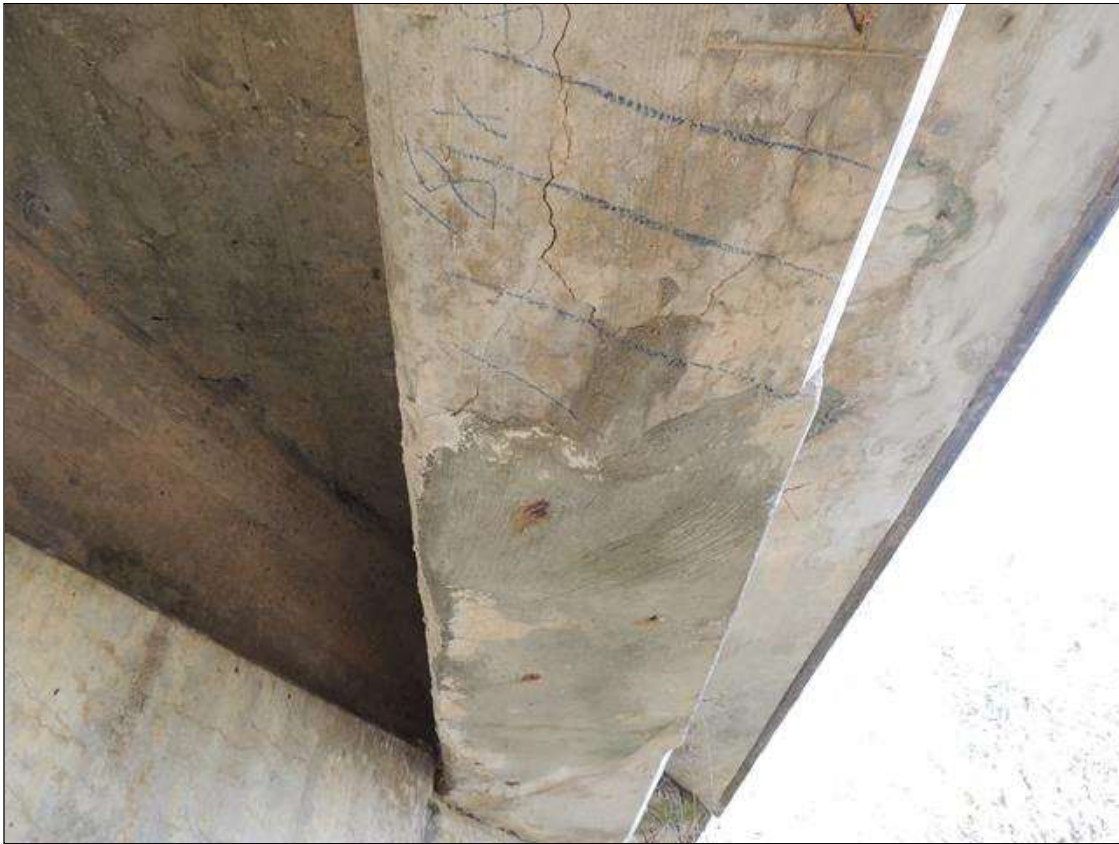
Span 4 Beam 4: 7 Feet of Delamination/Spall/Patched Area: Delaminated. Spall 1 in. or less deep or 6 in. or less in diameter. BOTTOM OF G 4 IS CRACKED, PATCHED AND DELAMINATED FROM BENT 4 BACK 7' 18" WIDE AND UP FACE 5".

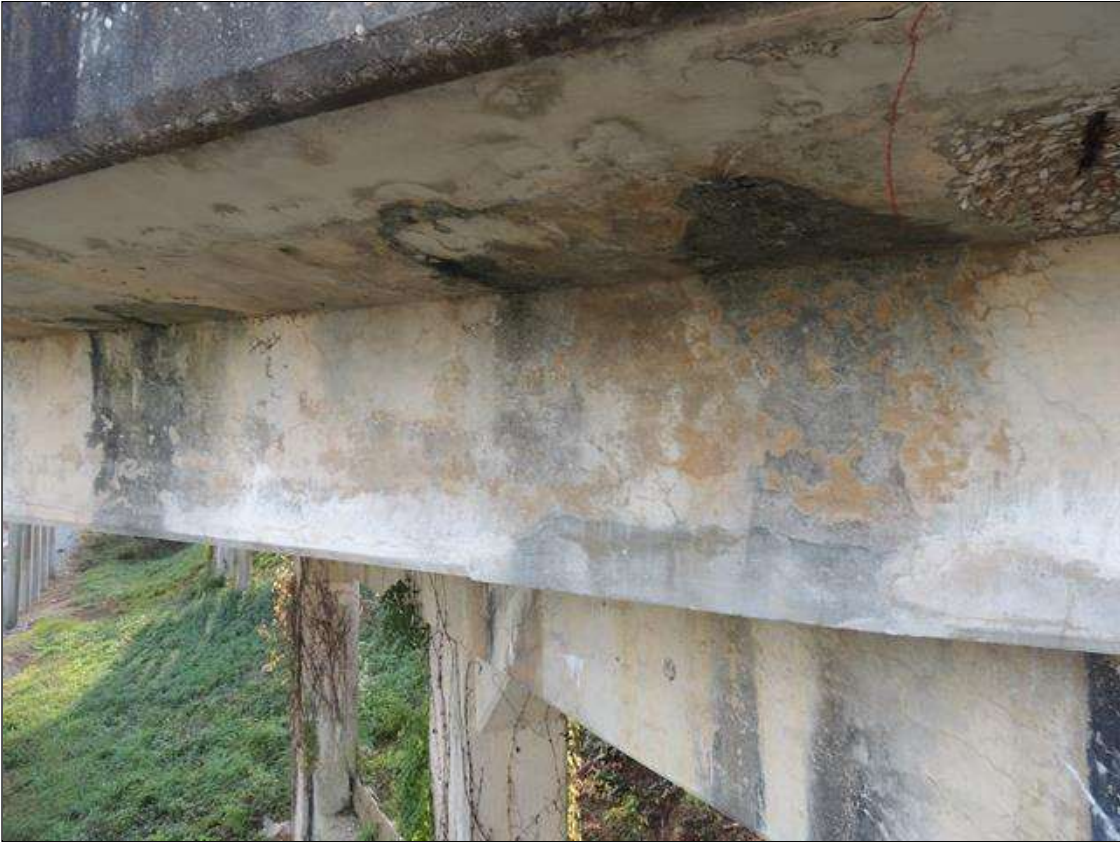
Span 4 Beam 4: 25 Feet of Cracking (RC and Other): Width 0.012-0.05 in. or spacing of 1.0-3.0 ft. RIGHT SIDE OF G 4 HAS SCATTERED MAP CRACKING IN FACE.

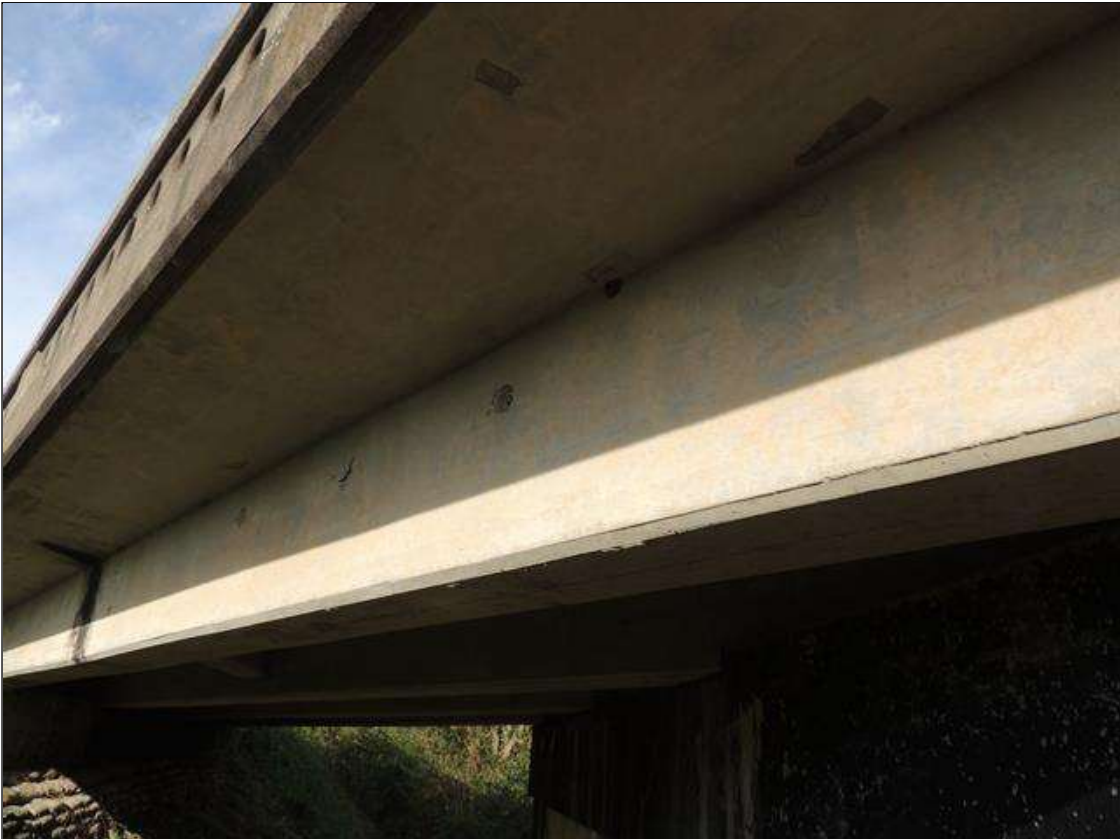
Span 5 Beam 1: 30 Feet of Cracking (RC and Other): Width 0.012-0.05 in. or spacing of 1.0-3.0 ft. LEFT SIDE OF G1 HAS SCATTERED MAP CRACKING IN FACE.

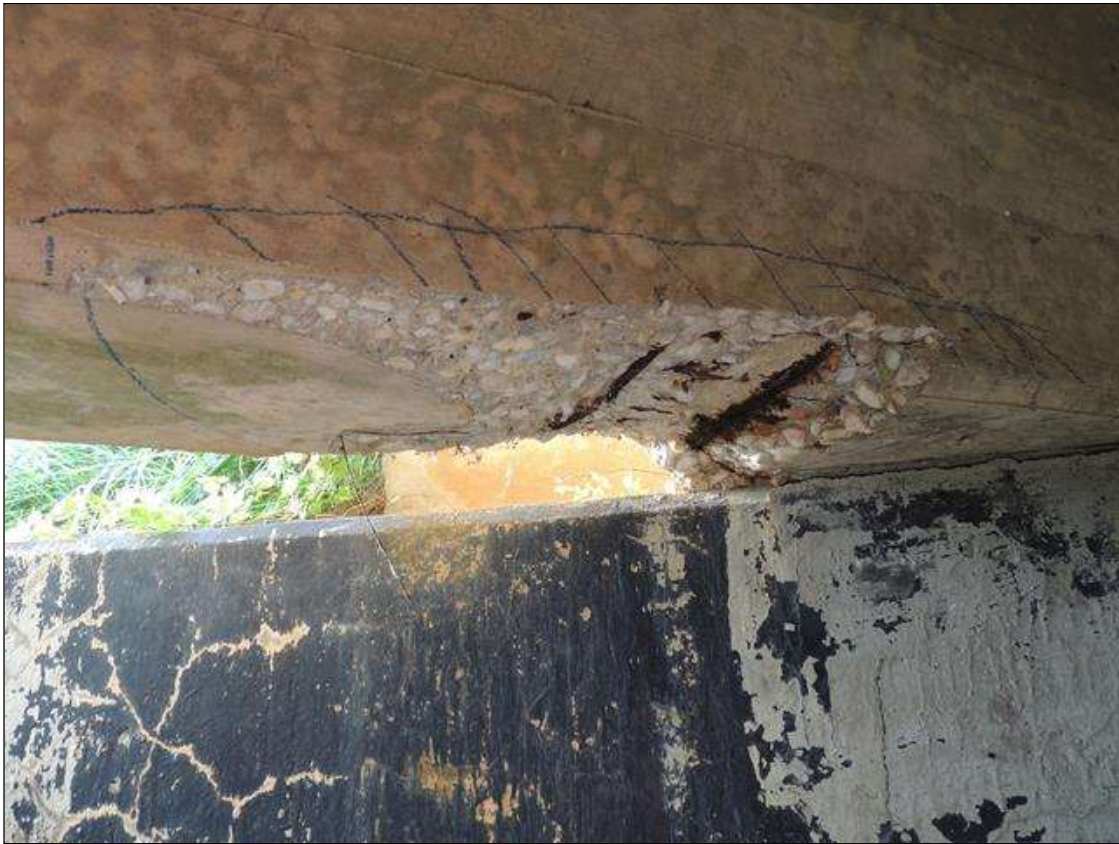
Span 5 Beam 1: 3 Feet of Delamination/Spall/Patched Area: The condition warrants a structural review to determine the effect on strength or serviceability of the element or bridge; OR a structural review has been completed and the defects impact strength or serviceability of the element or bridge. G 1 AT END BENT 2 SPALLED, CRACKED AND DELAMINATED WITH LARGE REBAR EXPOSED. THE AREA IS 18" WIDE X 2 1/2" DEEP X 32" LONG IN FACE AND BOTTOM.

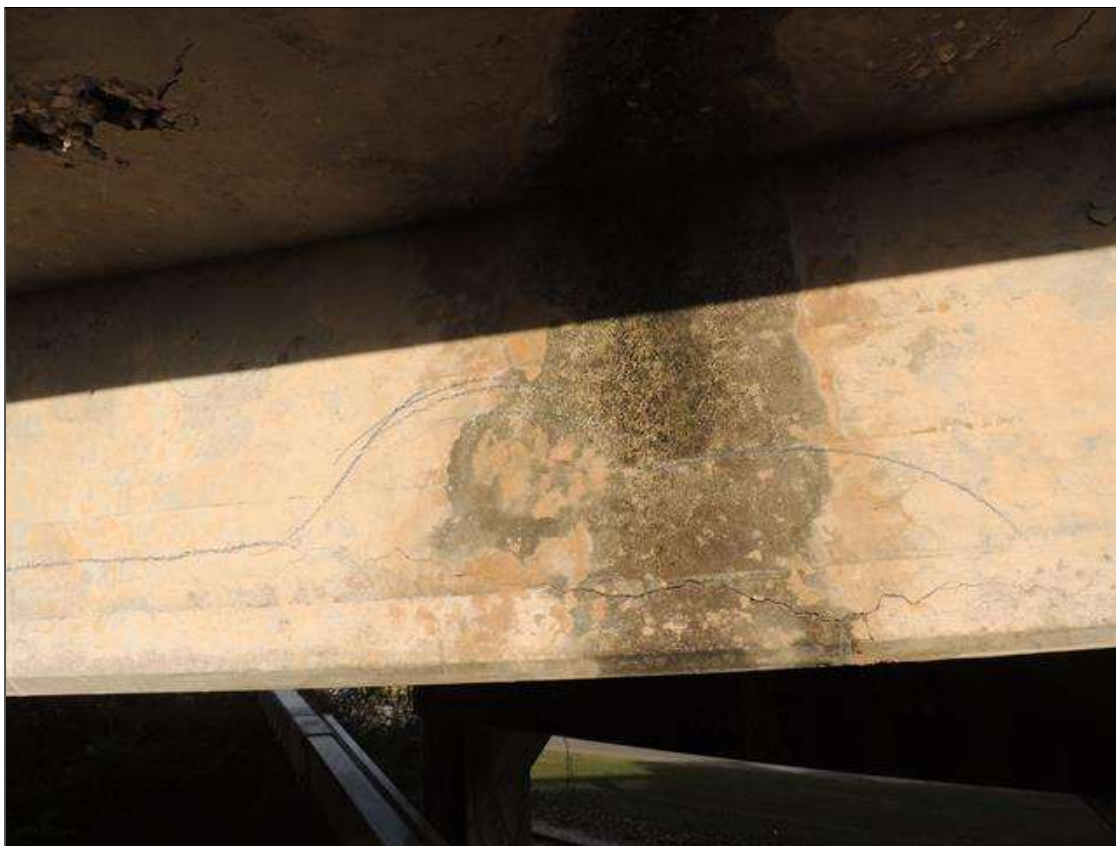
Span 5 Beam 1: 10 Feet of Cracking (RC and Other): Width 0.012-0.05 in. or spacing of 1.0-3.0 ft. G1 LEFT FACE NEAR MID SPAN IS CRACKED.

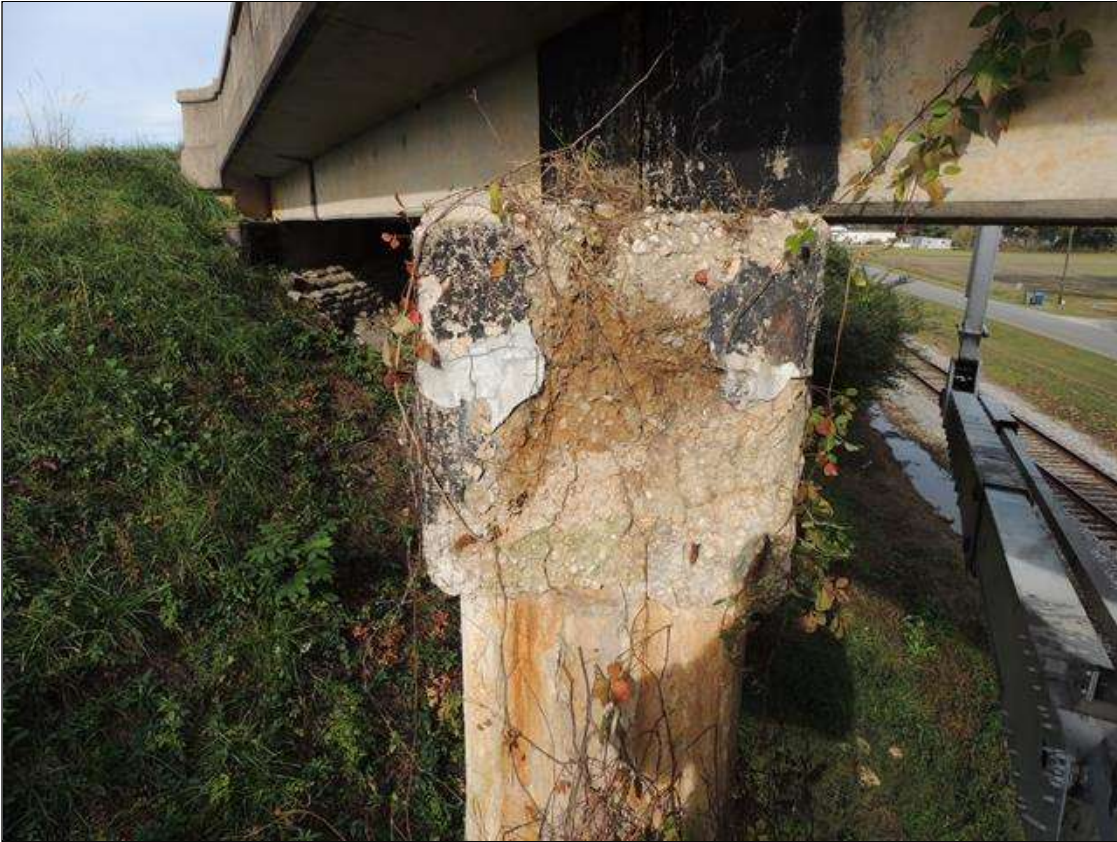
Bent 4 Cap : 6 Feet of Delamination/Spall/Patched Area: The condition warrants structural review to determine the effect on strength and serviceability of the element or the bridge; OR a structural review has been completed and the defects impact strength or serviceability of the element or bridge. LEFT END OF CAP IS SPALLED & DELAMINATED. 3' ON SOUTH AND NORTH FACES. 37" X 37" ON END UP TO 4" DEEP.

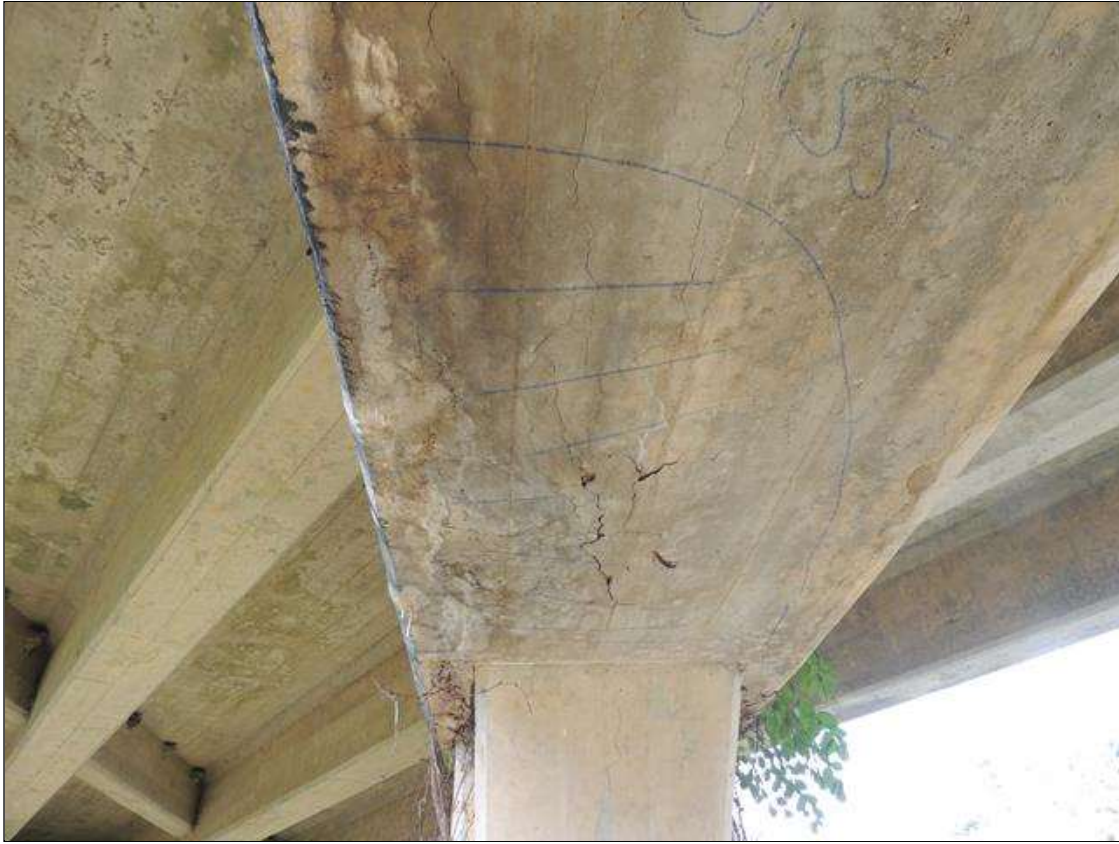
Bent 4 Cap : 15 Feet of Cracking (RC and Other): Width 0.012-0.05 in. or spacing of 1.0-3.0 ft. BOTTOM OF CAP BETWEEN COL. 1 7 COL. 2 CRACKED AND DELAMINATED WITH EFFLO 35" X 55".

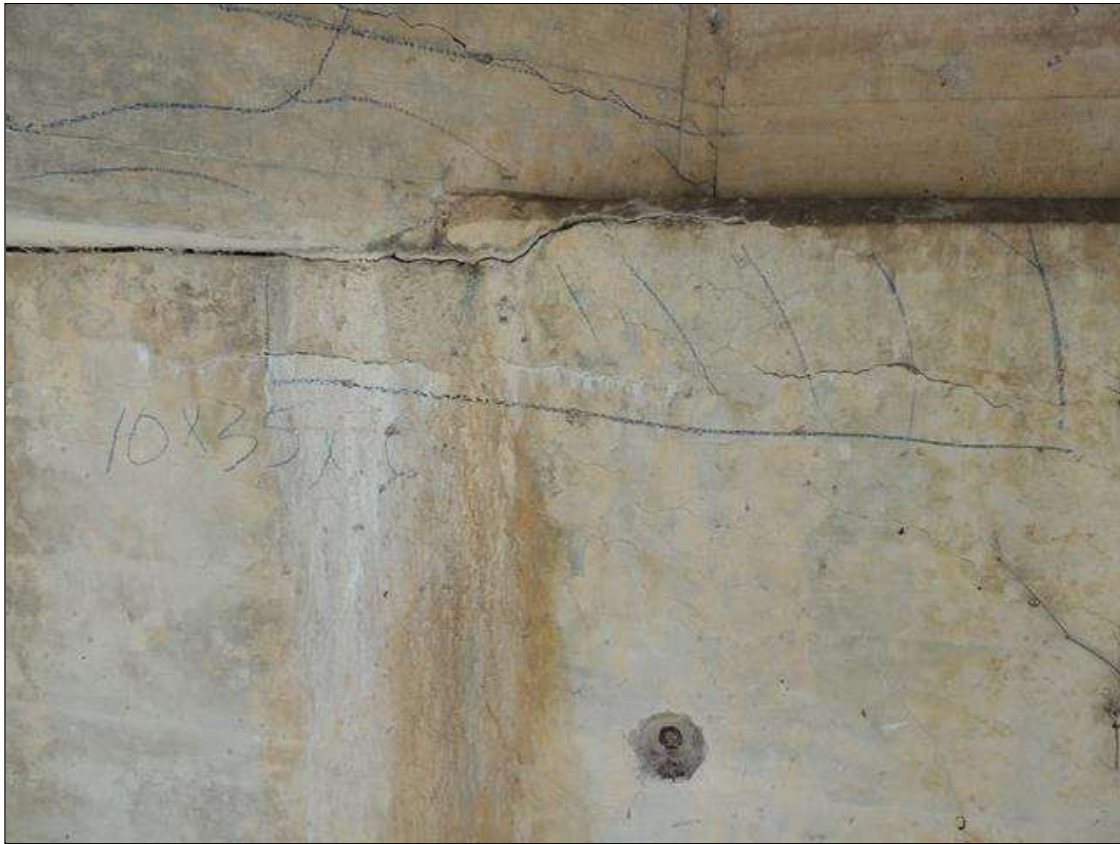
Bent 4 Cap : 3 Feet of Delamination/Spall/Patched Area: Delaminated. Spall 1 inch or less deep or 6 inches or less in diameter. SOUTH FACE OF CAP IS CRACKED AND DELAMINATED RIGHT OF G 2. AREA IS 10" DOWN FACE 35" LONG & 5" ON TOP.

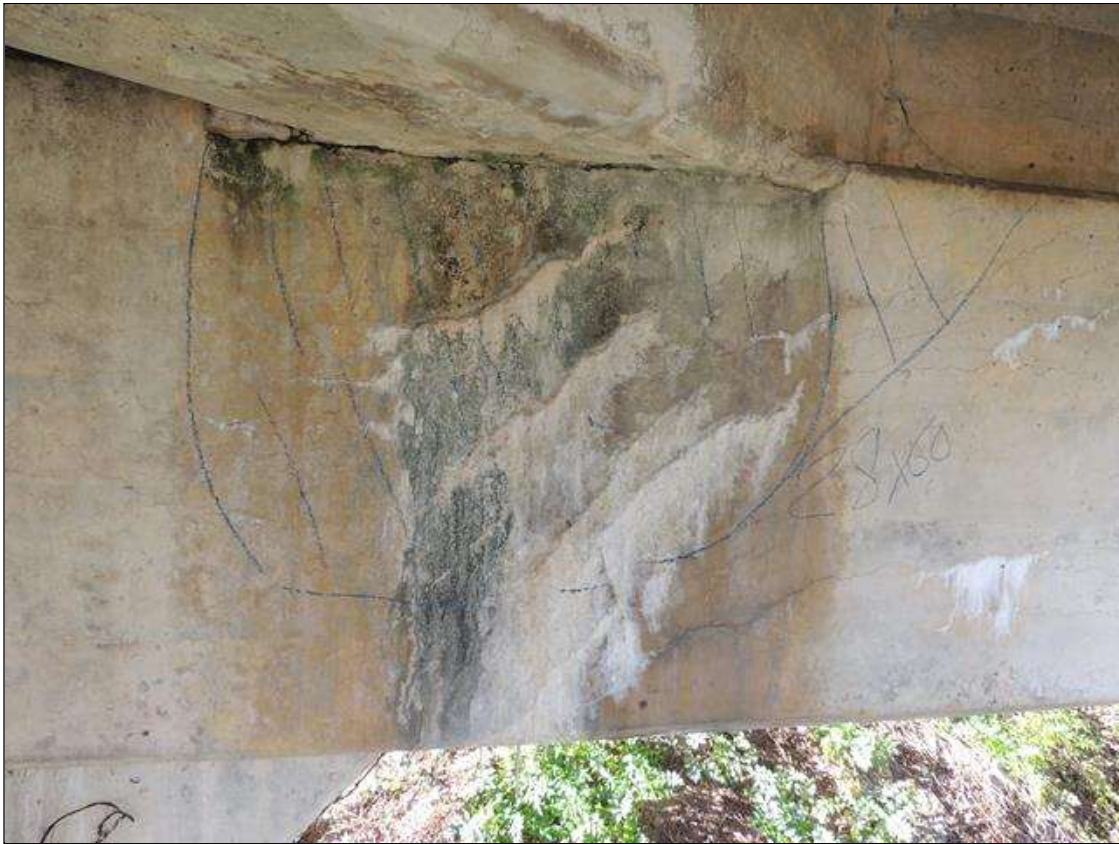
Bent 4 Cap : 5 Feet of Delamination/Spall/Patched Area: Delaminated. Spall 1 inch or less deep or 6 inches or less in diameter. SOUTH FACE OF CAP IS CRACKED AND DELAMINATED 28" UNDER G 3 AND DOWN FACE 5'.

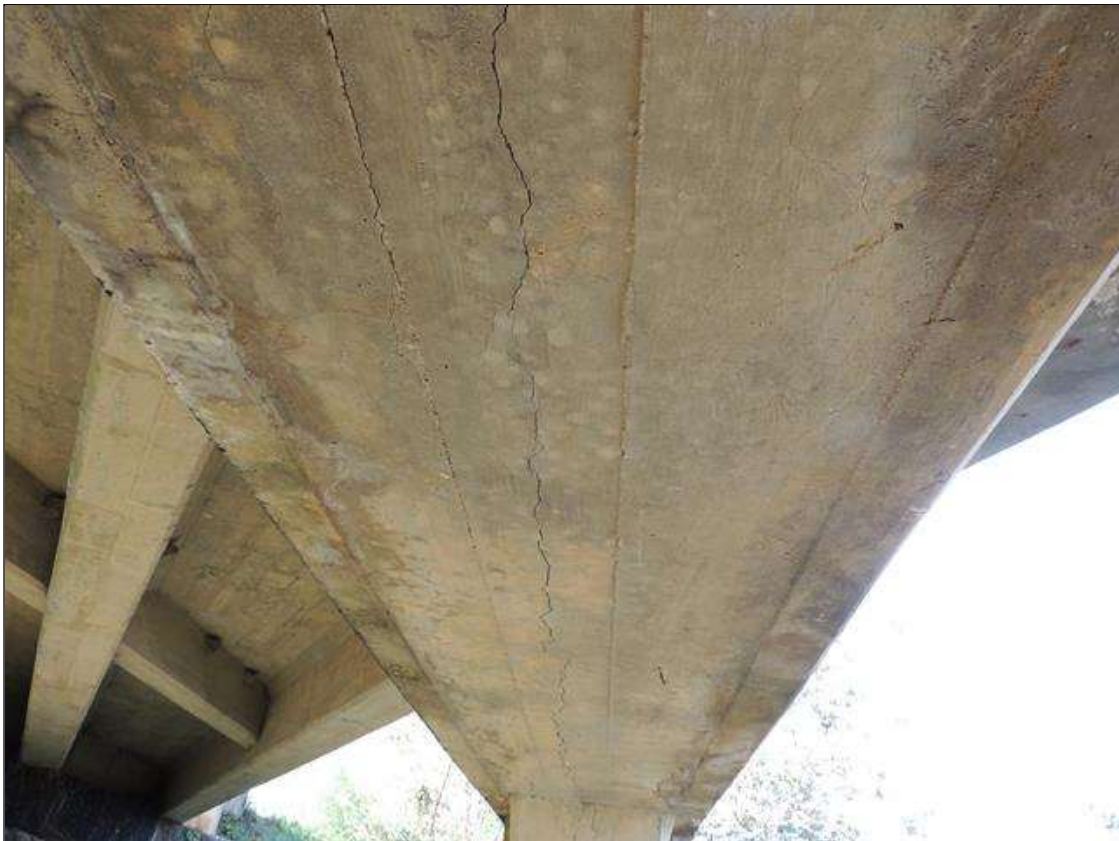
Bent 4 Cap : 10 Feet of Cracking (RC and Other): Width greater than 0.05 in. or spacing of less than 1 ft. BOTTOM OF CAO HAS SCATTERED CRACKING FROM COL. 2 TO COL. 3.

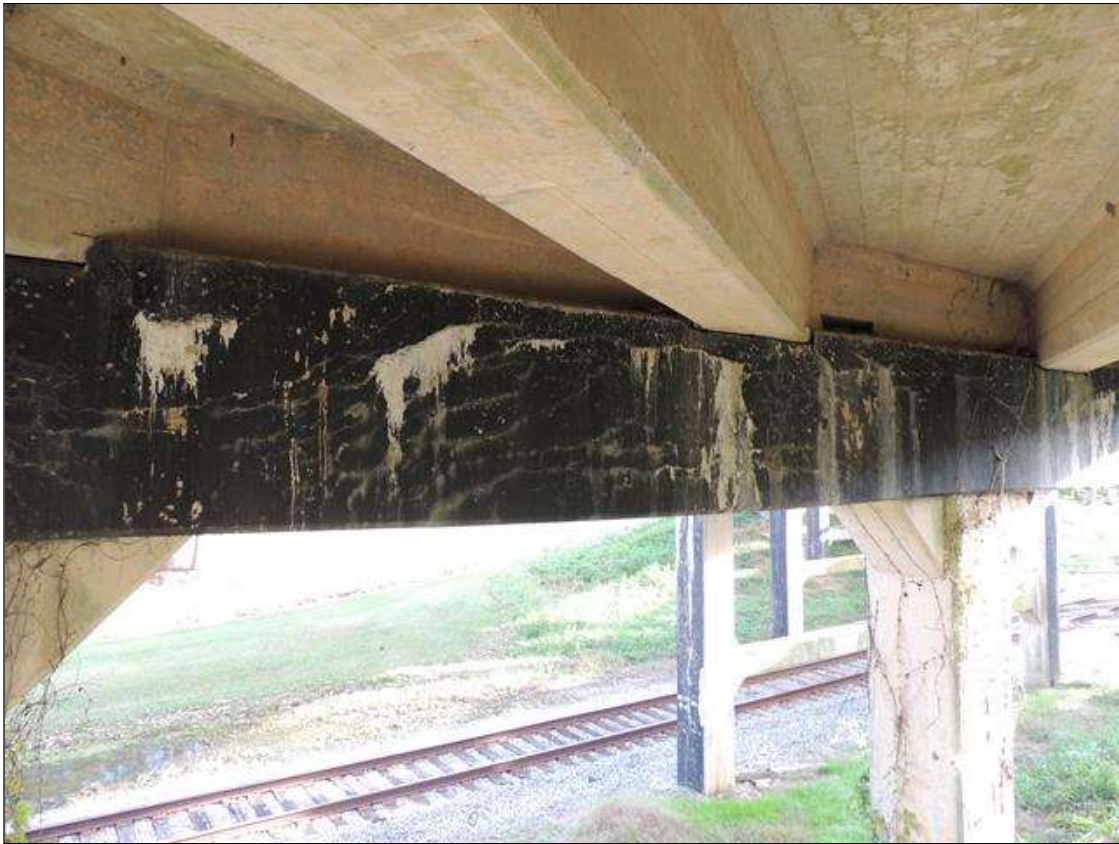
Bent 4 Cap : 6 Feet of Cracking (RC and Other): Width greater than 0.05 in. or spacing of less than 1 ft. NORTH FACE OF CAP HAS SCATTERED MAP, HORIZONTAL AND VERTICAL CRACKS.

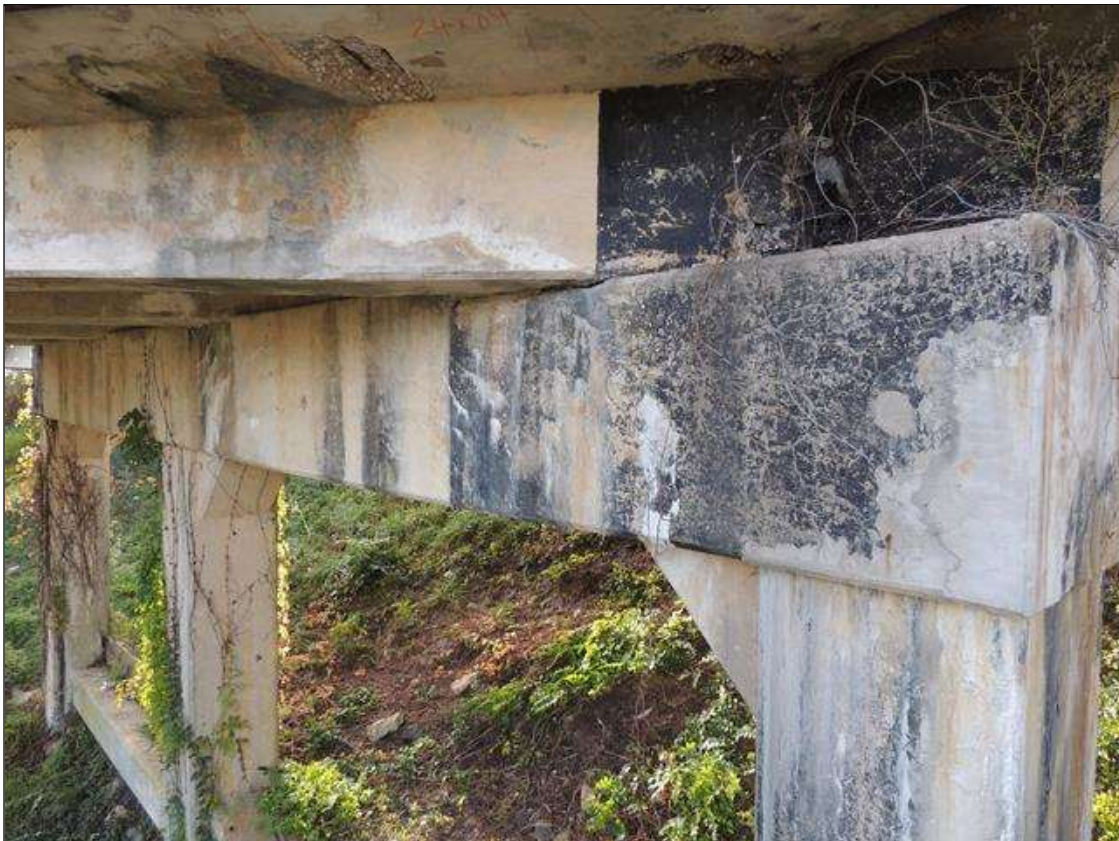
Bent 4 Cap : 0 Feet of Cracking (RC and Other): Width 0.012-0.05 in. or spacing of 1.0-3.0 ft. SOUTH FACE OF CAP HAS SCATTERED MAP CRACKING WITH EFFLO STAINING.

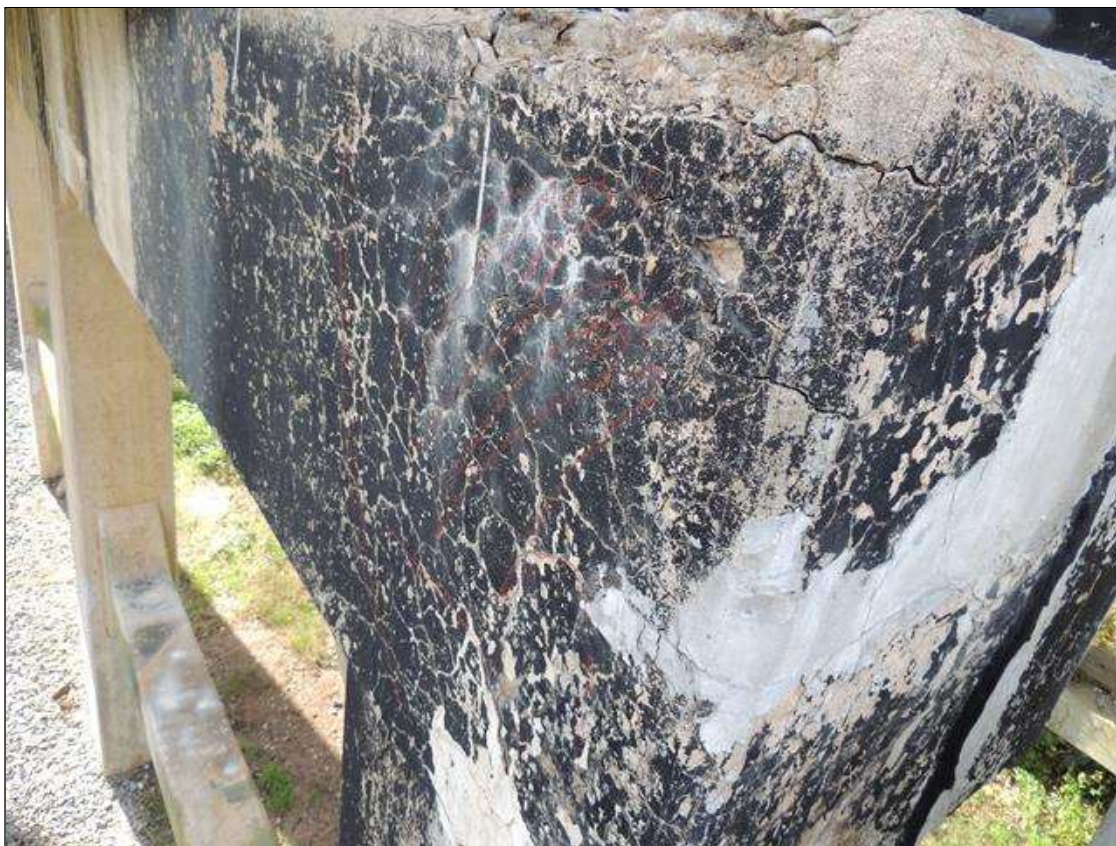
Bent 3 Cap : 3 Feet of Delamination/Spall/Patched Area: Spall greater than 1 inch deep or greater than 6 inches in diameter. SOUTH FACE OF CAP @ RIGHT END HAS A AREA THAT IS CRACKED SPALLED AND DELAMINATED. THE AREA IS 30" X 36".
