NC DEPARTMENT OF TRANSPORTATION
 DIVISION OF HIGHWAYS
 STRUCTURE MANAGEMENT UNIT

ATTENTION: **PM ISSUED FOR CAPS, GIRDERS AND COL.**

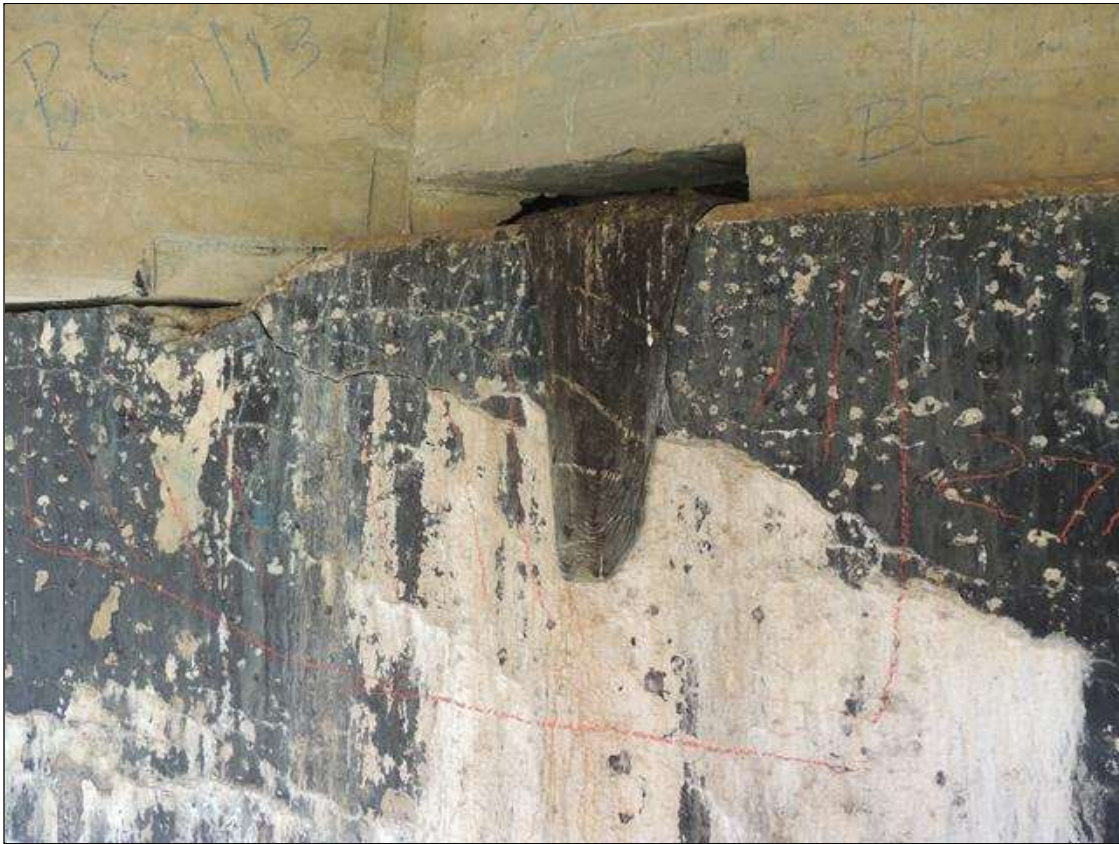
Bent 3 Cap : 5 Feet of Delamination/Spall/Patched Area: Delaminated. Spall 1 inch or less deep or 6 inches or less in diameter. NORTH FACE OF CAP IS CRACKED, SPALLED AND DELAMINATED WITH HEAVY EFFLO AT G 3.
AREA IS 27" X 54"

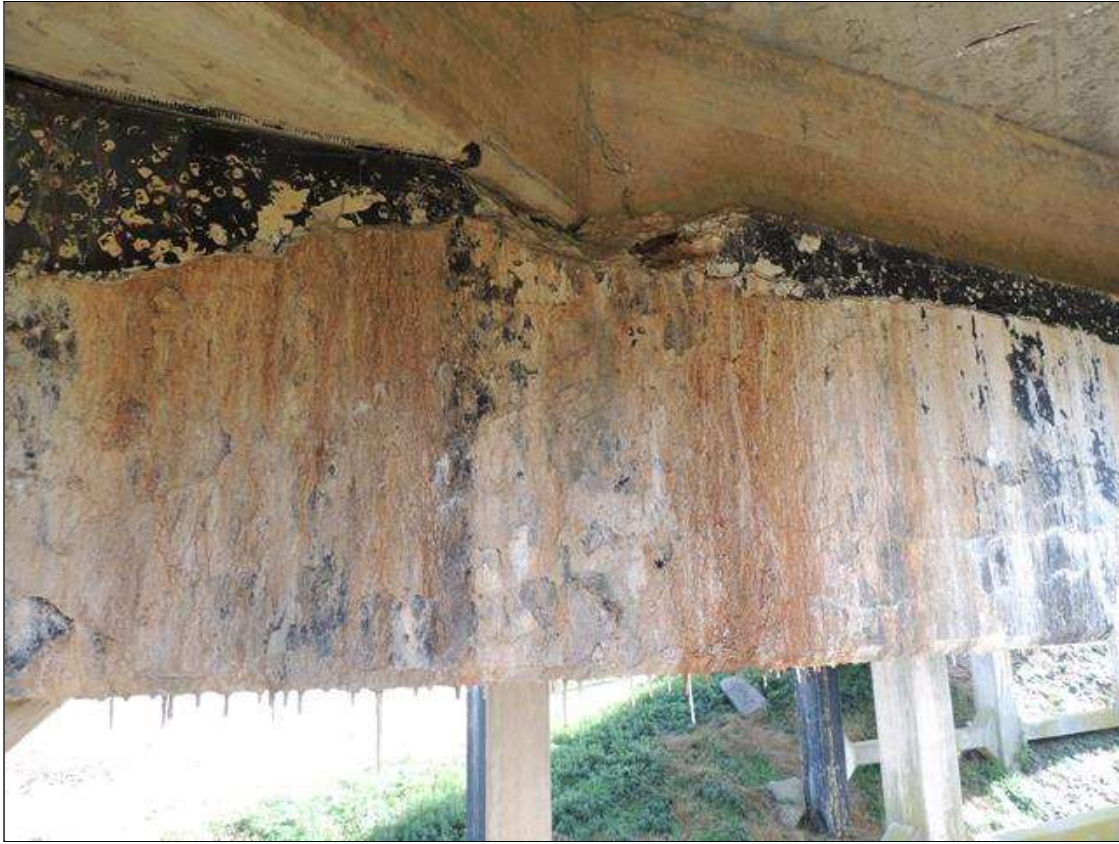
Bent 3 Cap : 10 Feet of Delamination/Spall/Patched Area: Spall greater than 1 inch deep or greater than 6 inches in diameter. NORTH FACE OF CAP IS CRACKED , SPALLED AND DELAMINATED WITH EXCESSIVE EFFLO FROM G 1 TO G 2 42" TOP TO BOTTOM 10' LONG. SPALLED AREA IS 11" X 27" X 9" DEEP.

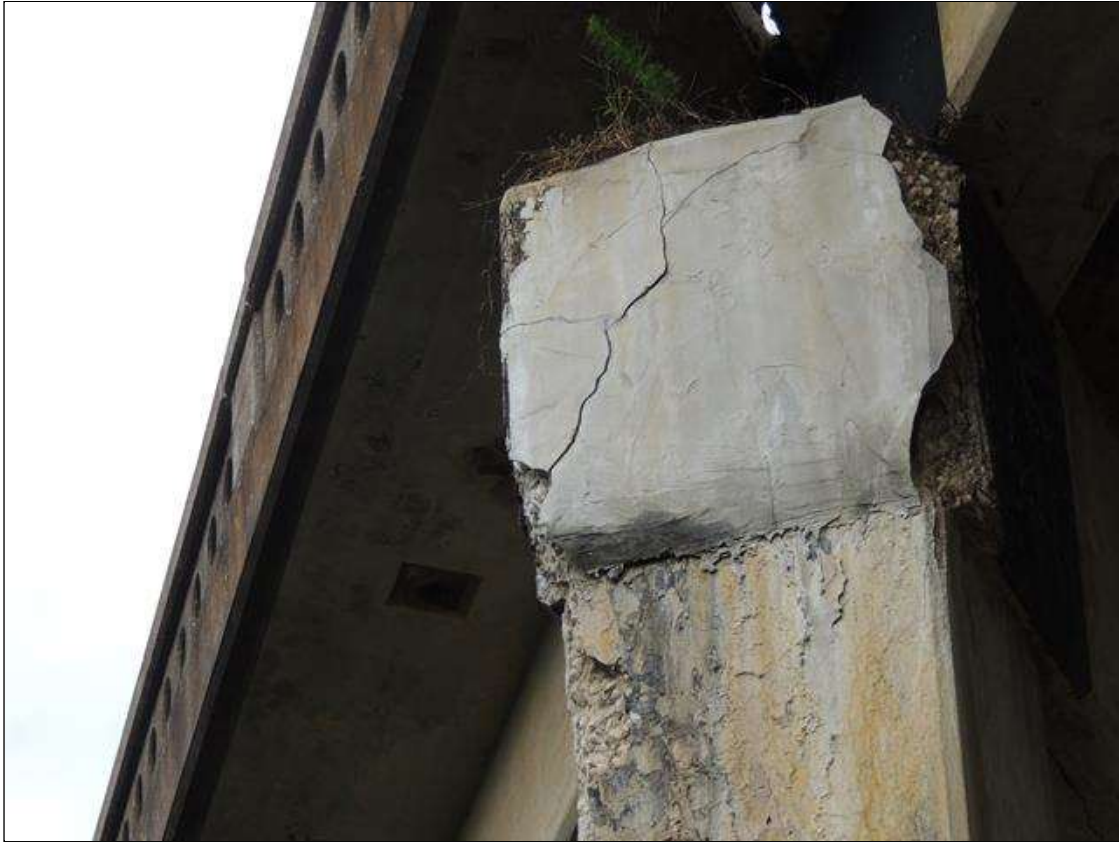
Bent 3 Cap : 12 Feet of Delamination/Spall/Patched Area: The condition warrants structural review to determine the effect on strength and serviceability of the element or the bridge; OR a structural review has been completed and the defects impact strength or serviceability of the element or bridge. LEFT END OF CAP IS CRACKED, SPALLED DELAMINATED AND DETERIORATED 37" X 37". 3' X 5" DEEP ON NORTH AND SOUTH FACES.

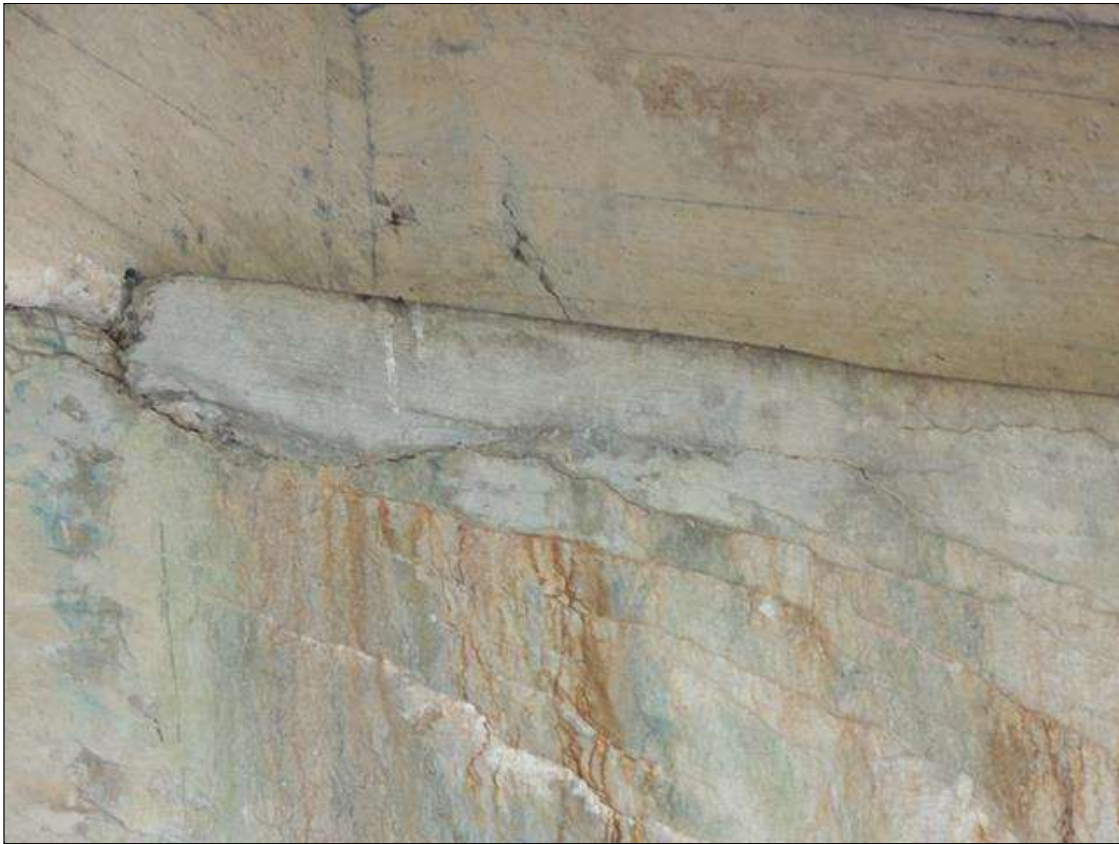
Bent 3 Cap : 3 Feet of Delamination/Spall/Patched Area: Delaminated. Spall 1 inch or less deep or 6 inches or less in diameter. SOUTH FACE OF CAP IS PATCHED AND DELAMINATED RIGHT OF G 2 10" DOWN FACE 36" LONG.

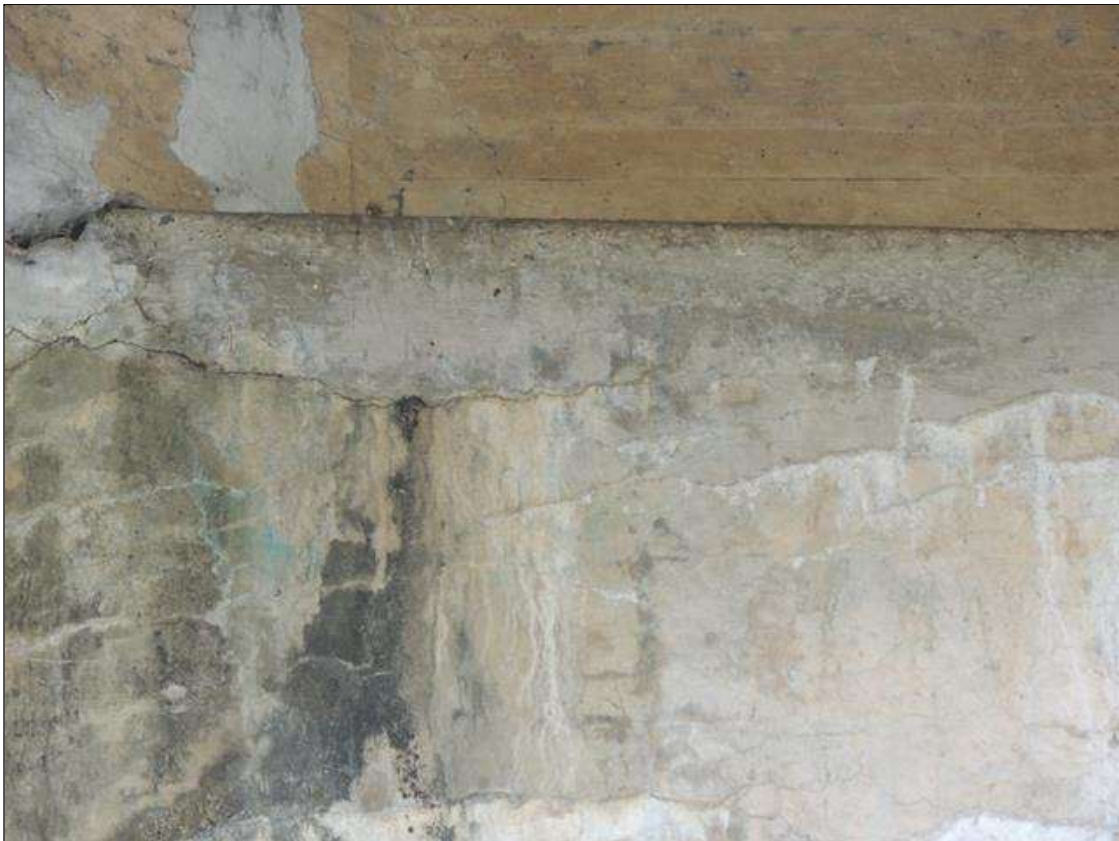
Bent 3 Cap : 4 Feet of Delamination/Spall/Patched Area: Delaminated. Spall 1 inch or less deep or 6 inches or less in diameter. SOUTH FACE OF CAP IS PATCHED AND DELAMINATED RIGHT OF G 3 12" DOWN FACE 4' LONG.

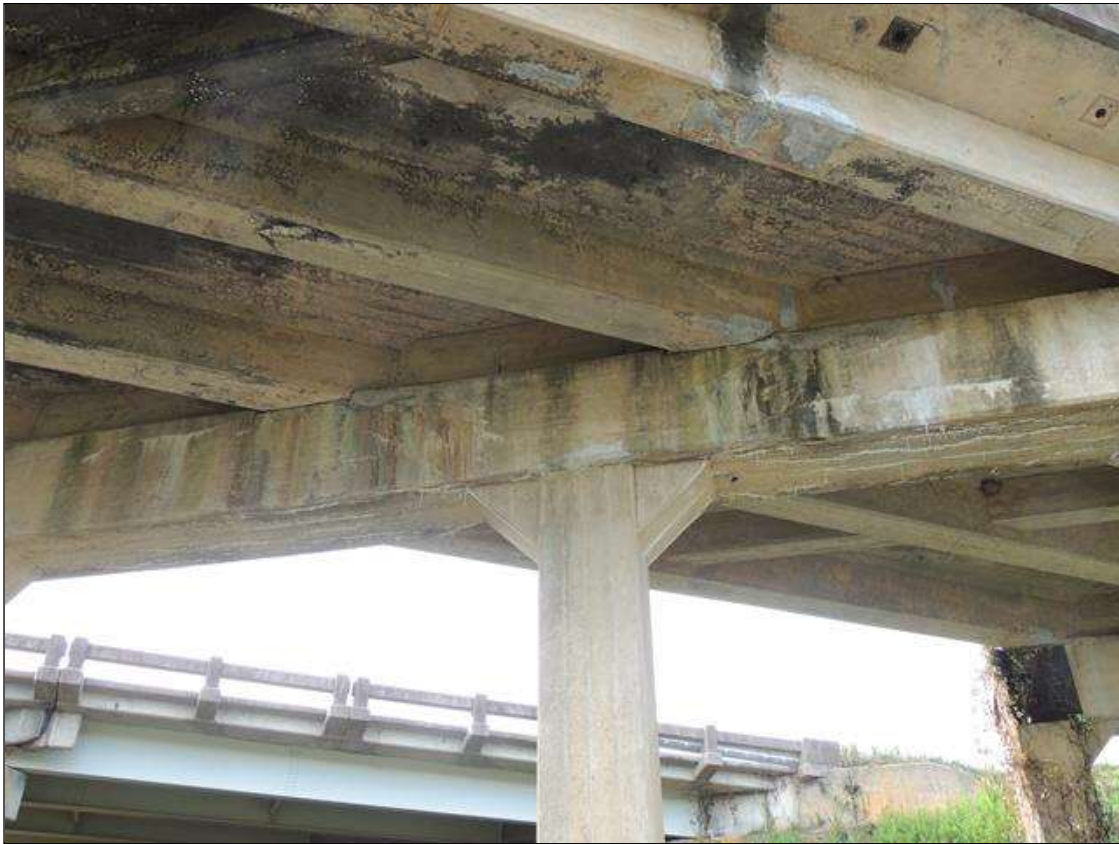
Bent 3 Cap : 8 Feet of Cracking (RC and Other): Width greater than 0.05 in. or spacing of less than 1 ft. SOUTH FACE OF CAP HAS MAP CRACKING WITH HEAVY EFFLO LEFT OF G 2 TO G 4.

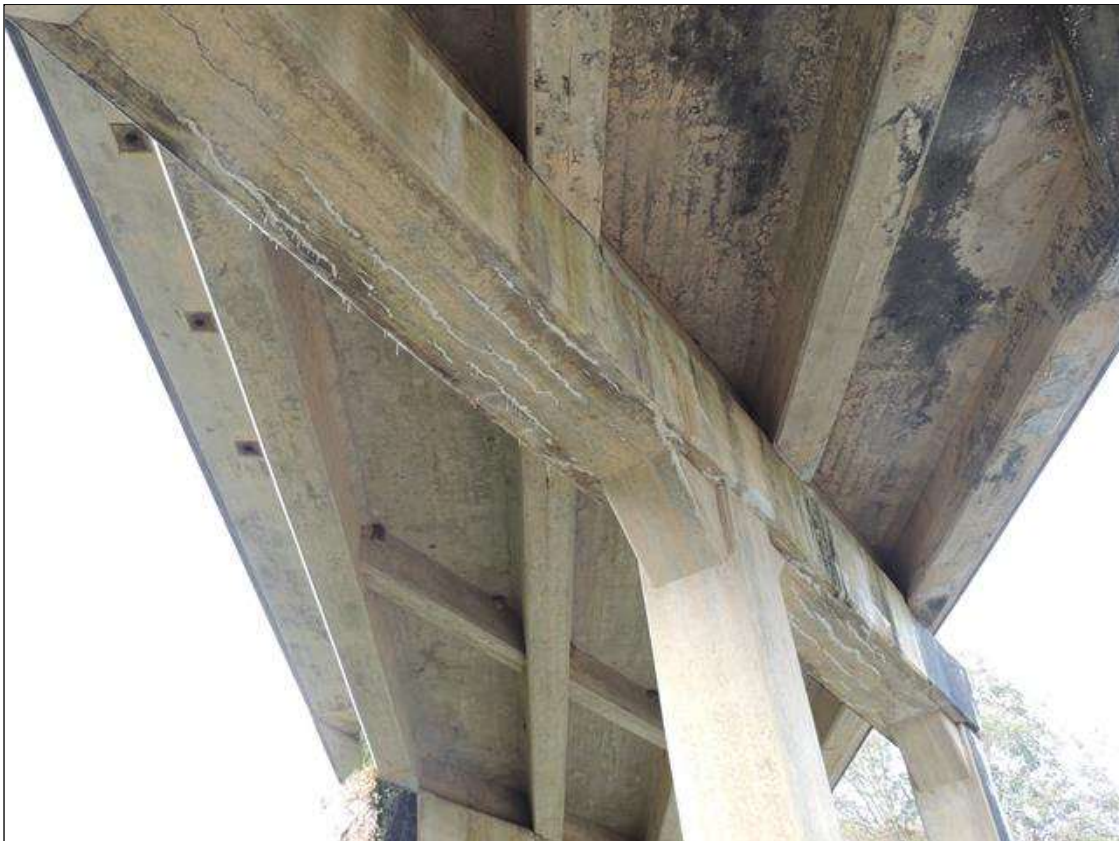
Bent 3 Cap : 0 Feet of Cracking (RC and Other): Width greater than 0.05 in. or spacing of less than 1 ft. BOTTOM OF CAP BETWEEN COL. 1 & 2 AND COL. 3 & 4 HAVE AREAS OF HEAVY MAP CRACKING WITH EFFLO.

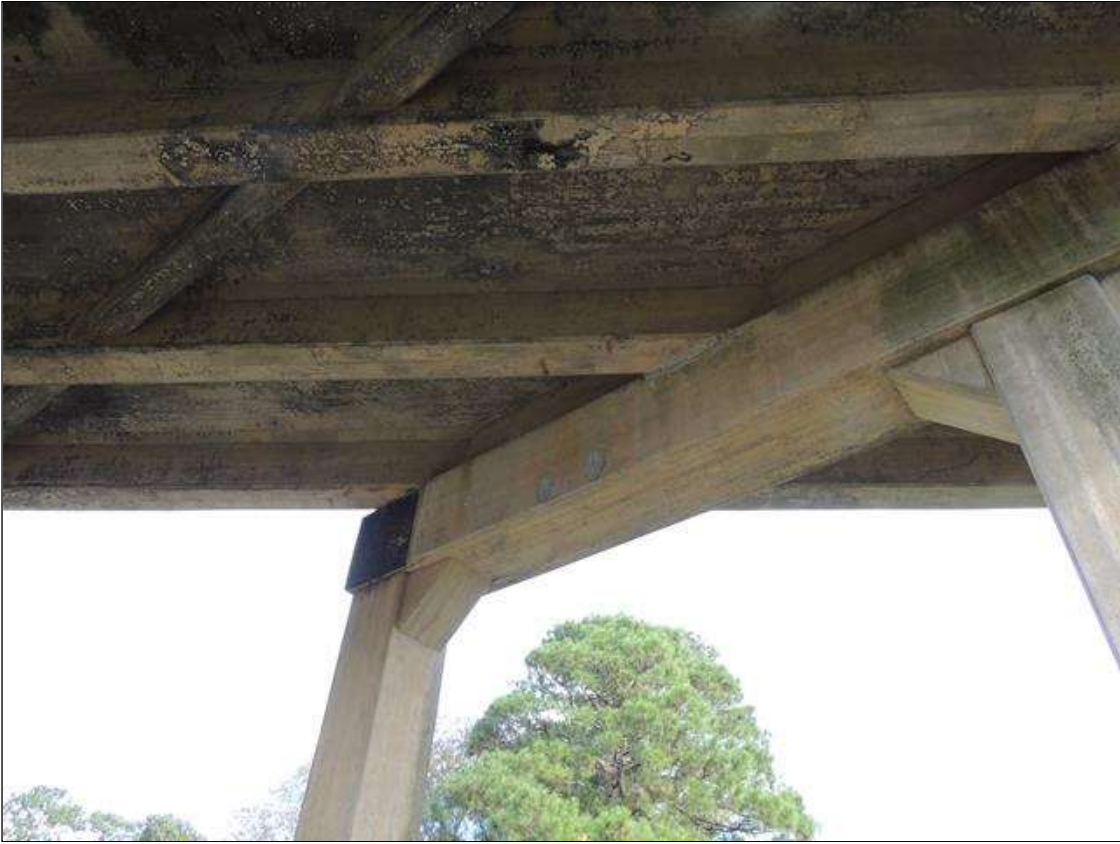
Bent 2 Cap : 0 Feet of Delamination/Spall/Patched Area: Delaminated. Spall 1 inch or less deep or 6 inches or less in diameter. NORTH FACE OF CAP HAS 3 PATCHED AREAS IN FACE AT G 3.

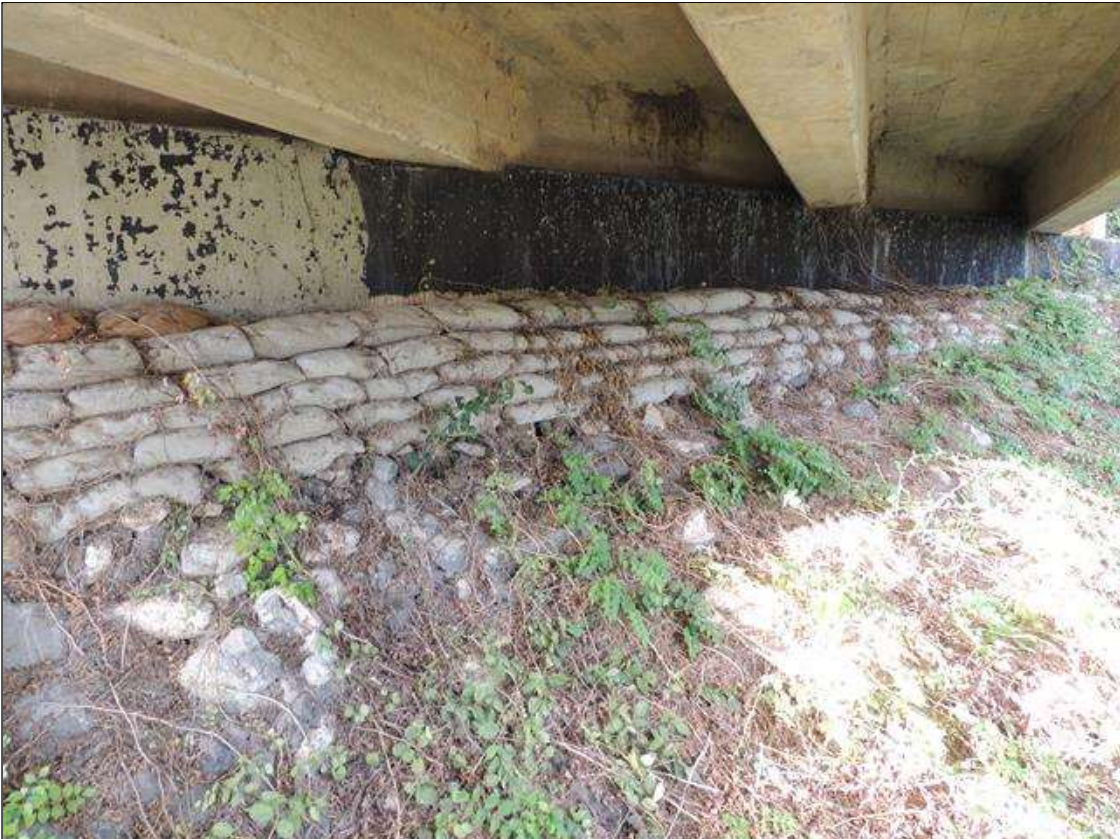
End Bent 2 Cap : 45 Feet of Cracking (RC and Other): Width 0.012-0.05 in. or spacing of 1.0-3.0 ft. FACE OF END BENT 2 CAP HAS SCATTERED MAP CRACKING FROM LEFT END TO RIGHT END.

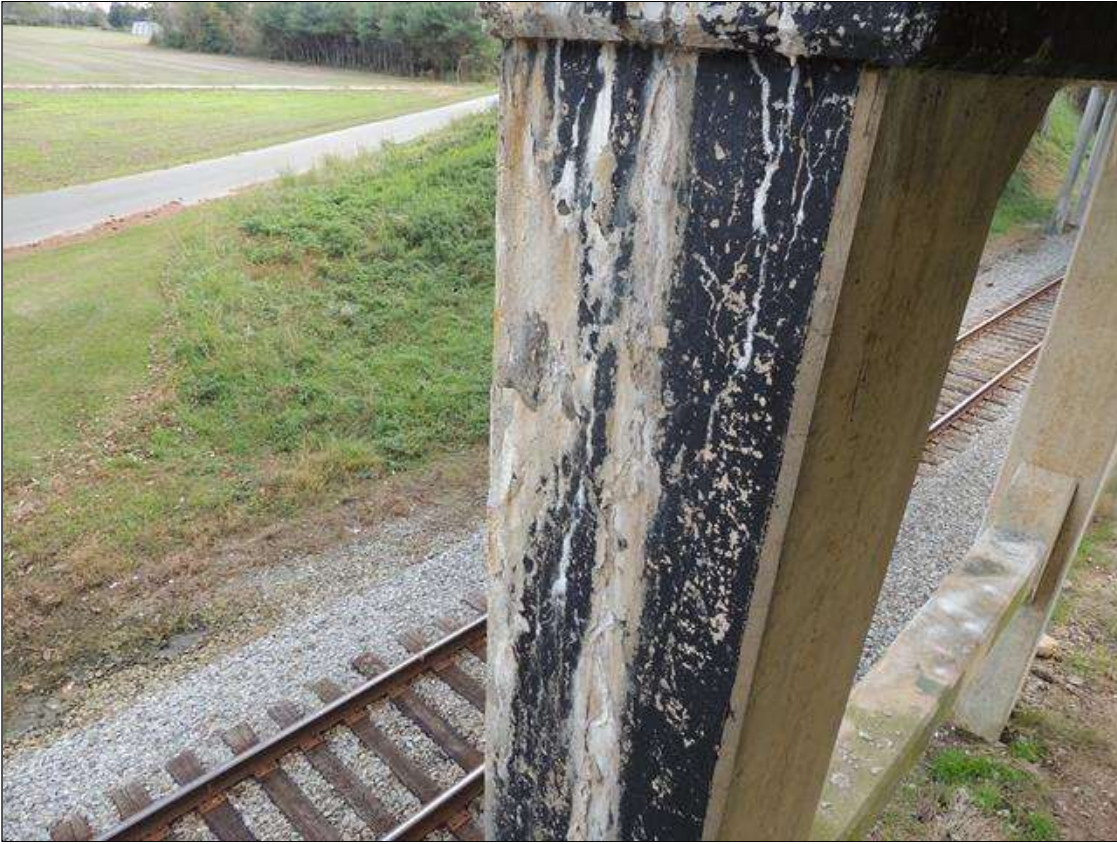
Bent 4 Pile 3: 1 Each of Delamination/Spall/Patched Area: Delaminated. Spall 1 in. or less deep or 6 in. or less in diameter. EAST FACE IS CRACKED FROM TOP DOWN 16' X 25" WIDE.

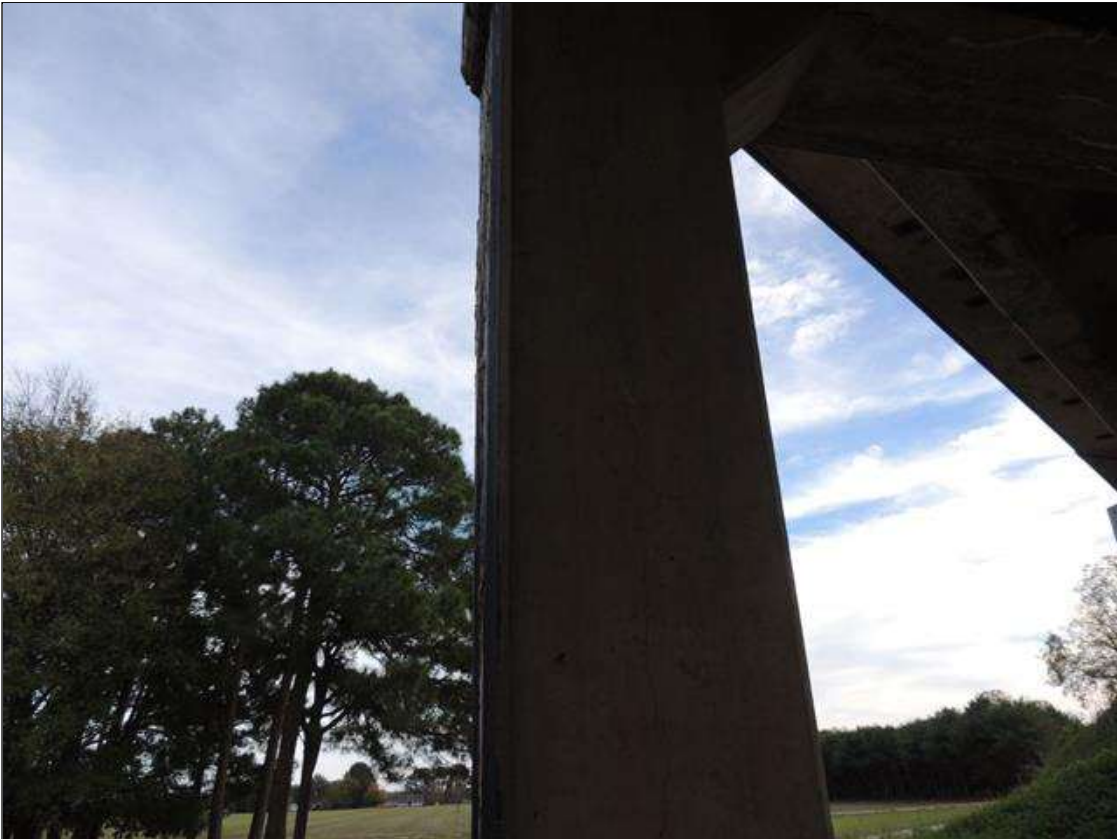
Bent 4 Pile 3: 0 Each of Cracking (RC and Other): Width 0.012-0.05 in. or spacing or 1.0-3.0 ft. NORTH FACE HAS SCATTERED VERTICAL AND MAP CRACKING WITH SOME DELAMINATION. SIMILAR IN OTHER FACES.

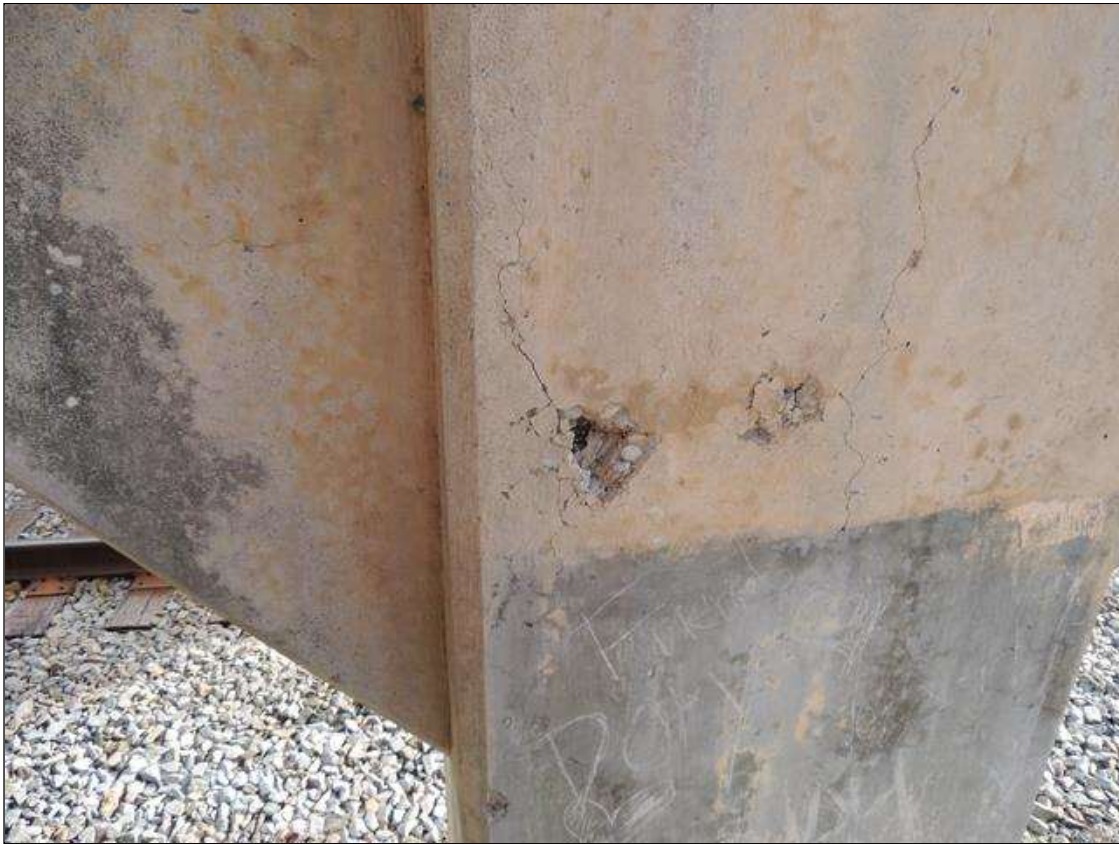
Bent 3 Pile 2: 1 Each of Delamination/Spall/Patched Area: Delaminated. Spall 1 in. or less deep or 6 in. or less in diameter. COL. HAS CRACKED , SPALLED AND DELAMINATED AREAS 6' ABOVE GROUND 7" X 12".

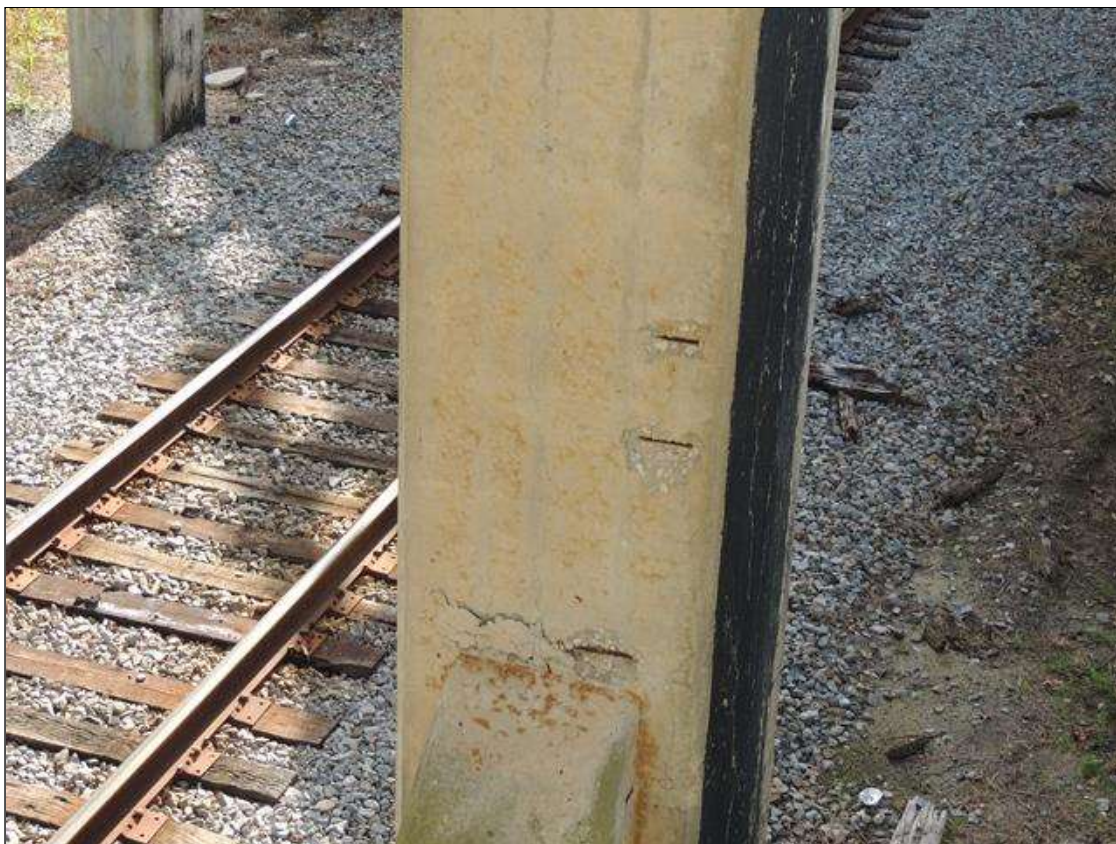
Bent 3 Pile 1: 1 Each of Delamination/Spall/Patched Area: Delaminated. Spall 1 in. or less deep or 6 in. or less in diameter. COL. 1 EAST FACE HAS 3 SPALLED AREAS ABOVE SRTUT. AREAS ARE 5" X 5" X 3/4" DEEP AND 7" X 18" X 3/4" DEEP.

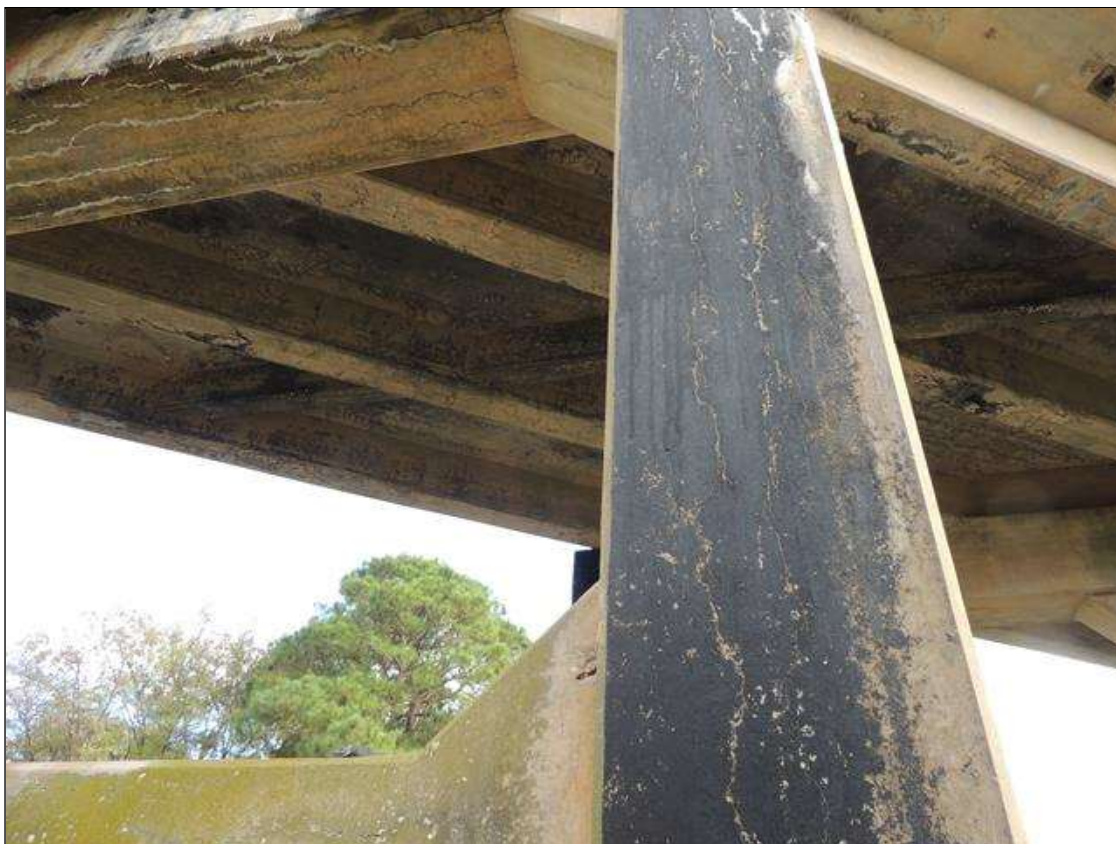
Bent 3 Pile 1: 0 Each of Cracking (RC and Other): Width 0.012-0.05 in. or spacing or 1.0-3.0 ft. NORTH FACE OF COL. HAS SCATTERED MAP AND VERTICAL CRACKS. SIMILAR ON THE EAST AND SOUTH FACES.

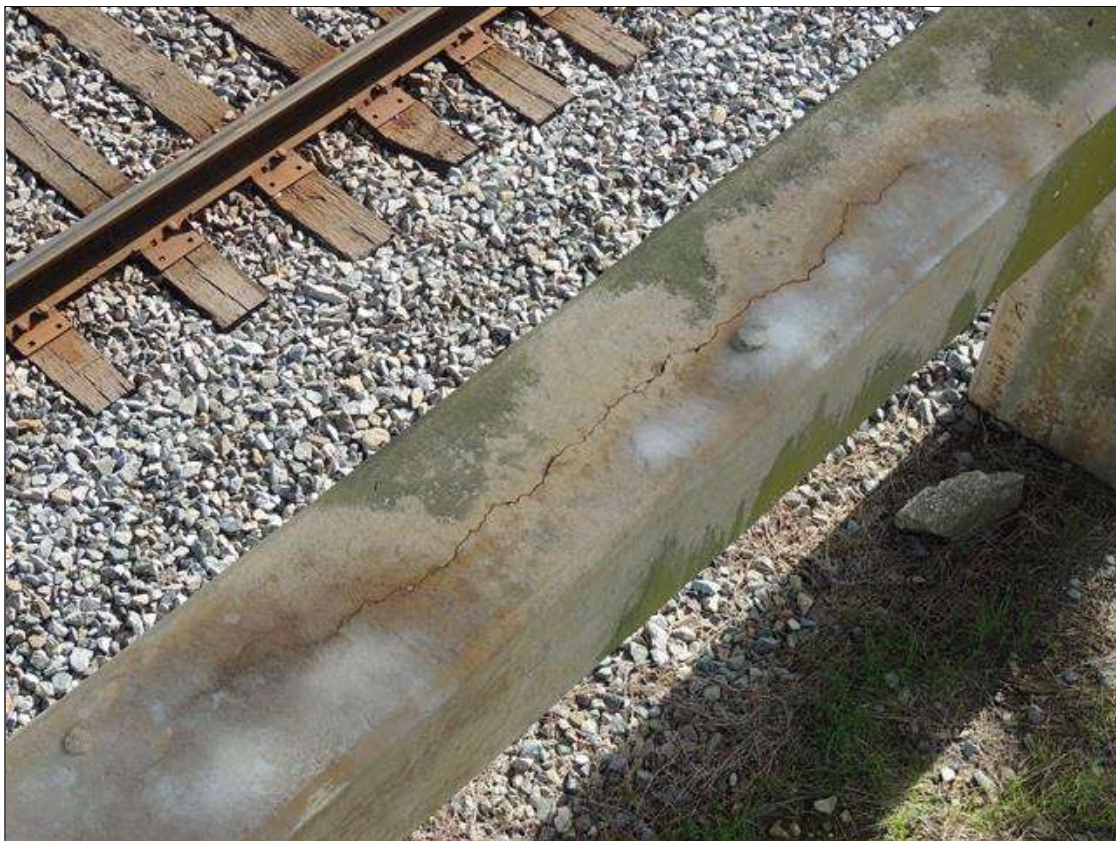
TOP OF STRUT BETWEEN COL. 1 AND COL. 2 @ BENT 3 IS CRACKED ON TOP 12' LONG

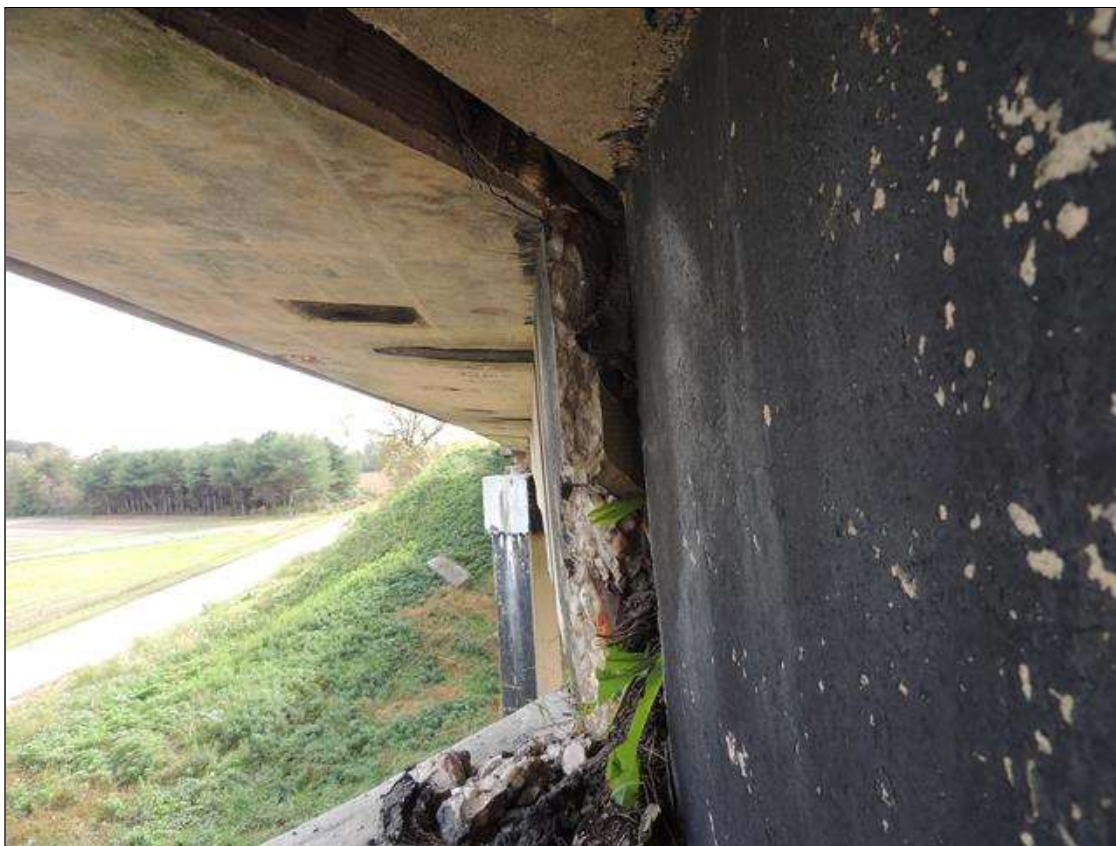
SPAN 3 HAS SHIFTED 3" TO EAST OVER BENT 3.

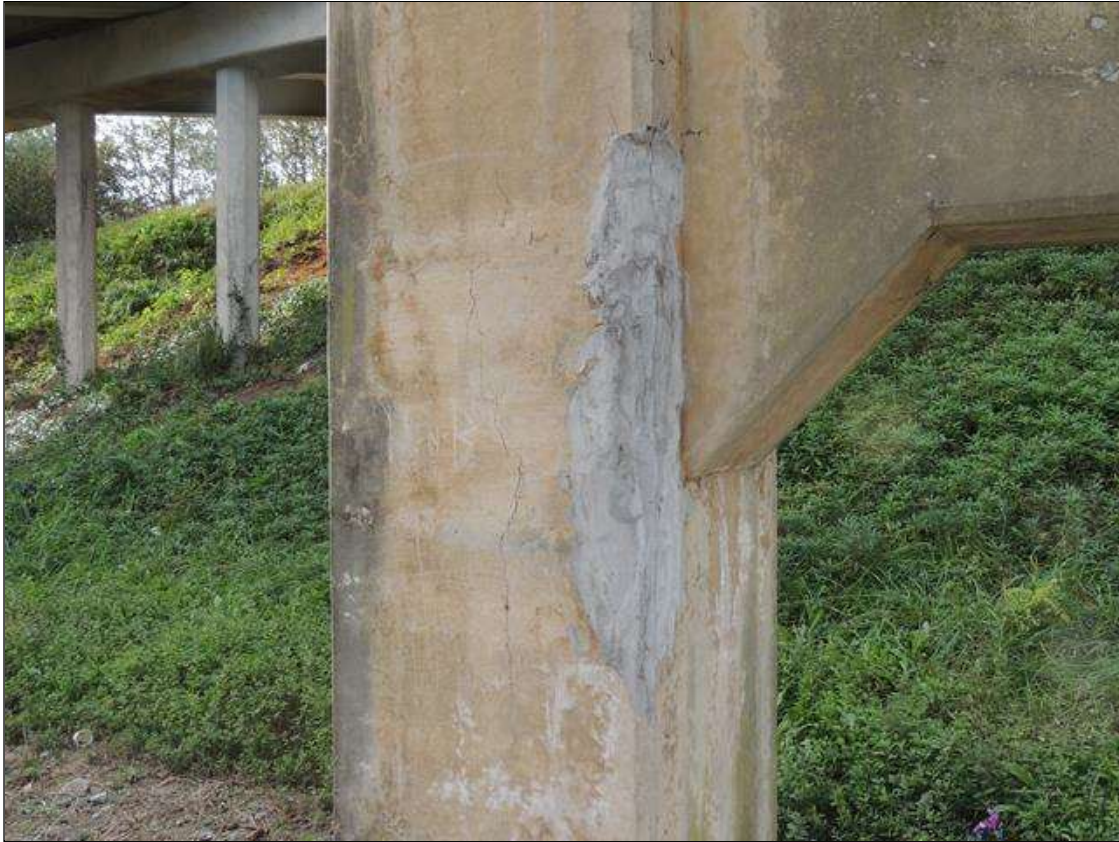
Bent 3 Pile 1: 0 Each of Delamination/Spall/Patched Area: Delaminated. Spall 1 in. or less deep or 6 in. or less in diameter. COL. 1 HAS A PATCHED AREA SOUTH EAST CORNER @ STRUT AREA IS 3' HIGH AND 4" ON EACH FACE.

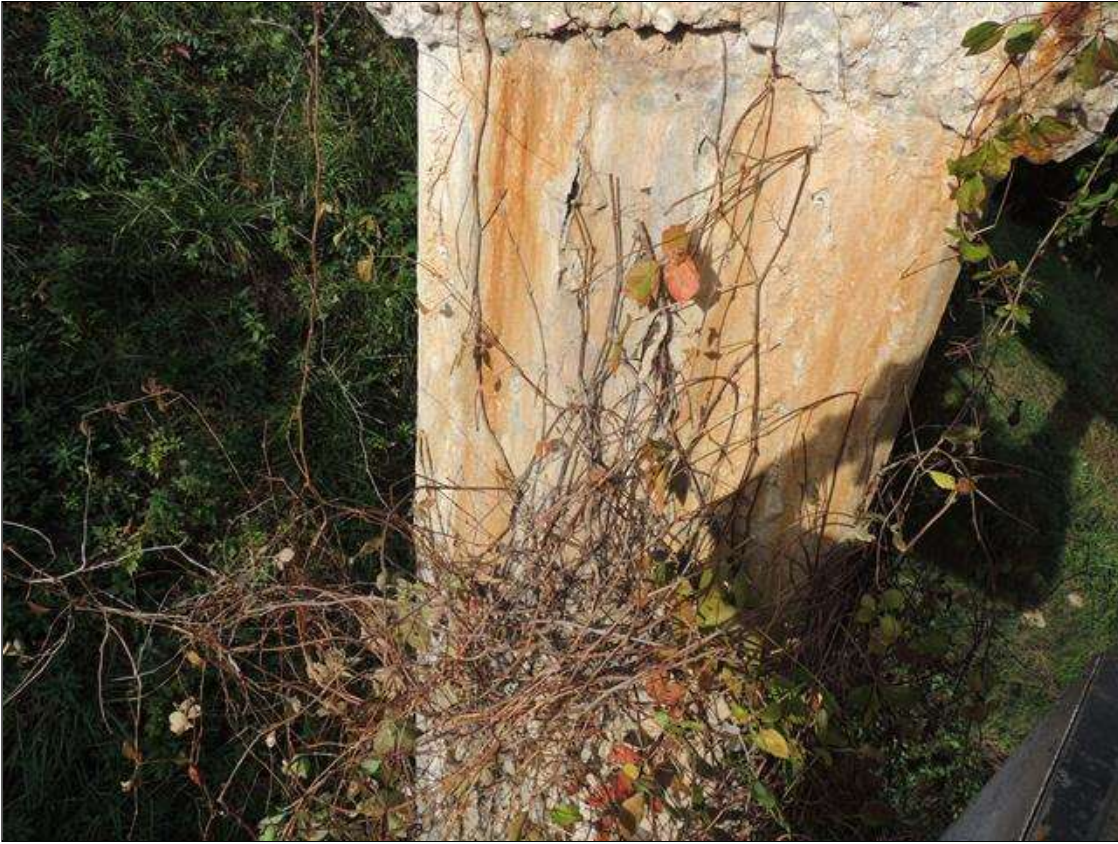
Bent 4 Pile 1: 0 Each of Delamination/Spall/Patched Area: Spall greater than 1 in. deep or greater than 6 in. diameter. WEST FACE OF COL. HAS CRACKS WITH HEAVY EFFLO STAINS FROM TOP DOWN 14' 30" WIDE.

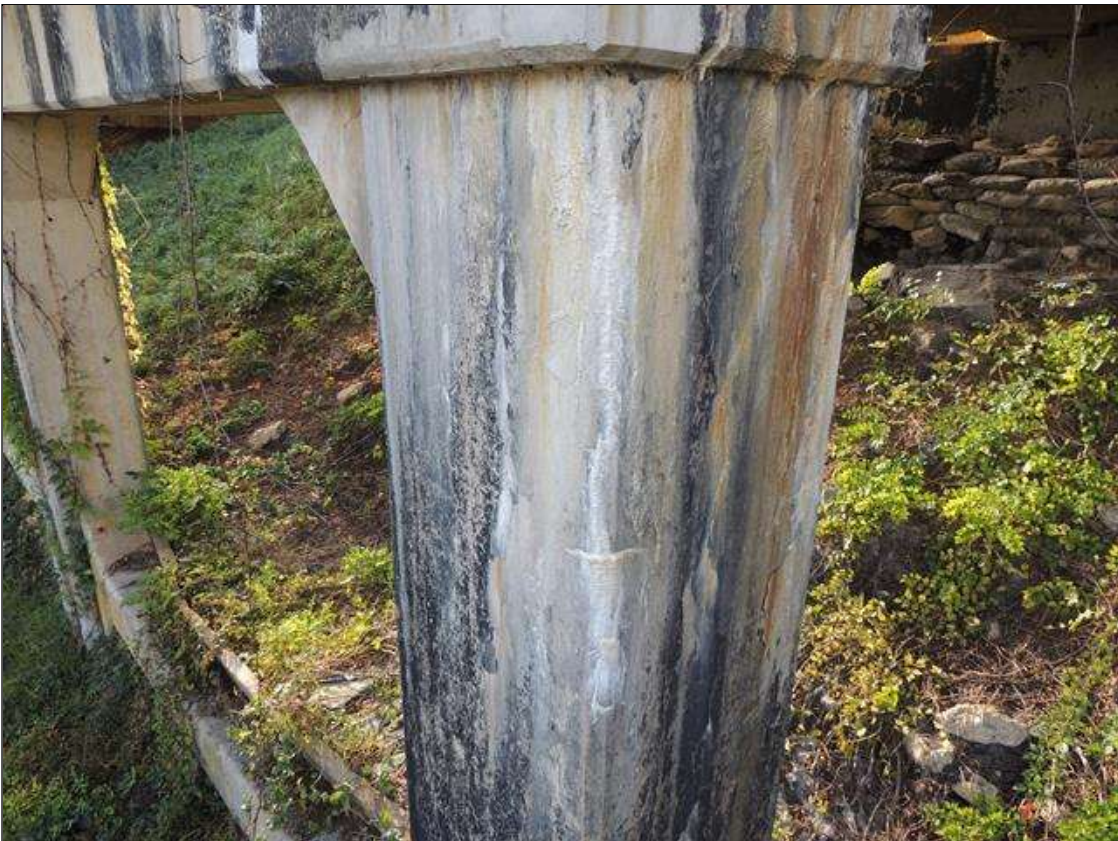
Bent 4 Pile 3: 0 Each of Cracking (RC and Other): Width 0.012-0.05 in. or spacing or 1.0-3.0 ft. SOUTH AND EAST FACES OF COL. 3 HAVE CRACKS WITH HEAVY EFFLO FROM CAP DOWN 10'. OTHER FACES ARE CRACKED.

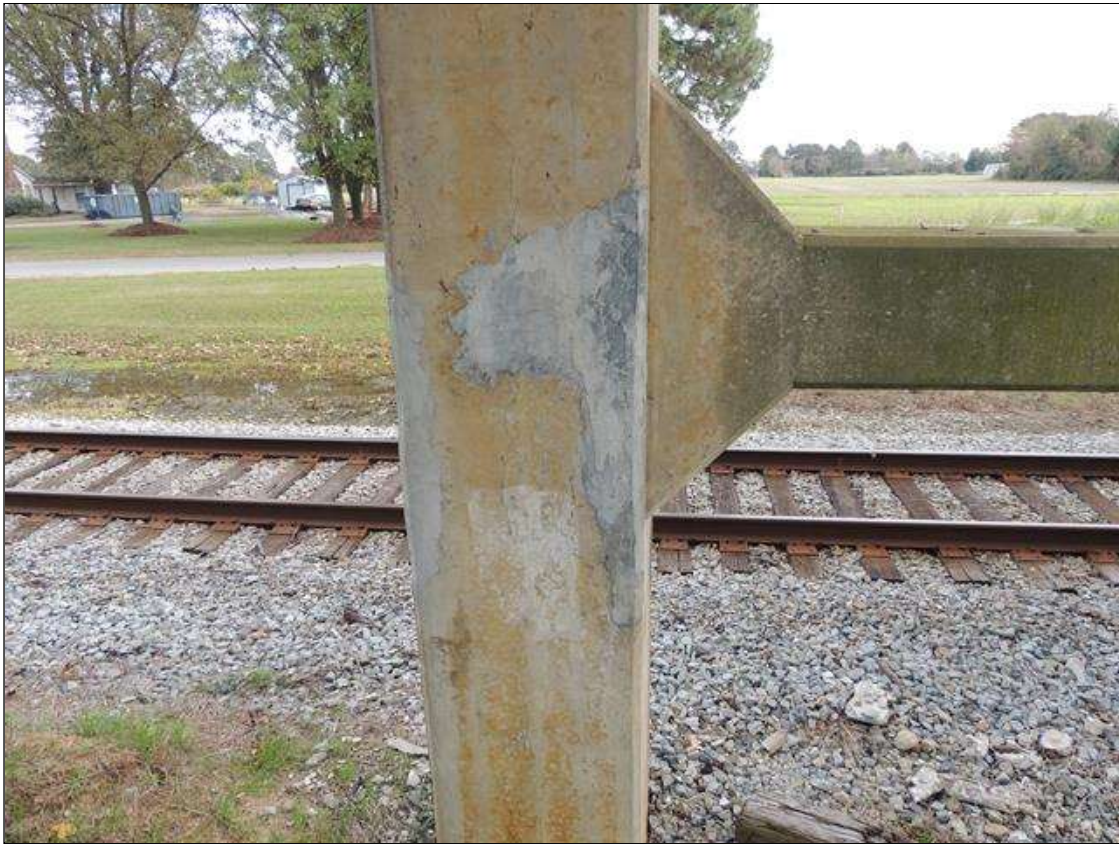
BENT 3 COL. 3 NORTH FACE HAS 2 PATCHED AREAS 4' ABOVE GROUND EXTENDING & 30 " WIDE.

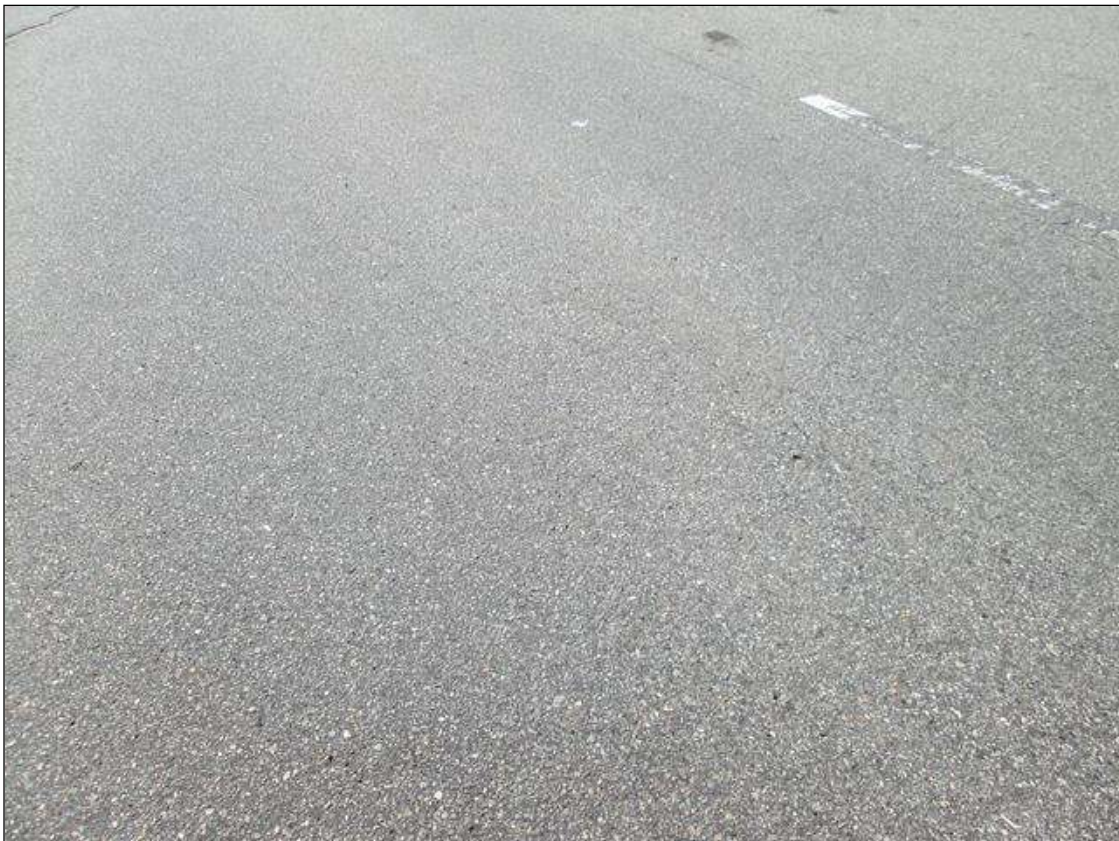
WEARING SURFACE SPAN 3 (SIM. IN ALL SPANS)

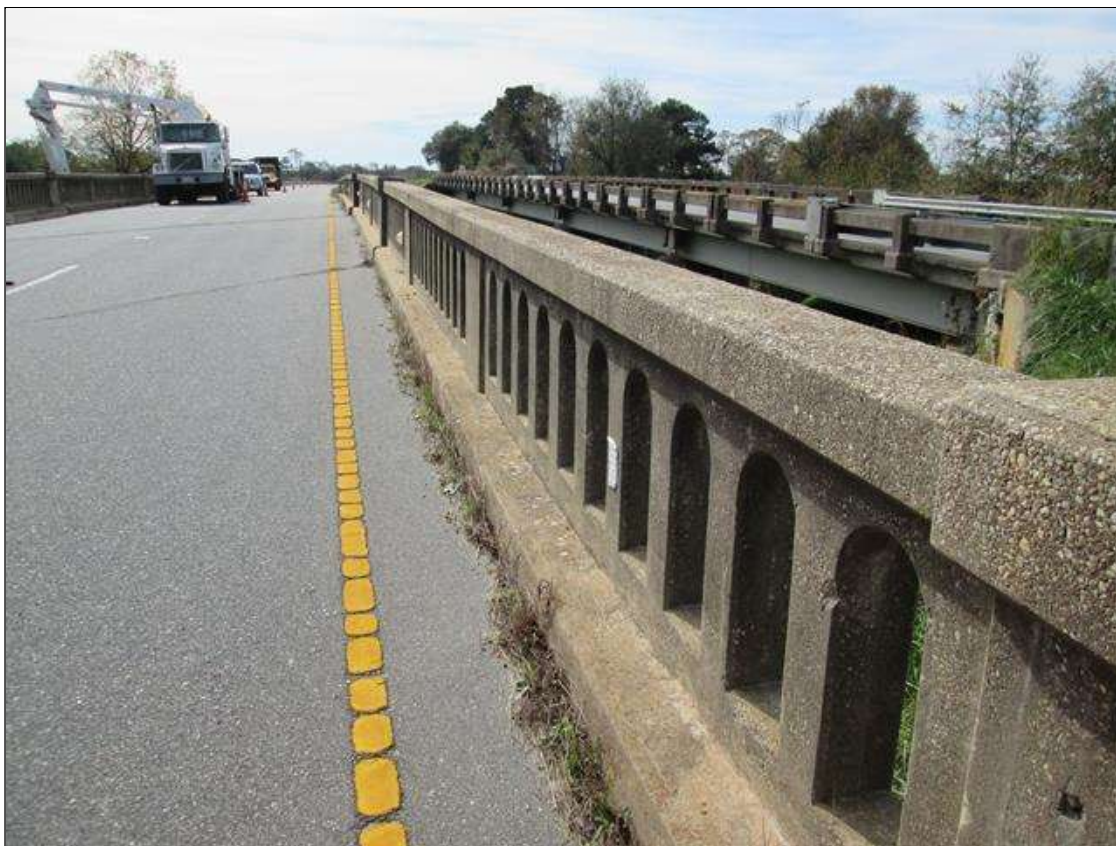
RAIL AND CURB LEFT SIDE SPAN 2. (SIM IN ALL SPANS BOTH SIDES)

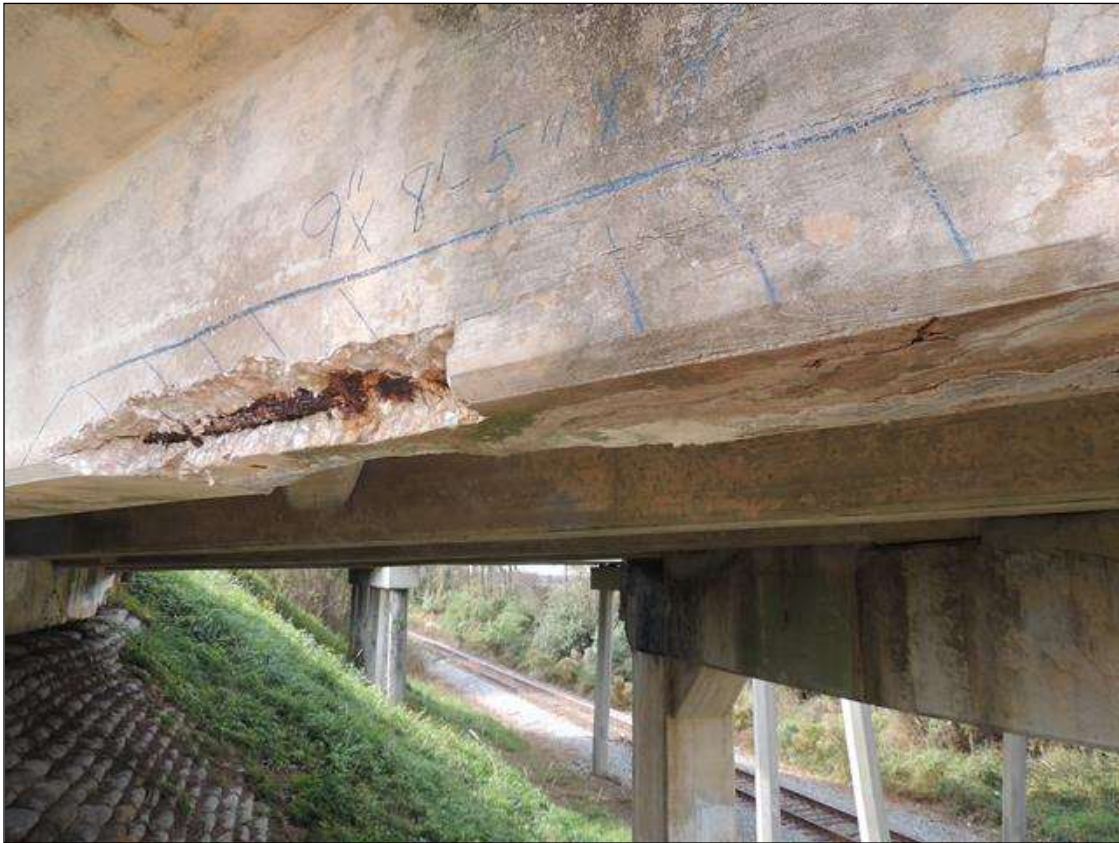
SPAN 1 G4 CRACKED SPALLED AND DELAMINATED AREA ALONG BOTTOM AND BOTH FACES AT MID SPAN.
AREA IS 9" HIGH X 8' 5" LONG X 18"
