NC DEPARTMENT OF TRANSPORTATION
 DIVISION OF HIGHWAYS
 STRUCTURE MANAGEMENT UNIT

ATTENTION: **PM ISSUED FOR CAPS, GIRDERS AND COL.**

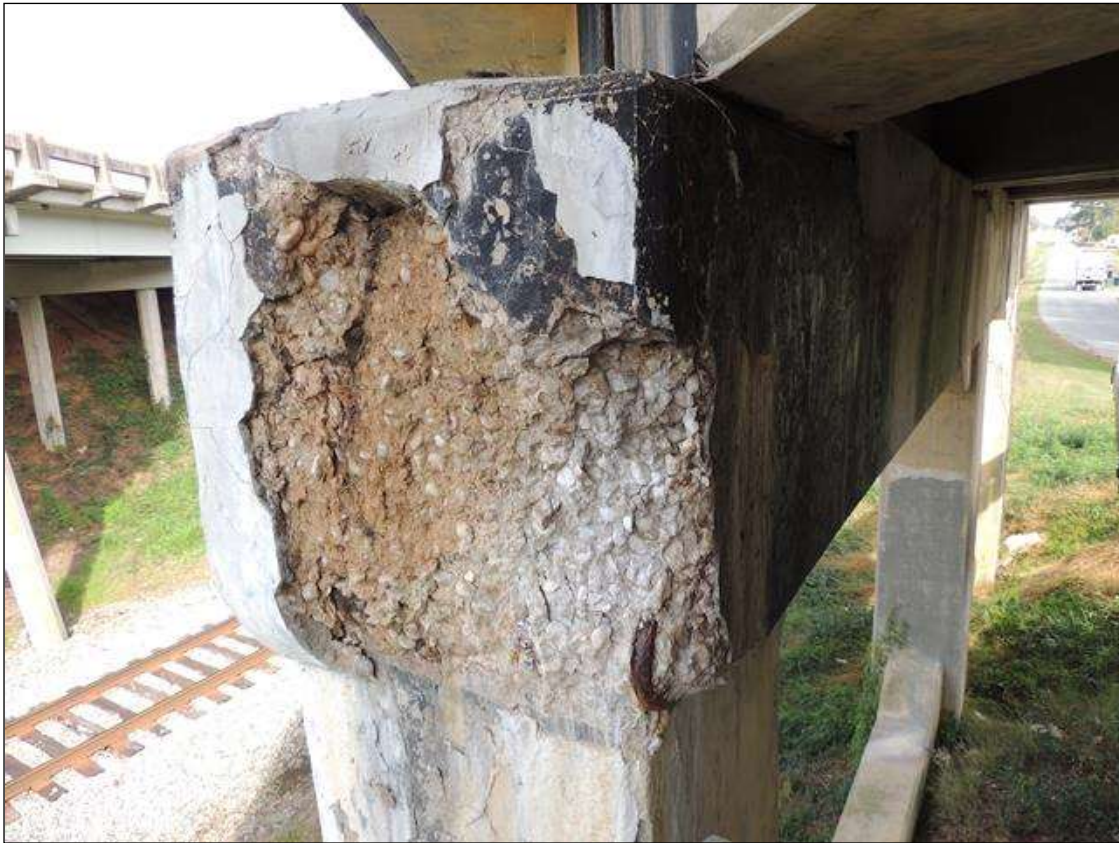
LEFT END OF BENT 1 CAP AND SOUTH FACE . SPALLED, CRACKED , DELAM. & DETERIORATED FROM LEFT END OUT 4' LONG X 38" WIDE X 3' TOP AND BOTTOM WITH REBAR.

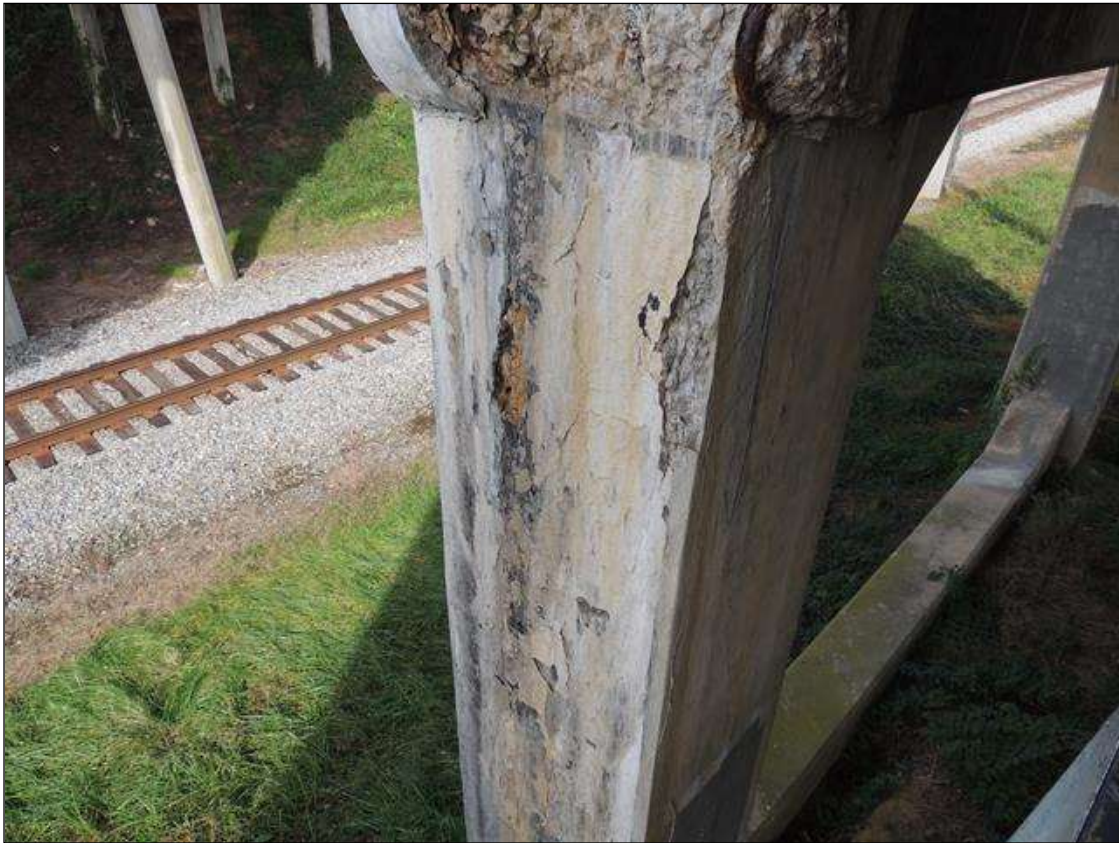
BT. 1 COL. 1 WEST FACE CRAKED, DELAM. & DETERIORATED. TOP TO BOTTOM 13' X 31" WIDE WITH HEAVY EFFLO AND EXTENDS AROUND SOUTH & NORTH FACES 10"

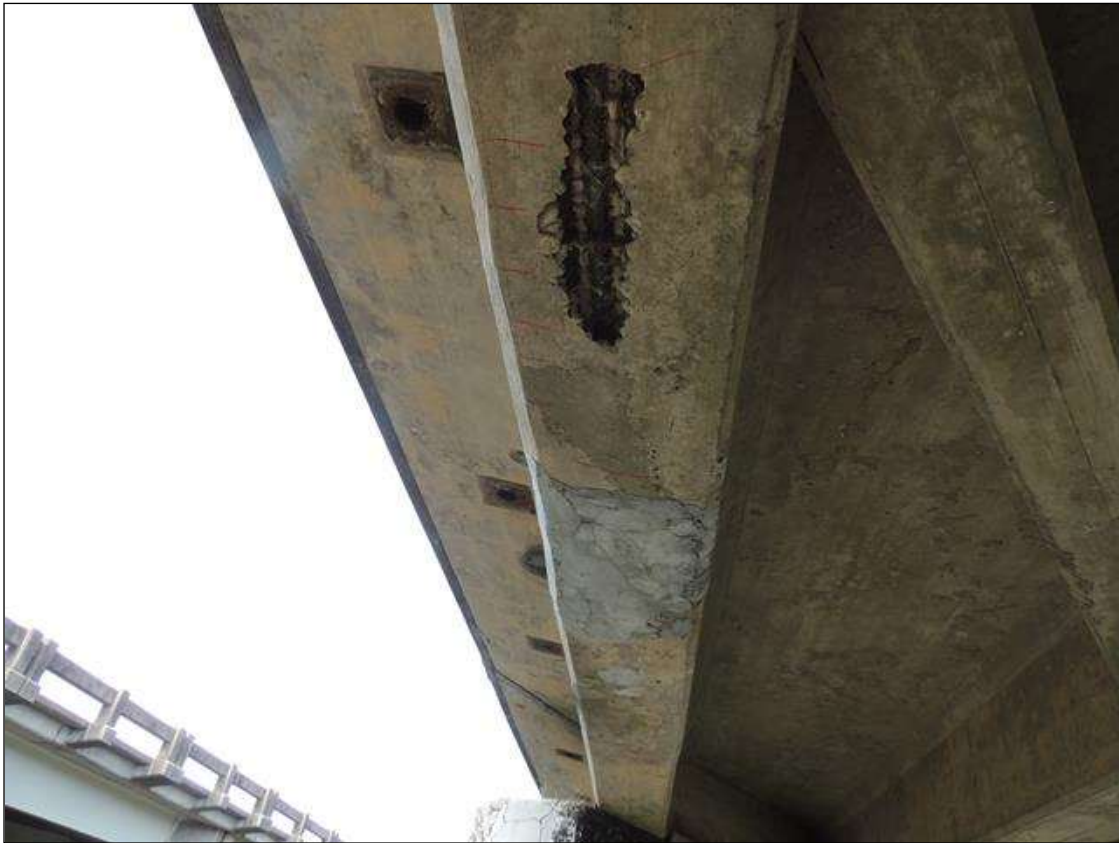
SP. 2 G1 FROM MIDSPAN NORTH 13'. LT., RT. FACES & BOTTOM SPALLED, CRACKED, DELAM. & PATCHED. SPALLED AREA 10" X 50" X 3 1/2" D.3 REBAR EXPOSED.

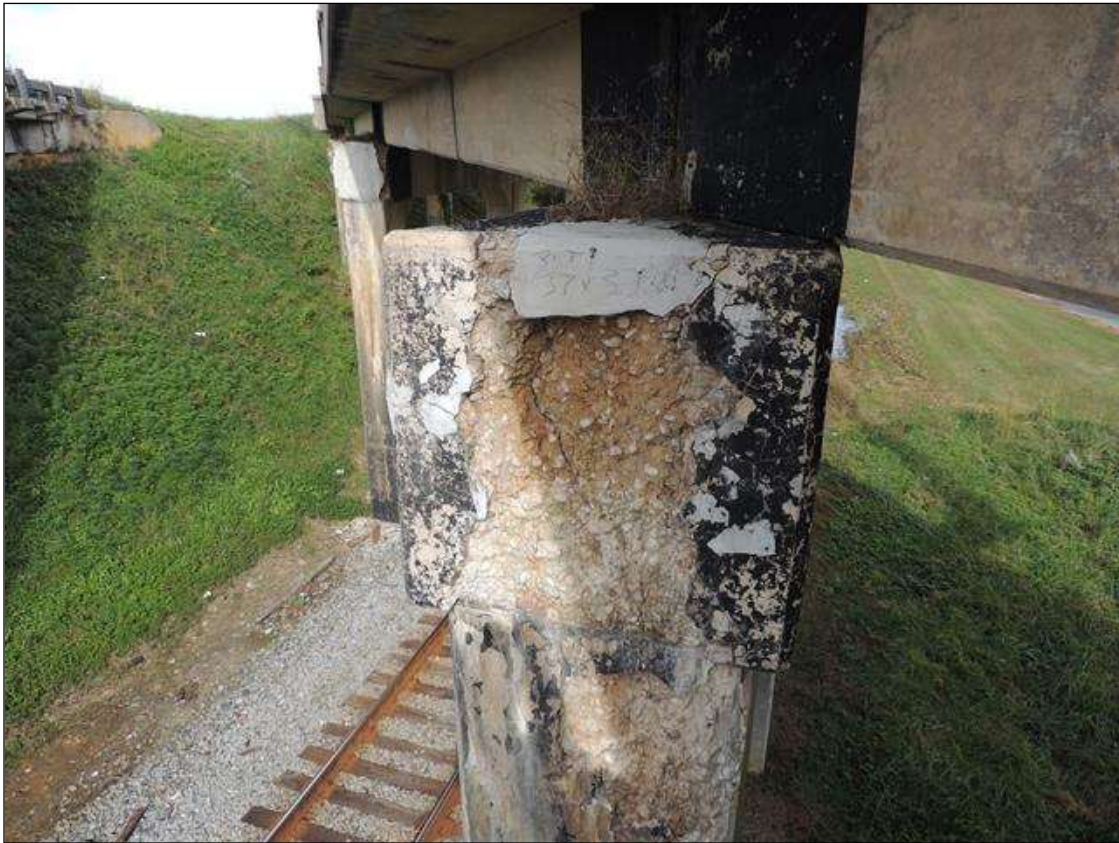
BT. 2 CAP LT. END, NORTH & SOUTH FACES HEAVLY CRACKED, DELAM, SPALLED & DETERIORATED. 3' N & S FACE 37" WIDE X 37" DOWN X 4" DEEP.

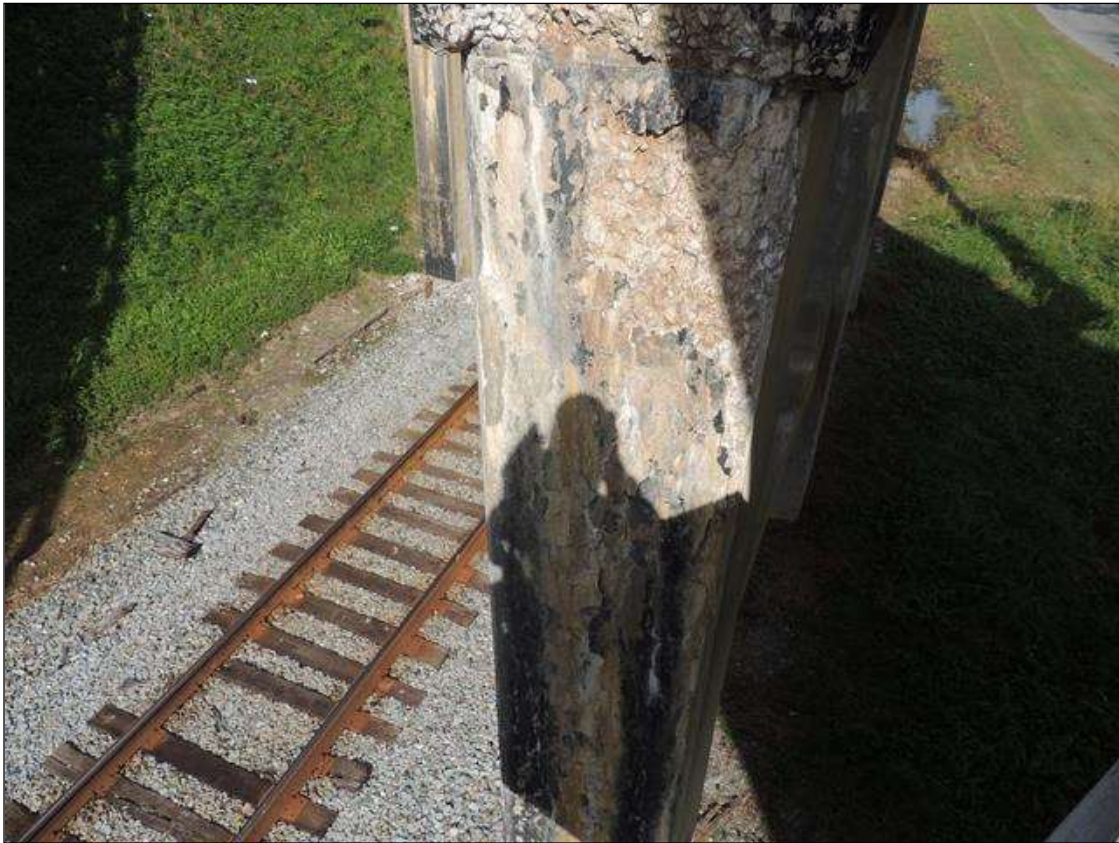
BT. 2 COL.1 W FACE CRACKED, DELAM, SPALLED & DETERIORATED WITH EFFLO. FROM BOTTOM OF CAP DOWN 20' X 30" W X 9" ON EACH FACE 3" DEEP.

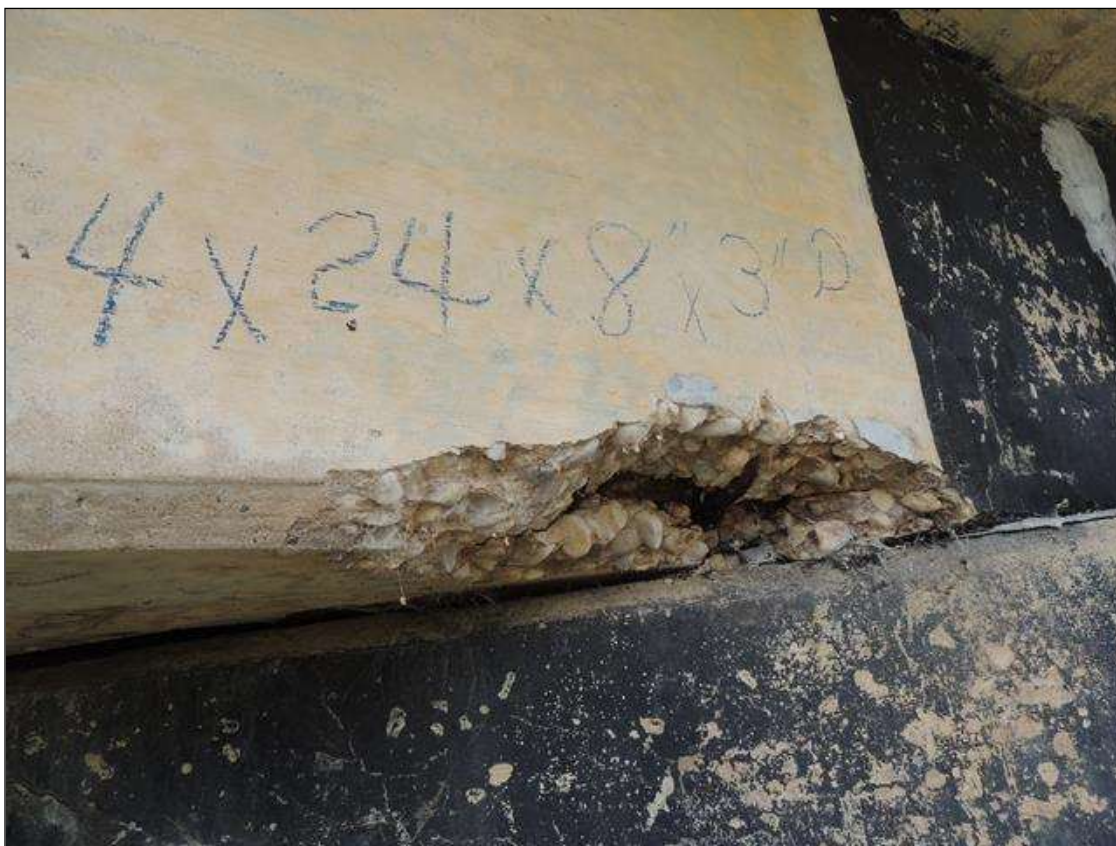
BT. 2 RT. BOTTOM SIDE G4. SPALLED, DELAM. WITH REBAR STIRRUPS EXPOSED 4" X 24" L X 8" UNDER BOTTOM 3" DEEP.

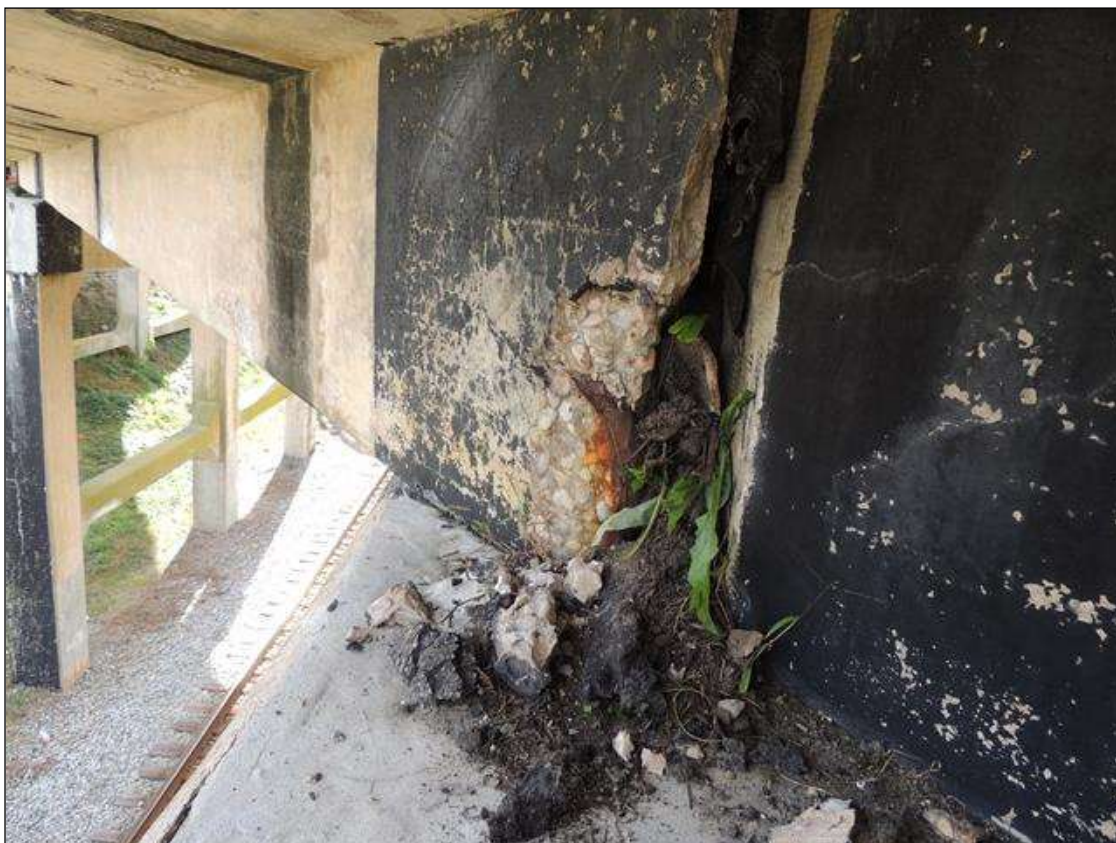
SP. 3 RT. SIDE G 4 DELAM. & SPALLED AREA OVER BT. 3 9" X 24" WITH LARGE REBAR EXPOSED.

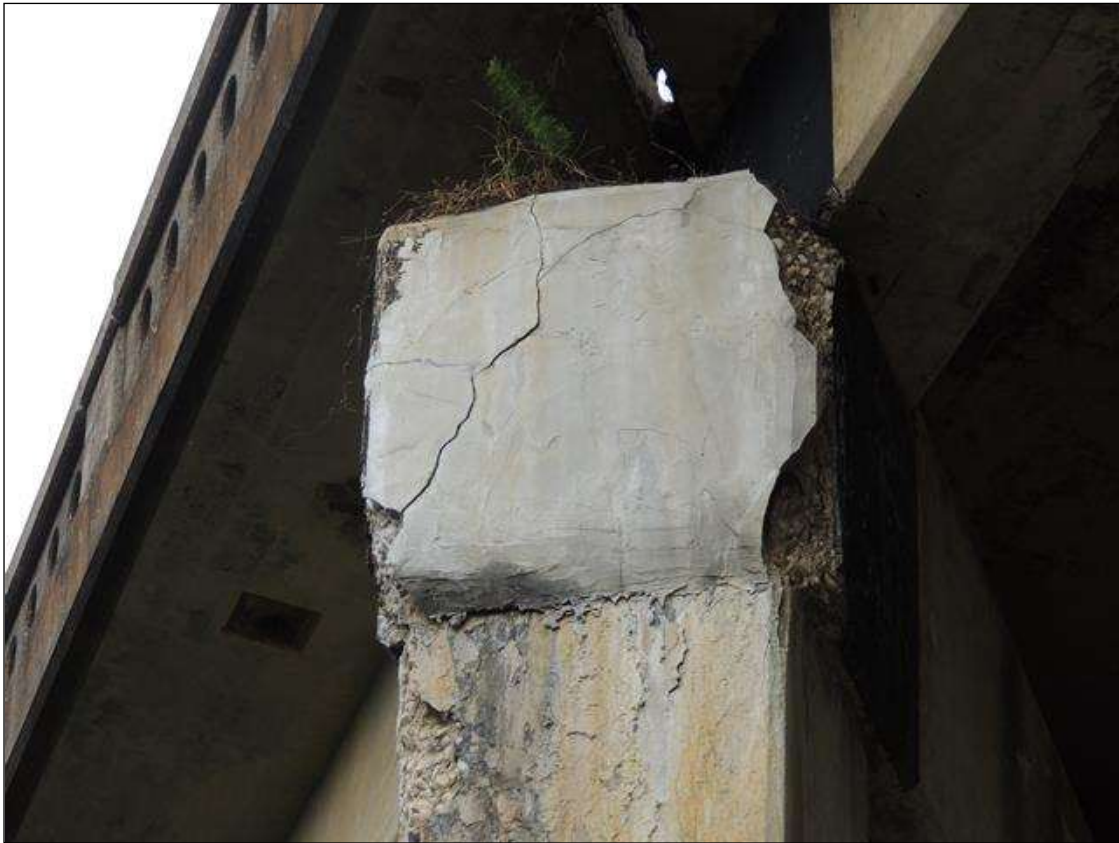
BT. 3 CAP LT. END CRACKED, SPALLED, DELAM.& DETERIORATED. 37" X 37" 3' ON N. & S. FACE 5" DEEP.

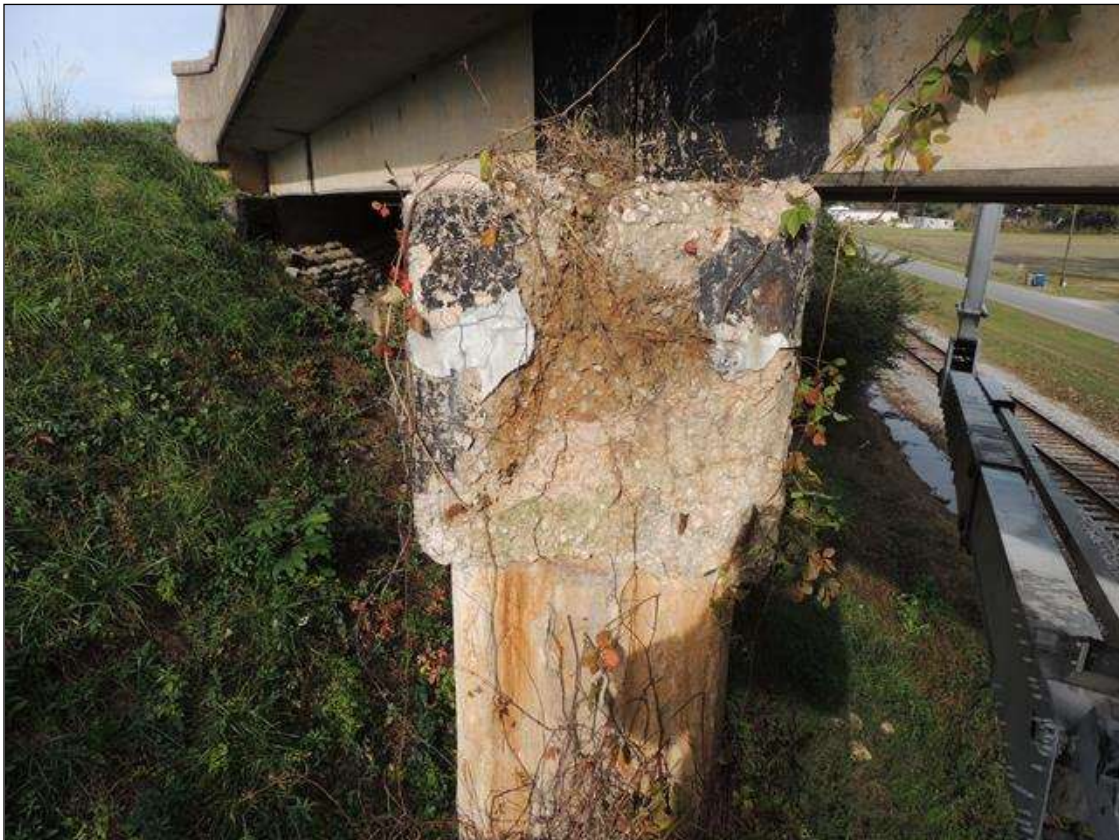
BT. 4 LT. END OF CAP CRACKED, SPALLED, DELAM. & DETERIORATED 3' ON N & S FACE AND 37" X 37" ON END 3" TO 4" DEEP.

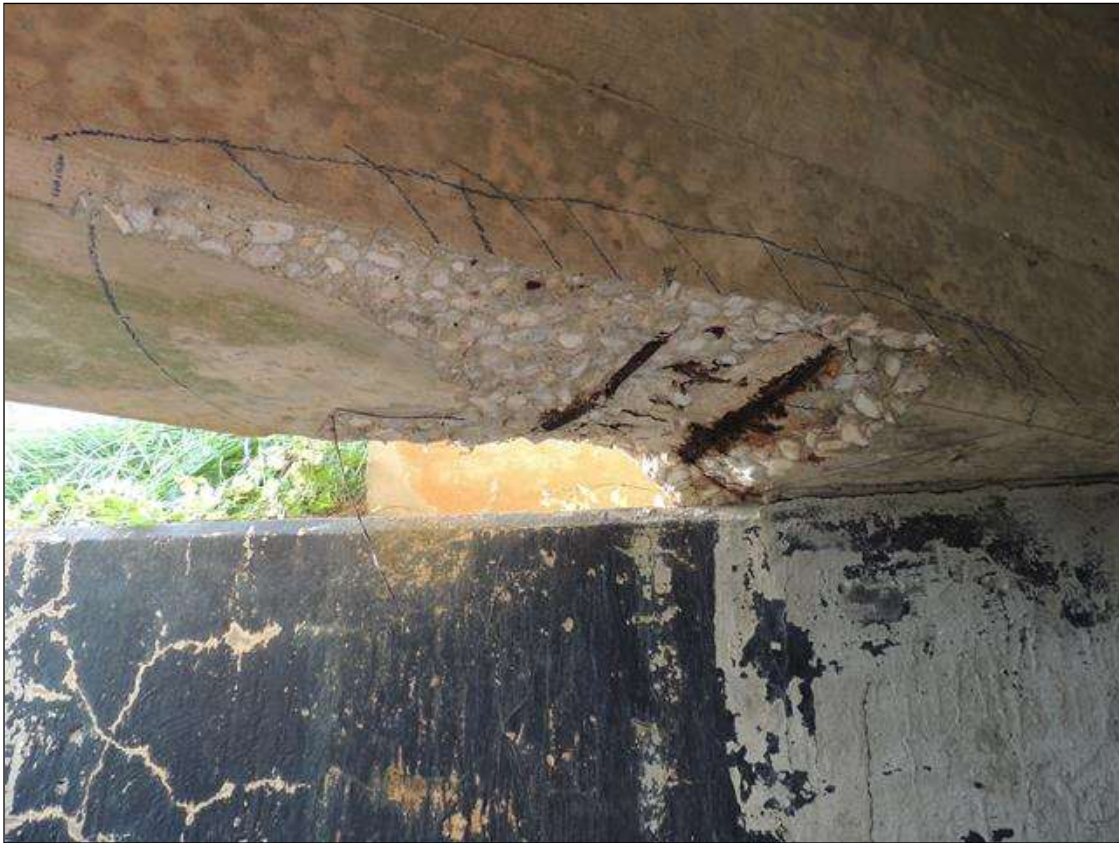
SPAN 5 G1 @ END BENT 2 SPALLED , DELAM. AND CRACKED 32" X 2 1/2" X 18"
