NC DEPARTMENT OF TRANSPORTATION
 DIVISION OF HIGHWAYS
 STRUCTURE MANAGEMENT UNIT

ATTENTION: **PROMPT ACTION REQUEST, SNOOPER, NEW WEARING SURFACE OVERLAY**

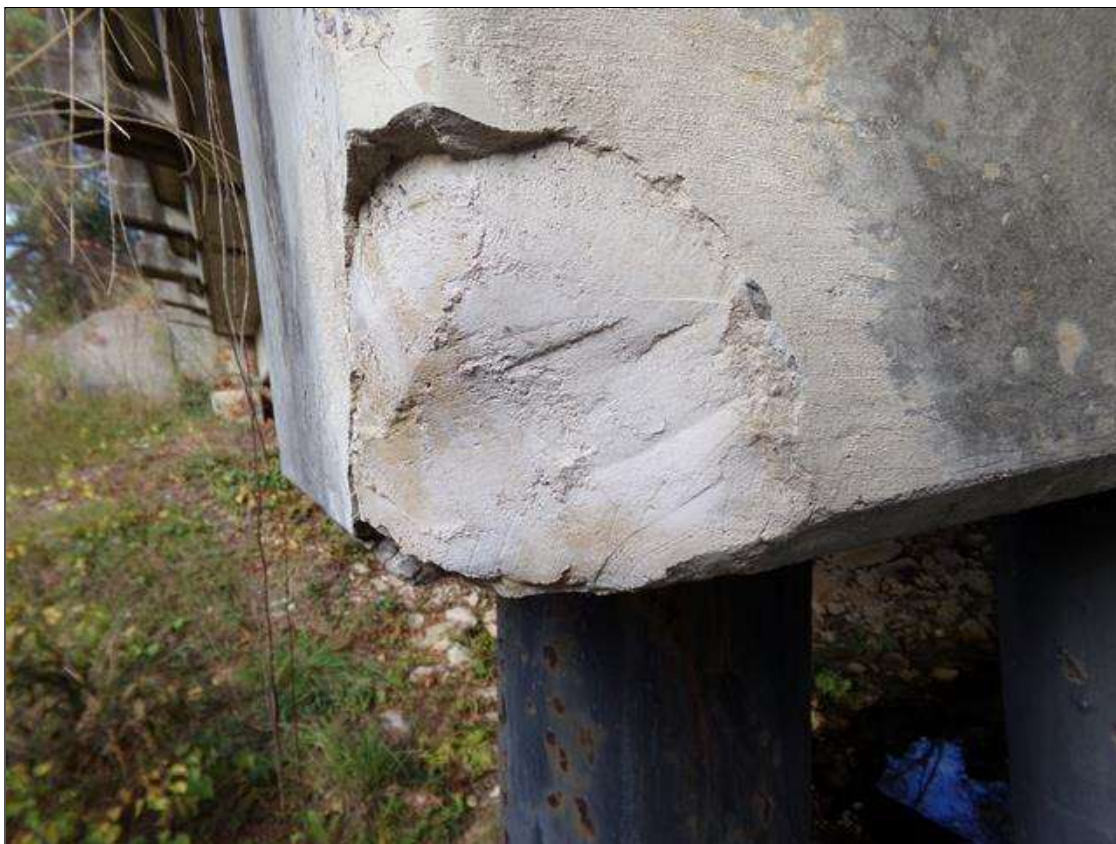
Bent 1 Cap 1: 8" X 7" X 5" DEEP SPALL IN THE SOUTHEAST CORNER AT BOTTOM OF CAP (PATCHED)

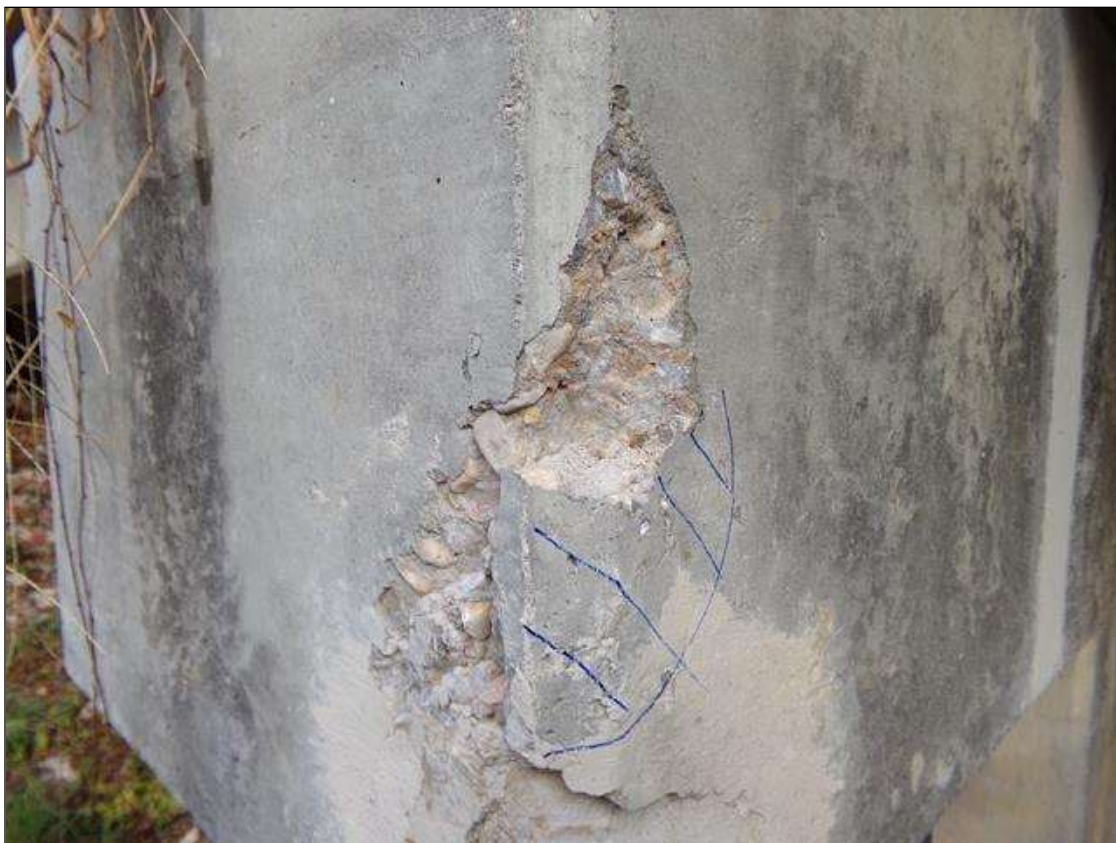
Bent 1 Cap 1: 10" X 10" X 1 1/2" DEEP SPALL AND AREA OF DELAMINATION AT SOUTHEAST CORNER

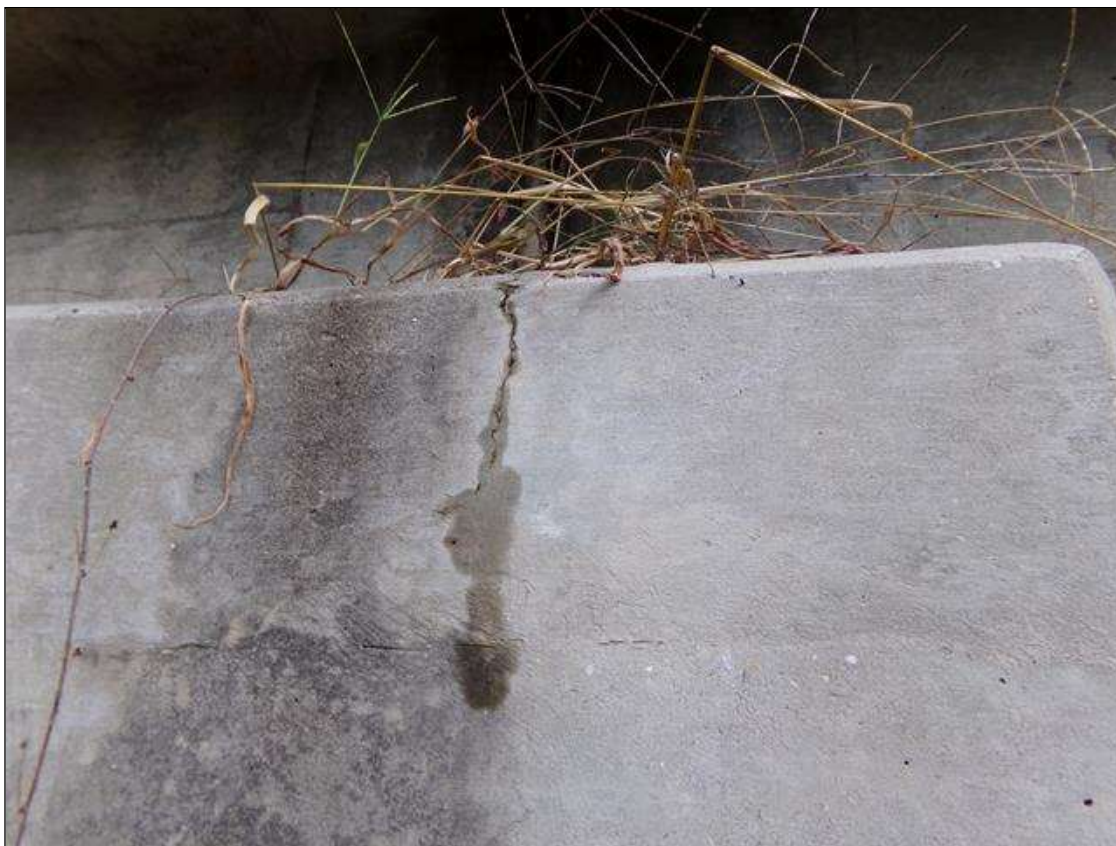
Bent 1 Cap 1: 9 INCHES X 1/32 INCHES VETICAL CRACK ON SOUTH FACE AT TOP OF CAP

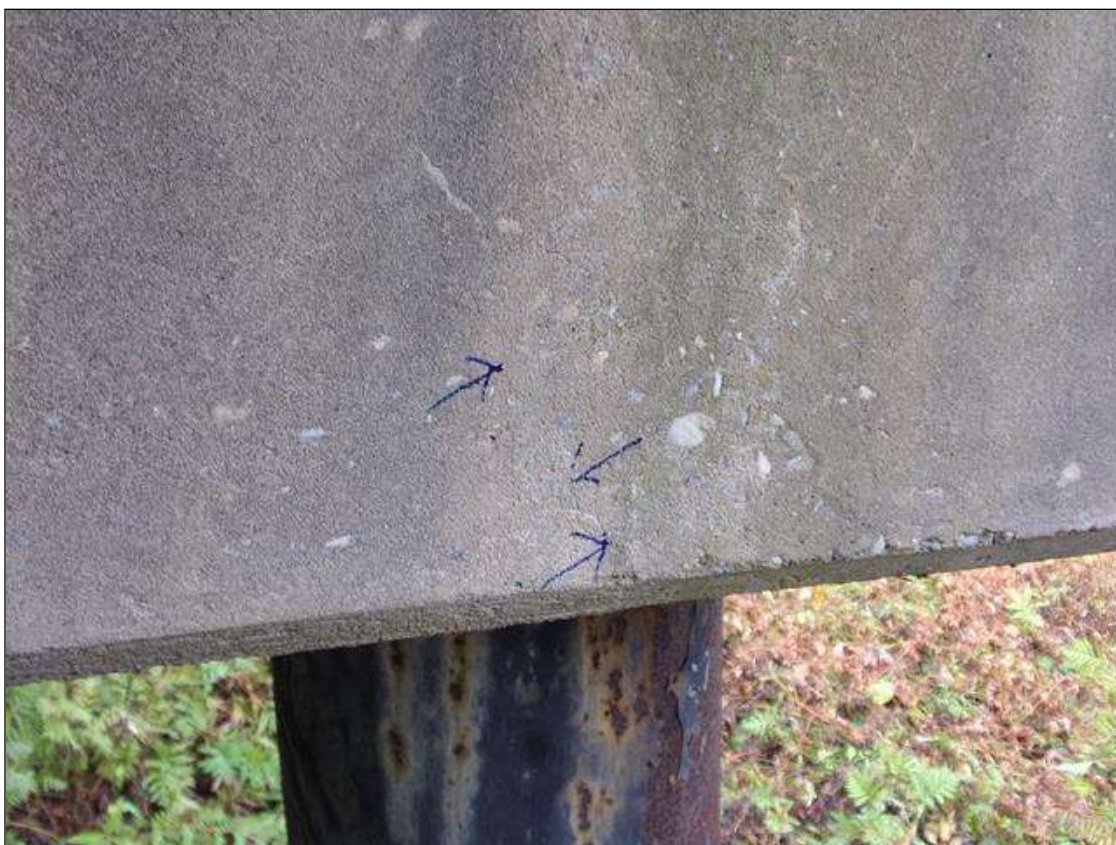
Bent 1 Cap 1: 6 INCHES X 1/64 INCHES DIAGONAL CRACK ON EAST FACE BENEATH BEAM 1.

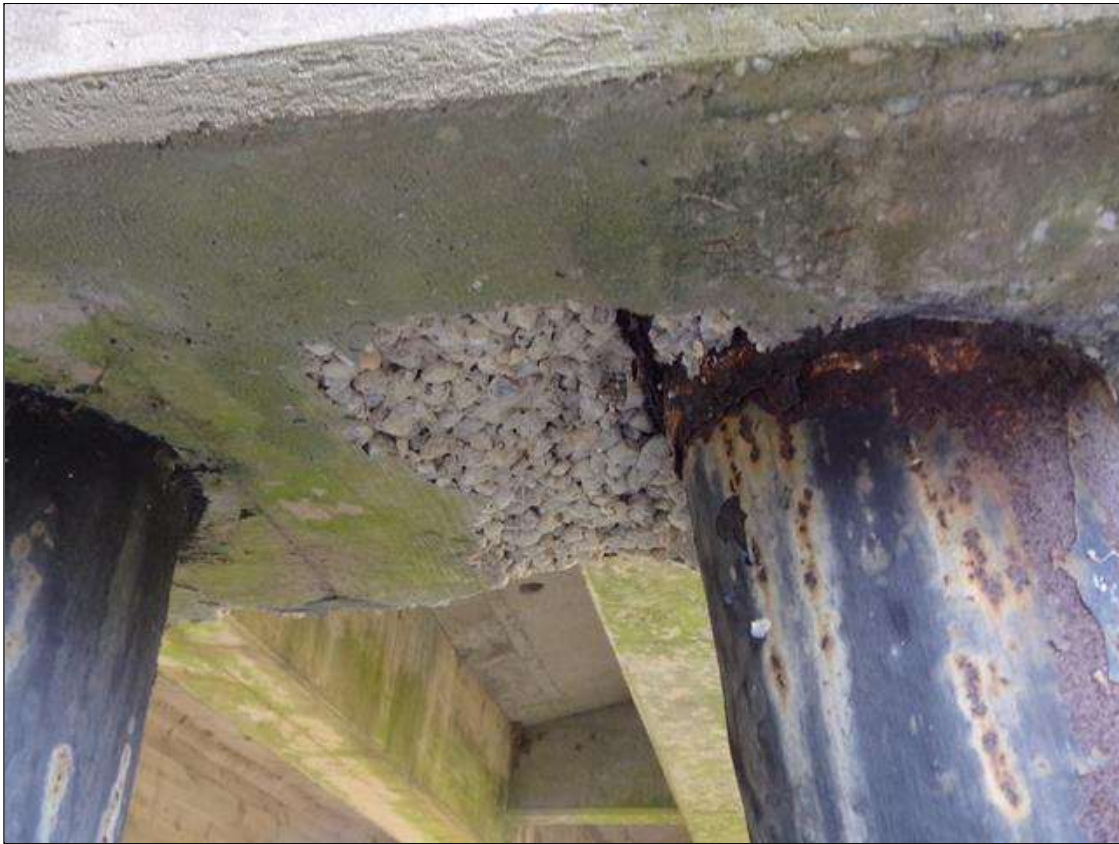
Bent 1 Cap 1: 14 INCHES X 26 INCHES X 2.5 INCHES DEEP SPALL ON BOTTOM FACE BETWEEN PILES 1 AND 2 (PAR)

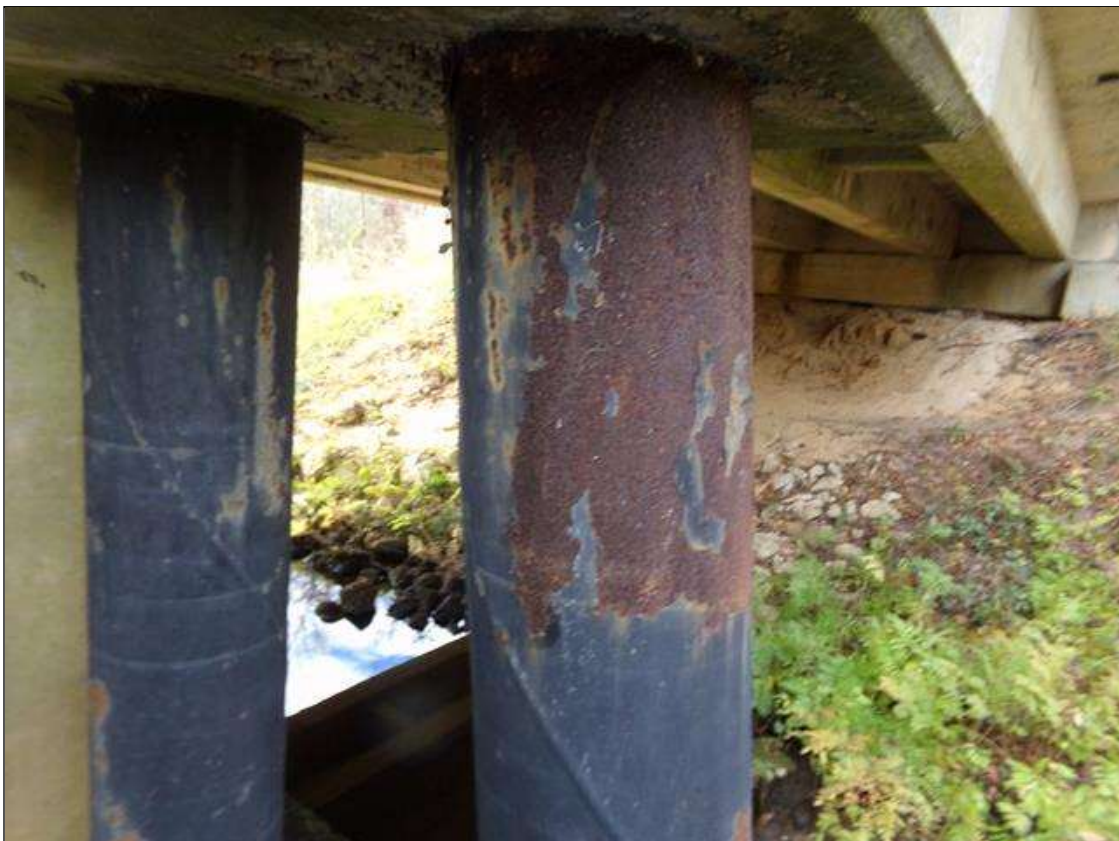
Bent 1 Pile 1: 7 FEET OF PEELING PAINT WITH RUST AND SURFACE RUST AT RANDOM THROUGHOUT

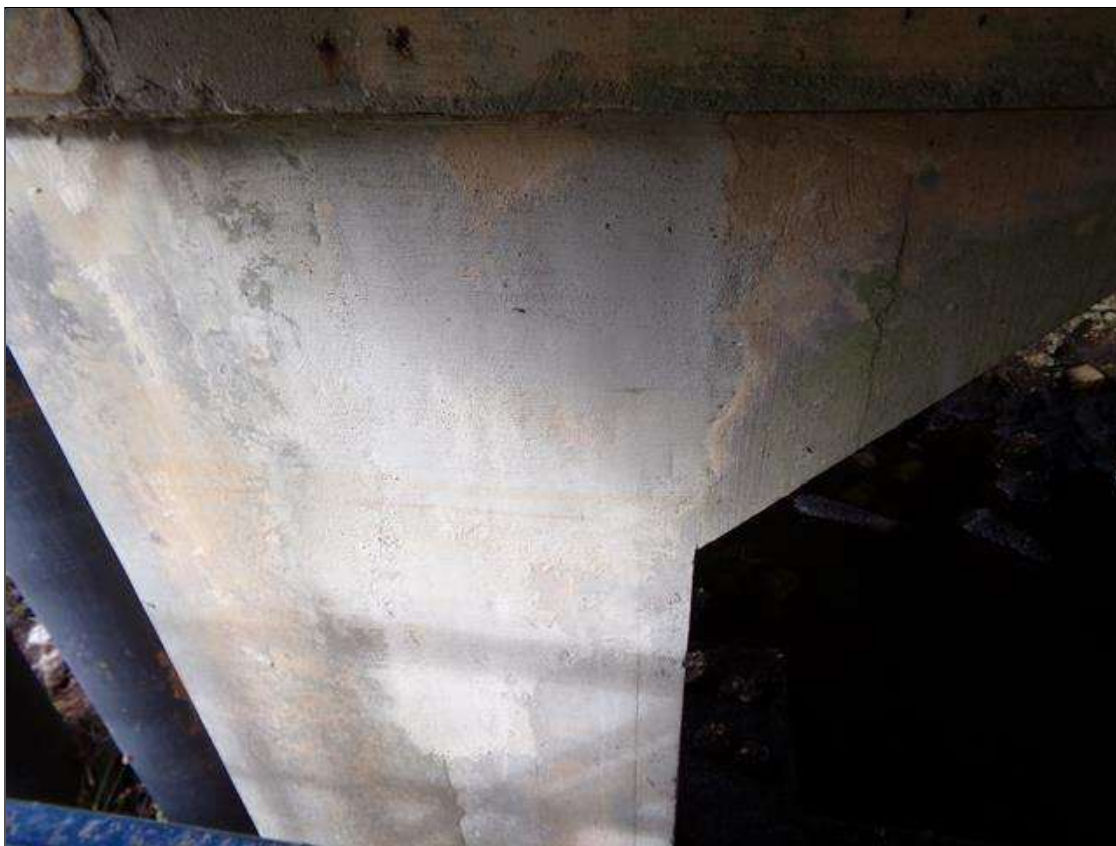
Bent 1 Pile 4: 18 INCHES X 46 INCHES SOUND PATCHED AREA ON EAST FACE AT TOP OF CAP.

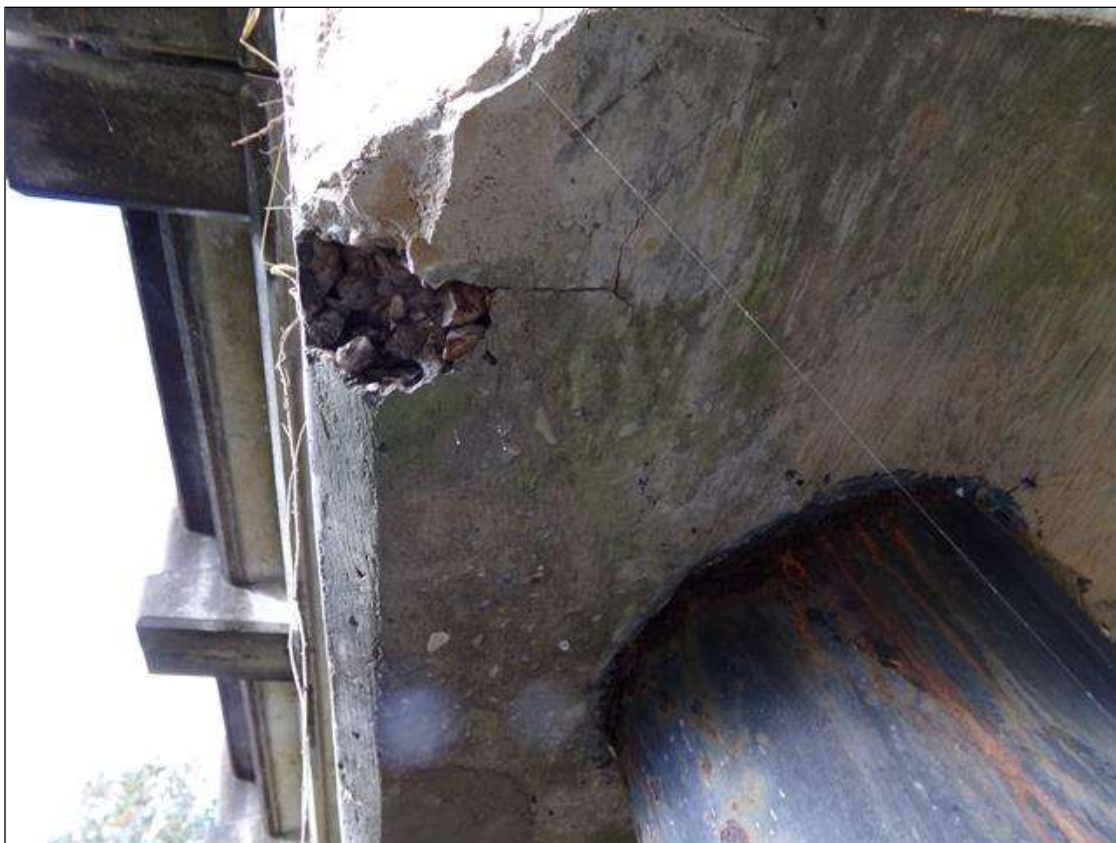
Bent 1 Cap 1: 4 INCH X 3 INCH X 1 INCH DEEP SPALL ON BOTTOM OF CAP AT SOUTH END

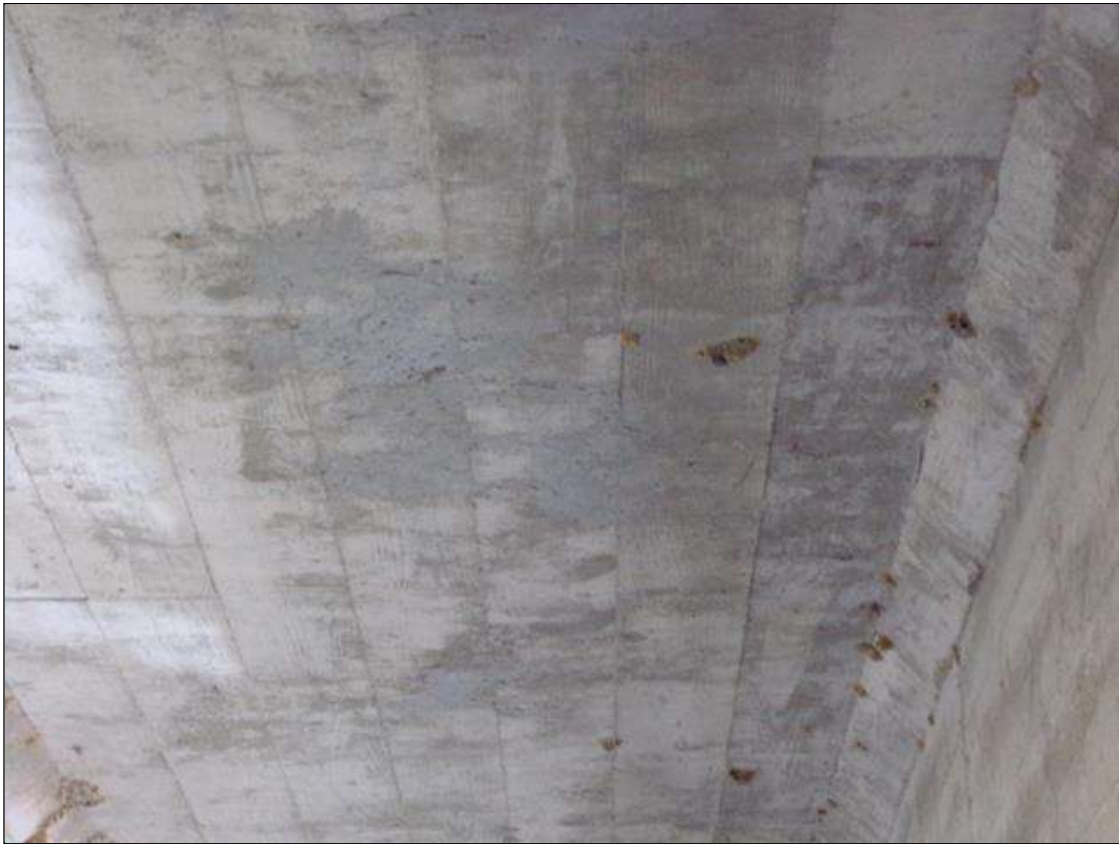
Span 2 Deck: 35 SQUARE FEET UP TO 2 FEET X 1 FEET PATCHED AREAS AT RANDOM THROUGHOUT DECK UNDERSIDE BETWEEN BEAMS 2 AND 4

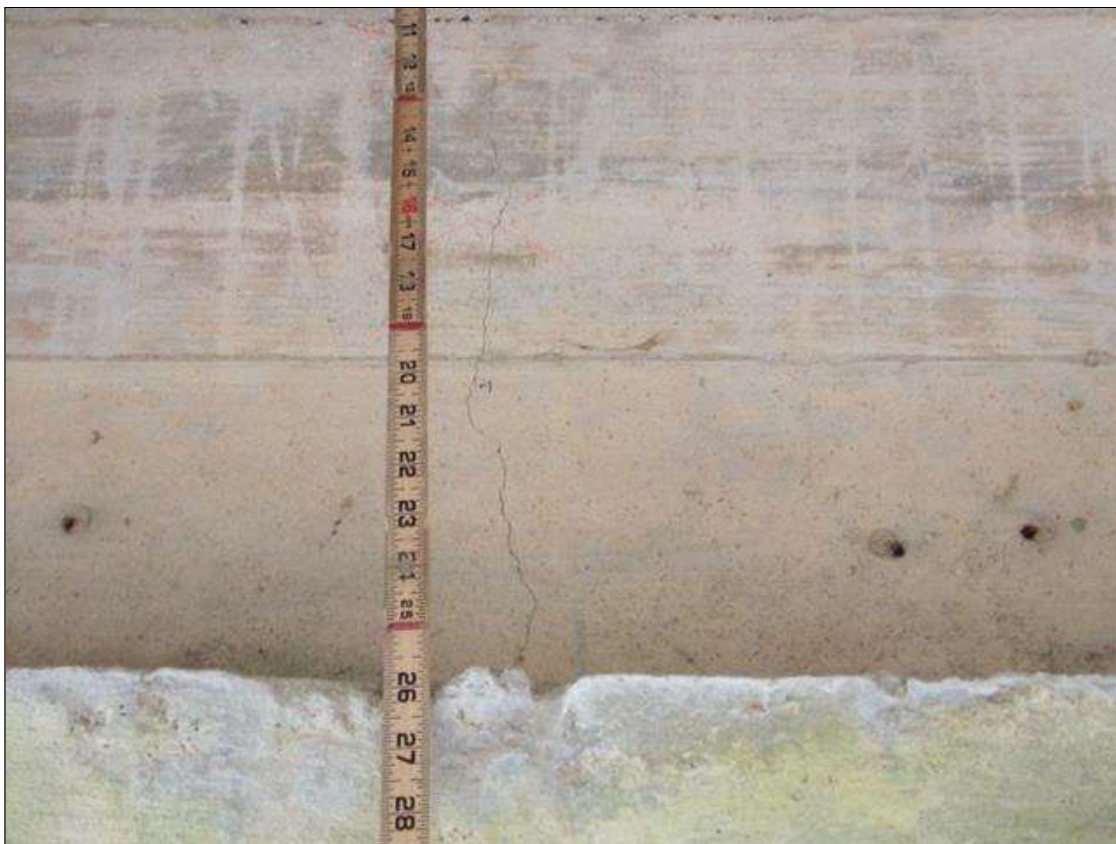
SPAN 2 Beam 2: 26 INCHES X 1/64 INCHES VERTICAL CRACK ON EAST FACE OF BENT 1 END DIAPHRAGM BETWEEN BEAMS 2 AND 3 BEGINNING AT TOP OF CAP.

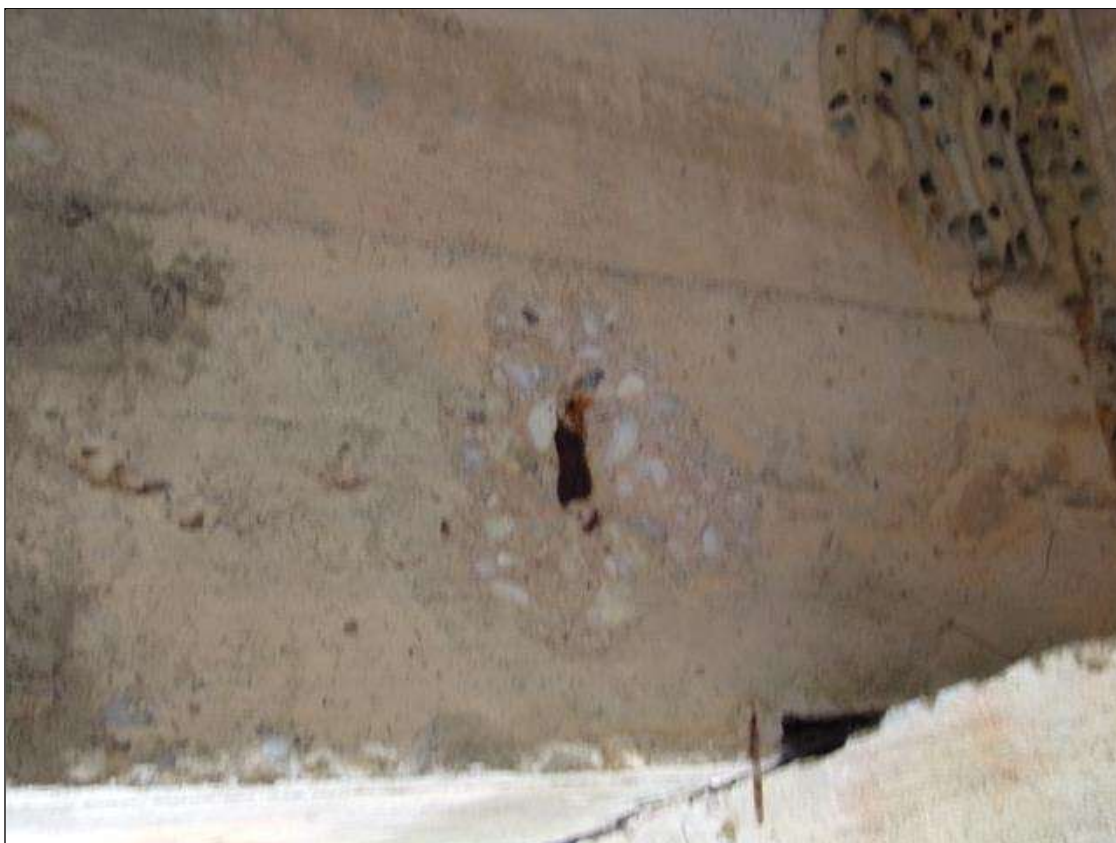
SPAN 2 Beam 4: 6 INCHES DIAMETER X 1/2 INCH DEEP SPALL WITH EXPOSED REINFORCING ON NORTH FACE AT BENT 1.

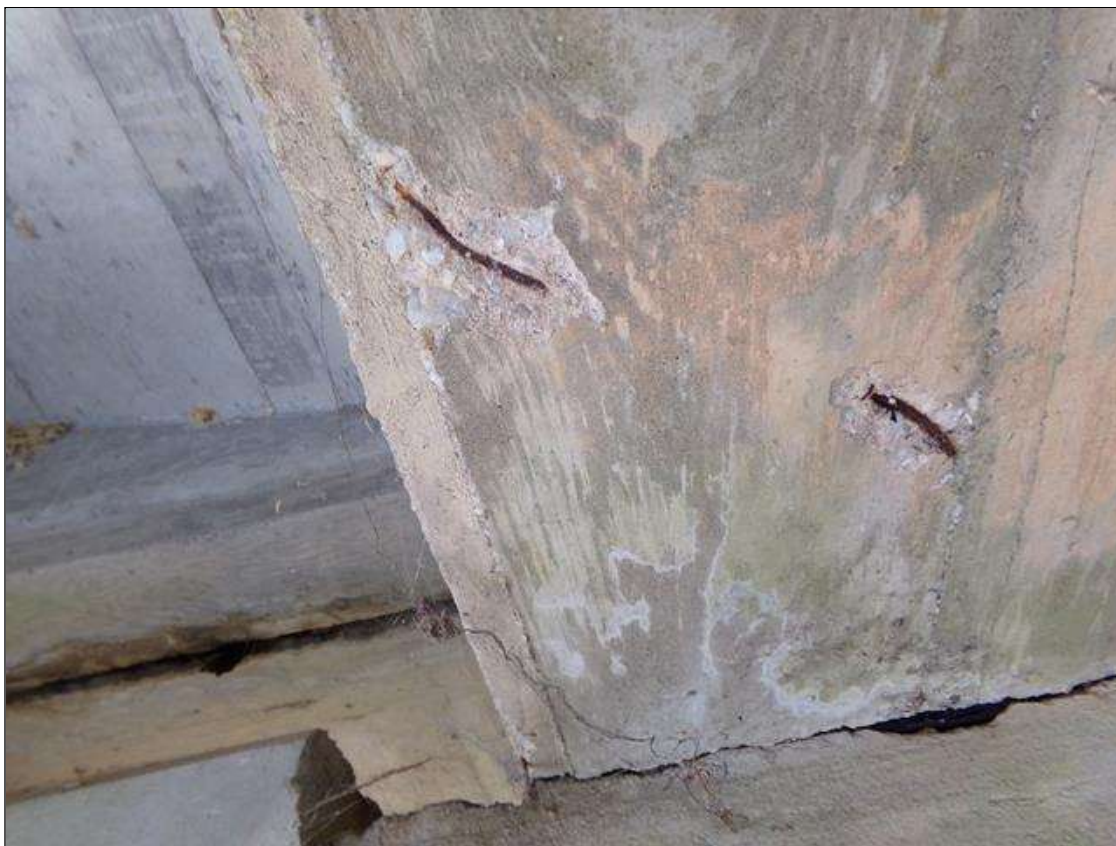
SPAN 2 Beam 4: (2) UP TO 3 INCHES X 2 1/2 INCHES X 1/2 INCH DEEP SPALL ON BOTTOM OF BEAM AT BENT 1

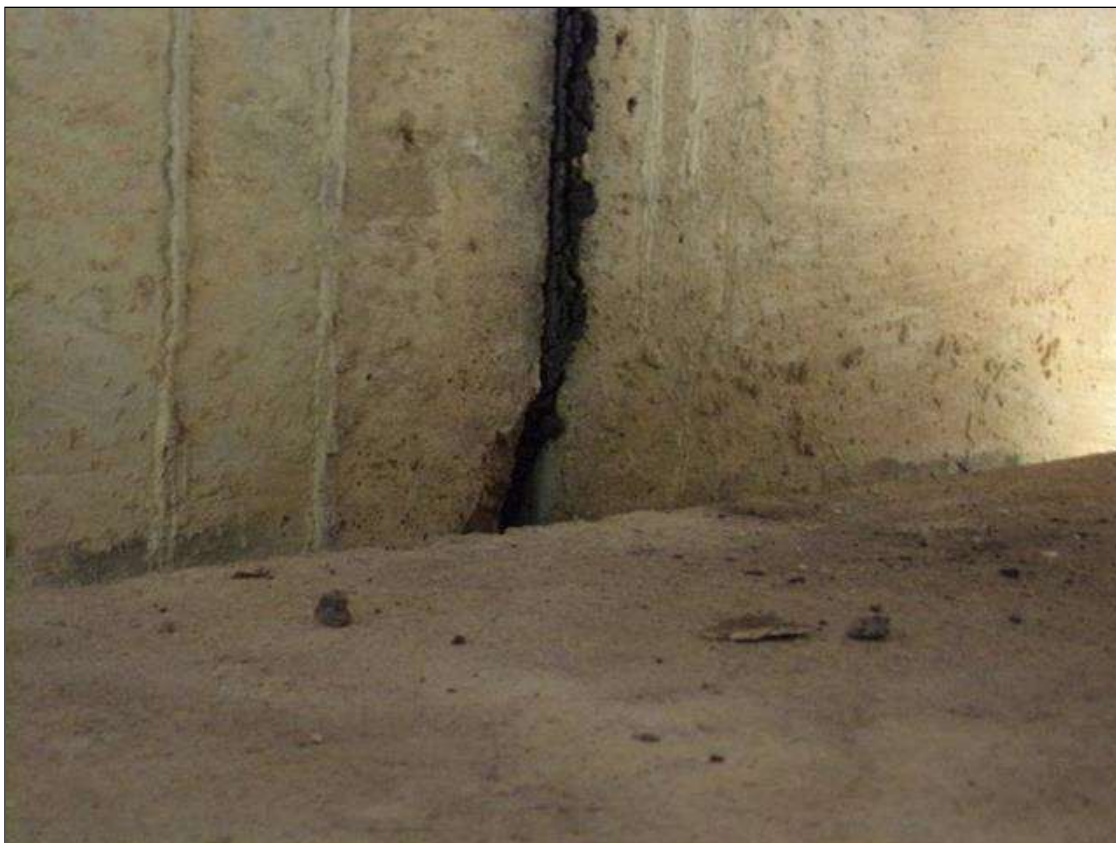
Span 2 Beam 1: 2 INCH X 4 INCH X 1 INCH DEEP SPALL ON LEFT SIDE OF BEAM AT BENT 1

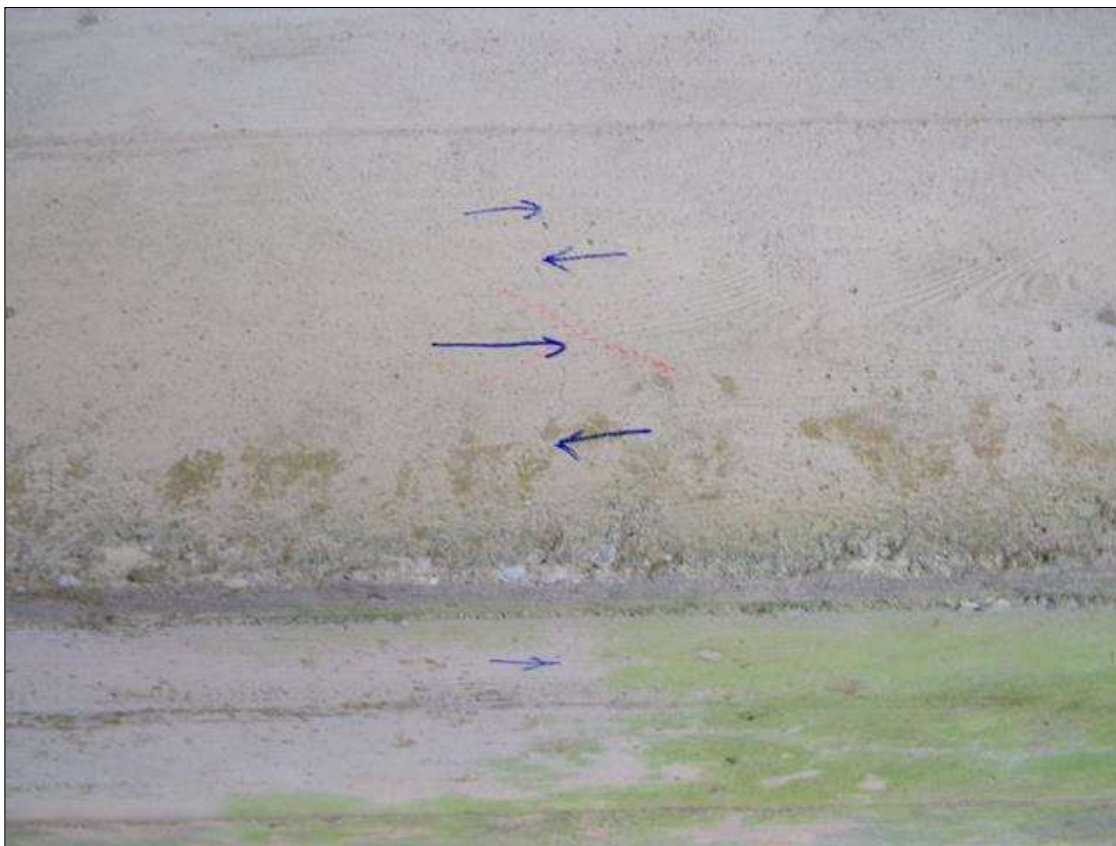
Span 2 Beam 2: (13) UP TO 1/64 INCHES WRAPAROUND CRACKS AT RANDOM THROUGHOUT.

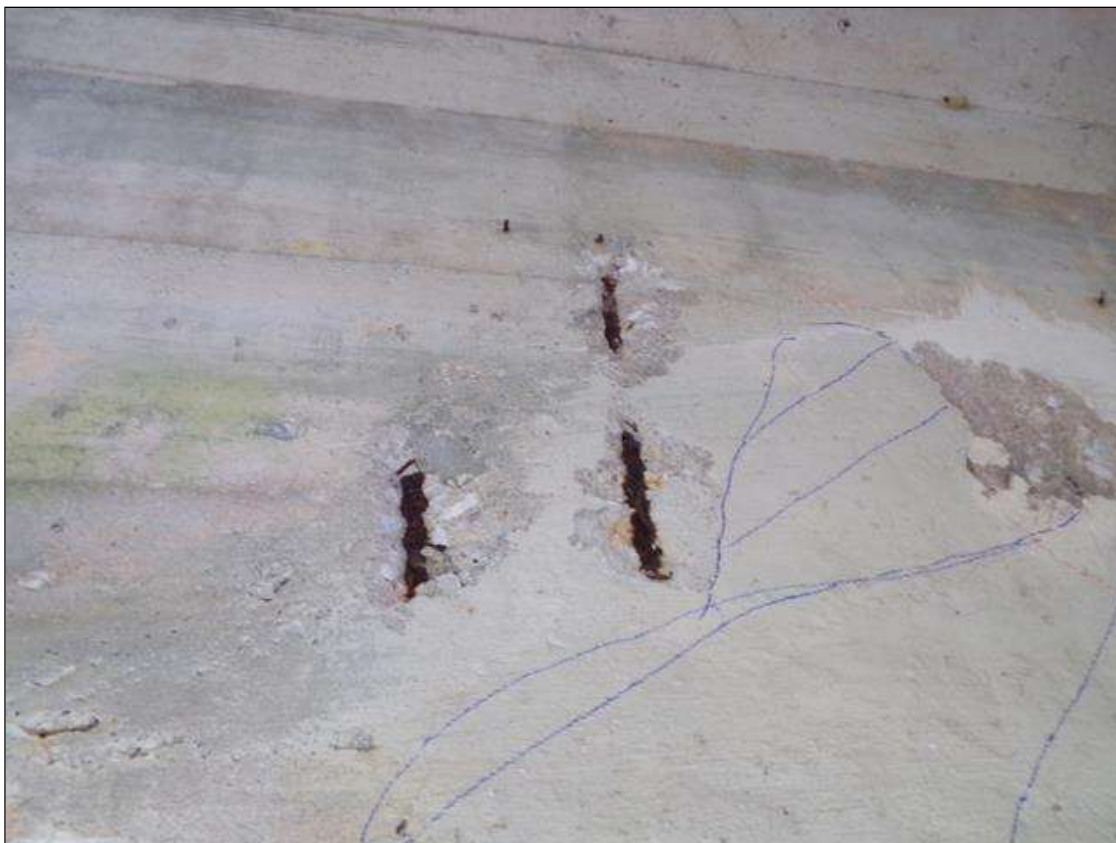
SPAN 2 Beam 2: (4) UP TO 4 INCH X 6 INCH X 1/2 INCH DEEP SPALLS WITH EXPOSED REINFORCING ON EAST FACE, 3 FEET FROM BENT 2.

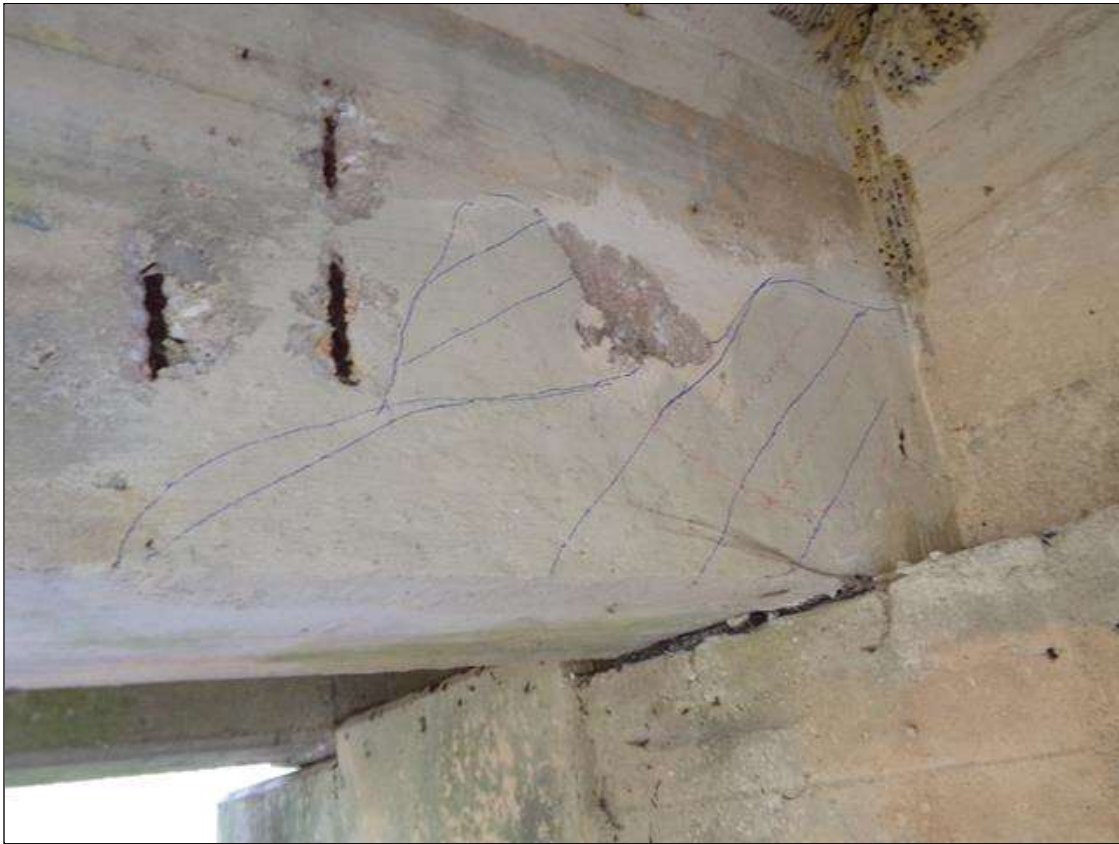
SPAN 2 Beam 2: 8 INCHES X 6 INCHES X 1 INCHES DEEP SPALL WITH ASSOCIATED 38 INCHES X 16 INCHES DELAMINATION ON SOUTH FACE AT BENT 2.

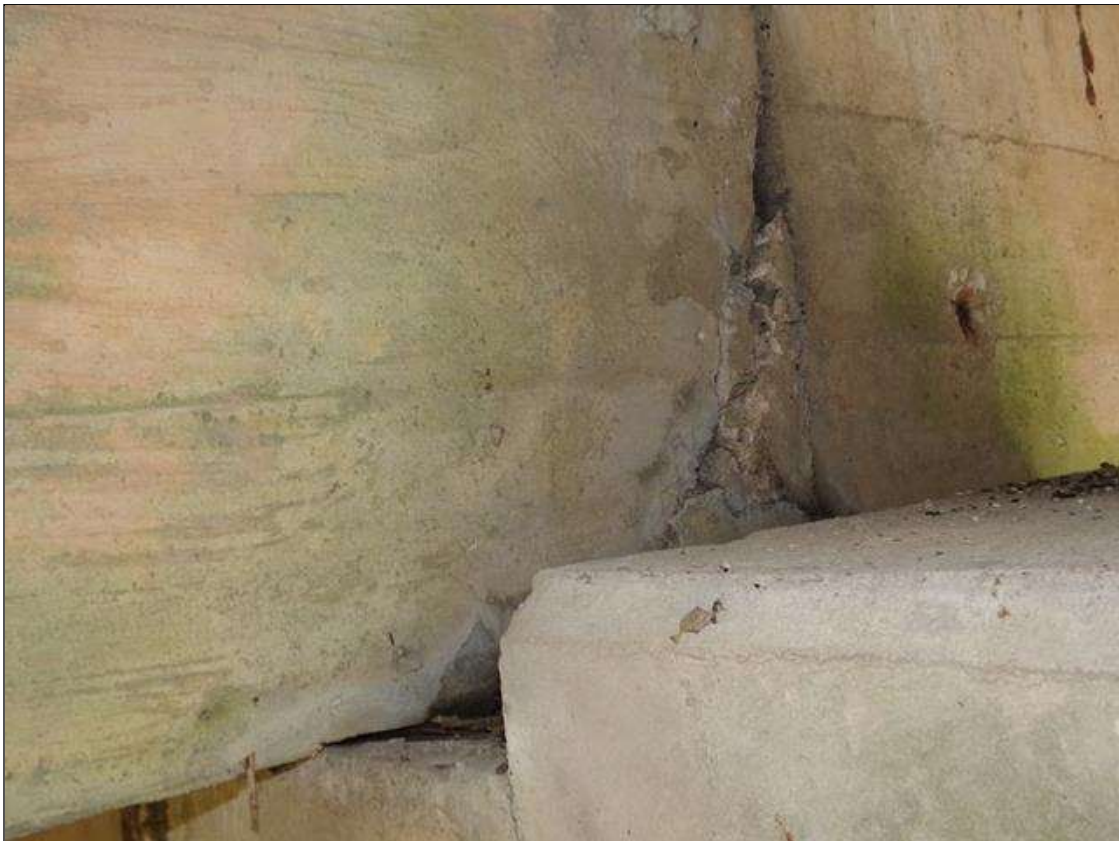
SPAN 2 Beam 4: 9 INCHES X 4 INCHES X 1/2 DEEP INCHES SPALL WITH ASSOCIATED 18 INCHES X 9 INCHES DELAMINATION ON SOUTH FACE AT BENT 2.

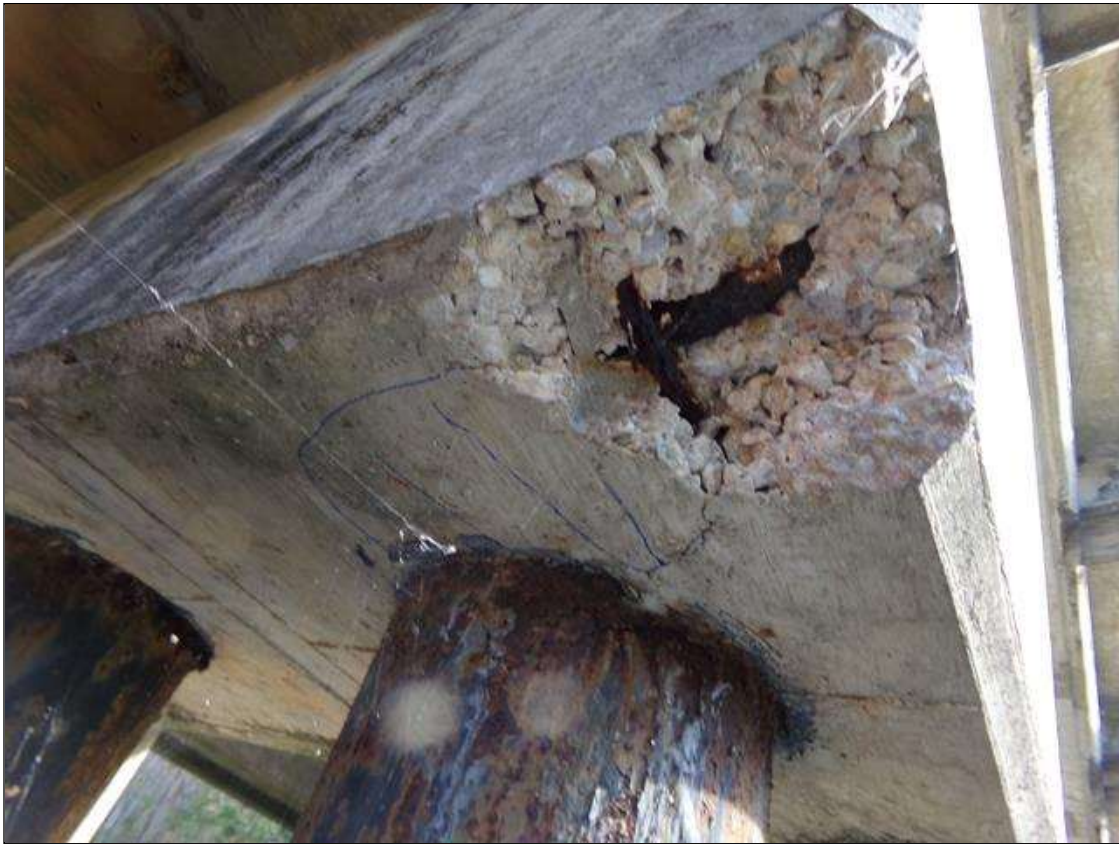
Bent 2 Cap 1: 19 INCH X 12 INCH X 4 INCH DEEP SPALL WITH EXPOSED REINFORCING AND AREA OF DELAMINATION ON SOUTHWEST BOTTOM CORNER (PAR)

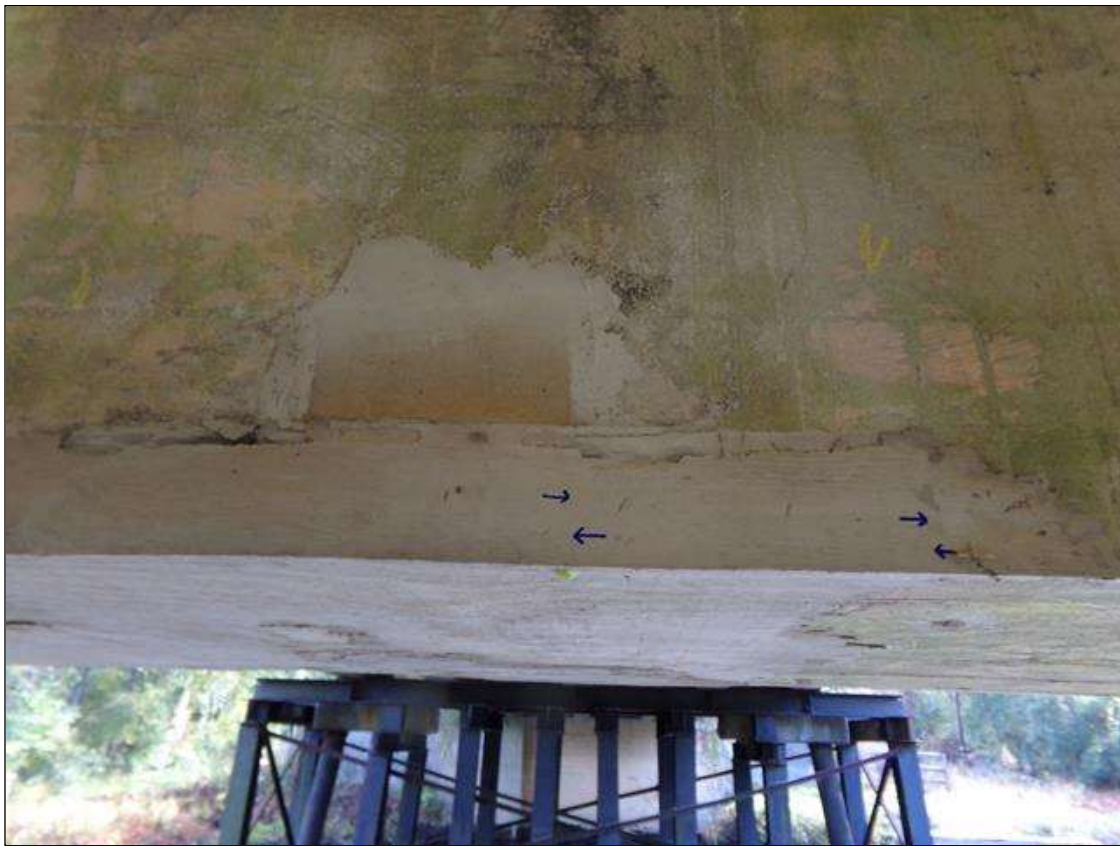
Bent 2 Cap 1: 21 INCHES X 4 INCHES X 3 INCHES DEEP SPALL WITH ASSOCIATED 32 INCHES X 1/32 INCHES VERTICAL CRACK ON WEST FACE BENEATH BEAM 3 AND ASSOCIATED 22 INCHES X 9 INCHES DELAMINATION ON BOTTOM FACE (PATCHED WITH HAIRLINE VERTICAL CRACKS)

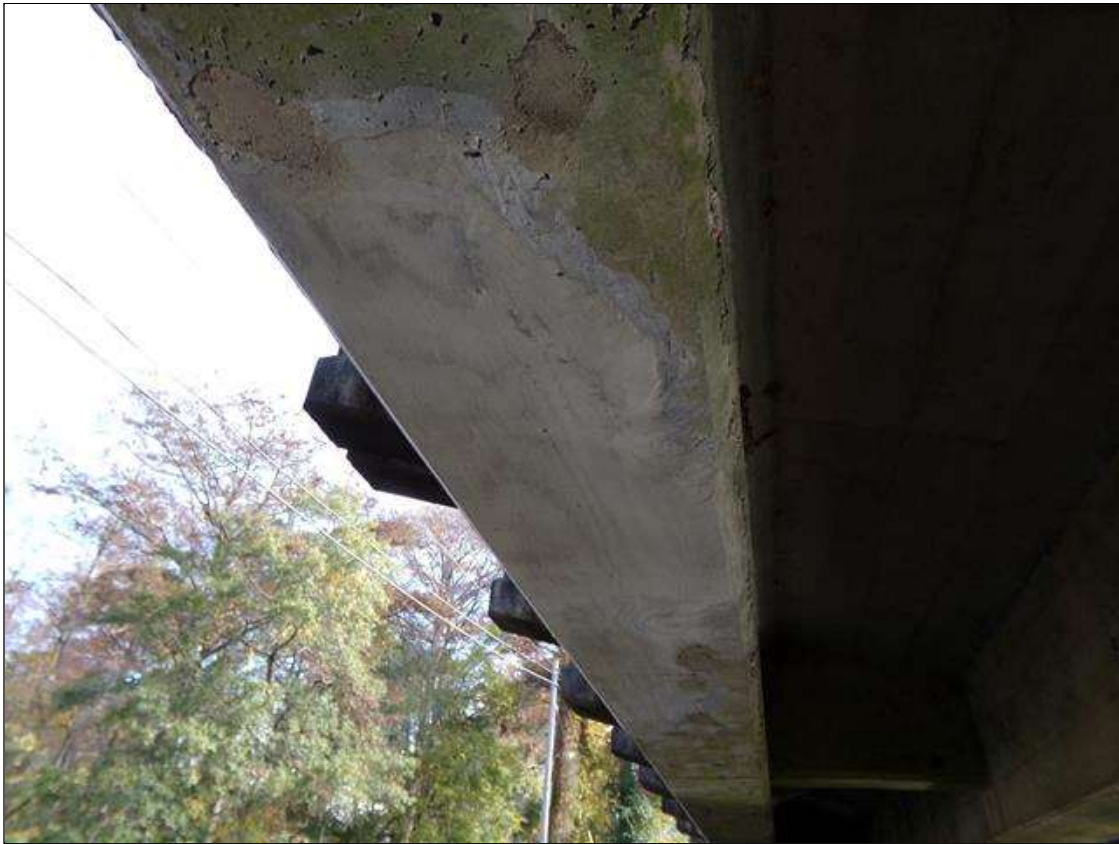
SPAN 3 Beam 1: 70 INCHES X 3 INCHES X UP TO 4 INCHES SPALL WITH EXPOSED REINFORCING ON THE SOUTH BOTTOM CORNER, 8 FEET FROM BENT 2.(PATCHED)

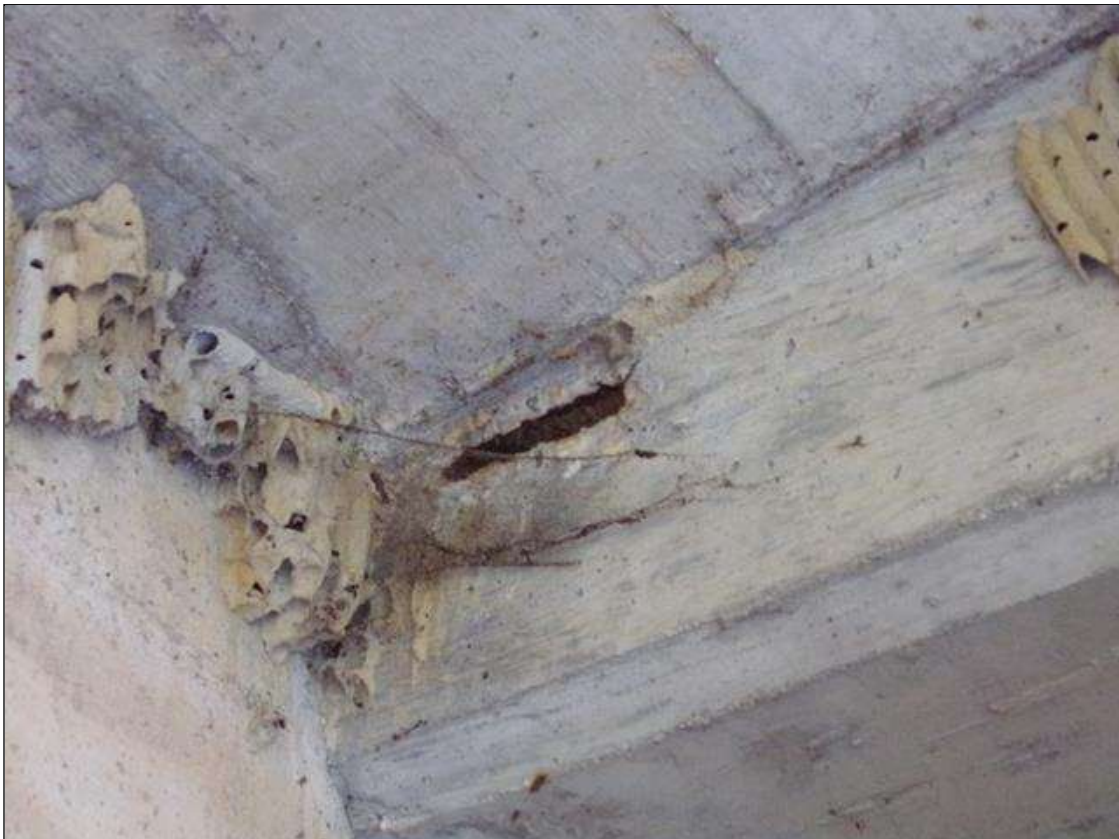
SPAN 3 Beam 1: 5 INCHES X 2 INCHES X 1/4 INCHES DEEP SPALL WITH EXPOSED REINFORCING ON WEST FACE OF BENT 2 END DIAPHRAGM BETWEEN BEAMS 1 AND 2.

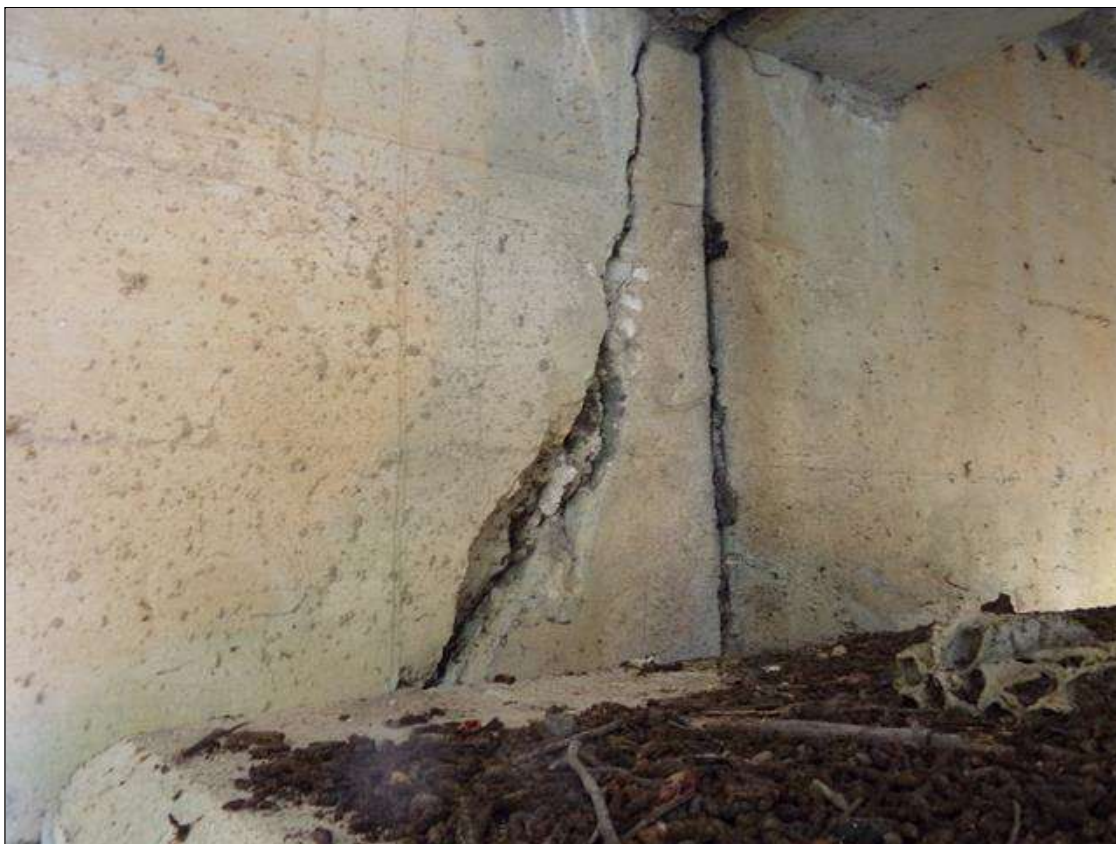
SPAN 3 Beam 2: 9 INCHES X 20 INCHES X 2 INCHES DEEP SPALL ON NORTH FACE AT BENT 2

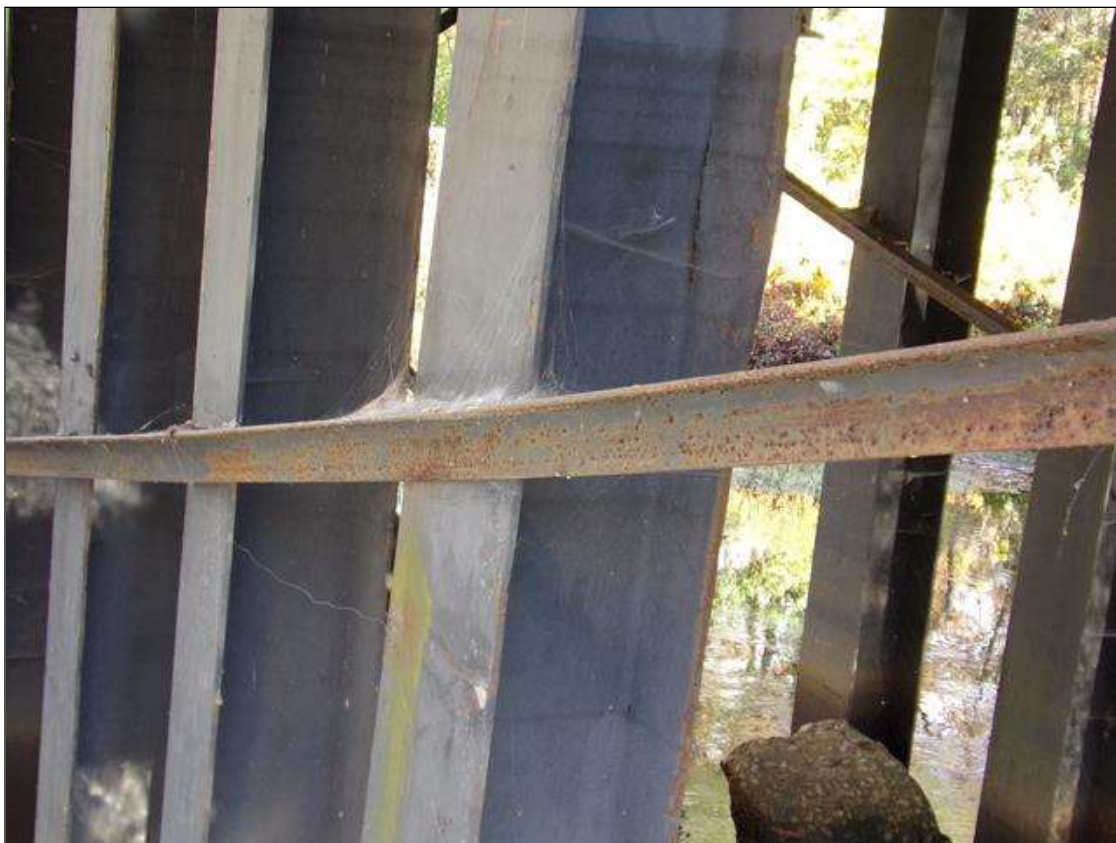
Bent 3 Row 1 Pile 1: 35 FEET OF SURFACE RUST ON WEST CROSS BRACING.

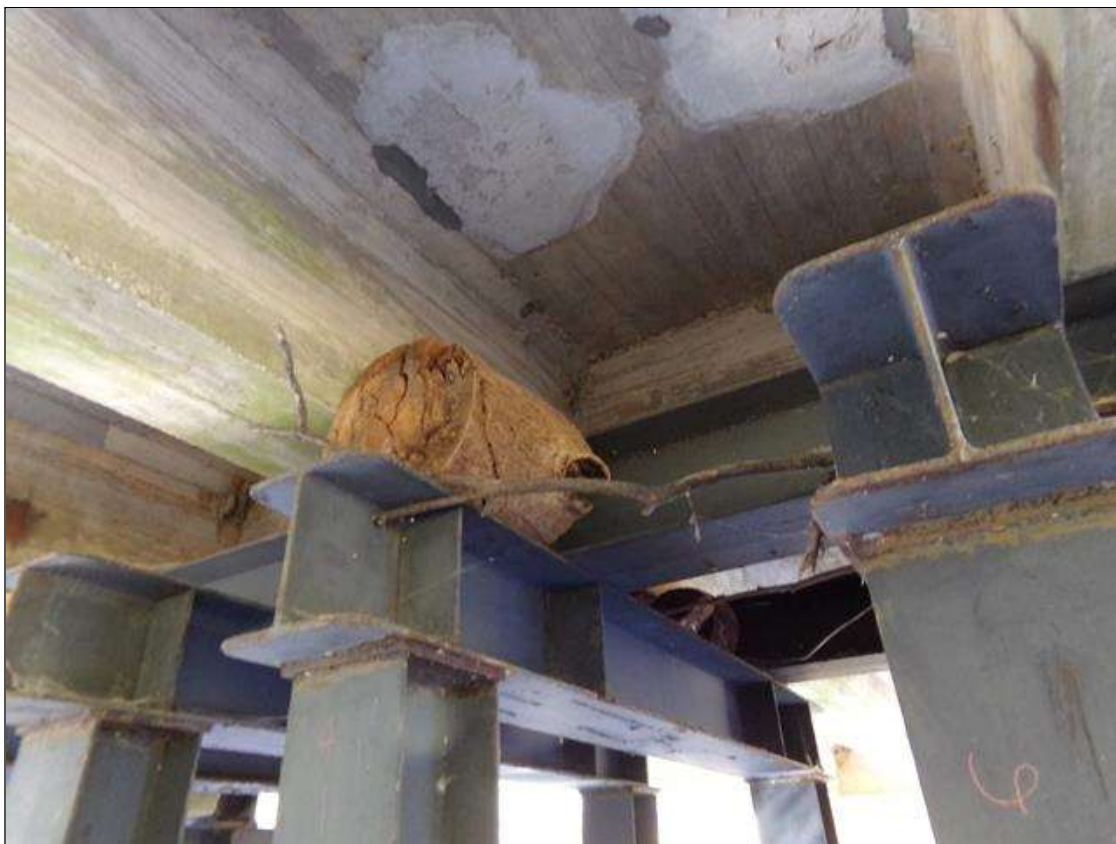
3 FEET X 4 FEET X 18 INCHES HIGH DRIFT AND DEBRIS ON SPAN 4 FACE OF CRUTCH BENT ON TOP OF PILE 4 (SPAN 3 FACE SIMILAR)
