NC DEPARTMENT OF TRANSPORTATION
 DIVISION OF HIGHWAYS
 STRUCTURE MANAGEMENT UNIT

ATTENTION: **PROMPT ACTION REQUEST, SNOOPER, NEW WEARING SURFACE OVERLAY**

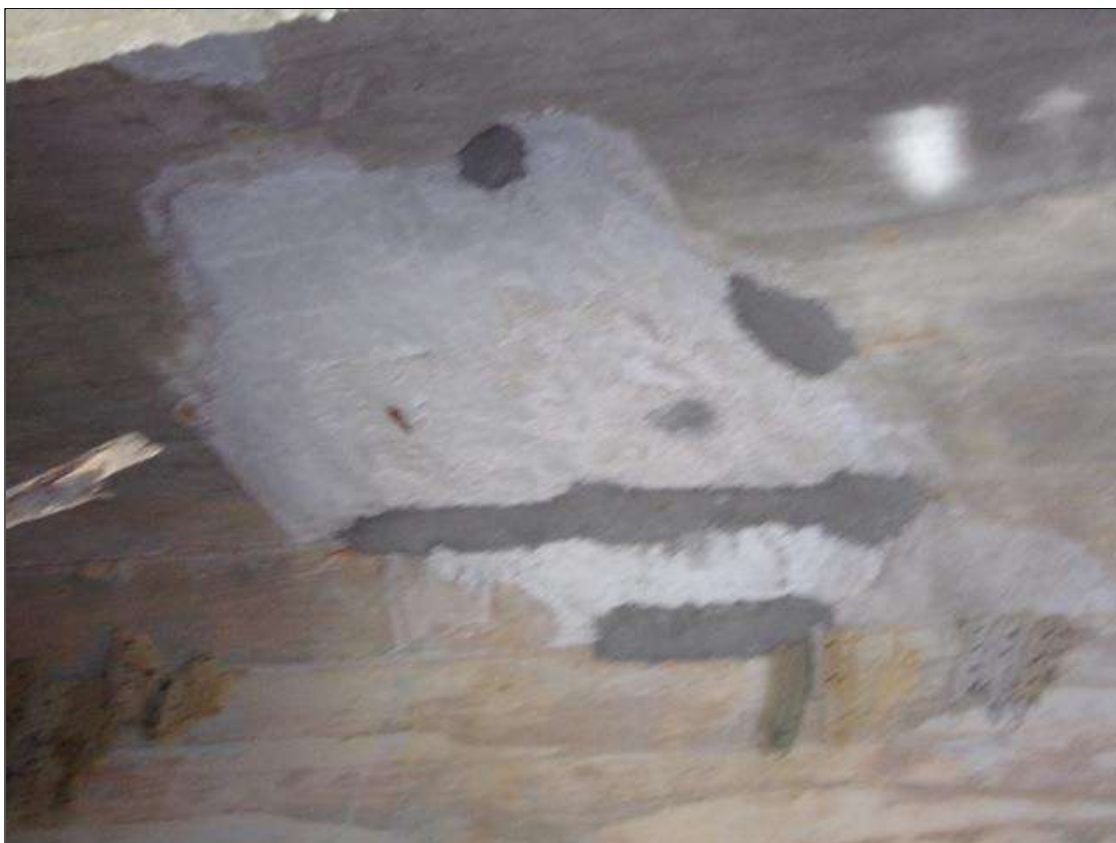
SPAN 4 Deck: 36 INCH X 24 INCH AREA OF PATCH WITH 2 INCH X 1 INCH X 1/2 INCH DEEP SPALL WITH EXPOSED REBAR ON BOTTOM OF DECK IN BAY 2 AT BENT 3

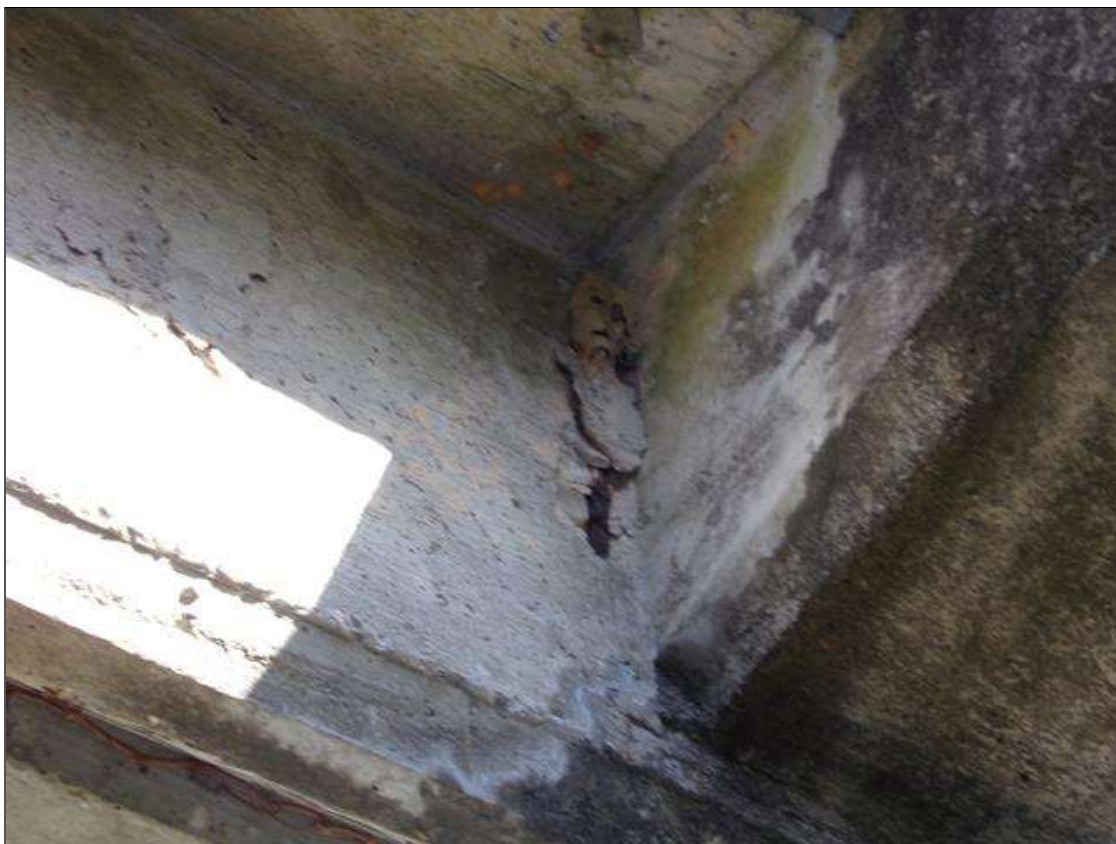
Span 4 Deck: 4 INCHES X 8 INCHES X 3/4 DEEP INCHES SPALL WITH EXPOSED REINFORCING AND AREA OF DELAMINATION ON SOUTH FACE AT WEST FACE OF 3RD RAIL POST BLOCKOUT FROM END BENT 2.

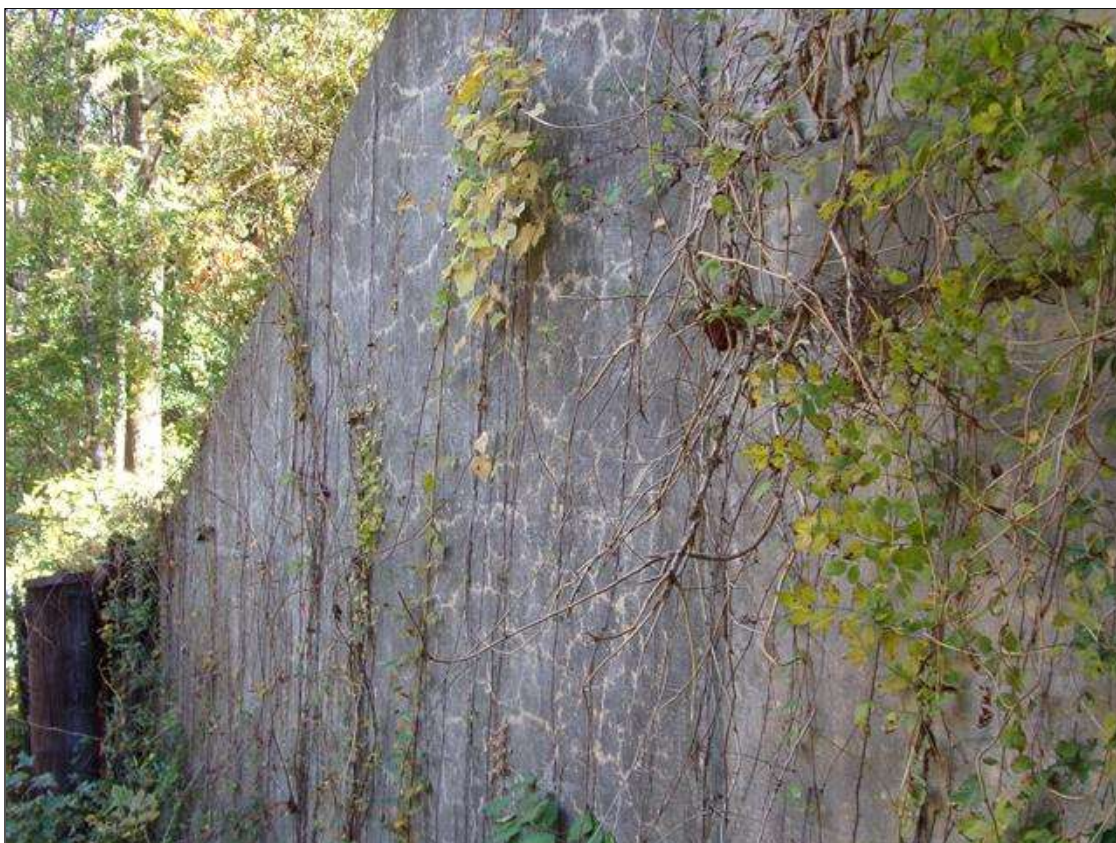
End Bent 2 Abutment: 10 FEET X 12 FEET AREA OF HAIRLINE MAP CRACKING ON NORTHEAST ABUTMENT EXTENSION

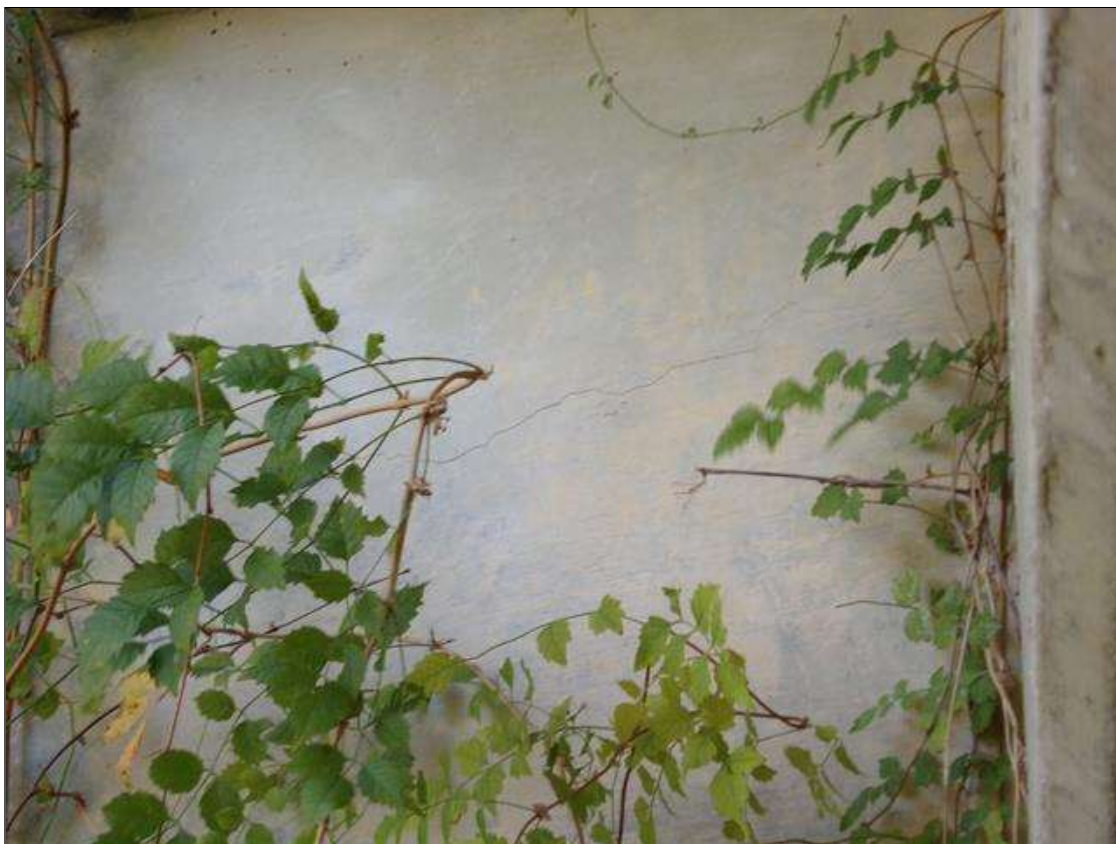
End Bent 2 Abutment: (2) UP TO 6 FEET X 1/64 INCHES HORIZONTAL CRACKS AT NORTH END

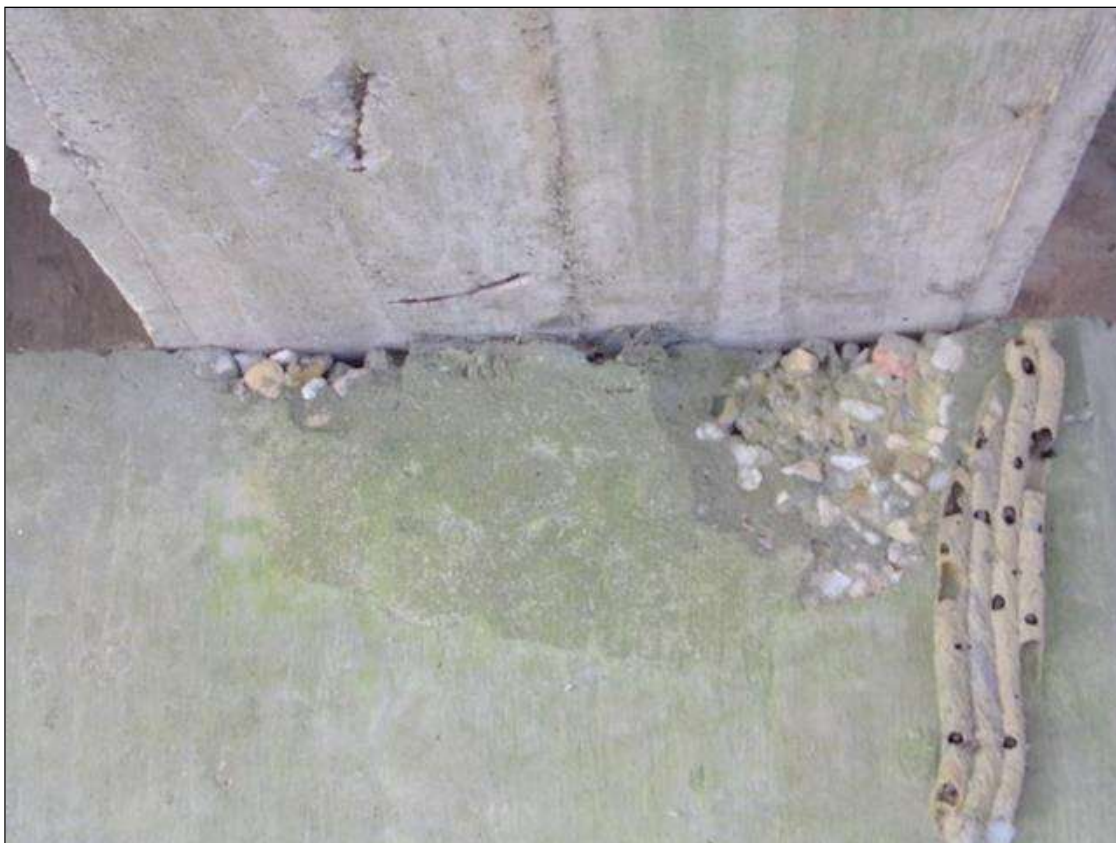
End Bent 2 Cap 1: (2) UP TO 8 INCHES X 6 INCHES X 1 INCHES DEEP SPALL ON WEST FACE OF BEAM 2
BLOCKOUT AT TOP OF CAP.

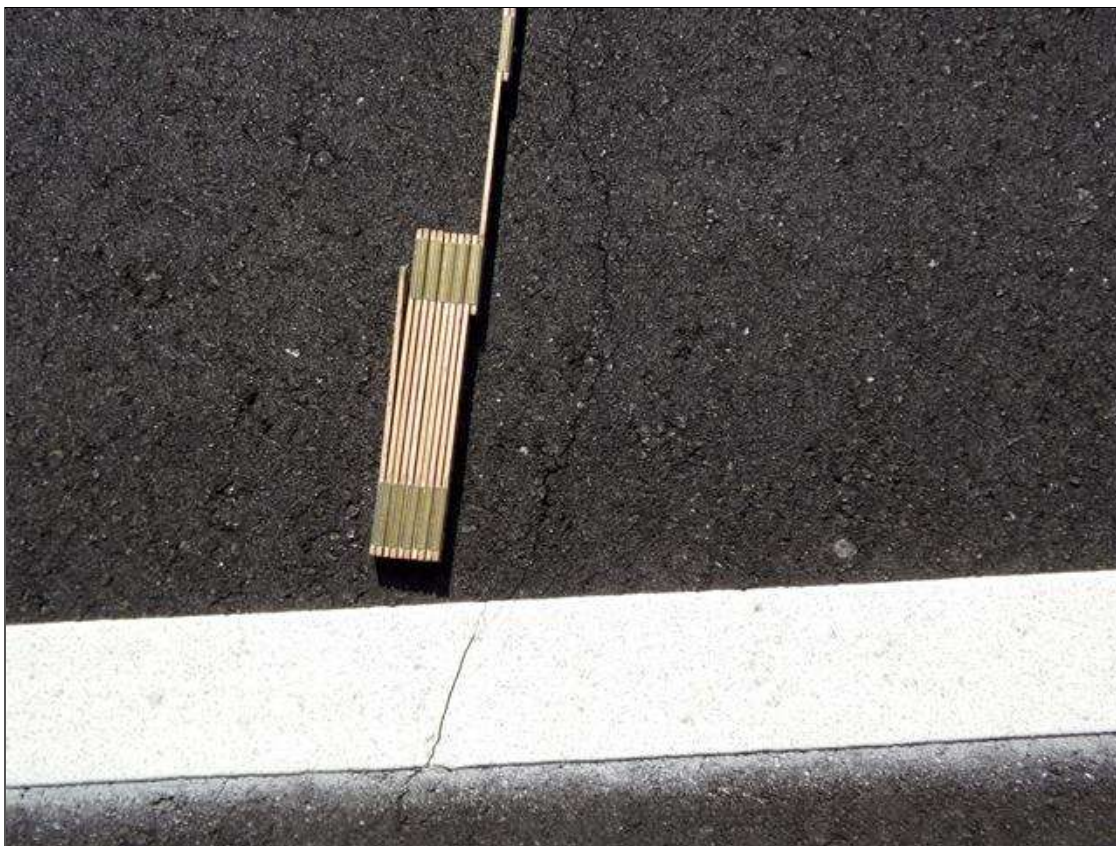
Span 4 Wearing Surface: 6 SQUARE FEET HAIRLINE TRANSVERSE CRACK AT END BENT 2

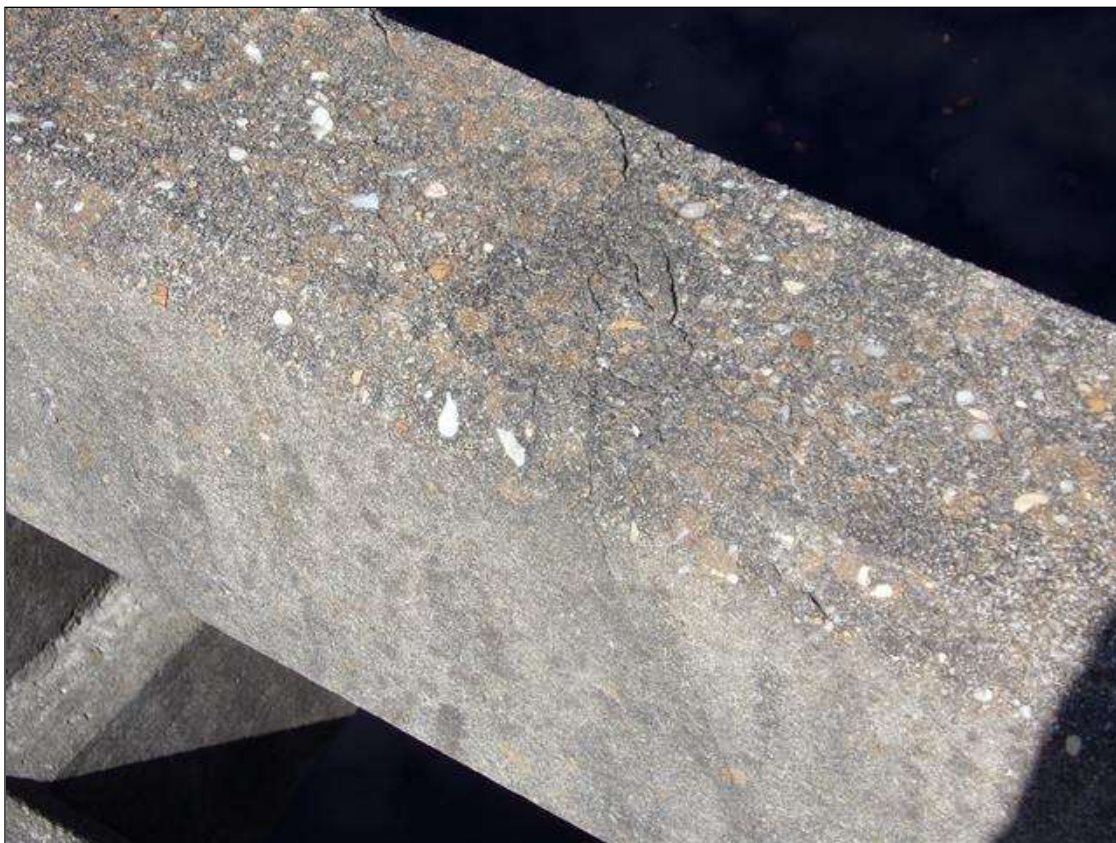
SPAN 4 Left Bridge Rail: (4) UP TO 1/16 INCHES CRACKS ON TOP AND NORTH FACE, 18 FEET FROM END BENT

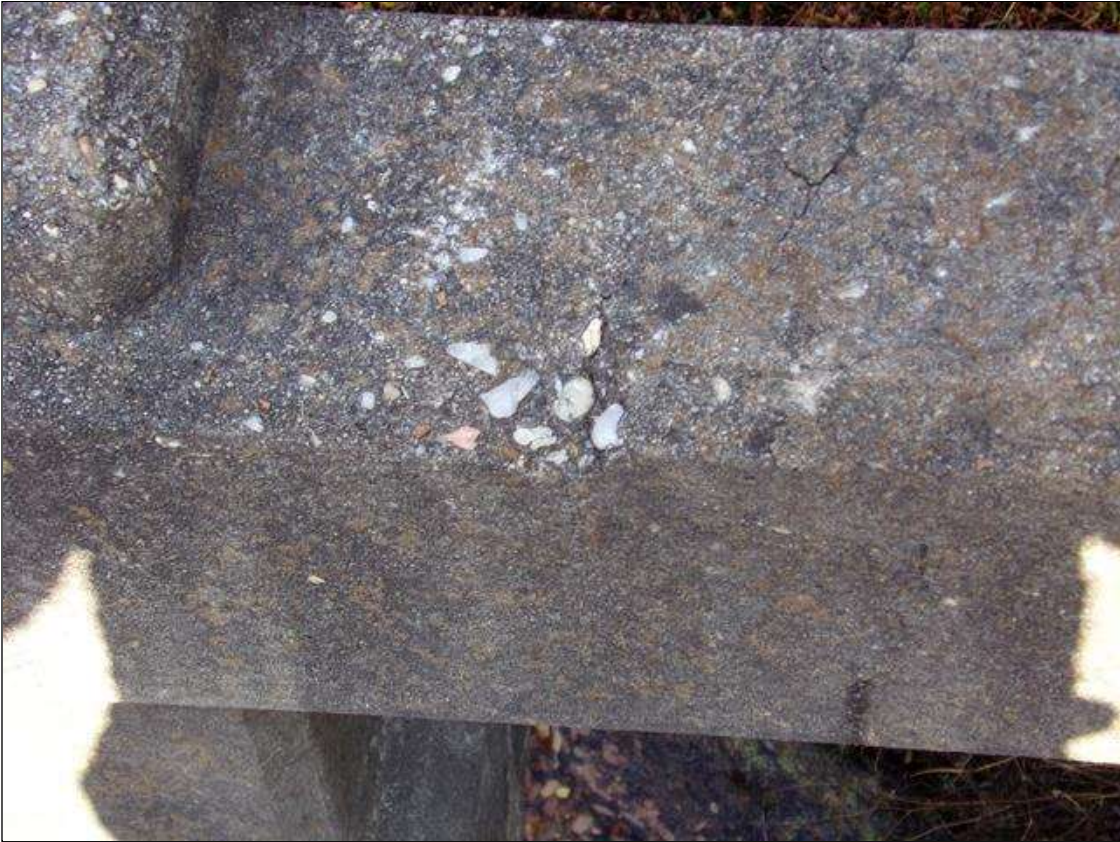
SPAN 4 Left Bridge Rail: 20 INCHES OF UP TO 1/2 INCHES GOUGES AND 1/16 INCHES WRAPAROUND CRACKS ON ALL FACES OF RAIL 15 FEET FROM BENT 3.

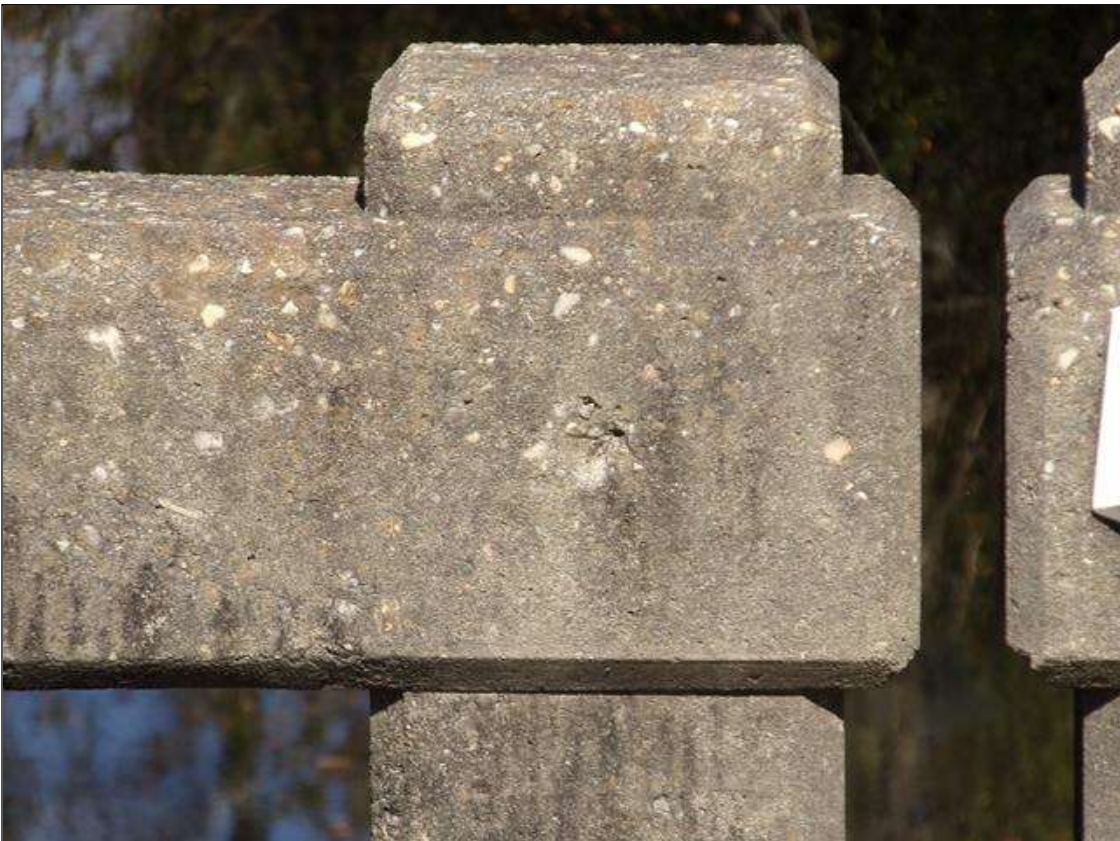
SPAN 4 Left Bridge Rail: 3 INCHES X 2 INCHES X 2 INCHES DEEP SPALL ON TOP AND SOUTH FACES, 19 FEET FROM END BENT 2.

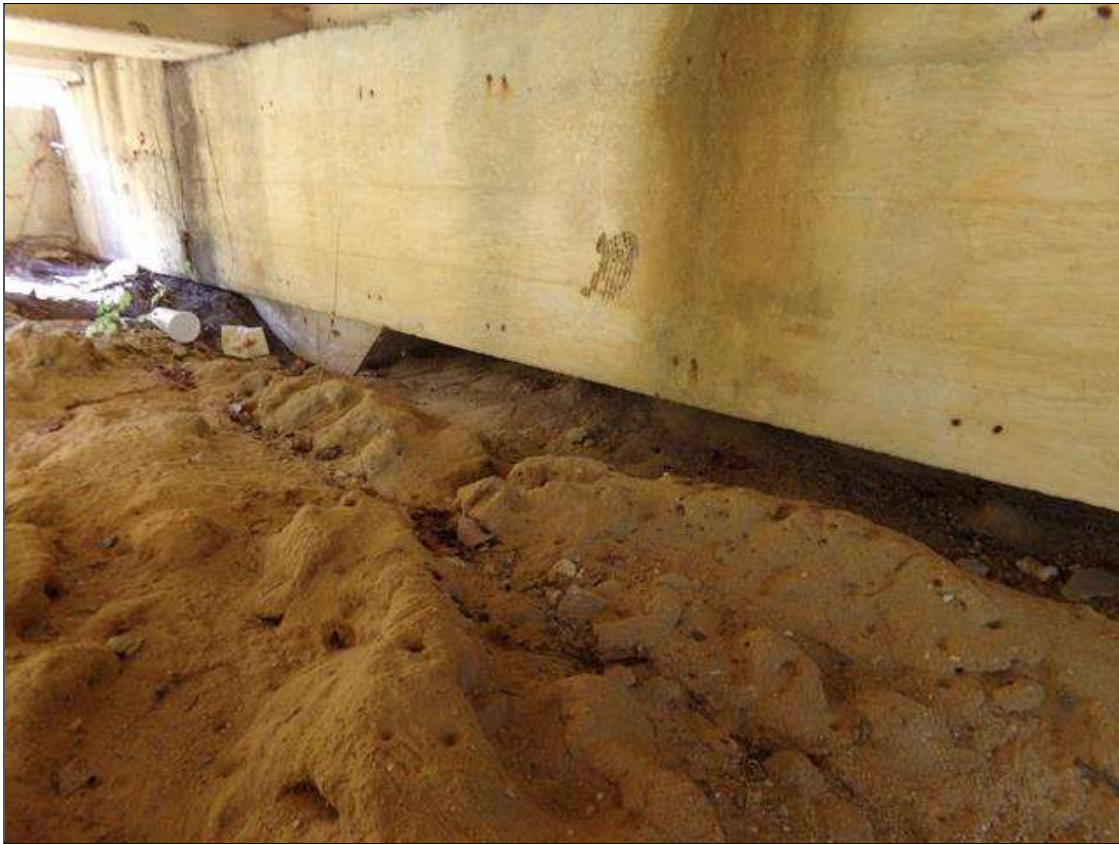
End Bent 1 Abutment: 29 FEET X 38 INCHES DEEP UNDERNEATH UNDER END BENT 1 CAP (PAR)

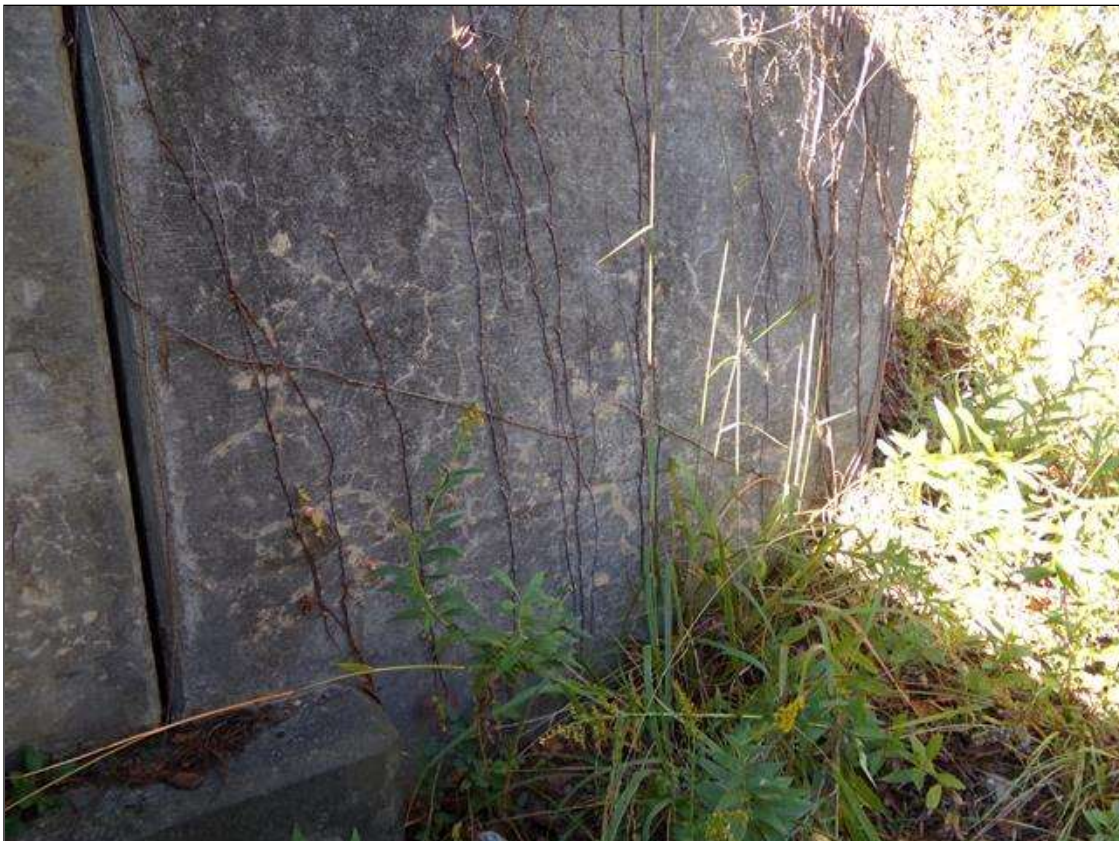
4 FEET X 4 FEET AREA OF HAIRLINE MAP CRACKING WITH EFFLORESCENCE ON NORTHWEST WINGWALL

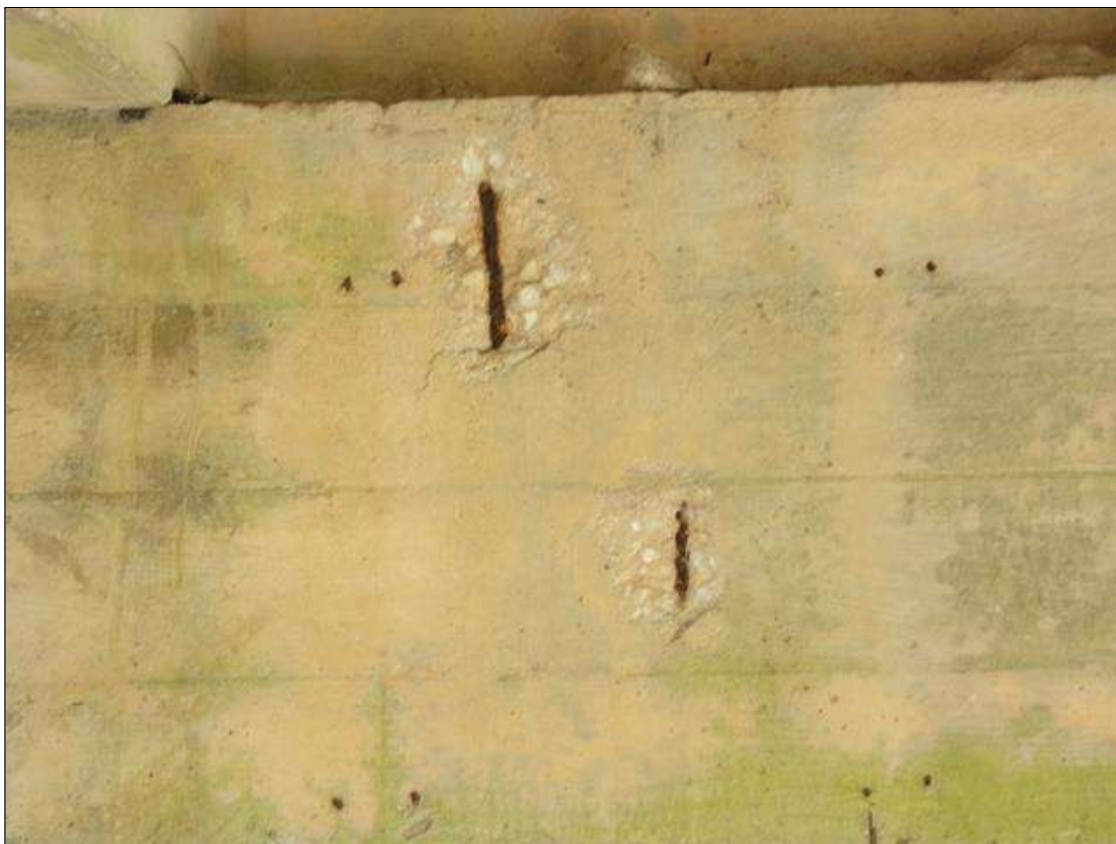
Bent 1 Cap 1: (2) UP TO 8 INCHES X 12 INCHES X 1/2 INCH DEEP SPALLS WITH EXPOSED REINFORCING ON WEST FACE BETWEEN BEAMS 2 AND 3.

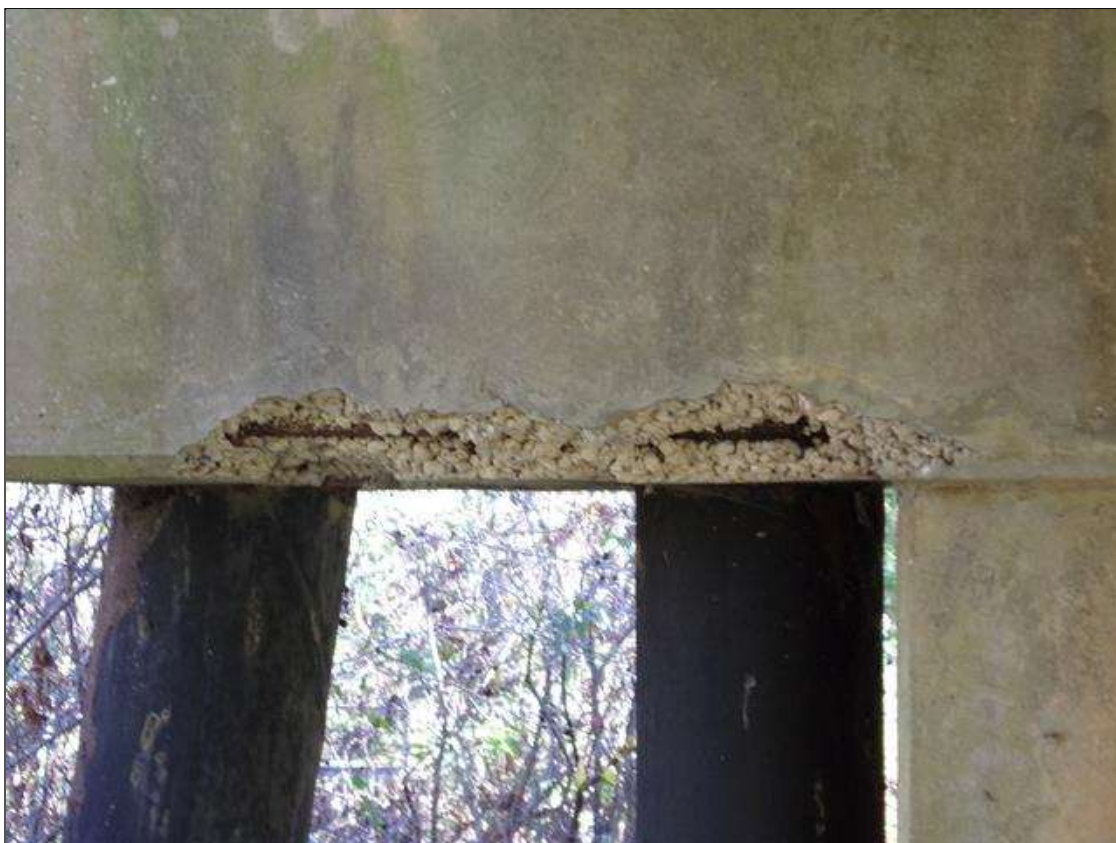
Bent 1 Cap 1: 45 INCHES X 7 INCHES X 6 INCHES DEEP SPALL WITH EXPOSED REINFORCING ON WEST FACE BENEATH BEAM 1 AT BOTTOM OF CAP (PAR)

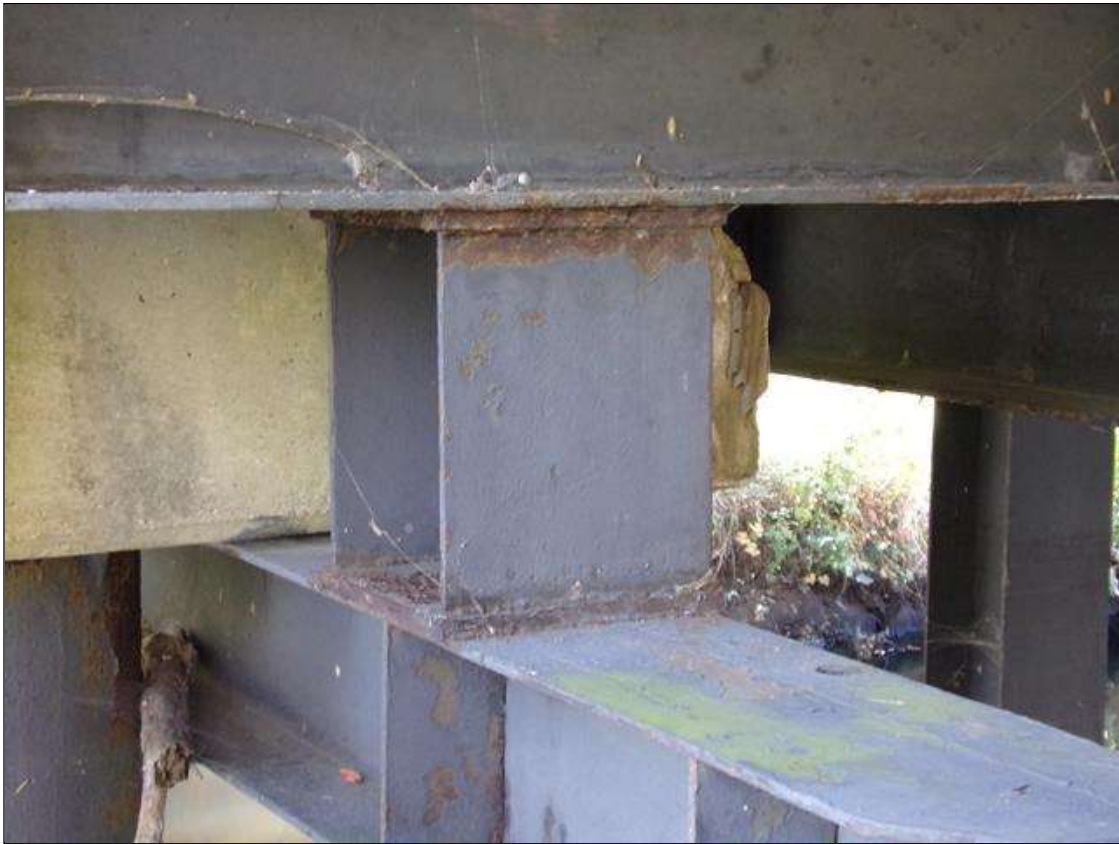
Bent 3 Row 1 Pile 1: 8 FEET OF FRECKLED RUST WITH ISOLATED LOCATIONS OF SURFACE RUST AT RANDOM THROUGHOUT.
