**BRIDGE INSPECTION RECORD AND SUMMARY  
FOR SHORED STRUCTURES OR STRUCTURES  
WITH TEMPORARY REPAIRS MADE TO KEEP  
A BRIDGE OPEN**

BRIDGE: **270008** COUNTY: **Dare** DATE: **5/7/2012**

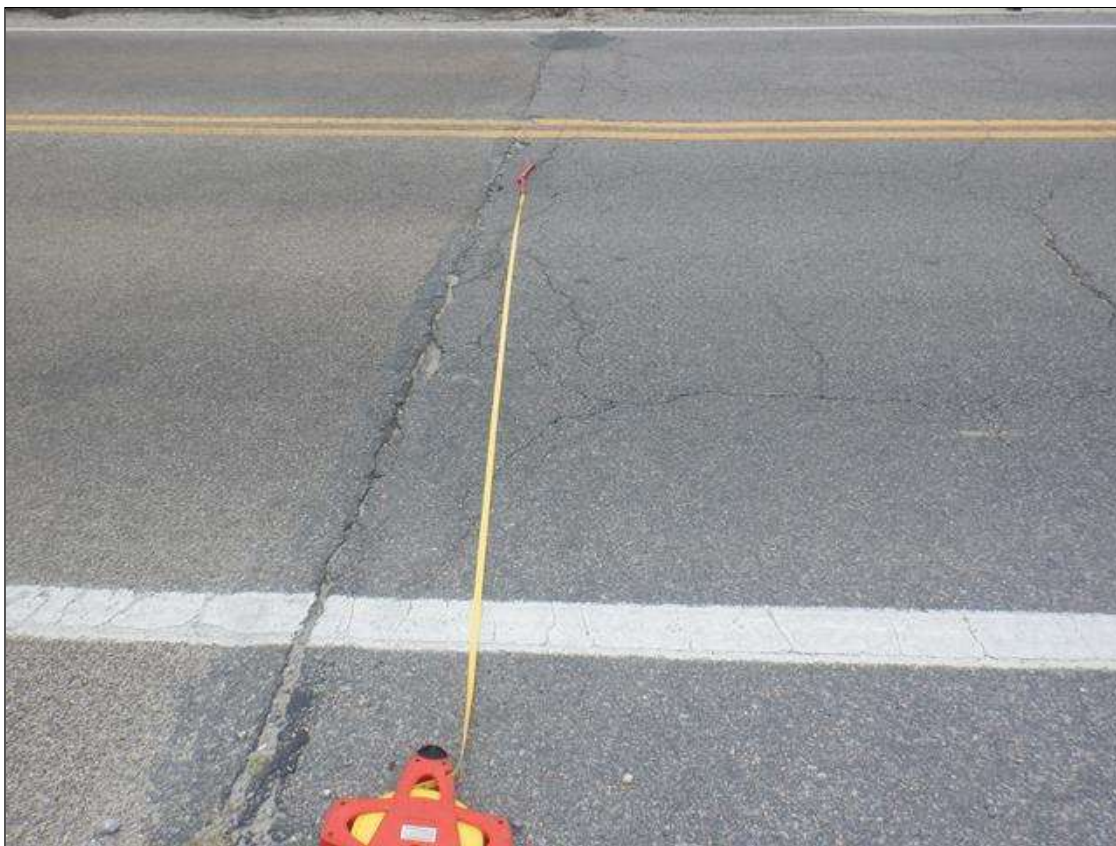
Span 1 Wearing Surface: CRACKED TO .50 INCH, SPALLED TO 3 INCHES WIDE X FULL WIDTH OF ROADWAY OVER END BENT 1.

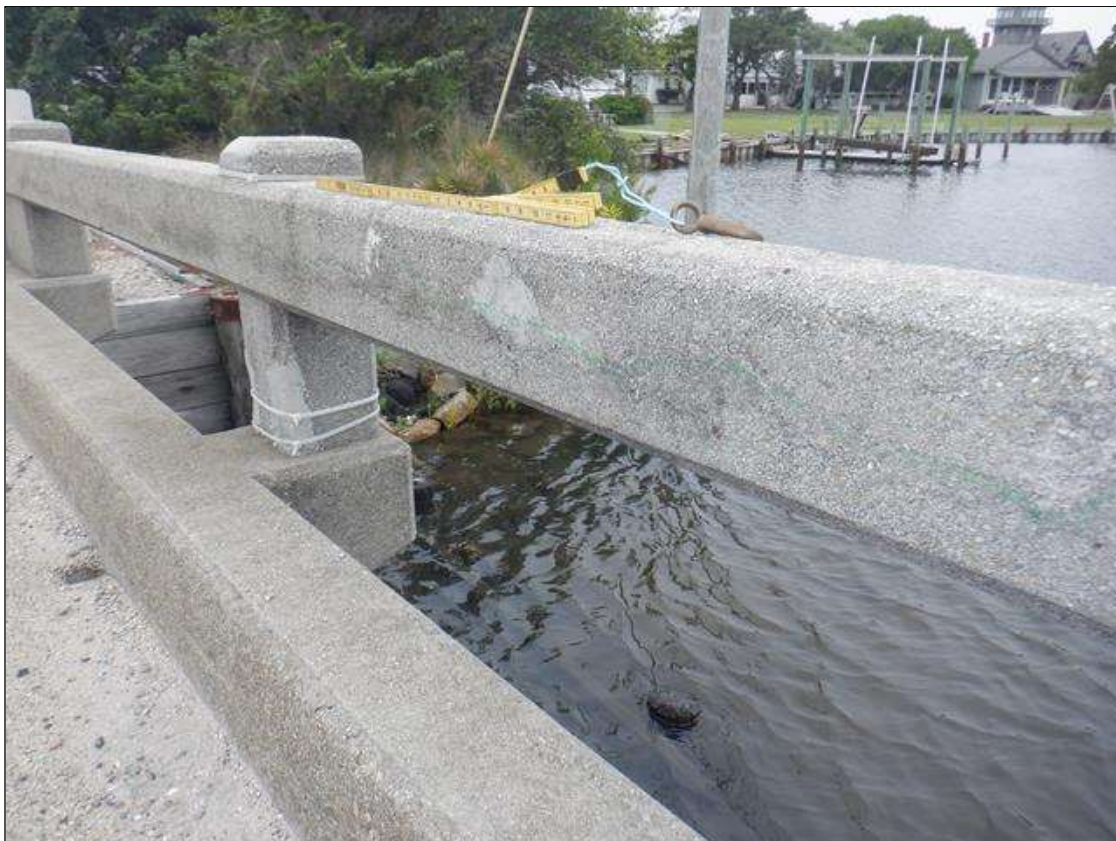
Span 1 Left Bridge Rail: CRACKED TO .062 INCH AND DELAMINATED ALONG INSIDE OF TOP RAIL X FULL LENGTH OF SPAN.

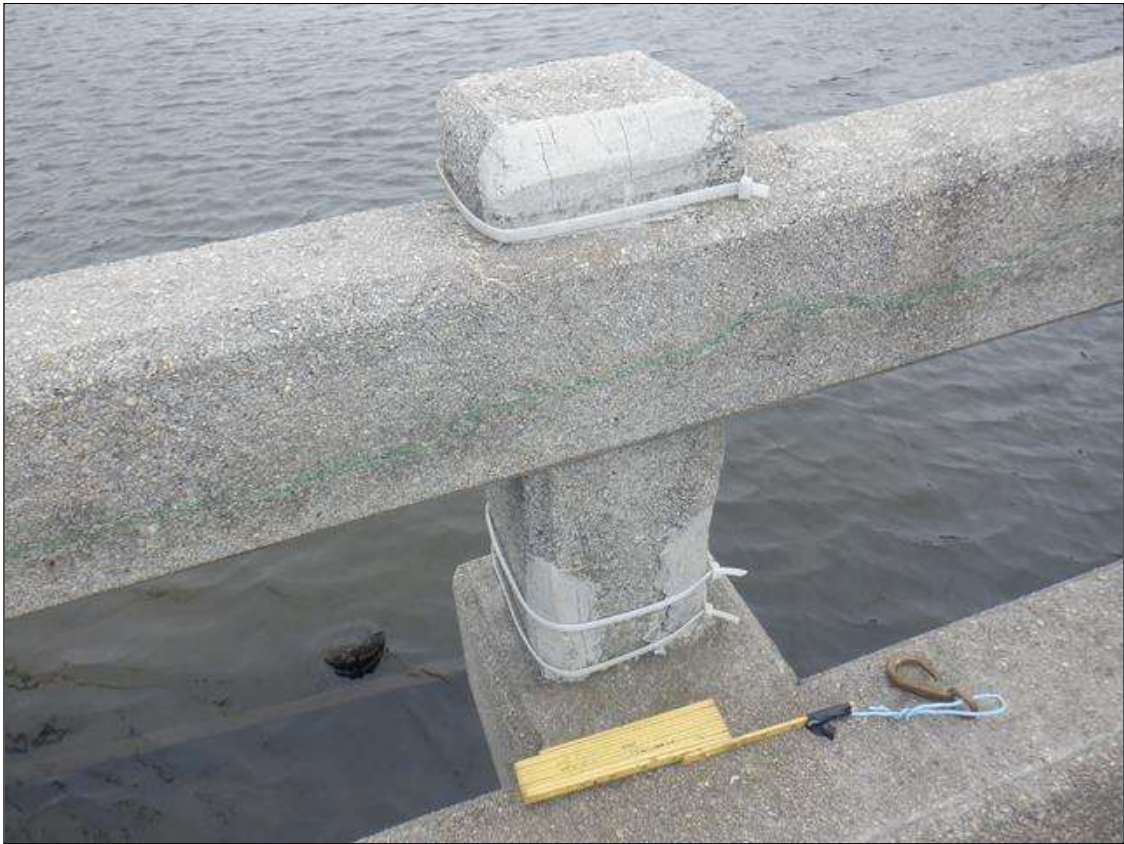
Span 1 Left Bridge Rail: PATCHED AREAS ON RAIL POST 1 2 AND 3.

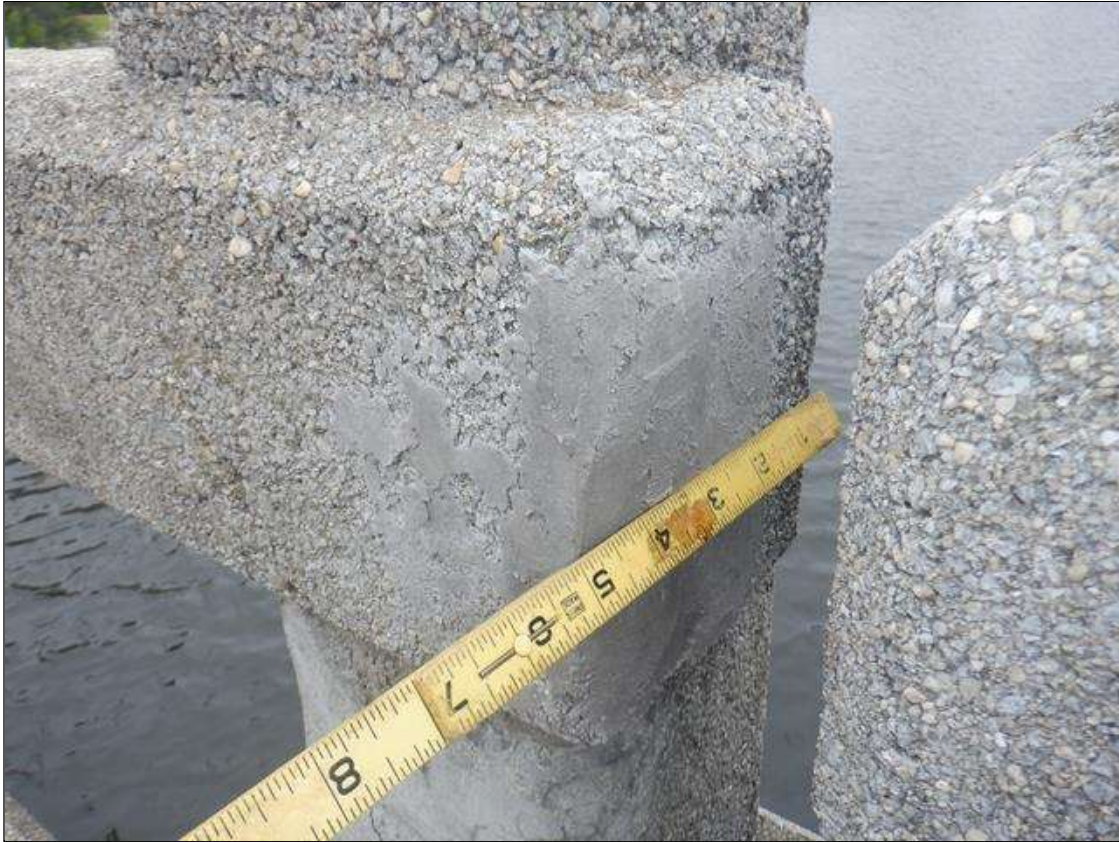
Span 2 Left Bridge Rail: PAR: RAIL OVER POST 3 HAS A 2 INCH X 3 INCH CORNER SPALL EXPOSING REINFORCING STEEL. AREA HAS BEEN REPAIRED

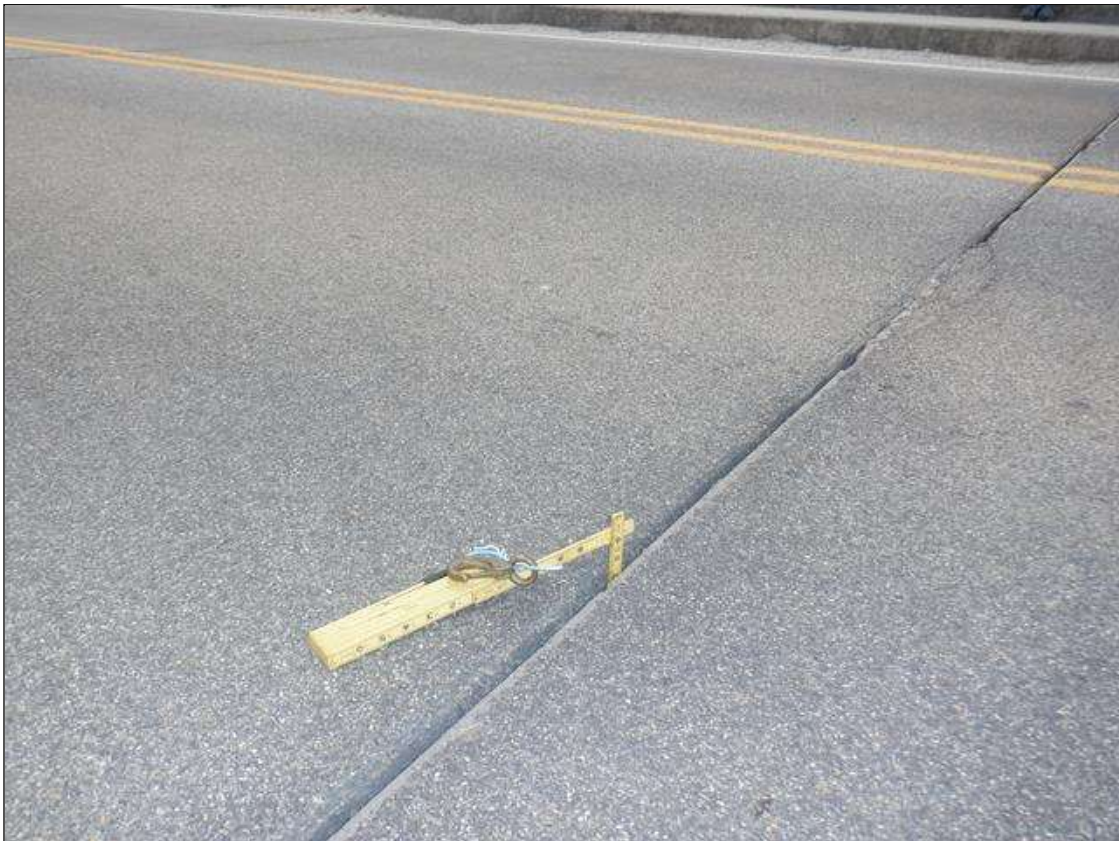
Span 2 Expansion Joint: JOINT HAS A 1 INCH GAP WHERE JOINT MATERIAL IS MISSING, ALLOWING WATER TO DRAIN ON SUPERSTRUCTURE AND SUBSTRUCTURE COMPONENTS.

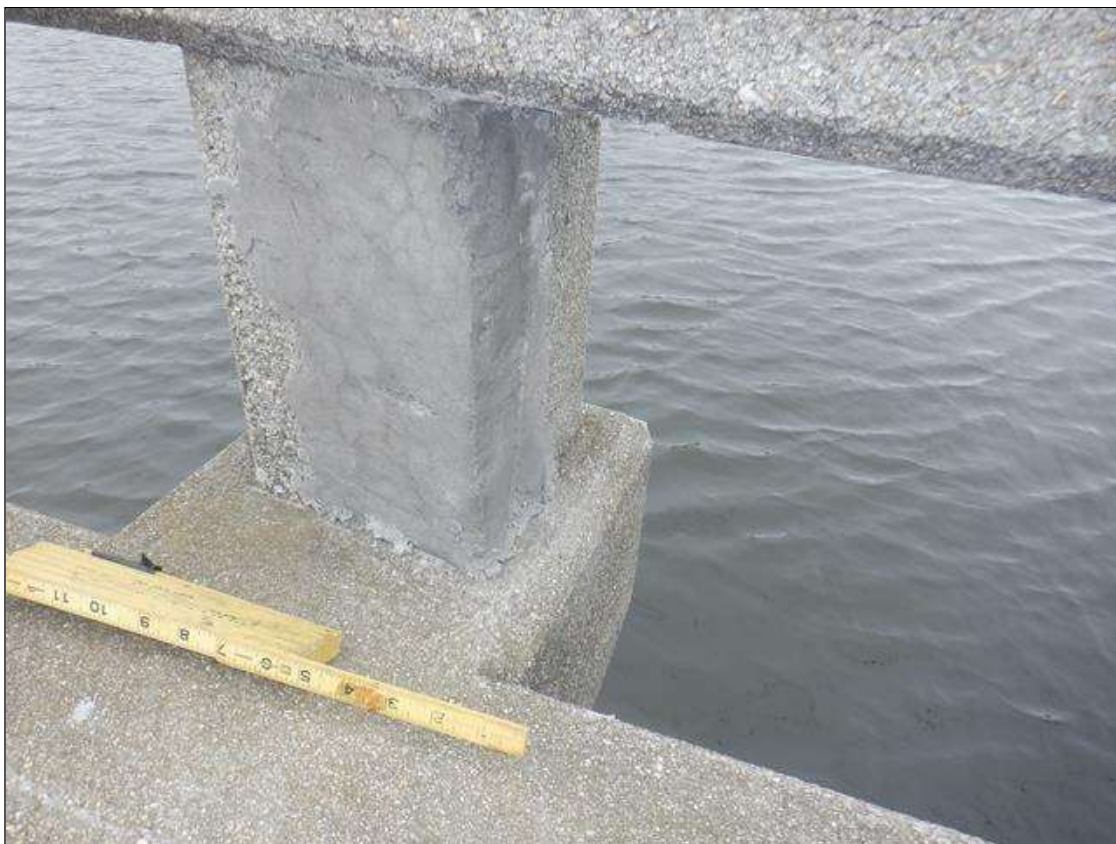
Span 3 Left Bridge Rail: PAR: RAIL POST 2 HAS A FAILED PATCH WITH EXPOSED REINFORCING STEEL 2 INCH DIAMETER. AREA HAS BEEN REPAIRED.

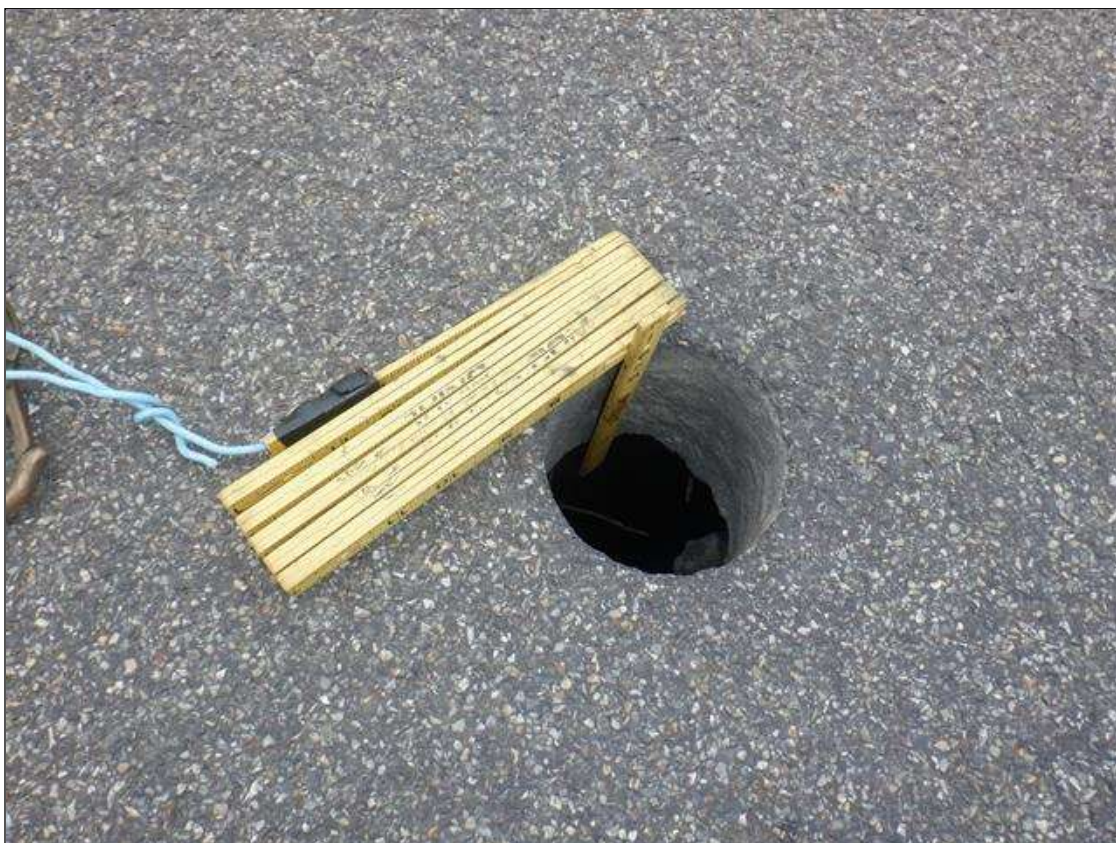
Span 3 Deck: PAR- 4 INCH DIAMETER HOLE THROUGH DECK IN SOUTH BOUND LANE.

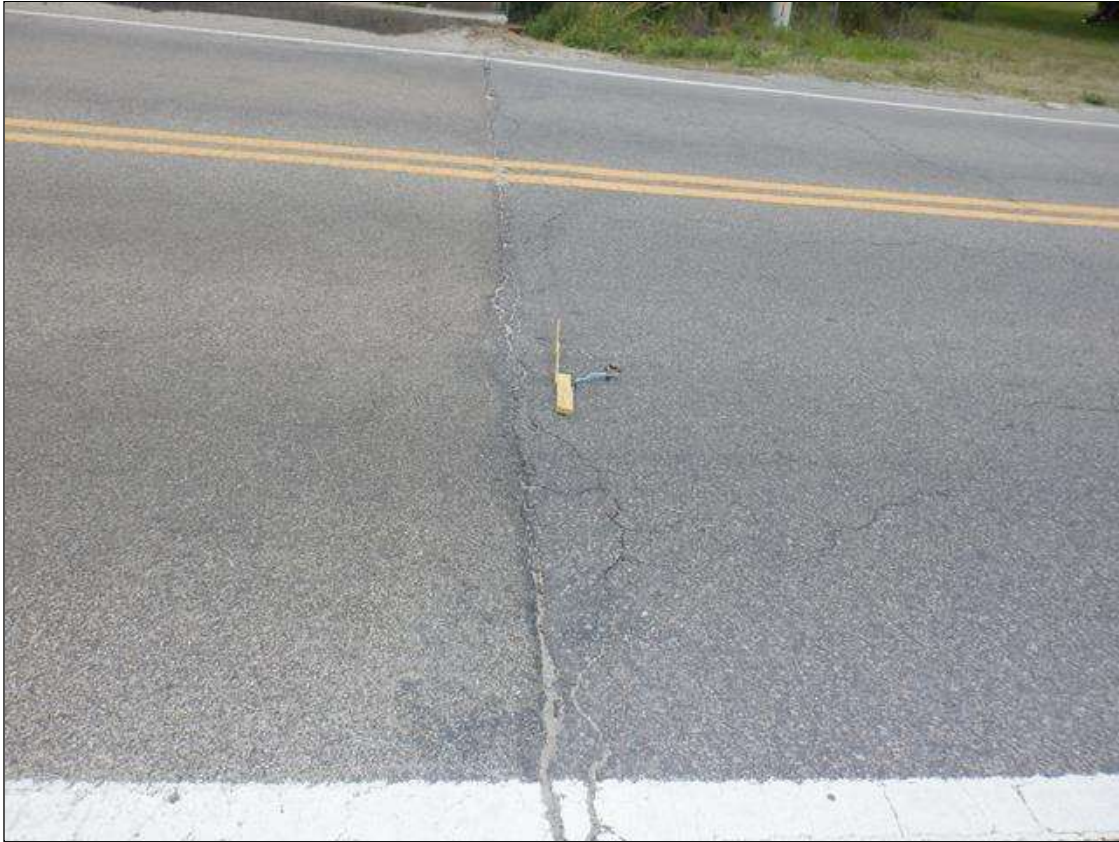
Span 5 Wearing Surface: CRACKED TO .50 INCH, SPALLED TO 1 INCH X FULL WIDTH OF ROADWAY OVER END BENT 2.

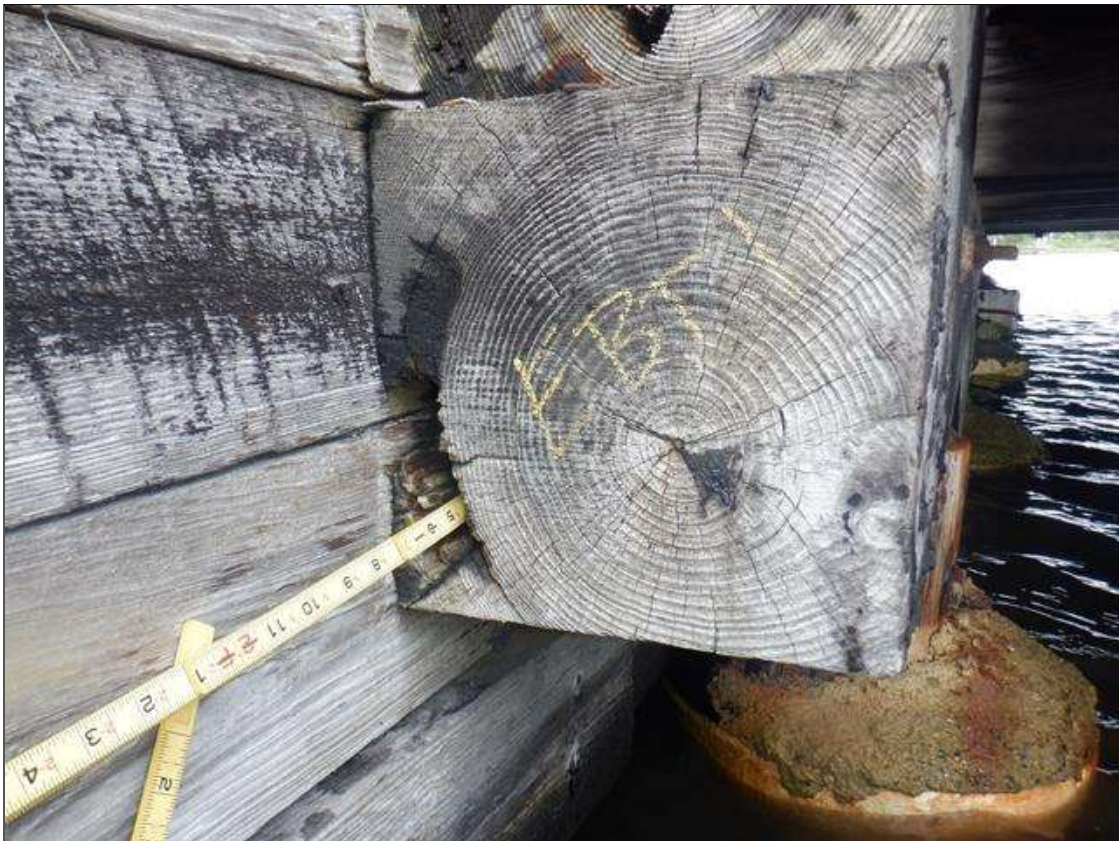
End Bent 1 Cap 1: PAR: EAST END DECAYED FROM END BACK 16 INCHES, 5 INCHES TALL X 2 INCHES WIDE .

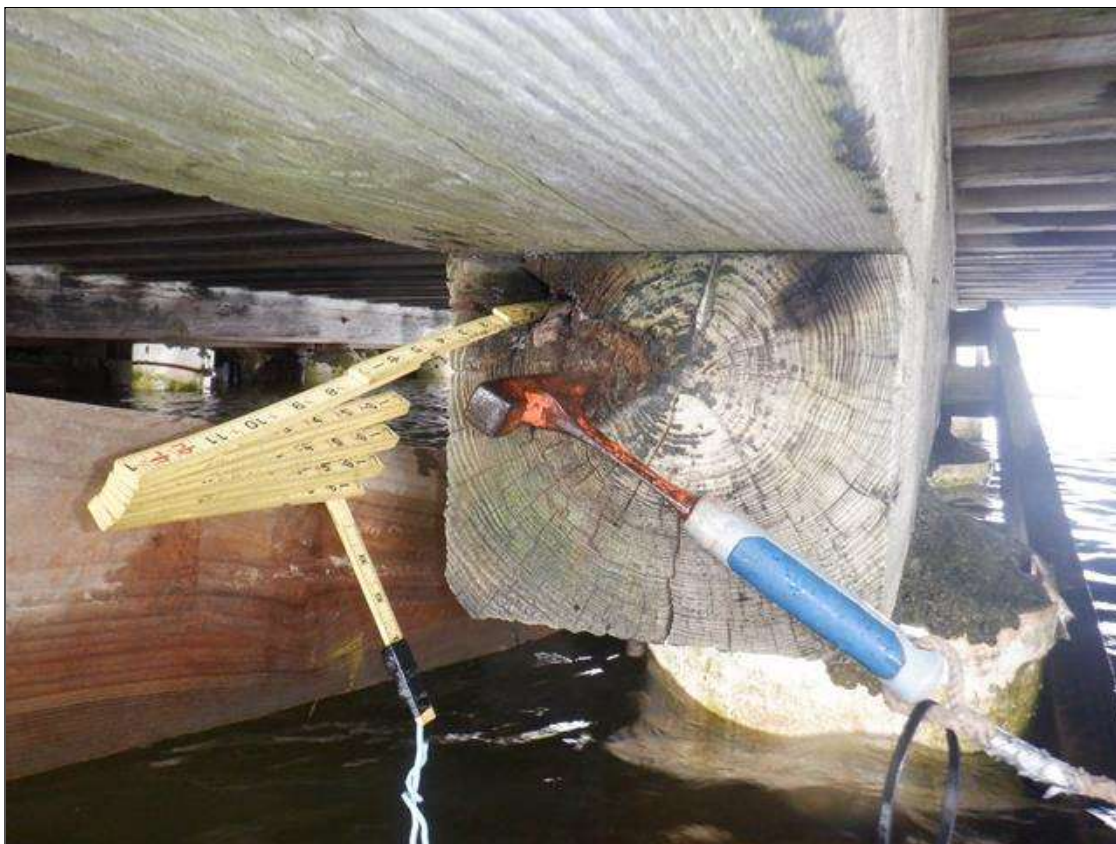
Bent 1 Cap: SUBCAP HAS DECAY ON EAST END TOP CORNER, 4 INCH DIAMETER X 14 INCHES DEEP

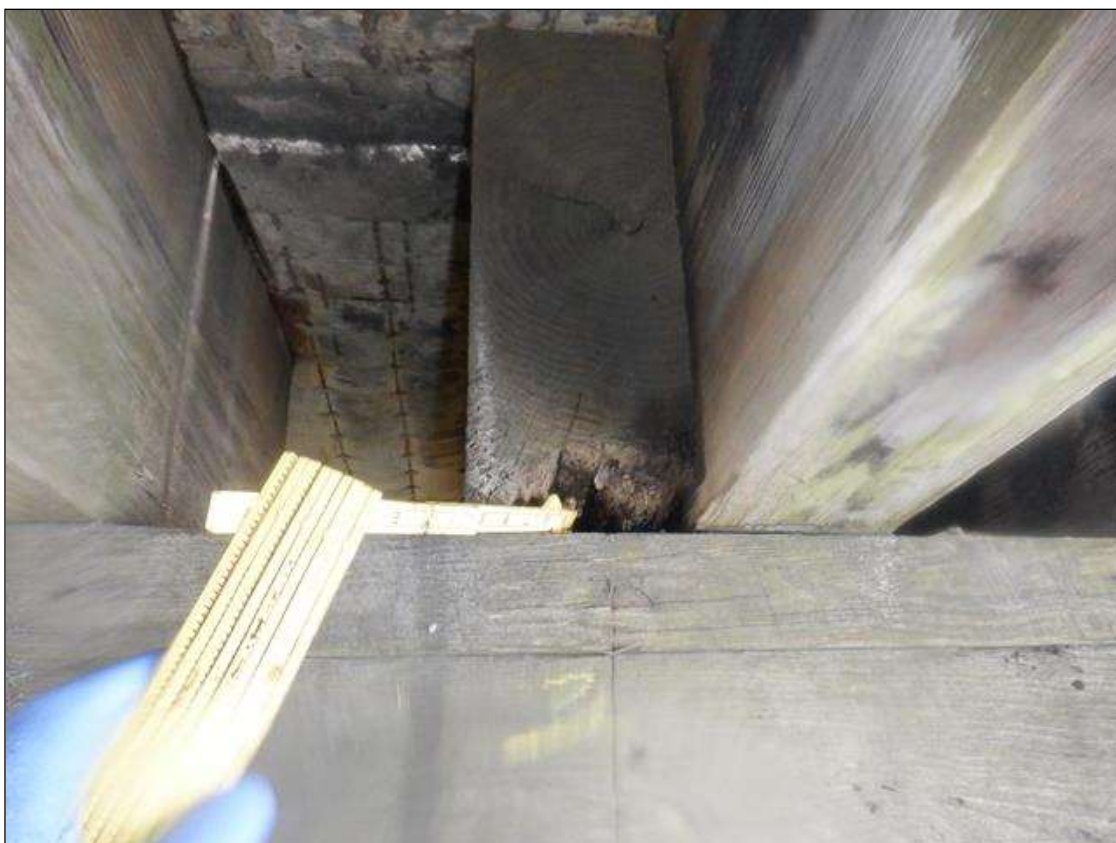
Span 1 Beam 3: PAR- DECAYED ON END OVER BENT 1, 4 INCHES TALL X 6 INCHES WIDE X 5 INCHES DEEP.

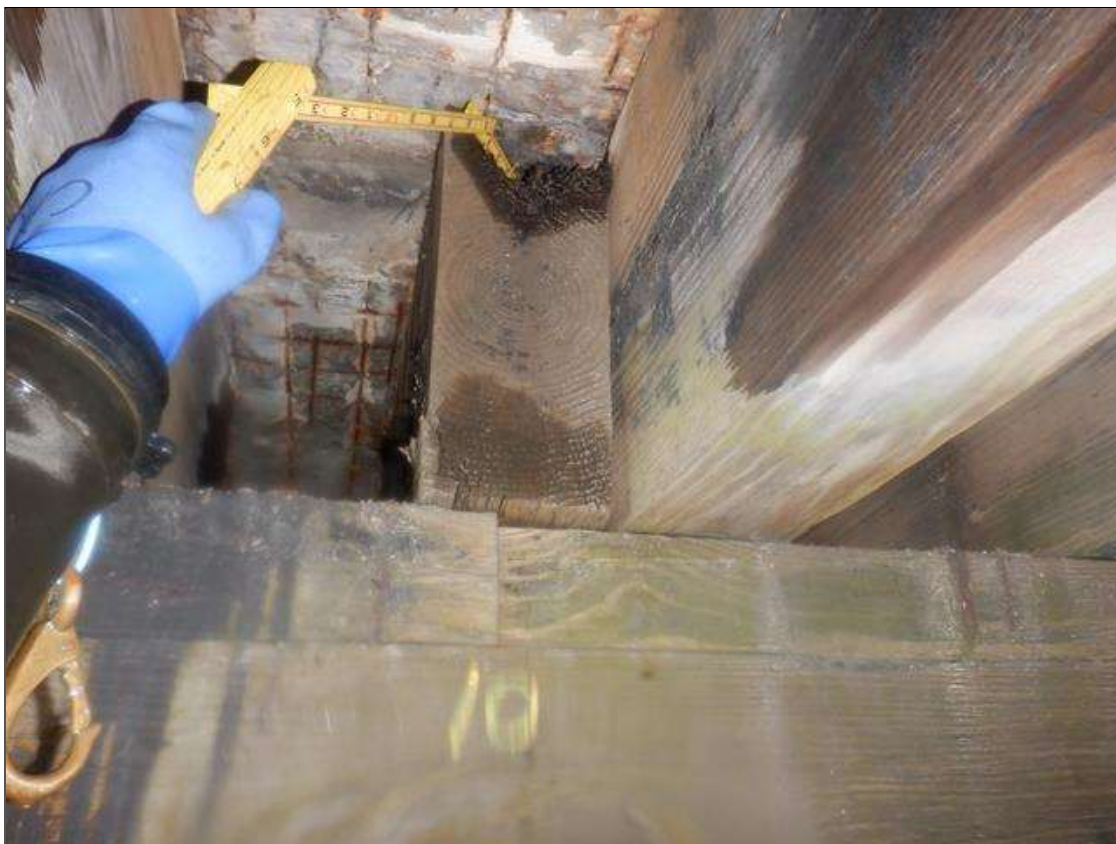
Span 1 Beam 10: PAR- DECAYED ON END OVER BENT 1, 4 INCHES TALL X 6 INCHES WIDE X 5 INCHES DEEP.

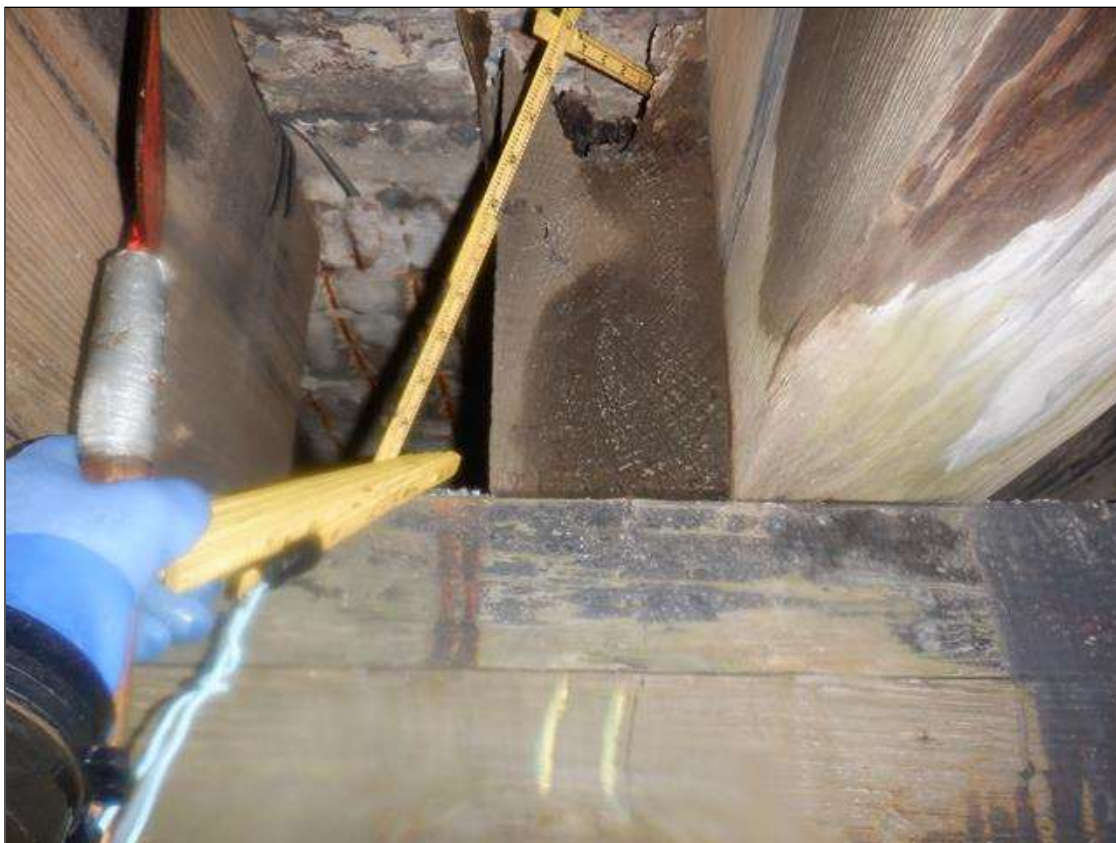
Span 1 Beam 11: PAR- DECAYED ON END OVER BENT 1, 5 INCHES TALL X 6 INCHES WIDE X 6 INCHES DEEP.

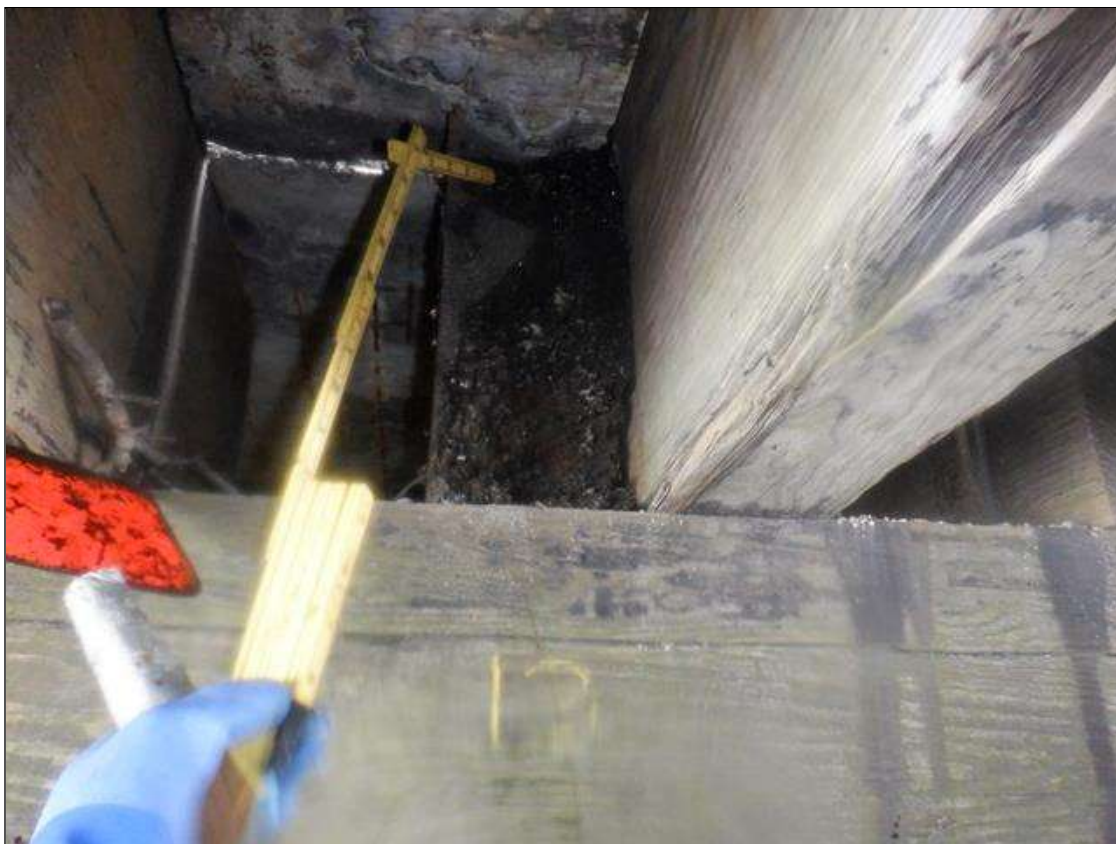
Span 1 Beam 13: PAR- DECAYED ON END OVER BENT 1, 4 INCHES TALL X 6 INCHES WIDE X 5 INCHES DEEP.

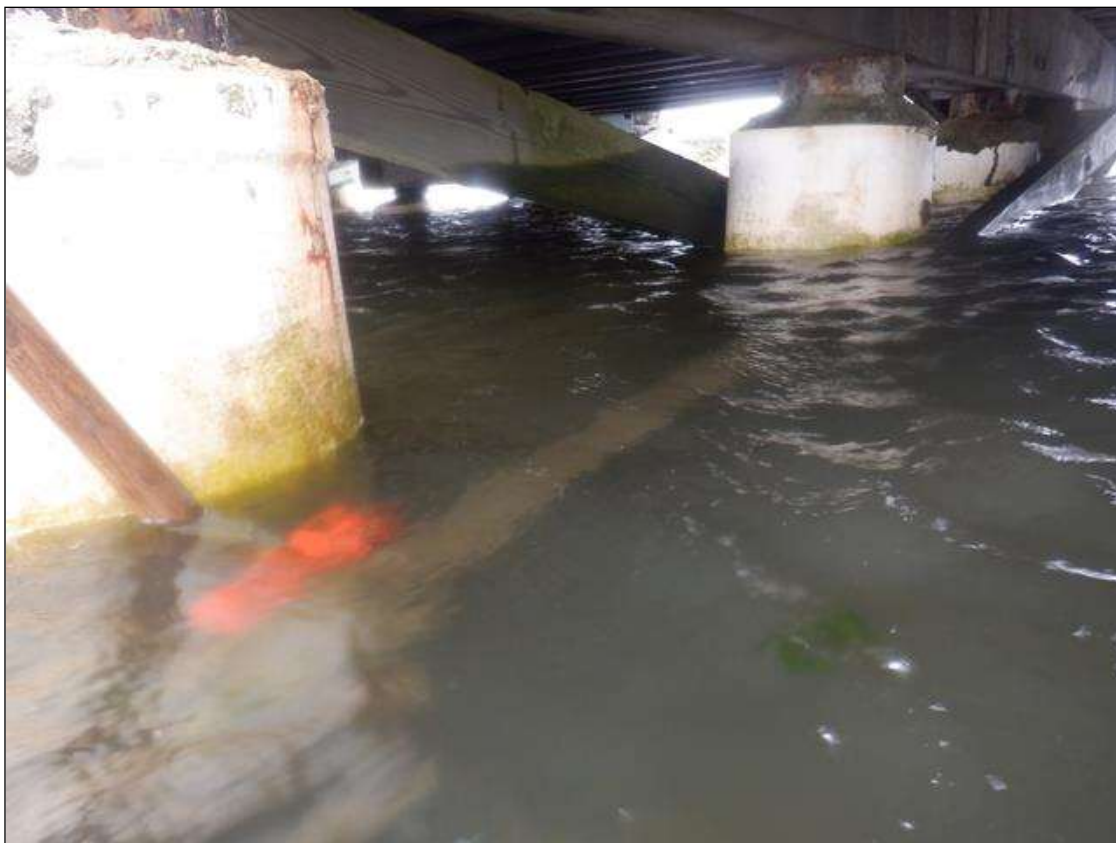
Bent 1 Pile 1: PAR: X-BRACING DECAYED AND DETACHED FROM PILE.

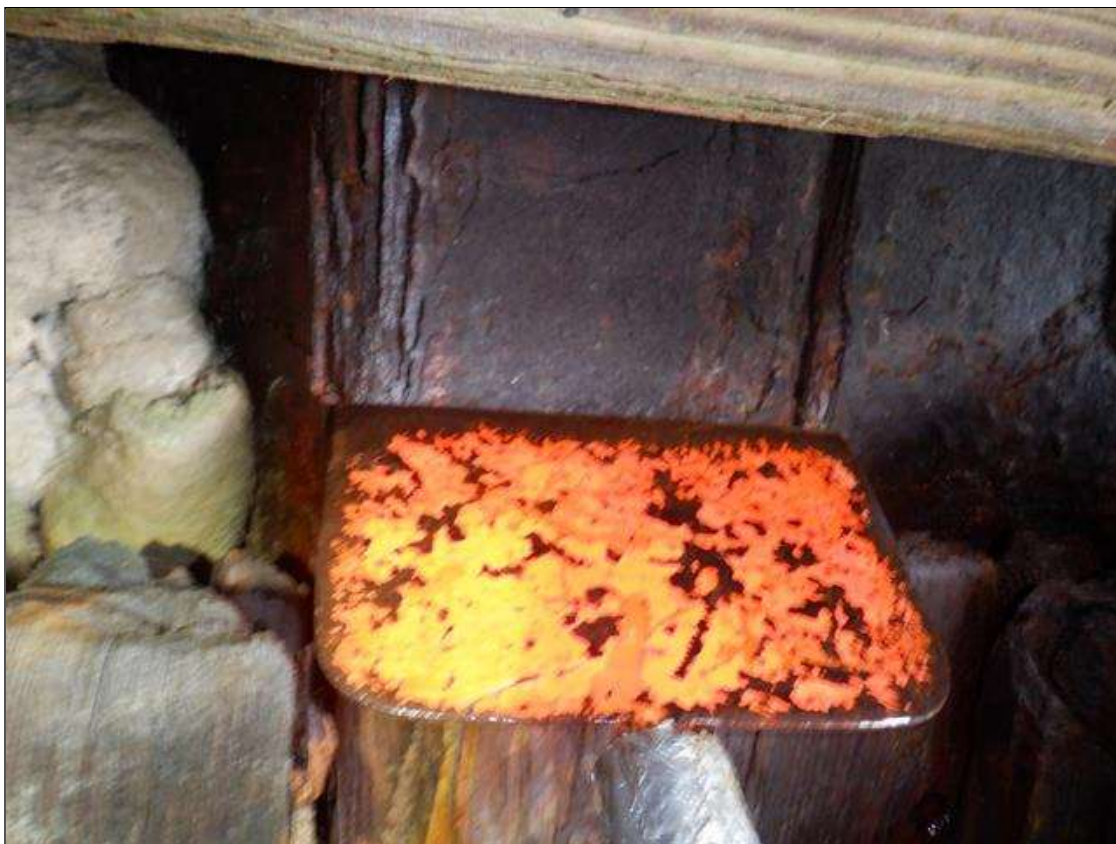
RUST AND SCALE ON SHEET PILE OLD TIMBER ABUTMENT. BOTH END BENT 1 AND 2.

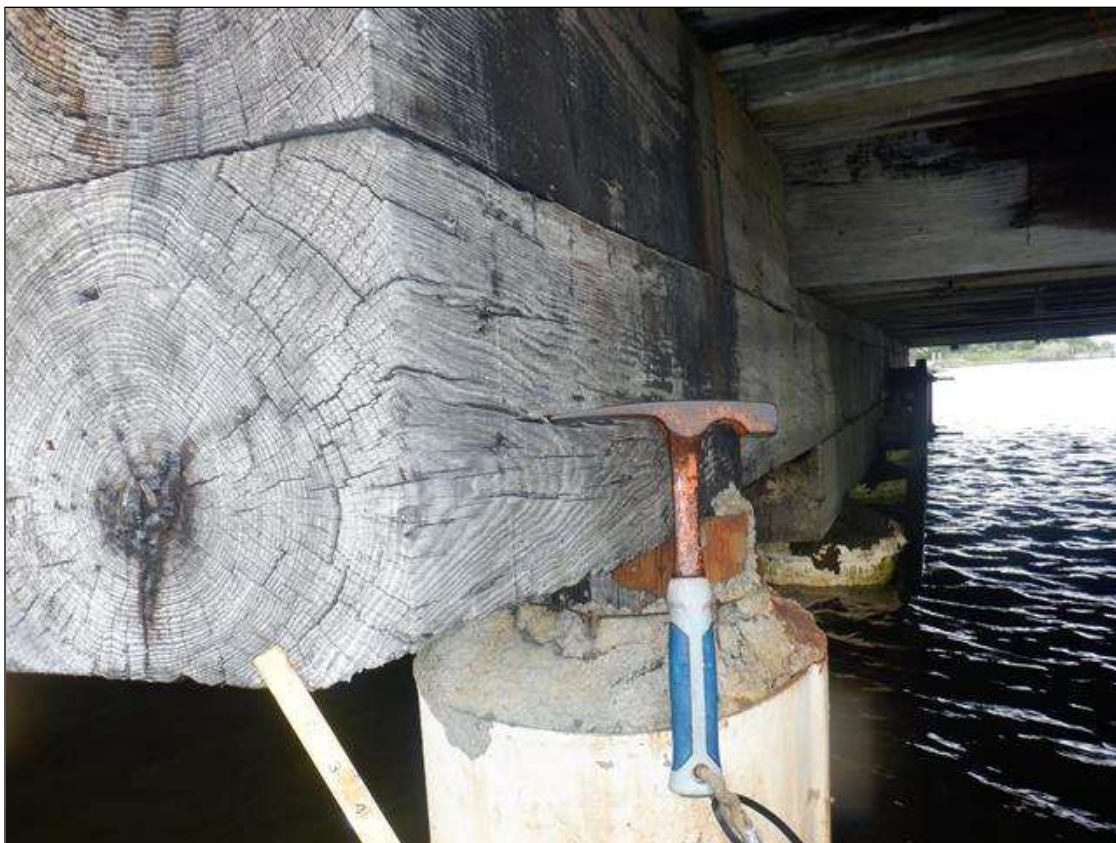
ALL CAPS HAVE CHECKS TO .125 INCH WIDE AND .25 INCH ON ENDS, SOFT TO .50 INCH ON ENDS.

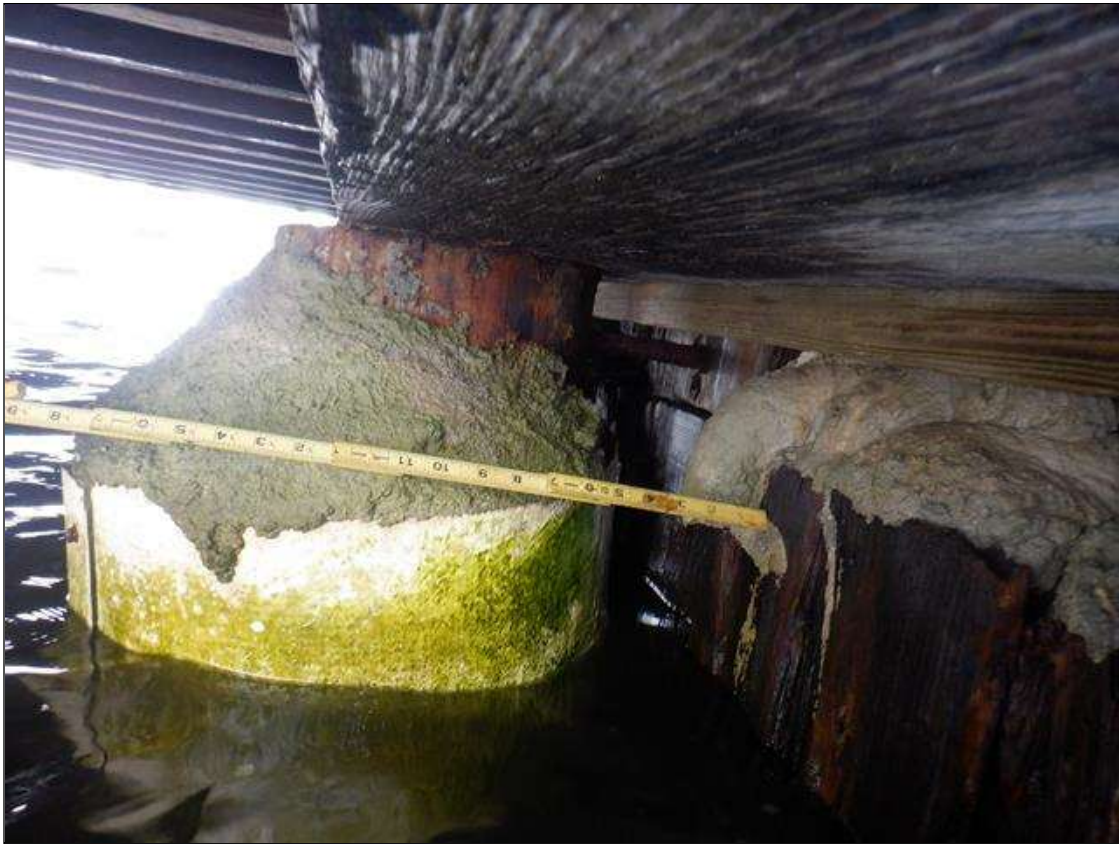
CONCRETE JACKET REPAIRS ARE IN POOR CONDITION WITH LIMITED COVERAGE. ALL PILES HAVE CHECKS TO .125 INCH WIDE, SOFT TO .50 INCH DEEP WHERE TIMBER PILE IS EXPOSED.

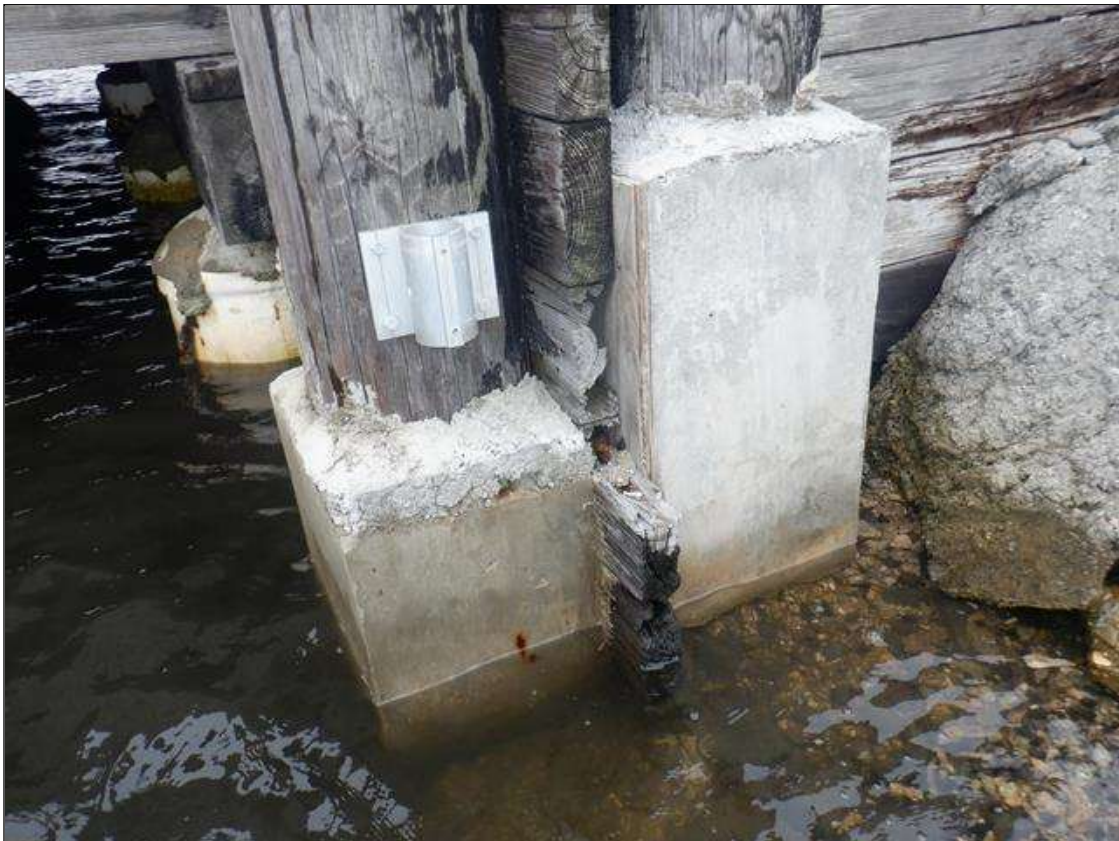
PREVIOUS PAR ADDRESSED. ALL RETAINING PILES HAVE BEEN ENCASED IN CONCRETE.

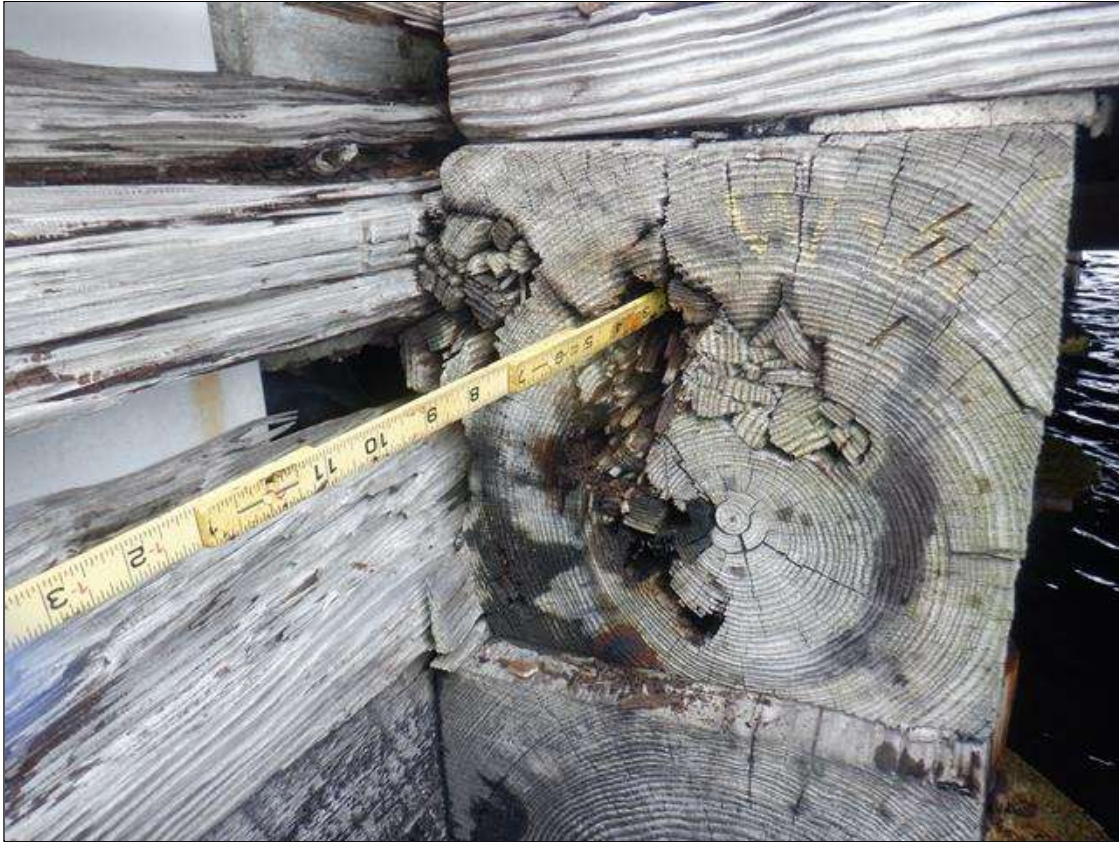
End Bent 1 Cap: PAR- PEDESTRAIN WALKWAY SUBCAP HAS DECAY ON THE EAST END CENTER OF CAP. 8 INCH DIAMETER X 4 INCHES DEEP

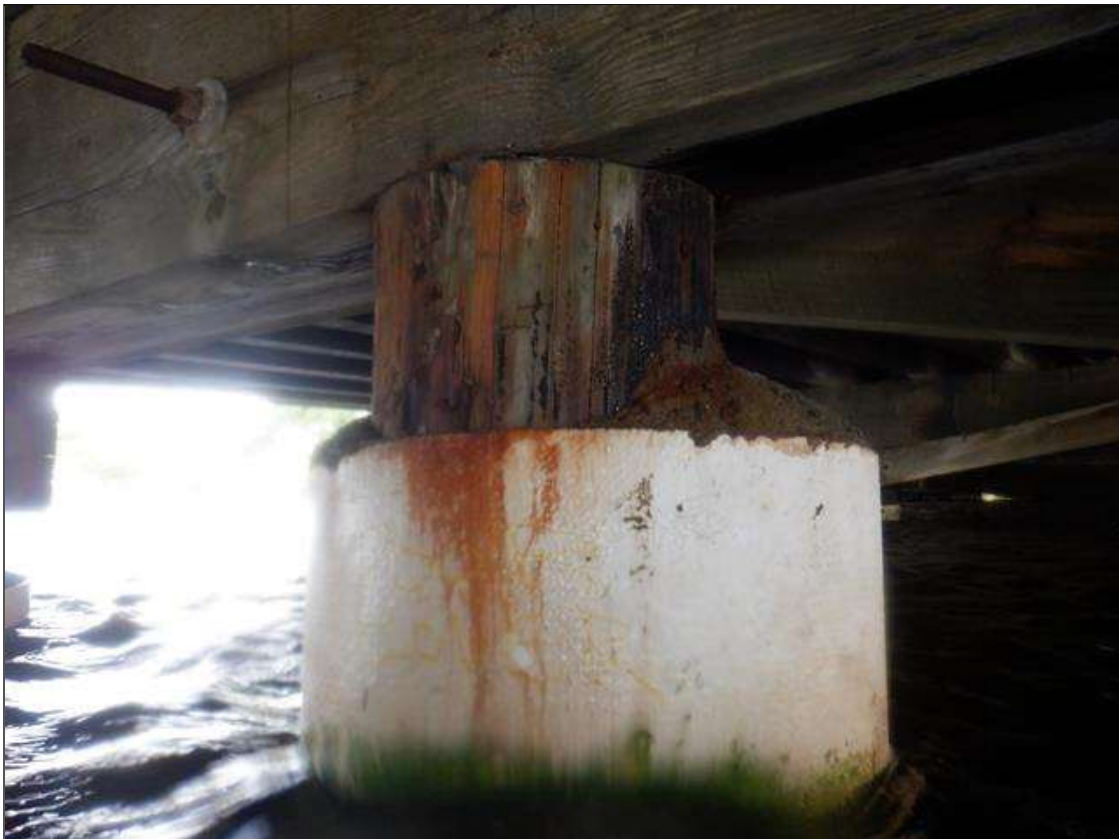
ALL PILES ARE JACKETED WITH CONCRETE FROM 1 FOOT ABOVE MUDLINE TO 8-10 INCHES BELOW CAP. CONCRETE JACKET REPAIRS ARE IN POOR CONDITION WITH LIMITED COVERAGE.

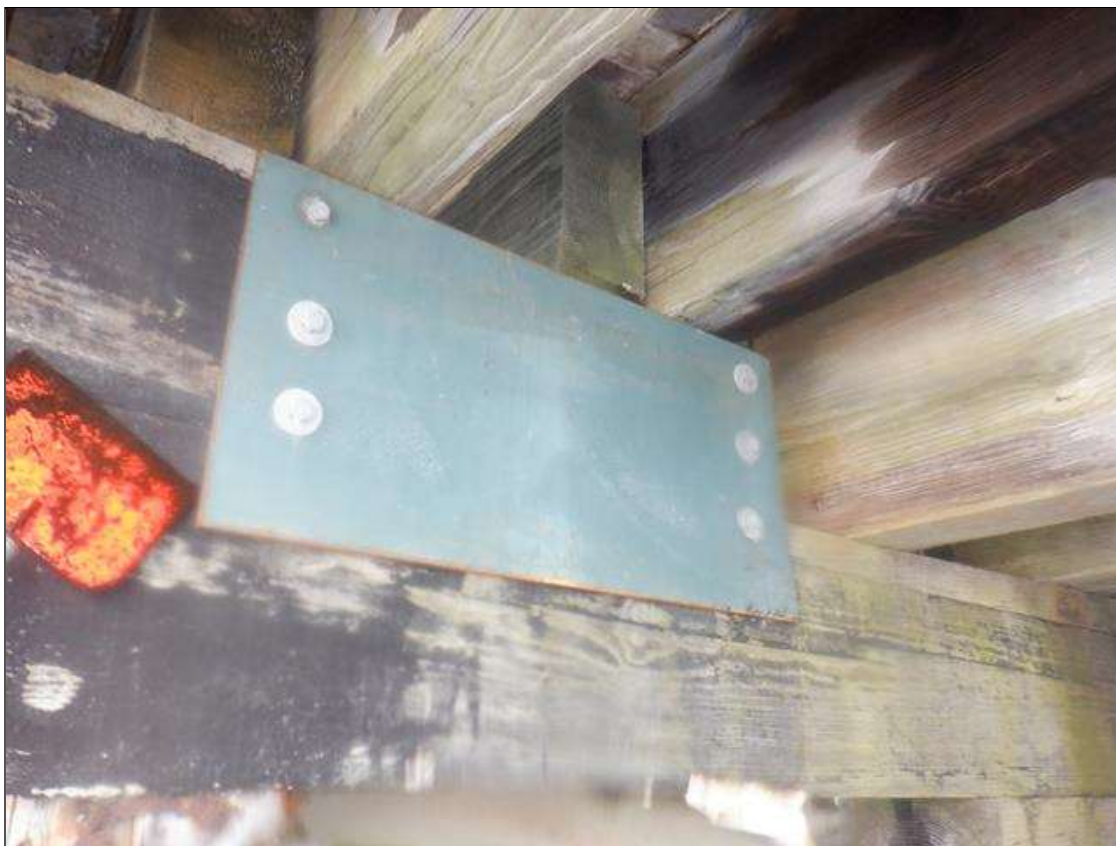
Bent 2 Cap: PEDESTRAIN WALKWAY SUBCAP HAS BEEN REPAIRED WITH A STEEL SPLICE PLATE.

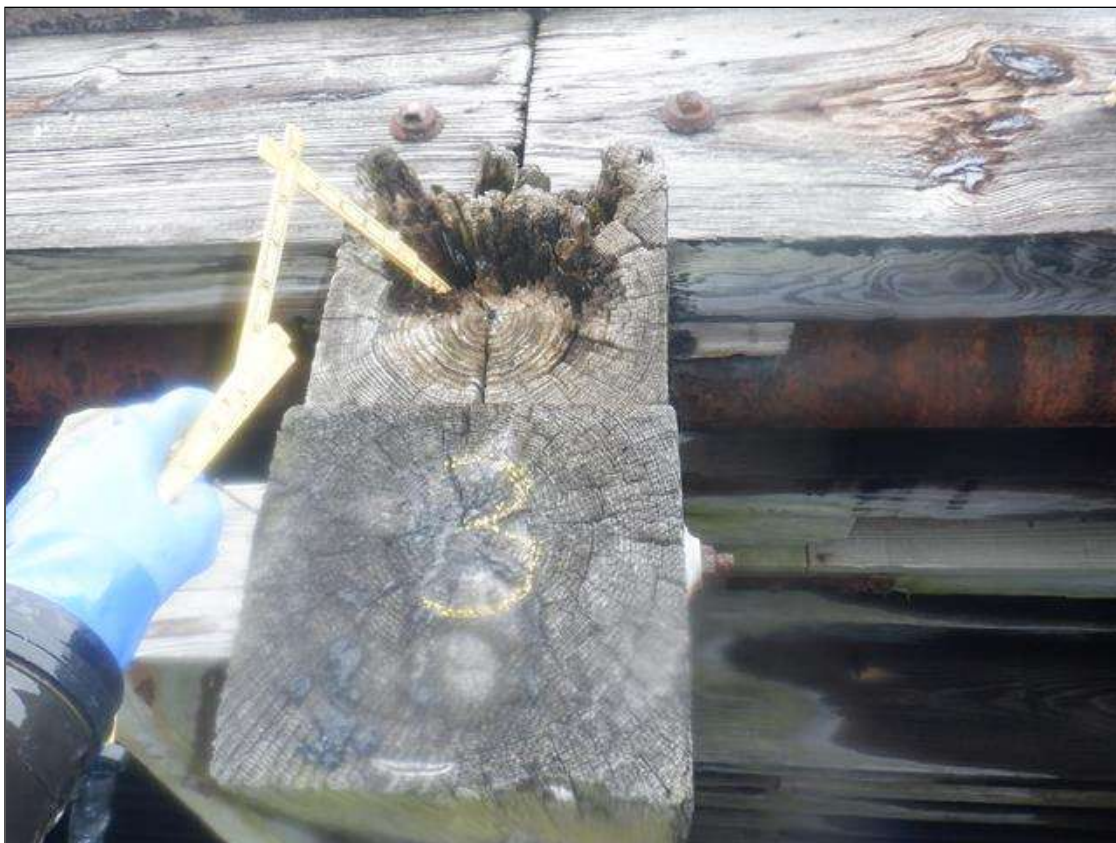
Bent 3 Cap: PAR: PEDESTRAIN WALKWAY SUBCAP HAS DECAY ON EAST END IN CENTER. 9 INCH DIAMETER X 9 INCHES DEEP.

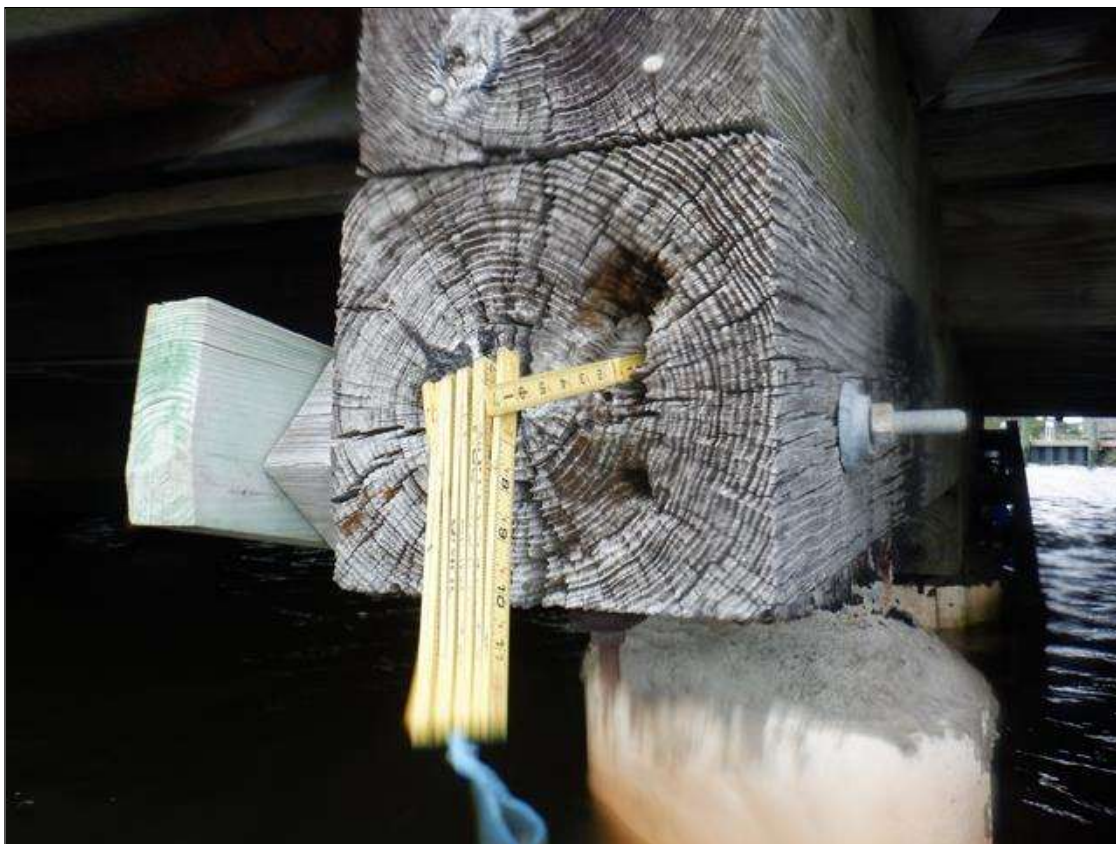
Bent 4 Cap: PAR: EAST END OF CAP AT CENTER, DECAYED AREA 8 INCH DIAMETER X 13 INCHES DEEP.
