**BRIDGE INSPECTION RECORD AND SUMMARY  
FOR SHORED STRUCTURES OR STRUCTURES  
WITH TEMPORARY REPAIRS MADE TO KEEP  
A BRIDGE OPEN**

BRIDGE: **270008** COUNTY: **Dare** DATE: **5/7/2012**

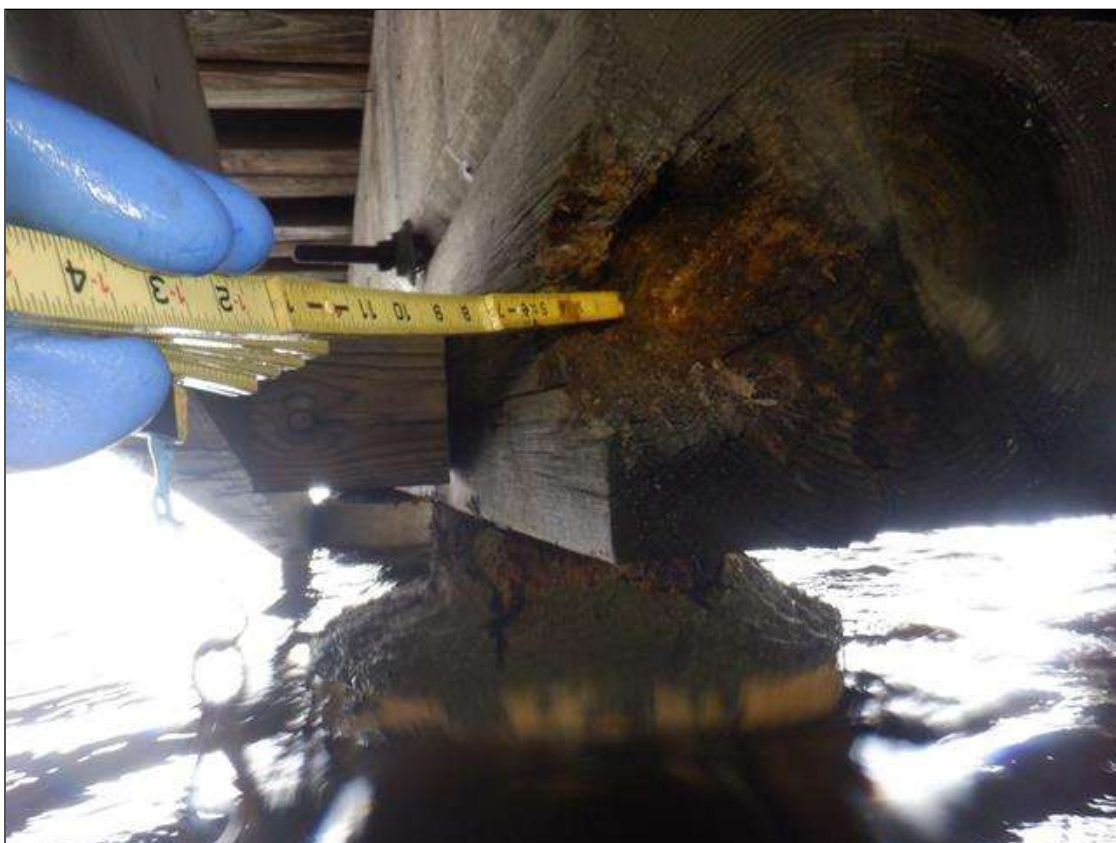
Bent 4 Cap: PAR: BENT 4 SUBCAP WEST END HAS AN AREA OF DECAY 6 INCH DIAMETER X 6 INCHES DEEP.

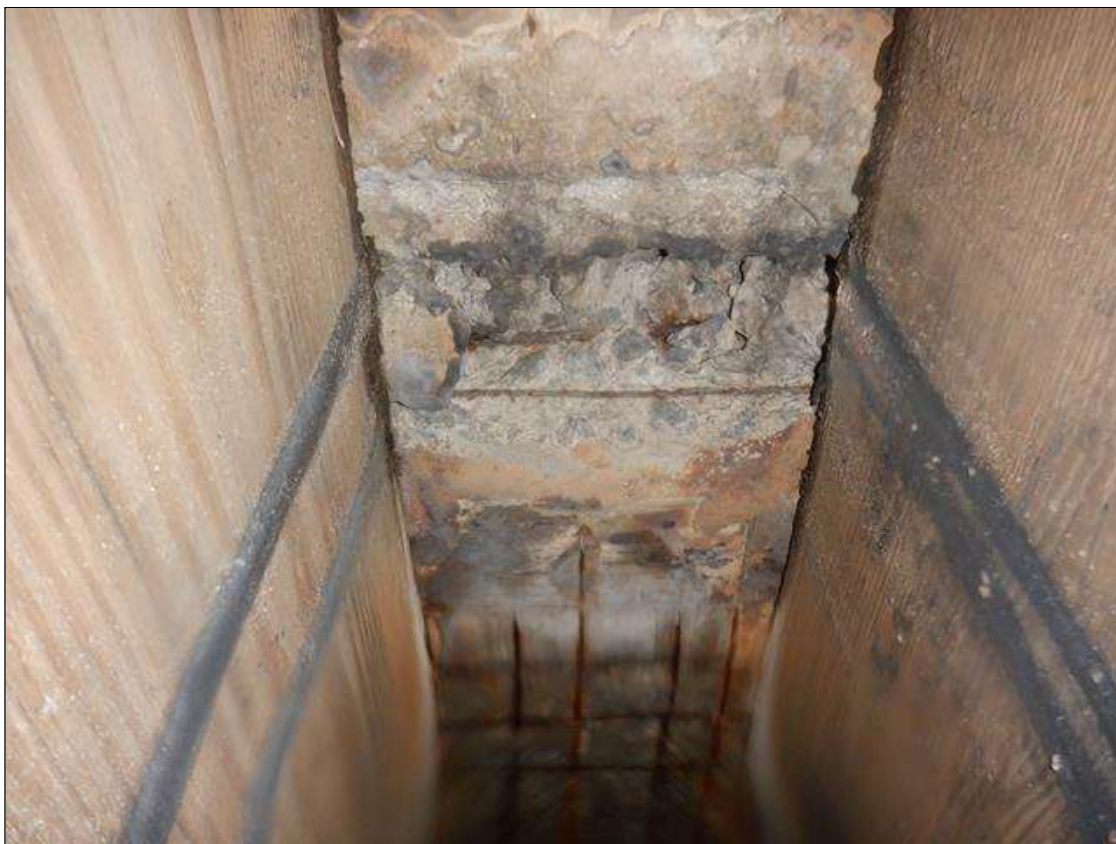
OPEN AREA ON EXPANSION JOINT ALLOWING DEBRIS AND WATER LEAKAGE THROUGH.

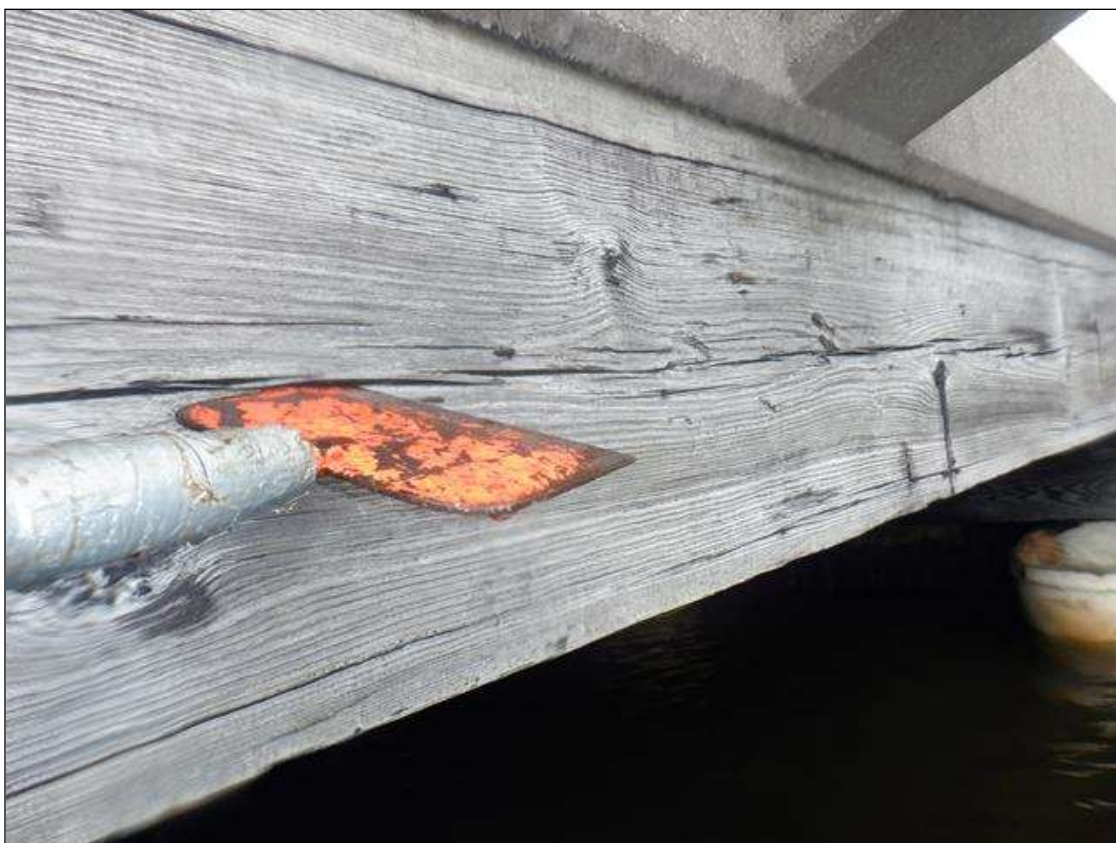
EXTERIOR JOISTS HAVE CHECKS TO .25 INCH WIDE, WEATHERED, AND SOFT TO .50 INCH DEEP

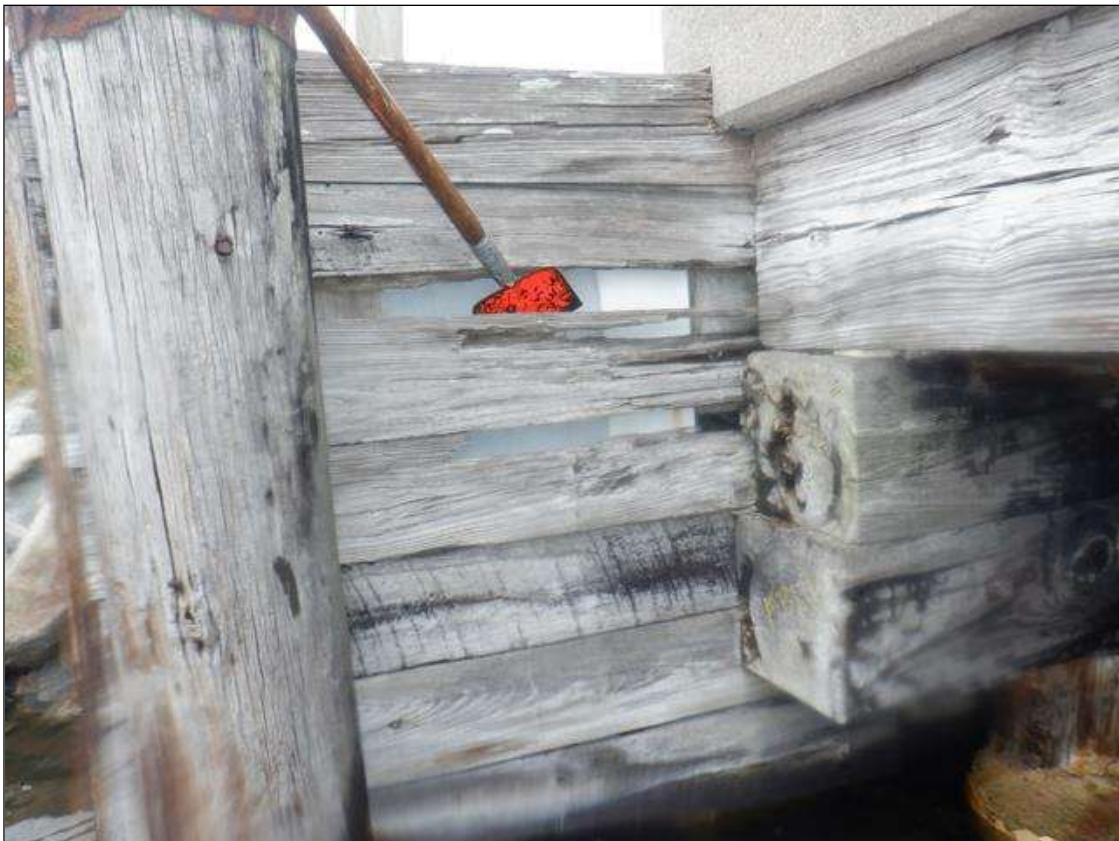
VINYL SHEETING HAS BEEN DRIVEN BEHIND SOUTH EAST TIMBER ABUTMENT. GOOD CONDITION

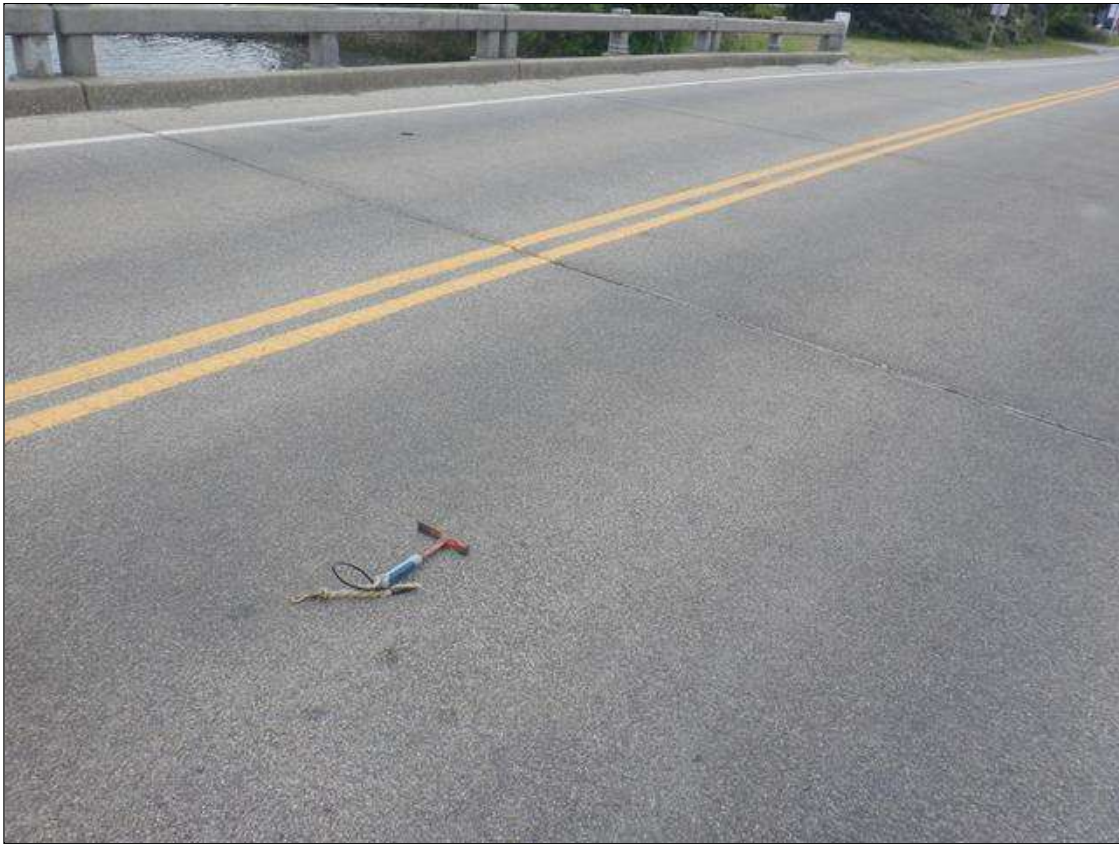
EPOXY WEARING SURFACE OVERVIEW

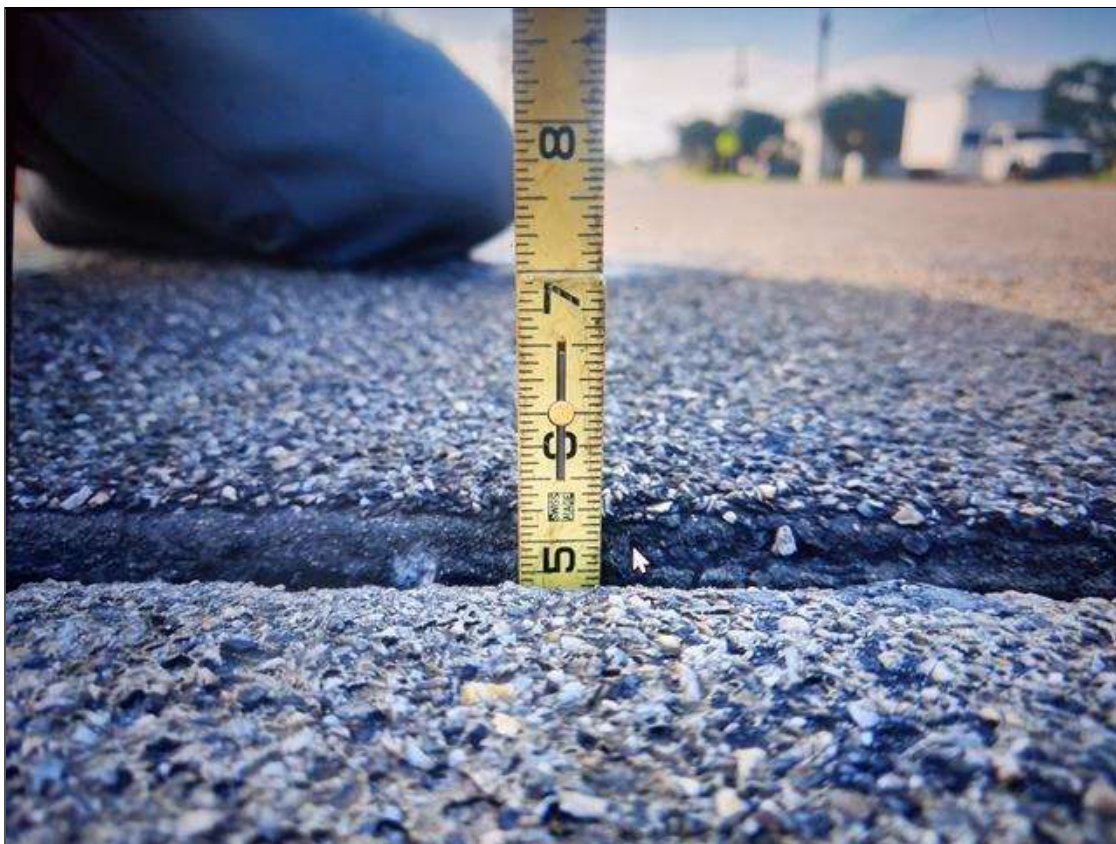
EPOXY WEARING SURFACE IS .375 INCH THICK
