NC DEPARTMENT OF TRANSPORTATION

Structure Safety Report

Routine Eleme	nt Inspection - Cont	ract
COUNTY: DAVIDSON		80058	FREQUENCY: 24 MONTHS
FACILITY CARRIED: NC109		MILE	E POST:
LOCATION: 0.3 MI. N. JCT. SR2	266		
FEATURE INTERSECTED: US64			
LATITUDE: 35° 46' 17.63"	LONGITU	JDE: 80° 6' 6.59"	
SUBSTRUCTURE: END BENTS:	RC CAP ON TIMBER PILES,	INT.BENTS:RC POST & BE	AM
1@48'6 ,1@47'6,1@39 SPANS: <mark>2@47'6 ,1@39'6</mark>	9'6		
	TEMPORARY SHORING	SCOUR CRITICAL	SCOUR PLAN OF ACTION
PRESENT CONDITION: Poor		INSPECTION DATE: 01/0	7/2016
POSTED SV: Not Posted		POSTED TTST: Not P	Posted
OTHER SIGNS PRESENT: 4 DE	LINEATORS, 4 VERTICAL C	LEARANCE SIGNS

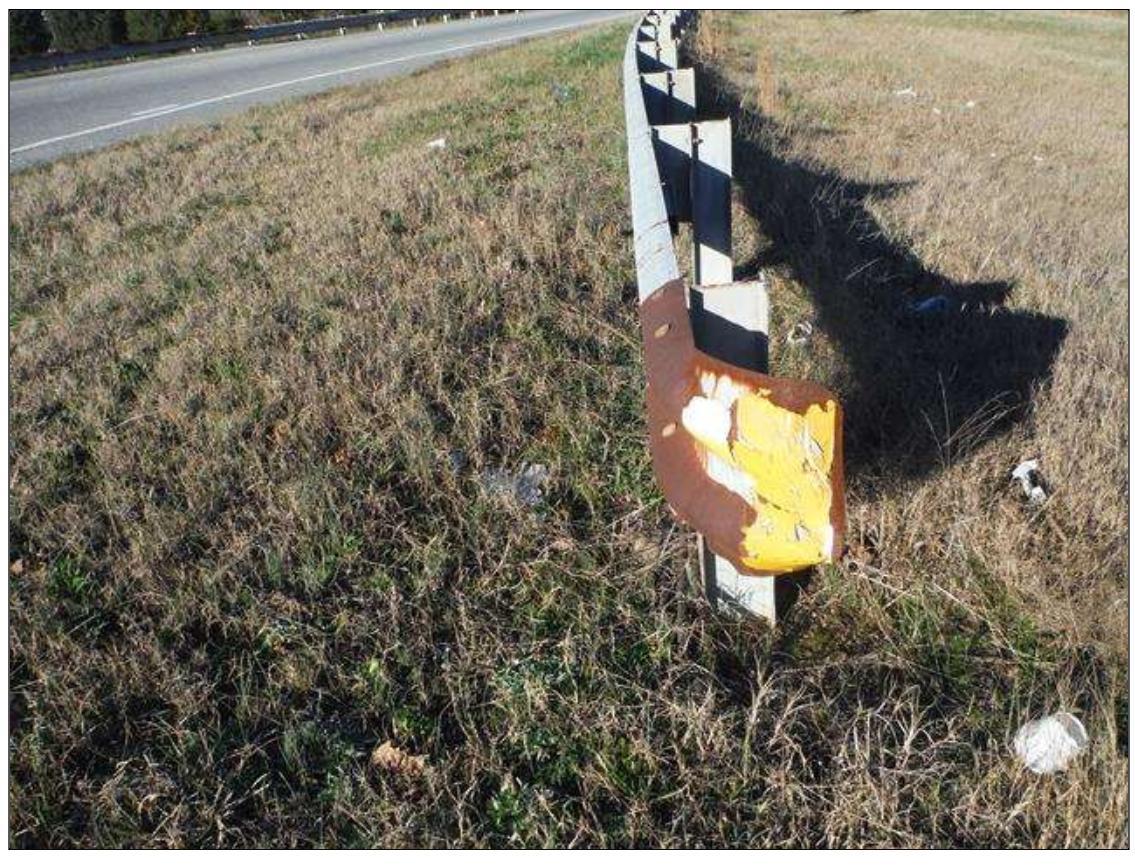
IMPACT DAMAGE TO GUARDRAIL END TREATMENT AT SOUTHEAST CORNER

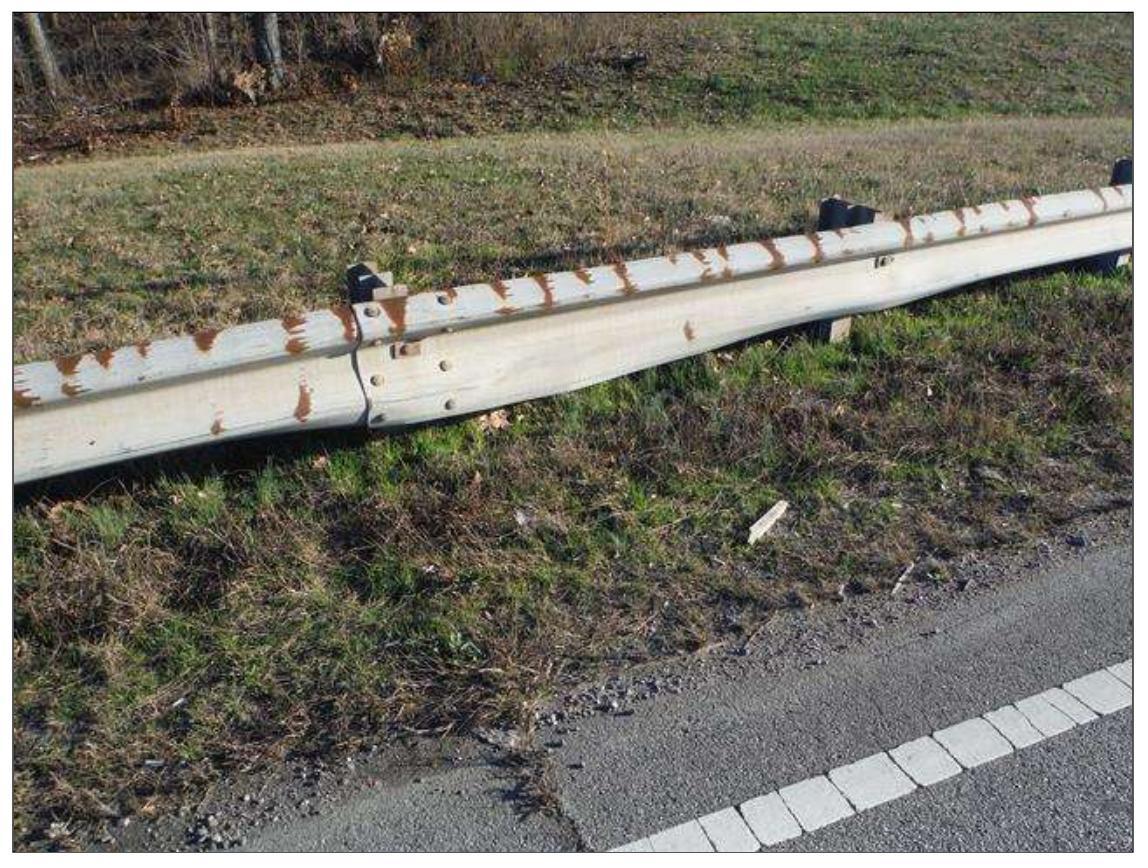
10 FT. OF IMPACT DAMAGE TO SOUTHEAST GUARDRAIL 50 FT. FROM BRIDGE

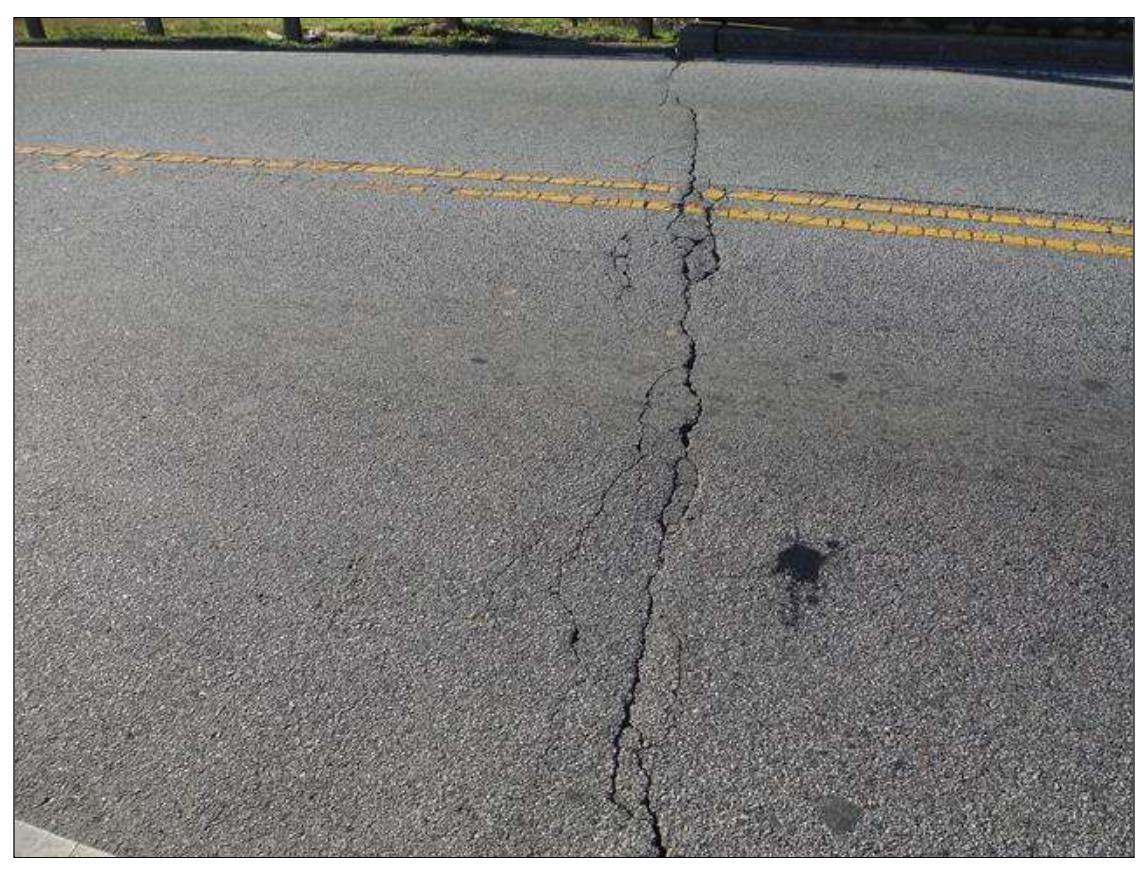
26 FT. LONG TRANSVERSE CRACK AT END BENT 1

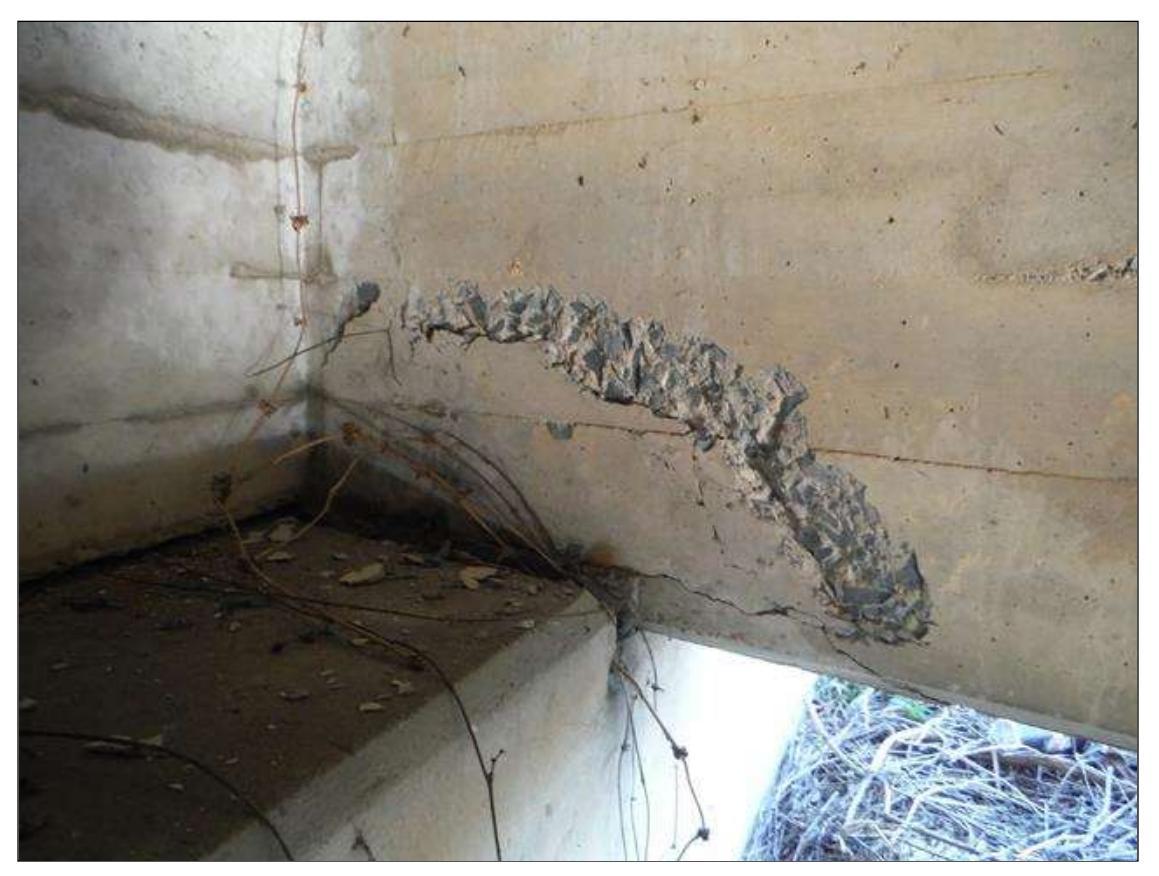
29" X 12" DELAMINATION IN WEST FACE AT END BENT 2

Span 3 Beam 4: 29" X 12" DELAMINATION IN WEST FACE AT END BENT 2

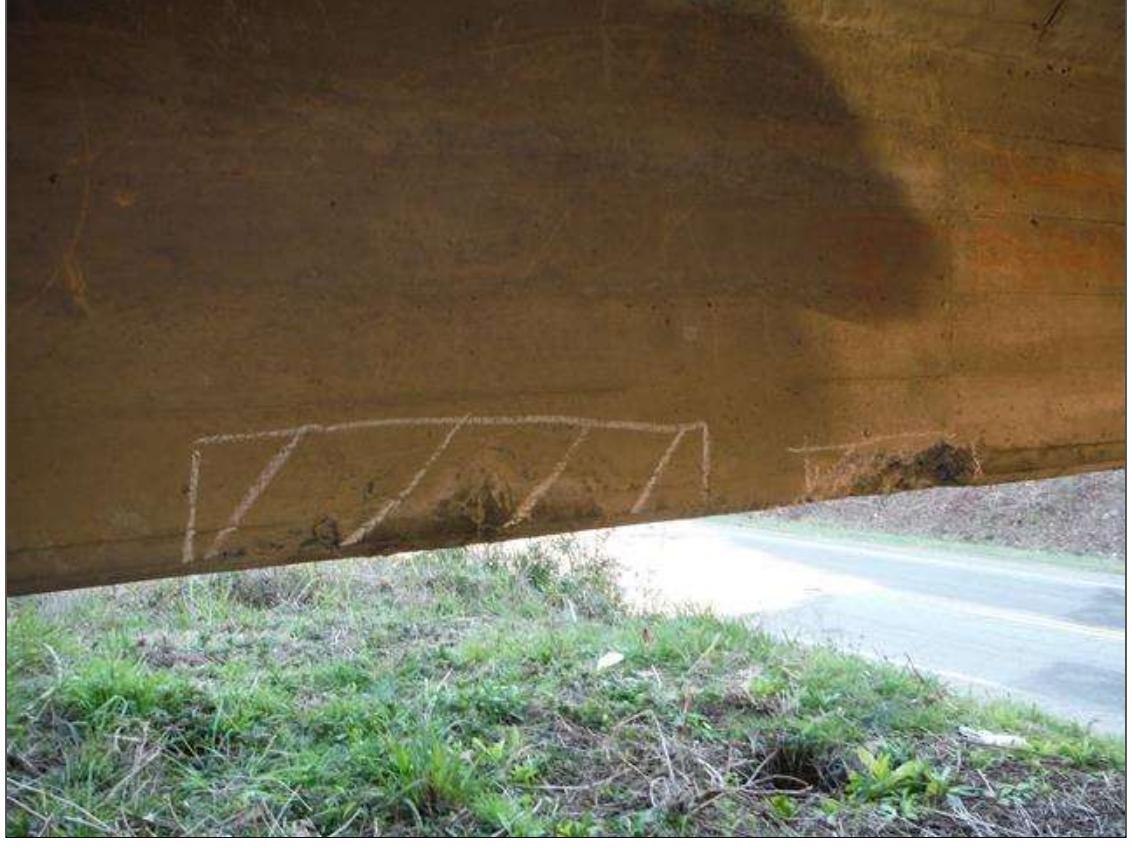
28" X 6" DELAMINATION AND 14" X 4" X 3" DEEP SPALL IN WEST FACE 10 FT. FROM END BENT 2

Span 3 Beam 4: 28" X 6" DELAMINATION AND 14" X 4" X 3" DEEP SPALL IN WEST FACE 10 FT. FROM END BENT 2

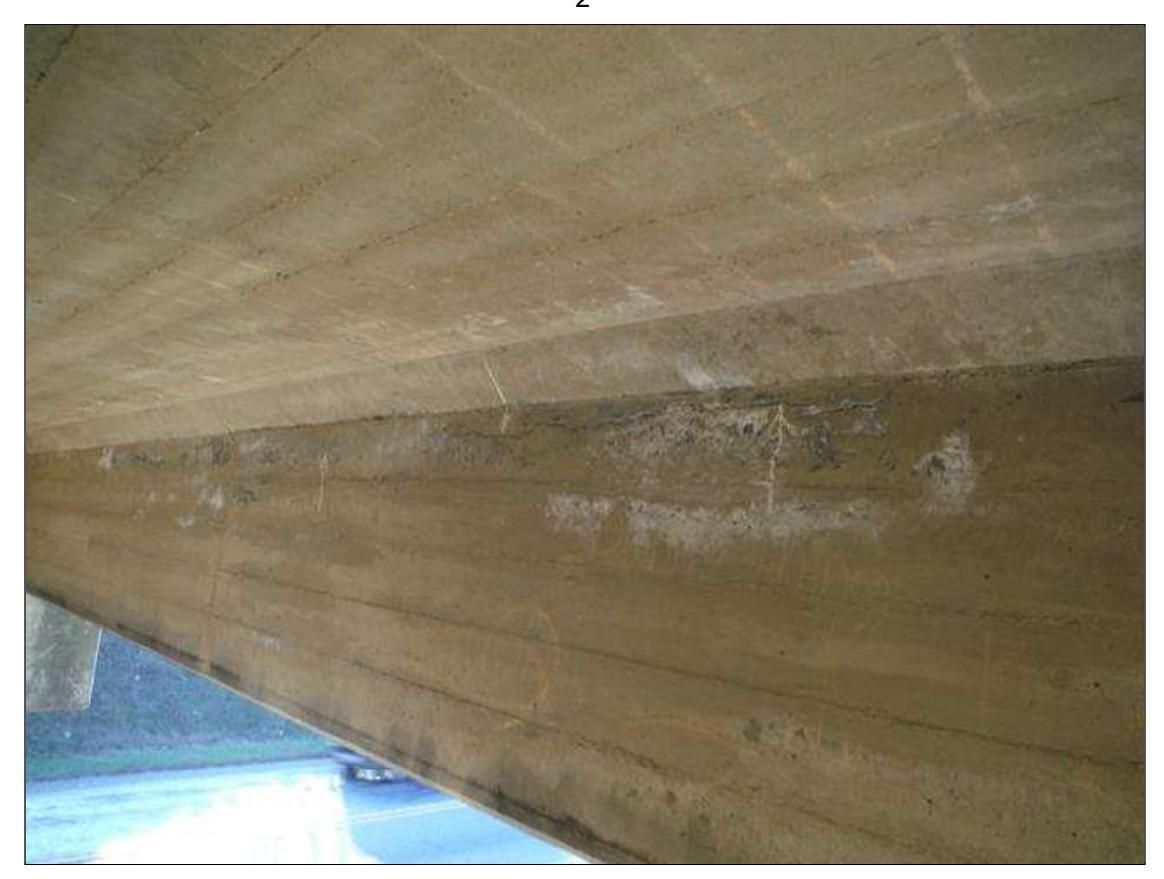
Span 3 Beam 1: 10 FT. LONG LONGITUDINAL CRACK 1/16" WIDE IN EAST FACE NEAR MIDSPAN

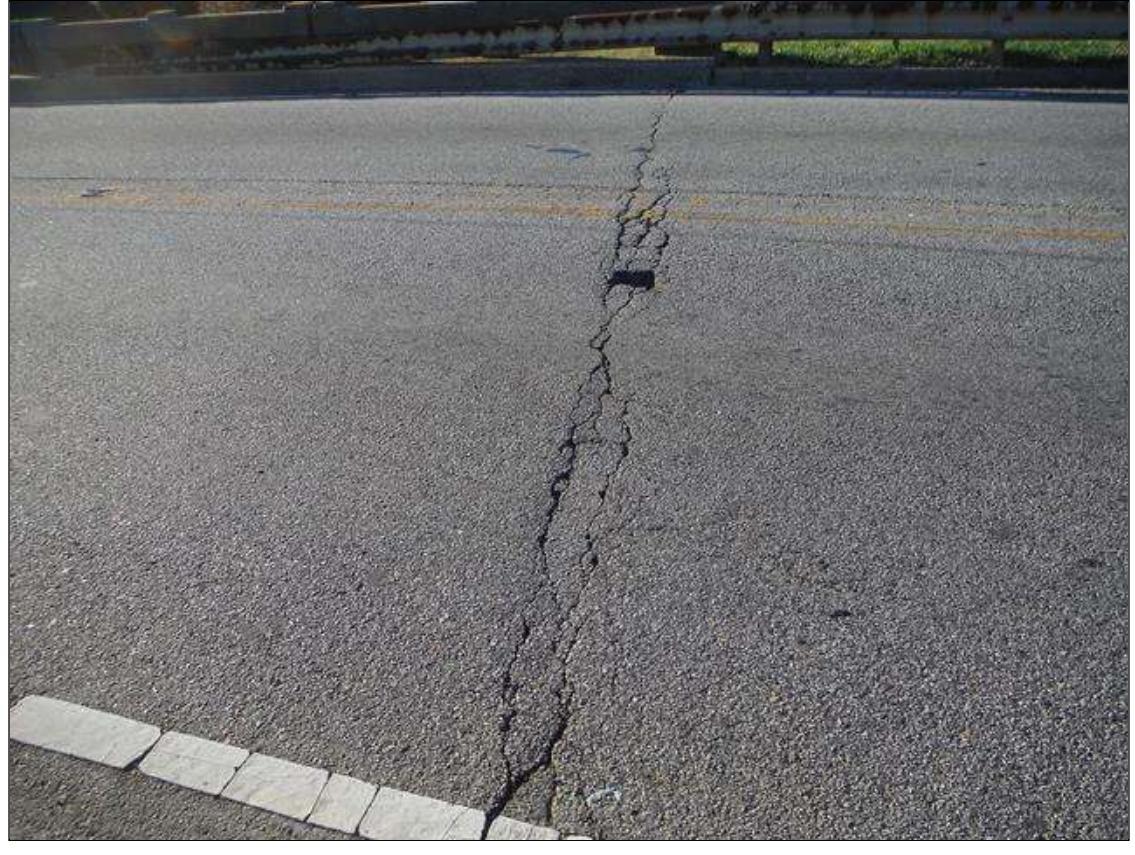
Span 3 Wearing Surface: 6" DIAMETER X 2" DEEP POTHOLE AT END BENT 2

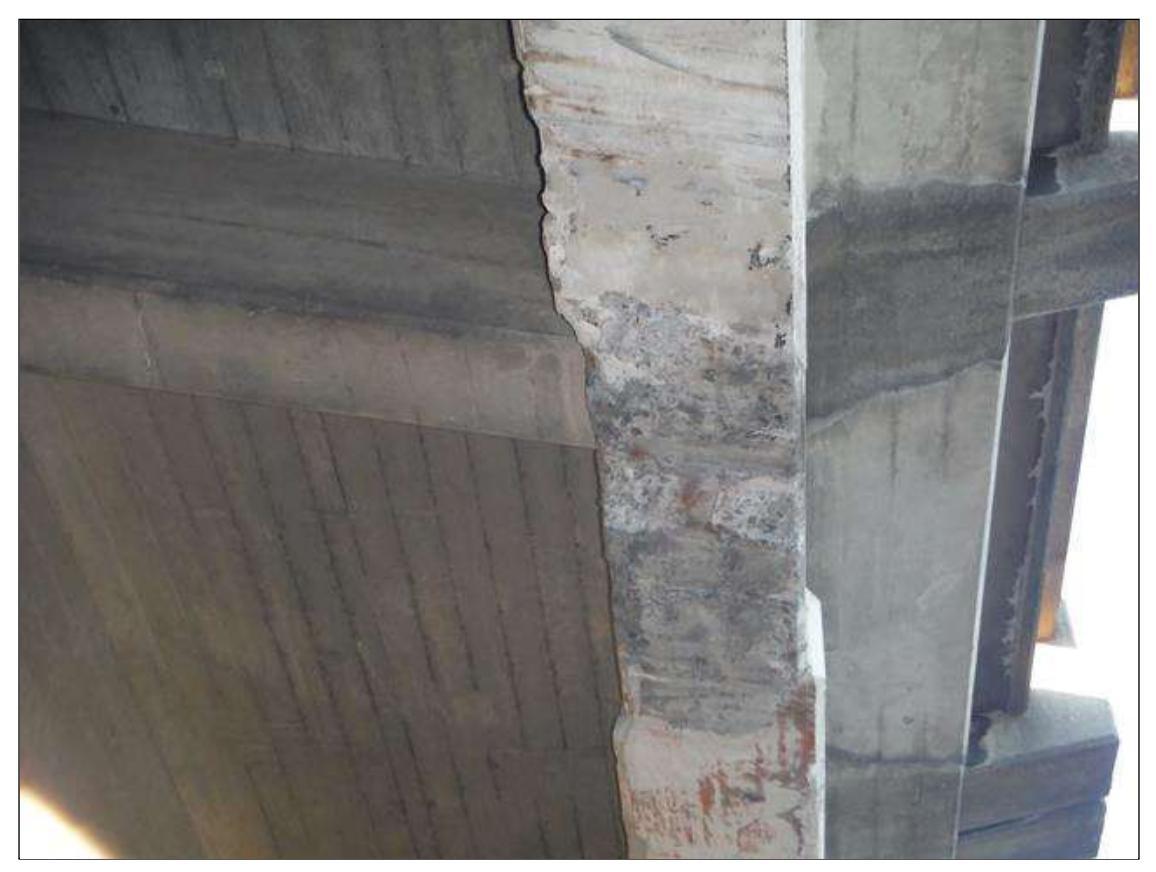
Span 2 Beam 4: 48" X 18" X 1" DEEP SPALL FROM IMPACT DAMAGE AT MIDSPAN

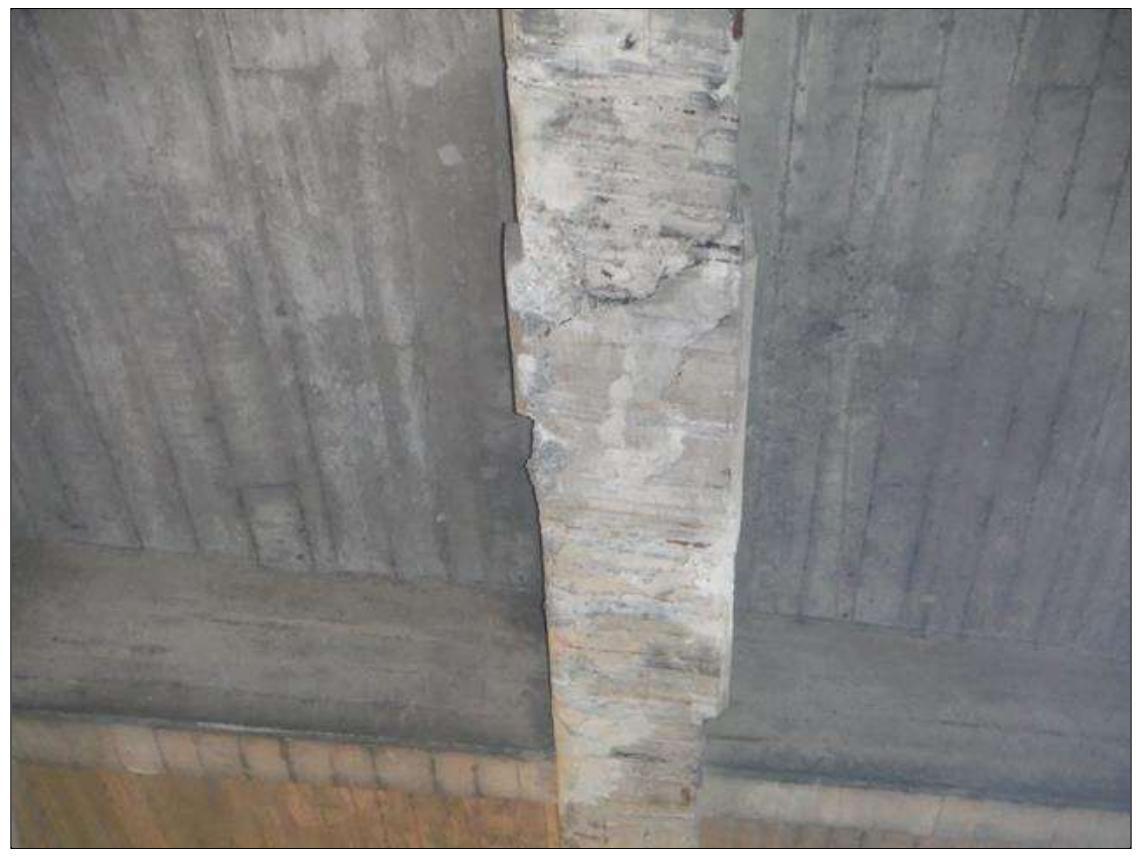
Span 2 Beam 3: 72" X 18" X 1" DEEP SPALL FROM IMPACT DAMAGE AT MIDSPAN

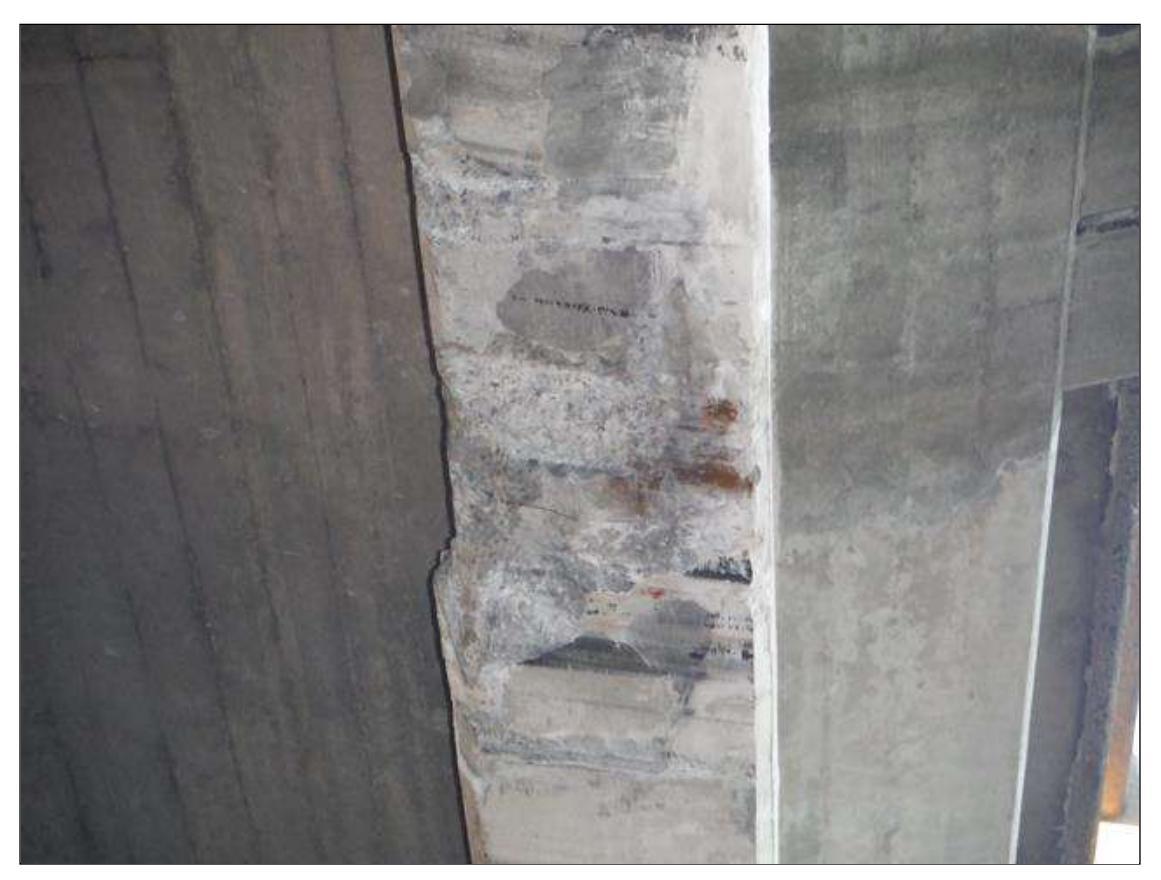
Span 2 Beam 4: 48" X 18" X 1" DEEP SPALL FROM IMPACT DAMAGE AT 1/4 POINT

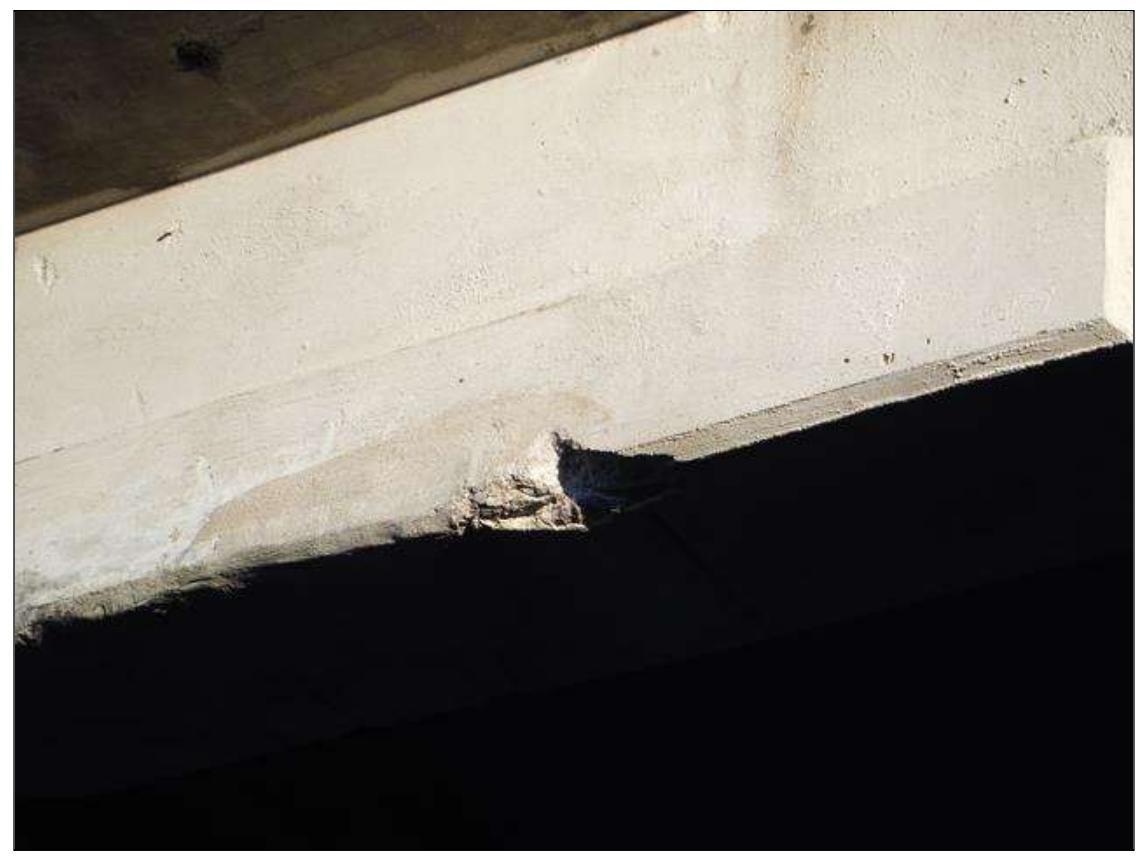
Span 2 Beam 1: 12" X 6" X 1" DEEP SPALL FROM IMPACT DAMAGE NEAR MIDSPAN

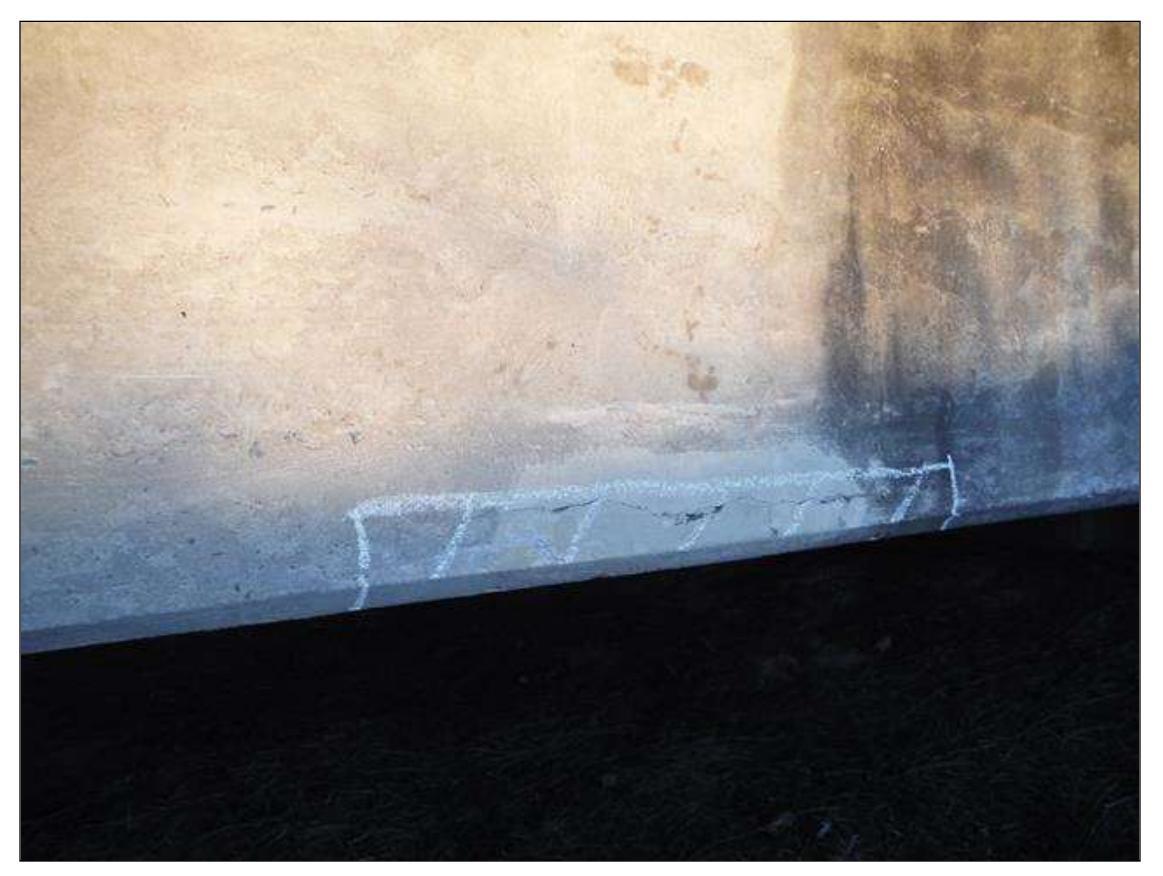
Span 1 Beam 1: 27" X 4" DELAMINATION IN WEST FACE NEAR MIDSPAN

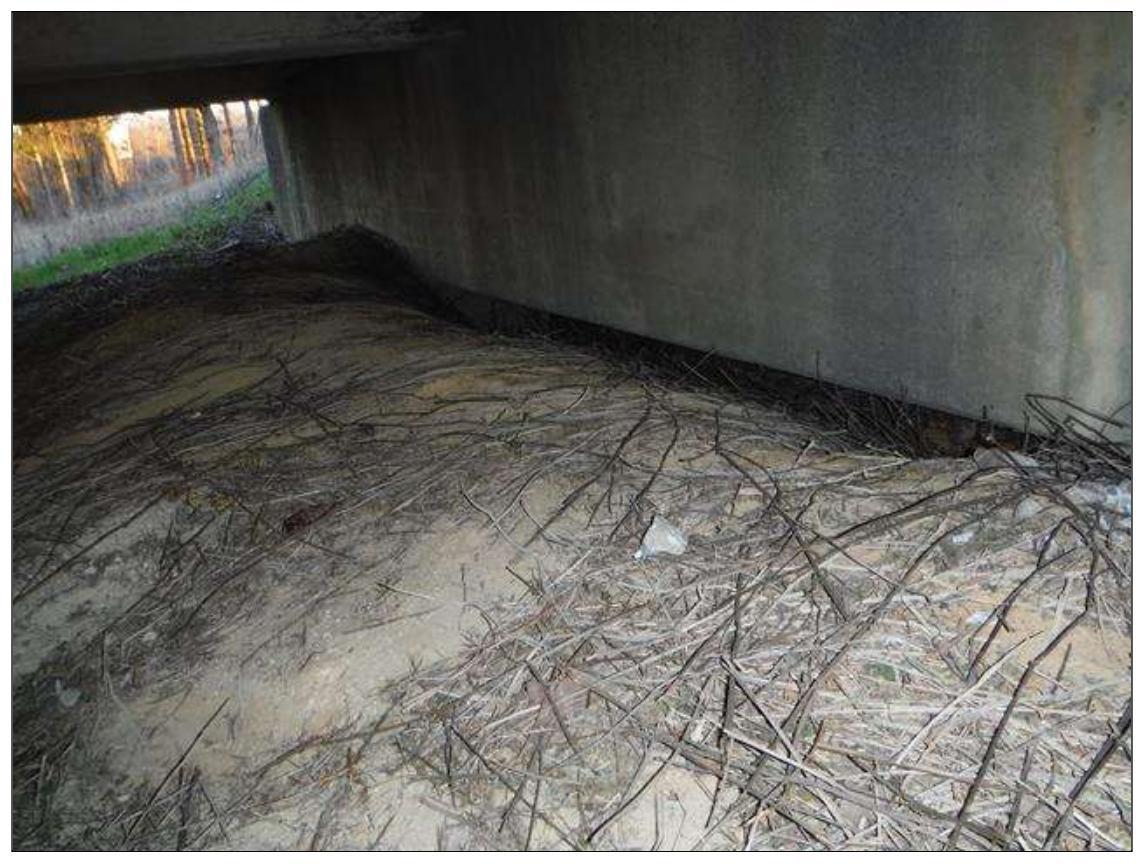
10 FT. LONG X 1 FT. HIGH AREA OF EROSION WITH 32" OF UNDERMINING OF END BENT 1 CAP UNDER BAYS 2 AND 3

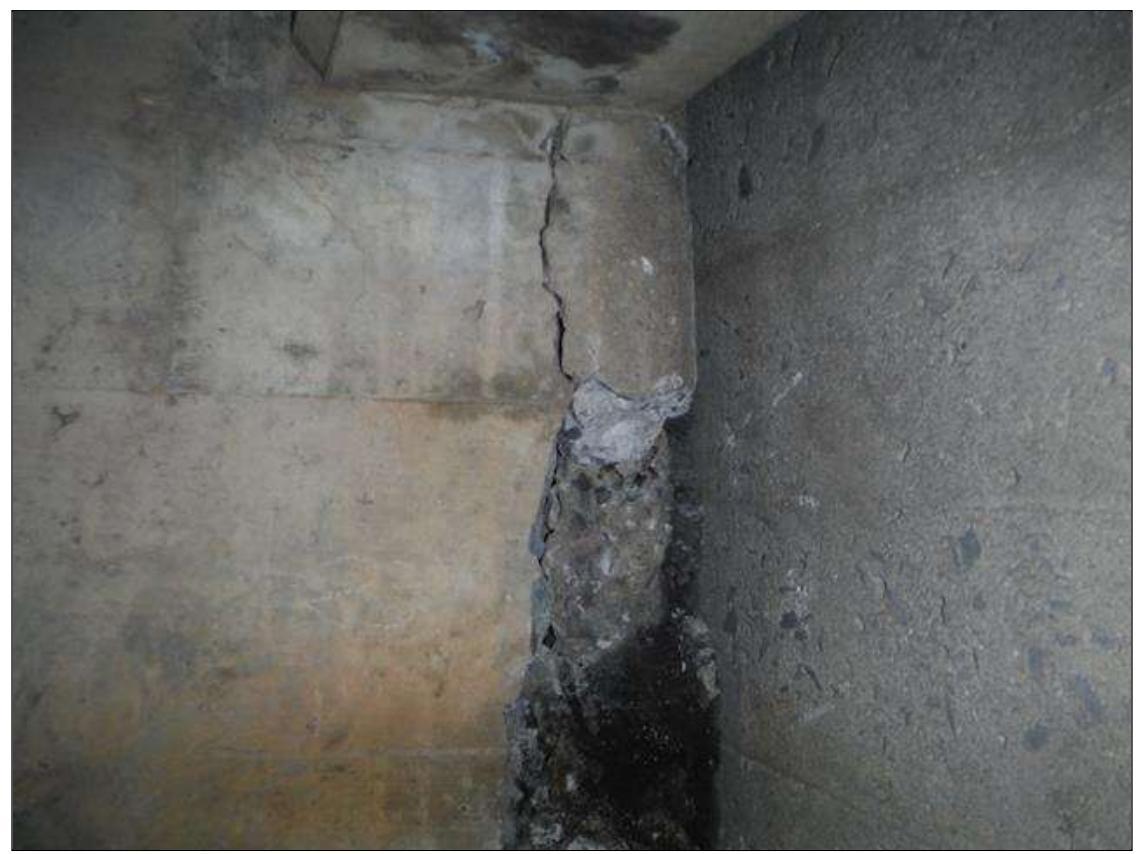
Span 1 Beam 2: 20" X 18" X 3" DEEP SPALL AT END OF GIRDER AT END BENT 1

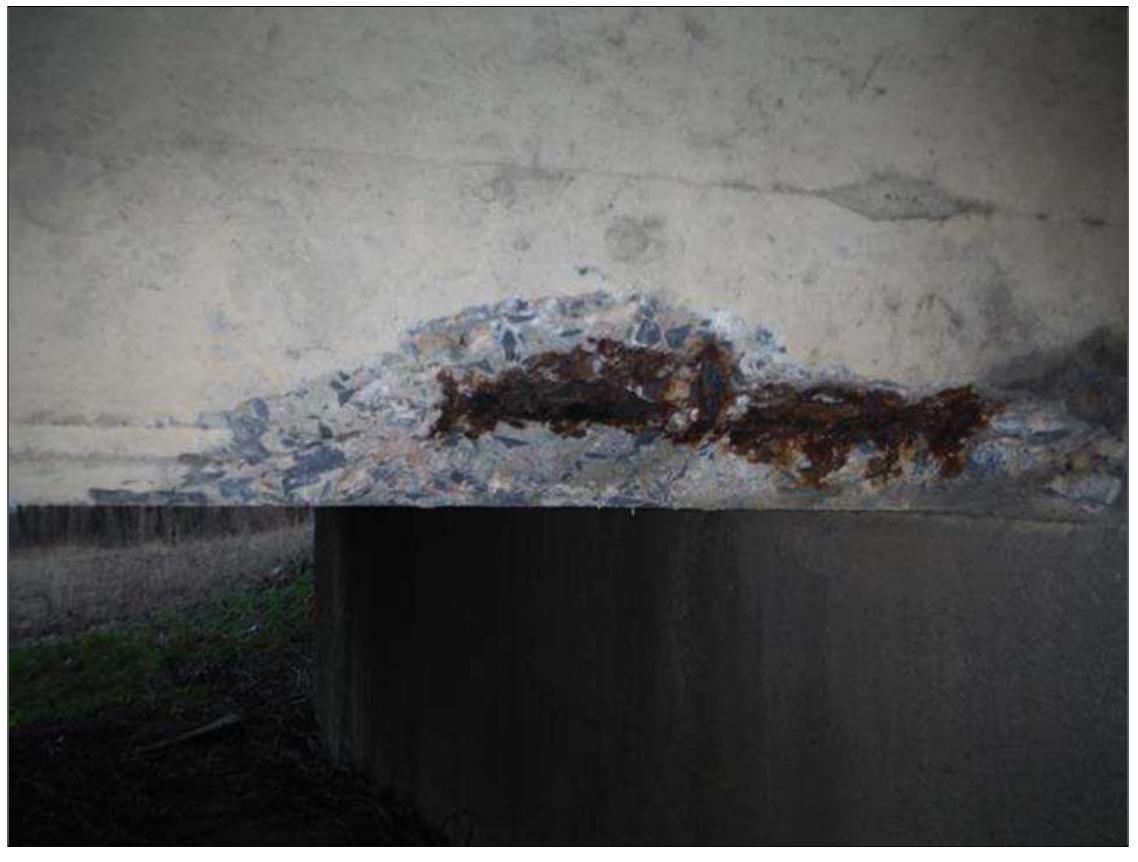
Span 1 Beam 3: 22" X 5" X 3" DEEP SPALL WITH EXPOSED REBAR IN WEST FACE AT END BENT 1

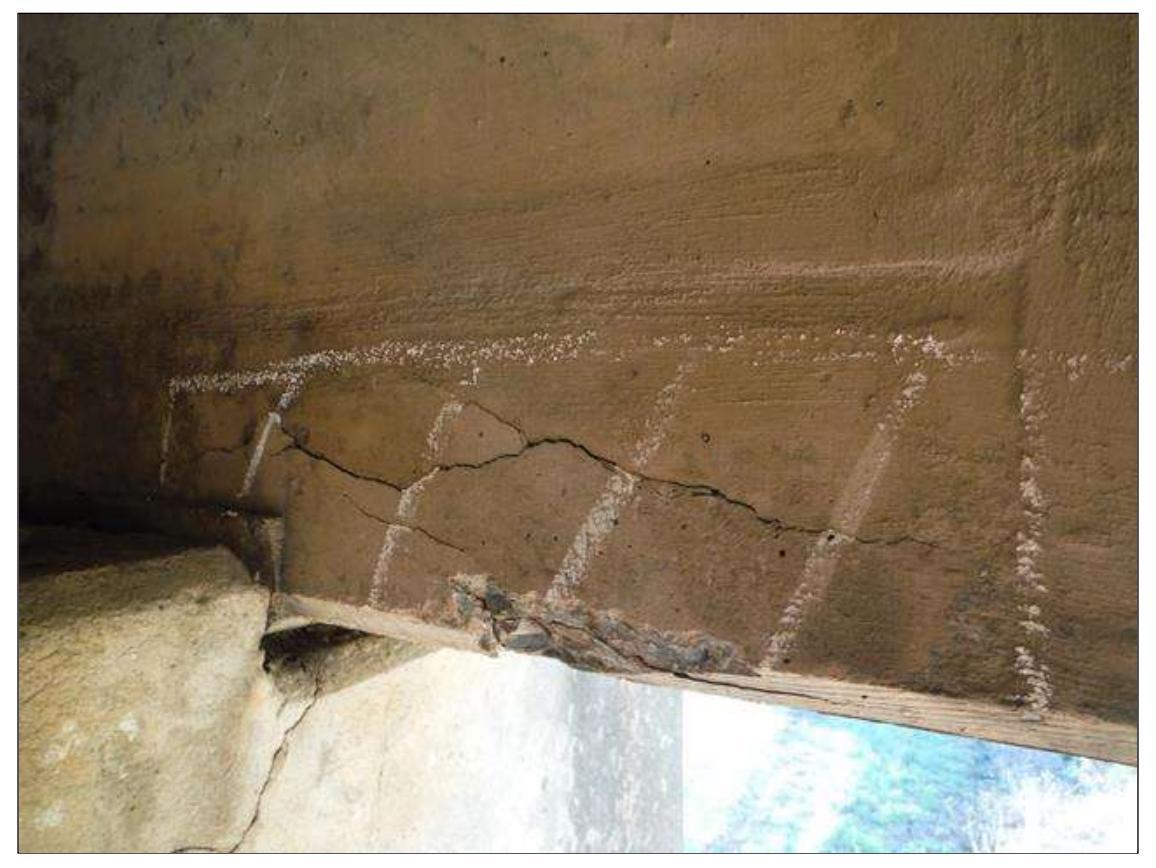
Span 3 Beam 1: 21" X 6" DELAMINATION IN EAST FACE AT BENT 2
