STATE OF NORTH CAROLINA
DEPARTMENT OF TRANSPORTATION

Subject: **REQUEST FOR THE LIFTING OF "ON HOLD STATUS"** for the Section 401 Water Quality Certification for the proposed replacement of Bridge No. 118 over Lanes Creek on SR 1937 (Old Pageland Marshville Road) in Union County, Federal Aid Project No. BRZ-1937(2); Division 10; TIP No. B-4652; WBS 33818.1.1.

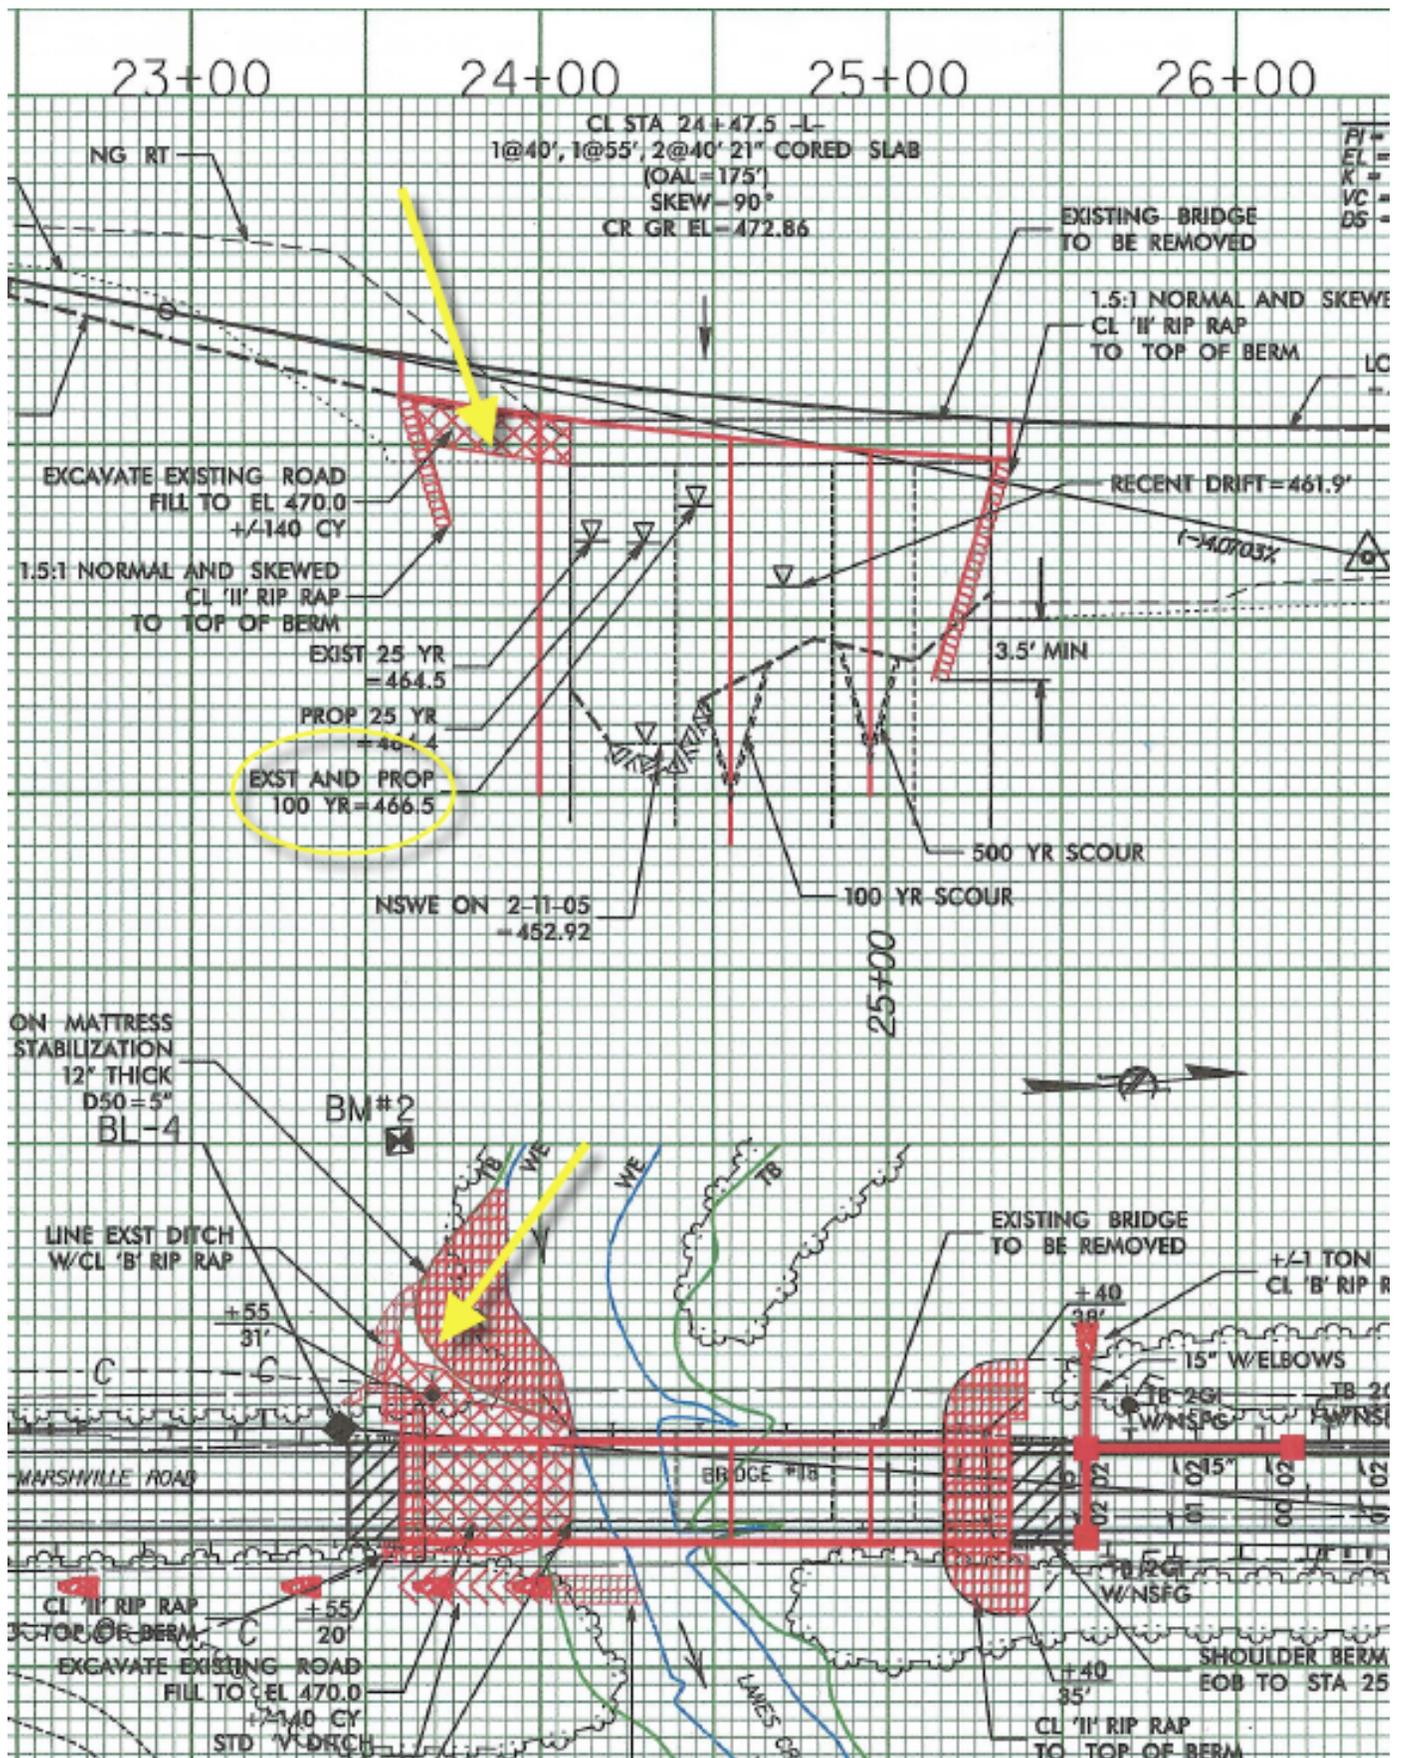
Figure 1

Though the current bank identified above is currently stable, it is evident that channel flow has, over time, impacted the upstream, right bank causing the channel to migrate behind the

existing bridge's end bent. This is shown in the enclosed Figure 1, which is the plan view from the Bridge Survey Report.

In the bridge profile view, also depicted in Figure 1, shows that despite having a longer proposed structure, it does not provide any additional significant flow area in the floodplain than the existing bridge. The excavation (hatching) shown on the left (right upstream bank-yellow arrow) has been done to provide minimal area for future structure inspections and not increased floodplain flow. The design year and 100 year flood events do not even reach this excavated area. The attached plan sheet with contours (Figure 3) may help display a clearer picture of the situation.

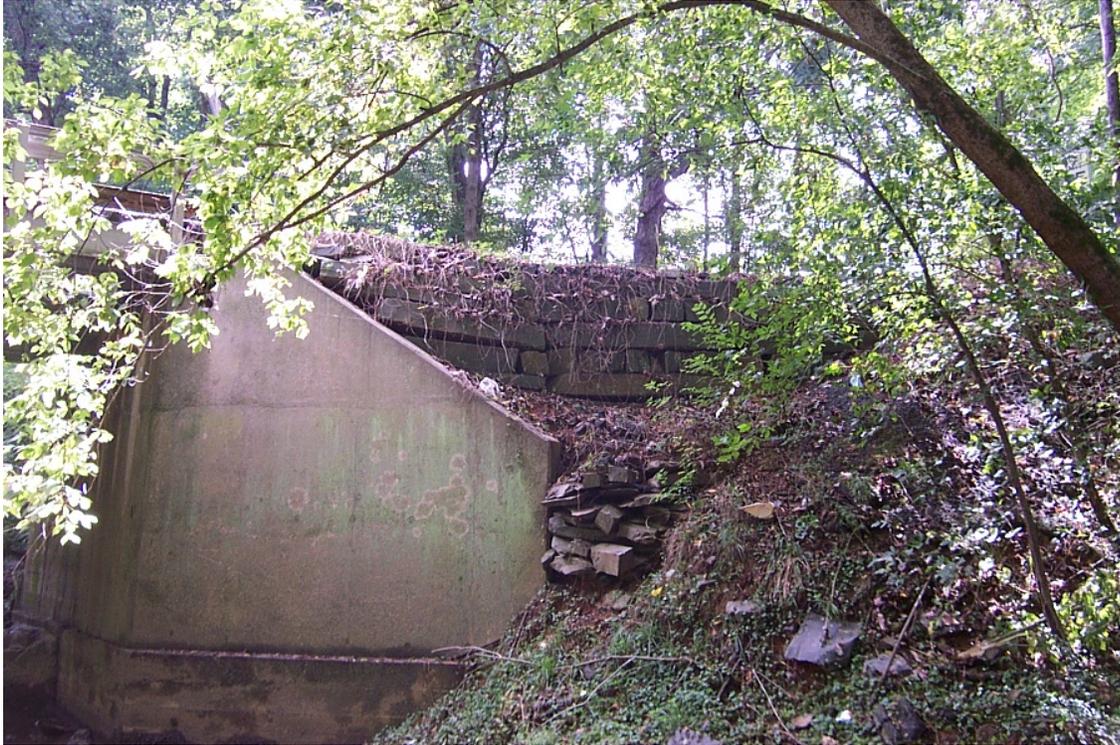
Photos are also included (Figure 2) which indicate damage from erosion of this bank, trees leaning in towards the channel and that this bridge has experienced flooding events exceeding the 100 year event (see the debris caught in the existing bridge's superstructure). NCDOT Hydraulics Unit designed a longer bridge per the Department's minimum bridge criteria which specifics that we set back the proposed bridge 10 feet or more from the top of bank (TB in the plan view below). We believe that the gabion mattress bank reinforcement is warranted to impede channel migration which could occur during excessive flooding events. This mattress is designed to be placed on top of the existing bank and stay in place (not launch stabilization material into the channel). If left unprotected, the channel migration could, over the life of the new structure, cause the right abutment to fail.

Right Upstream Abutment (same side as the bank in question).

In the Department's Hydraulic model, the average Design (25 year) channel velocities are near 7 feet per second. As flow impacts this bank, flow vortices and increased velocities occur which cannot be numerically determined without a much more complex hydraulic model. Therefore, the best structure, in this situation, to handle the velocities is the use of a gabion mattress.

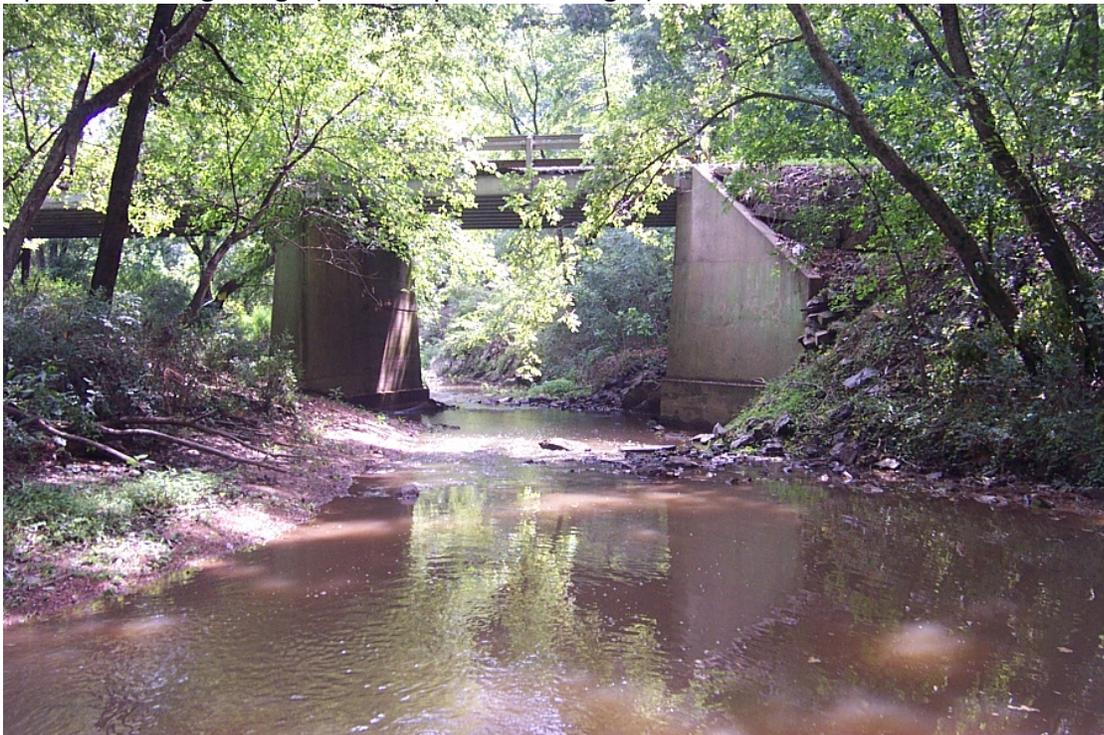
Upstream facing bridge (bank in question on right). Subsidence noted with bent trees.

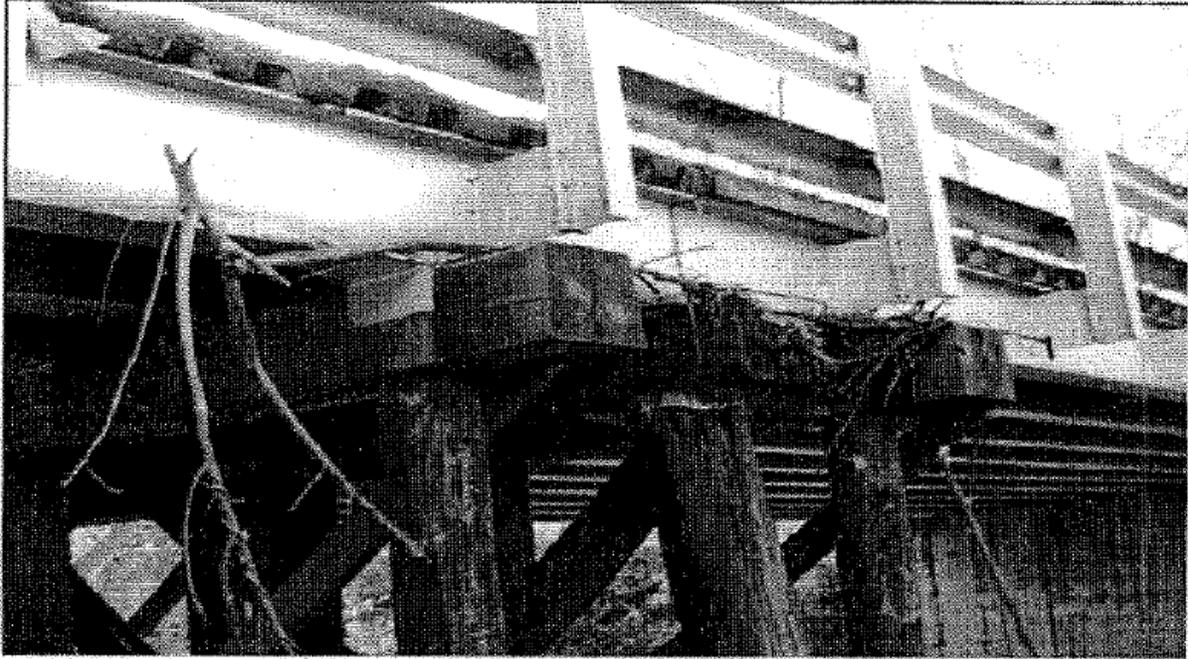
Condition Photos

HIGH WATER SIGNS ON THE CAPS
