NC DEPARTMENT OF TRANSPORTATION
 DIVISION OF HIGHWAYS
 STRUCTURE MANAGEMENT UNIT

ATTENTION: **PLATFORM TRUCK AND TRAFFIC CONTROL USED,
 PARS ISSUED**

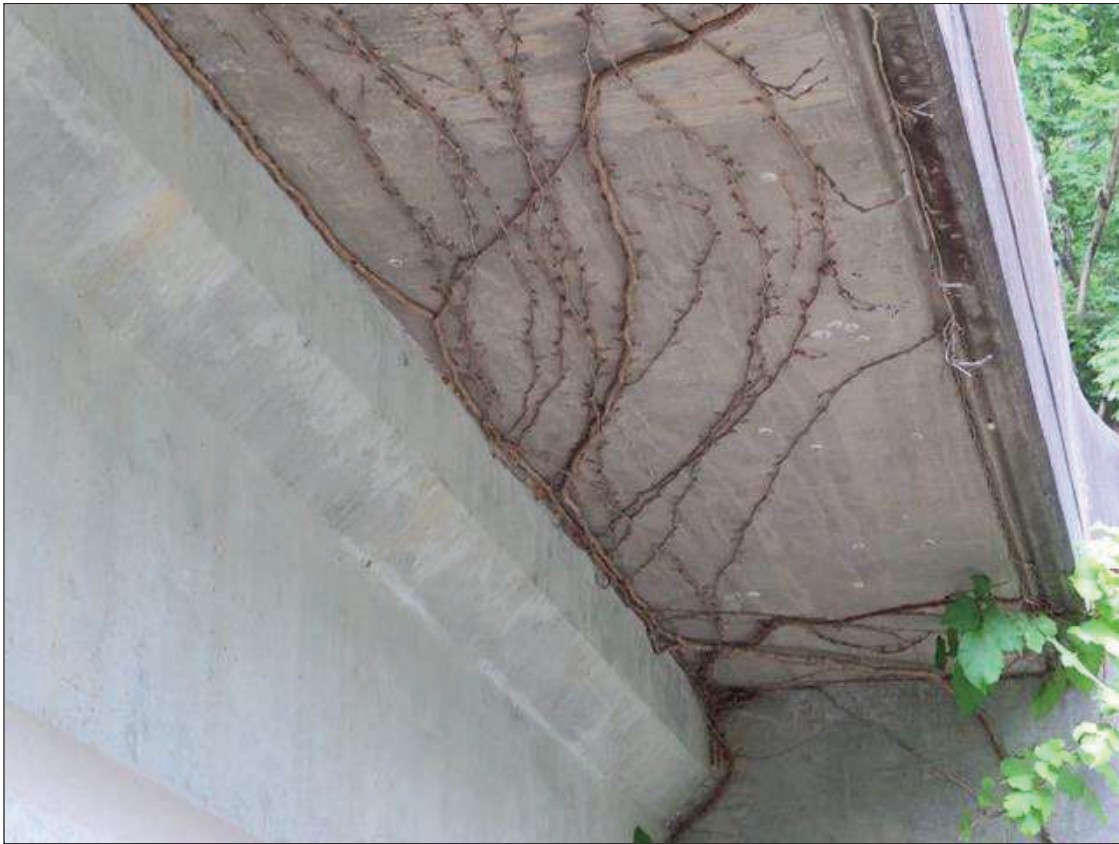
40 FEET OF VEGETATION GROWTH IN WEST OVERHANG

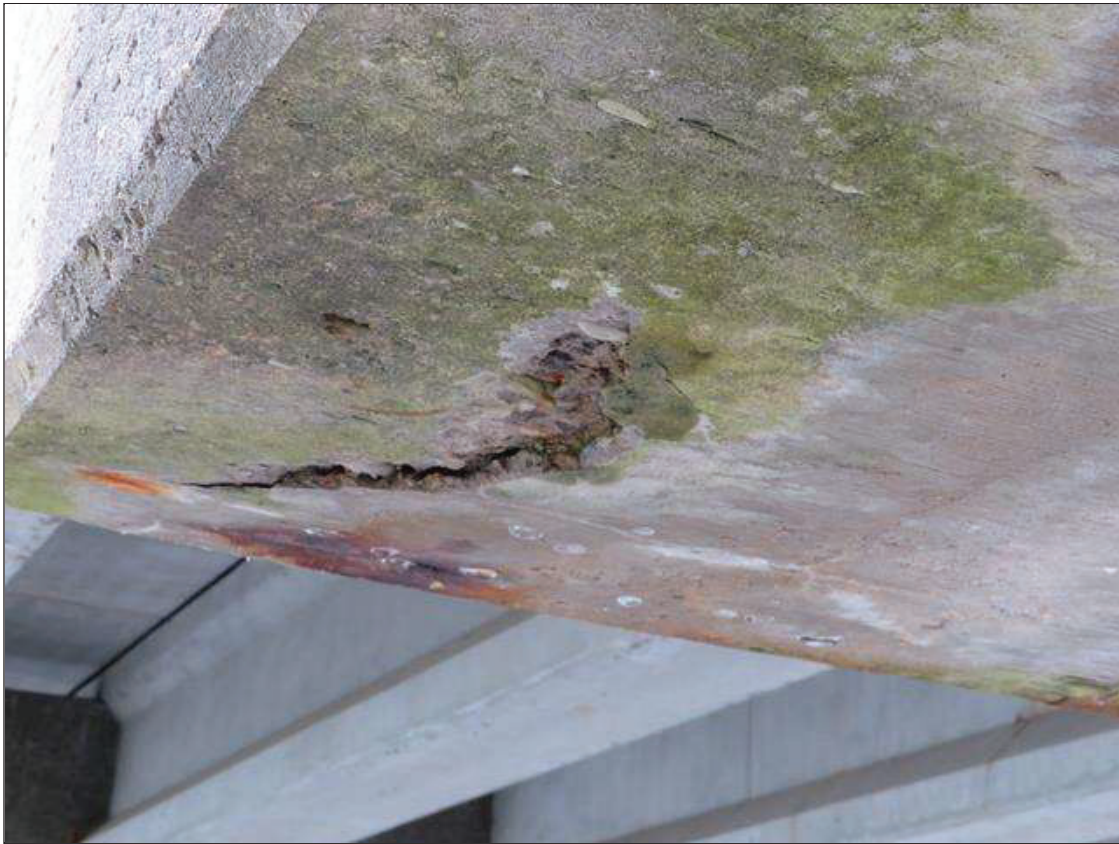
Bent 1 Cap 1: 12 INCHES DIAMETER X 1 INCH DEEP SPALL AND AREA OF DELAMINATION ON BOTTOM OF CAP AT WEST END

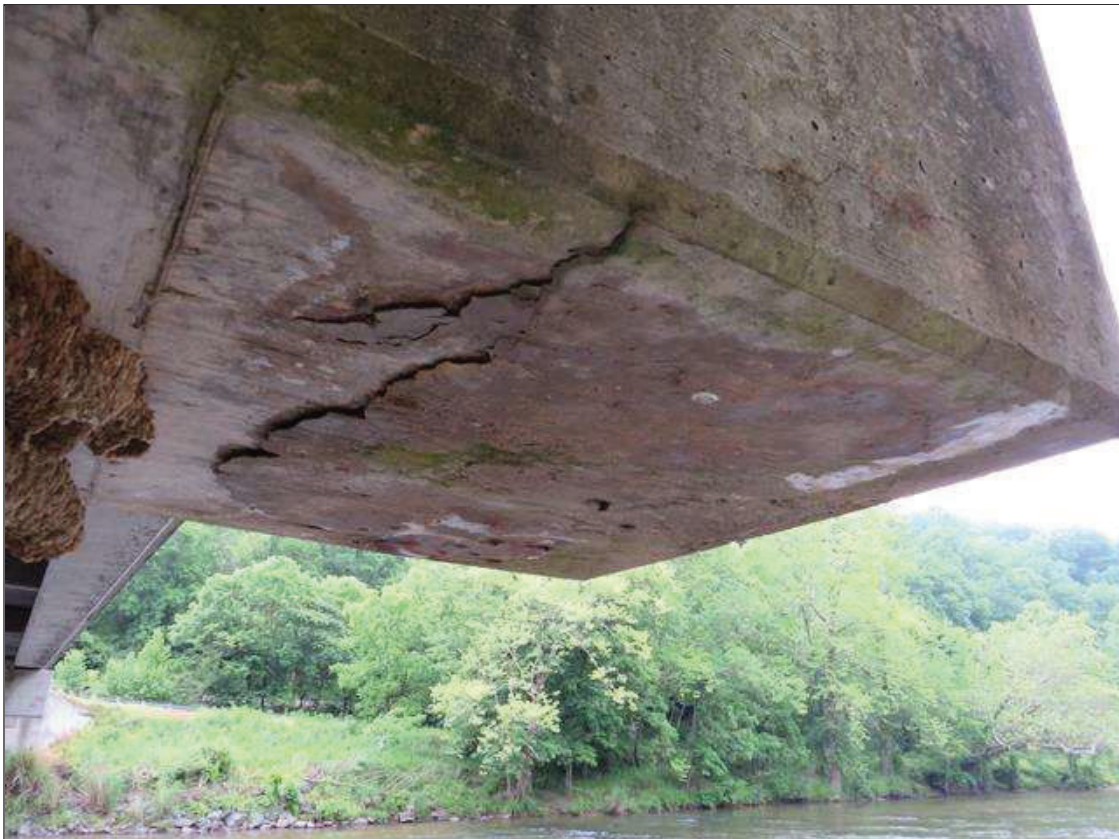
Bent 1 Cap 1: 22 INCHES LONG X 30 INCHES WIDE AREA OF DELAMINATION ON BOTTOM OF CAP AT EAST END

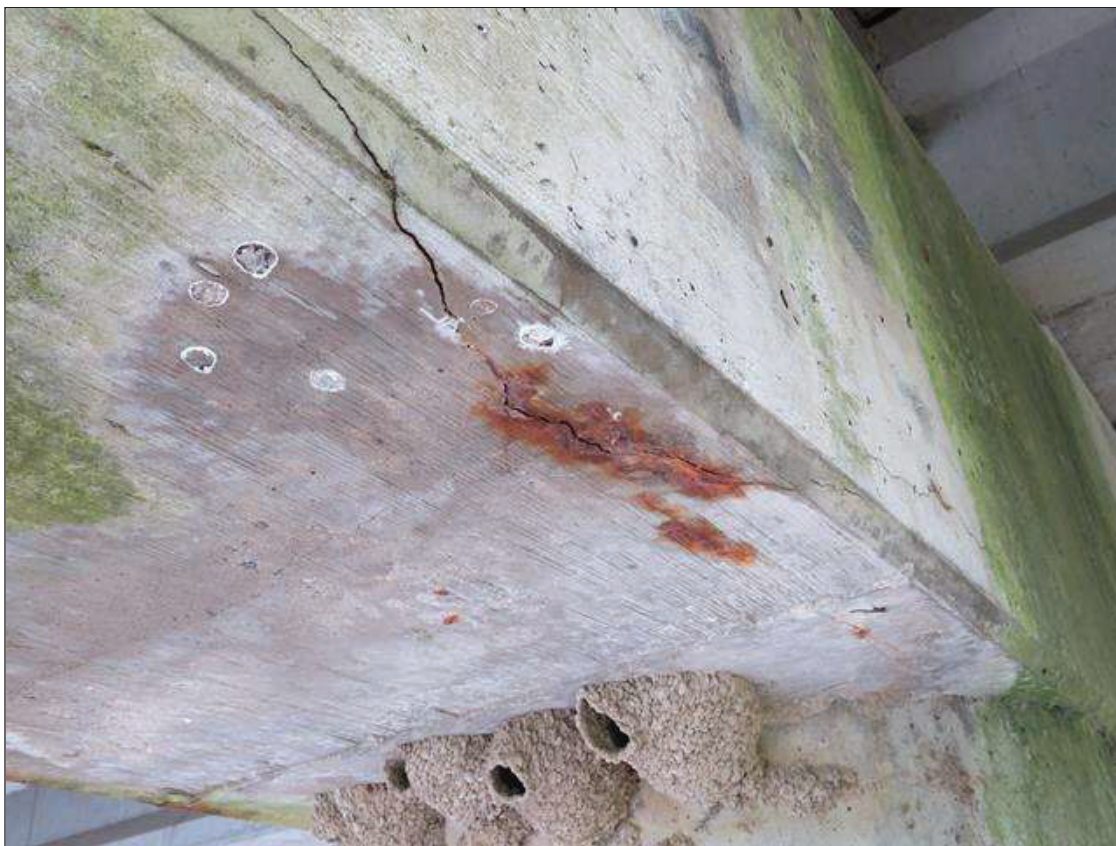
Bent 1 Cap 1: 5 FEET 1/16 INCH WIDE LONGITUDINAL CRACK WITH RUST STAINS ON BOTTOM OF CAP AT WEST END

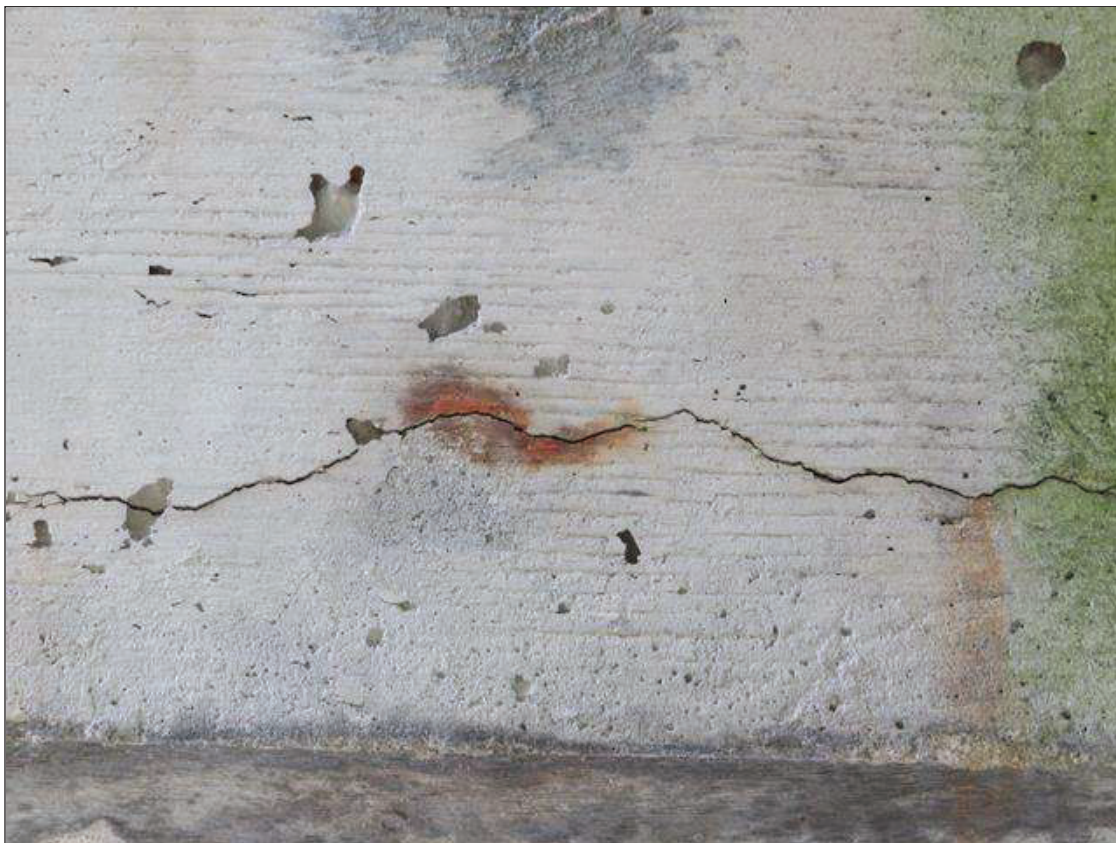
Bent 1 Cap 1: LOWER 3 INCHES OF THE CAP, SCATTERED ALONG THE LENGTH OF BOTH FACES HORIZONTAL CRACKING TO 1/16 INCH WIDE WITH RUST STAINING

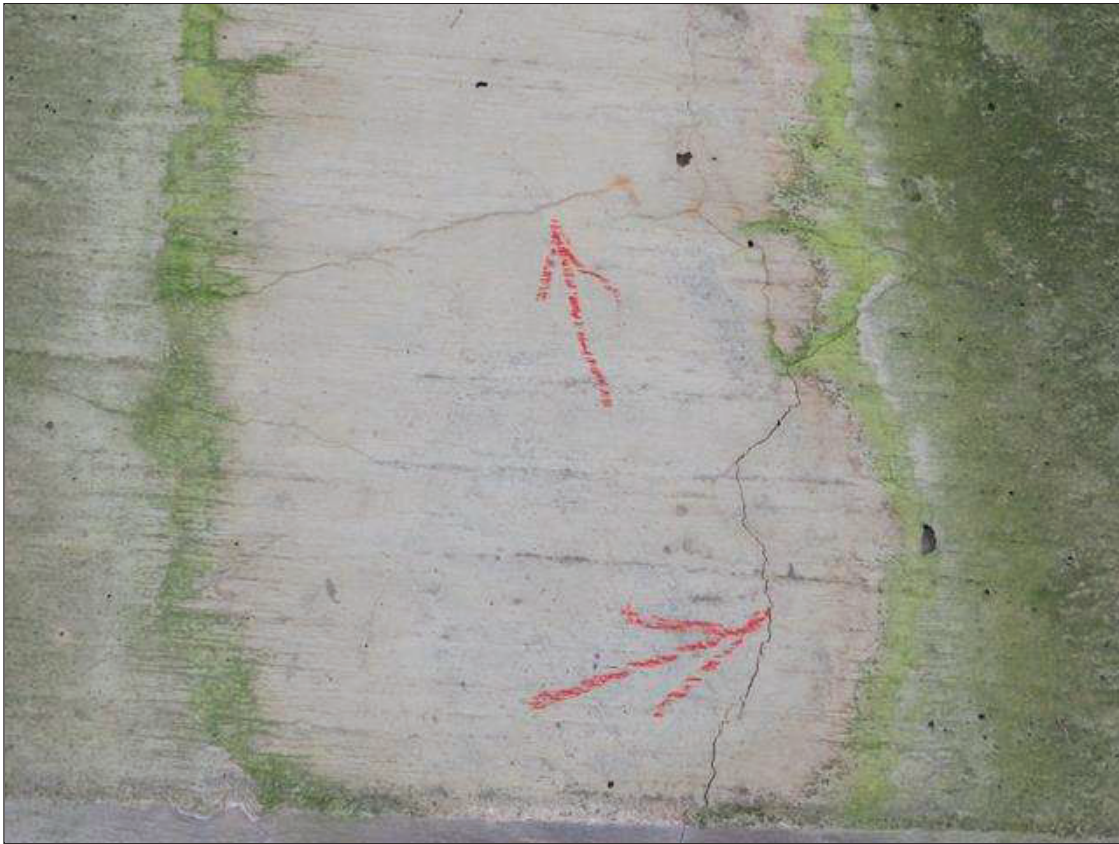
Bent 1 Cap 1: SCATTERED IN THE CAP FACES, MAP CRACKING TO 1/32 INCH WIDE

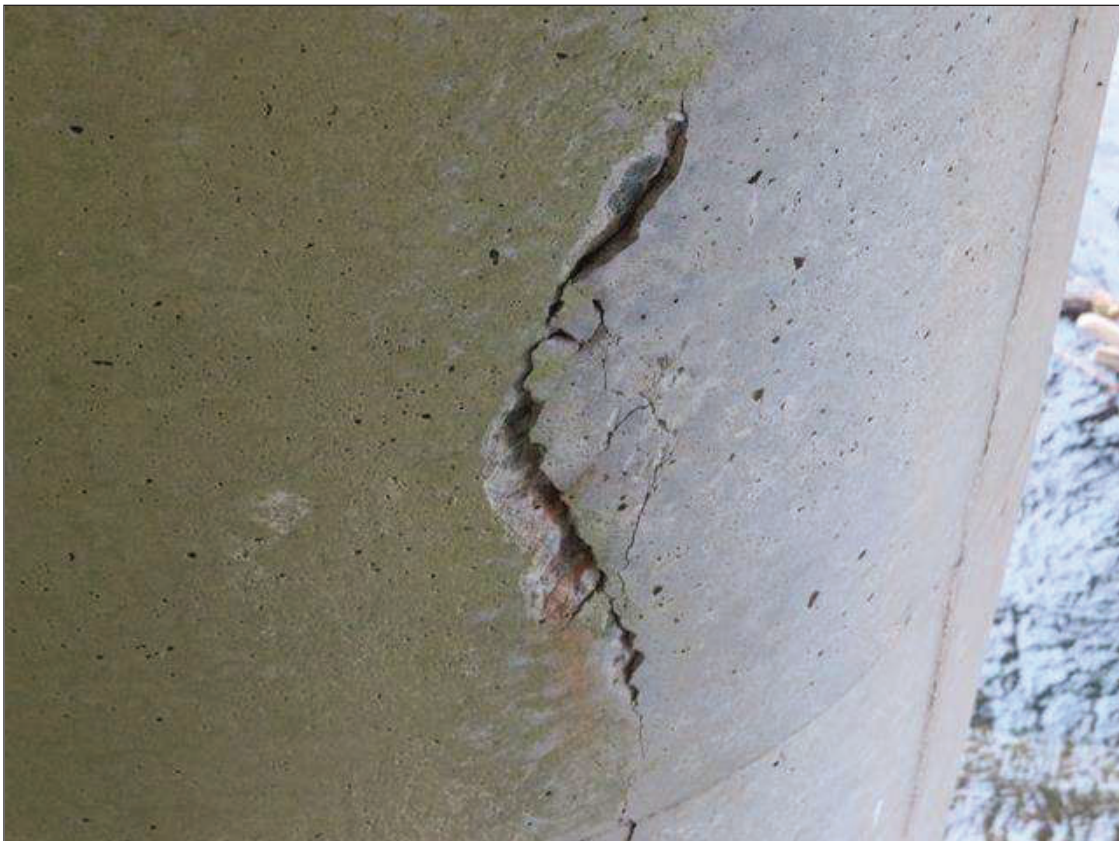
Bent 1 Pile 1: 4 FEET HIGH X 10 INCHES WIDE X 1/2 INCH DEEP SPALL AND AREA OF DELAMINATION WITH EFFLORESCENCE ON SOUTHEAST FACE, 5 FEET FROM BOTTOM OF CAP

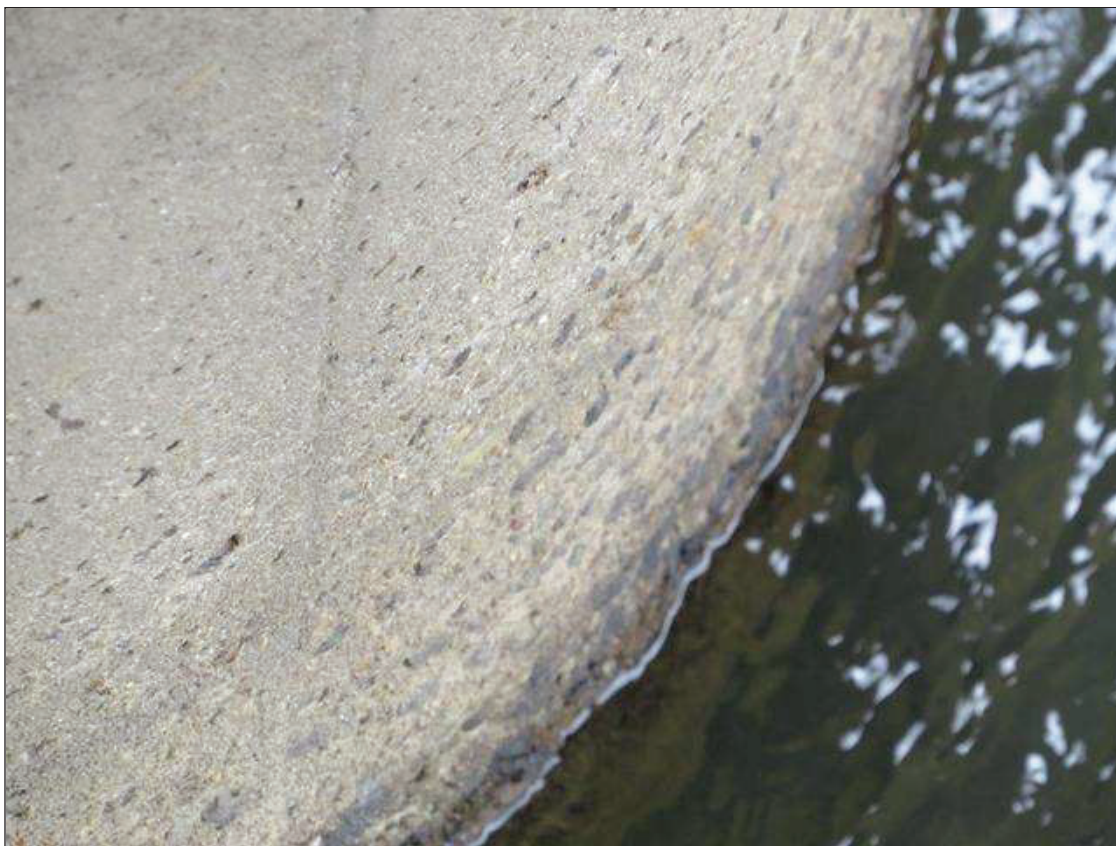
Bent 1 Pile 1: 1 FOOT HIGH ABRASION AT WATERLINE

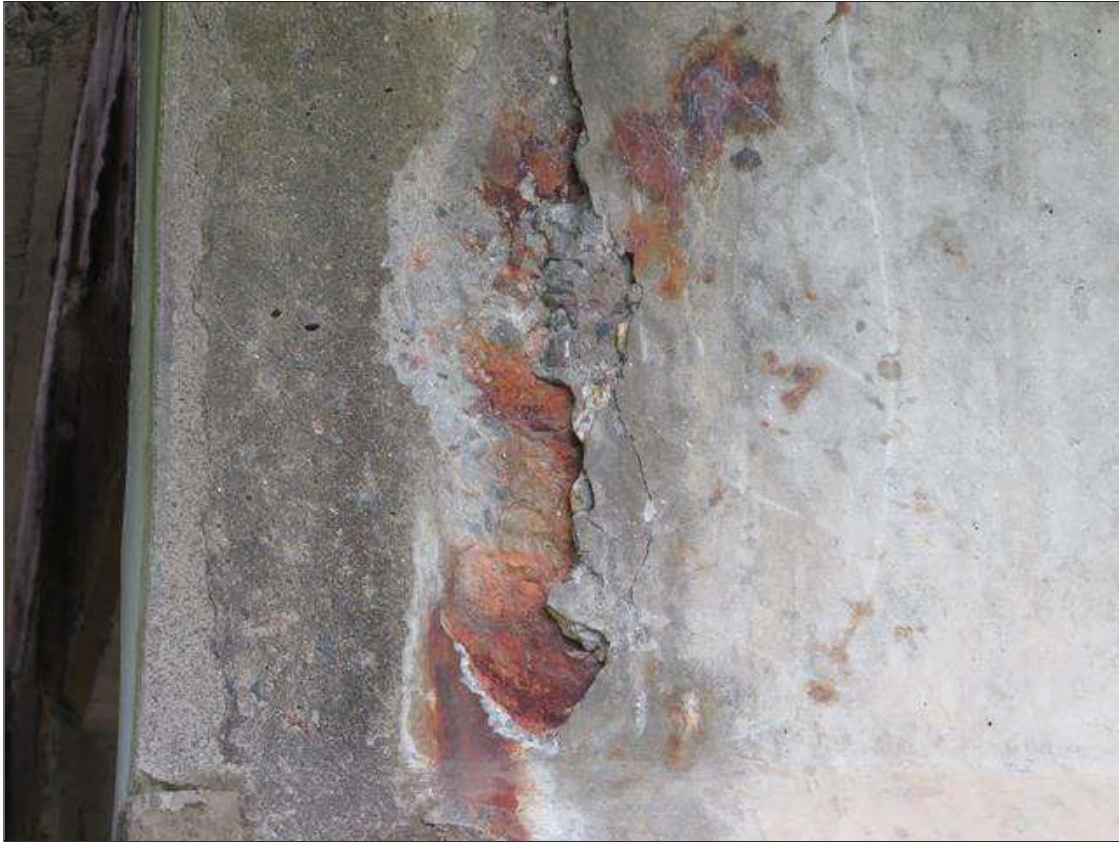
Span 2 Beam 4: GIRDER END AT BENT 1, EAST SIDE OF THE WEB, MAP CRACKING TO 1/16 INCHES WIDE WITH 9 INCHES LONG X 16 INCHES HIGH X 1/2 INCH DEEP SPALL AND AREA OF DELAMINATION WITH EFFLORESCENCE STAINING, AND RUST STAINING (PAR)

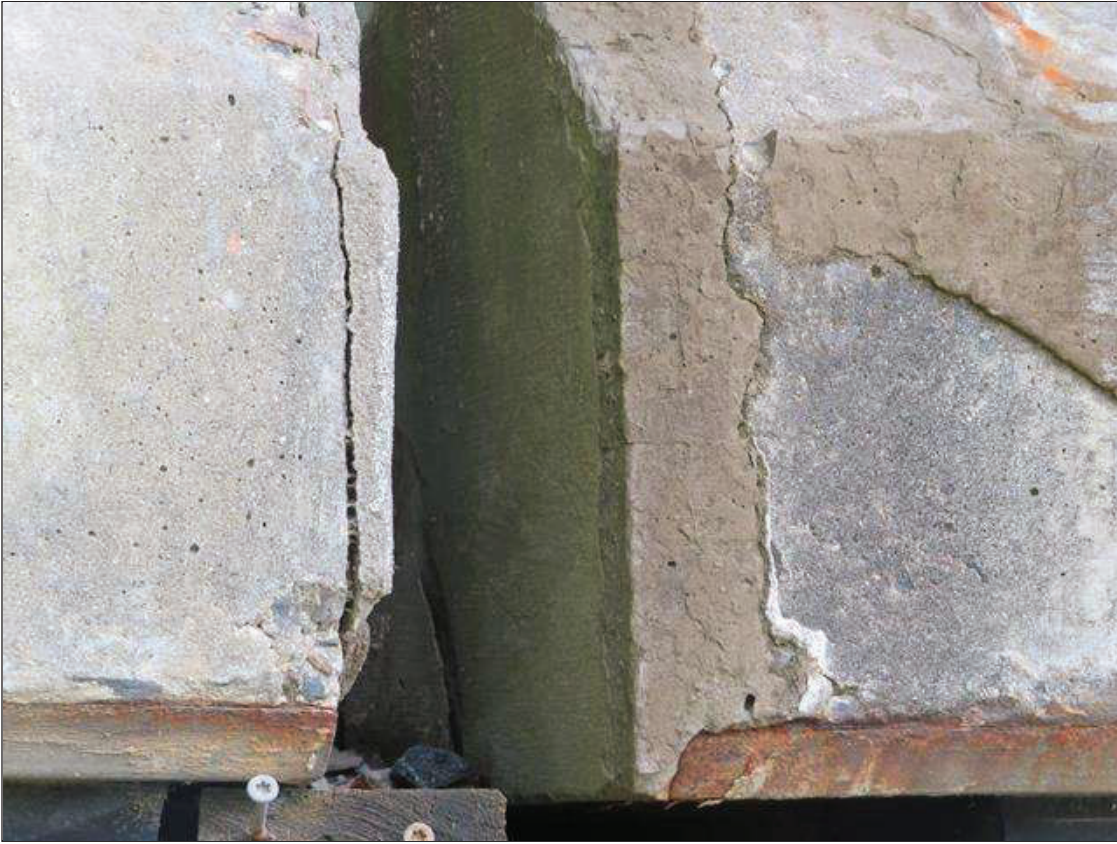
Span 2 Beam 4: SOUND PATCHING, FORMERLY 12 INCHES WIDE X 15 INCHES HIGH X 2 INCHES DEEP SPALL, WITH EXPOSED STRAND ENDS, SOUTH FACE

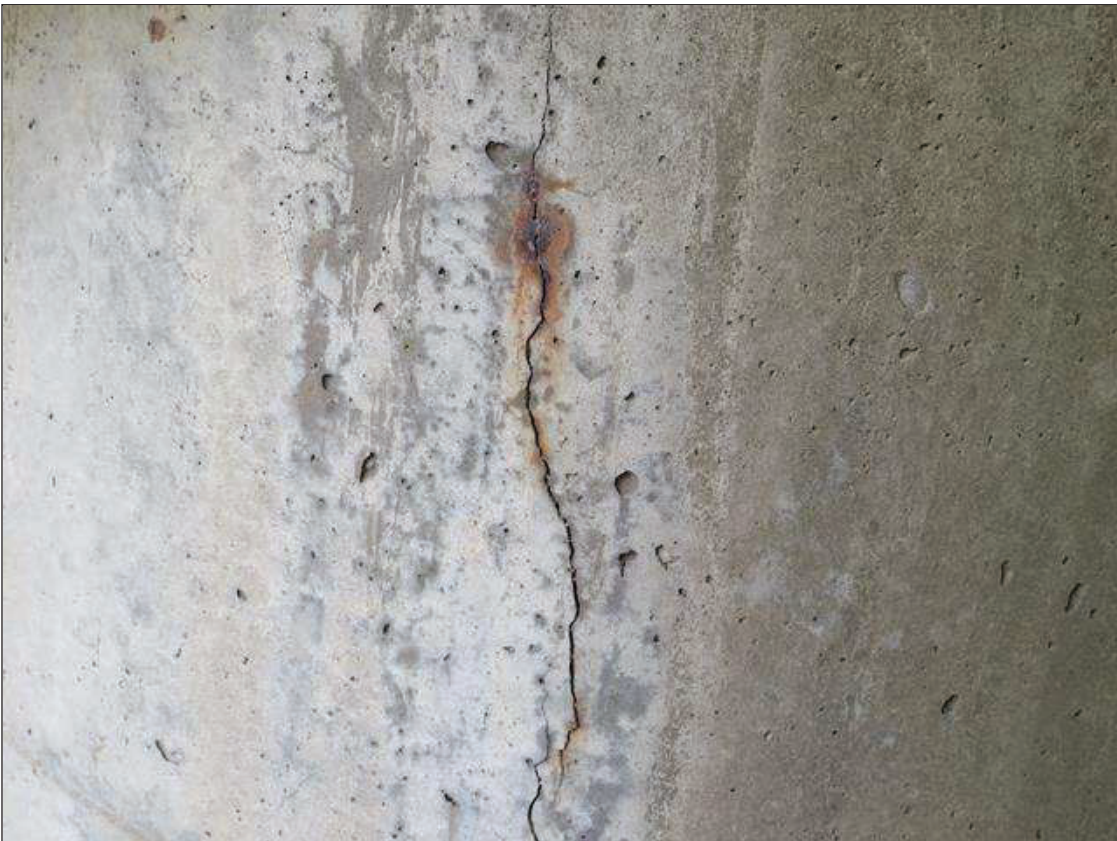
Bent 1 Pile 2: SCATTERED IN THE COLUMN, GENERALLY ON THE NORTH SIDE, VERTICAL CRACKING AND MAP CRACKING TO 1/16 INCH WIDE WITH RUST STAINING

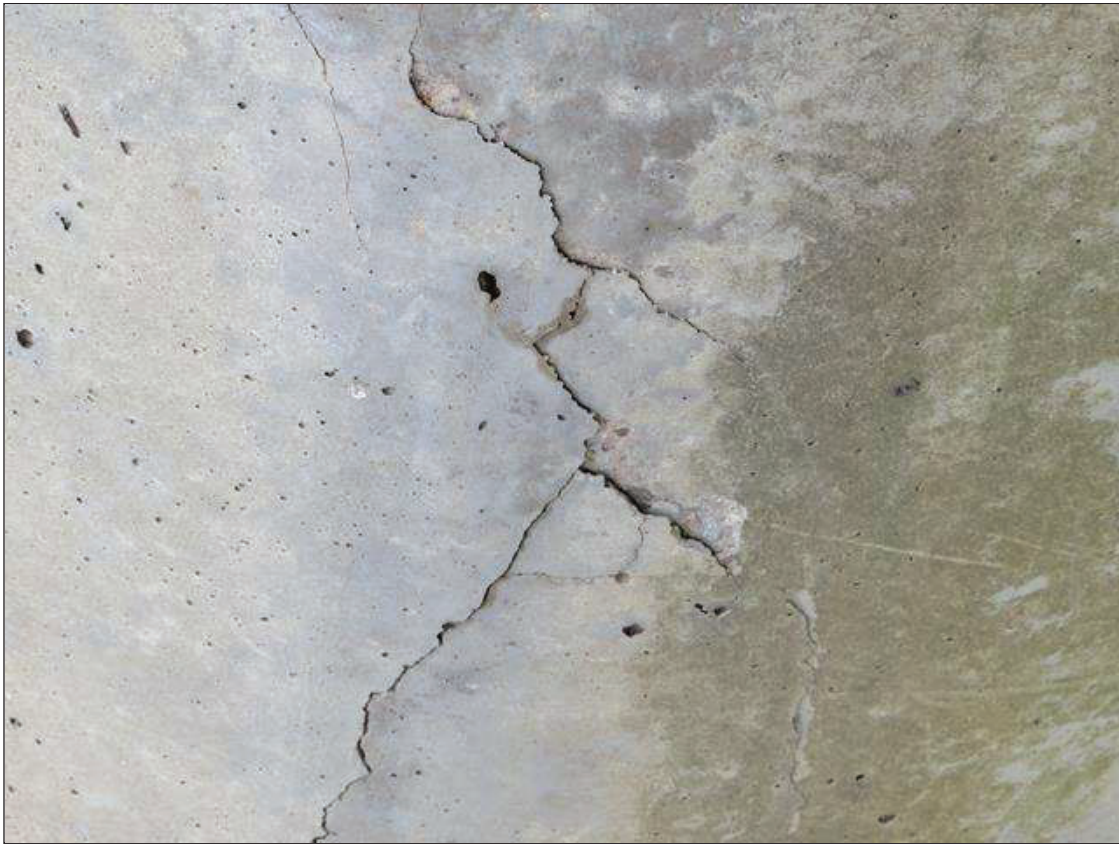
Bent 1 Pile 2: NORTH SIDE OF COLUMN, DELAMINATED AREA WITH ADJACENT SPALLS 15 FEET HIGH X 10 INCHES WIDE X 1/2 INCH DEEP

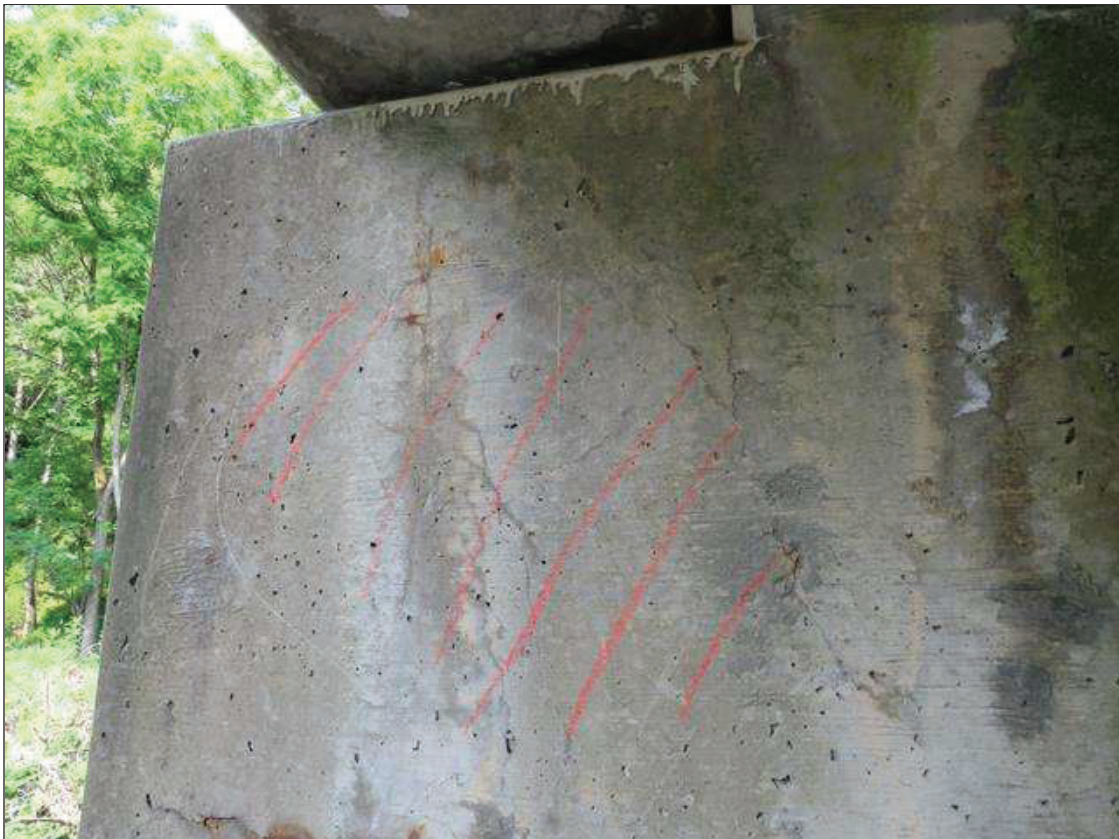
Bent 1 Cap 1: 30 INCHES DIAMETER DELAMINATED AREA WITH RUST STAINING, NORTH FACE, EAST END OF CAP

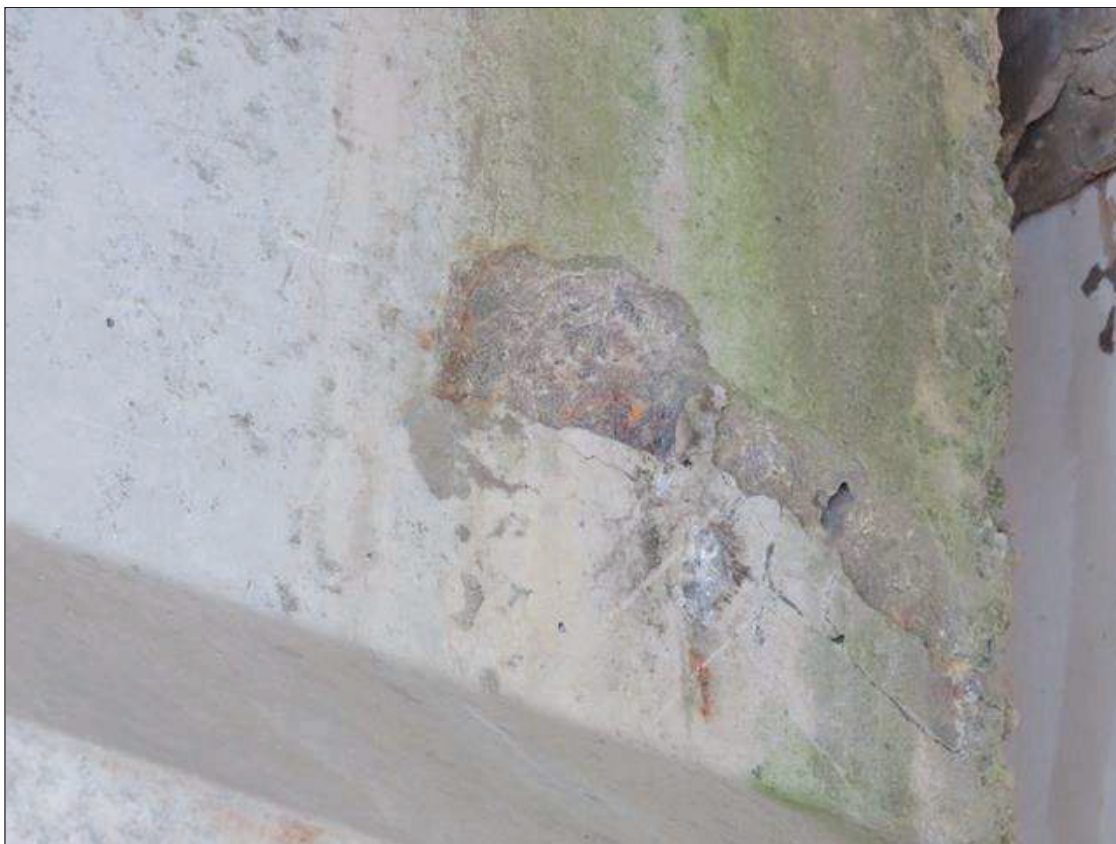
Span 2 Beam 3: GIRDER END AT BENT 1, LEFT SIDE OF THE WEB, MAP CRACKING TO 1/16 INCHES WIDE WITH 9 INCHES LONG X 6 INCHES HIGH X 1/2 INCH DEEP SPALL WITH ADJACENT DELAMINATION

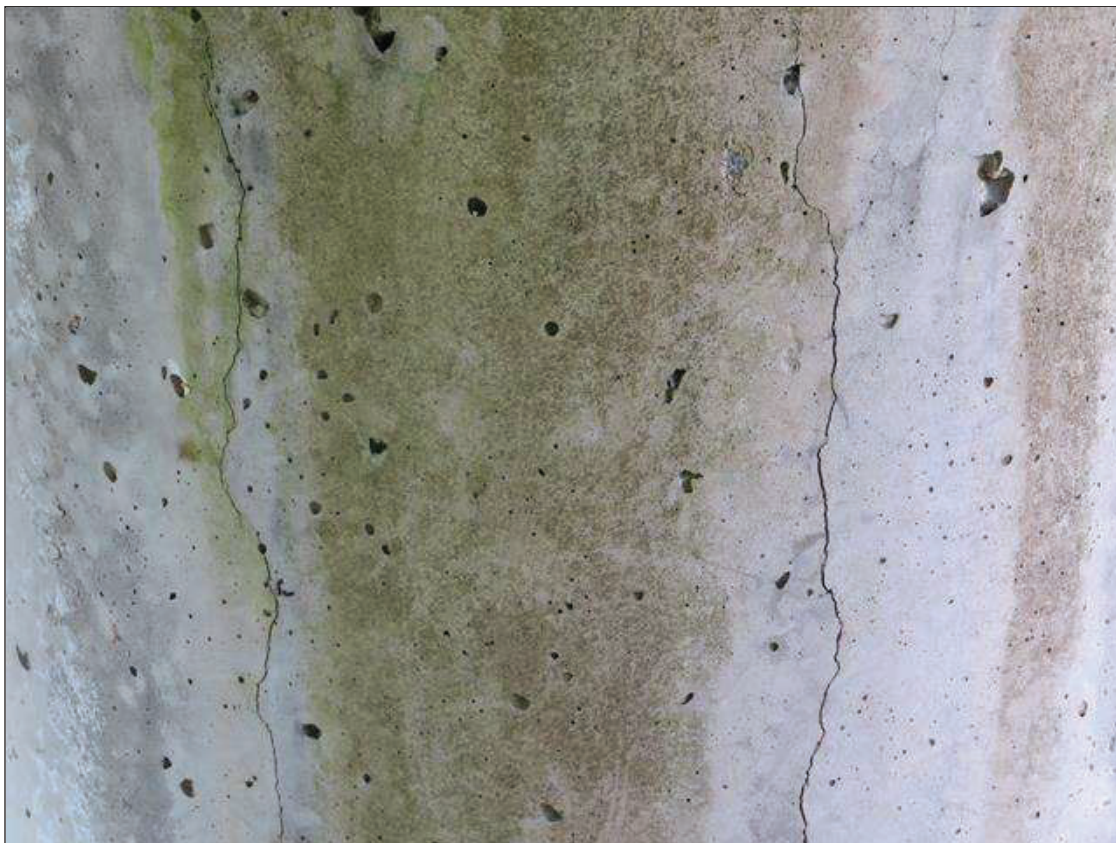
Bent 2 Pile 2: SCATTERED IN THE COLUMN, ON BOTH SIDES, VERTICAL CRACKING AND MAP CRACKING TO 1/16 INCH WIDE WITH ASSOCIATED DELAMINATION

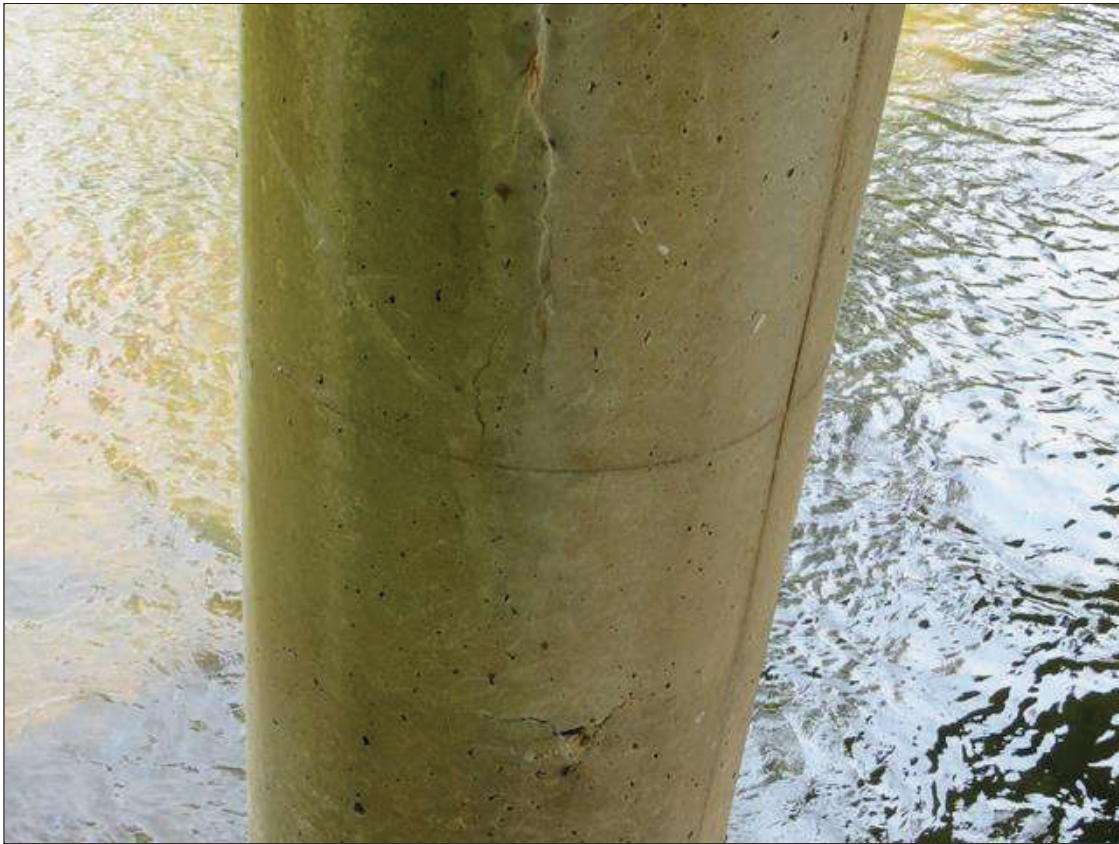
Bent 2 Pile 1: 12 FEET HIGH X 1 FOOT WIDE X 1 INCH DEEP SPALL WITH EXPOSED REBAR AND AREA OF DELAMINATION ON SOUTH FACE

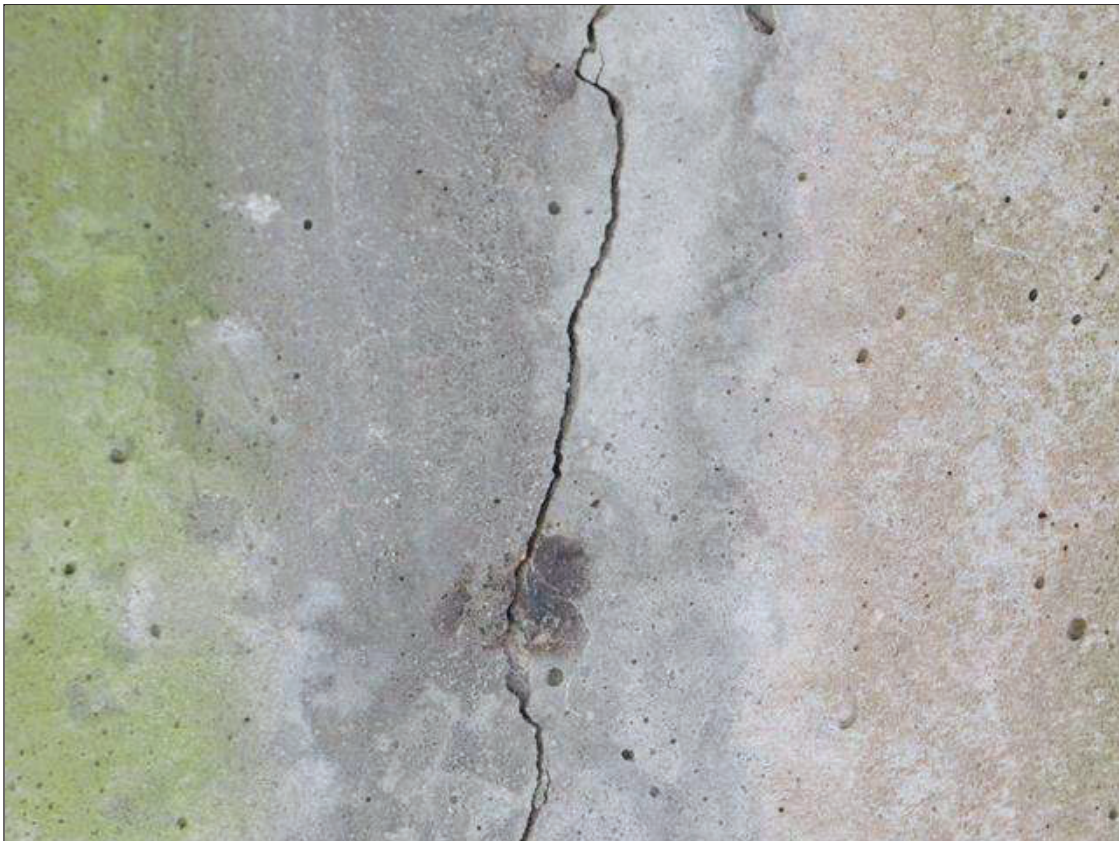
Bent 2 Pile 1: SCATTERED IN THE COLUMN, ON BOTH SIDES, VERTICAL CRACKING AND MAP CRACKING TO 1/16 INCH WIDE AND SCATTERED RUST STAINING

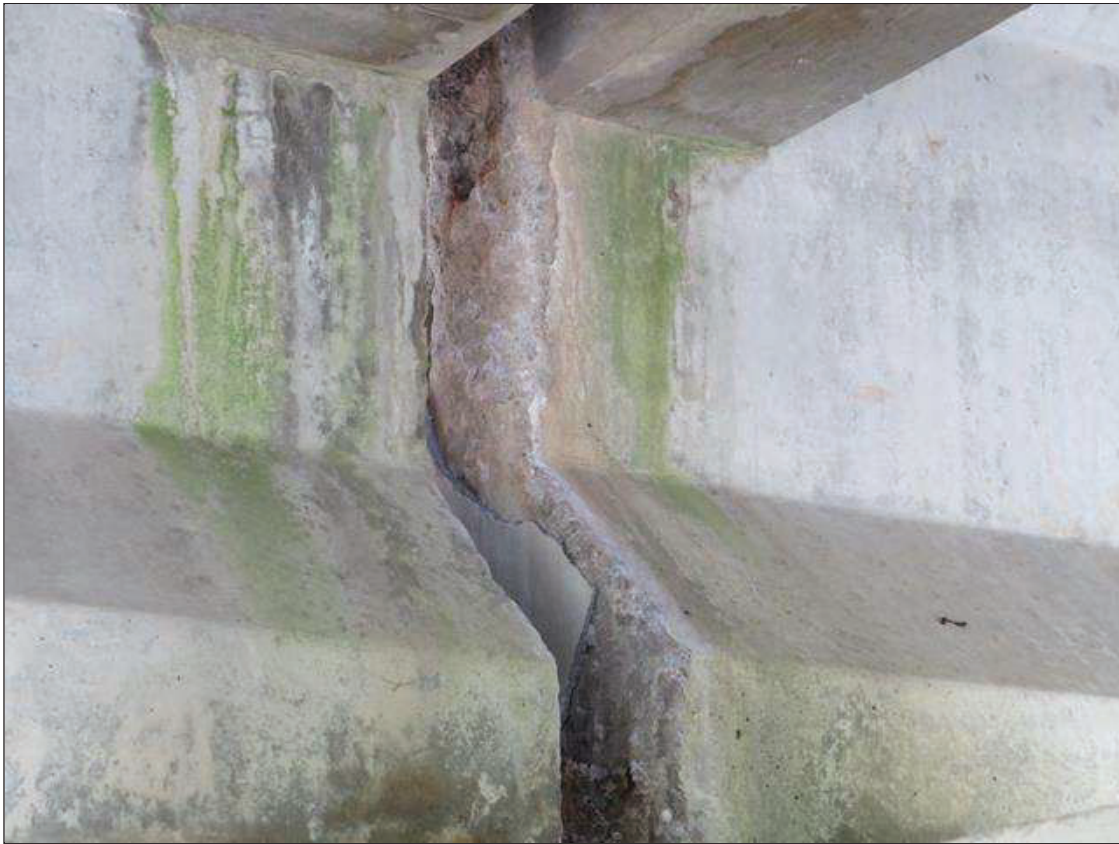
Span 2 Beam 3: GIRDER END AT BENT 2, AT THE END OF THE GIRDER FOR FULL HEIGHT, SPALLING UP TO 1 INCH DEEP. THE TIPS OF THE PRESTRESSING ARE EXPOSED (PAR)

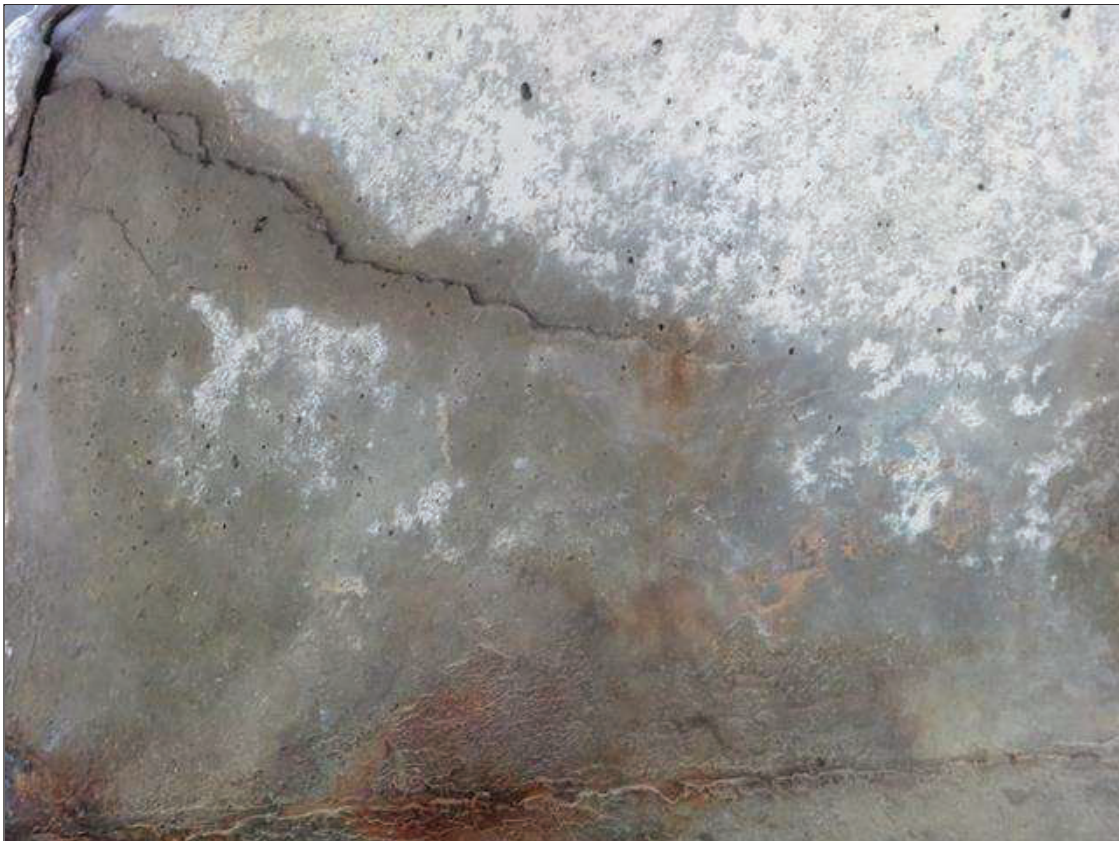
Span 3 Beam 2: GIRDER END AT BENT 2, RIGHT LOWER FLANGE, DIAGONAL CRACKING TO 1/32 INCH WIDE WITH RUST STAINING AND ADJACENT DELAMINATION 10 INCHES LONG X 8 INCHES HIGH

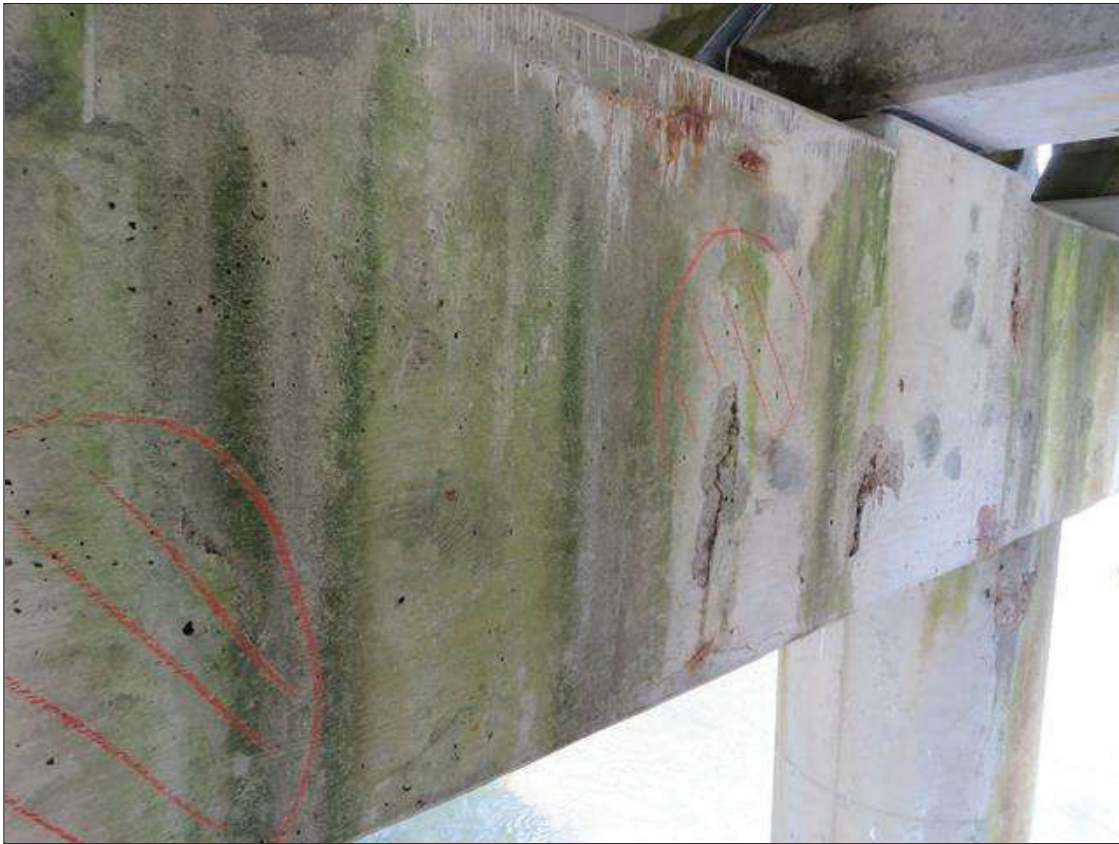
Bent 2 Cap 1: NORTH FACE AT BAY 2 AND UNDER GIRDER 2, (4) AREAS UP TO 12 INCHES DIAMETER X 3/4 INCHES DEEP SPALLS AND DELAMINATION

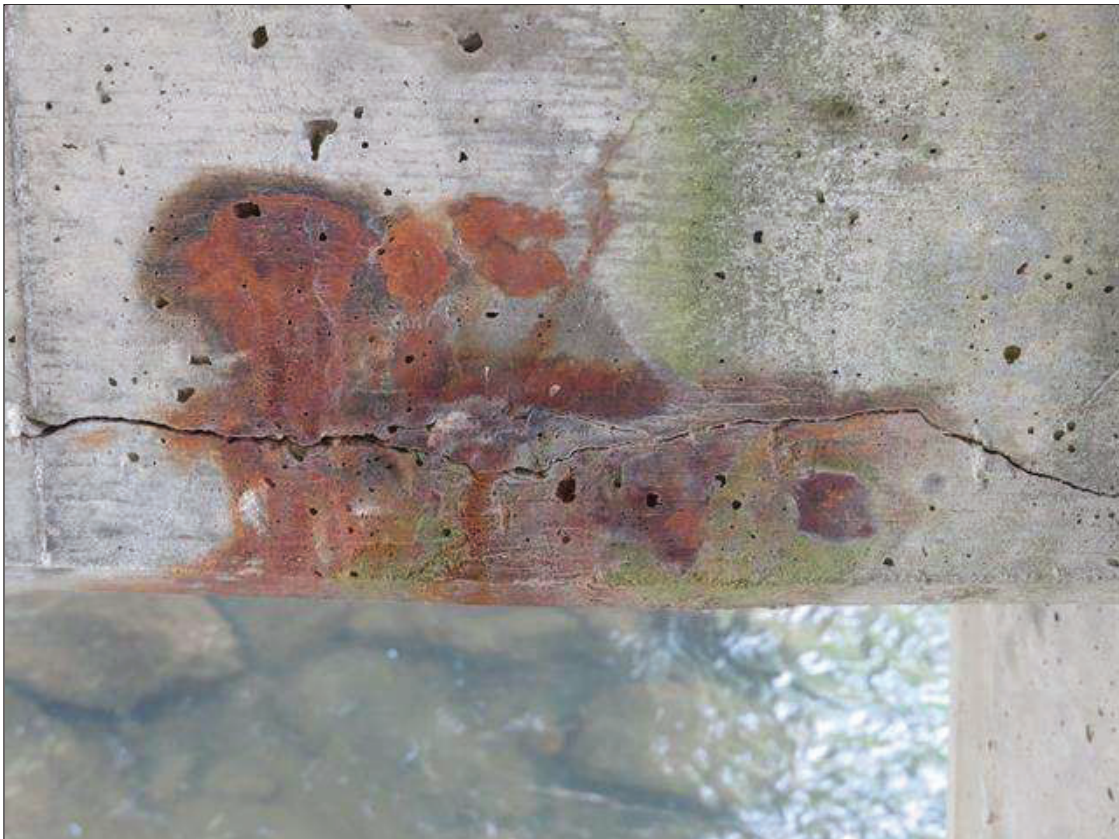
Bent 2 Cap 1: LOWER 3 INCHES OF THE CAP, SCATTERED ALONG THE LENGTH OF CAP UNDER BAYS 1 AND 2, HORIZONTAL CRACKING TO 1/16 INCH WIDE WITH RUST STAINING

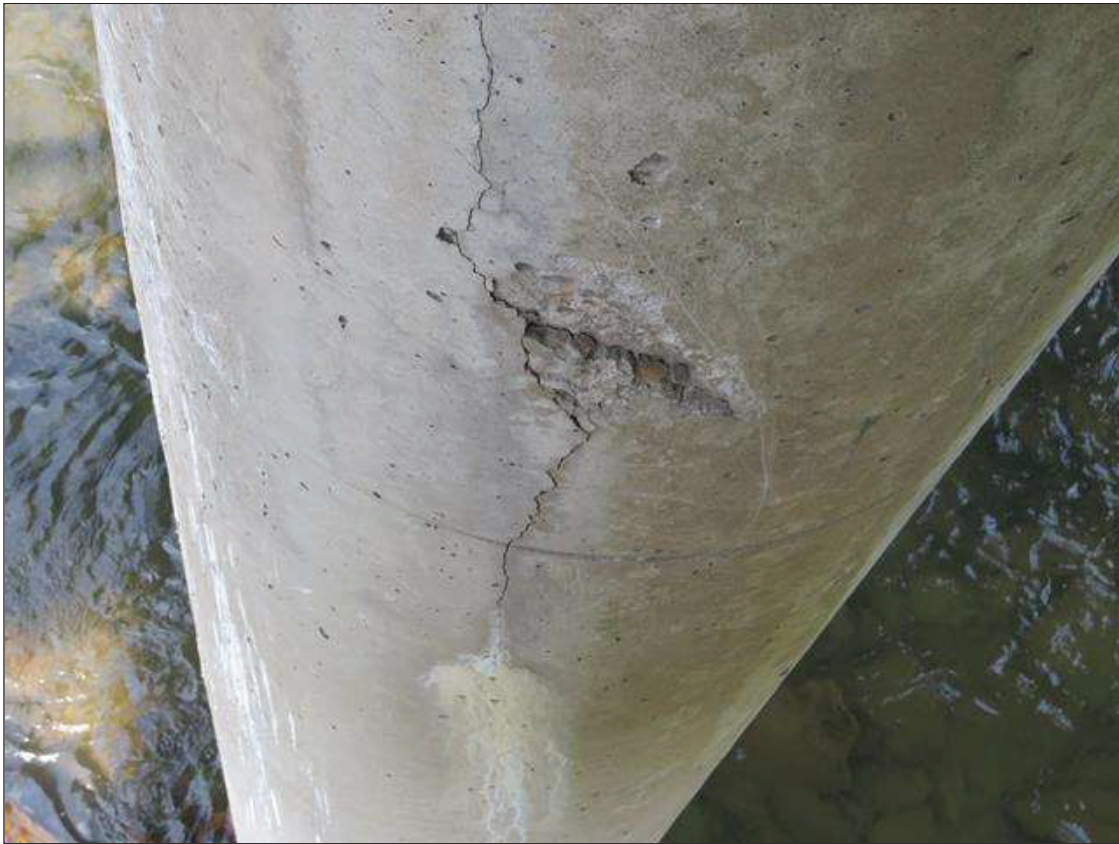
Bent 2 Pile 2: 4 FEET HIGH X 10 INCHES WIDE AREA OF DELAMINATION WITH 8 INCHES HIGH X 8 INCHES WIDE X 1/2 INCH DEEP SPALL ON NORTH FACE

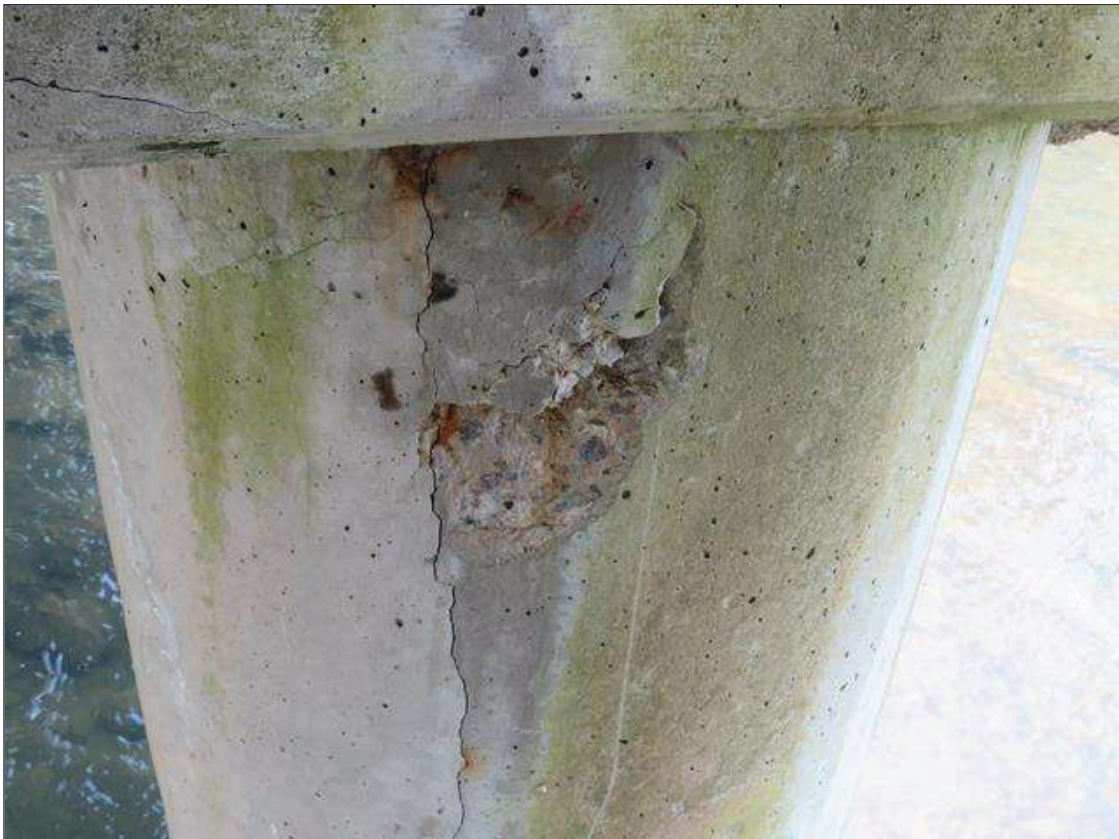
Bent 2 Pile 1: NORTH SIDE ADJACENT TO BOTOM OF CAP, SPALLED AREA WITH ADJACENT DELAMINATION 1 FOOT HIGH X 8 INCHES WIDE X 1 INCH DEEP
