NC DEPARTMENT OF TRANSPORTATION
 DIVISION OF HIGHWAYS
 STRUCTURE MANAGEMENT UNIT

ATTENTION: **PLATFORM TRUCK AND TRAFFIC CONTROL USED,
 PARS ISSUED**

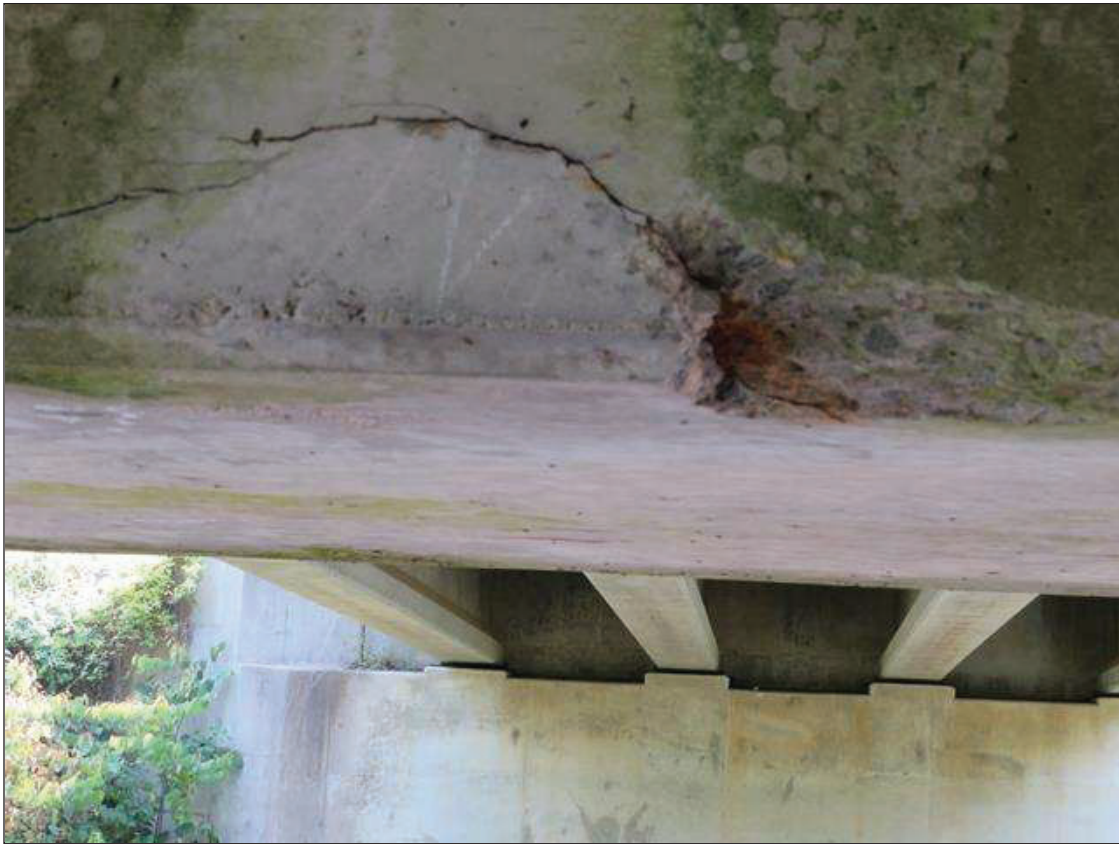
Bent 3 Cap 1: SOUTH FACE AT BOTTOM CORNER, 11 FEET FROM WEST END OF CAP, 3 FEET LONG X 6 INCHES HIGH DELAMINATED/SPALLED AREA UP TO 3 INCHES DEEP (PAR)

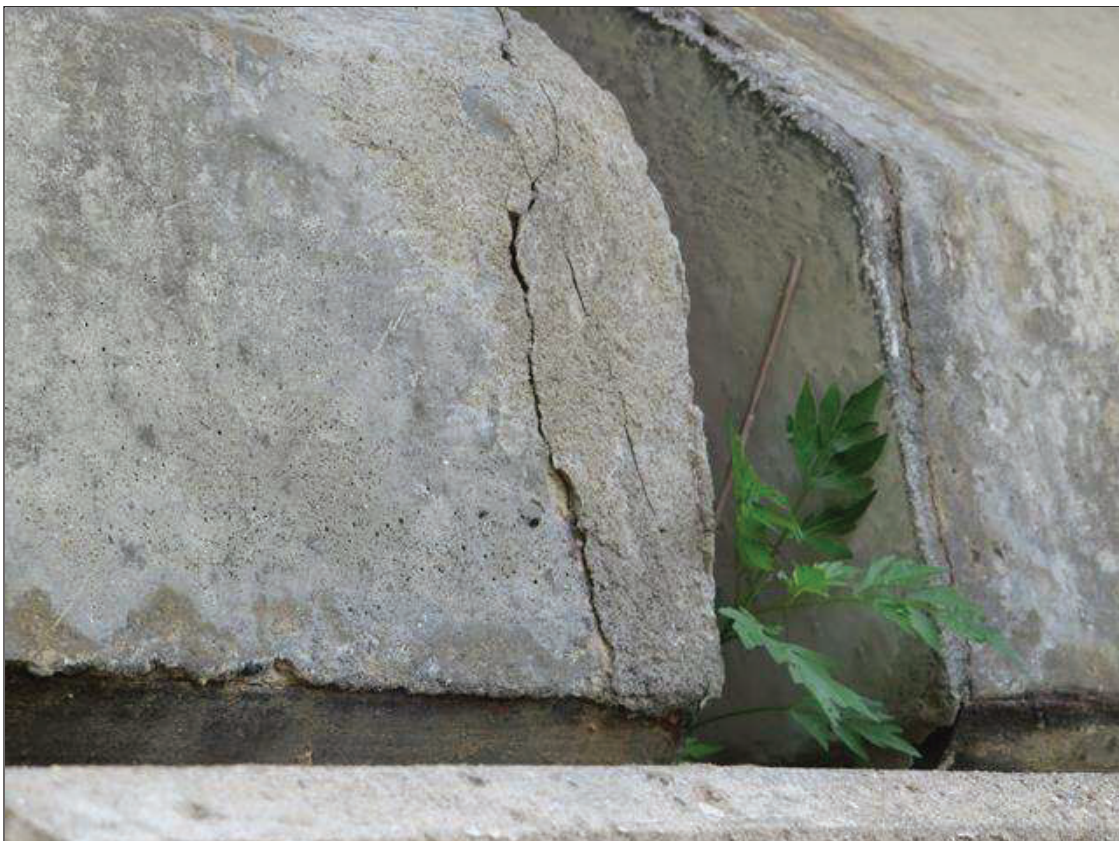
Span 3 Beam 4: GIRDER END ON RIGHT SIDE AT BENT 3 APPROXIMATELY 3 INCHES BACK, VERTICAL CRACKING TO 1/16 INCH WIDE

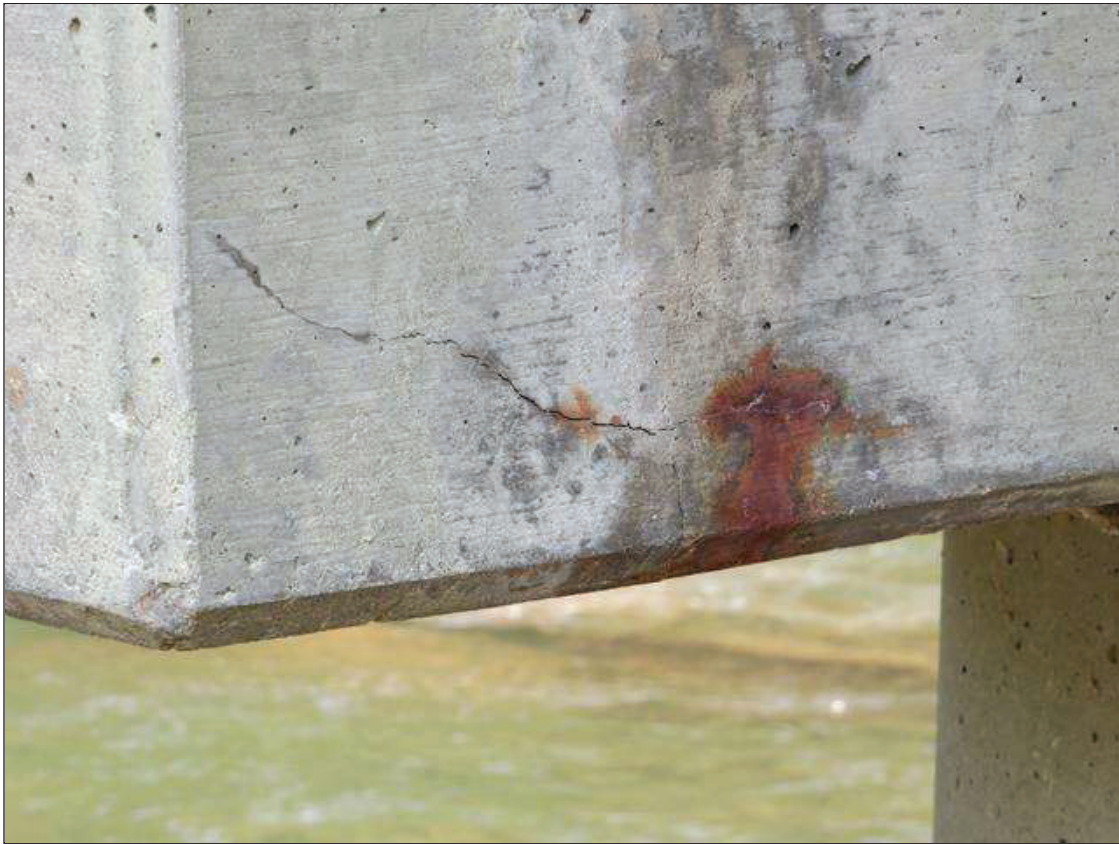
Bent 3 Cap 1: NORTH FACE, LOWER 3 INCHES OF THE CAP AT THE EAST END, HORIZONTAL CRACKING WITH RUST LEAKAGE TO 1/16 INCH WIDE

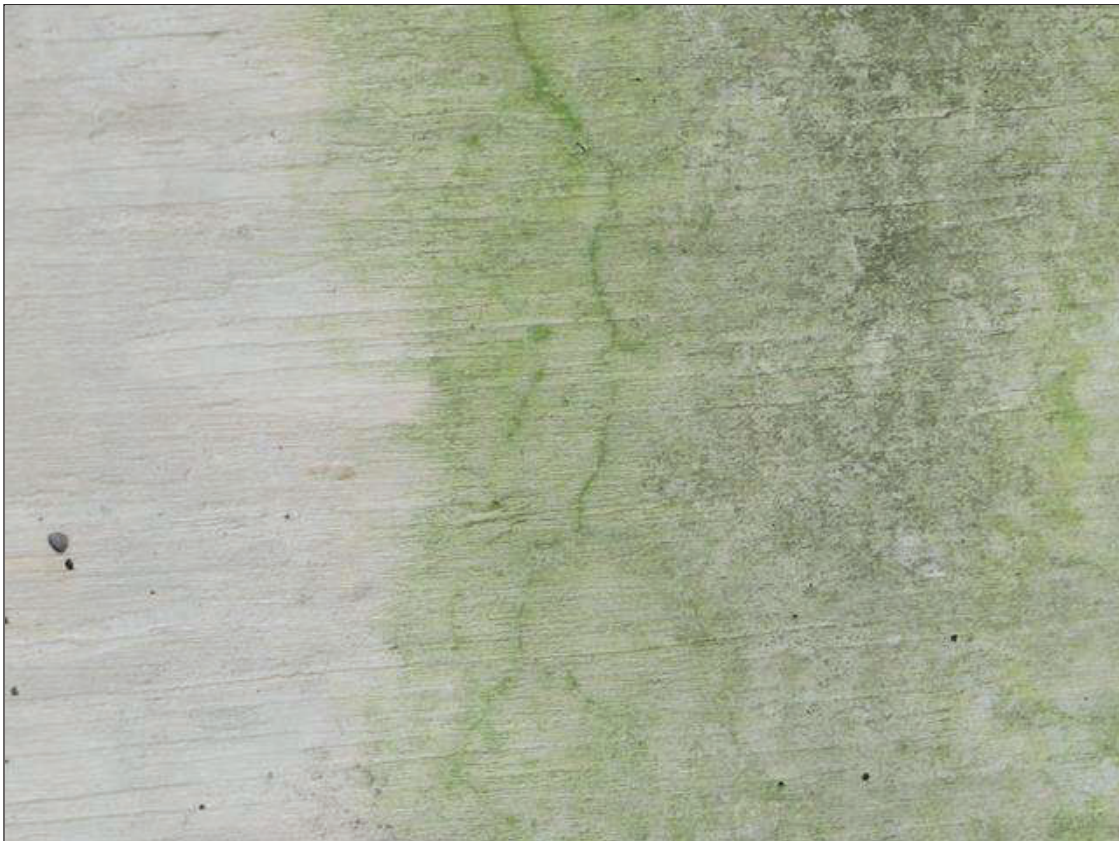
Bent 3 Cap 1: SCATTERED IN THE CAP FACES, HAIRLINE MAP CRACKING

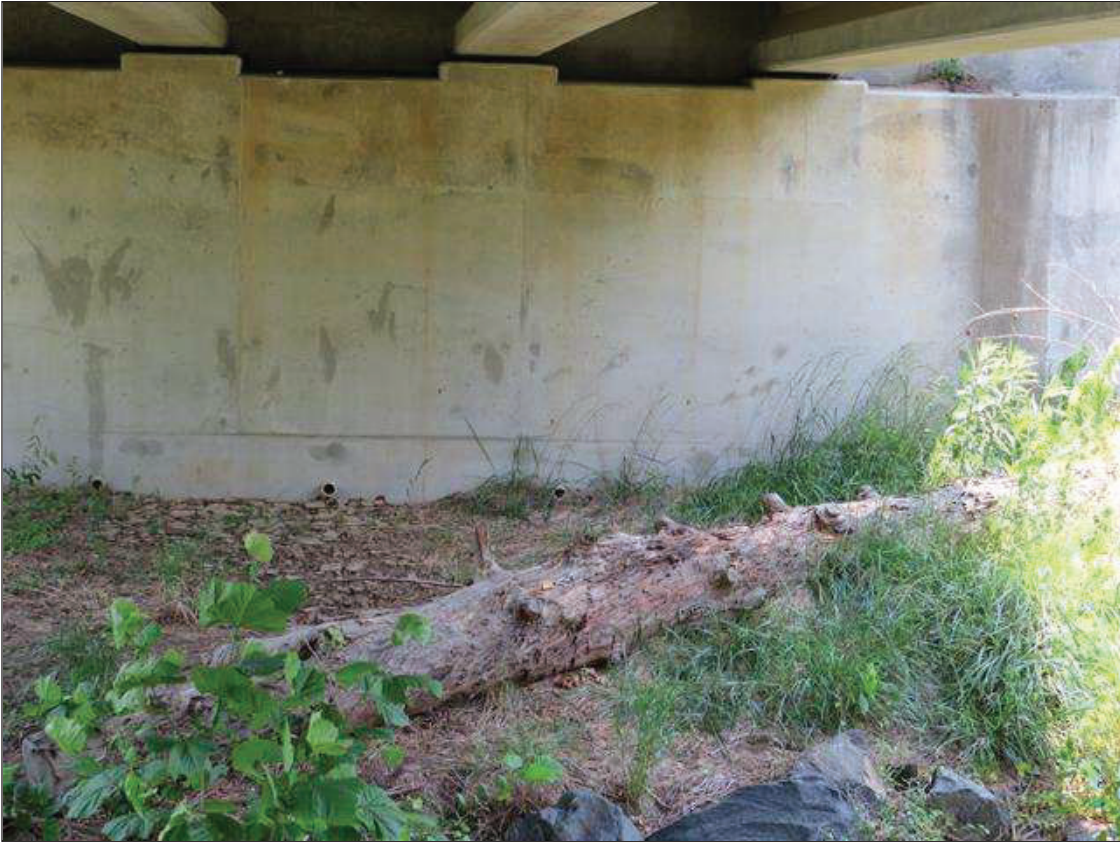
DRIFT (2 FEET DIAMETER) AT END BENT 2 ABUTMENT

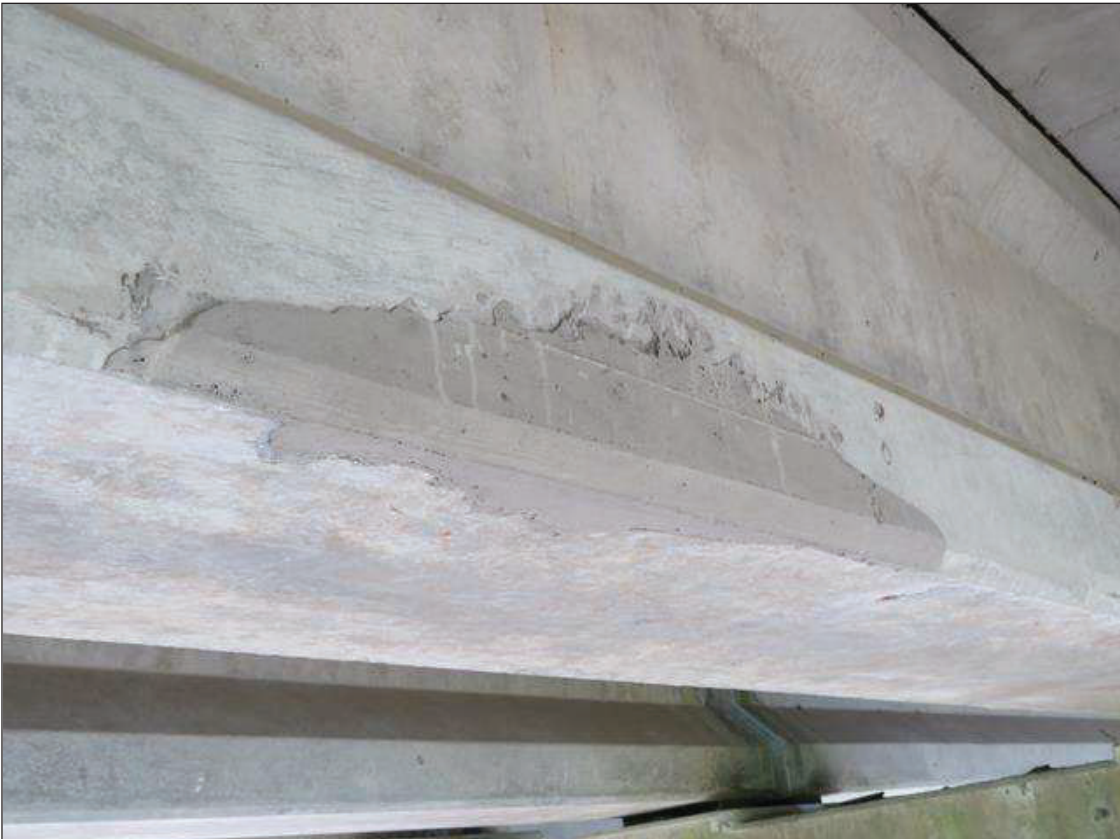
Span 4 Beam 2: PATCH AREA, FORMERLY 3 FEET LONG X UP TO 5 INCHES HIGH X 3 INCHES DEEP SPALL WITH EXPOSED STRAND, WEST FACE, 8 FEET FROM BENT 3

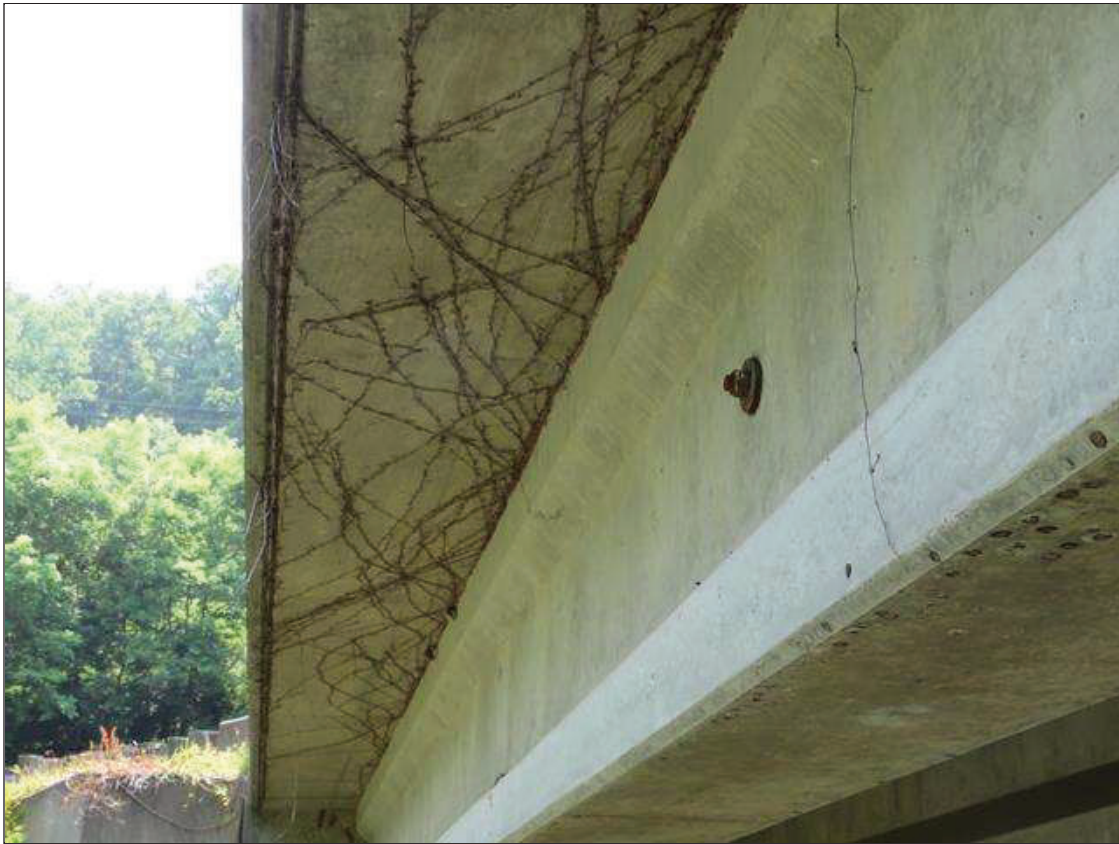
40 FEET LONG VEGETATION GROWTH IN WEST OVERHANG

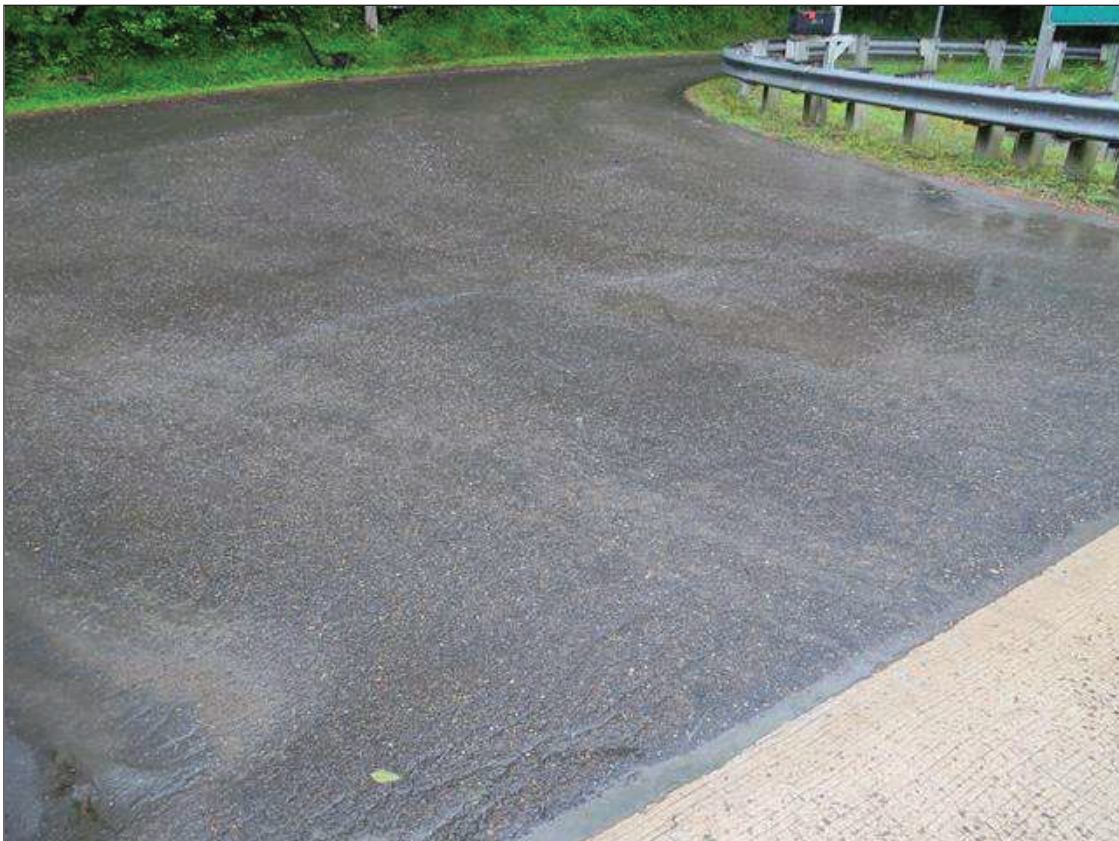
END BENT 1 ASPHALT WEARING SURFACE APPROACH 30 SQUARE FEET OF UP TO 1/4 INCH WIDE CRACKING

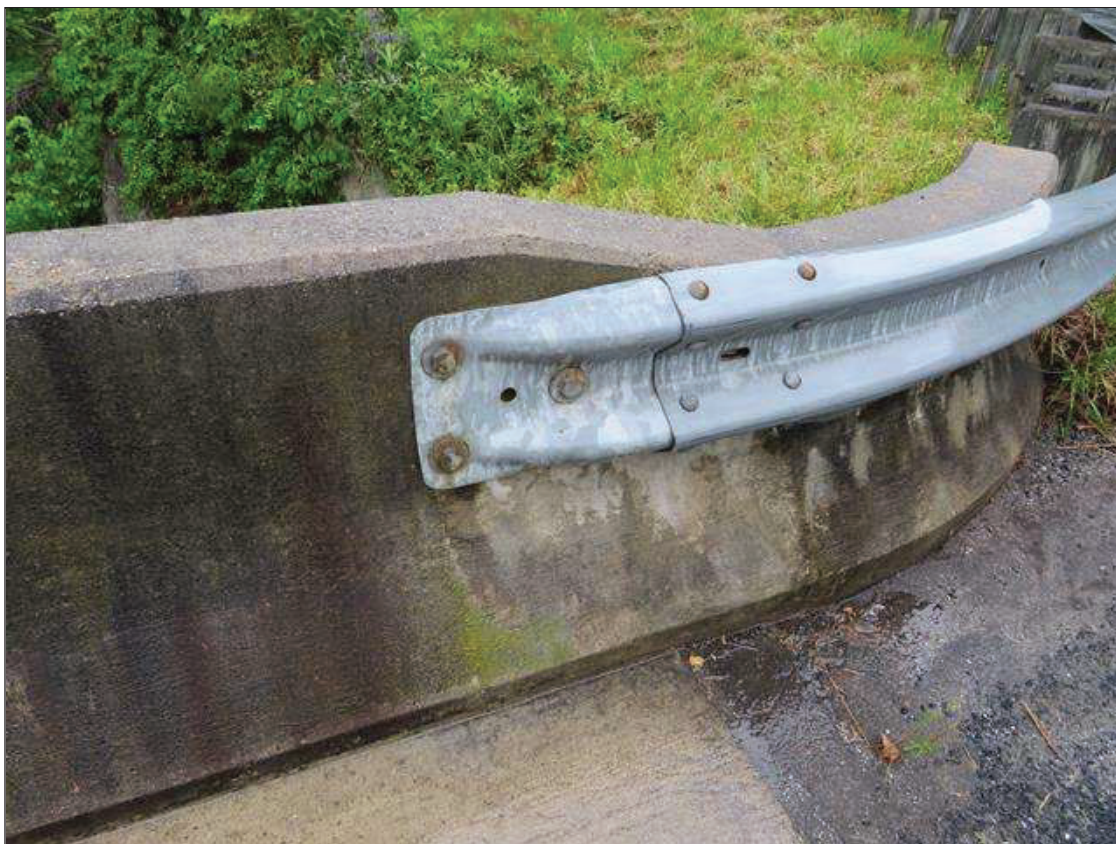
END BENT 2 LEFT SIDE GUARDRAIL ATTACHMENT MISSING 1 CONNECTION BOLT (PAR)

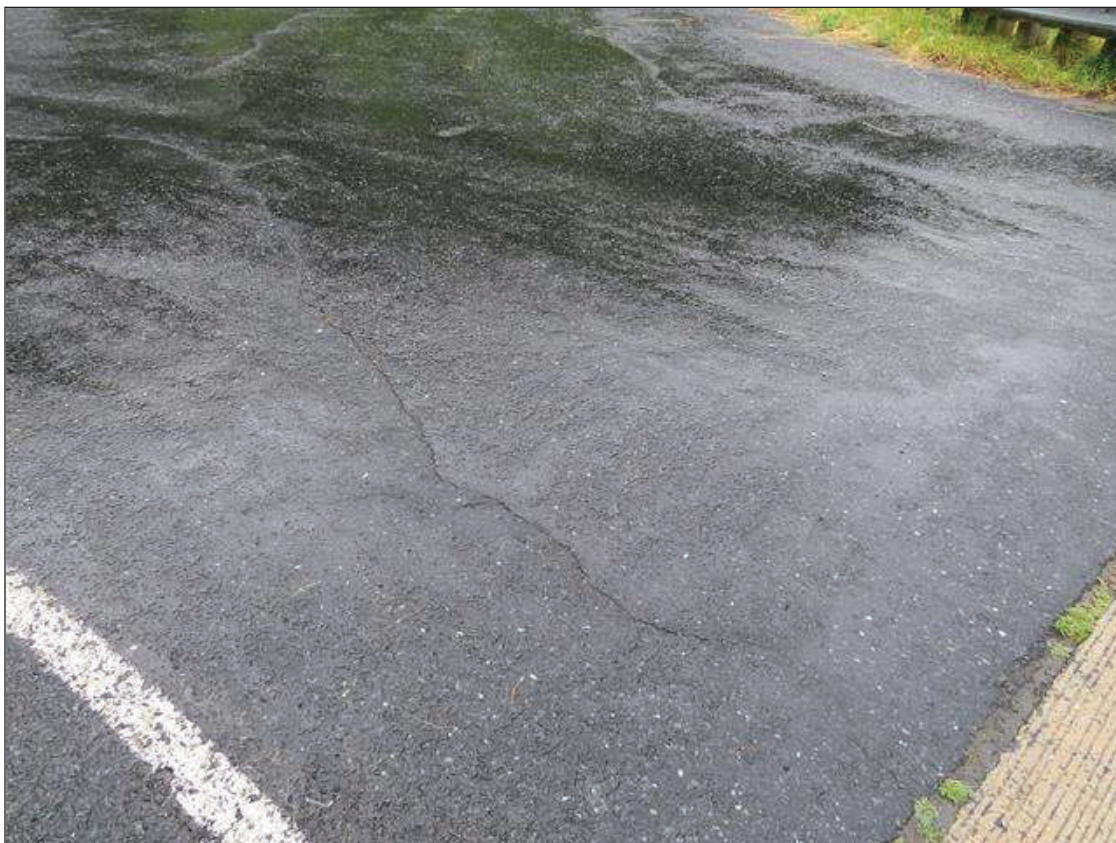
END BENT 2 ASPHALT WEARING SURFACE APPROACH 25 SQUARE FEET OF UP TO 1/8 INCH WIDE CRACKING

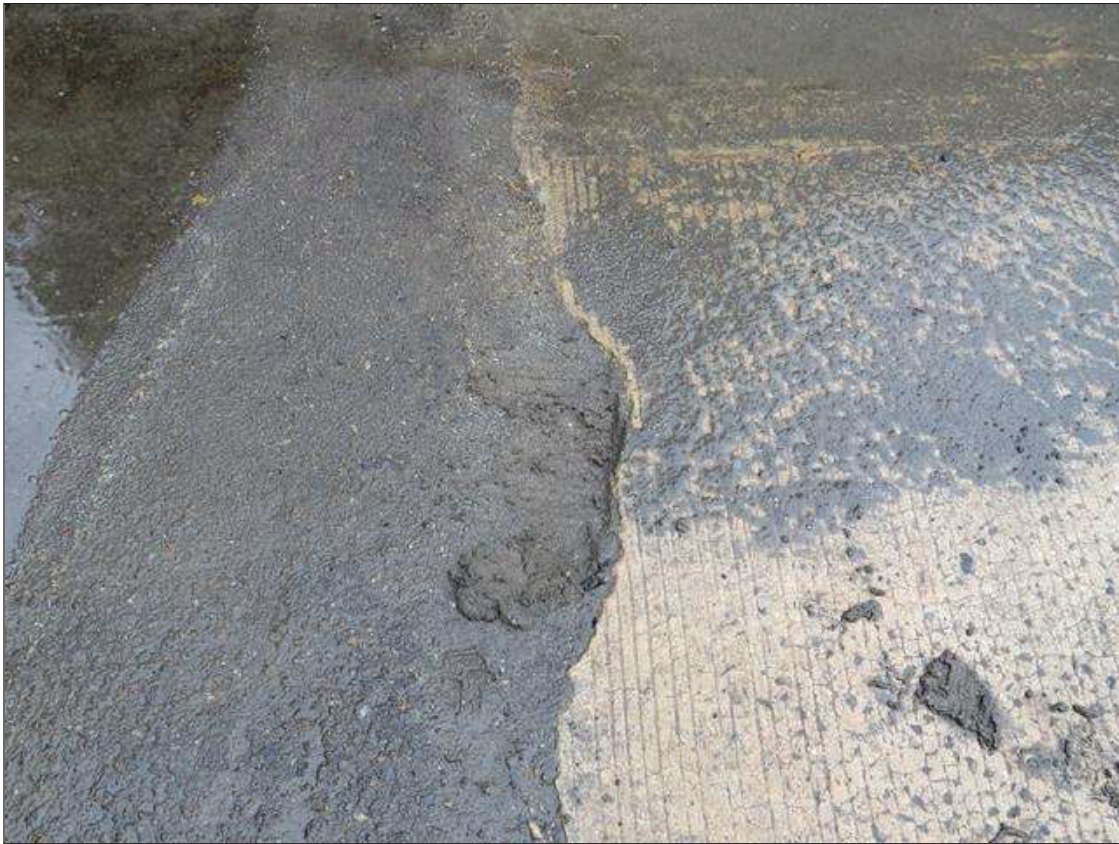
Span 1 Deck: (4) UP TO 32 INCHES WIDE X 7 INCHES LONG X 2 INCHES DEEP SPALLS ALONG END BENT 1

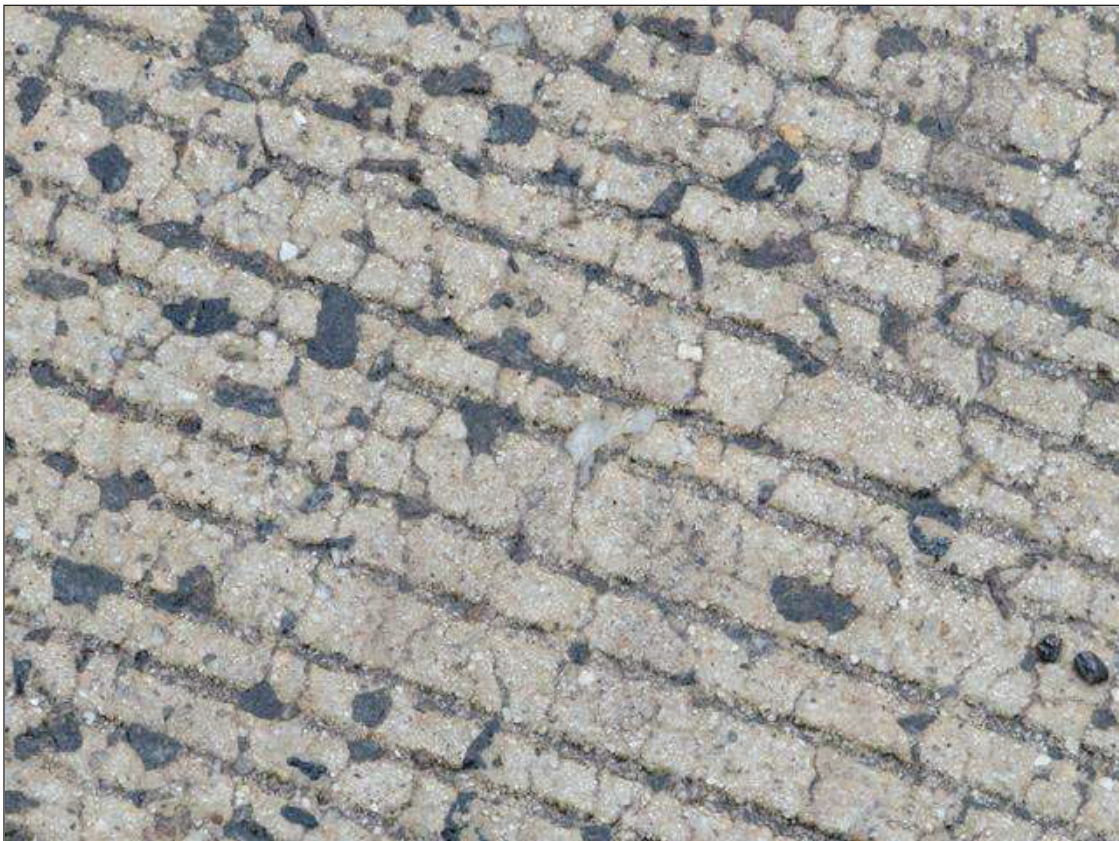
Span 1 Deck: TOP OF THE DECK, MAP CRACKING TO 1/32 INCH THROUGHOUT

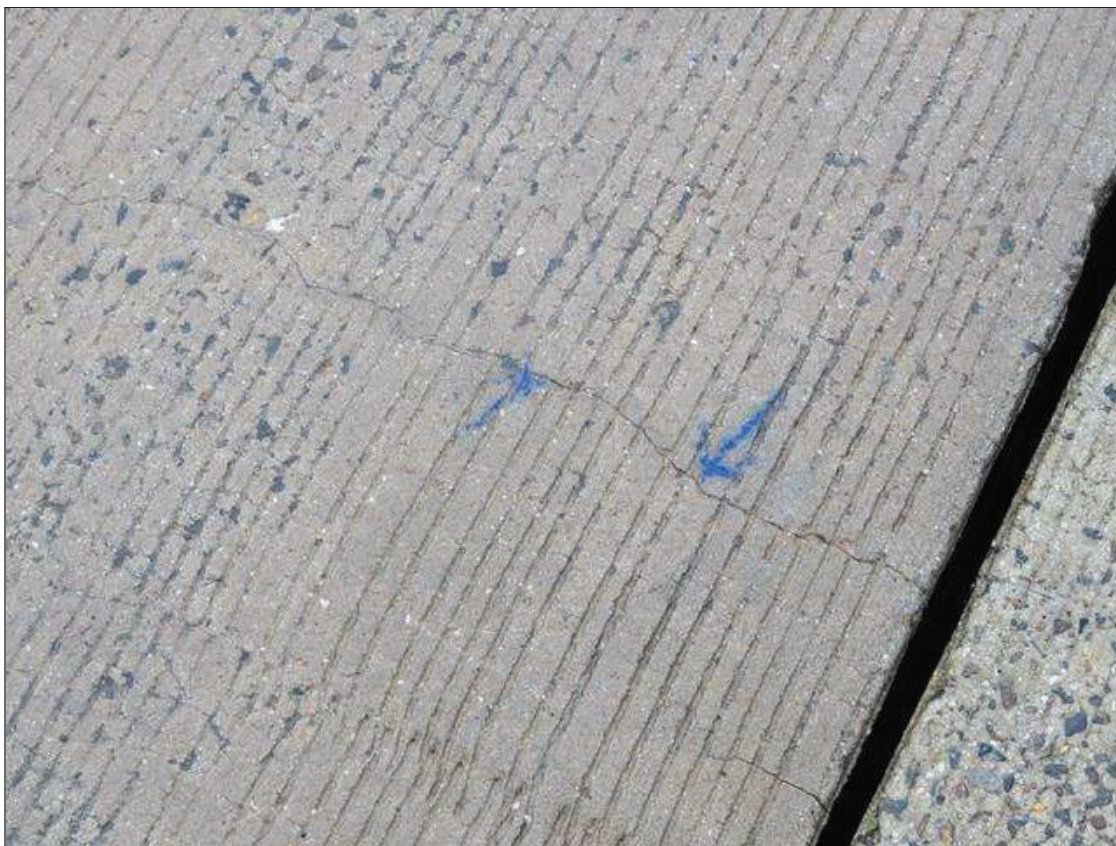
Span 2 Deck: 5 SQUARE FEET HAIRLINE LONGITUDINAL AND TRANSVERSE CRACKS EXTENDING FROM BENT 1 JOINT

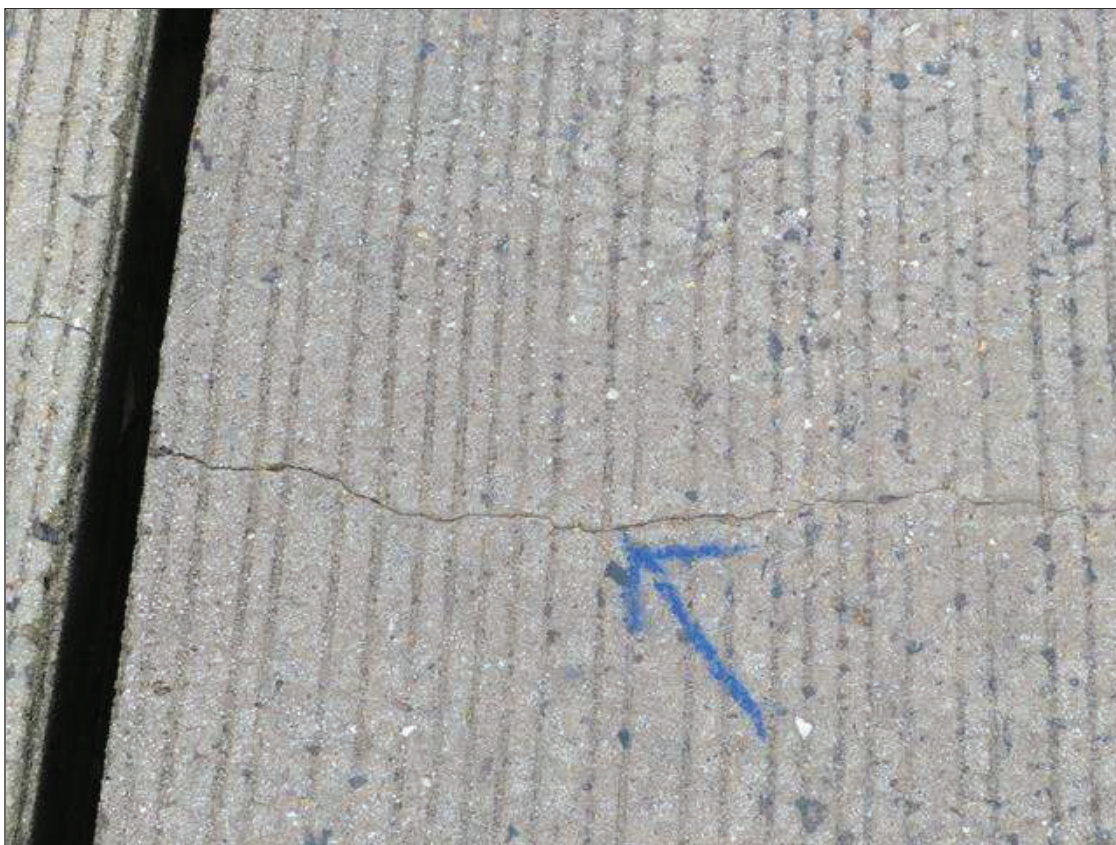
Span 2 Deck: 3 SQUARE FEET HAIRLINE LONGITUDINAL CRACKS EXTENDING FROM BENT 2 JOINT

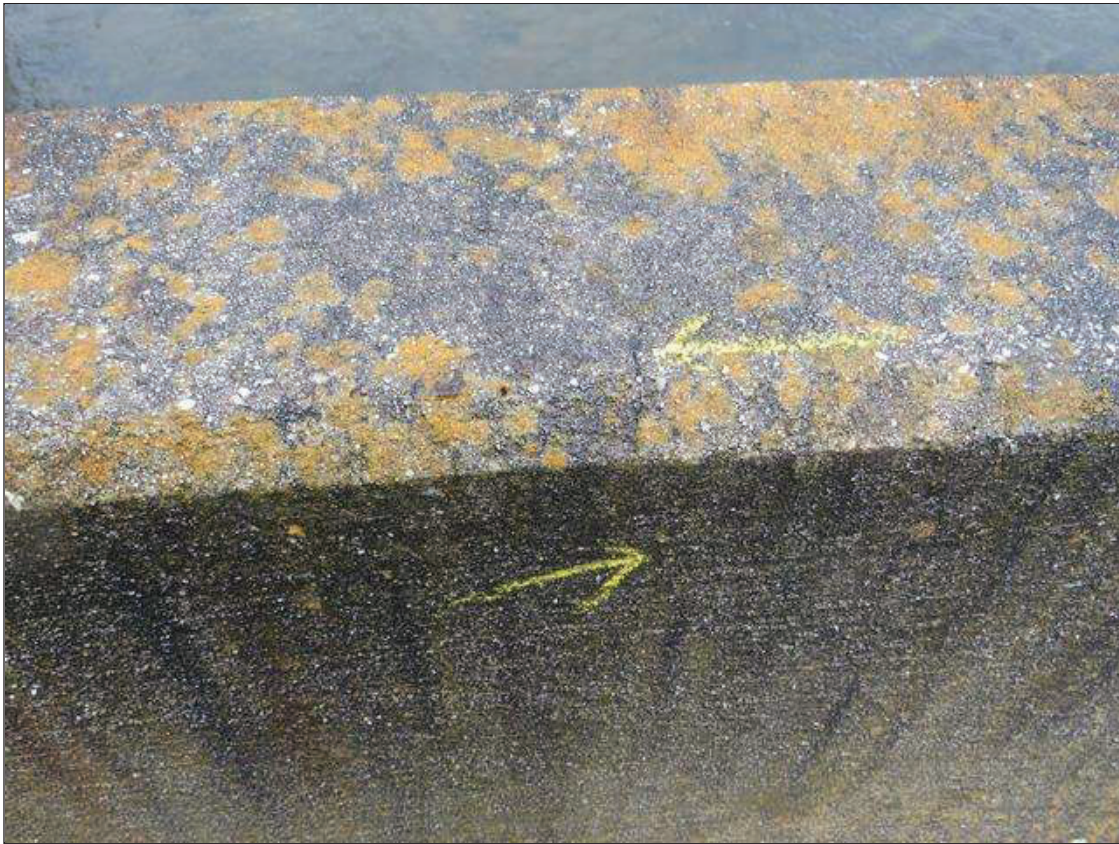
Span 2 Left Bridge Rail: (2) HAIRLINE VERTICAL AND TRANSVERSE CRACKS

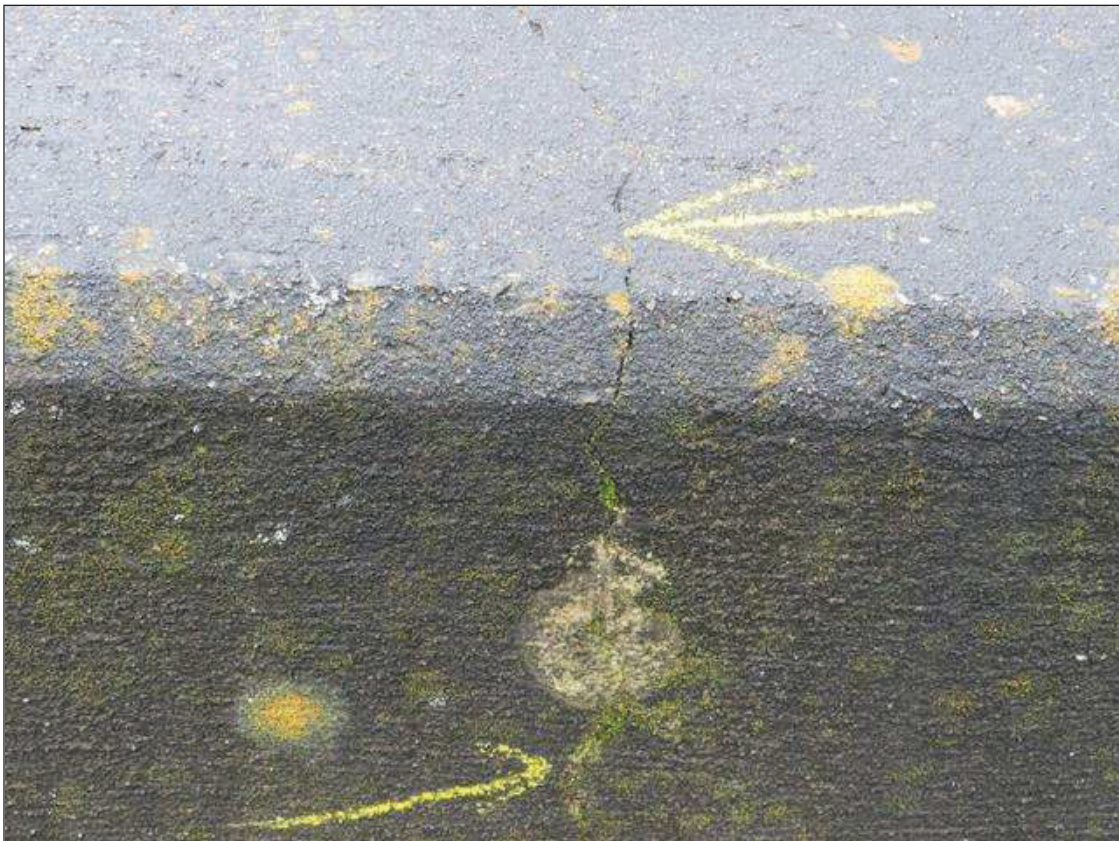
Span 2 Right Bridge Rail: VERTICAL CRACKING TO 1/32 INCH WITH EFFLORESCENCE STAINING NEAR MID SPAN

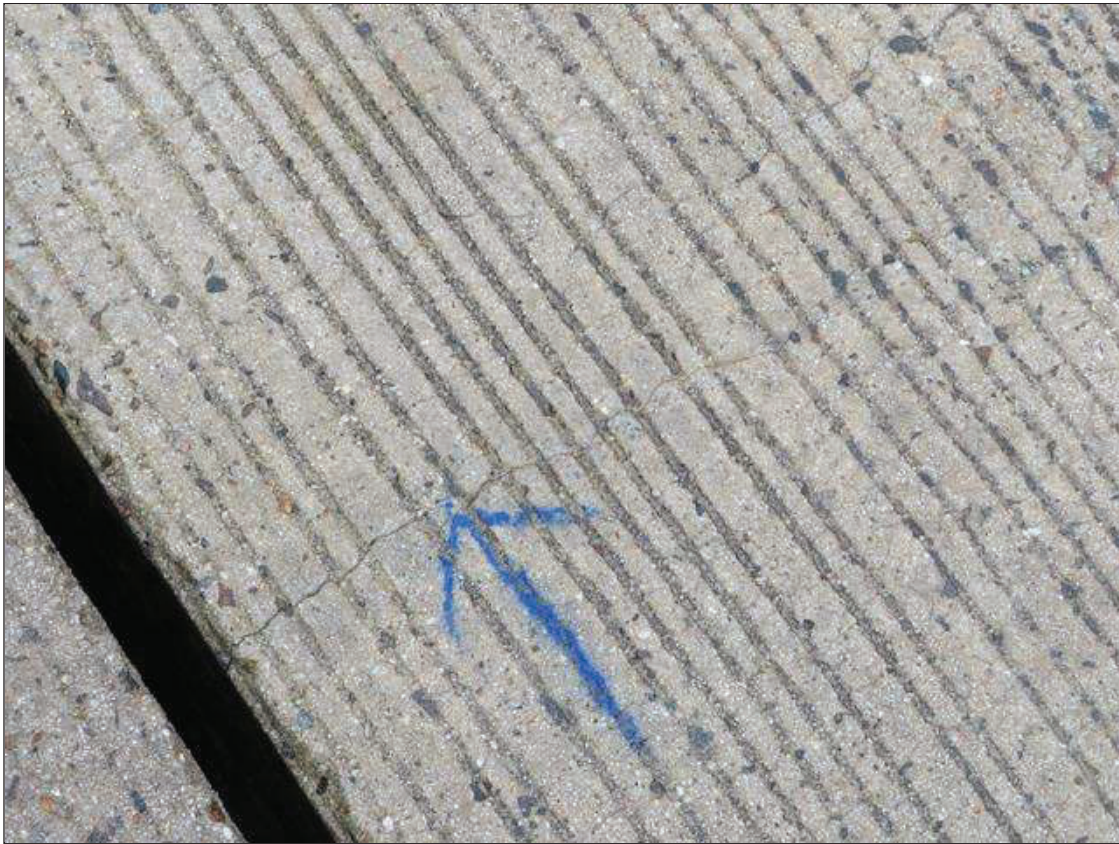
Span 3 Deck: 7 SQUARE FEET HAIRLINE LONGITUDINAL CRACKS EXTENDING FROM BENT 2 JOINT

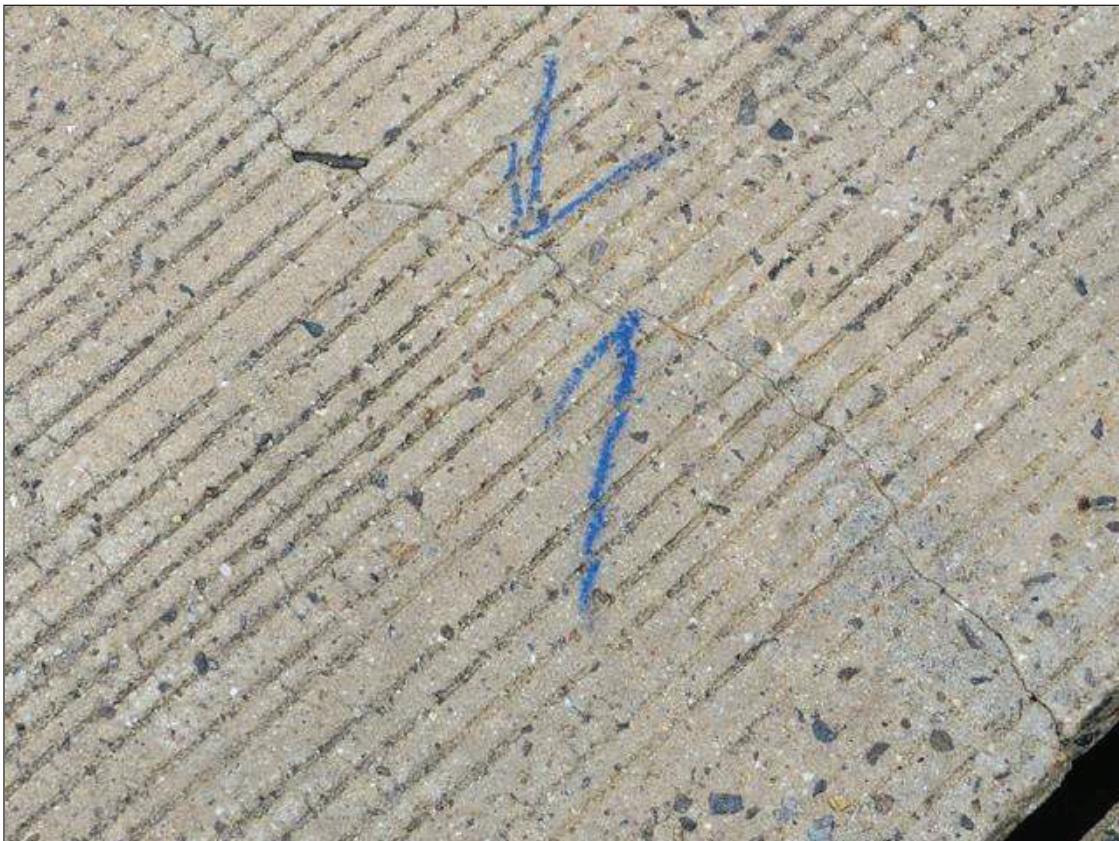
Span 3 Deck: 12 SQUARE FEET HAIRLINE LONGITUDINAL CRACKS EXTENDING FROM BENT 3 JOINT

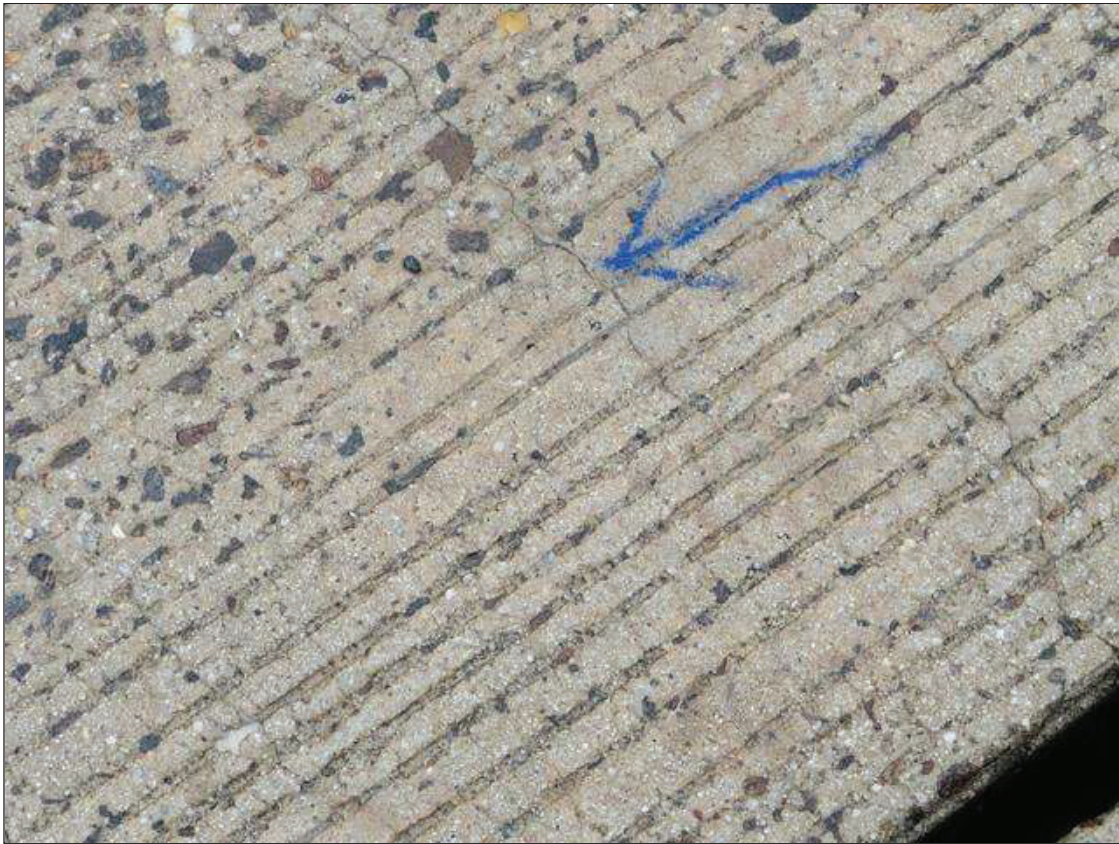
Span 4 Deck: 3 SQUARE FEET HAIRLINE LONGITUDINAL CRACKS EXTENDING FROM BENT 3 JOINT

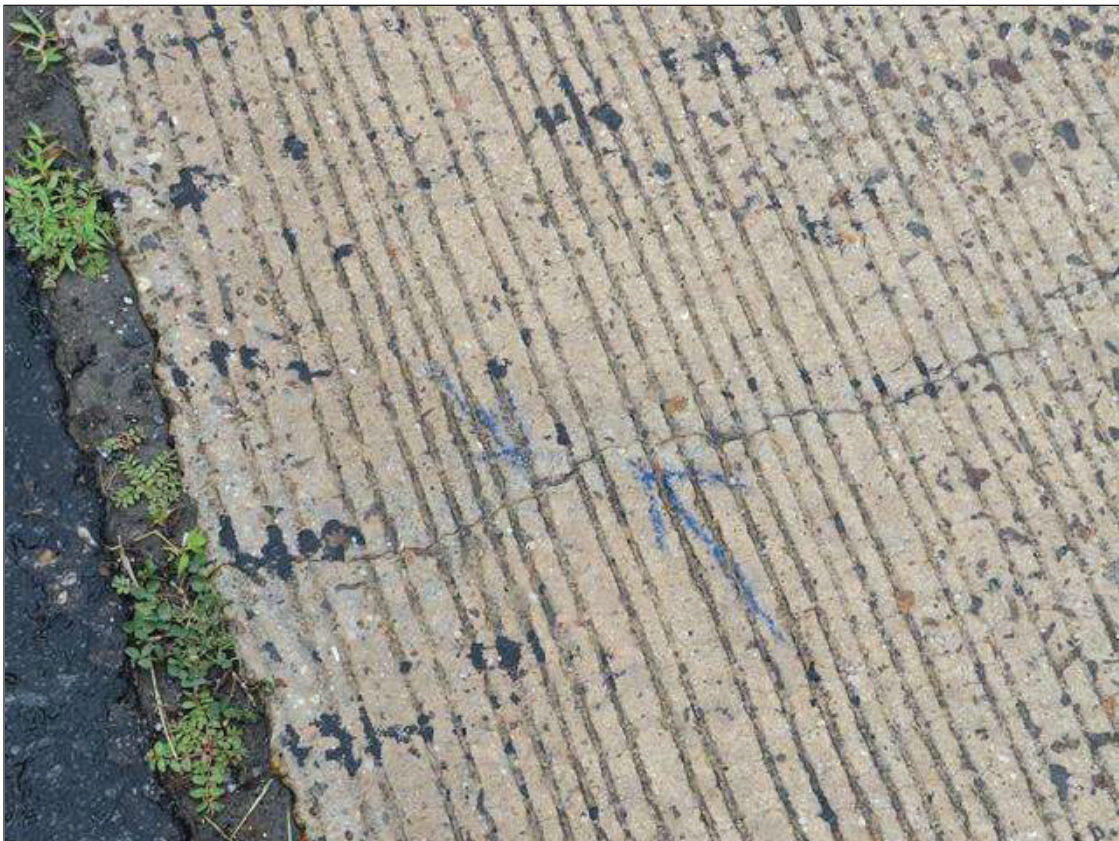
Span 4 Deck: 6 SQUARE FEET HAIRLINE LONGITUDINAL CRACKS EXTENDING FROM END BENT 2

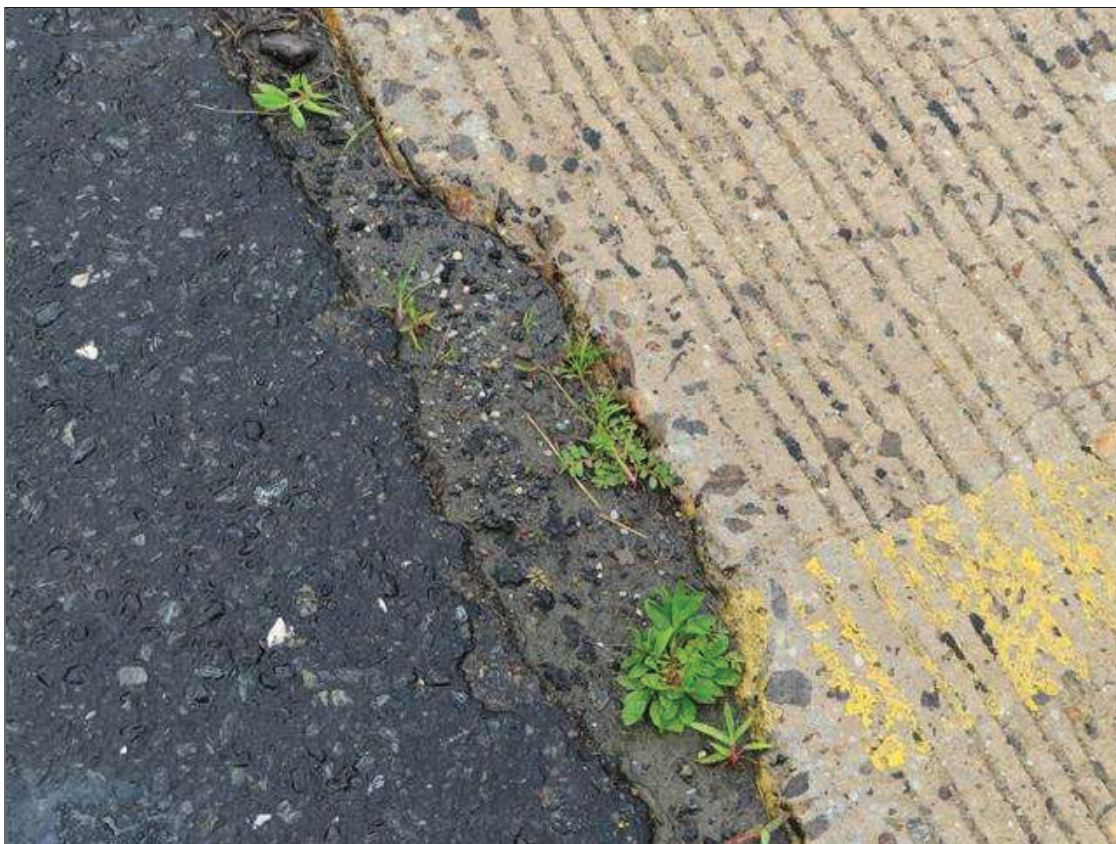
Span 4 Deck: (3) UP TO 12 INCHES WIDE X 1.5 INCHES LONG X 1.5 INCHES DEEP SPALLS ALONG END BENT 2

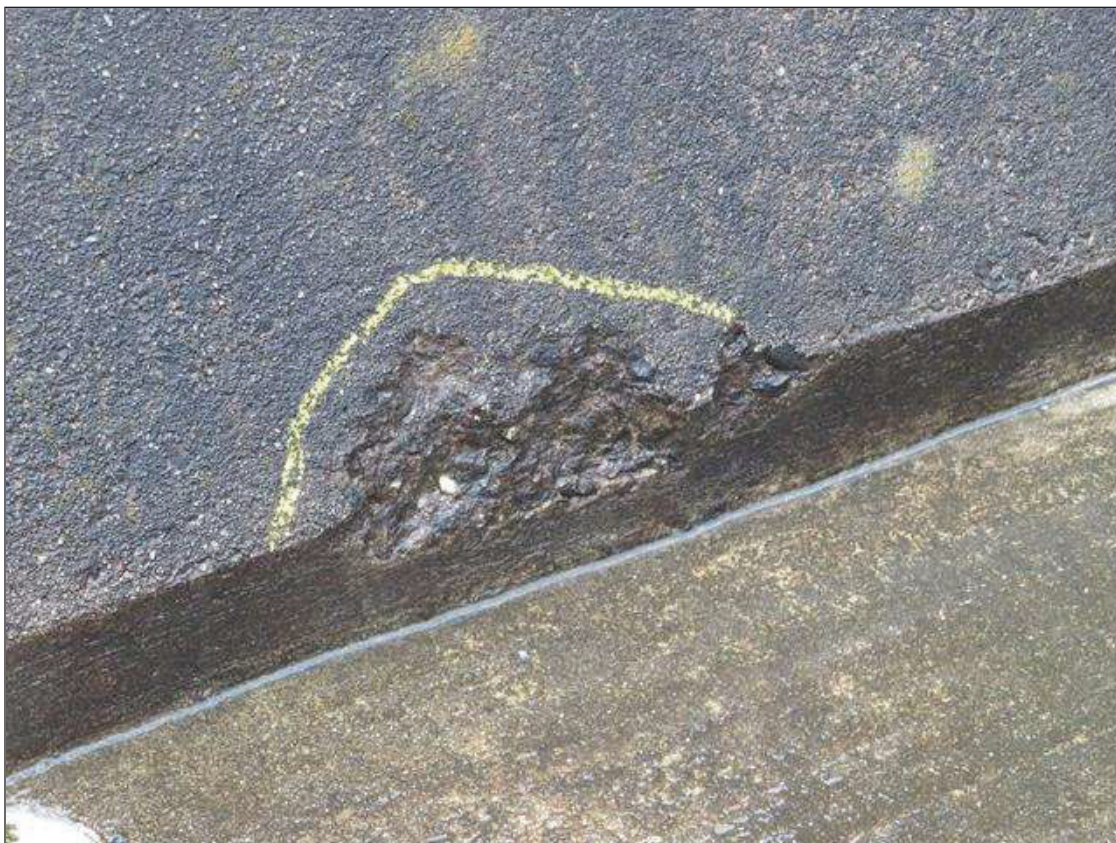
Span 4 Right Bridge Rail: 9 INCHES LONG X 3 INCHES HIGH X 1/2 INCH DEEP SPALL, 17 FEET FROM BENT 3

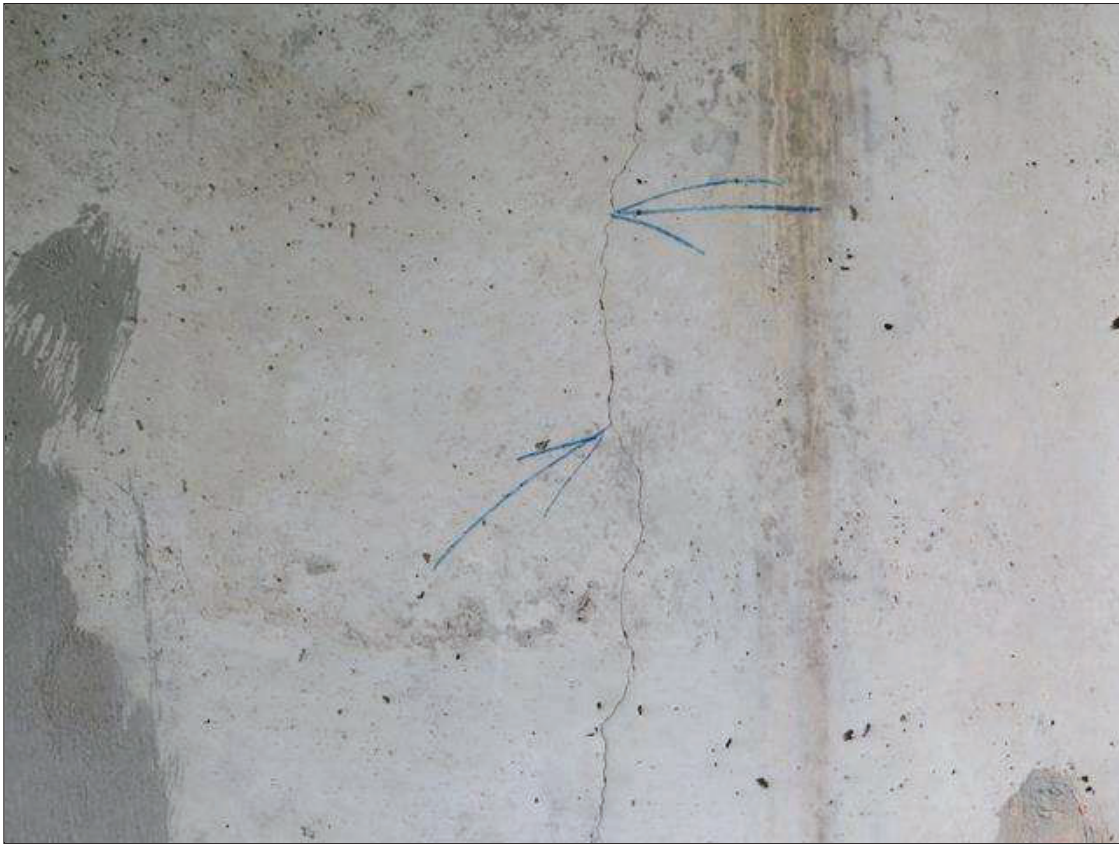
End Bent 1 Abutment: (2) UP TO 12 FEET X 1/64 INCH WIDE VERTICAL CRACKS, AT RANDOM THROUGHOUT NORTH FACE.

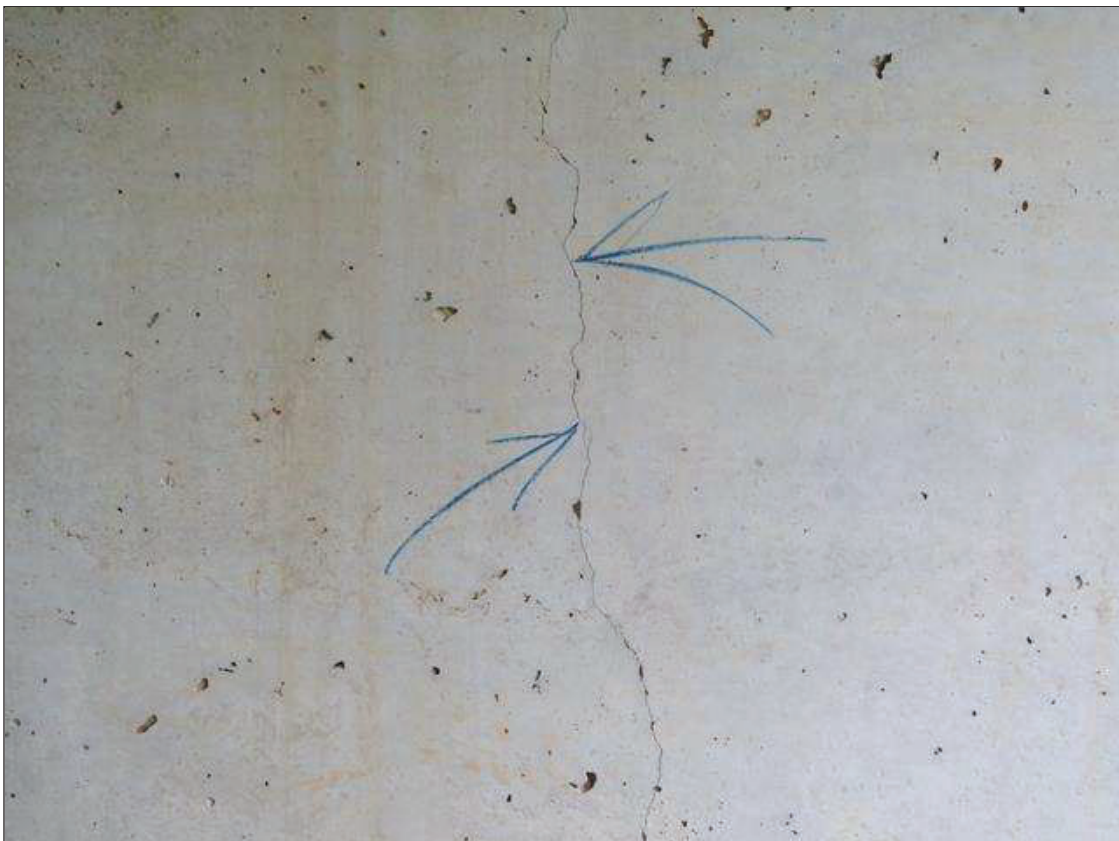
End Bent 2 Abutment: (3) UP TO 8 FEET HIGH X 1/32 INCH WIDE VERTICAL CRACKS, AT RANDOM THROUGHOUT SOUTH FACE.
