NC DEPARTMENT OF TRANSPORTATION
 DIVISION OF HIGHWAYS
 STRUCTURE MANAGEMENT UNIT

ATTENTION: **PLATFORM TRUCK AND TRAFFIC CONTROL USED,
 PARS ISSUED**

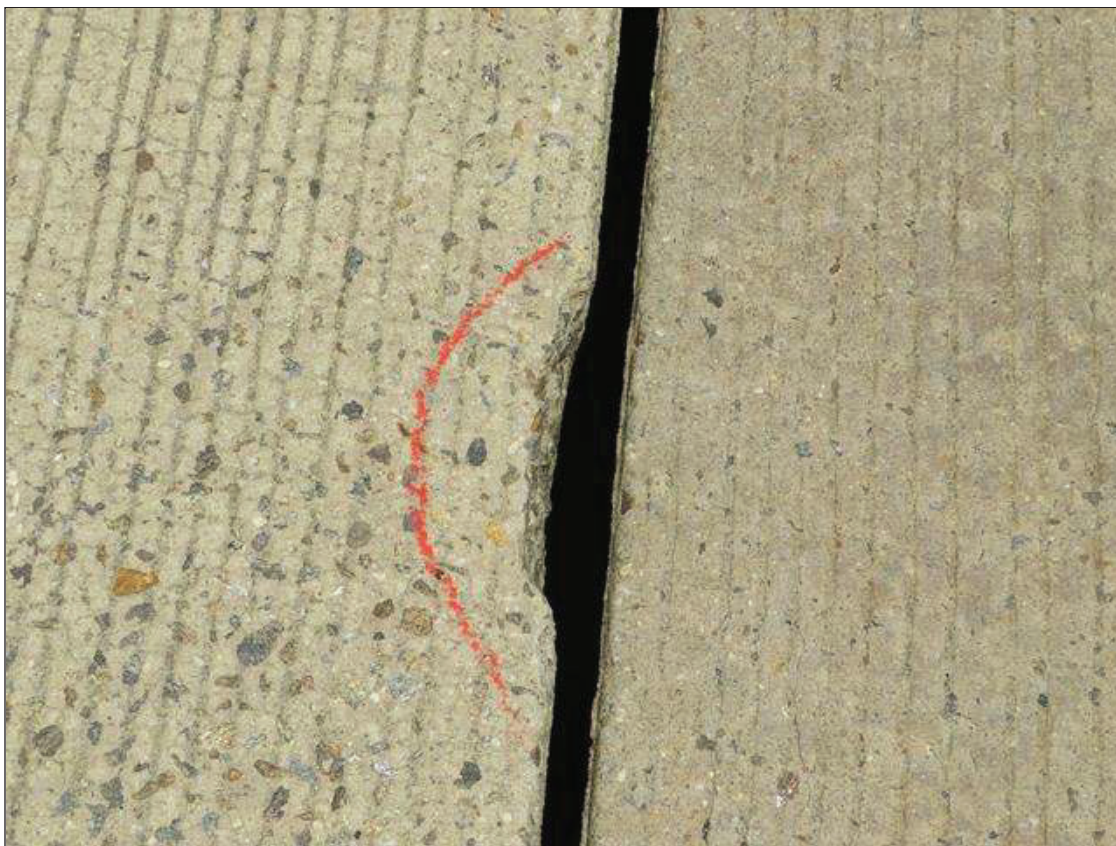
Span 2 Expansion Joint: BENT 1 OPEN JOINT, CHIPPING UP TO 7 INCHES WIDE X 3/4 INCHES LONG X 3/4 INCHES DEEP, SCATTERED

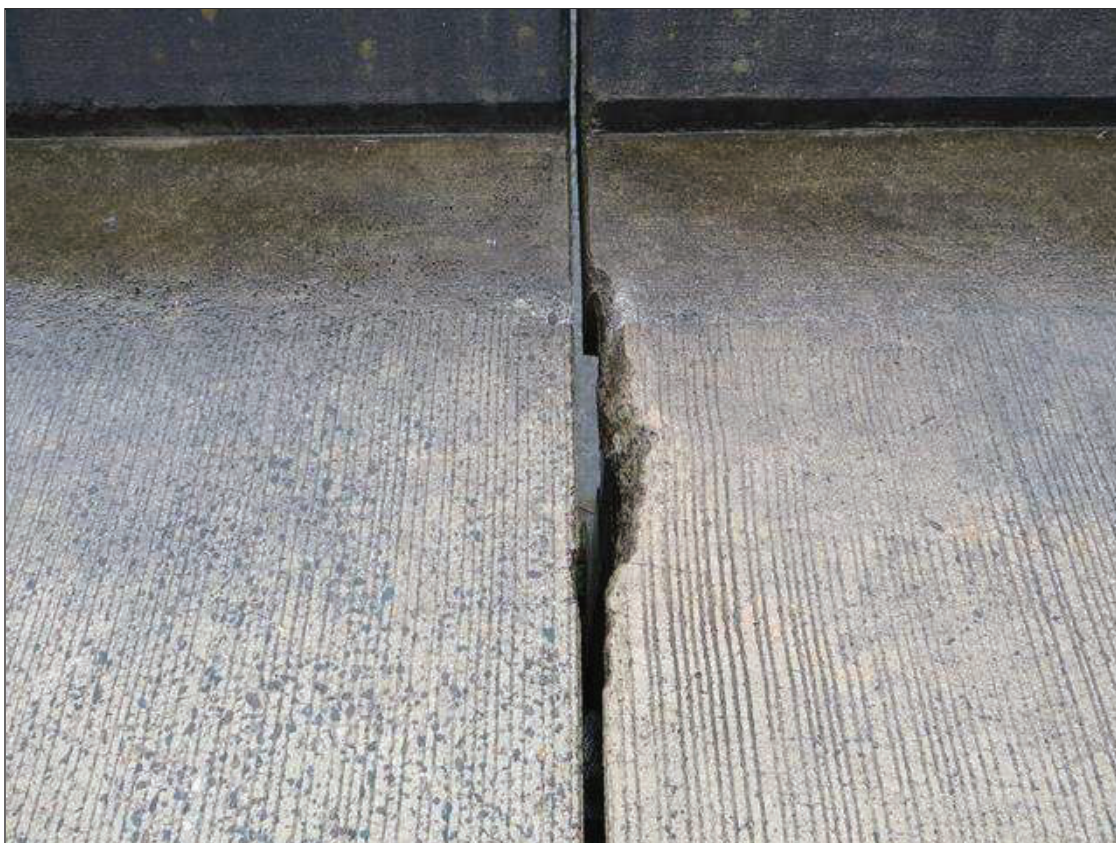
Span 3 Deck: SPALLED AREA (2 FEET WIDE X 3 INCHES LONG X 4 INCHES DEEP) AT NORTH END ADJACENT TO RIGHT RAIL (PAR)

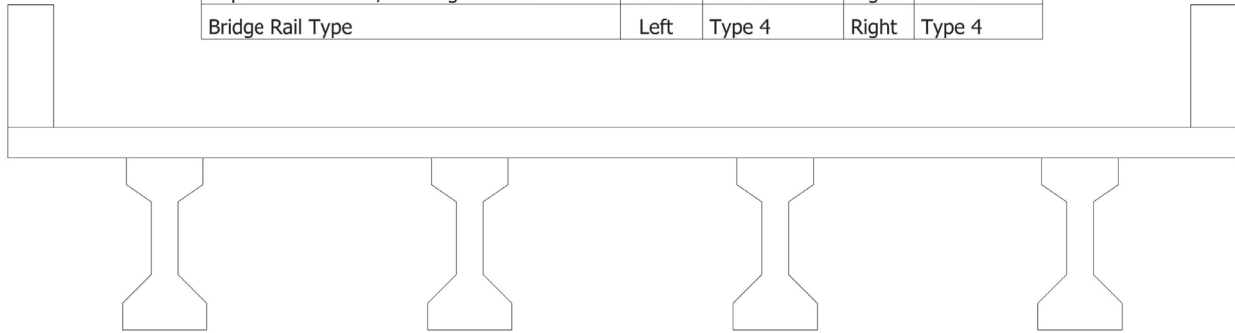
| Measurements for Span # | 1 - 4 | | |
