Geophysical Anomaly Investigation Report

TIP: R-2408B WBS: 34427.1.1

Guy Duval Property, Parcel #39

Report on Geophysical Surveys to Locate Possible UST's

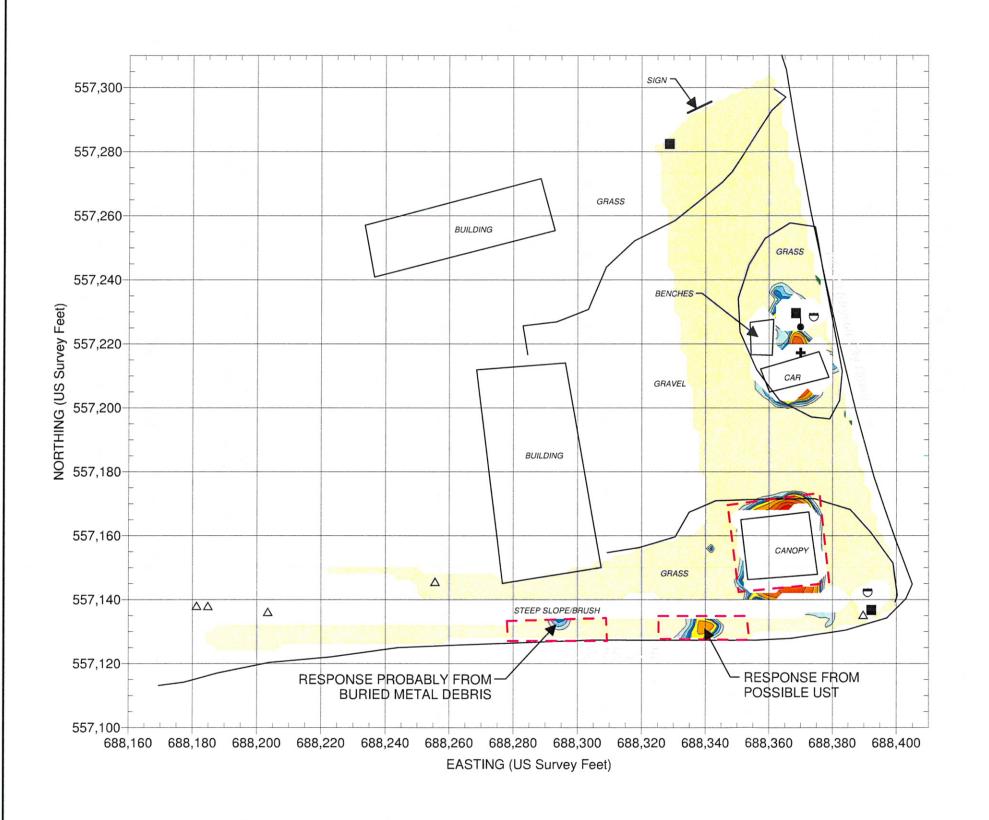
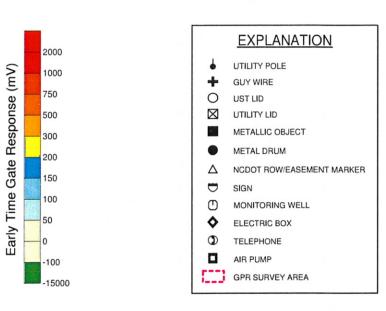
FIGURE 2

Note: The contour plot shows the earliest and most sensitive time gate of the EM61 bottom coil/channel in millivolts (mV). The EM data were collected on May 21, 2008, using a Geonics EM61-MK2 instrument. Positioning for EM61 survey provided using a submeter Trimble ProXRS DGPS system. Coordinates are in the US State Plane 1983 System, North Carolina Zone 3200, using the NAD 1983 datum. GPR data were acquired on May 27, 2008, using a Geophysical Survey Systems SIR 3000 equipped with a 400 MHz antenna.

State Project R-2408A and B Macon County, NC PARCEL 39 EM61 EARLY TIME GATE RESULTS

The contoured EM61 data are shown on Figures 2 and 3. The EM61 early time gate results are plotted on Figure 2. The early time gate data provide the most sensitive detection of metal object targets, regardless of size. Figure 3 shows the difference between the response of the top and bottom coils of the EM61 instrument (differential response). The difference is taken to remove the effect of surface and very shallowly buried metallic objects. Typically, the differential response emphasizes anomalies from deeper and larger objects such as UST's.

The early time gate and differential results show several anomalies attributed to known site features, and two anomalies not attributed to known site features (Figures 3 and 4). GPR data were collected over the two anomalies not attributed to known site features, and around and under the metal canopy in the corner of the parcel. The anomaly at Easting 688,294, Northing 557,132 appears to be caused by buried metal debris. The GPR data collected in the area of the anomaly at Easting 688,340, Northing 557,131 was inconclusive. Due to the high amplitude of this anomaly, we cannot rule out the possible presence of a metal UST at this location.

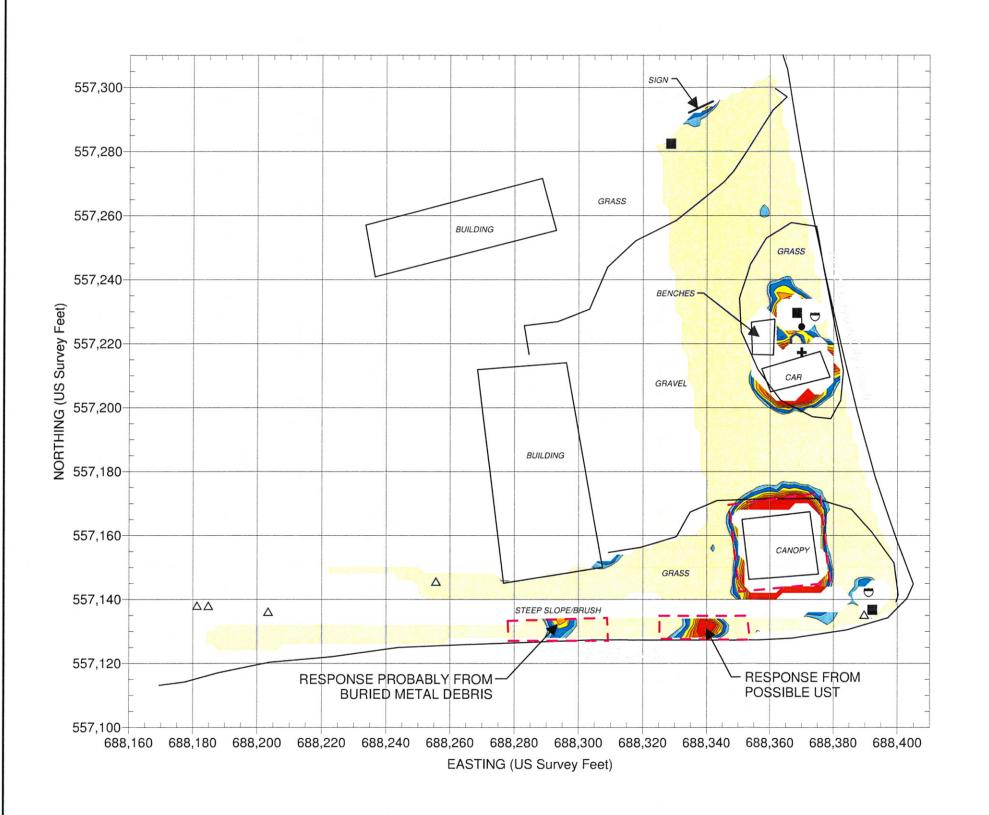
FIGURE 3

Note: The contour plot shows the difference, in millivolts (mV), between the readings from the top and bottom coils of the EM61. The difference is taken to reduce the effect of shallow metal objects and emphasize anomalies caused by deeper metallic objects, such as pipes and tanks. The EM data were collected on May 21, 2008, using a Geonics EM61-MK2 instrument. Positioning for the EM61 survey provided using a submeter Trimble ProXRS DGPS system. Coordinates are in the US State Plane 1983 System, North Carolina 3200 Zone, using the NAD 1983 datum. GPR data were acquired on May 27, 2008, using a Geophysical Survey Systems SIR 3000 equipped with a 400 MHz antenna.

PARCEL 39 EM61 DIFFERENTIAL RESULTS

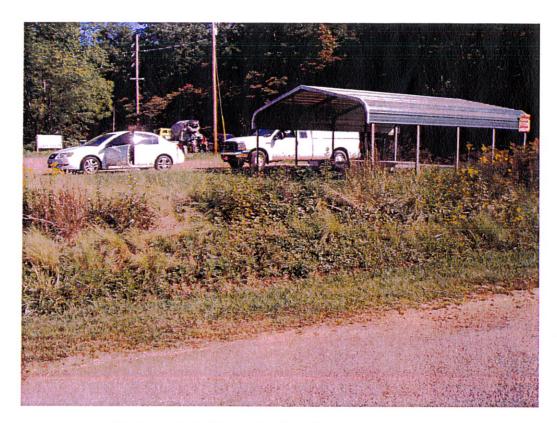
Photograph 1: Excavation location prior to work

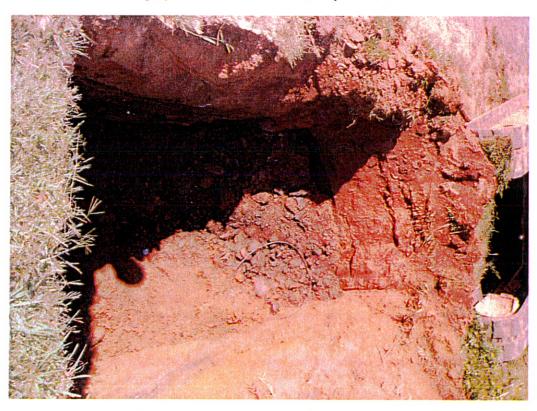
No UST or significant buried debris was encountered during exploratory excavations conducted in two areas on the Guy Duval property (NC DOT Parcel #39). Pieces of buried concrete, asphalt, and metal debris likely caused GPR data to be misinterpreted as a potential UST. Upon completion of excavation activities, the areas were backfilled with the excavated soil and disturbed areas were seeded and covered with straw. Based on the results of excavation activities, only minor debris is expected to be encountered in this area of the Guy Duval property during proposed NC DOT road work.

Photograph 2: Minor debris buried in soil

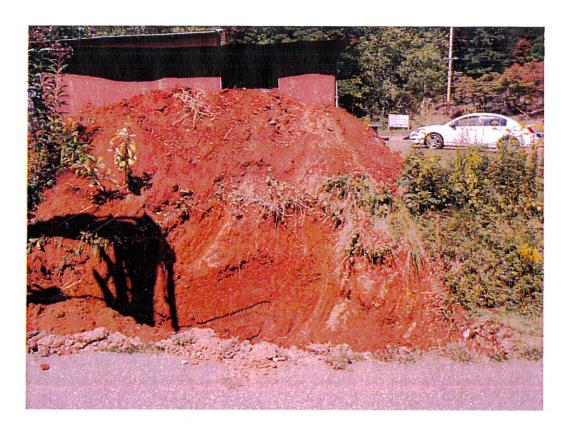
On September 23, 2008, H&H mobilized to the site to conduct exploratory excavation and potential UST removal activities. H&H contracted Soil Solutions, Inc. (SSI) of Winston-Salem, North Carolina to perform the excavation activities. Excavations were conducted at each anomaly location. Excavated soil was stockpiled adjacent to each excavation pit. The western excavation (possible buried metal) dimensions were 14.5 ft by 10.5 ft and 7.5 ft deep. The eastern excavation (possible UST) dimensions were 14 ft by 6.5 ft and 7.5 ft deep. During excavation activities, no USTs were encountered; however, several pieces of concrete, asphalt, and metal were found buried approximately 2 to 7.5 feet below the ground surface in each excavation area. As shown in the photographs in Appendix B, the amount of buried debris appears to be minor. The debris likely caused the GPR data to be misinterpreted as a potential UST in the eastern excavation. The excavation areas are shown on Figure 2.

Photograph 3: Soil excavation and stockpile

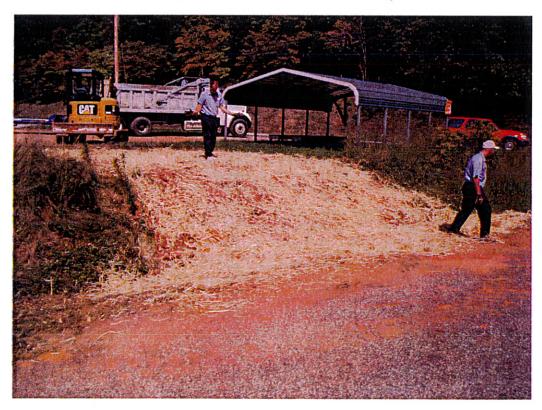
Photograph 4: View of area after exploratory excavation

The excavations were backfilled with the excavated soil and compacted in lifts to match existing grade. Disturbed areas were seeded and covered with straw.
