INITIAL ABATEMENT ACTION REPORT FOR CLOSED ORPHAN UNDERGROUND STORAGE TANK

**101 Park Street, Carlene Green Crisp Property
Parcel #4
Canton, North Carolina
TIP # B-3656, WBS Element # 33202.1.2
Haywood County**

October 14, 2010

**Gasoline UST (UST #002)
Parcel #4
Carlene Green Crisp Property
101 Park Street
Canton, NC**

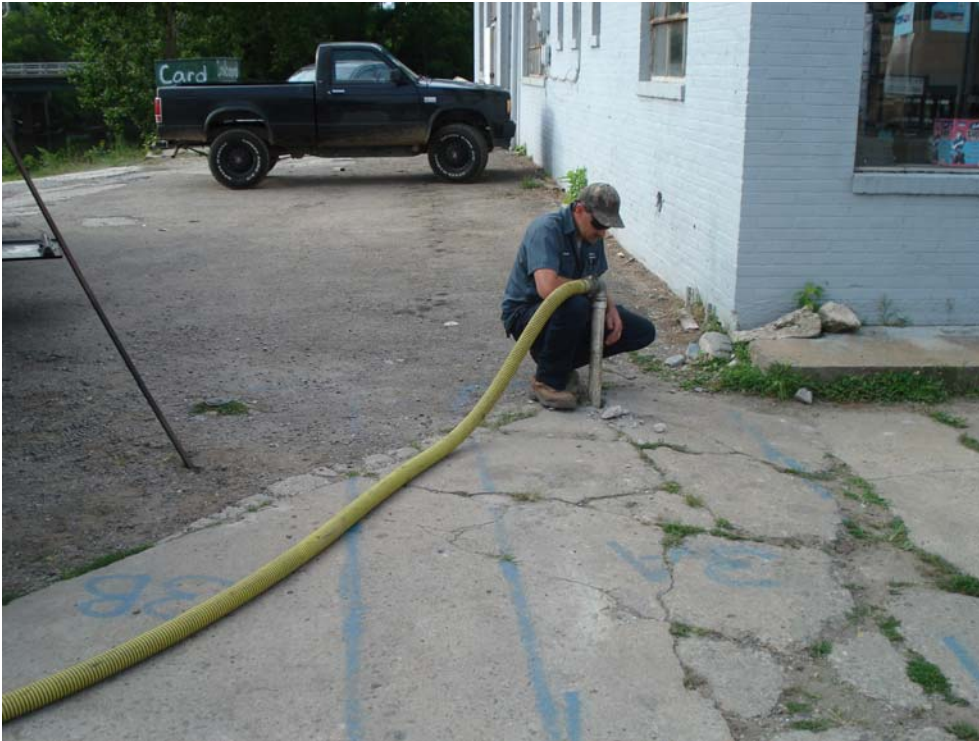
Photograph 1: View looking south at removal of residual liquid from UST #002 fill pipe prior to removal of UST #001 and UST #002

1,000 gallons of residual waste oil/water (> 90% water) was removed from UST #001, and 426 gallons of residual gasoline/water (> 90% water) was removed from UST #002 using a vacuum truck. Once the USTs were removed, the exteriors of the USTs were examined, and no corrosion holes or rust were identified on the bottom or sides of either UST.

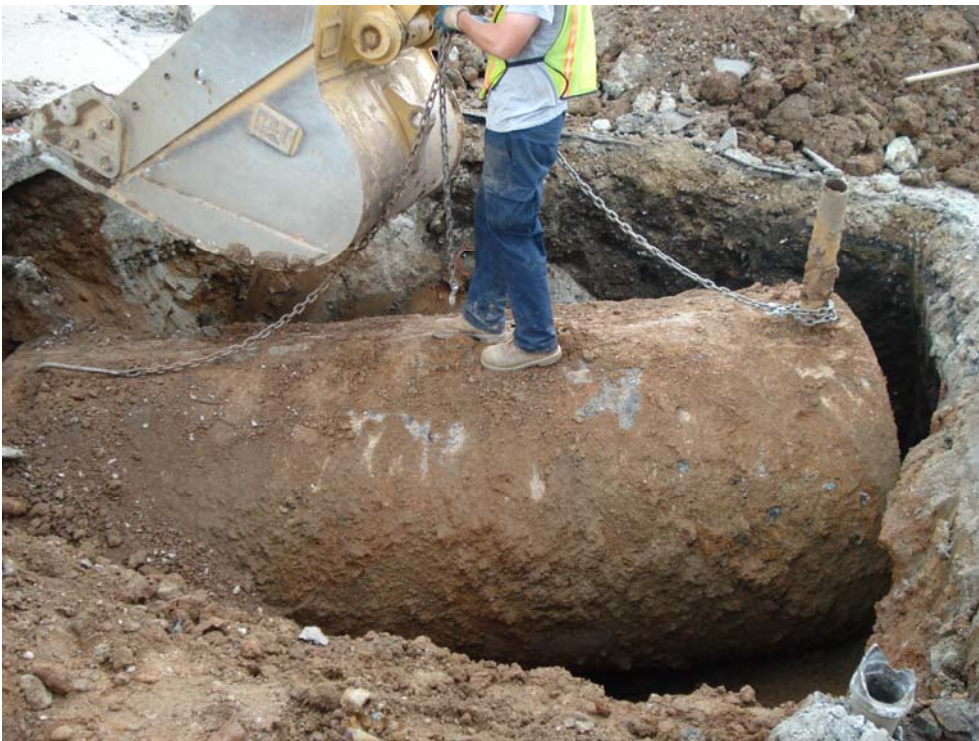
Photograph 2: View looking east at removal of UST #001. UST fill pipe for UST #002 is shown in lower right corner of photo.

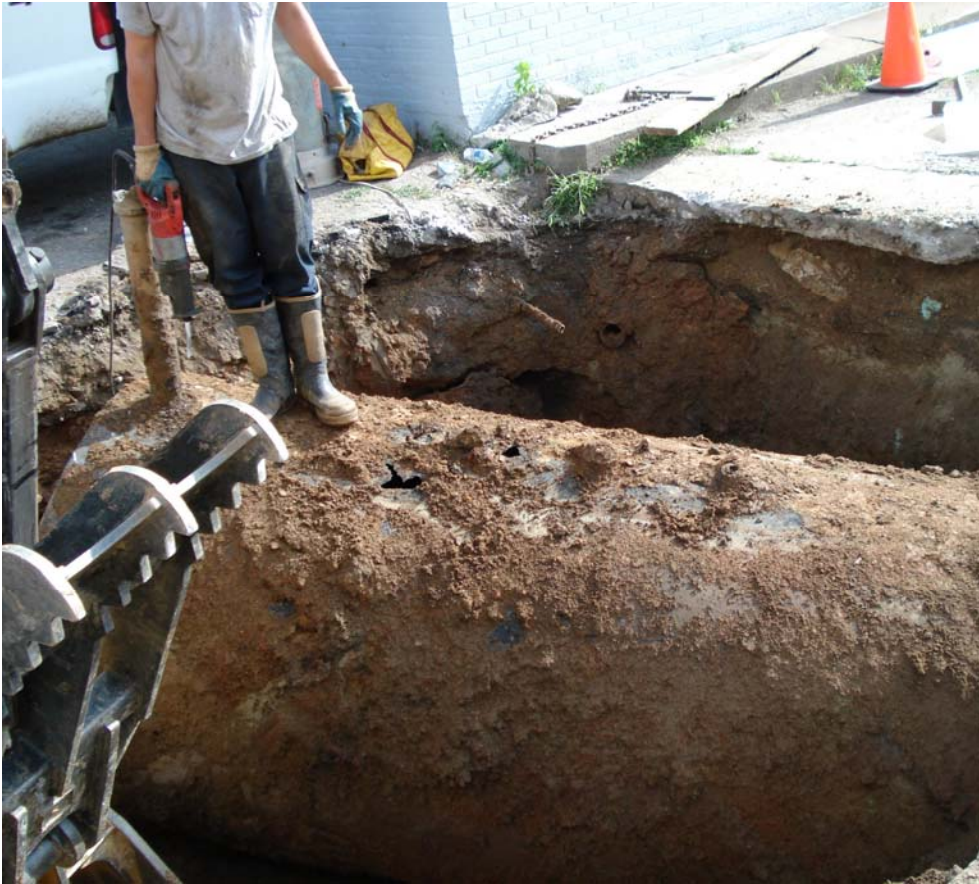
Photograph 3: View looking southwest at removal of UST #002. Holes shown on top of tank were created by UST removal contractor.

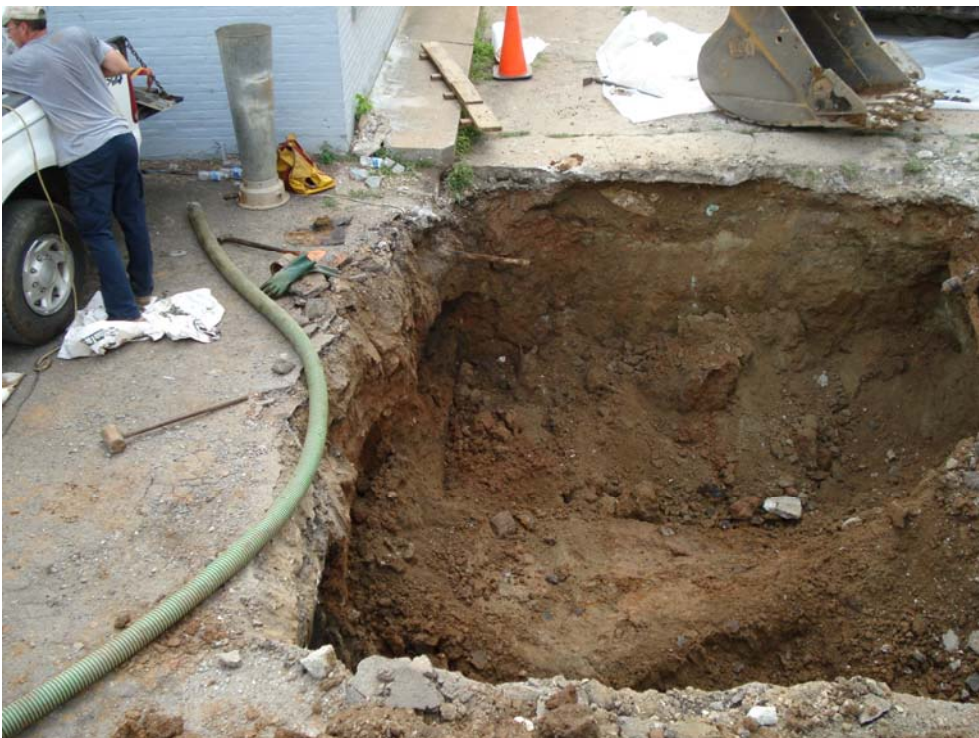
Photograph 4: View looking west at UST pit following removal of UST #001 and UST #002..

A pit 13 feet wide by 15 feet long by 8 feet deep remained following the removal of UST #001 and UST #002, as shown in Figure 2.

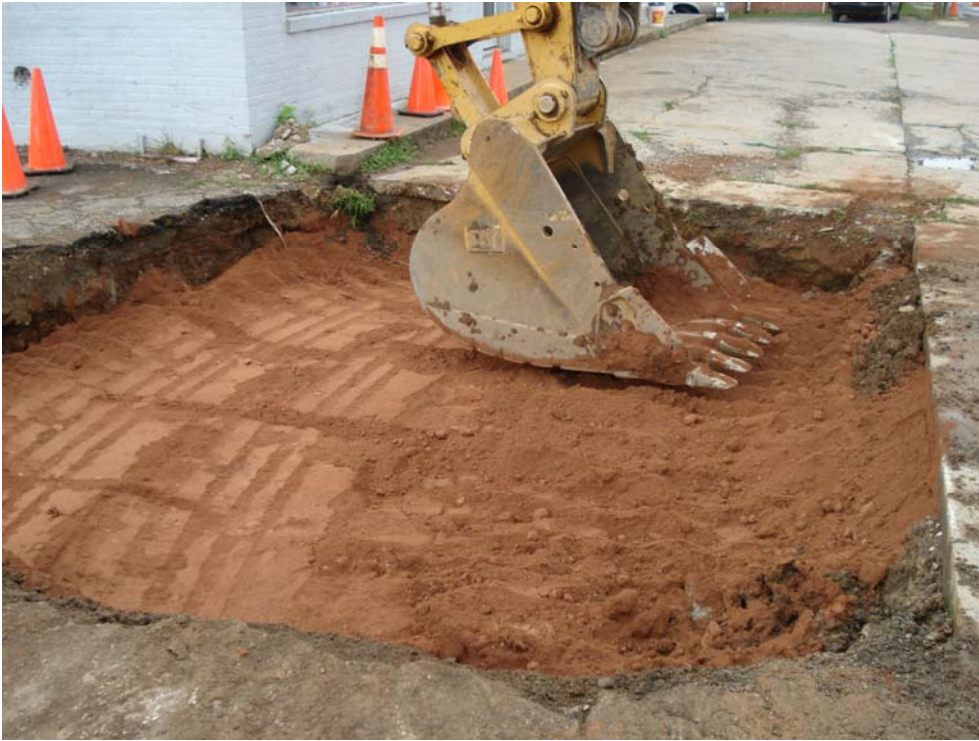
Photograph 5: View looking southwest at compaction of fill material that had been backfilled into UST excavation.

A trackhoe was used to remove the USTs, and backfill and compact the excavation (see photographs in Appendix IX).

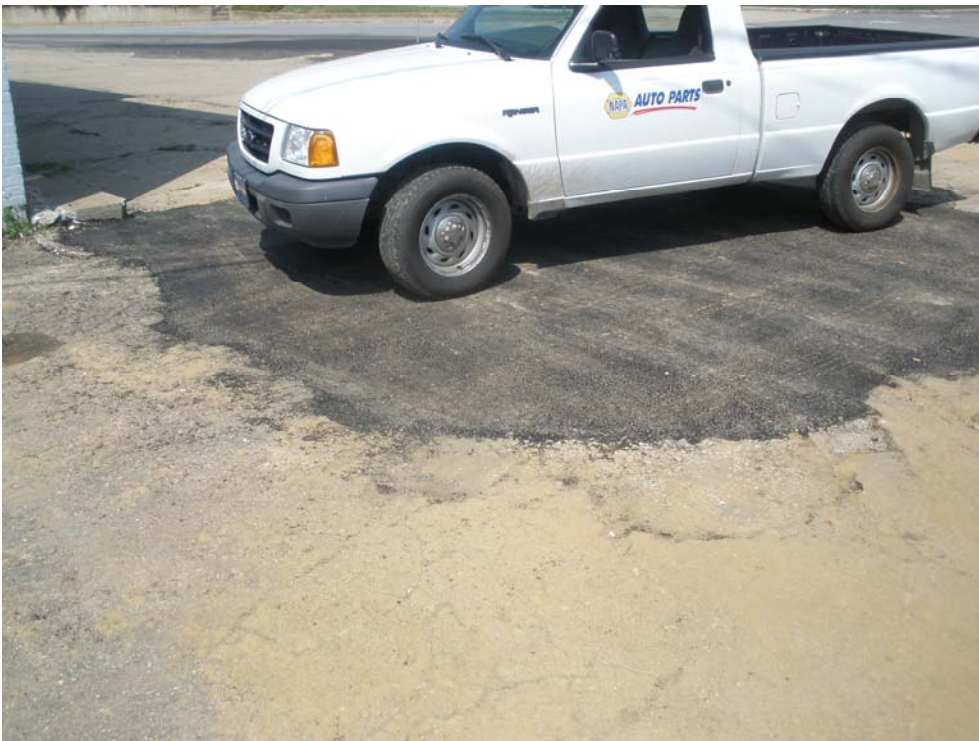
Photograph 6: View northwest at newly-applied asphalt paving over UST excavation.

A 24-hour release notification (NCDENR Form UST-61) was submitted to the Asheville Regional Office of NCDENR on August 31, 2010 based on the detection of 12 mg/kg DRO in soil sample P4-3, which exceeded the NCDENR action level of 10 mg/kg. The excavation was backfilled with clean fill material to land surface and compacted following collection of the closure soil samples, then paved with new asphalt (see Photographs 5 and 6 in Appendix IX).

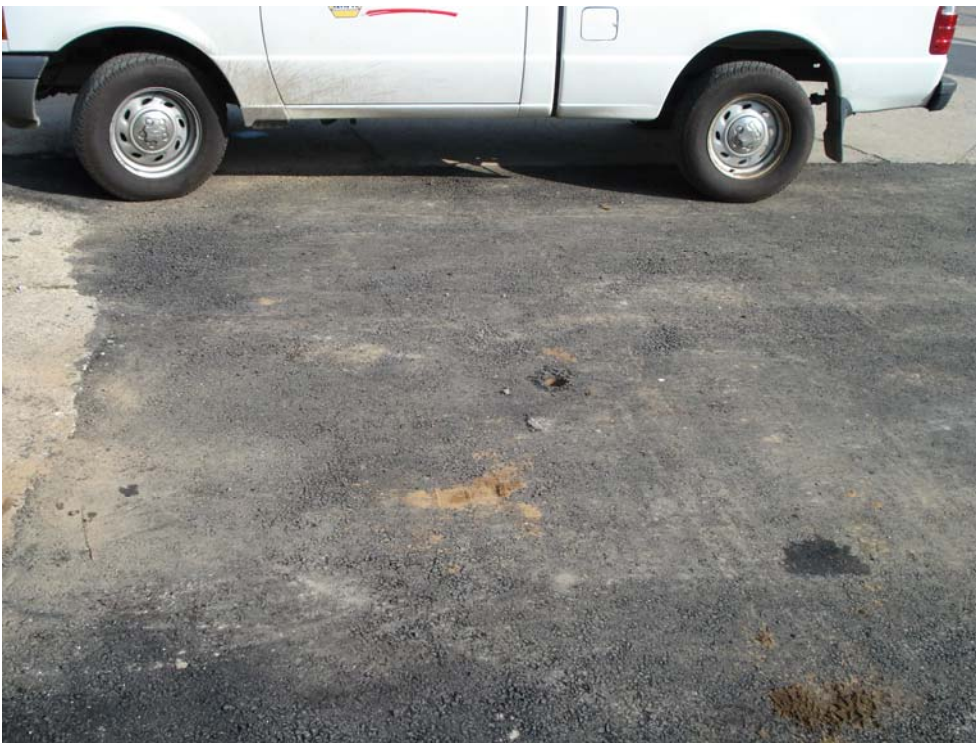
Photograph 7: View looking west at DPT borehole for collection of confirmation soil sample SB4-3A.

A confirmation soil sample, SB4-3A, was collected on September 16, 2010 at 8 feet below ground surface at the same location as UST #002 closure soil sample P4-3 and analyzed for risk-based parameters specified in NCENR's UST closure guidance document for gasoline USTs (VOCs by 8260B and VPH by the MADEP Method).
