APPENDIX A
PREVIOUS REPORTS

Re: Preliminary Site Assessment Report
State Project: 8.T020401 (R-2414)
County: Camden
Description: Site 4: F&H Used Cars; Widening of US 158 from Elizabeth City to Belcross

**PHASE I LIMITED SITE ASSESSMENT
for
A FORMER WINSLOW OIL FUEL STATION
(CURRENTLY F&H USED CARS)**

**Project Number P94057
August 2001**

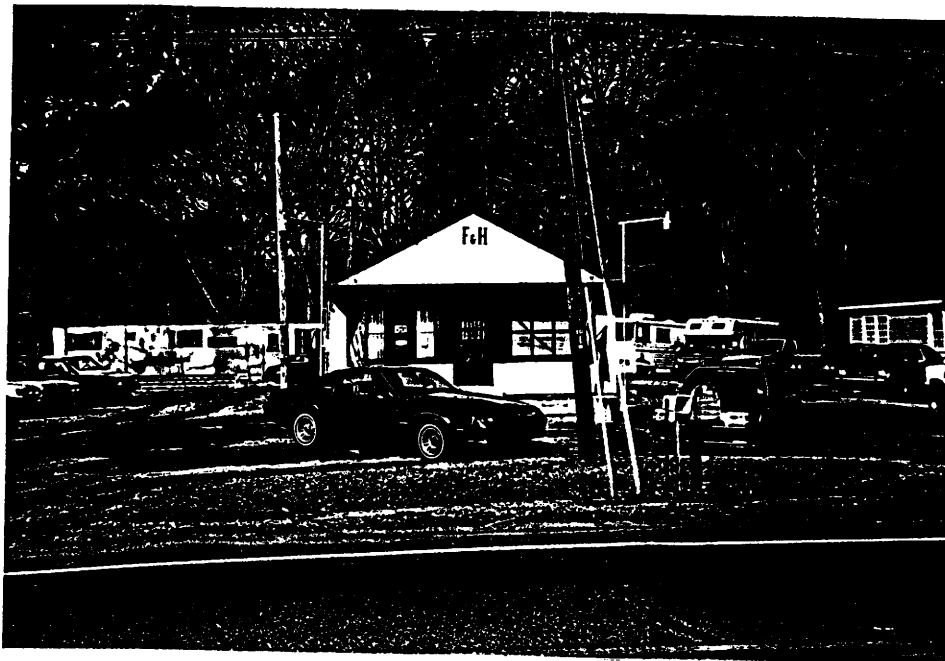
**Photograph 1: A view of the F&H Used Cars property.
Former pump island is located in front of the building.**

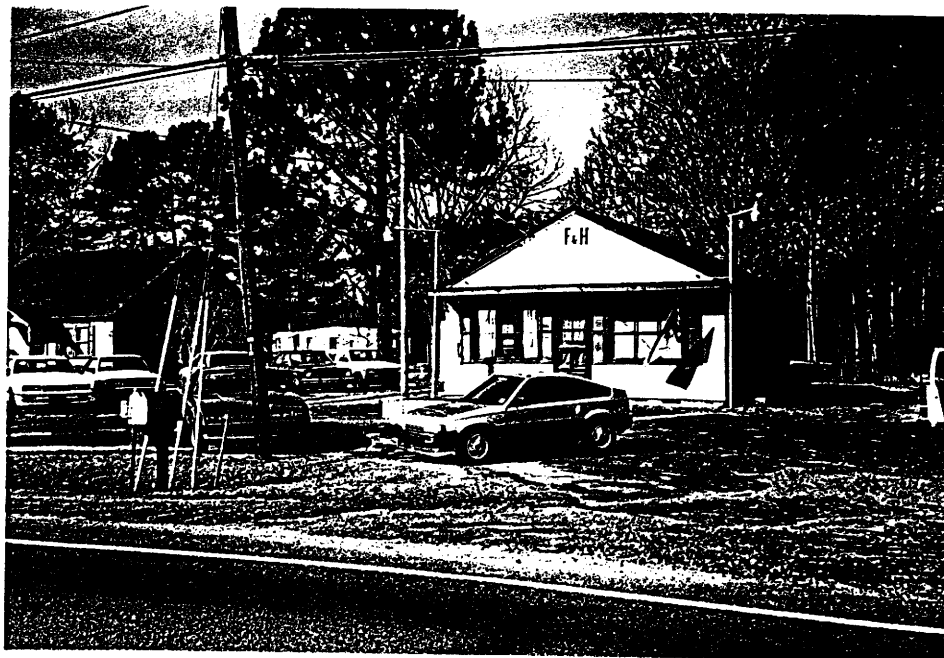
**Photograph 2: A view of the F&H Used Cars property.
The USTs are located immediately right of the building.**

It is recommended that the two USTs located on the F&H Used Cars property be removed and properly disposed and that contaminated soil encountered during removal activities also be excavated and properly disposed.

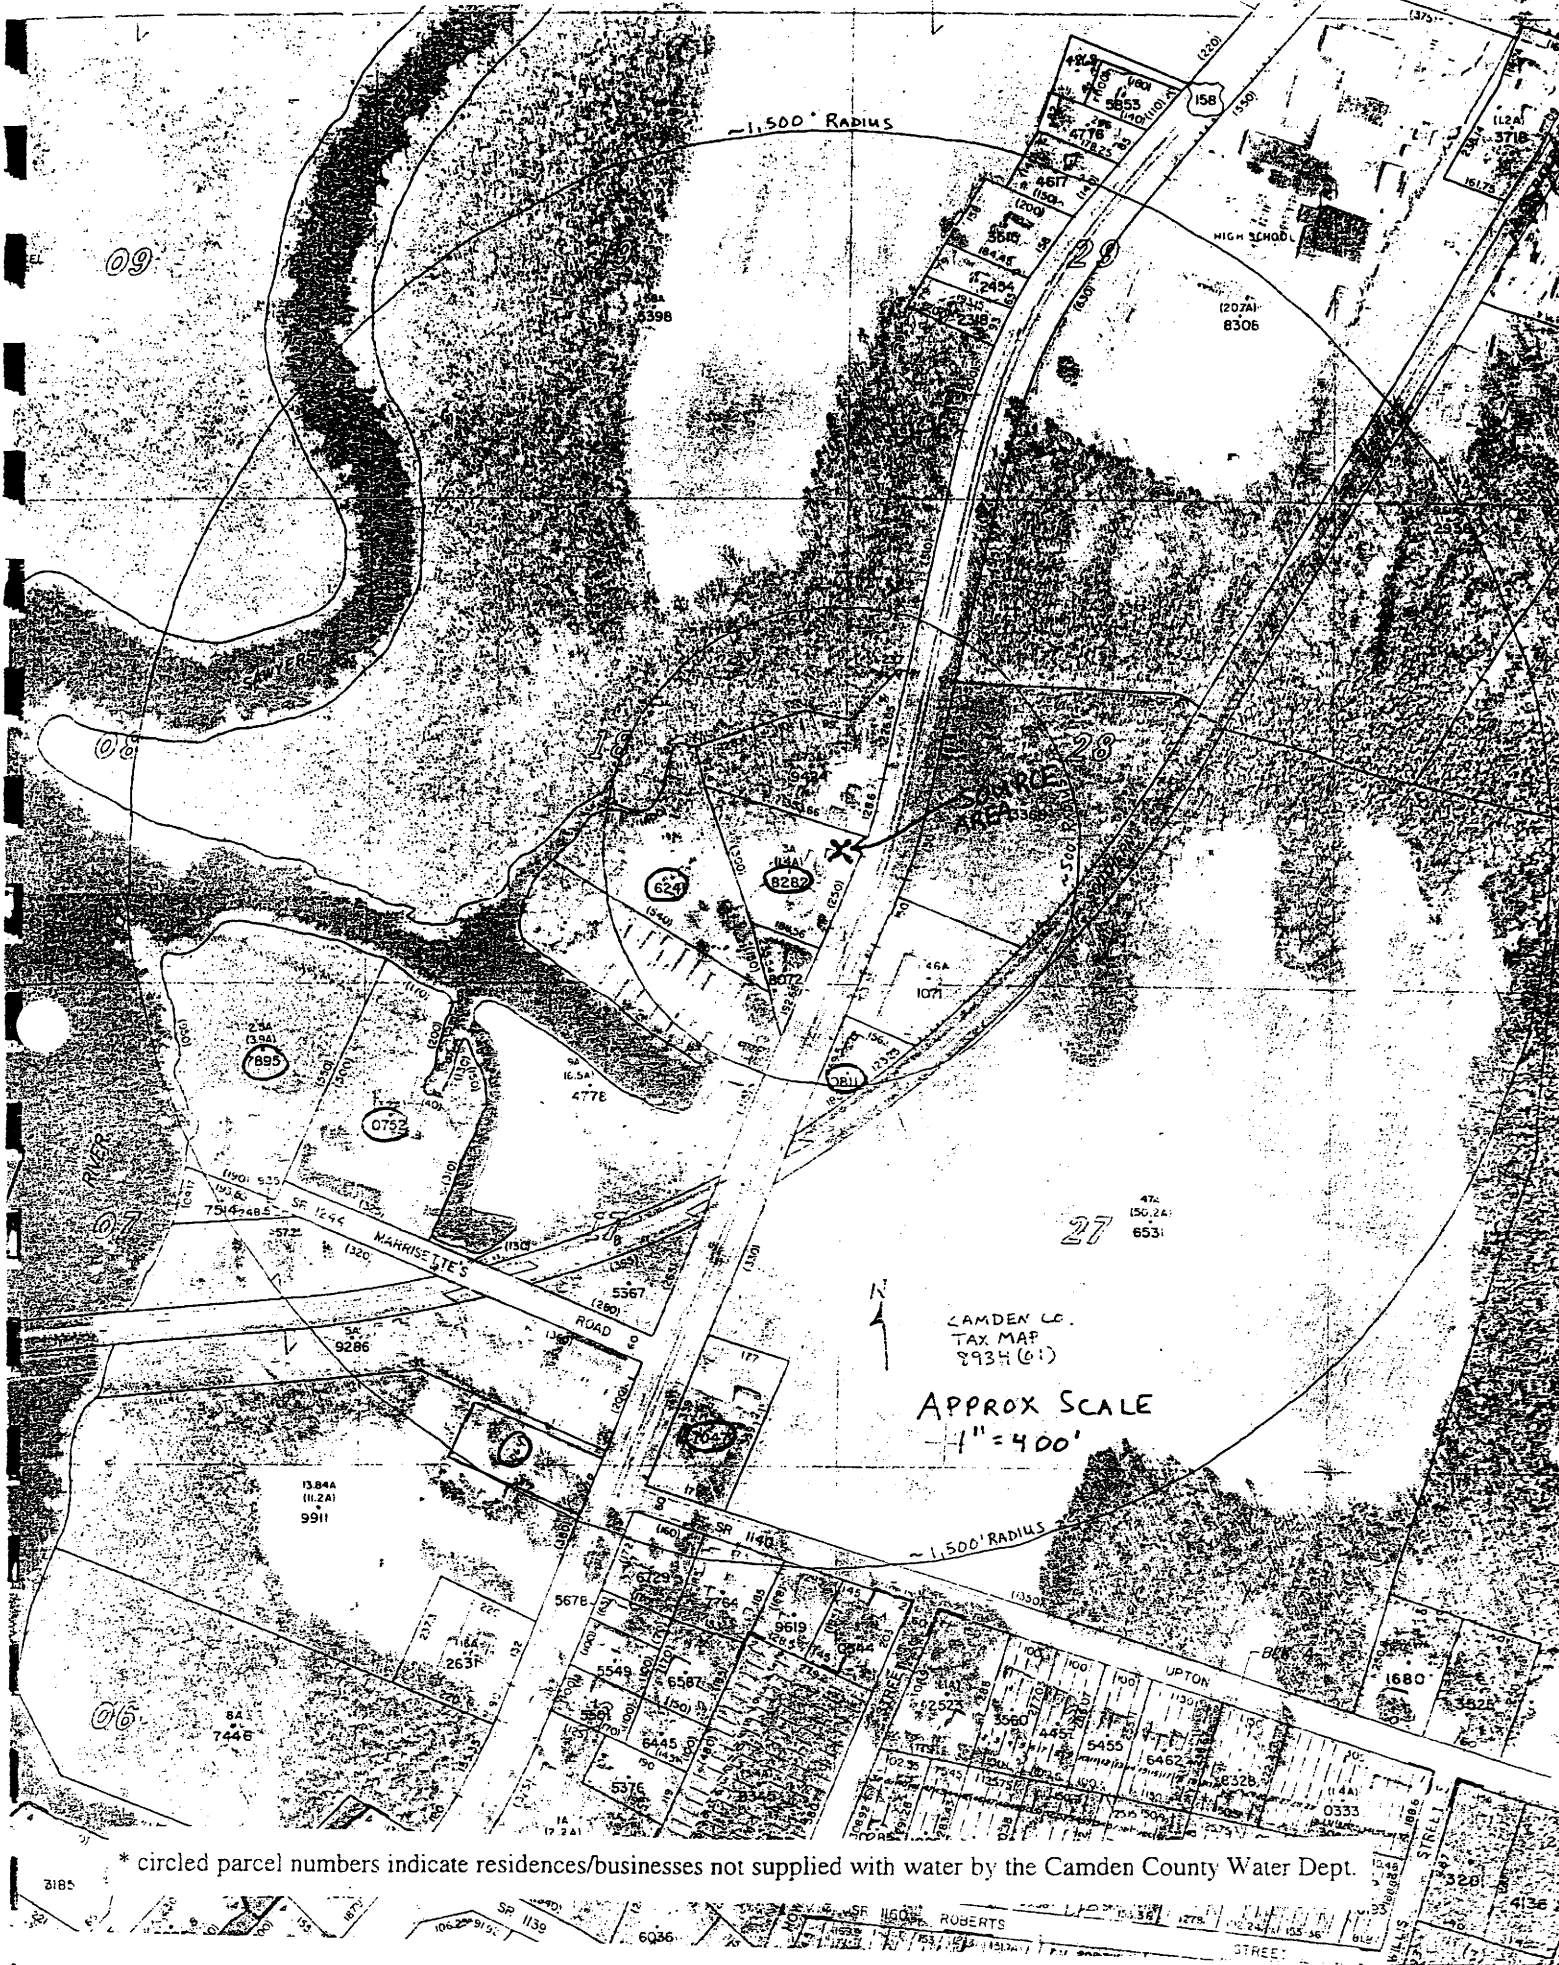
CAMDEN CO.
TAX MAP
8934 (01)
APPROX SCALE
1" = 400'

* circled parcel numbers indicate residences/businesses not supplied with water by the Camden County Water Dept.

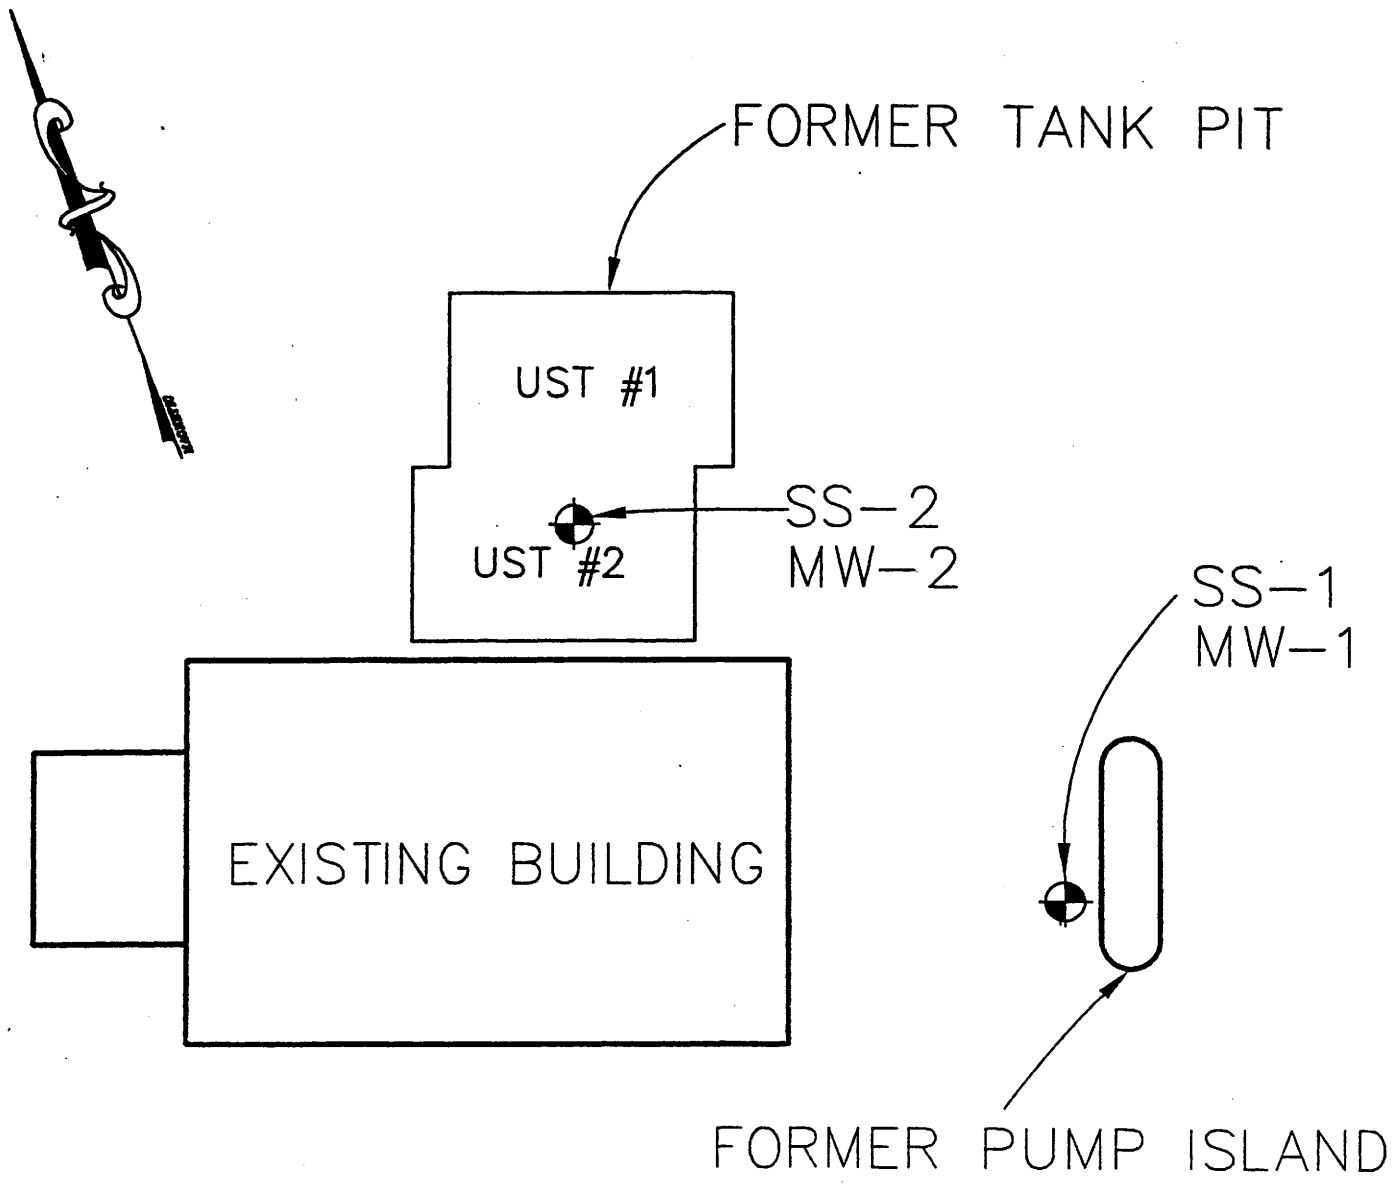
As a requirement by NCDENR, Division of Waste Management, UST Section, two monitoring wells were installed (one in the area of the former tank pit and one in the area of the former dispenser island) as part of a Limited Site Assessment, Phase I. The position of these sampling wells is shown on Figure 3, Site Layout. Representatives of Q&A visited the site on July 6, 2001 for sampling. As part of this assessment, soil and groundwater samples were collected as specified in the July 2001 "Guidelines for Assessment and Corrective Action". The samples were placed in sterile containers provided by the

SAMPLING LOCATION
- SS SOIL SAMPLE
- MW MONITORING WELL LOCATION AND GROUNDWATER SAMPLE
