PRELIMINARY SITE ASSESSMENT

**PARCEL #19, B&B FOOD MART
3921 LEGION ROAD, HOPE MILLS, NORTH CAROLINA**

**NCDOT WBS ELEMENT 34865.2.3
STATE PROJECT U-2809B**

December 20, 2010

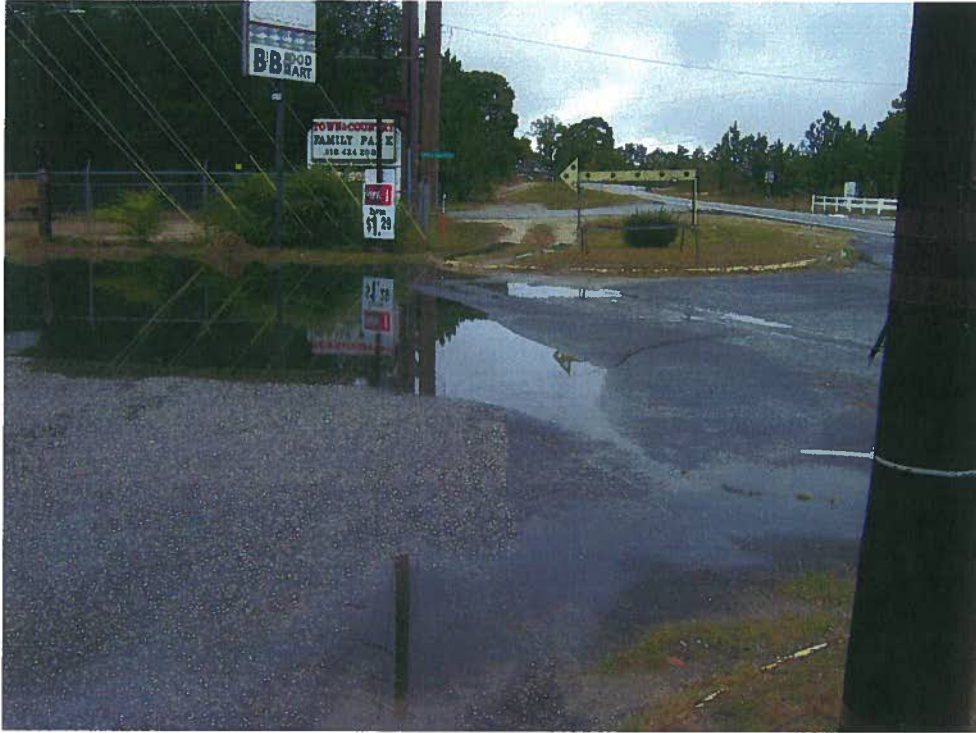
Photograph 1 – View looking south in the area where two soil samples were collected.

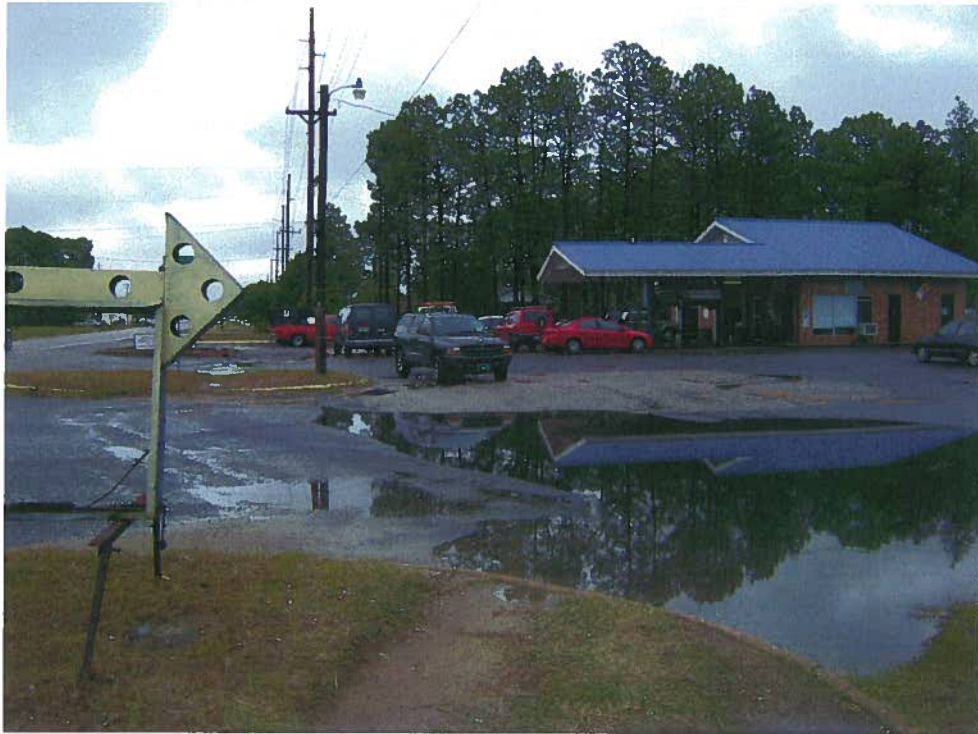
Photograph 2 – View looking north towards parcel #22

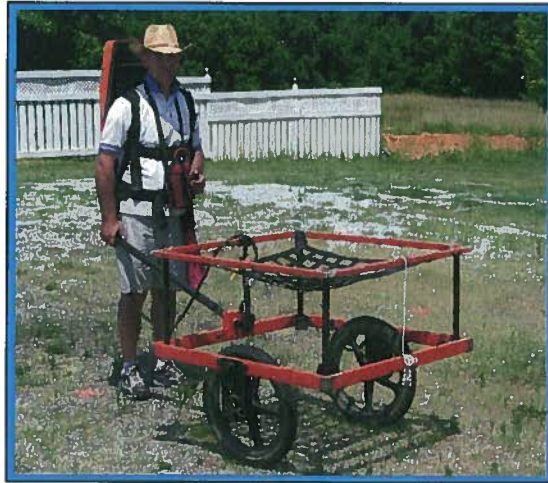
The photograph shows the Geonics EM61 metal detector that was used to conduct the metal detection survey across Parcel 19 on October 22, 2010.

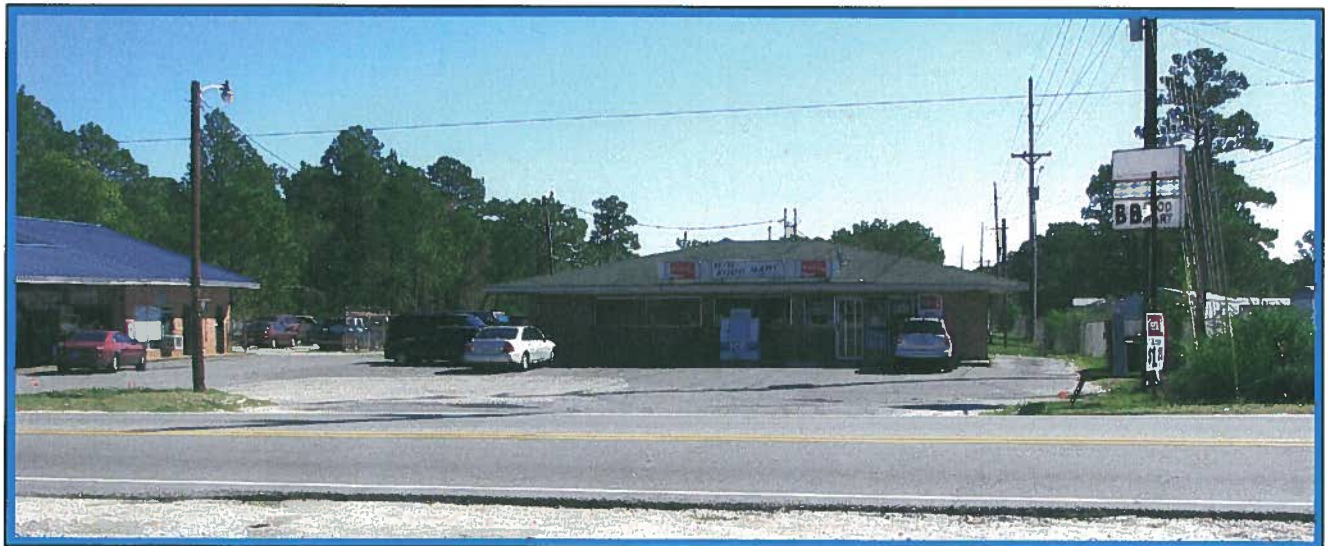
The photograph shows the front portion of the Rang Van Lu property (Parcel 19) located at the intersection of Legion Road and Mantis Drive in Fayetteville, North Carolina. The photograph is viewed in an easterly direction.

Kleinfelder representative Mr. John Stewart, P.G. provided site maps to Pyramid Environmental personnel during the week of September 30, 2010, which identified the geophysical survey area of the Rang Van Lu property. The geophysical survey area had a maximum length and width of 110 feet and 70 feet, respectively. Photographs of the geophysical equipment used in this investigation and a portion of the geophysical survey area at Parcel 19 are shown in **Figure 1**.

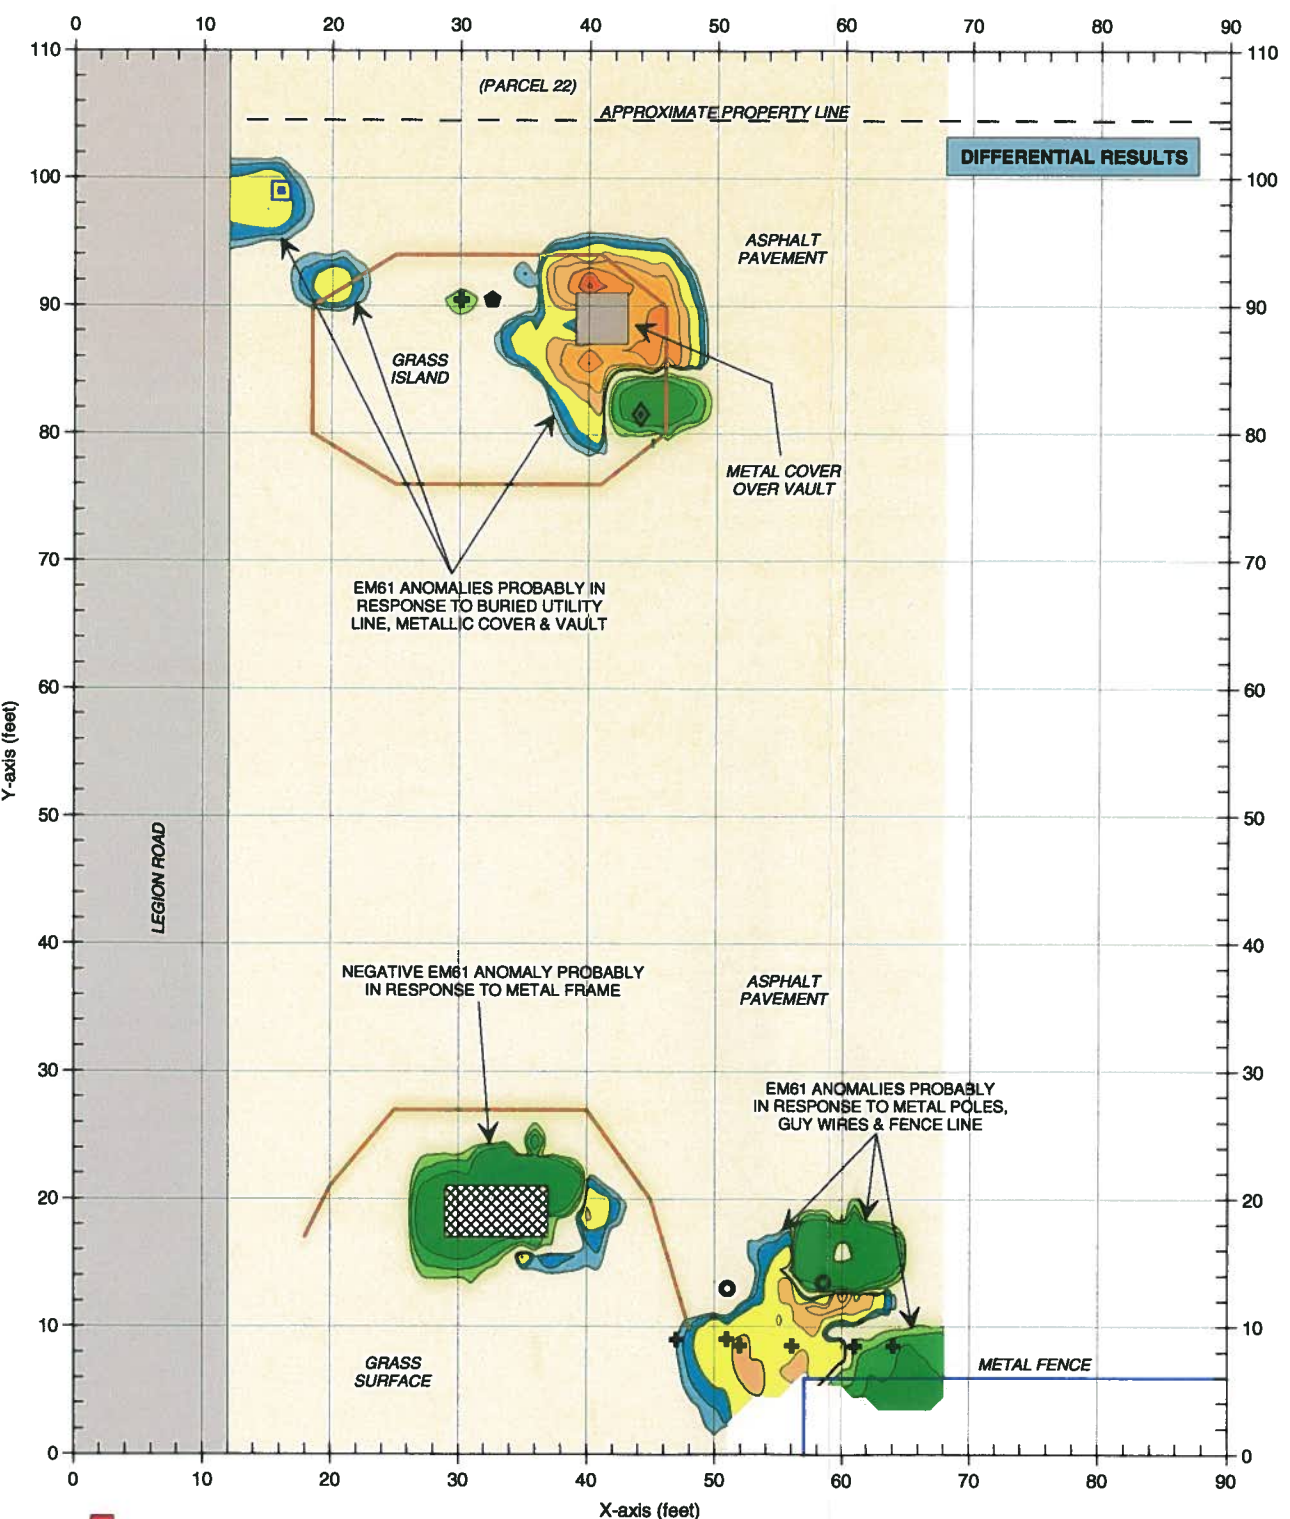
FIGURE 2

The contour plot shows the bottom coil (most sensitive) and differential results of the EM61 instrument in millivolts (mV). The bottom coil response shows buried metallic objects regardless of size. The differential response focuses on larger, buried metallic objects such as drums and USTs and ignores smaller miscellaneous, buried, metal debris.

The EM61 data were collected on October 22, 2010 using a Geonics EM61 instrument. Due to an absence of differential EM61 anomalies, ground penetrating radar (GPR) surveys were not conducted at Parcel 19.

The geophysical investigation suggests that the surveyed portion of the property does not contain metallic USTs.

EM61 METAL DETECTION RESULTS

The EM61 bottom coil anomalies centered near grid coordinates X=20 Y=93 are probably in response to steel reinforced concrete curbing and a buried utility line(s). The high amplitude bottom coil anomaly centered near grid coordinates X=41 Y=89 is probably in response to a metal cover which lies over a vault containing a utility line junction. The EM61 anomalies centered near grid coordinates X=35 Y=20 and X=55 Y=12 are probably in response to a metal sign frame, metal sign poles, concrete curbing, and other surface objects.

The linear EM61 bottom coil anomaly intersecting grid coordinates X=15 Y=8 is possibly in response to a buried line or conduit. The isolated bottom coil anomalies located near coordinates X=25 Y=35, X=38 Y=52 and X=35 Y=64 are probably in response to small, miscellaneous, metal objects or debris.

Due to the absence of EM61 differential anomalies that are not in response to known objects, ground penetrating radar surveys were not conducted at this site and the EM61 results suggest that the surveyed portion of Parcel 19 does not contain metallic USTs.
