Reference: Preliminary Site Assessment  
Mary Spires Property (Parcel #5)  
405 S. Bragg Blvd.  
Spring Lake, Cumberland County, North Carolina  
NCDOT Tip No. U-4444B  
WBS Element 36492.1.2  
AECOM Project No. 60158550

## **GEOPHYSICAL INVESTIGATION REPORT**

**AECOM Environment**  
**GEOPHYSICAL INVESTIGATION REPORT**  
**MARY SPIRES PROPERTY (PARCEL 5)**  
**Spring Lake, North Carolina**

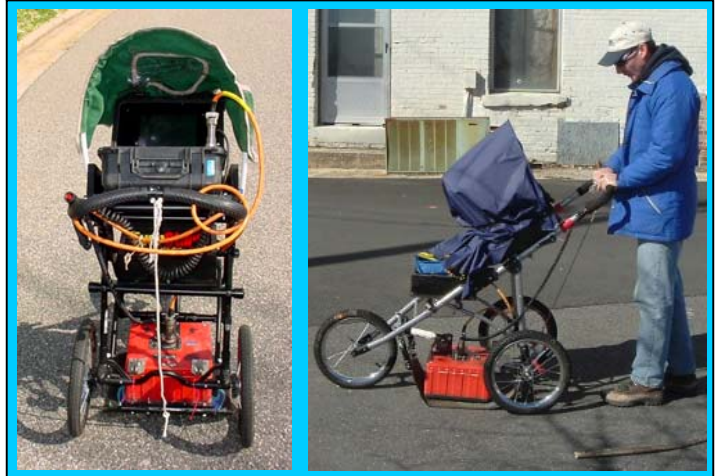
The photographs show the SIR-2000 GPR system equipped with a 400 MHz antenna that were used to conduct the ground penetrating radar investigation at the Mary Spires property on August 2, 2010.

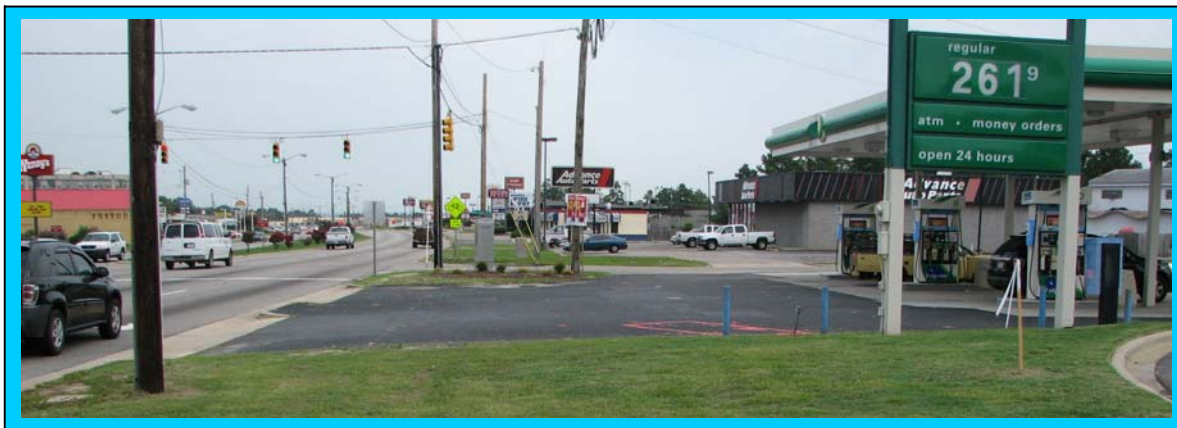
The photograph shows the proposed ROW area (front portion) at the Mary Spires property located along the east side of South Bragg Boulevard in Spring Lake, North Carolina. The photograph is viewed in a northerly direction.

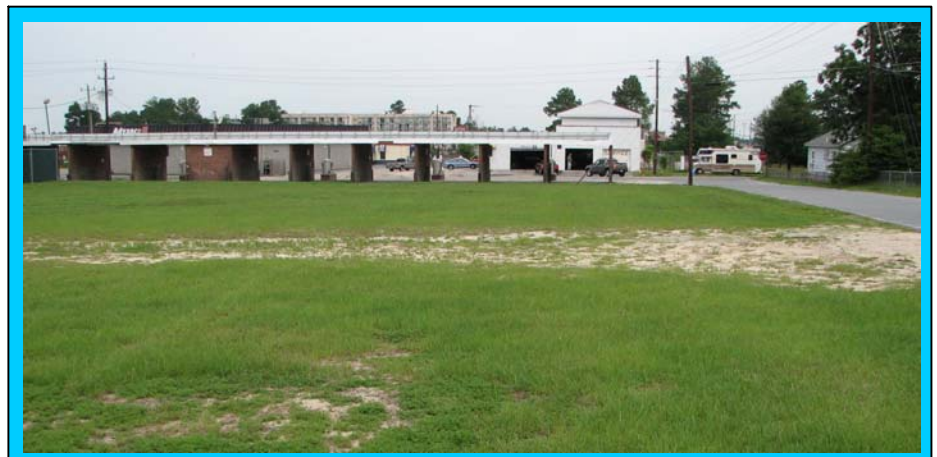
The photograph shows the proposed ROW area (back portion) at the Mary Spires property located along the west side of Monroe Street in Spring Lake, North Carolina. The photograph is viewed in a northerly direction.

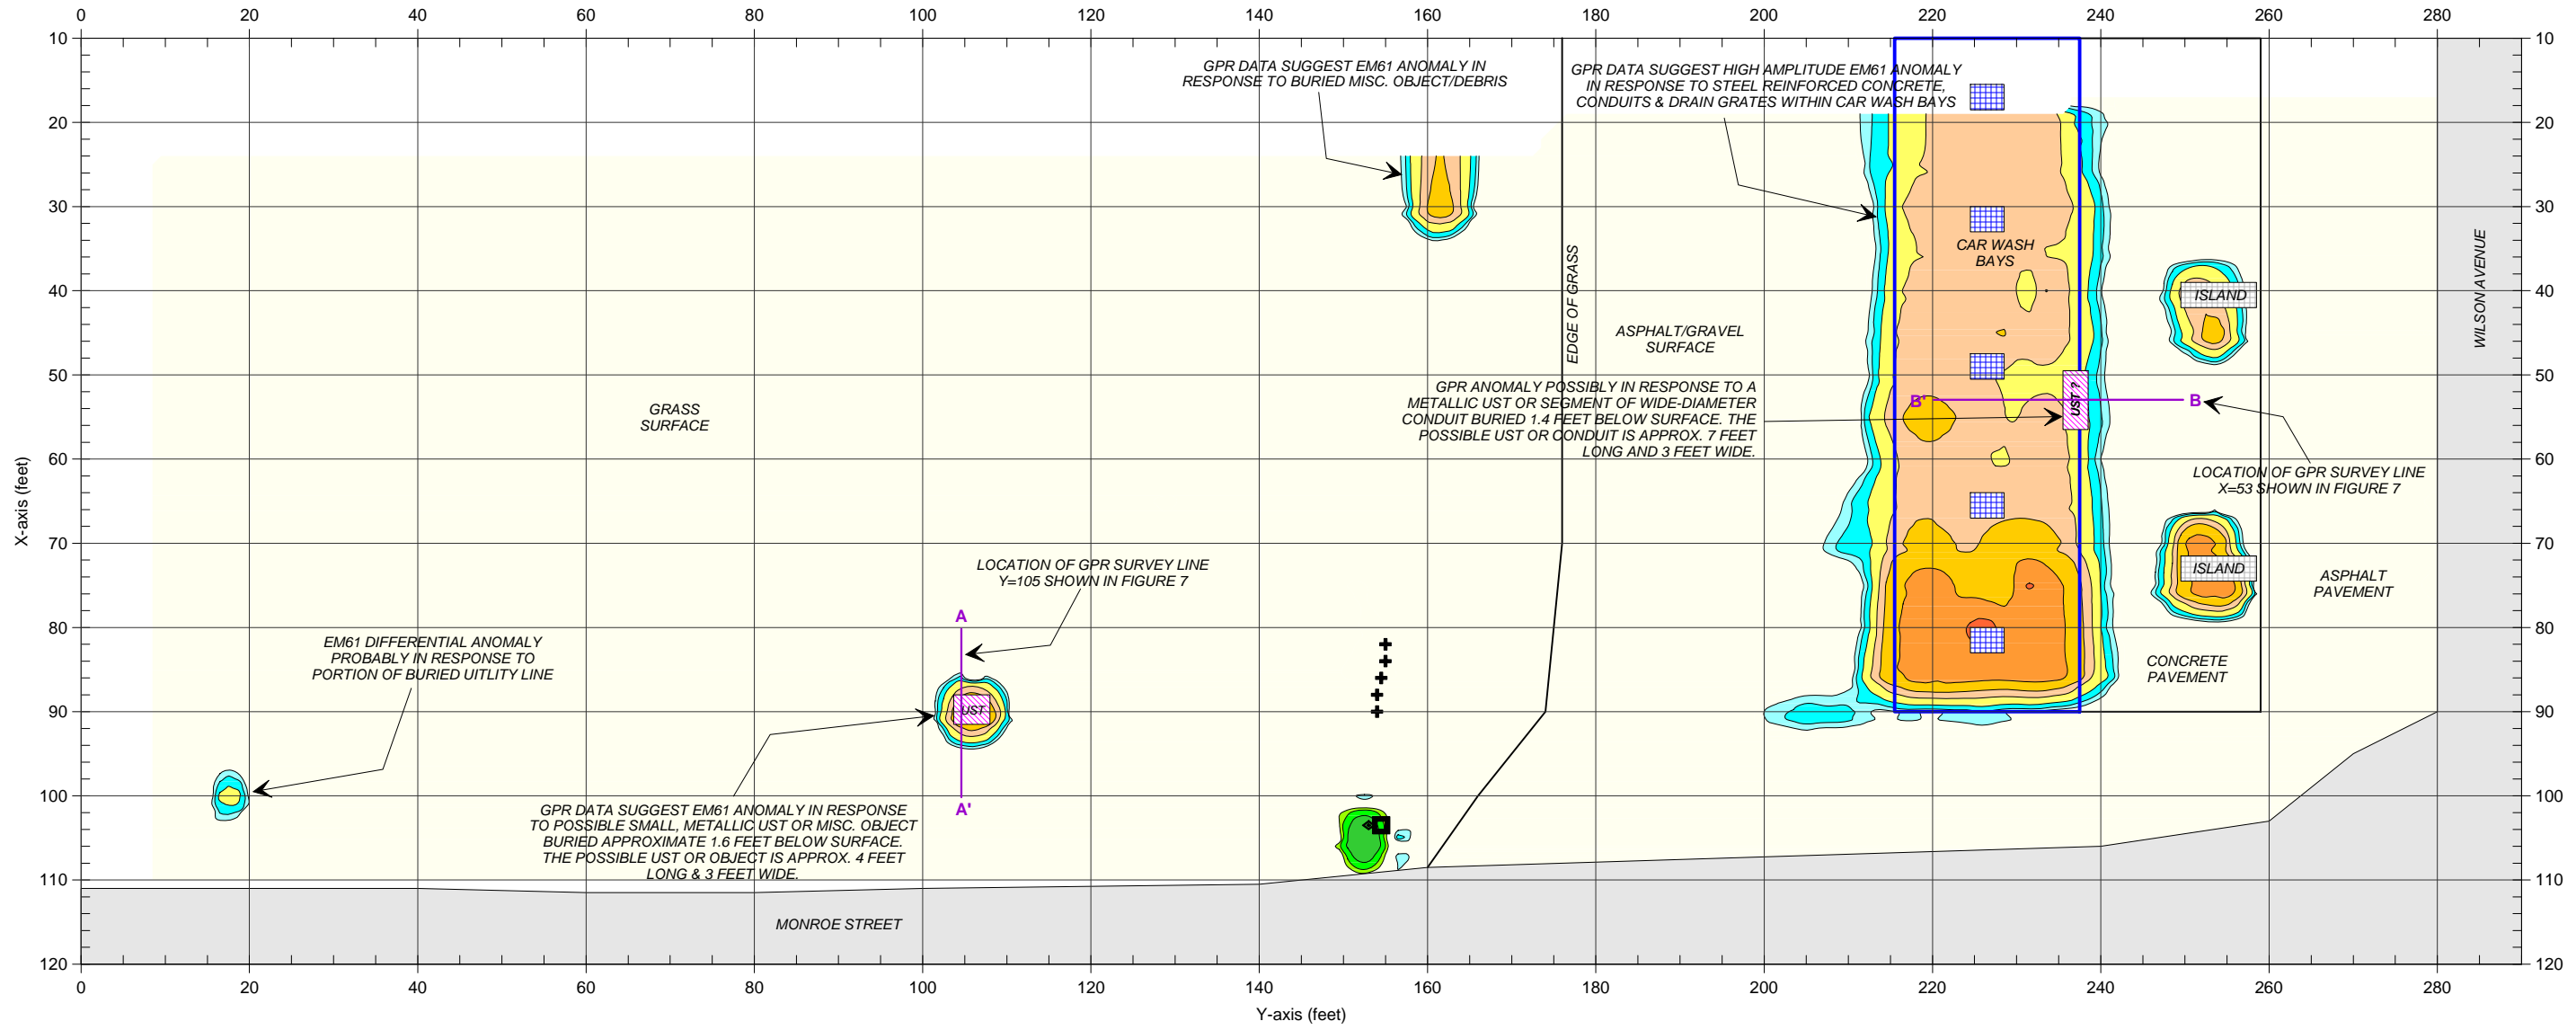
FIGURE 6

GPR data suggest the EM61 differential anomaly centered near grid coordinates X=90 Y=105 is in response to a possible, small, metallic UST or a miscellaneous object buried approximately 1.6 feet below present grade. The possible UST or object appears to be approximately 4 feet long and 3 feet wide. The approximate footprint of the possible, metallic UST or object was marked in the field using orange marking paint and pin flags. An image of GPR survey line Y=105 which crosses the UST or object and a photograph showing the location of the possible UST are presented in **Figure 7**.

Based on GPR data, the large EM61 differential anomaly centered near grid coordinates X=55 Y=225 is primarily in response to steel reinforced concrete, drain grates and conduits that are located within the bays of the car wash facility. However, the GPR surveys detected a possible UST or a short segment of wider diameter (greater than 1 foot) conduit centered near grid coordinates X=53 Y=236. The possible UST or short segment of conduit appears to be approximately 7 feet long, 3 feet wide and buried 1.4 feet below the concrete pavement. The approximate footprint of the possible, metallic UST or conduit was marked in the field using orange marking paint. An image of GPR survey line X=53 which crosses the UST or conduit and a photograph showing the location of the possible UST are presented in **Figure 7**.

The remaining EM61 anomalies shown in Figures 5 and 6 are probably in response to known surface objects, structures and/or buried lines.

Note: The contour plot shows the differential response between the bottom and top coils of the EM61 instrument in millivolts (mV). The differential response focuses on larger, buried metallic objects such as drums and USTs and ignores smaller miscellaneous, buried, metal debris. The EM61 data were collected on July 21, 2010 using a Geonics EM61 instrument. Ground penetrating radar (GPR) data were acquired on August 2, 2010 using a Geophysical Survey Systems SIR 2000 instrument with a 400 MHz antenna.

The geophysical investigation detected two possible, metallic USTs within the back proposed ROW area.

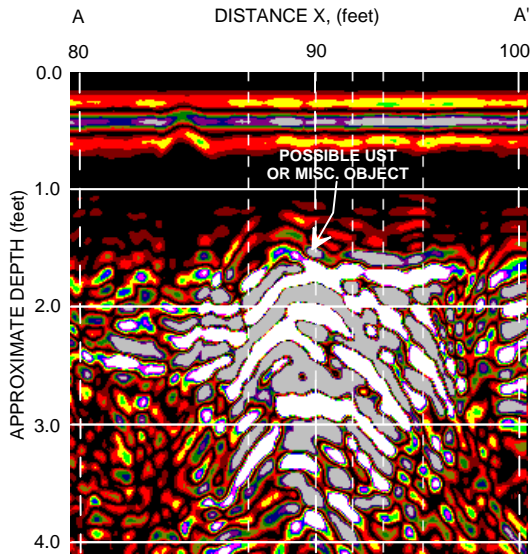
**GPR IMAGE OF LINE Y=105**

- GPR data suggest the EM61 differential anomaly centered near grid coordinates X=90 Y=105 is in response to a possible small metallic UST or a miscellaneous object buried approximately 1.6 feet below present grade. The possible UST or object appears to be approximately 4 feet long and 3 feet wide.

The GPR image obtained along a portion of survey line Y=105 recorded a high amplitude, hyperbolic anomaly that is possibly in response to a metallic UST or a misc. object buried approximately 1.6 feet below surface. The solid purple line labeled AA' in the photograph below and in Figure 6 shows the location of the GPR image.
