Reference: Preliminary Site Assessment
Willie Brantley Property (Parcel #11)
100 Wilson Avenue.
Spring Lake, Cumberland County, North Carolina
NCDOT Tip No. U-4444B
WBS Element 36492.1.2
AECOM Project No. 60158550

**SOIL FIELD SCREENING AND ANALYTICAL RESULTS
WILLIE BRANTLEY PROPERTY (PARCEL #11)
SPRING LAKE, CUMBERLAND COUNTY, NORTH CAROLINA
NCDOT PROJECT NO. U-4444B
WBS ELEMENT 36492.1.2
AECOM PROJECT NO. 60158550**

GEOPHYSICAL INVESTIGATION REPORT

WILLIE BRANTELY SITE (PARCEL 11)

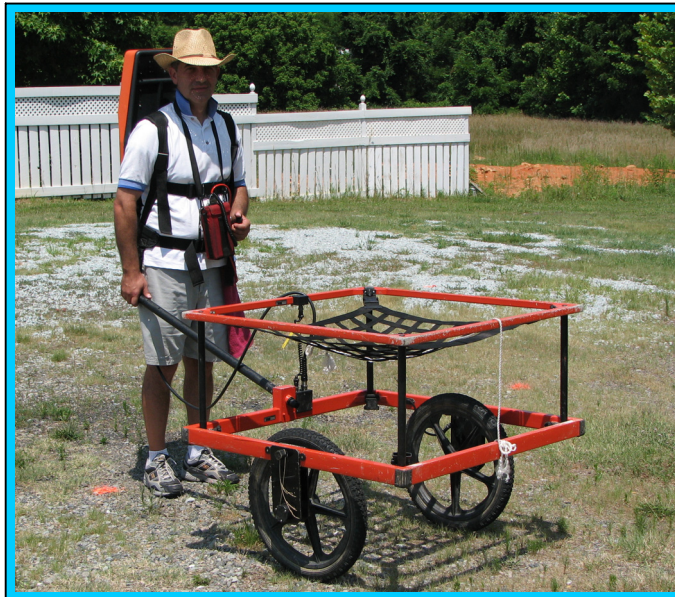
FIGURE 1

The photograph shows the Geonics EM61 metal detector that was used to conduct the metal detection survey across the proposed ROW area at the Willie Brantely site on July 21, 2010.

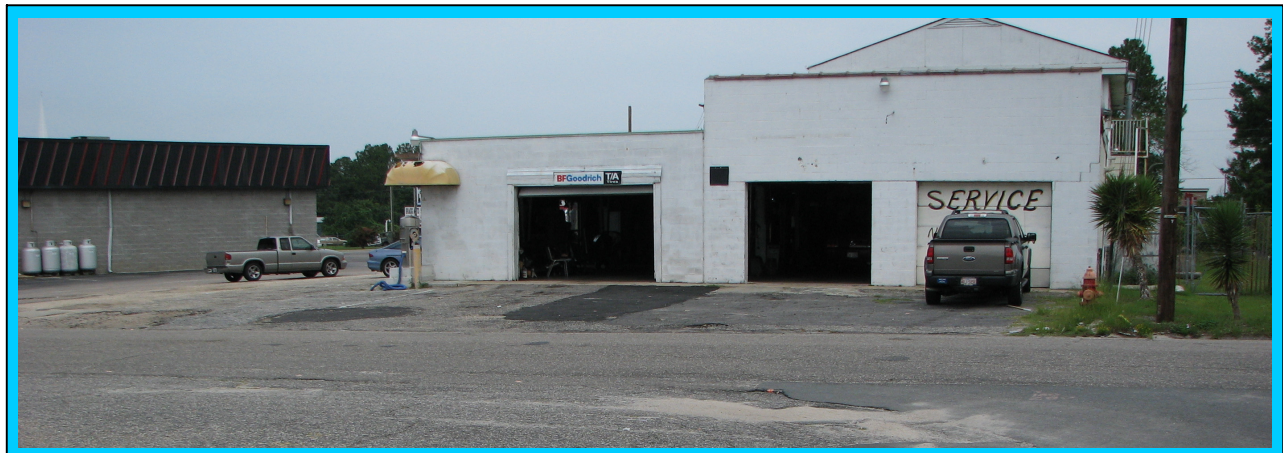
The photograph shows the proposed ROW area at the Willie Brantely site located along the northerly side of Wilson Avenue in Spring Lake, North Carolina. The photograph is viewed in a northwesterly direction.

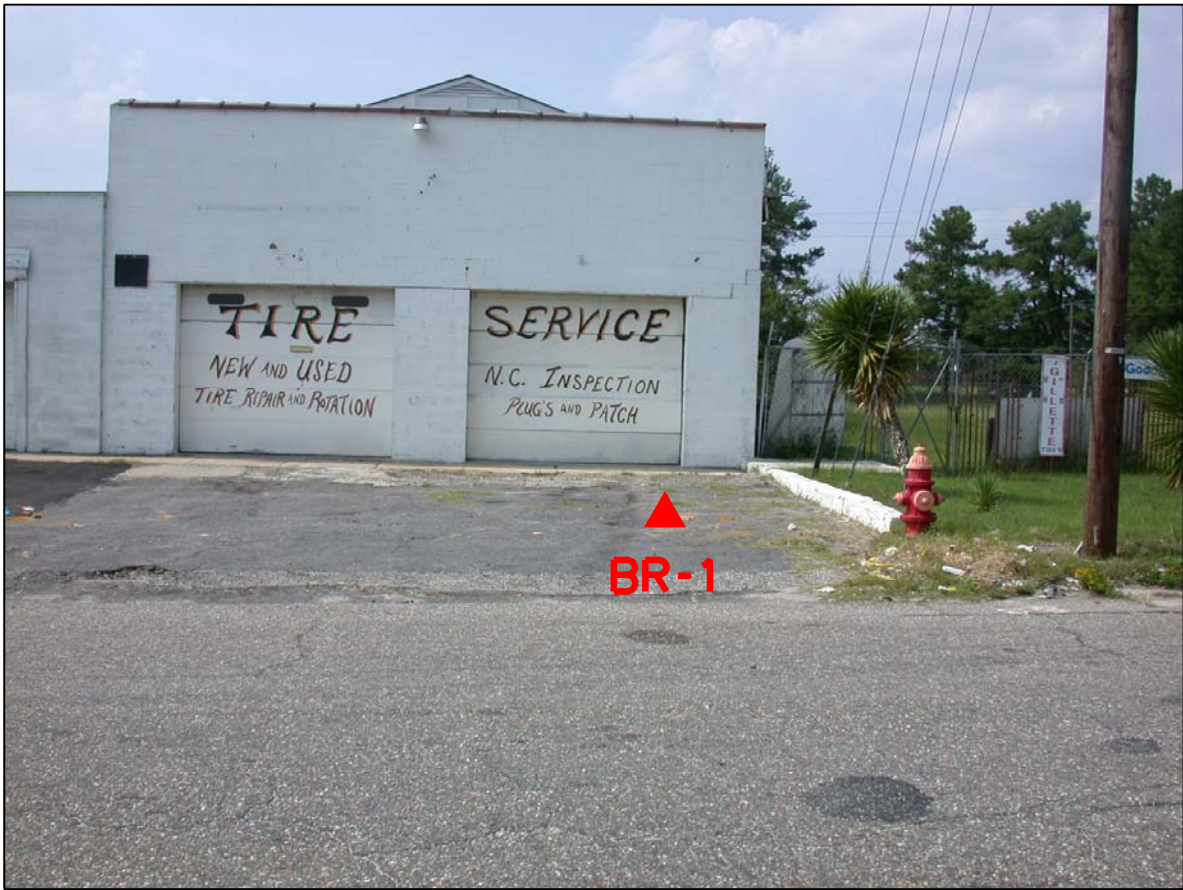
PHOTO 1 - BORING IN PROPOSED R/W LOOKING NORTH

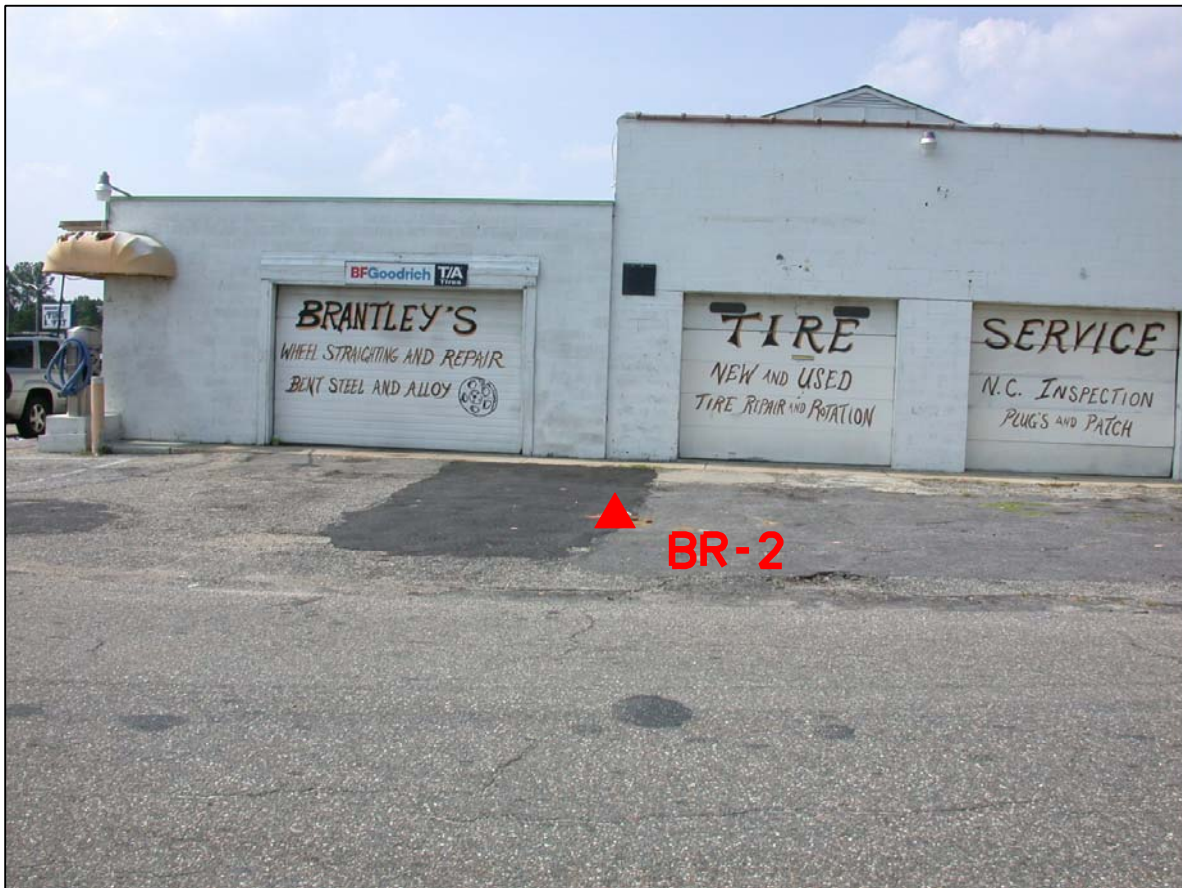
PHOTO 2 - BORINGS IN PROPOSED R/W LOOKING NORTH

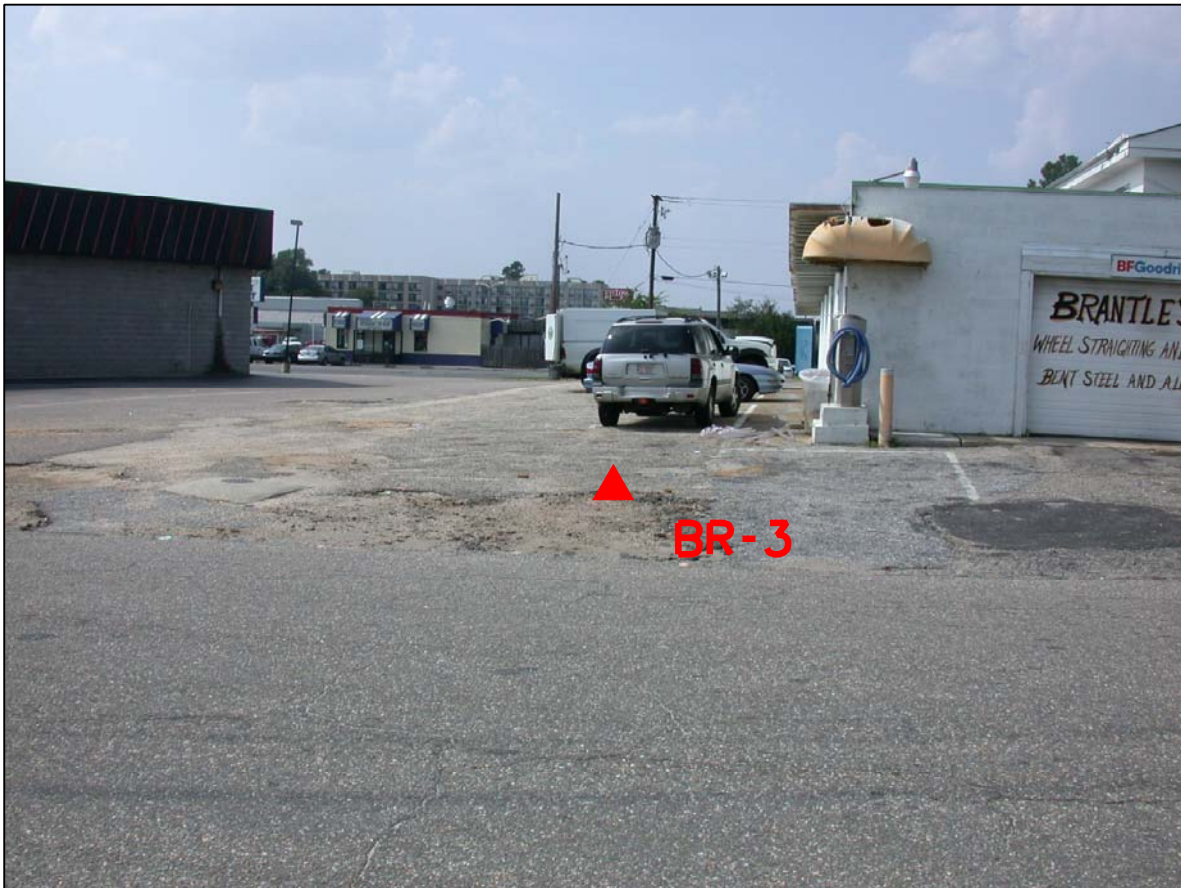
PHOTO 3 - BORING WITHIN PROPOSED R/W LOOKING NORTH
