Reference: Preliminary Site Assessment
Ruby Tuesday, Inc., Property (Parcel #28)
223 S. Bragg Blvd.
Spring Lake, Cumberland County, North Carolina
NCDOT Tip No. U-4444B
WBS Element 36492.1.2
AECOM Project No. 60158550

**SOIL FIELD SCREENING AND ANALYTICAL RESULTS
 RUBY TUESDAY, INC., PROPERTY (PARCEL #28)
 SPRING LAKE, CUMBERLAND COUNTY, NORTH CAROLINA
 NCDOT PROJECT NO. U-4444B
 WBS ELEMENT 36492.1.2
 AECOM PROJECT NO. 60158550**

GEOPHYSICAL INVESTIGATION REPORT

RUBY TUESDAY INC. PROPERTY (PARCEL 28)

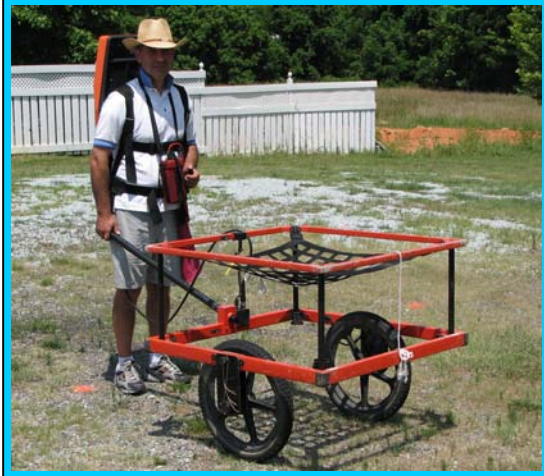
The photograph shows the Geonics EM61 metal detector that was used to conduct the metal detection survey across the proposed ROW areas at the Ruby Tuesday Inc. property on July 22, 2010.

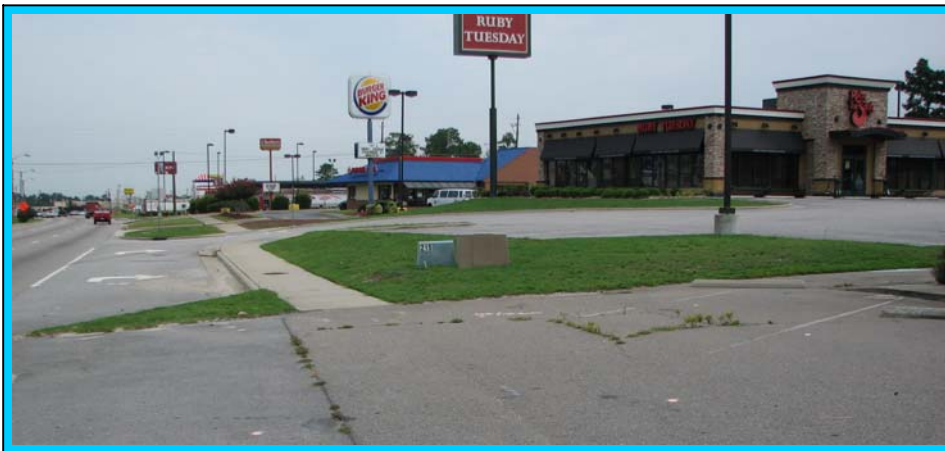
The photograph shows the front proposed ROW area at the Ruby Tuesday Inc. property located along the east side of South Bragg Boulevard in Spring Lake, North Carolina. The photograph is viewed in a northerly direction.

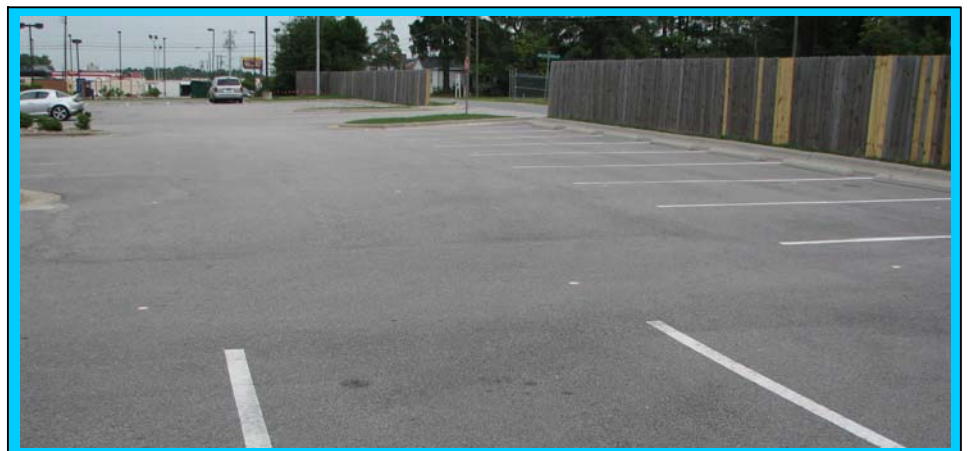
The photograph shows the back proposed ROW area at the Ruby Tuesday Inc. property located along the west side of South Third Street in Spring Lake, North Carolina. The photograph is viewed in a northerly direction.

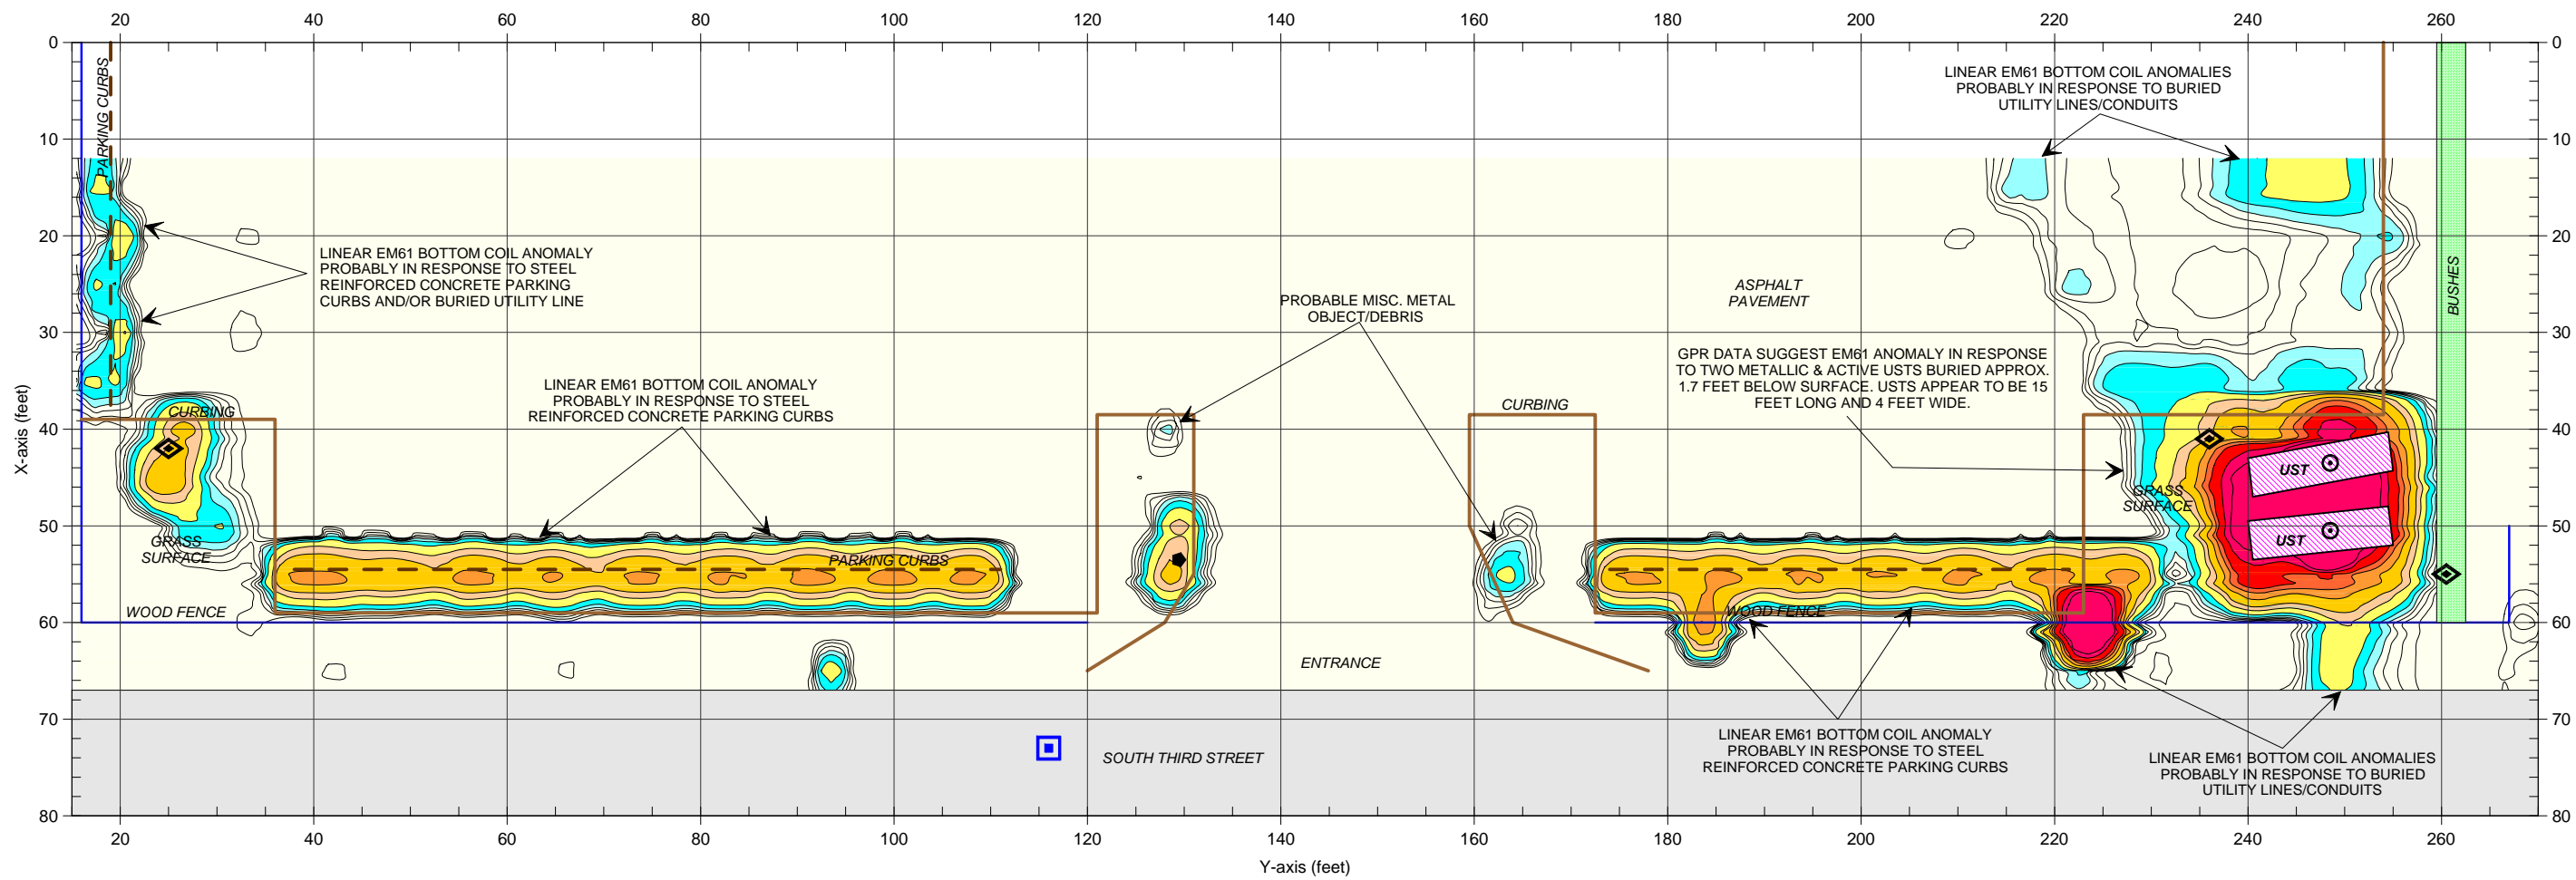
EM61 METAL DETECTION (BOTTOM COIL RESULTS)
FIGURE 4

The contour plot shows the bottom coil (most sensitive) response of the EM61 instrument in millivolts (mV). The bottom coil response shows buried metallic objects regardless of size. The EM metal detection data were collected on July 22, 2010 using a Geonics EM61 instrument. Ground penetrating radar (GPR) data were acquired on August 2, 2010 using a Geophysical Survey Systems SIR 2000 instrument with a 400 MHz antenna.

The geophysical investigation detected two probable, metallic USTs within the back ROW area of the site.

Contour plots of the EM61 bottom coil and differential results from the proposed back ROW area are presented in **Figures 4 and 5**, respectively. The linear EM61 bottom coil anomalies intersecting grid coordinates X=20 Y=222, X=20 Y=250 and X=65 Y=250 are probably in response to buried utility lines or conduits. The linear, bottom coil anomalies intersecting grid coordinates X=55 Y=80 and X=55 Y=200 are probably in response to the steel reinforced concrete parking curbs. Similarly, the linear bottom coil anomaly intersecting grid coordinates X=25 Y=18 is probably in response to the steel reinforced concrete parking curbs and/or a buried conduit. The bottom coil anomalies centered near grid coordinates X=40 Y=127 and X=55 Y=163 are probably in response to buried miscellaneous debris or small, insignificant objects.

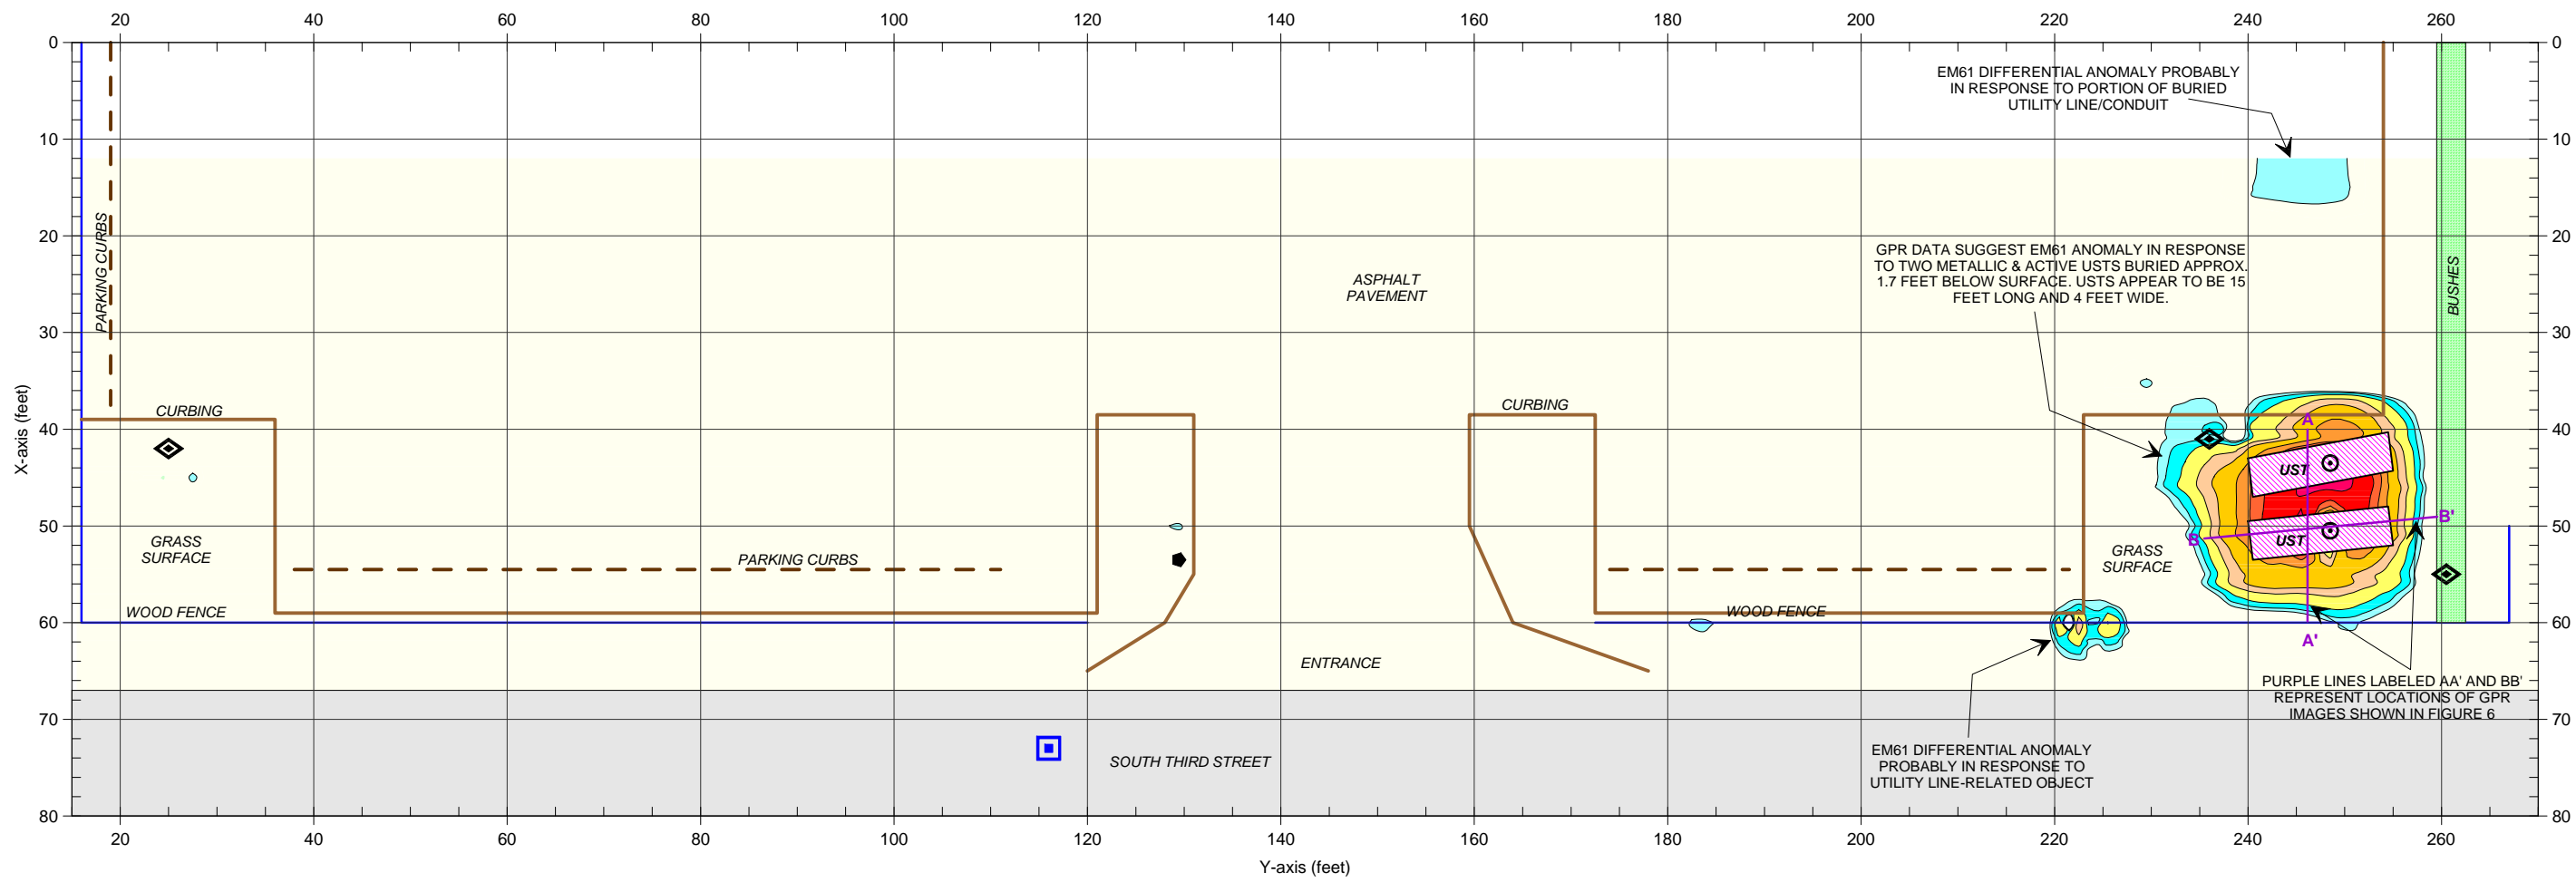
FIGURE 5

Note: The contour plot shows the differential response between the bottom and top coils of the EM61 instrument in millivolts (mV). The differential response focuses on larger, buried metallic objects such as drums and USTs and ignores smaller miscellaneous, buried, metal debris. The EM61 data were collected on July 22, 2010 using a Geonics EM61 instrument. Ground penetrating radar (GPR) data were acquired on August 2, 2010 using a Geophysical Survey Systems SIR 2000 instrument with a 400 MHz antenna.

The geophysical investigation detected two probable, metallic, active USTs within the back ROW area of the site.

GPR data suggest the high amplitude EM61 anomaly centered near grid coordinates X=47 Y=247 is in response to two active, metallic, propane USTs. Each of the two probable, active USTs is

The remaining EM61 anomalies shown in Figures 4 and 5 are probably in response to known surface objects, structures and/or buried lines.
