Reference: Preliminary Site Assessment
John Darden Heirs Property
108 N. Bragg Blvd.
Spring Lake, Cumberland County, North Carolina
NCDOT Tip No. U-4444B
WBS Element 36492.1.2
AECOM Project No. 60158550

GEOPHYSICAL INVESTIGATION REPORT

AECOM Environment
GEOPHYSICAL INVESTIGATION REPORT
JOHN DARDEN HEIRS PROPERTY
Spring Lake, North Carolina

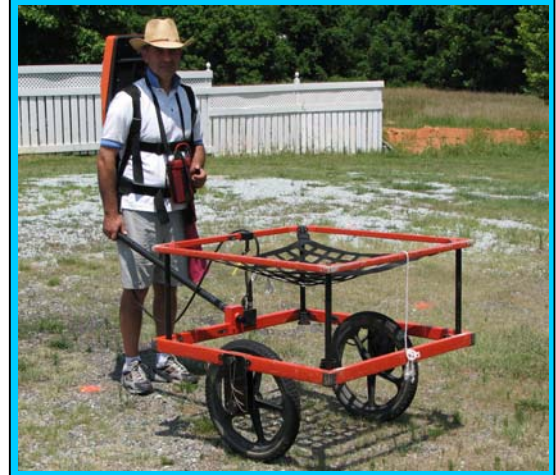
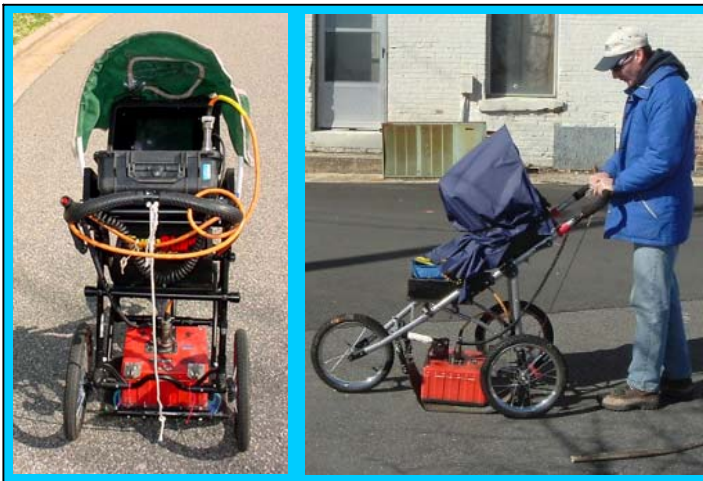
GPR surveys were conducted on August 3, 2010 across selected EM61 differential anomalies using a GSSI SIR-2000 unit equipped with a 400 MHz antenna. Data were digitally collected in a continuous mode along X-axis and/or Y-axis survey lines, spaced 2.5 to 5.0 feet apart using a vertical scan of 512 samples, at a rate of 48 scans per second. A 70 MHz high pass filter and an 800 MHz low pass filter were used during data acquisition with the 400 MHz antenna. GPR data were collected down to a maximum depth of approximately 5 feet, based on an estimated two-way travel time of 8 nanoseconds per foot. All of the GPR data were downloaded to a field computer and reviewed in the field and office using Radprint software.

The photographs show the SIR-2000 GPR system equipped with a 400 MHz antenna that were used to conduct the ground penetrating radar investigation at the John Darden property on August 3, 2010.

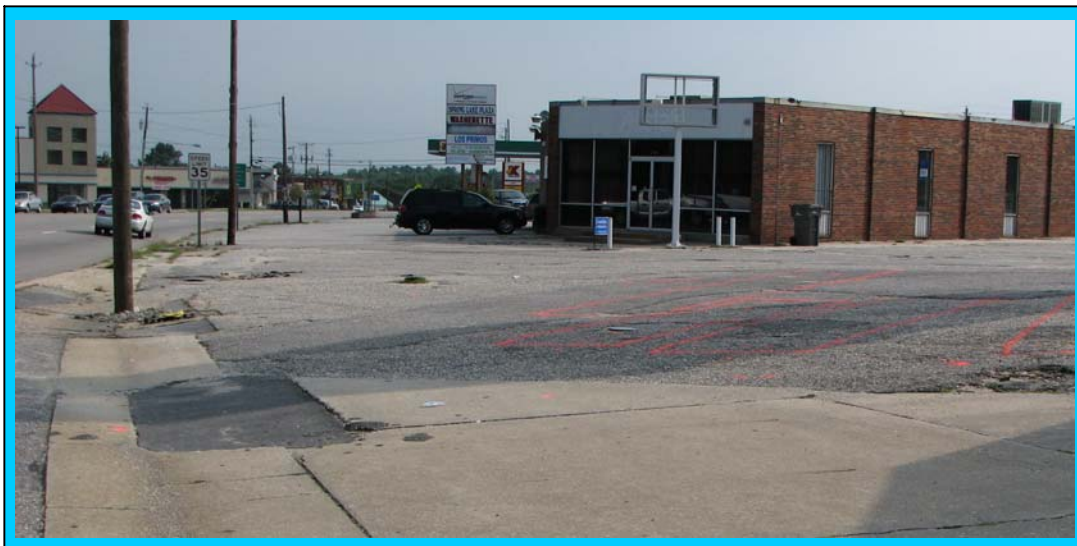
FIGURE 1

The John Darden Heirs property consists of an occupied office building surrounded by an asphalt-covered parking area. The proposed ROW area (geophysical survey area) encompassed the property located between the building and Lillington Highway and has a maximum length and width of 95 feet and 72 feet, respectively.

The photograph shows the proposed ROW area at the John Darden property located immediately north of the South Bragg Boulevard and Spring Avenue intersection in Spring Lake, North Carolina. The photograph is viewed in a northerly direction.

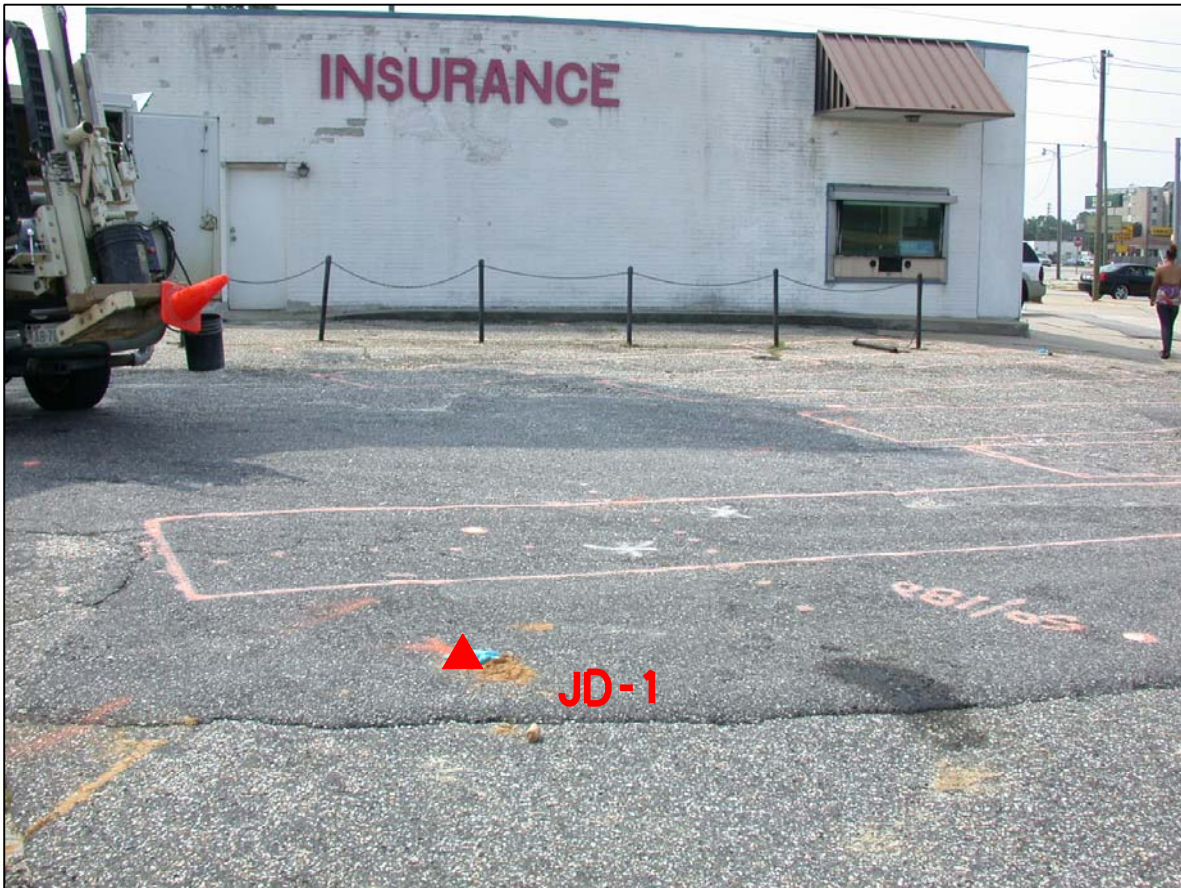
PHOTO 1 - BORING IN PROPOSED R/W LOOKING SOUTH

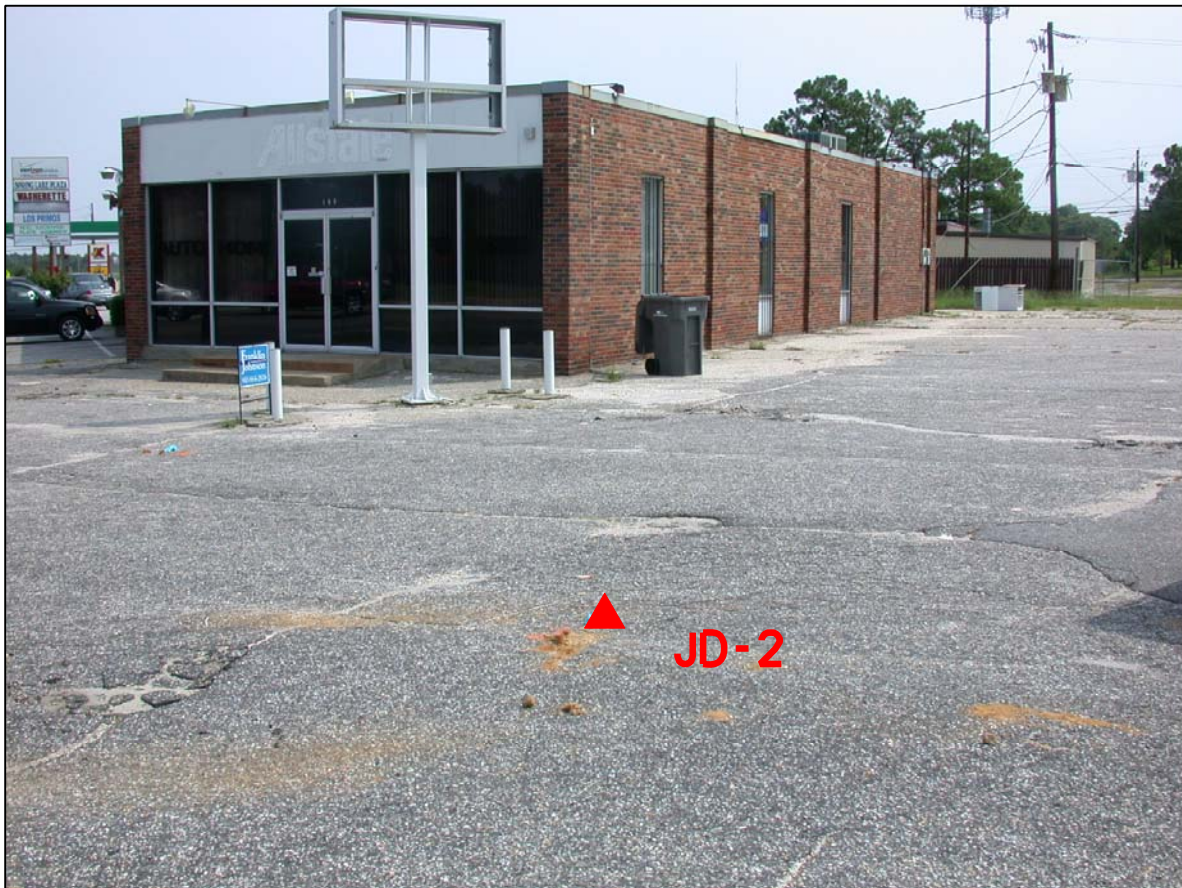
PHOTO 2 - BORING IN PROPOSED R/W LOOKING NORTHEAST

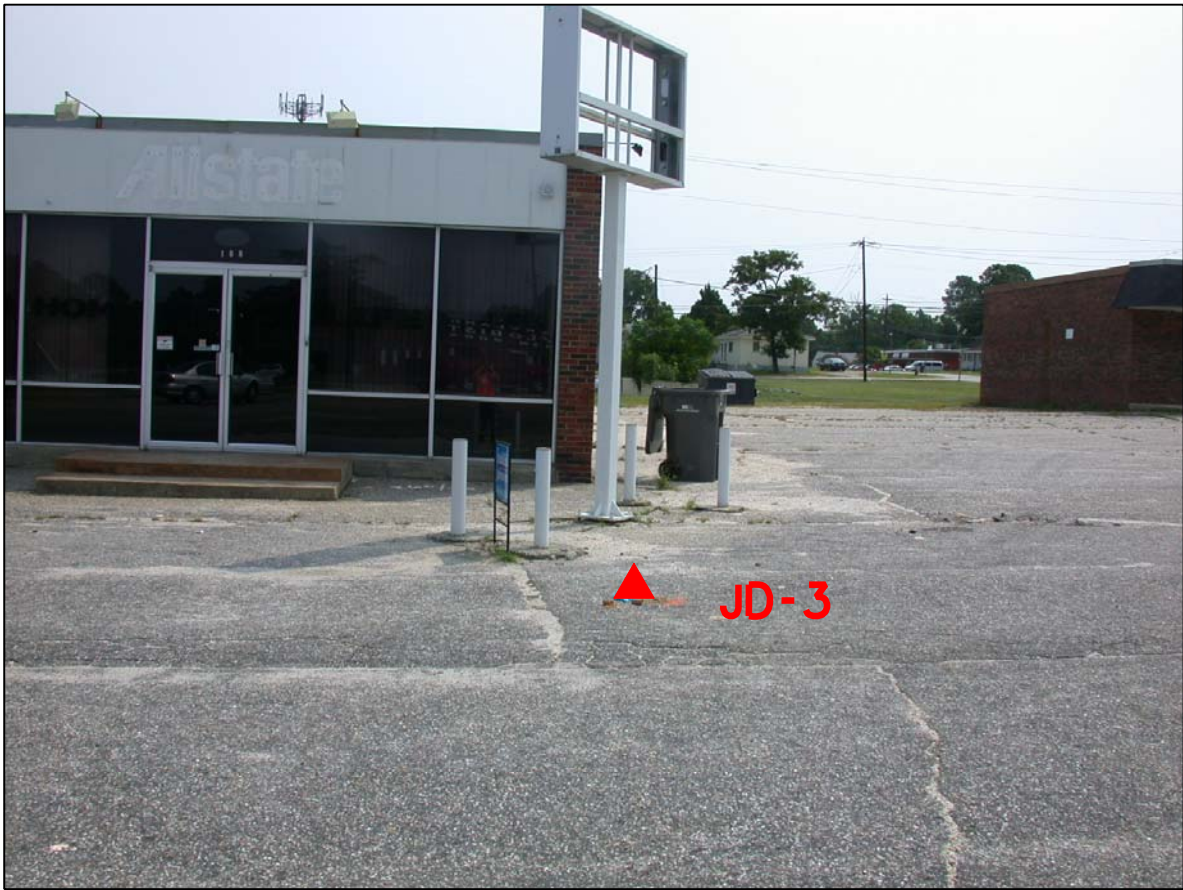
PHOTO 3 - BORING WITHIN PROPOSED R/W LOOKING EAST

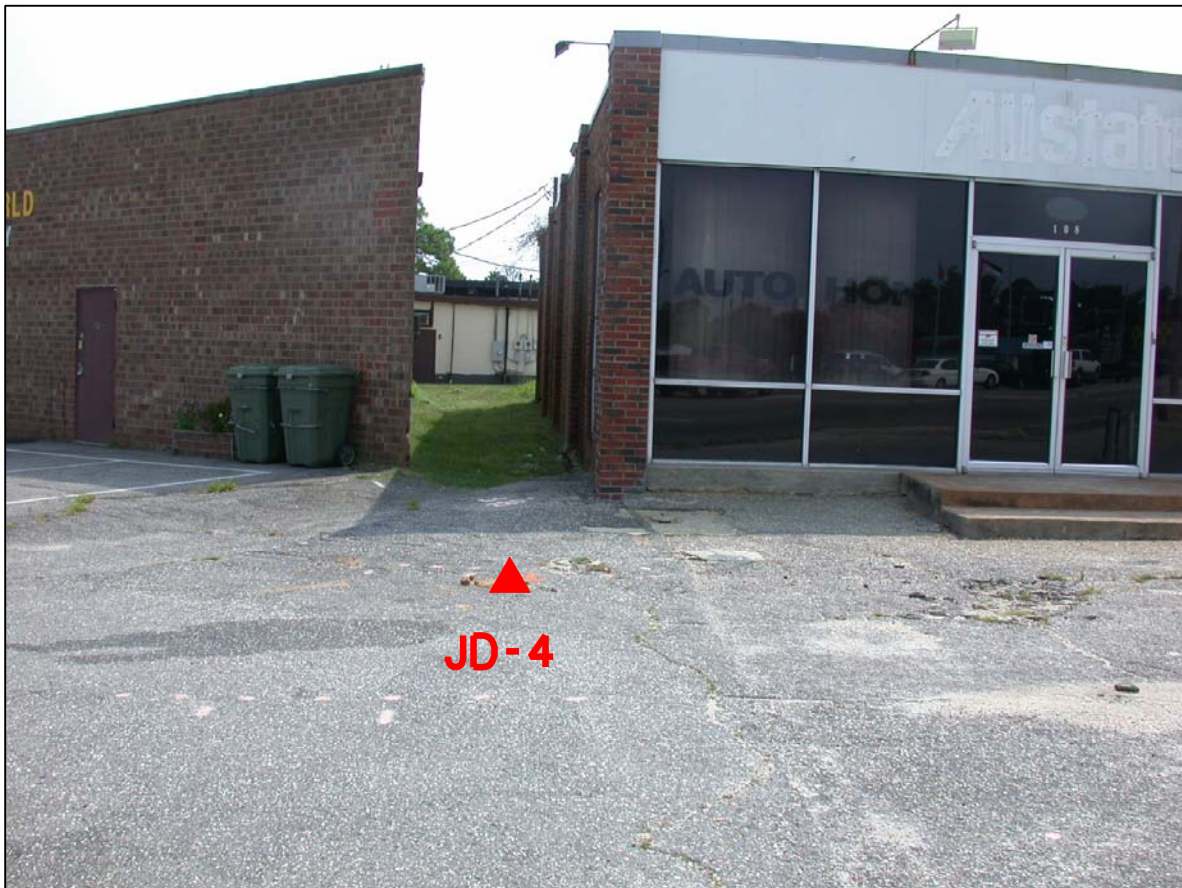
PHOTO 4 - BORING WITHIN PROPOSED R/W LOOKING EAST
