**PRELIMINARY SITE ASSESSMENT
SOUTHERN MOTORS
1605 SOUTH MAIN STREET (US HIGHWAY 29)
SALISBURY, ROWAN COUNTY, NORTH CAROLINA
NCDOT PROJECT: U-3459
WBS ELEMENT: 34951.1.1**

**Prepared for:
NC Department of Transportation
Geotechnical Engineering Unit
GeoEnvironmental Section
1589 Mail Service Center
Raleigh, North Carolina 27699-1589**

**Prepared by:
Solutions-IES
1101 Nowell Road
Raleigh, North Carolina 27607**

GEOPHYSICAL INVESTIGATION REPORT
GEOPHYSICAL SURVEYS FOR THE DETECTION OF METALLIC UST'S

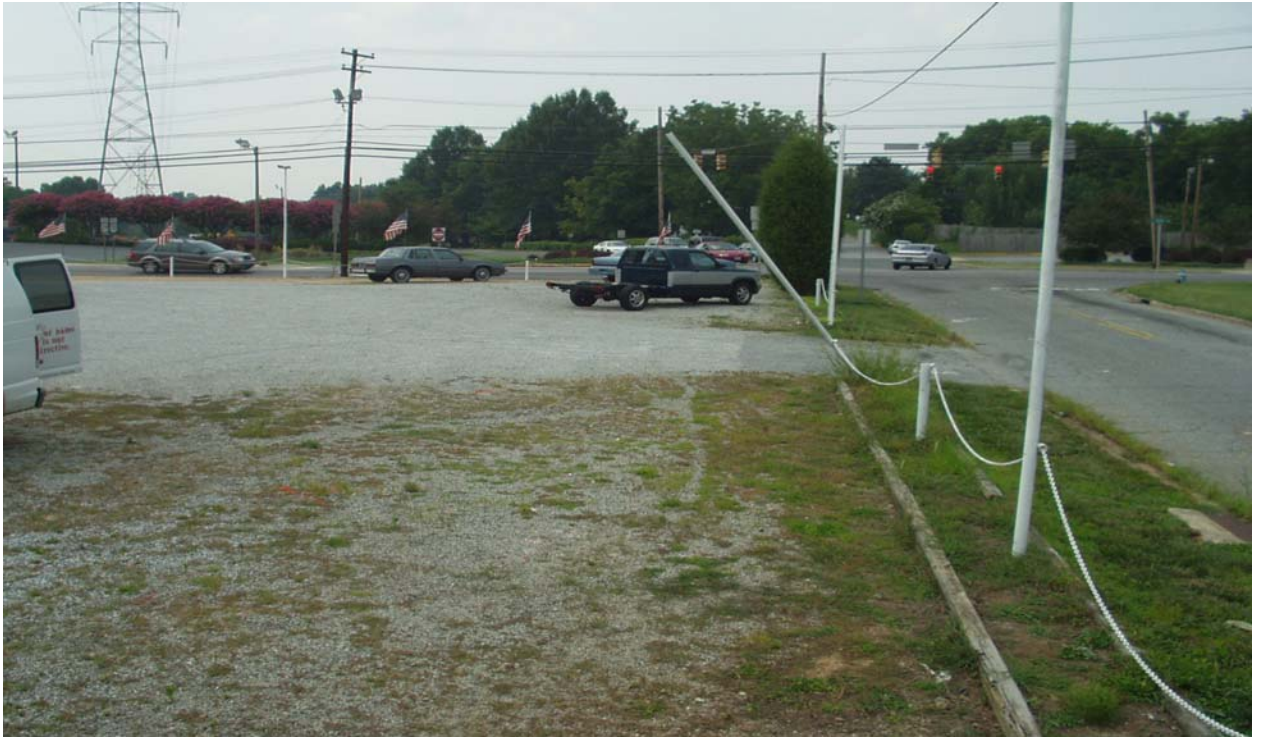
APPENDIX A
PHOTOGRAPH

Photograph – View from south to north along East “A” Avenue. Study Area in foreground along eastern boundary of site.

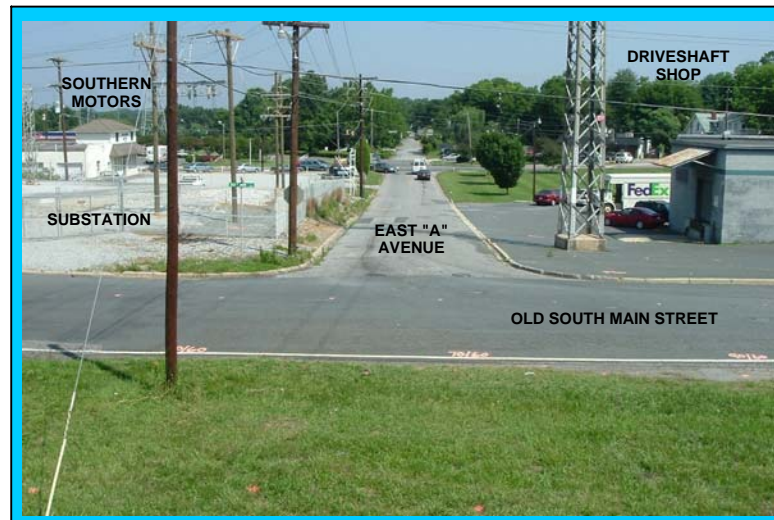
The photo shows the geophysical survey area across portions of the Southern Motors, The Driveshaft Shop and the Duke Power substation properties located along East "A" Avenue. The photo is veiwed in a northerly direction.

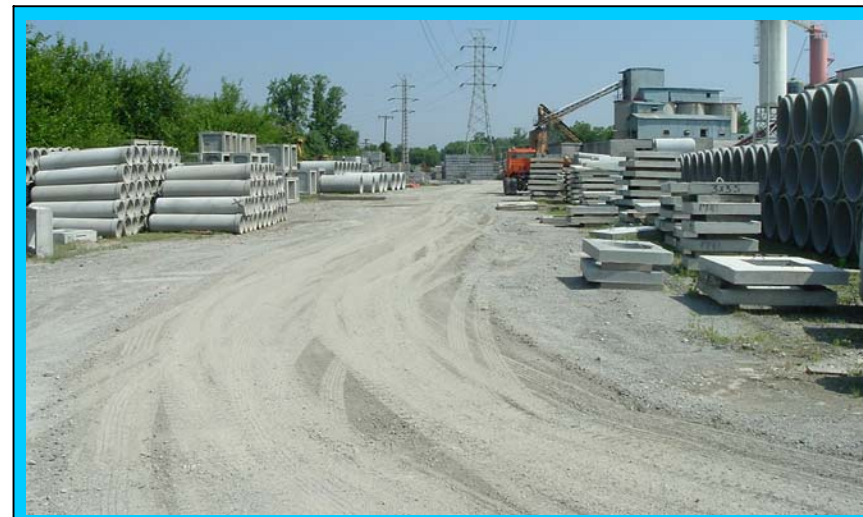
The photo shows the geophysical survey area across the western edge of the Johnson Concrete facility. The photo is veiwed in a northerly direction.

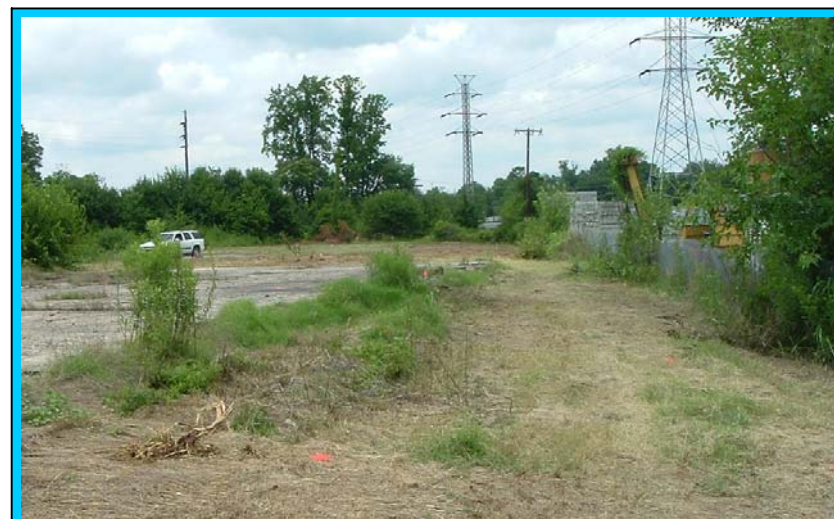
The photo shows the geophysical survey area across the eastern edge of the Former FCX Chemical site located contingent to the Johnson Concrete facility shown above. The photo is veiwed in a northerly direction.

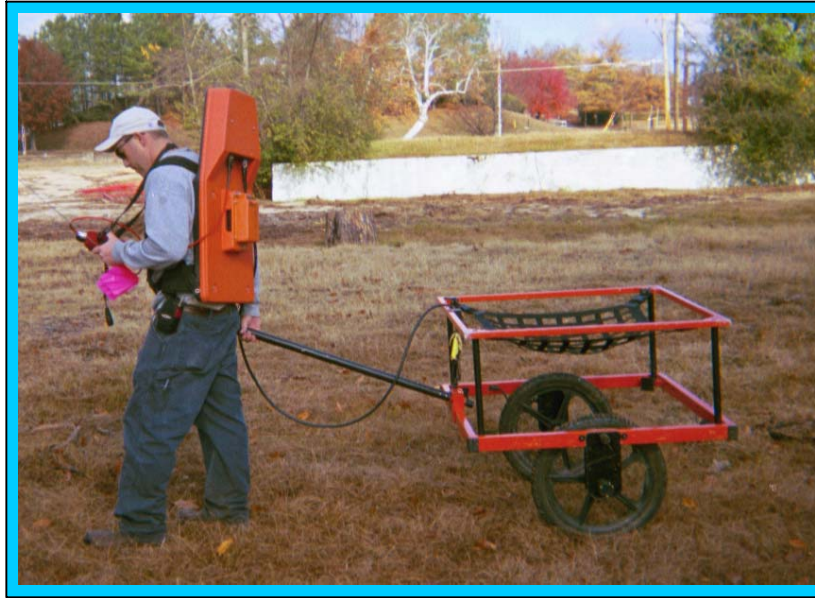
The photo shows the Geonics EM61 metal detector that was used to conduct the metal detection survey at the Old South Main Street and East "A" Avenue sites in Salisbury, North Carolina on June 26, 27, and July 7, 2006. The instrument has a maximum investigating depth of approximately 8 feet.

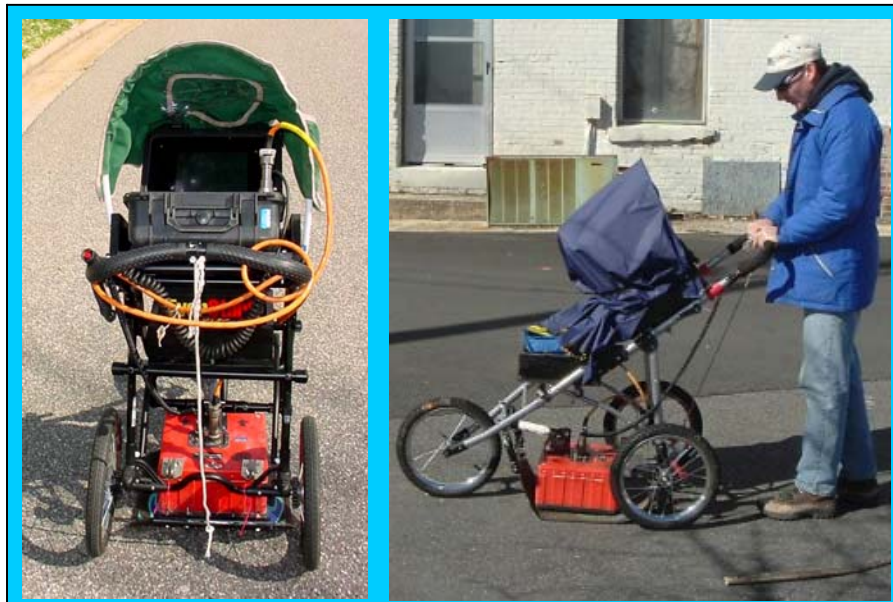
The photos show the SIR-2000 GPR system equipped with a 400 MHz antenna that were used to conduct the ground penetrating radar investigation at the Old South Main Street and East "A" Avenue sites in Salisbury, North Carolina on June 29 & July 7, 2006.
