PRELIMINARY SITE ASSESSMENT

**PARCEL #108, BOJANGLES PROPERTY
CHARLOTTE – US 74 (INDEPENDENCE BOULEVARD) FROM NC 24 - 27
(ALBEMARLE ROAD) TO IDELWILD ROAD
MECKLENBURG COUNTY, NORTH CAROLINA**

**NCDOT WBS ELEMENT 3479.1.1
STATE PROJECT U-0209B**

August 20, 2010

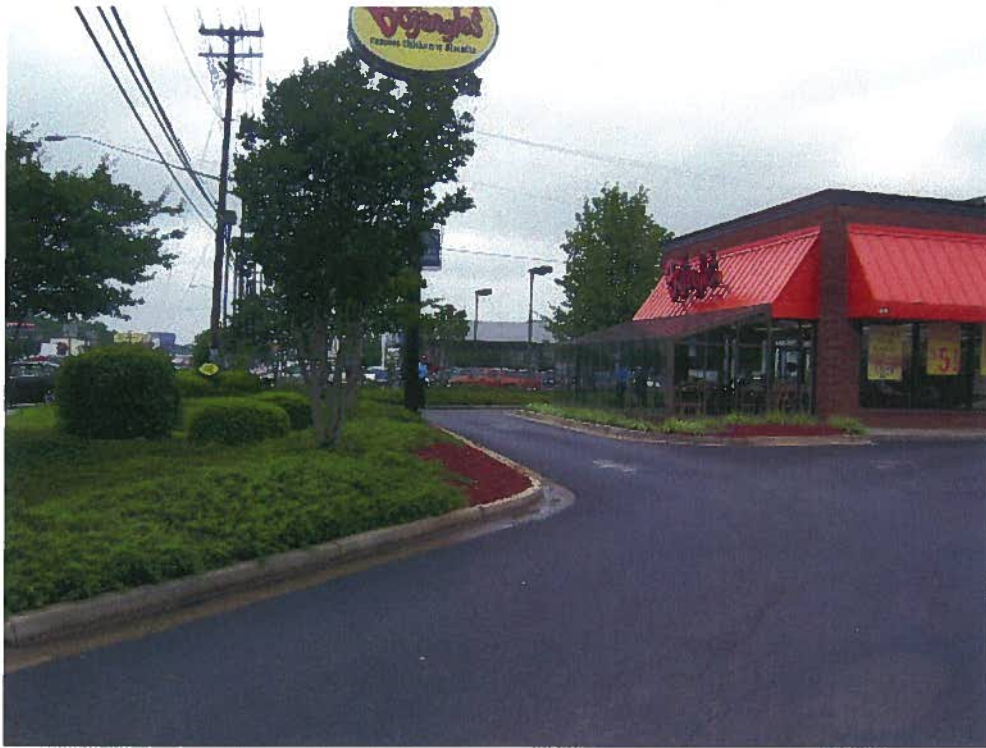
Photograph 1 – View of the Bojangle's property looking north.

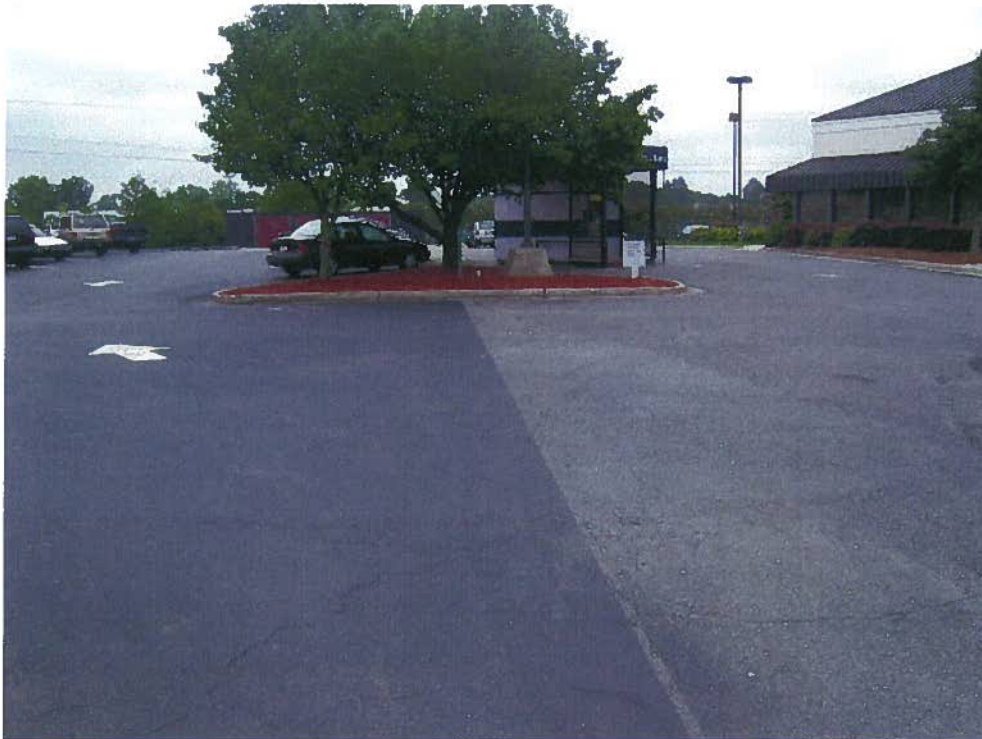
Photograph 2 – View of the Bojangle's property looking northeast (left side of photograph) with an adjacent ATM and bank (right side of photograph).

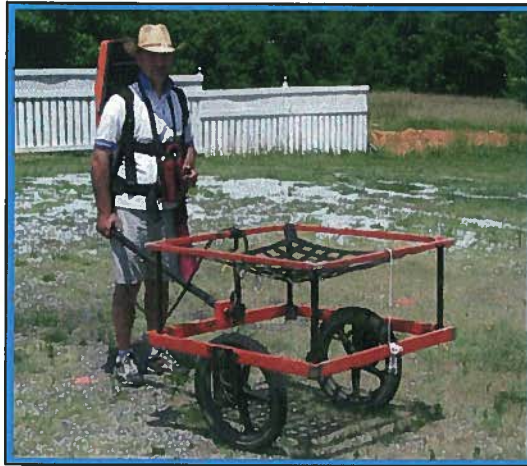
The photograph shows the Geonics EM61 metal detector that was used to conduct the metal detection survey across the FFCA/IPI property (Parcel 108) on June 24, 2010.

The geophysical investigation consisted of electromagnetic (EM) induction-metal detection surveys and ground penetrating radar (GPR) surveys. The EM survey was performed on June 24, 2010 using a Geonics EM61-MK1 metal detection instrument. According to the instrument specifications, the EM61 can detect a metal drum down to a maximum depth of approximately 8 feet. Smaller objects (1-foot or less in size) can be detected to a maximum depth of 4 to 5 feet. All of the EM61 data were

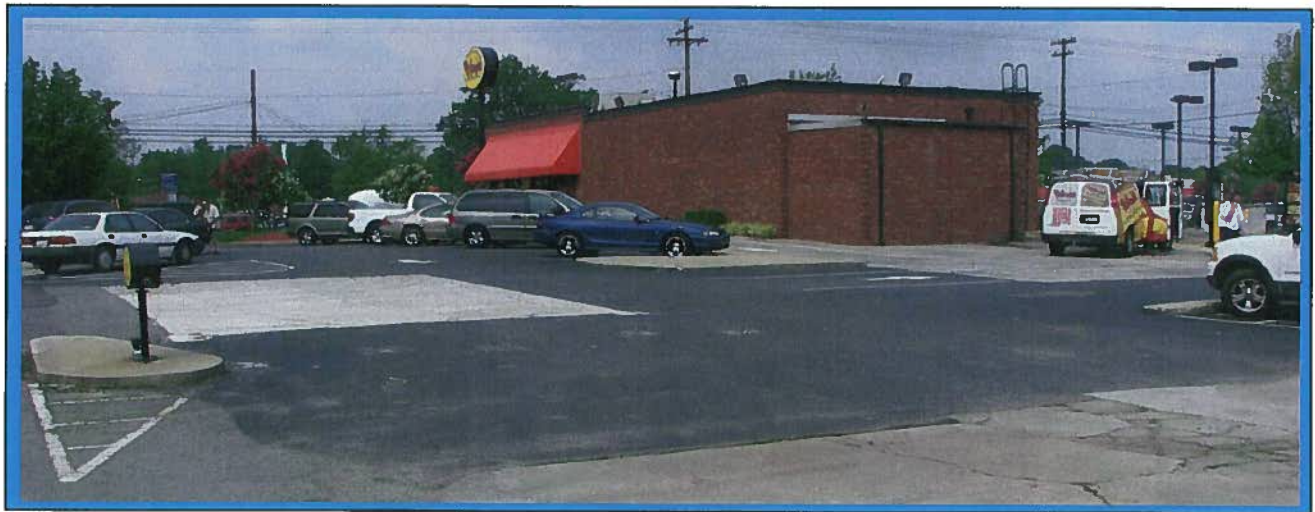
The photograph shows the back portion of the FFCA/IPI property located along the northerly side of Independence Boulevard in Charlotte, North Carolina. The photograph is viewed in a westerly direction.
