PRELIMINARY SITE ASSESSMENT

**PARCEL #154, JIFFY LUBE PROPERTY
CHARLOTTE – US 74 (INDEPENDENCE BOULEVARD) FROM NC 24 - 27
(ALBEMARLE ROAD) TO IDELWILD ROAD
MECKLENBURG COUNTY, NORTH CAROLINA**

**NCDOT WBS ELEMENT 3479.1.1
STATE PROJECT U-0209B**

August 20, 2010

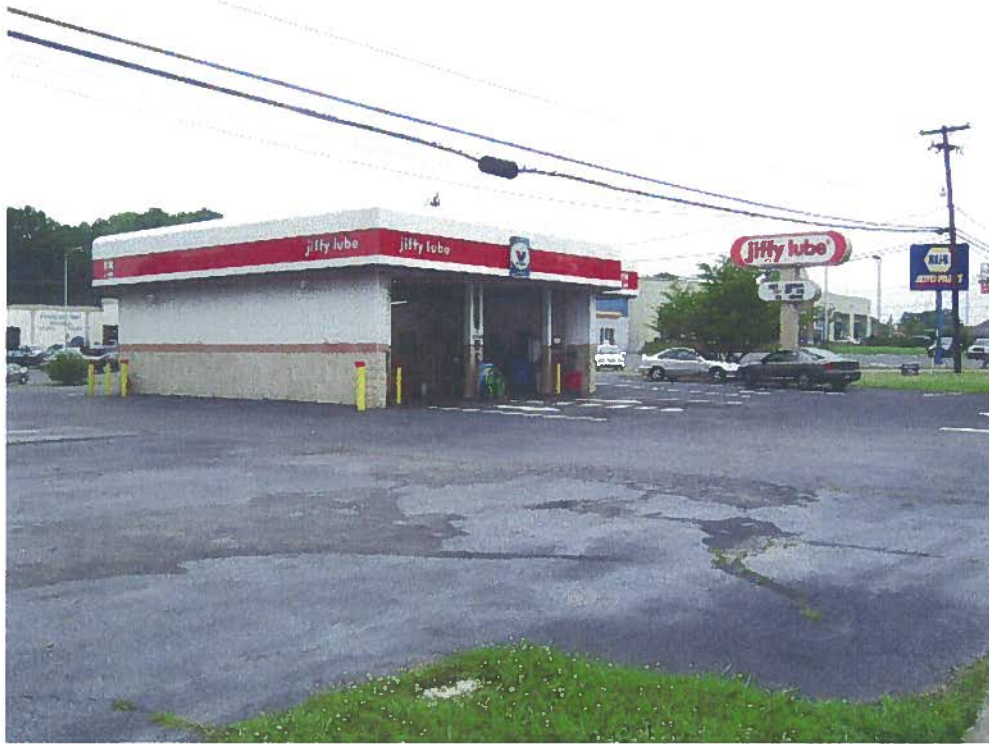
Photograph 1 – View of the Jiffy Lube property from the northwest corner looking southeast.

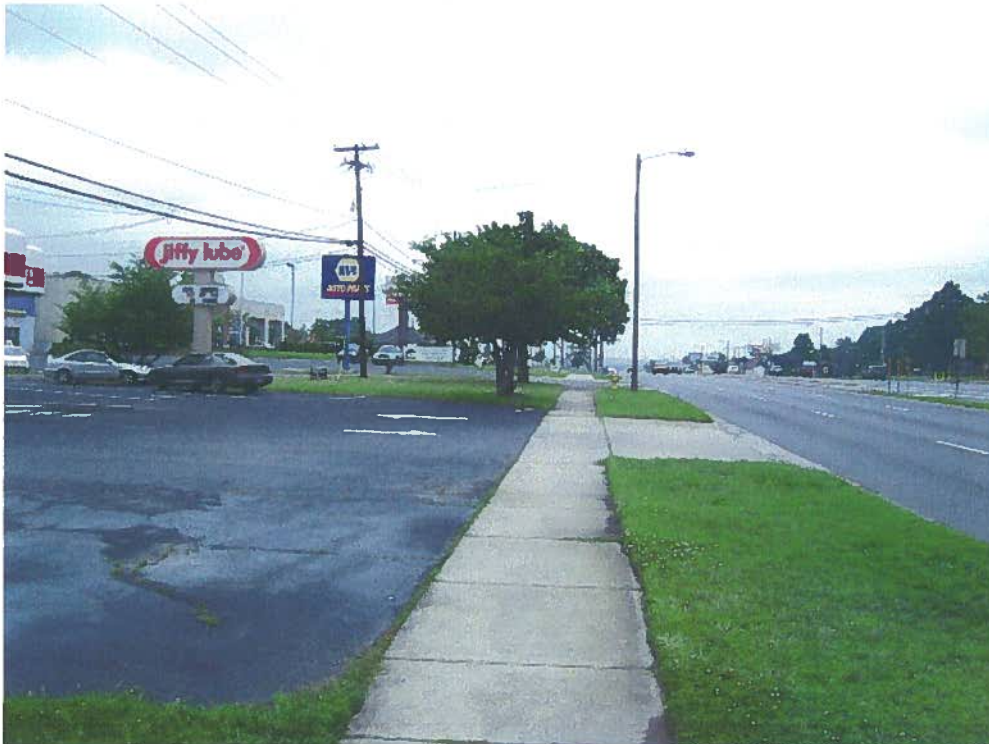
Photograph 2 – View of the Jiffy Lube property along East Independence Boulevard looking southeast.

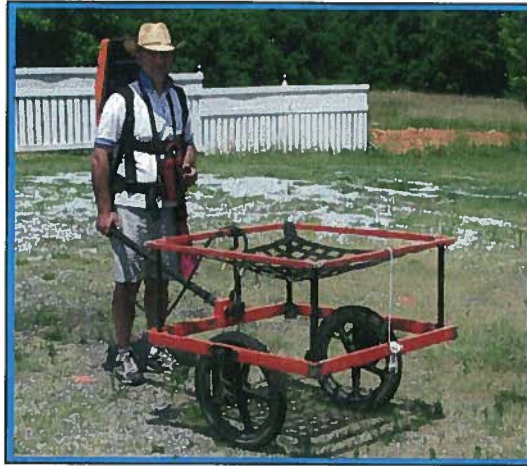
The photograph shows the Geonics EM61 metal detector that was used to conduct the metal detection survey across the geophysical survey area at the Hico Joan, LLC property (Parcel 154) on June 25, 2010.

The geophysical investigation consisted of electromagnetic (EM) induction-metal detection surveys. The EM survey was performed on June 25, 2010 using a Geonics EM61-MK1 metal detection instrument. According to the instrument specifications, the EM61 can detect a metal drum down to a

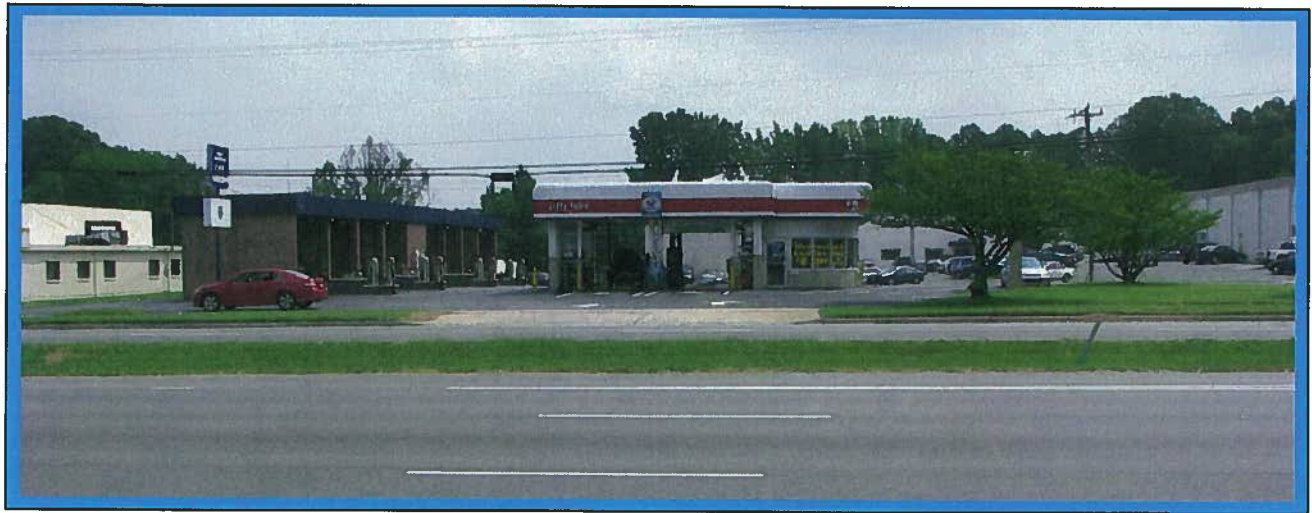
The photograph shows the southwestern (front) portion of the Hico Joan, LLC property located at the intersection of Independence Boulevard and Dion Avenue in Charlotte, North Carolina. The photograph is viewed in a northeasterly direction.
