TIP NO: P-5206A  
WBS: 52000.1.STR03T1B  
COUNTY: Rowan  
DIVISION: 9  
DESCRIPTION: Peeler Road – Grade Separation of NCRR/NS from Reid to North  
Kannapolis

SUBJECT: **Geotechnical Report for Planning**

## **Hazardous Materials Report**

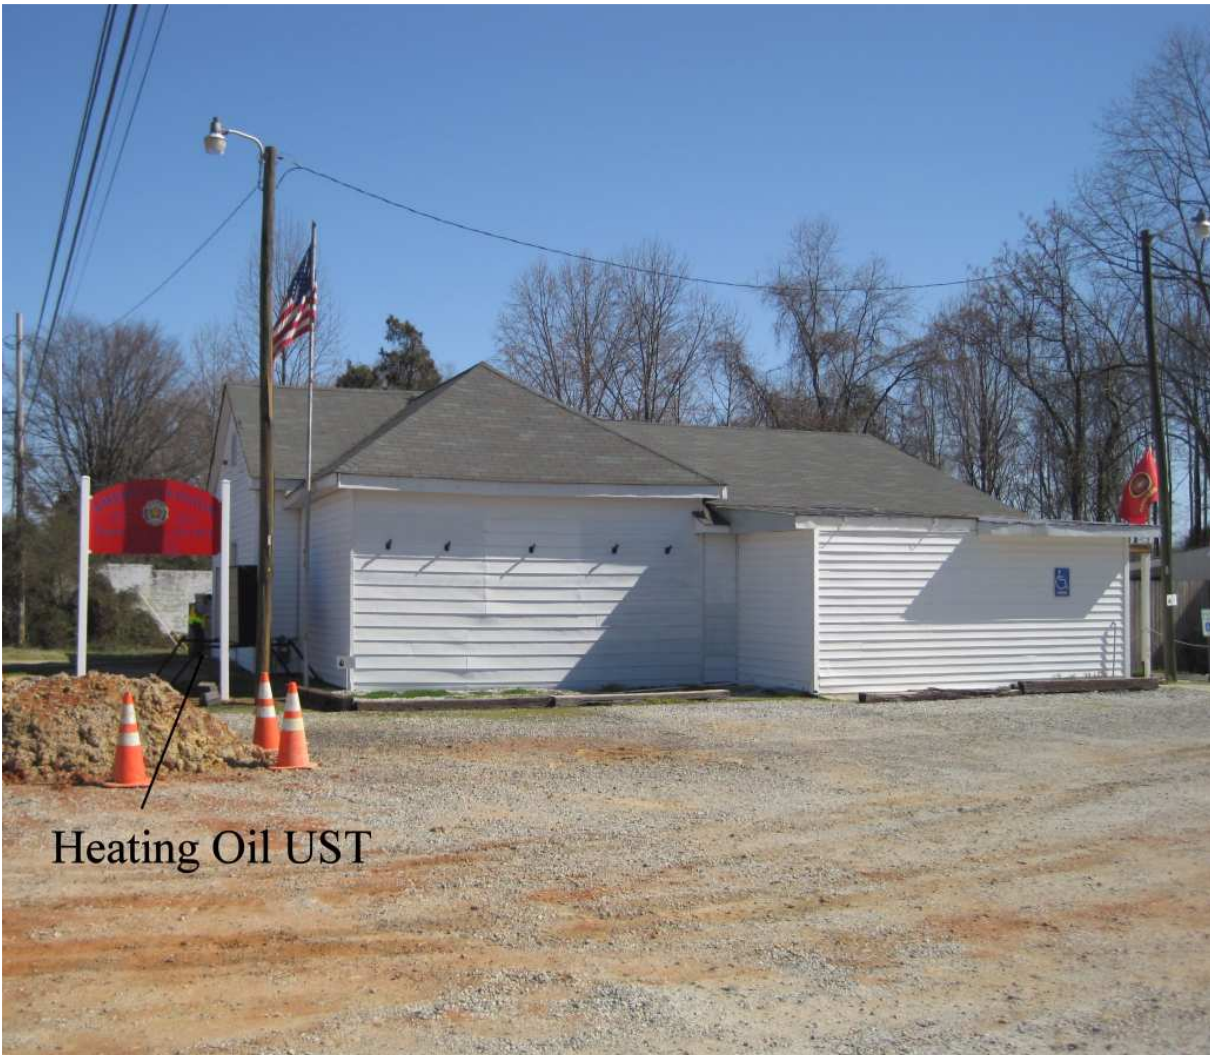
This building currently houses the American Legion Post 14. It is located southeast side US 29 (South Main street and across from the intersection with Cedar Springs Road). A heating oil tank is located on the northwest side of the structure and is located approximately 60 feet from the South Main Street median. This parcel does not appear on the UST Section registry and no groundwater incidents are associated with this operation. **This site is anticipated to present low geoenvironmental impacts to the project.**

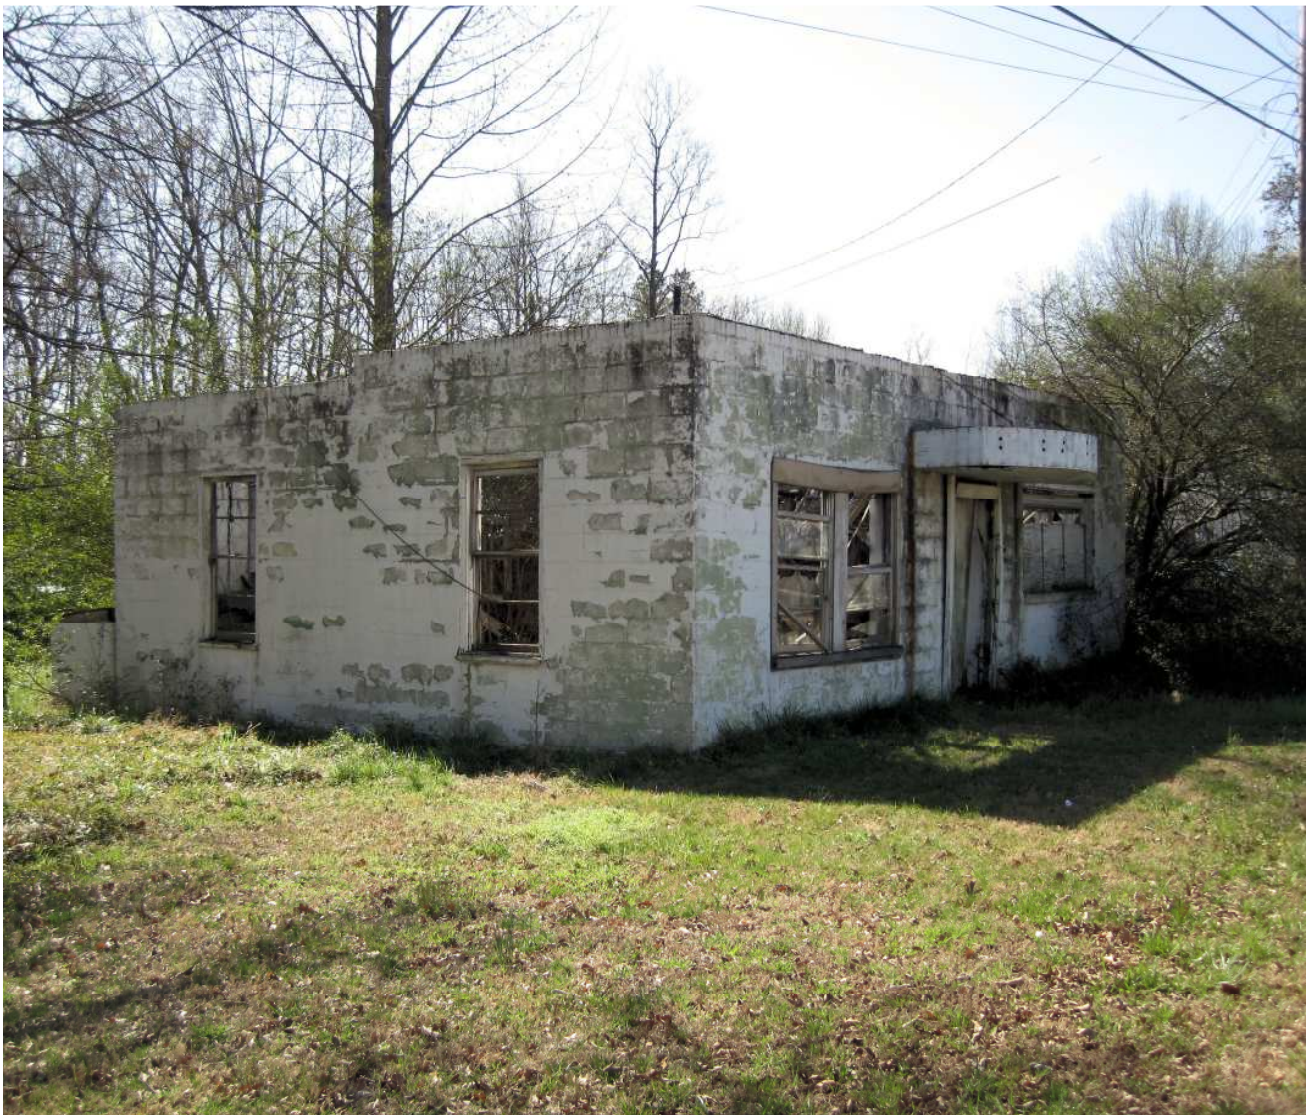
This former store and possible gas station is abandoned. It is located on the southeast side of US 29 (South Main Street) and just northeast of the Cedar Springs Road intersection. The front of the structure is 55 feet from the South Main Street median. This property does not appear on the UST Section registry and no evidence of USTs was observed. A single vent line is located on the southwest side of this structure. **This site is anticipated to present low geoenvironmental impacts to the project.**

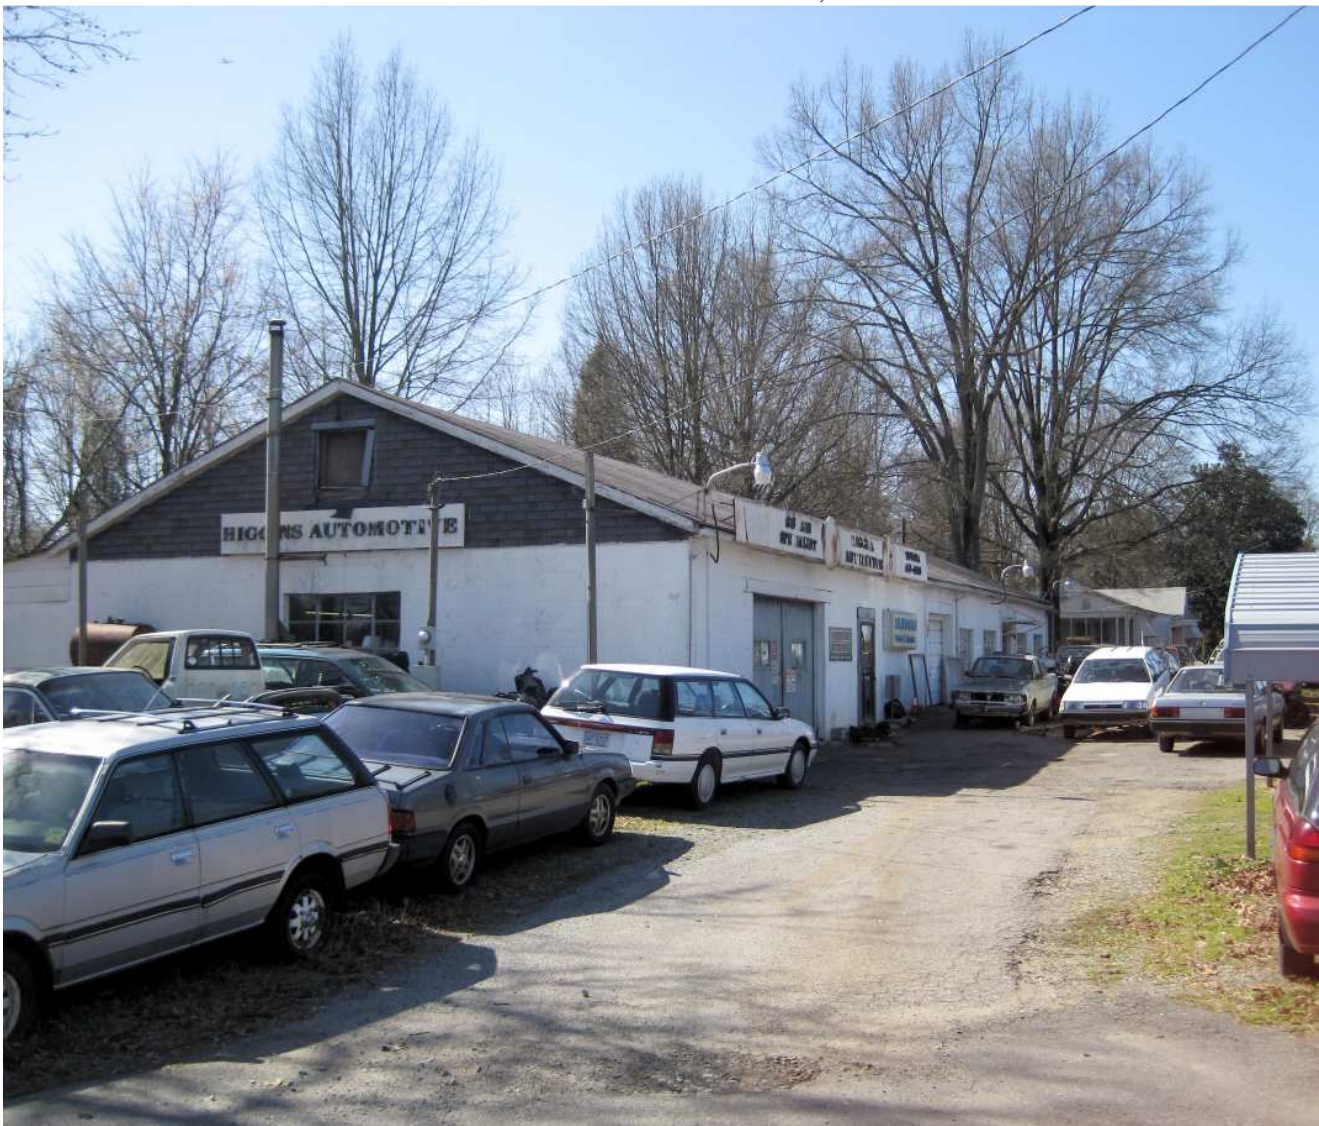
The facility currently operates as an automotive repair shop and a used car lot. According to tax records the building was first used as a warehouse. It is located in the south quadrant of the US 29 (South Main Street) and Peach Orchard Lane intersection. This property does not appear on the UST Section registry and no evidence of USTs was observed. However numerous vehicles are located on site making field observations difficult. **This site is anticipated to present low geoenvironmental impacts to the project.**

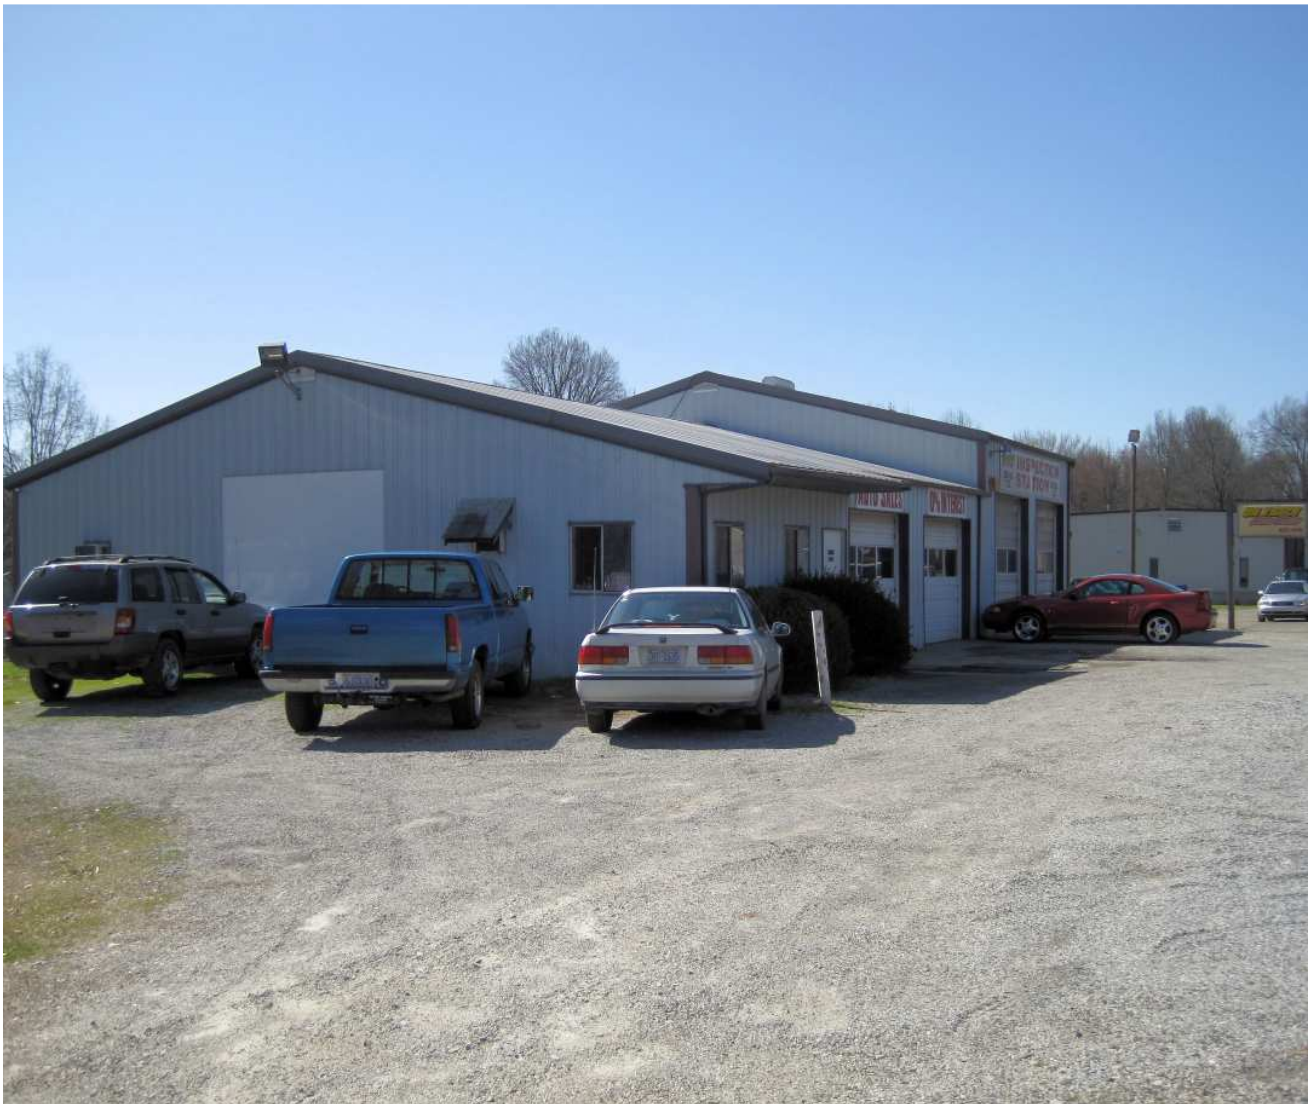
The facility currently operates as an automotive repair shop and is a well maintained operation. It is located on the south side of US 29 (South Main Street) and between the intersections of Peach Orchard Lane and Peach Orchard Road. This property does not appear on the UST Section registry and no evidence of USTs was observed. This business used above ground lifts. **This site is anticipated to present low geoenvironmental impacts to the project.**

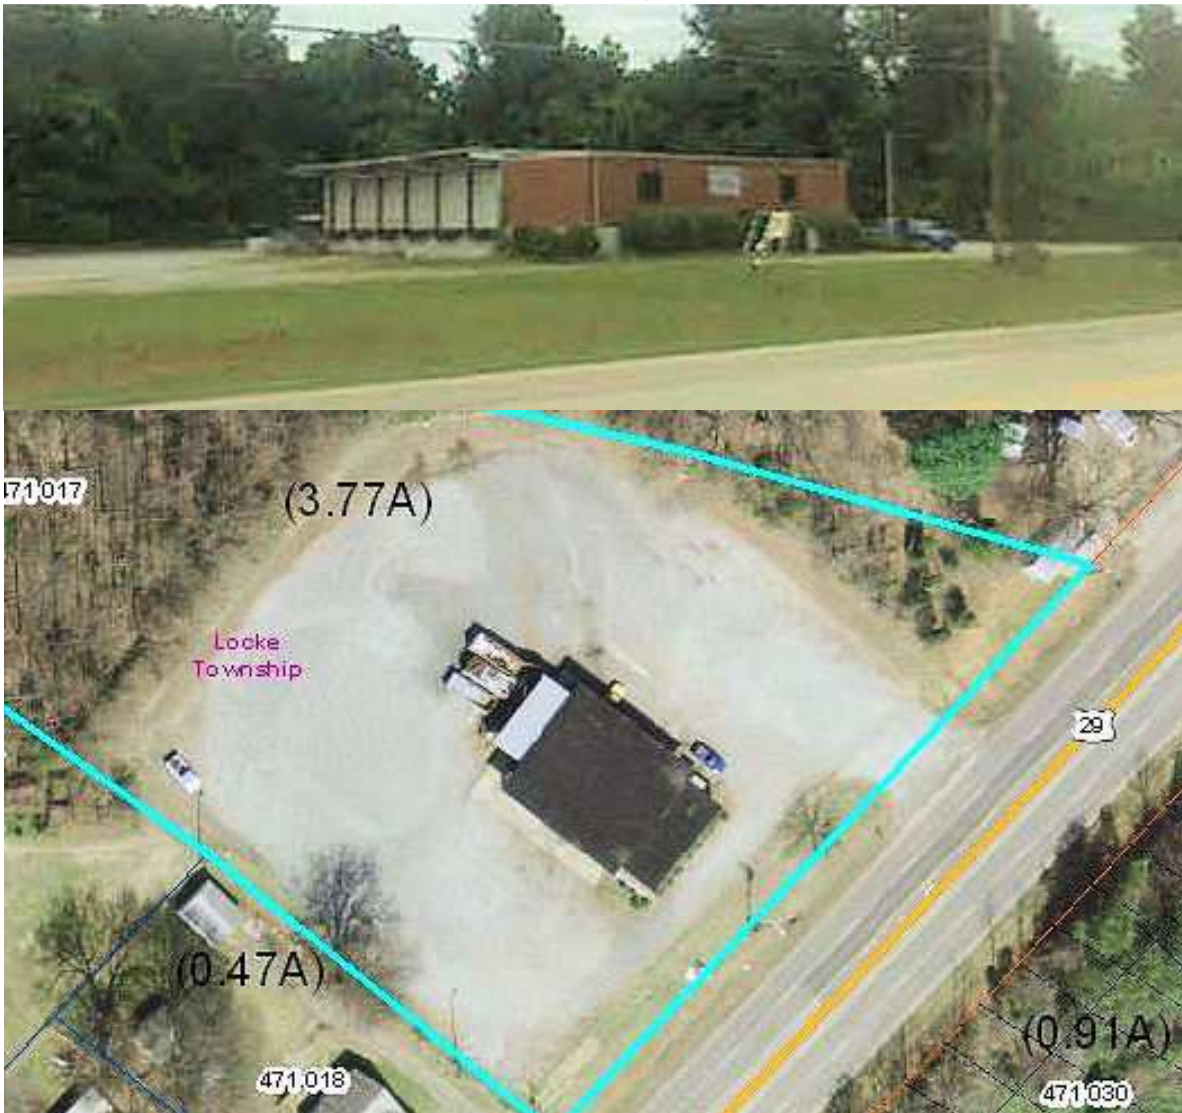
This currently closed facility once operated as a warehouse. It is located on the north side of US 29 (South Main Street) and between the intersections of Peach Orchard Lane and Peach Orchard Road. According to the UST Section registry one UST was closed in 1994. A ground water incident #14244 was assigned to this property at that time. The incident was closed out in 2001. **This site is anticipated to present low geoenvironmental impacts to the project.**

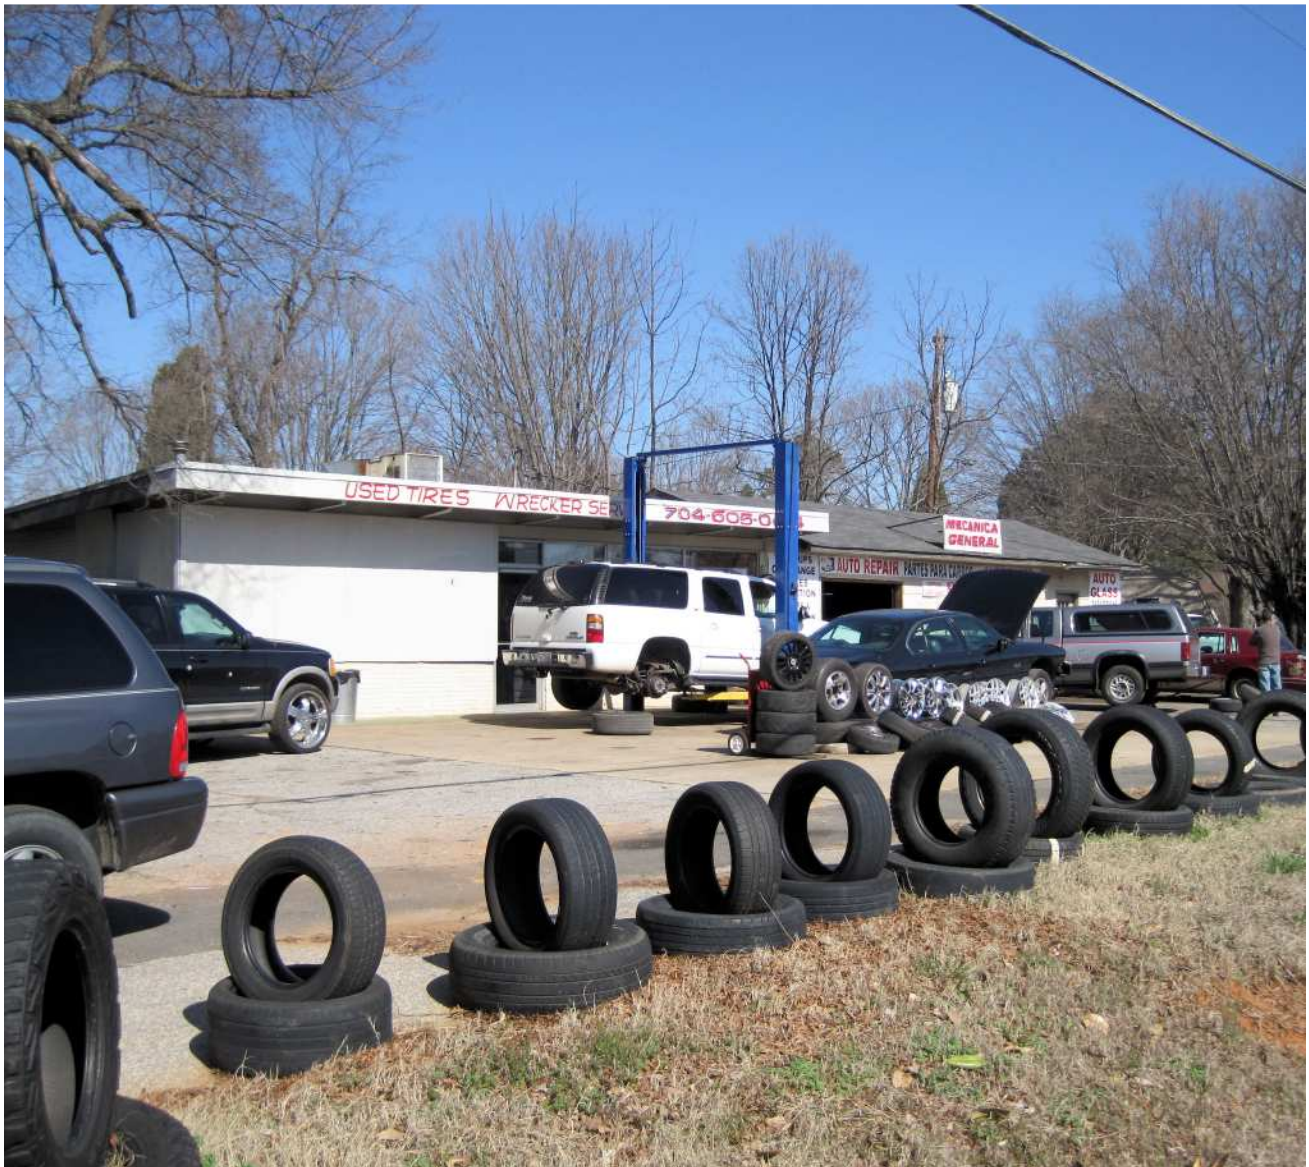
The facility currently operates as an automotive repair shop. According to tax records the building was first used as a retail business and possibly a gas station. It is located on the north side of US 29 (South Main Street) and across from the intersection of Peach Orchard Road. A tire display covers a possible former pump island. This property does not appear on the UST Section registry and no other evidence of USTs was observed. **This site is anticipated to present low geoenvironmental impacts to the project.**

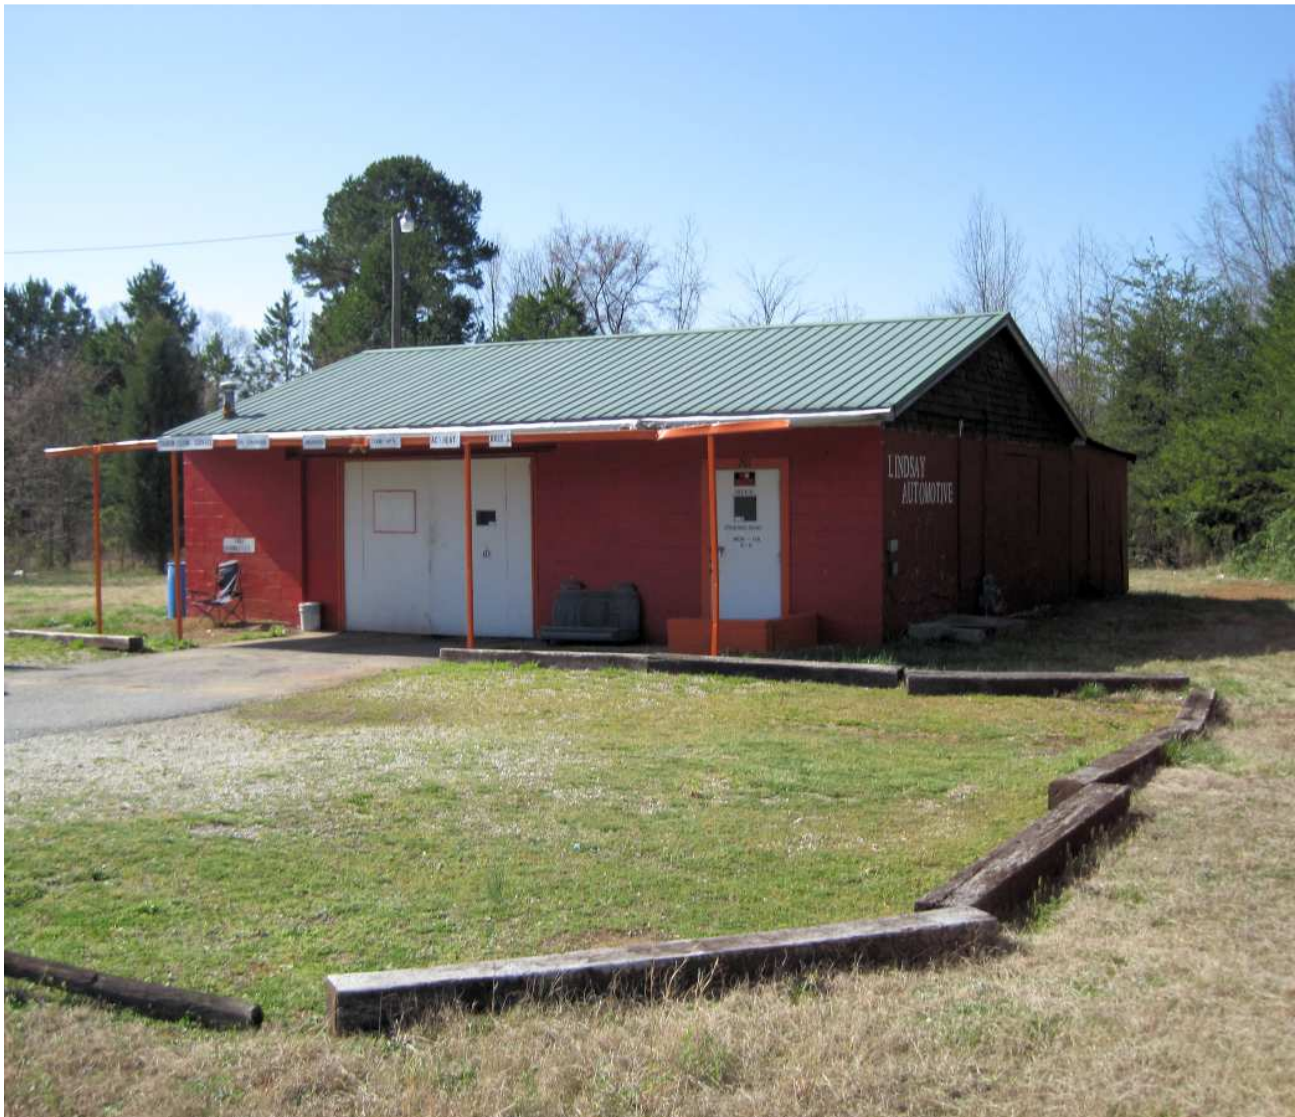
This closed facility operated as an automotive repair facility. Marc's Auto Repair also operated from this location. Modifications have been made to the original structure, which according to tax records, originally operated as a warehouse. It is located in the south quadrant of Peach Orchard Road and NCRR/NS Railroad intersection. This property does not appear on the UST Section registry and no evidence of USTs was observed. **This site is anticipated to present low geoenvironmental impacts to the project.**
