STATE OF NORTH CAROLINA
DEPARTMENT OF TRANSPORTATION

TIP NO: P-5206C
WBS: 52000.3.STR03T4A
COUNTY: Rowan
DIVISION: 9
DESCRIPTION: NCRR/NS Main Line from Mount Hope Church Road to East Blume Street

SUBJECT: **GeoEnvironmental Report for Planning**

Hazardous Materials Report

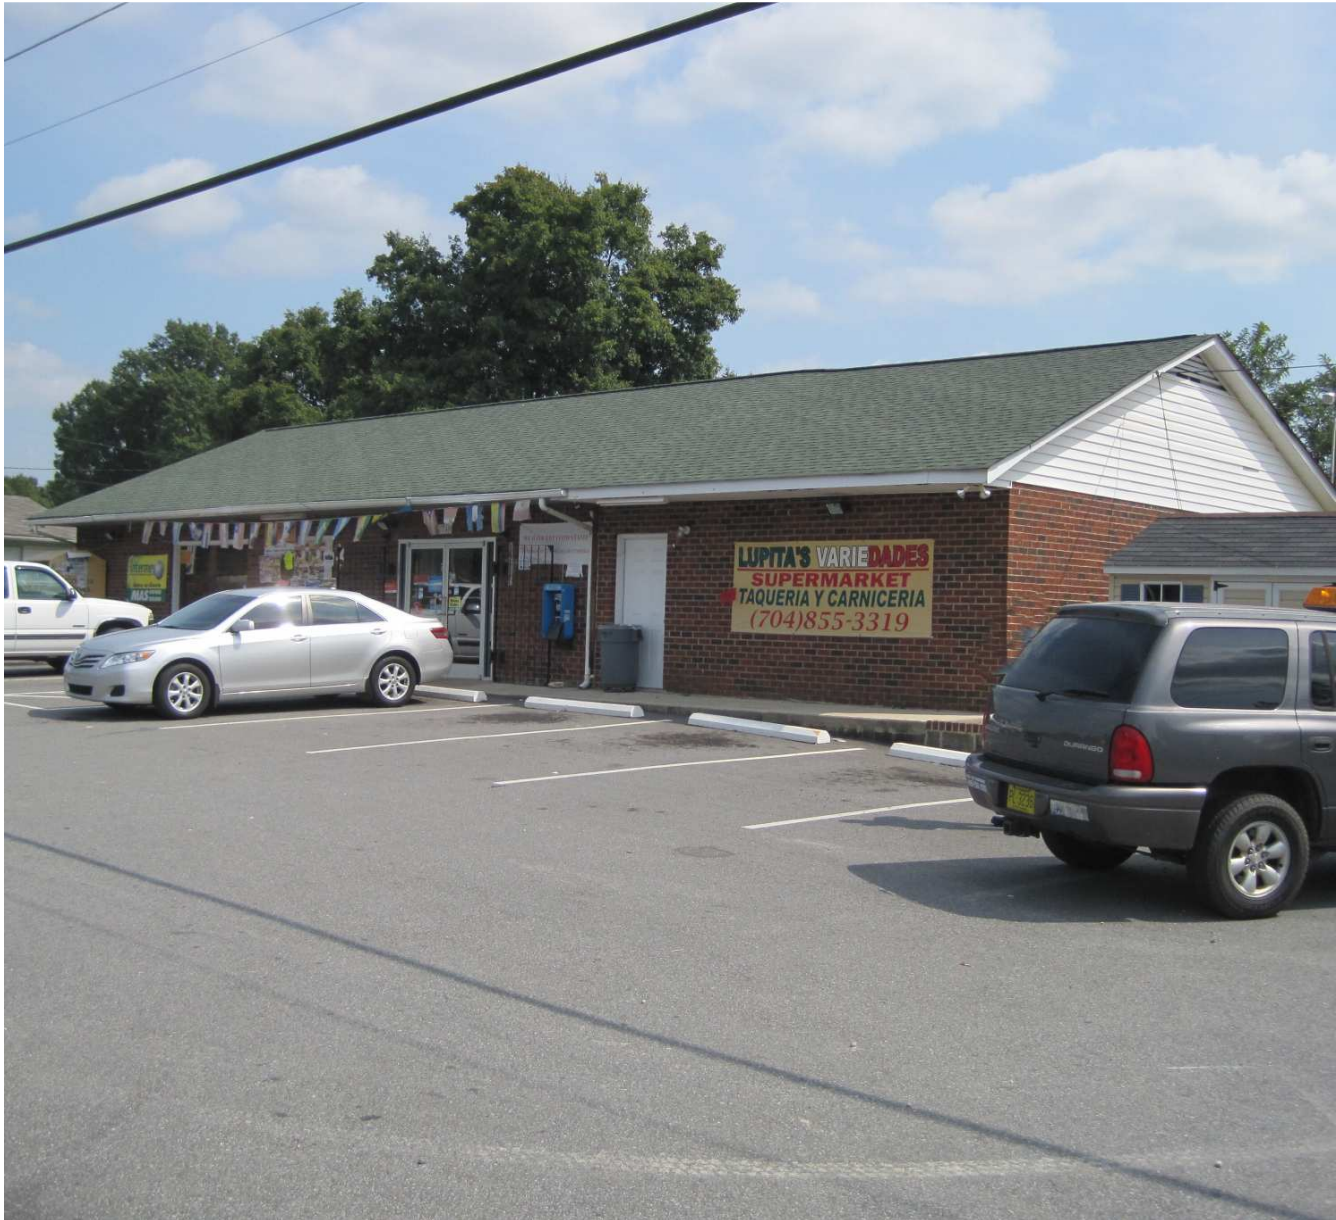
1)	Property Name Lupita's Variedades Supermarket 1740 N. Main Street China Grove, NC 28023	Property Owner: Paulino & Silvia Curiel 215 N. Bostian Street China Grove, NC 28023
----	---	---

This grocery store is located on the southeast side of US 29 (N. Main St) and 400 feet north of the Collins Road intersection. This parcel does not appear on the UST Section registry. This property does not appear on the Ground Water Incident database. **This site is anticipated to present low geoenvironmental impacts to the project.**

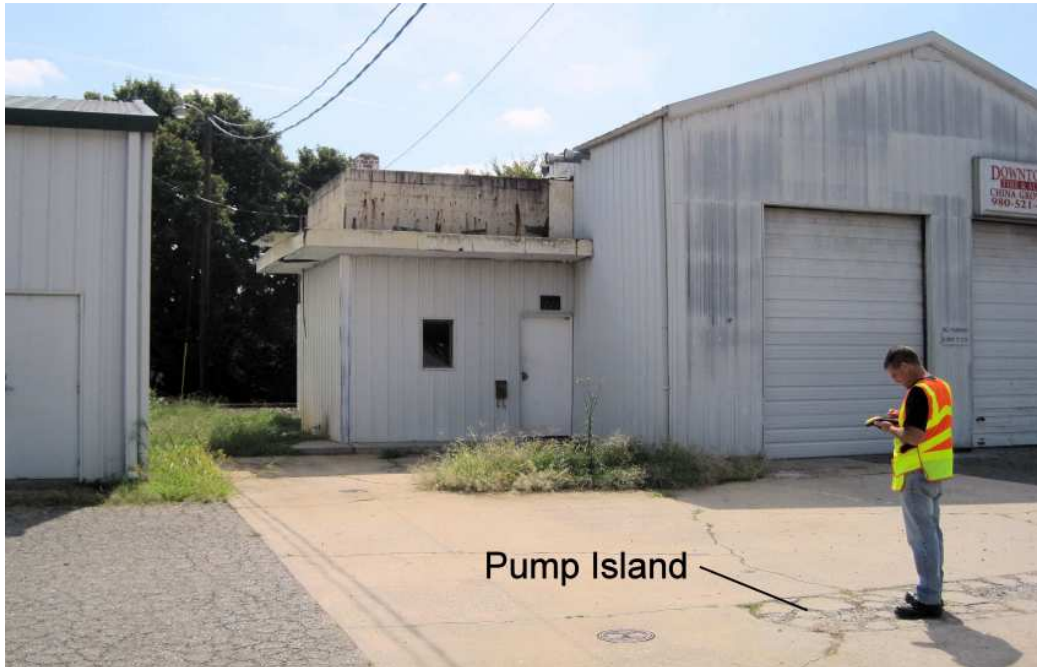
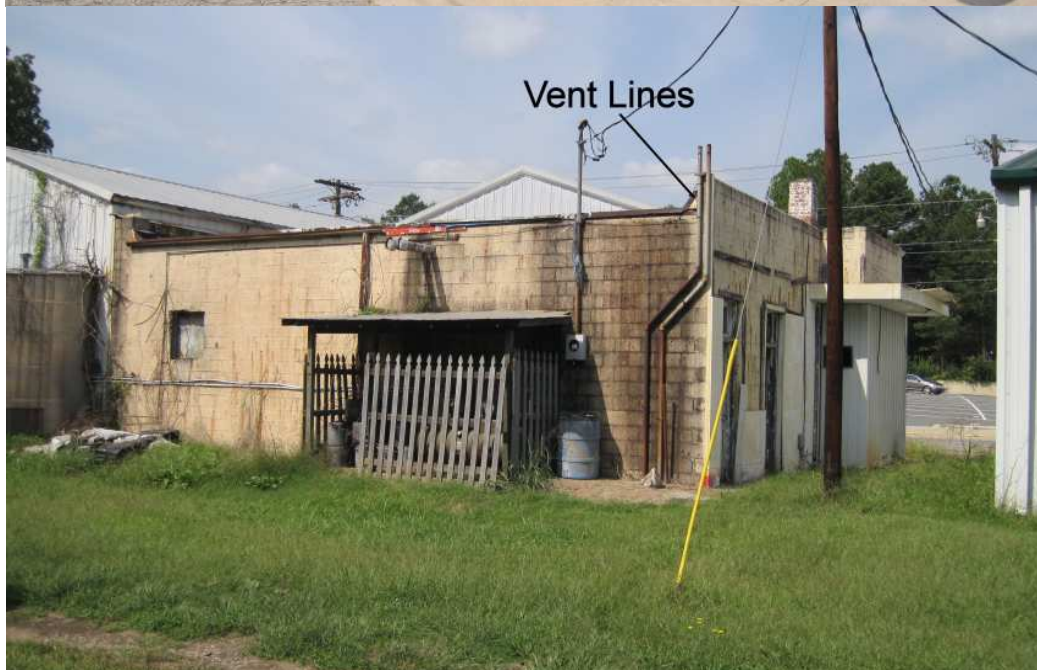
2)	Property Name Downtown Tire & Auto 221 S. Main Street China Grove, NC 28023	Property Owner: Hubert & WF Styles 1303 Killian Road Stanley, NC 28164
----	---	--

This former tire and automotive repair facility (also known as the Body Works) is located south of Main Street at the Patterson Street intersection. A gas station formerly operated at this location. The remains of a pump island are at the front and two (2) UST vent lines are at the rear of this structure. This parcel does not appear on the UST Section registry. There are no monitoring wells on site and no ground water incidents are associated with this facility. **This site is anticipated to present low geoenvironmental impacts to the project.**

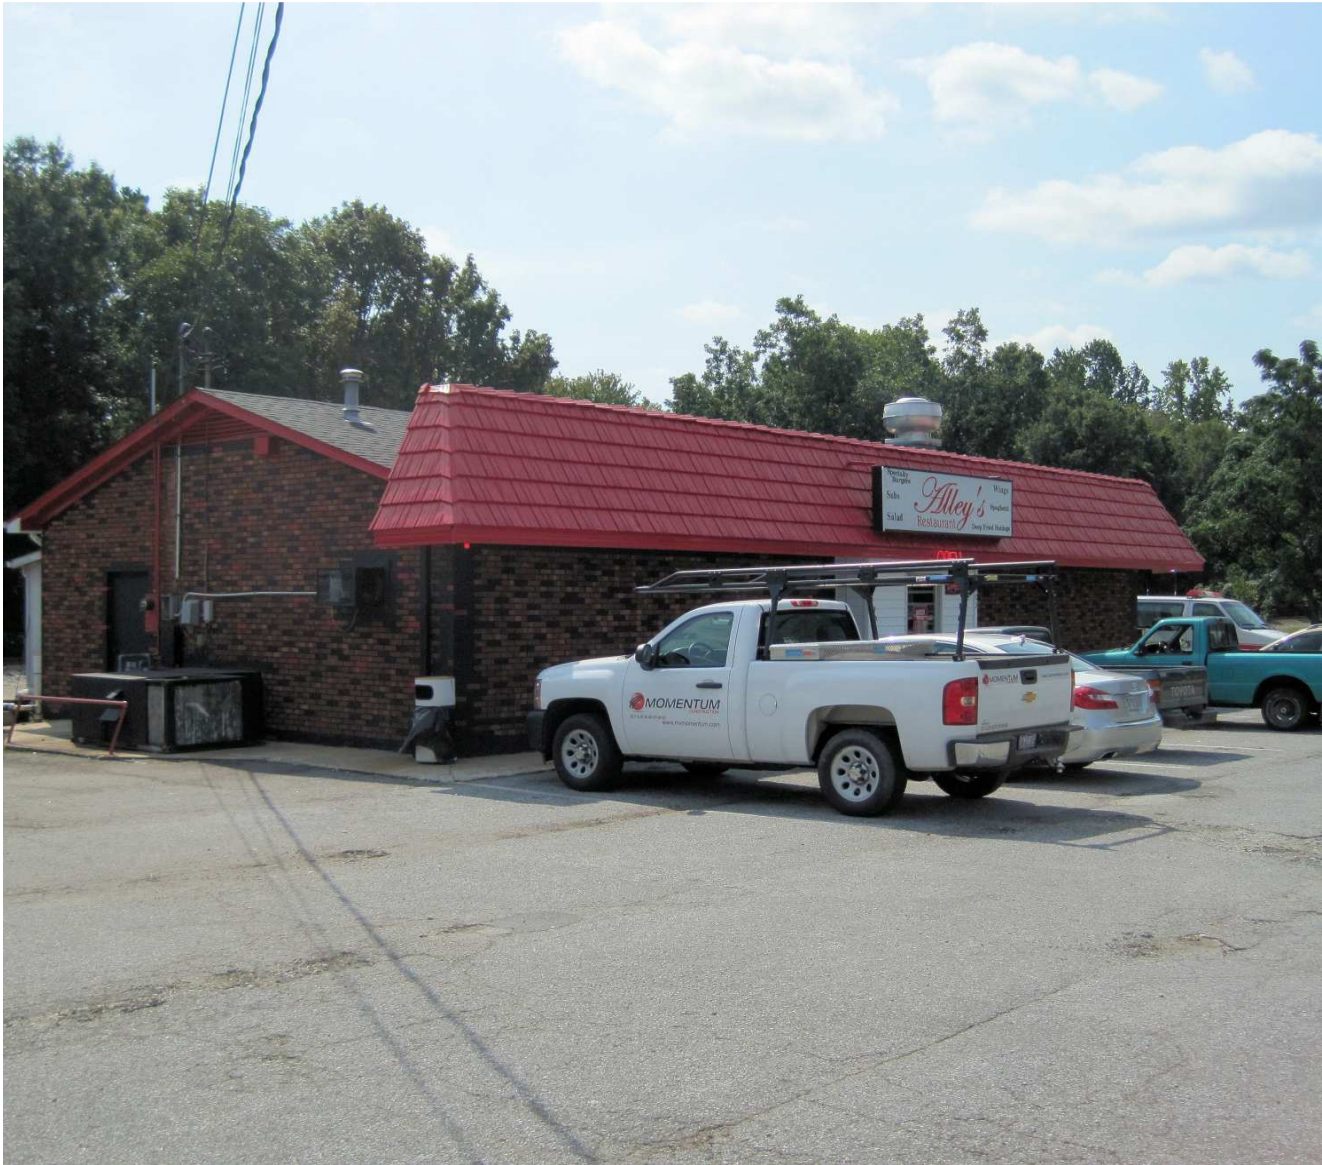
3)	Property Name Alley's Restaurant 303 S. Main Street China Grove, NC 28023	Property Owner: Margaret V. Smith 963 Holly Springs Road Mount Airy, NC 27030
----	---	---

This active restaurant is located south of Main Street and the Patterson Street intersection. A gas station and convenience store may have once operated at this location. This parcel does not appear on the UST Section registry. This property does not appear on the Ground Water Incident database. **This site is anticipated to present low geoenvironmental impacts to the project.**

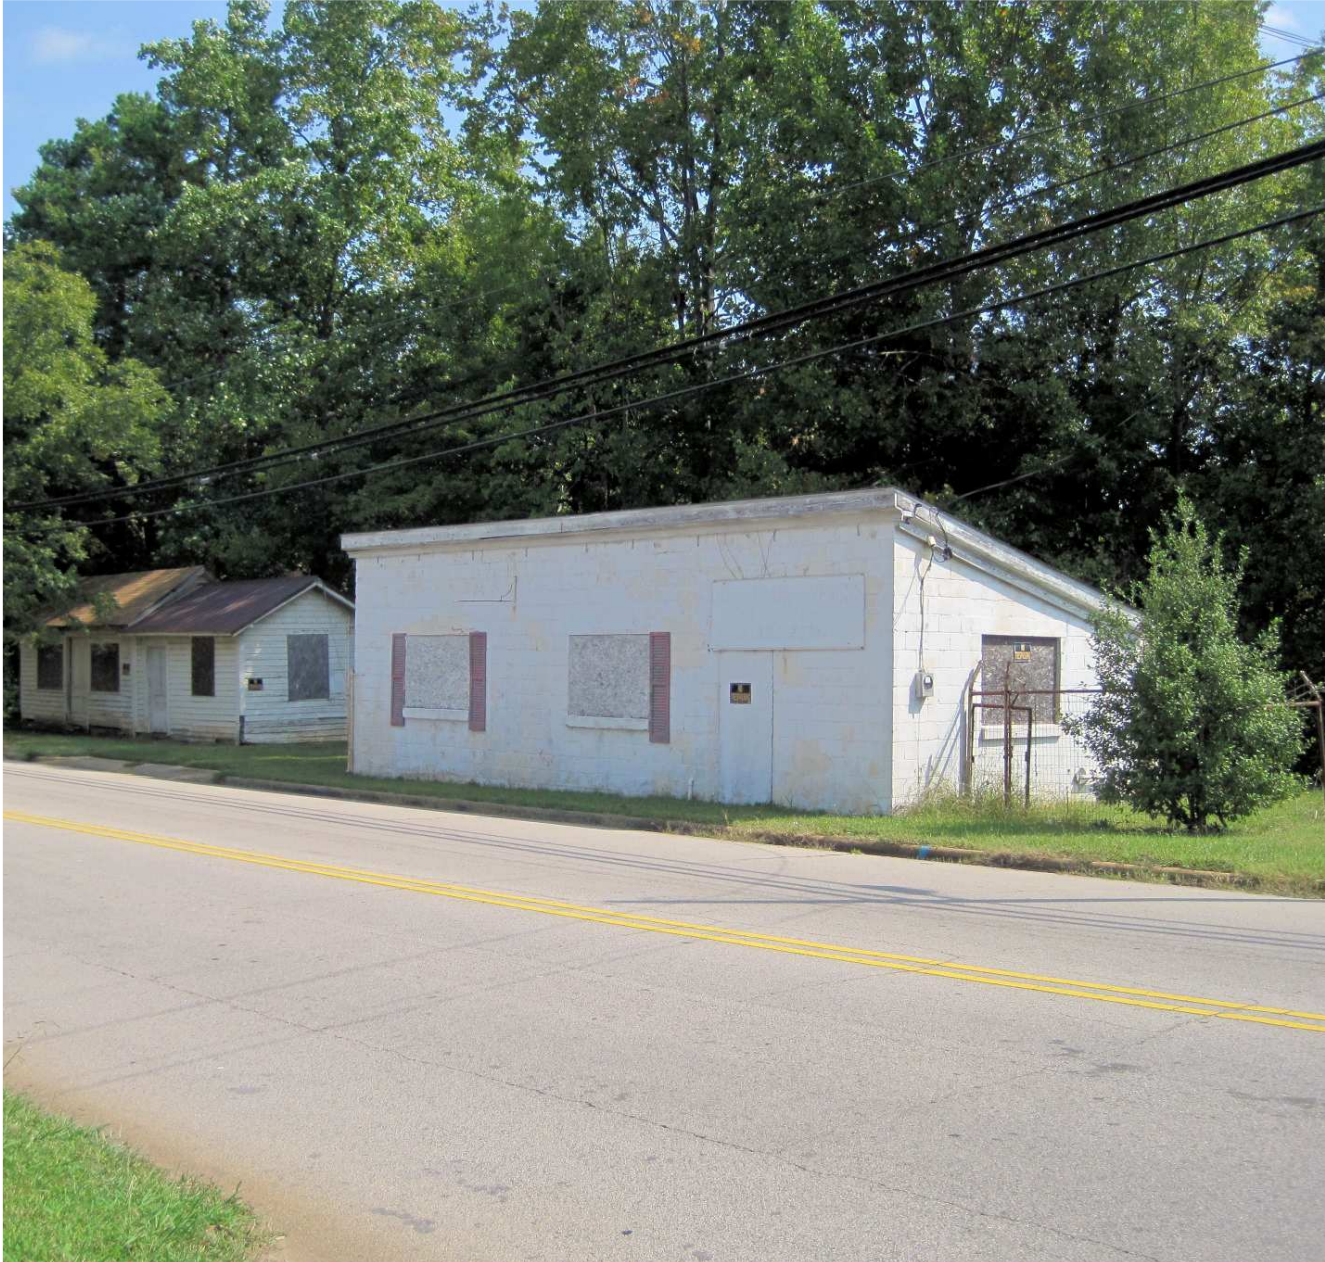
4)	Property Name Former Hair Train Express 711 S. Main Street China Grove, NC 28023	Property Owner: Donnie B. Sechler 136 Greenview Drive Kannapolis, NC 28081
----	--	--

This former retail business is located on the east side of South Main St and 550 feet north of the Kirk Street intersection. A gas station may have once operated at this location. This parcel does not appear on the UST Section registry. There are no monitoring wells on site and no ground water incidents are associated with this facility. **This site is anticipated to present low geoenvironmental impacts to the project.**

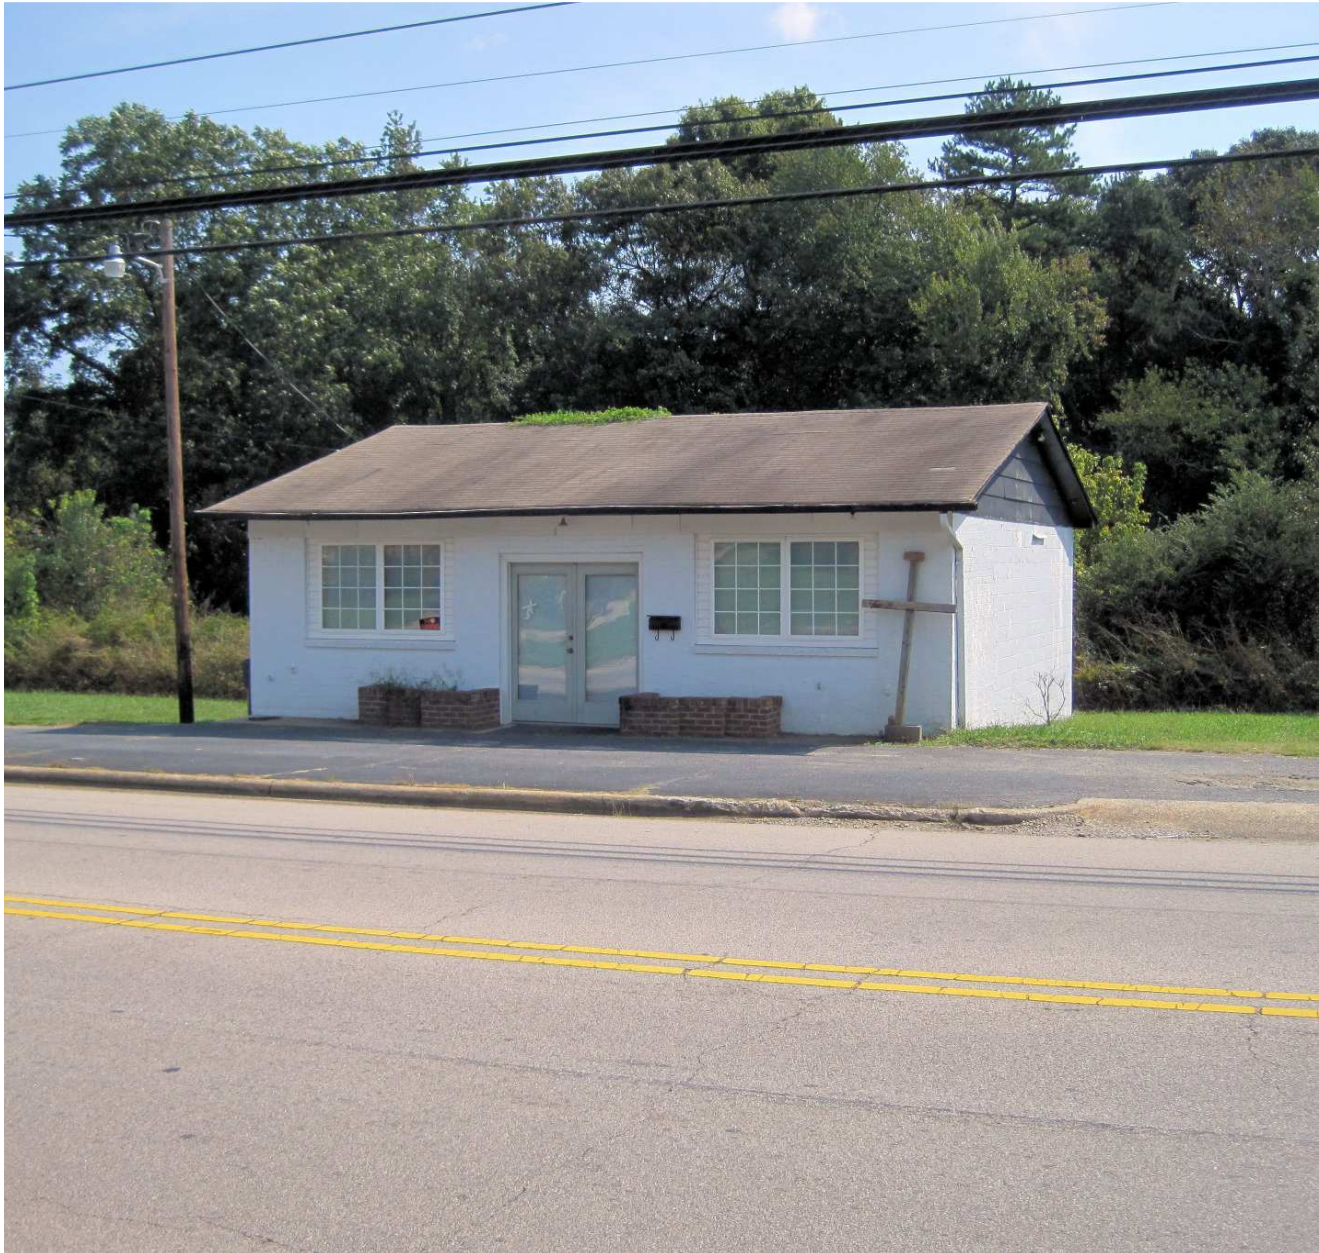
5)	Property Name Former CCI Telecom 809 S. Main Street China Grove, NC 28023	Property Owner: Johnny & Brenda Morgan 410 Rock Creek Road Rockwell, NC 28138
----	---	---

This church (Faith That Works Christian Church) and former retail business is located on the east side of South Main Street and 225 feet north of the Kirk Street intersection. A gas station may have once operated at this location. This parcel does not appear on the UST Section registry. There are no monitoring wells on site and no ground water incidents are associated with this facility. **This site is anticipated to present low geoenvironmental impacts to the project.**

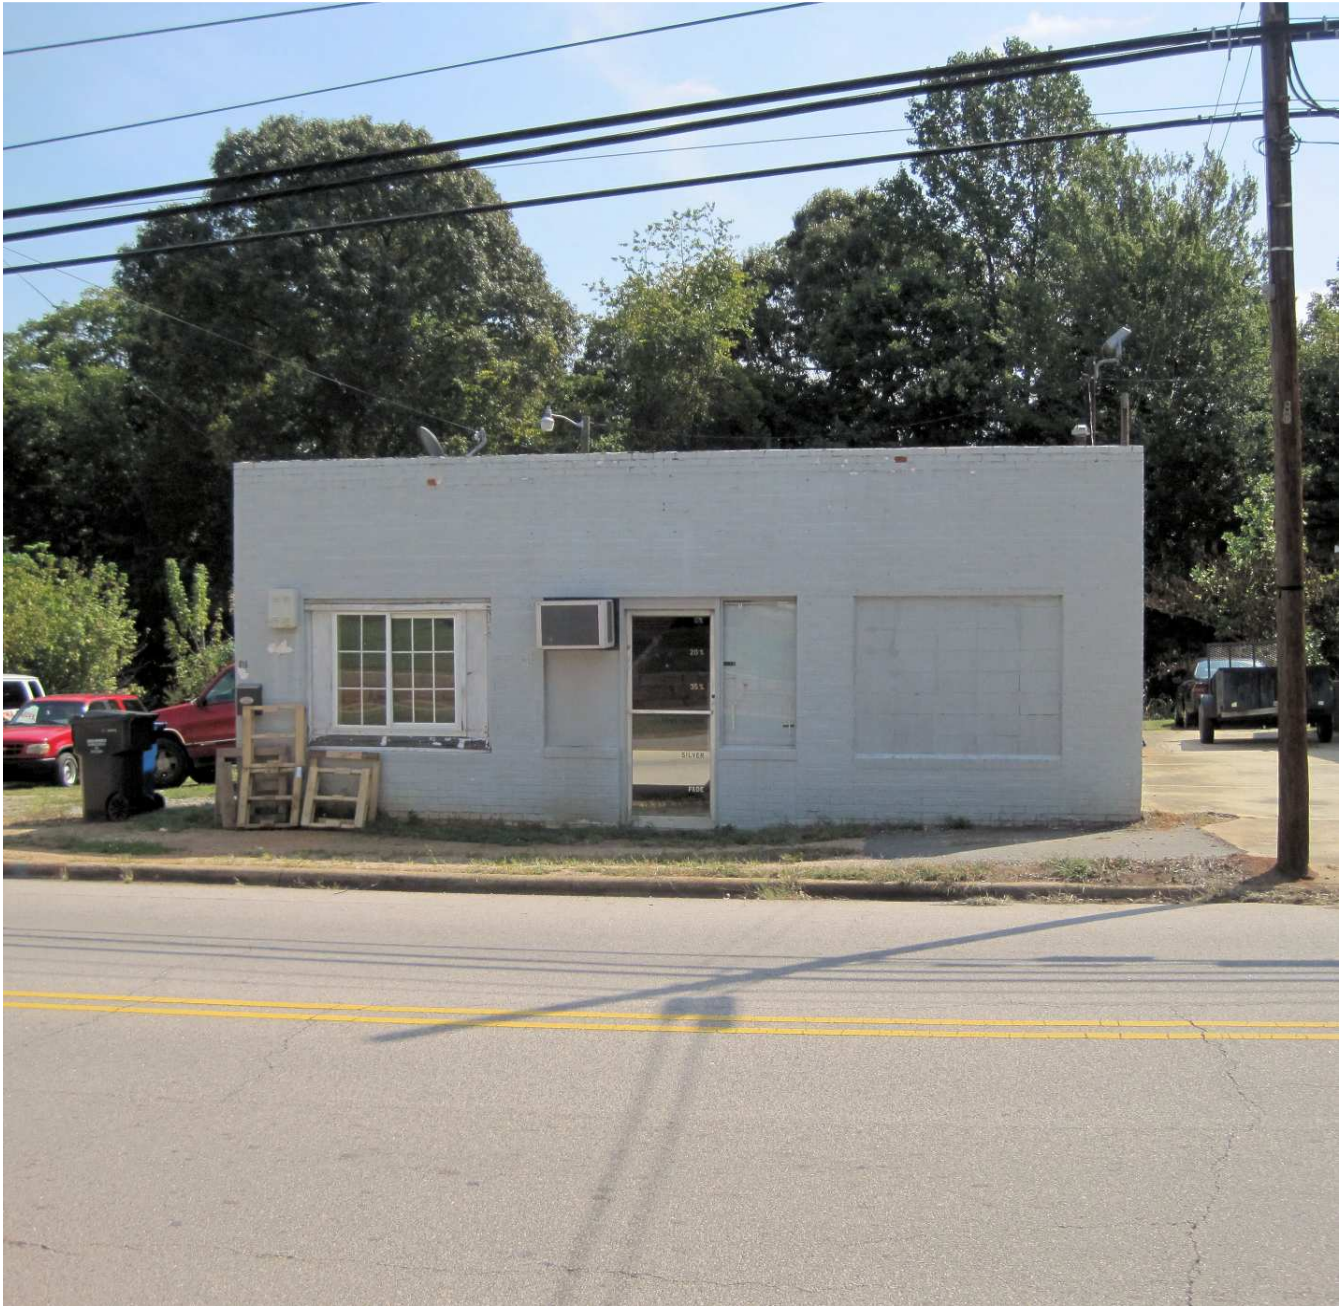
6)	Property Name Former Williams Auto Sales 819 S. Main Street China Grove, NC 28023	Property Owner: Junior & Joy Kirk 8035 Georgia Ave. Kannapolis, NC 28081
----	---	--

This closed retail business is located on the east side of South Main Street and across from the Kirk Street intersection. Many businesses, including Easy Tint and Tunes and China Grove Taxi have operated from this location. A gas station may have also operated at this location. This parcel does not appear on the UST Section registry. This property does not appear on the Ground Water Incident database. **This site is anticipated to present low geoenvironmental impacts to the project.**

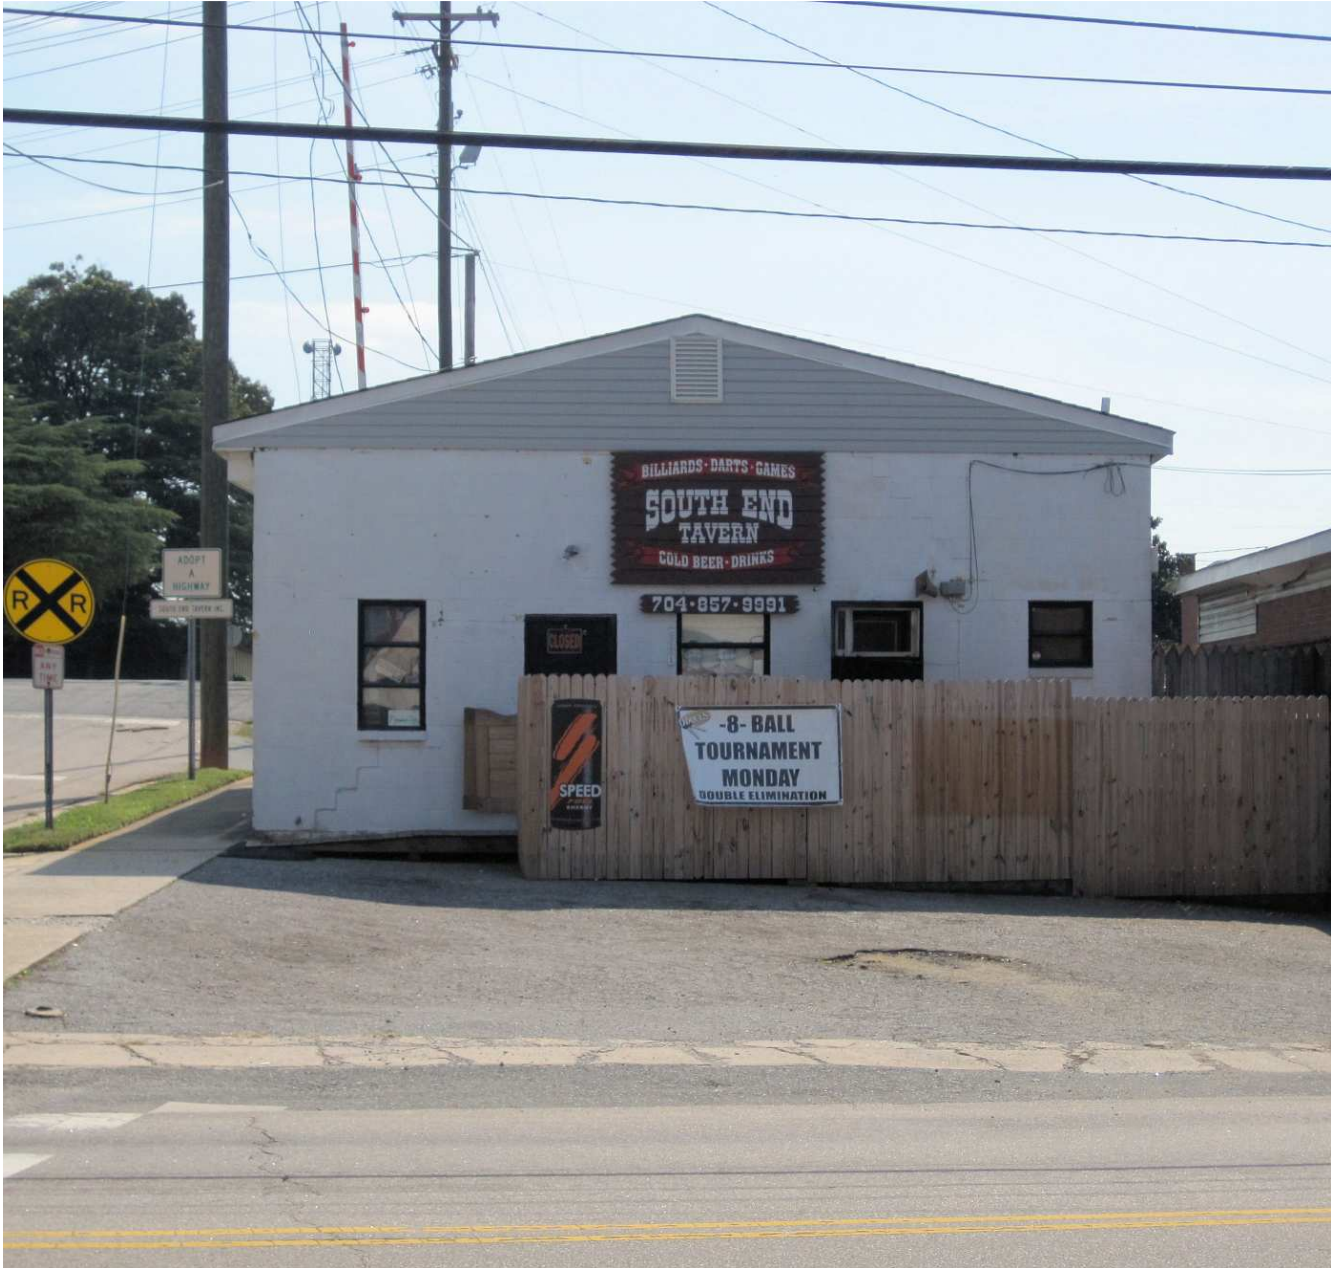
7)	Property Name South End Tavern 104 East Thom Street China Grove, NC 28023	Property Owner: Eva B. Stewart 301 N. Correll Street Landis, NC 28088
----	---	---

This closed bar is located on the south quadrant of South Main Street and Thom Street. This parcel does not appear on the UST Section registry. A gas station may have once operated at this location. There are no monitoring wells on site and no ground water incidents are associated with this facility. **This site is anticipated to present low geoenvironmental impacts to the project.**

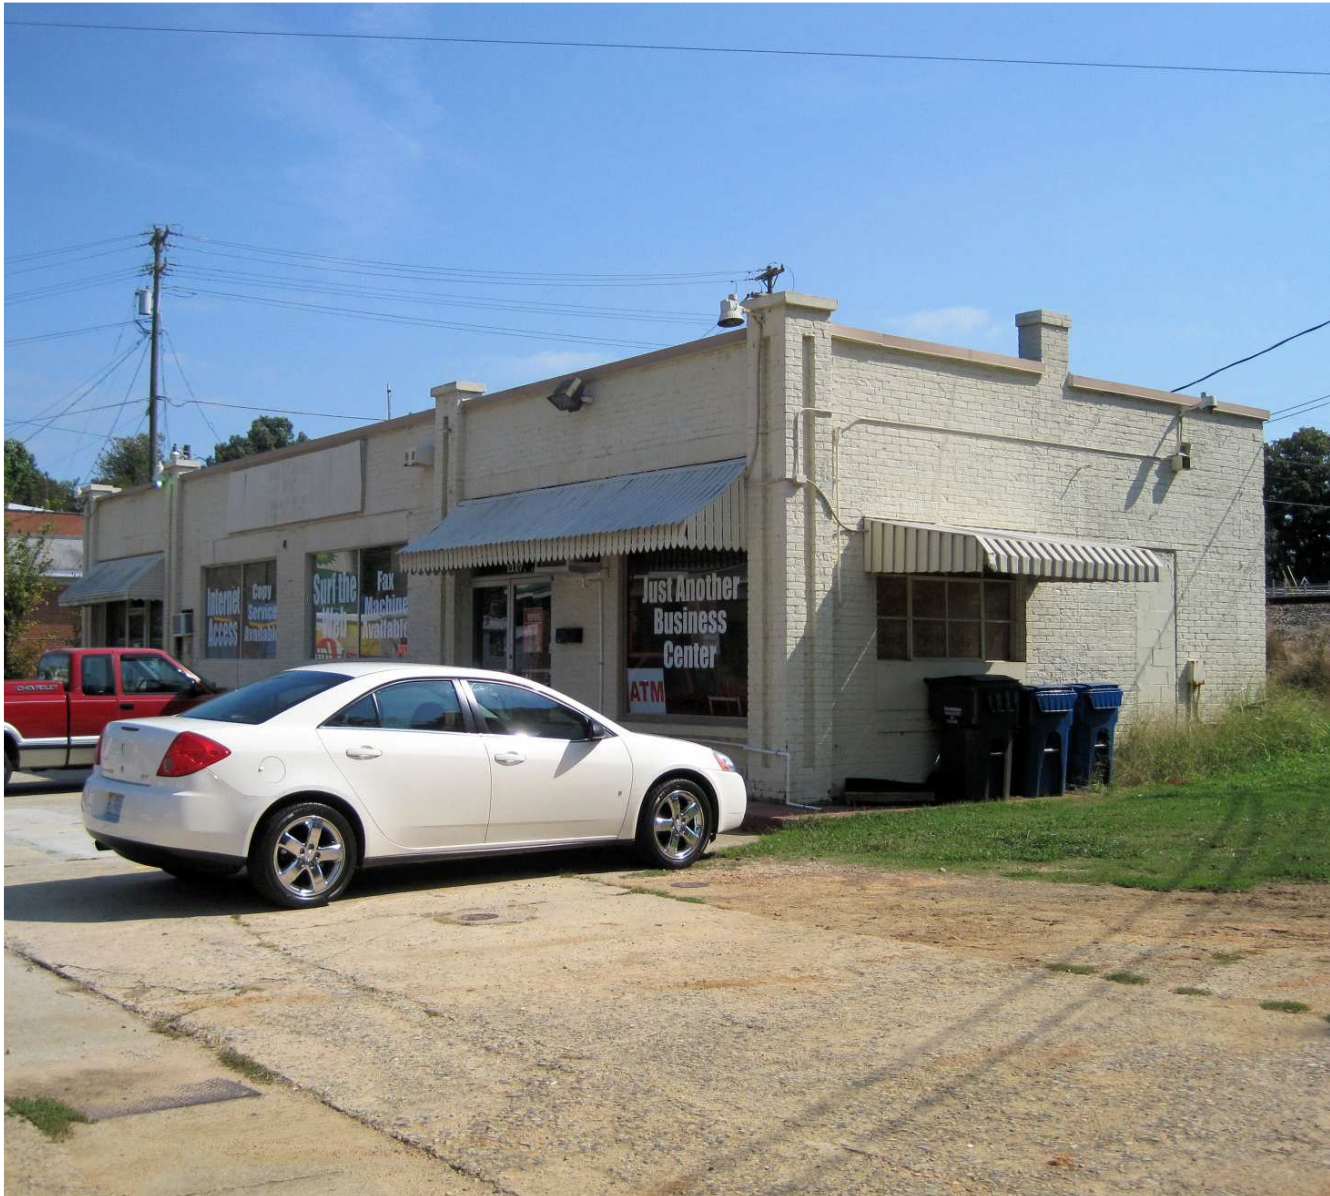
-
- 8) **Property Name**
Just Another Business Center
1113 S. Main Street
China Grove, NC 28023
- Facility ID #:** 0-019059
Incident #: 22556
- Property Owner:**
Allen & Barbara Welter
109 N. Main Street
China Grove, NC 28023
- UST Owner:**
Fred Lambe
312 Blackwelder Street
China Grove, NC 28023

This facility is located on the east side of South Main Street and 200 feet south of the East Thom Street intersection. Fred's One-Stop gas station originally operated from this location. Evidence of a pump island near the southeastern corner of this structure. According to the UST Section registry two (2) tanks were removed from this parcel in 2000. There are monitoring wells on site and Groundwater Incident # 22556 has been assigned to this property. **This site is anticipated to present low geoenvironmental impacts to the project.**

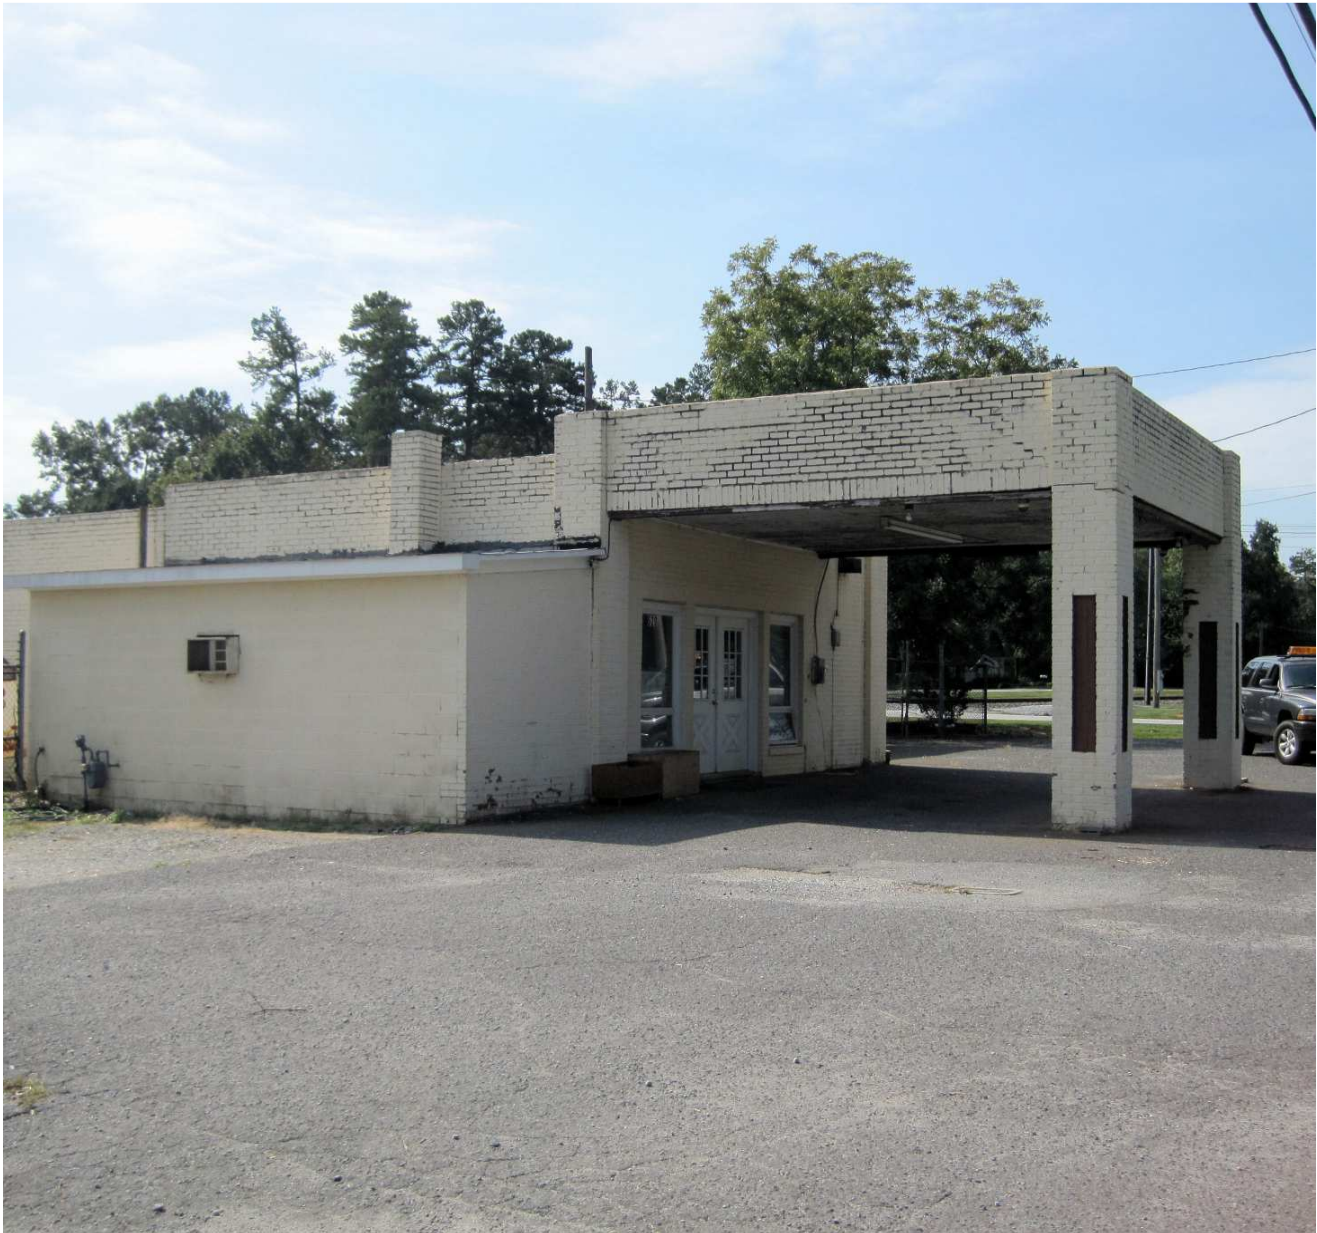
9)	Property Name The Plumbing Shoppe, Inc. 620 N. Main Street Landis, NC 28088	Property Owner: The Plumbing Shoppe, Inc. 620 N. Main Street Landis, NC 28088
----	---	---

This former tire and automotive repair facility is located south of North Main Street at the Patterson Street intersection. A gas station formerly operated at this location. This parcel does not appear on the UST Section registry. There are no monitoring wells on site and no ground water incidents are associated with this facility. **This site is anticipated to present low geoenvironmental impacts to the project.**
