PRELIMINARY SITE ASSESSMENT

**GLADE VALLEY – US HIGHWAY 21 SOUTH FROM ROARING GAP TO SPARTA
PARCEL #141, CAVEROCK FARMS LIMITED PARTNERSHIP PROPERTY
5087 US HIGHWAY 21 SOUTH
GLADE VALLEY, ALLEGHANY COUNTY, NORTH CAROLINA**

**NCDOT WBS ELEMENT 37044.1.1
STATE PROJECT R-3101**

January 13, 2012

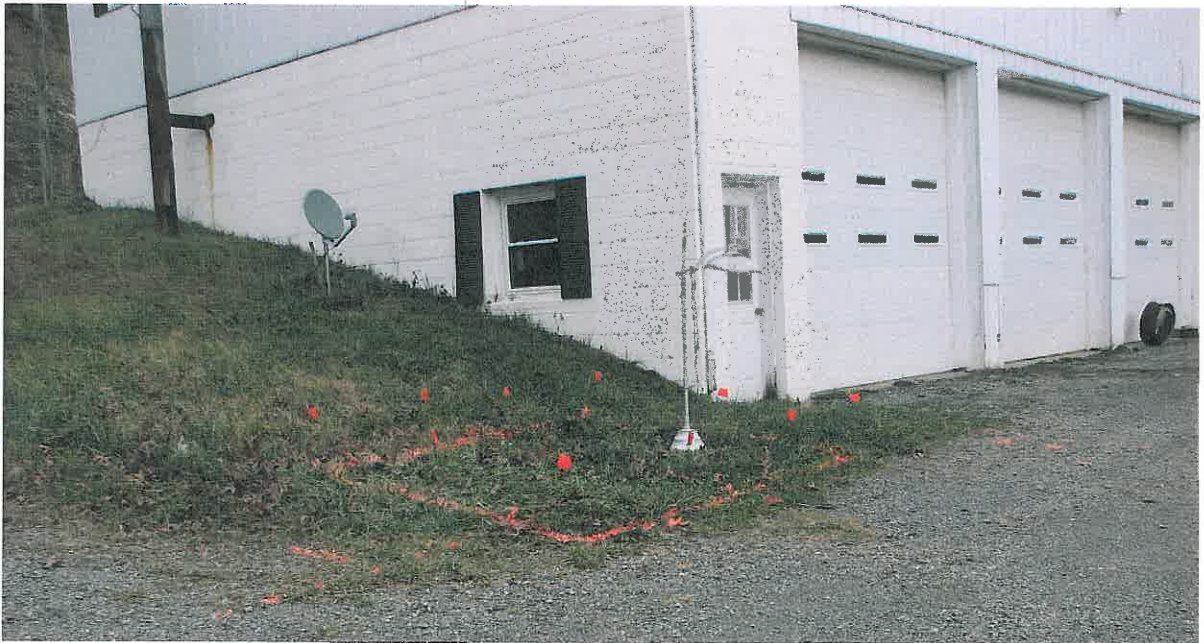
Photograph 2 View of the building looking east. Note the location of the suspected septic tank.

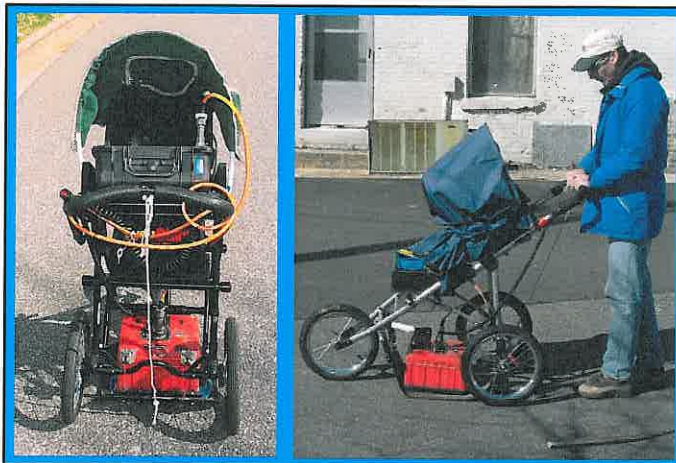
The photographs show the SIR-2000 GPR system equipped with a 400 MHz antenna that were used to conduct the ground penetrating radar investigation across selected EM61 differential anomalies at Parcel 141 on November 17, 2011.

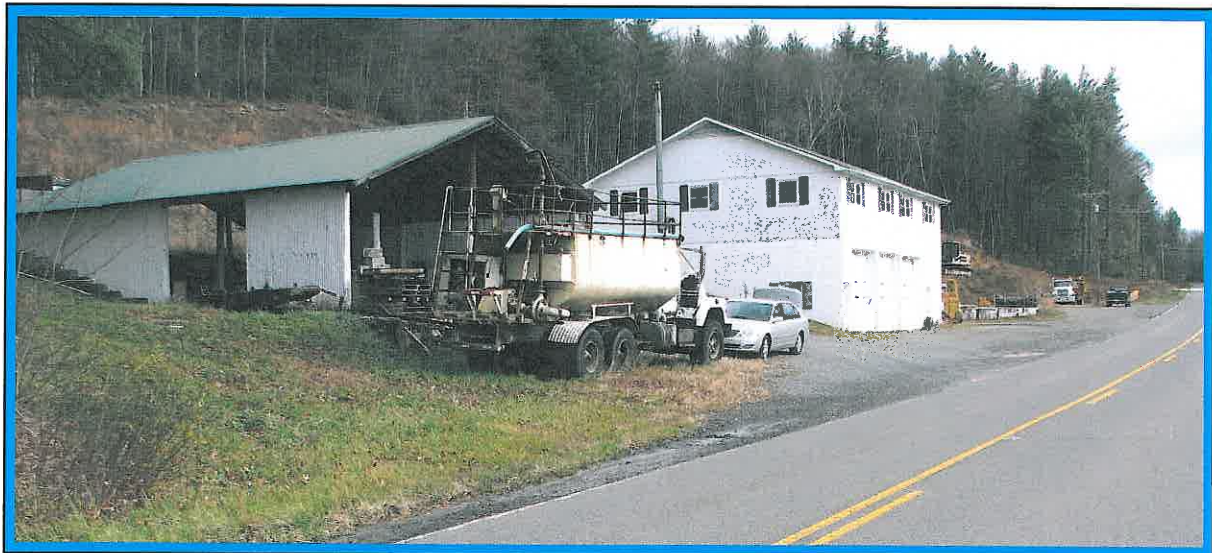
The photograph shows the front portion of the Caverock Farms L.P. property (Parcel 141) located at 5087 US Highway 21 South near Glade Valley, North Carolina. The geophysical investigation was performed across the front portion of the property. The photograph is viewed in a southeasterly direction.

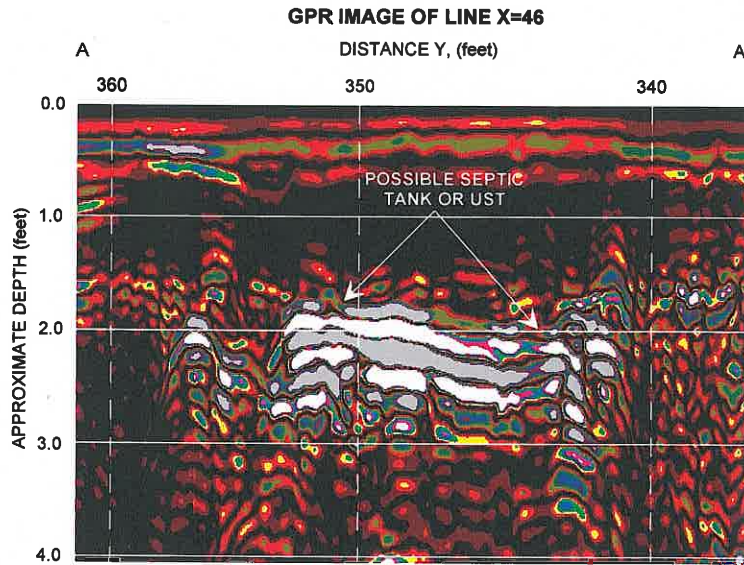
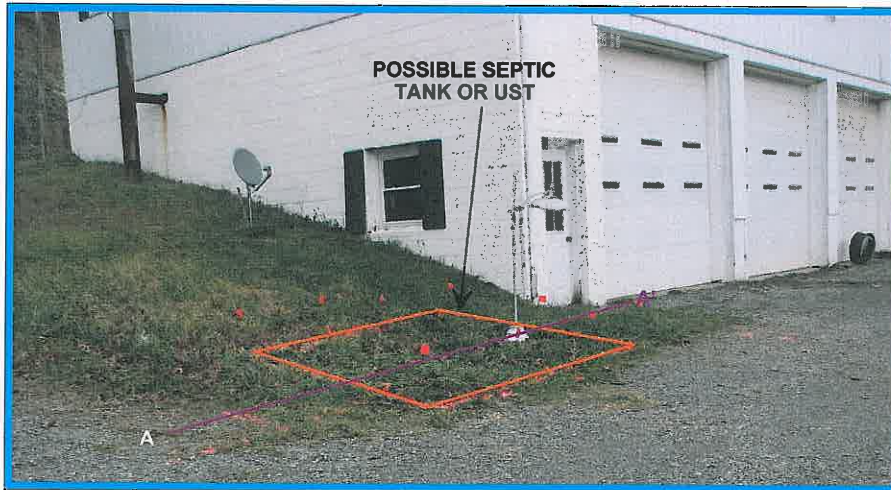
FIGURE 6

GPR data suggest the high-amplitude EM61 differential anomaly centered near grid coordinates X=36 Y=350 is in response to a possible septic tank, metallic UST or miscellaneous object that appears to have a flat top. Based on the GPR data, the possible septic tank or UST is approximately 9 feet long, 6.5 feet wide and buried 2 feet below present grade. The GPR image obtained along a portion of survey line X=46, which crosses the possible septic tank, UST or object and a photograph showing the location of the possible tank or object are presented in **Figure 6**. The foot print of the possible tank detected by the geophysical investigation was marked in the field using orange marking paint and pin flags.

- GPR data suggest the high-amplitude EM61 differential anomaly centered near grid coordinates X=36 Y=350 is in response to a possible septic tank, metallic UST or miscellaneous object that appears to have a flat top. Based on the GPR data, the possible septic tank or UST is approximately 9 feet long, 6.5 feet wide and buried 2 feet below present surface.

The GPR image obtained along a portion of survey line X=46 recorded a flat-lying, high-amplitude anomaly (GPR reflections shaded in white) that are possibly in response to a septic tank, UST or miscellaneous object buried approx. 2. feet below present grade. The solid purple line labeled AA' and the orange rectangle in the photograph below represent the location of the GPR image and the foot print of the possible septic tank or UST, respectively.

The orange rectangle in the photograph represents the approximate perimeter of a possible septic tank or UST or other miscellaneous object, as suggested by the GPR data. Centered near grid coordinates X=46 Y=350, the tank or object is approximately 9 feet long, 6.5 feet wide and buried 2 feet below present grade. The solid purple line in the photograph represents the approximate location of the GPR image shown above. The photograph is viewed in a southeasterly direction.
