PRELIMINARY SITE ASSESSMENT

**GLADE VALLEY – US HIGHWAY 21 SOUTH FROM ROARING GAP TO SPARTA
PARCEL #182, CLINT F. BEDSAUL AND LINDA T. BEDSAUL PROPERTY
3166 US HIGHWAY 21 SOUTH
GLADE VALLEY, ALLEGHANY COUNTY, NORTH CAROLINA**

**NCDOT WBS ELEMENT 37044.1.1
STATE PROJECT R-3101**

January 13, 2012

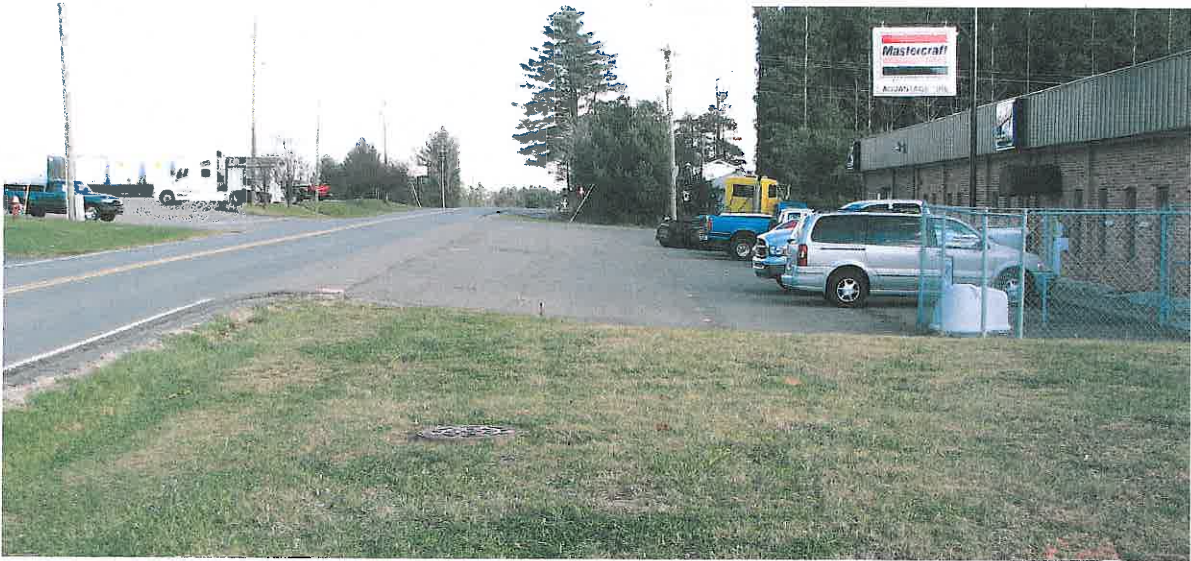
Photograph 1 View of the Clint F. Bedsaul and Linda T. Bedsaul property looking east. Highway 21 is to the left and the office building/repair shop is to the right in the photograph.

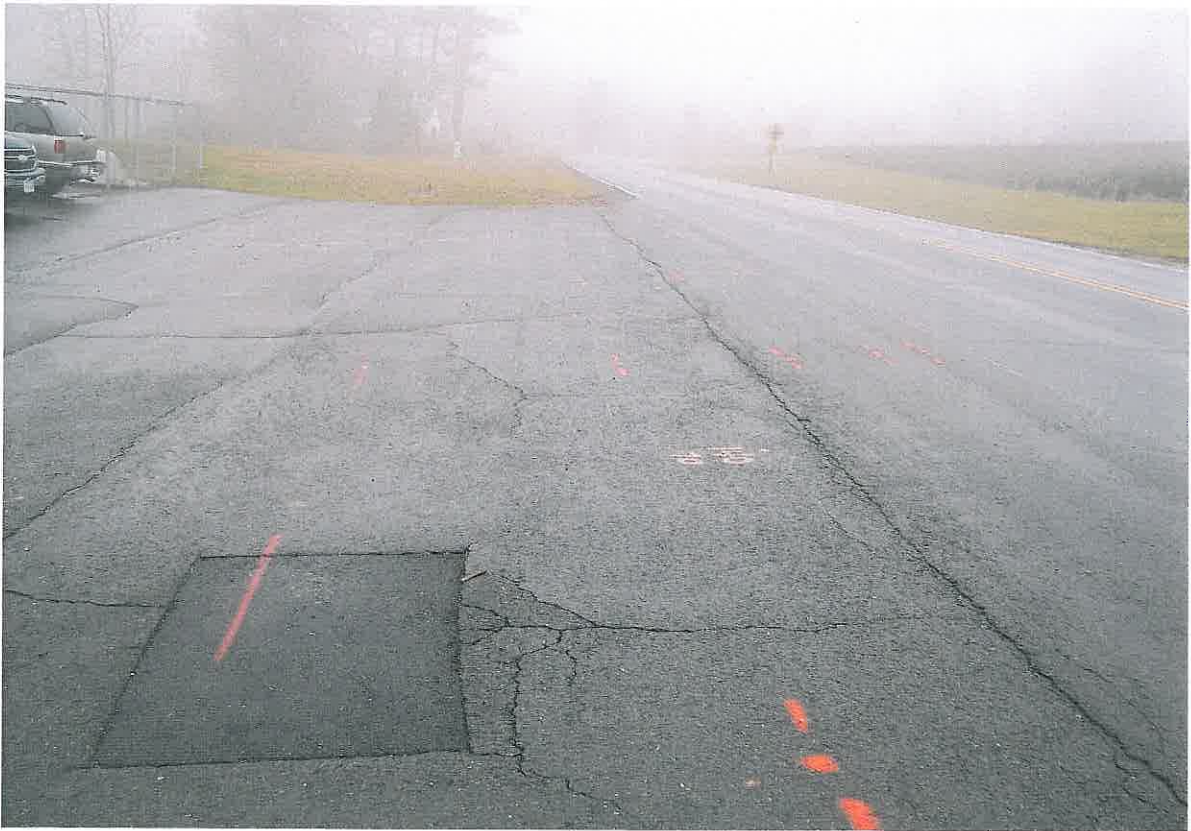
Photograph 2 View of the asphalt drive / parking area within the proposed right-of-way. The photograph is facing west.

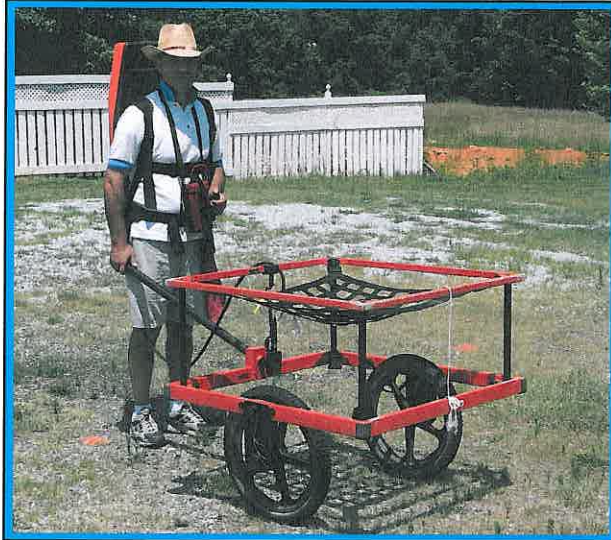
The photograph shows the Geonics EM61 metal detector that was used to conduct the metal detection survey across the proposed Right-of-Way area at Parcel 182 on November 10, 2011. Due to an absence of unexplained EM61 differential anomalies, ground penetrating radar scans were not performed at this site.

The geophysical investigation consisted of electromagnetic (EM) induction-metal detection surveys. The EM survey was performed on November 10, 2011 using a Geonics EM61-MK1 metal detection instrument. According to the instrument specifications, the EM61 can detect a metal drum down to a maximum depth of approximately 8 feet. Smaller objects (1-foot or less in size) can be detected to a maximum depth of 4 to 5 feet. All of the EM61 data were digitally collected at approximately 0.8 foot intervals along northwesterly-southeasterly parallel survey lines spaced five feet apart. All of the data were downloaded to a computer and reviewed in the field and office using the Geonics DAT61W and Surfer for Windows Version 7.0 software programs.

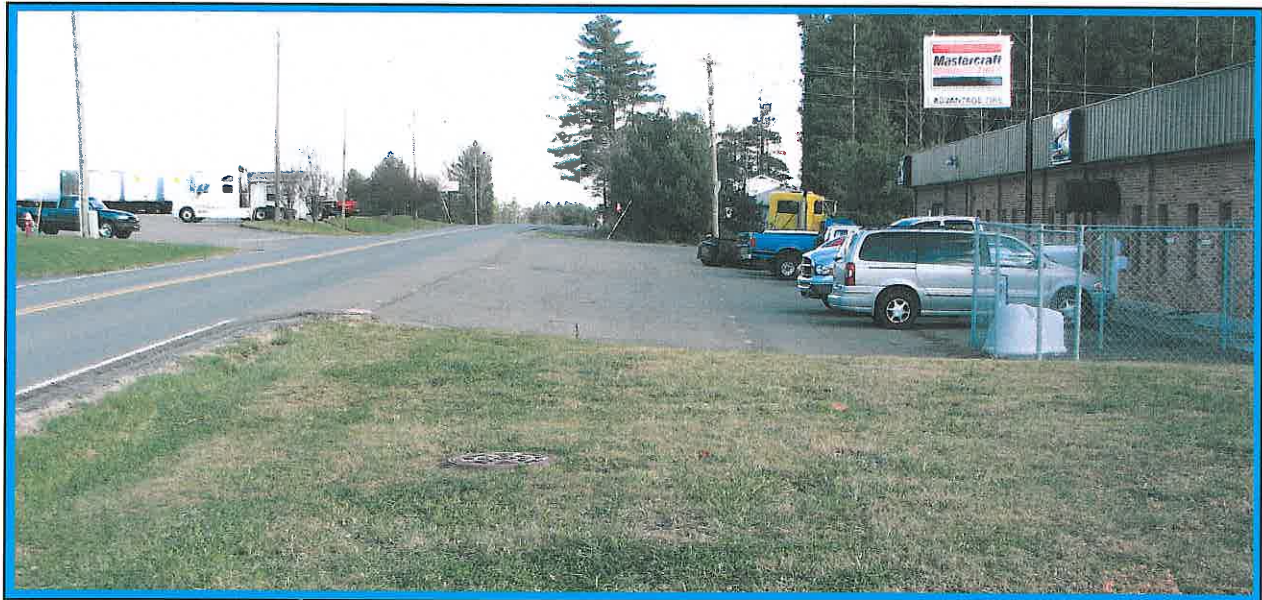
The photograph shows the front portion of the Clint and Linda Bedsaul property (Parcel 182) located at 3166 US Highway 21 South, near Glade Valley, North Carolina. The geophysical investigation was performed across the front portion of the property. The photograph is viewed in an easterly direction.
