Preliminary Site Assessment Report Northern Holdings, LLC Property

**Parcel 189
Durham
Durham County, North Carolina**

**H&H Job No. ROW-416
State Project U-0071
WBS Element #34745.1.1
August 15, 2013**

**Preliminary Site Assessment Report
Northern Holdings, LLC Property Parcel #189
Durham, Durham County, North Carolina
H&H Project ROW-416**

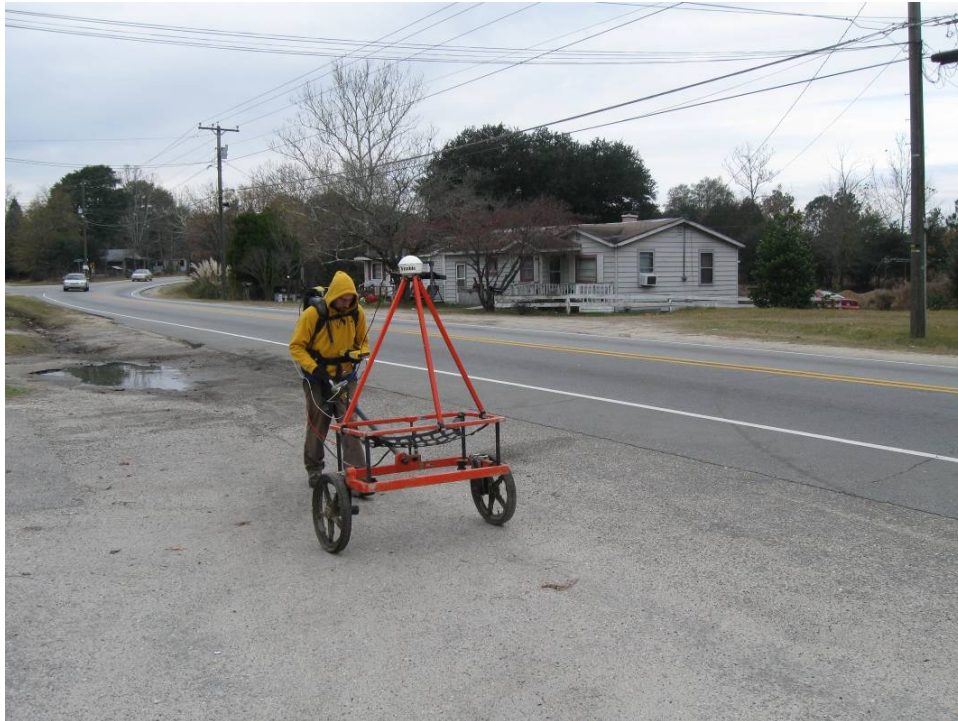
Geonics EM61-MK2 Metal Detector with Trimble DGPS Unit

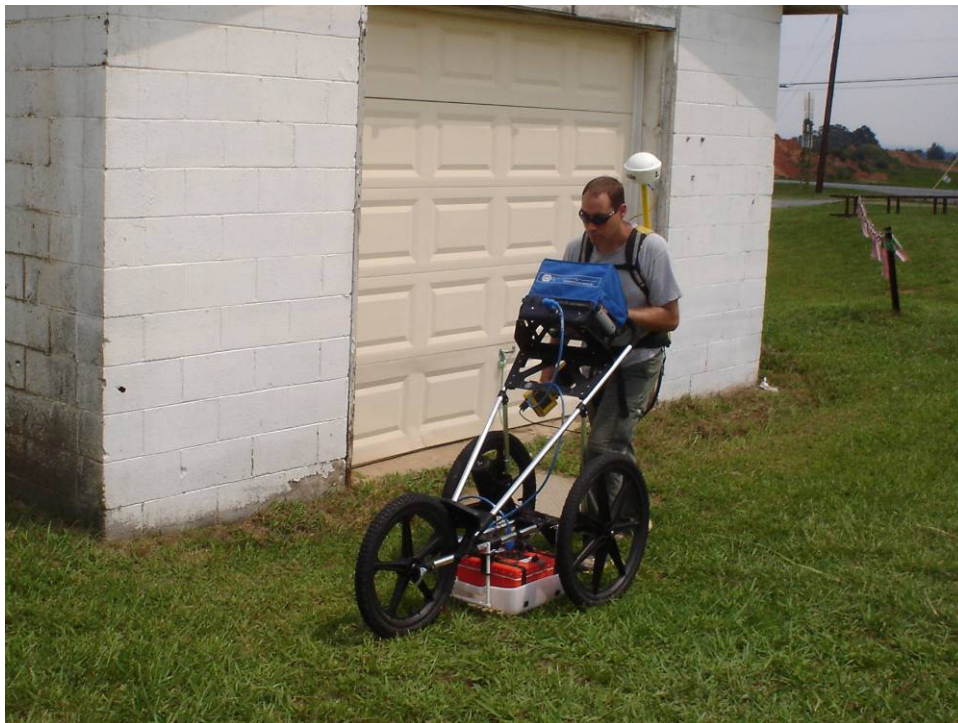
GSSI SIR-3000 Ground-Penetrating Radar with 400 MHz Antenna
