Pyramid Environmental & Engineering, P.C. Project # 2012-228
Preliminary Site Assessment (PSA) – Parcel 021

PRELIMINARY SITE ASSESSMENT
LOUISE LEE PROPERTY – PARCEL 021
HOME IMPROVEMENTS
2330 RAY ROAD
SPRING LAKE, HARNETT COUNTY, NORTH CAROLINA
STATE PROJECT: U-3465
WBS ELEMENT: 39017.1.1
OCTOBER 23, 2012

**PRELIMINARY SITE ASSESSMENT
LOUISE LEE PROPERTY – PARCEL 021
HOME IMPROVEMENTS
SPRING LAKE, HARNETT COUNTY, NORTH CAROLINA**

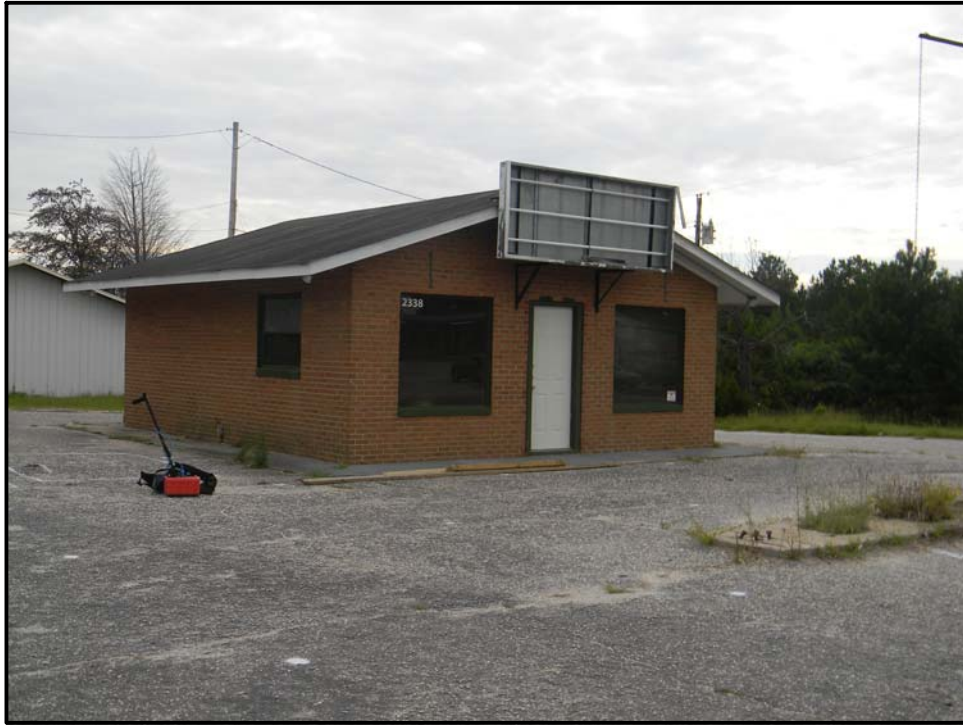
Photograph of portion of survey area, facing approximately southwest

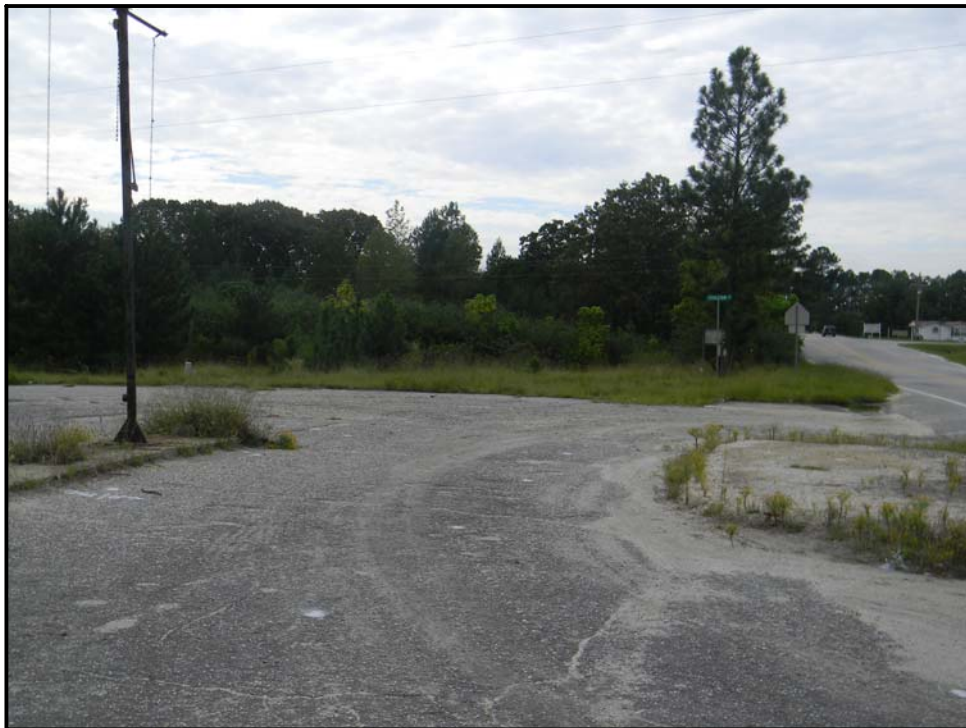
Photograph of portion of portion of survey area, facing approximately south

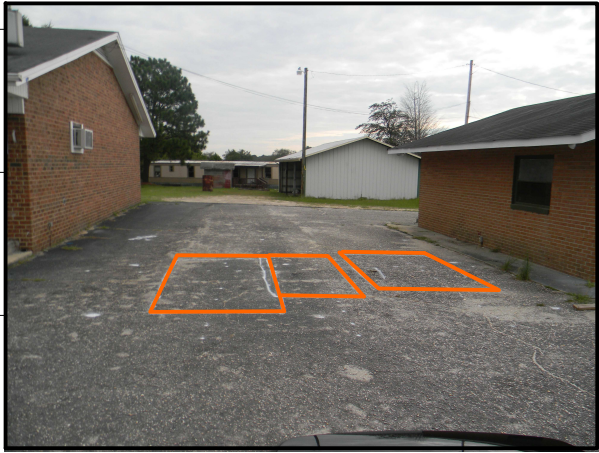
FIGURE 4

GPR TRANSECT LOCATIONS AND APPROXIMATE UST LOCATIONS

- The GPR scans confirmed the presence of three probable metallic USTs at the site. Specifically, three probable metallic USTs were mapped directly north of the building. The tanks were observed to be oriented west to east. The location of the USTs corresponded to visible caps/valves at the ground surface. The northernmost tank was approximately 7 feet wide and 11 feet long. The middle tank was approximately 4 feet wide and 8 feet long. The southernmost tank was approximately 6 feet wide and 9 feet long. The tops of the tanks were approximately 2 to 3 feet deep.

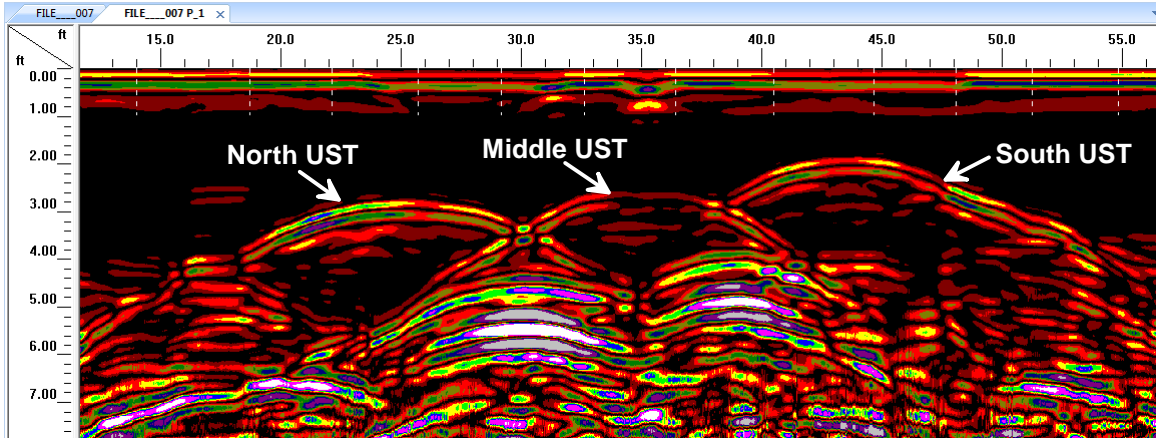
GPR Transect 1 - South to North Across the Three USTs

As stated above, GPR scans were performed and data viewed in real time across the high amplitude EM61 anomalies that could not be attributed to visible objects at the ground surface. The GPR scans confirmed the presence of three probable metallic USTs at the site. Specifically, three metallic USTs were mapped directly north of the building. The tanks were observed to be oriented west to east. The location of the USTs corresponded to visible caps/valves at the ground surface. The northernmost tank was approximately 7 feet wide and 11 feet long. The middle tank was approximately 4 feet wide and 8 feet long. The southernmost tank was approximately 6 feet wide and 9 feet long. The tops of the tanks were approximately 2 to 3 feet deep. Four specific GPR transects were performed perpendicular and parallel to the three USTs, and saved to the hard drive. Figure 4 presents the locations of these GPR transects, as well as a photograph depicting the approximate locations of the three USTs. Figure 5 presents select GPR transect images (Transects 1, 2 and 4).

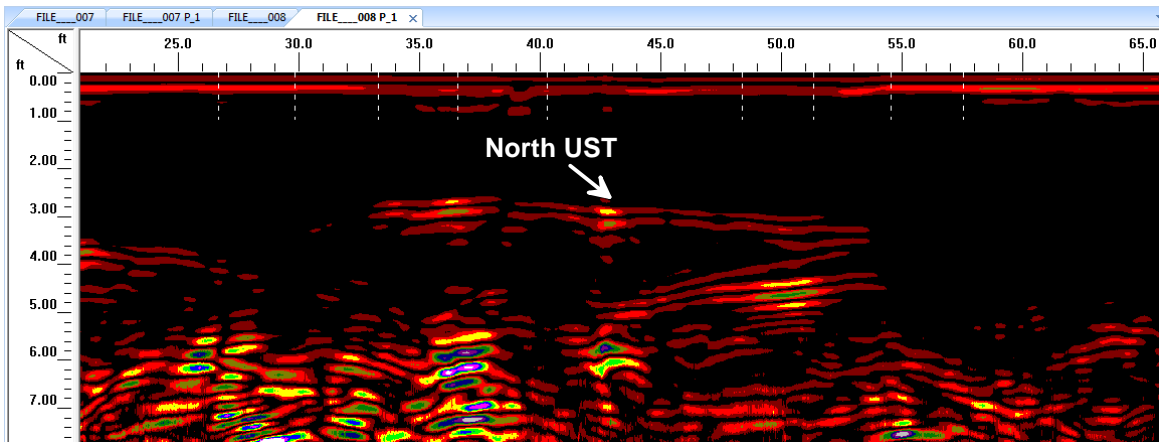
GPR Transect 2 - West to East Along Northern UST
