**PRELIMINARY SITE ASSESSMENT**  
**GORDON MASON PROPERTY – PARCEL 038**  
**STOP N' SHOP**  
**1899 RAY ROAD**  
**SPRING LAKE, HARNETT COUNTY, NORTH CAROLINA**  
**STATE PROJECT: U-3465**  
**WBS ELEMENT: 39017.1.1**  
**OCTOBER 24, 2012**

**PRELIMINARY SITE ASSESSMENT  
GORDON MASON PROPERTY – PARCEL 038  
STOP N’ SHOP  
SPRING LAKE, HARNETT COUNTY, NORTH CAROLINA**

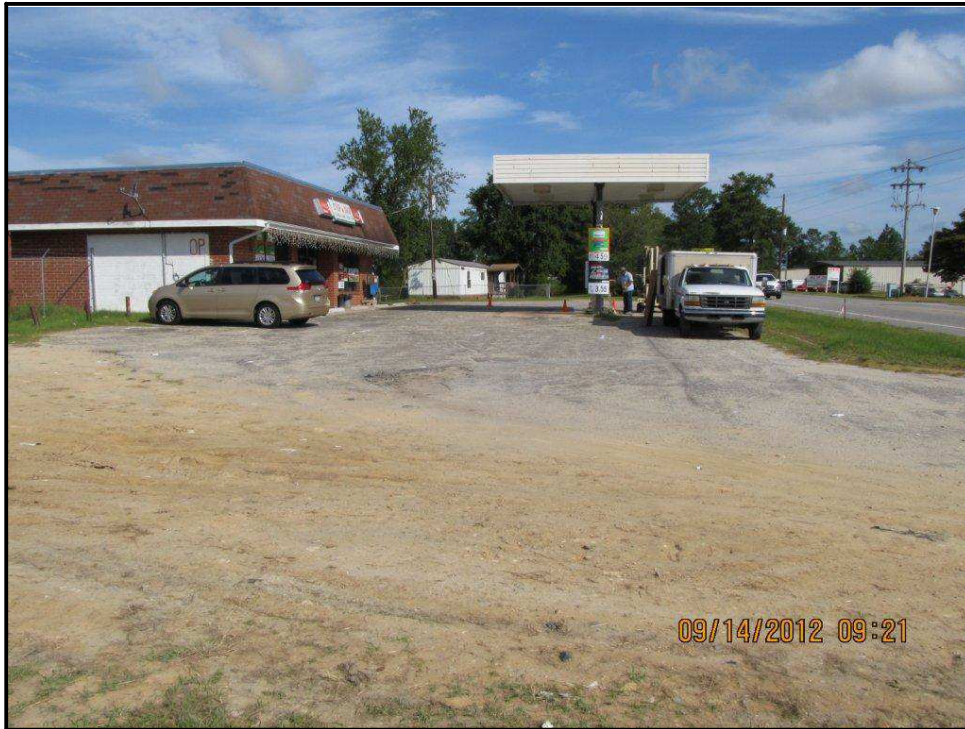
FIGURE 1

Photograph of North Survey Area, Facing Approximately North

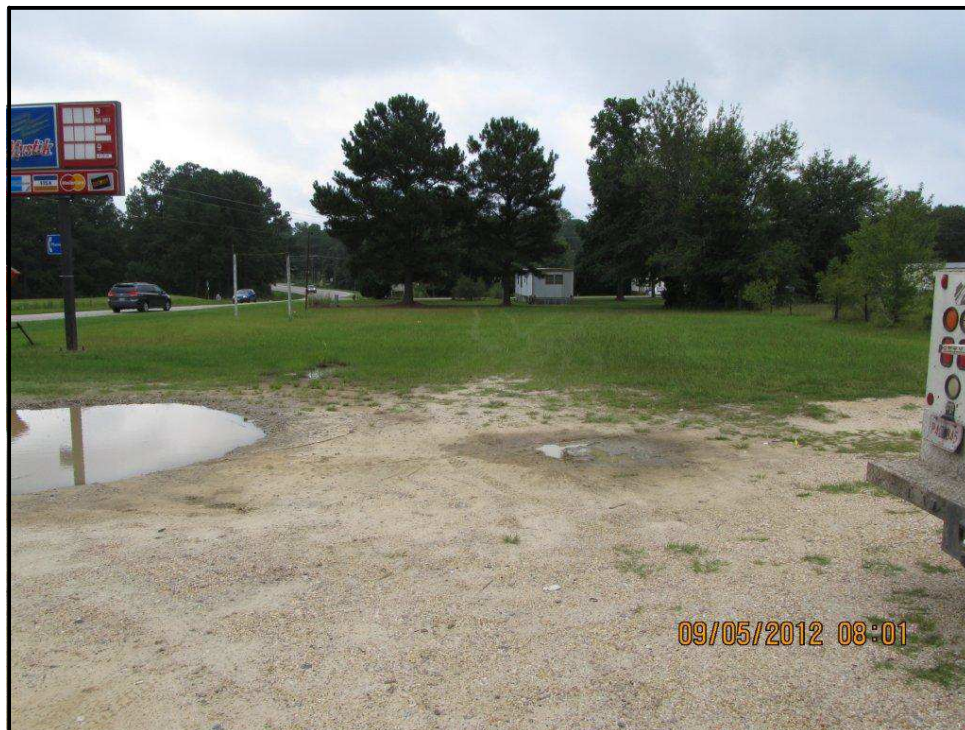
Photograph of South Survey Area, Facing Approximately South
