Reference: Preliminary Site Assessment  
Calvary Assembly of God of Spruce Pine Property  
1637 US 19E  
Spruce Pine, Mitchell County, North Carolina  
NCDOT Tip No. R-2519B  
WBS Element 35609.1.1  
AECOM Project No. 60241470

SOIL FIELD SCREENING AND ANALYTICAL RESULTS  
 CALVARY ASSEMBLY OF GOD OF SPRUCE PINE PROPERTY  
 SPRUCE PINE, MITCHELL COUNTY, NORTH CAROLINA  
 NCDOT PROJECT NO. R-2519B  
 WBS ELEMENT 35609.1.1  
 AECOM PROJECT NO. 60241470

## **GEOPHYSICAL INVESTIGATION REPORT**

#### **CALVARY ASSEMBLY OF GOD OF SPRUCE PINE PROPERTY**

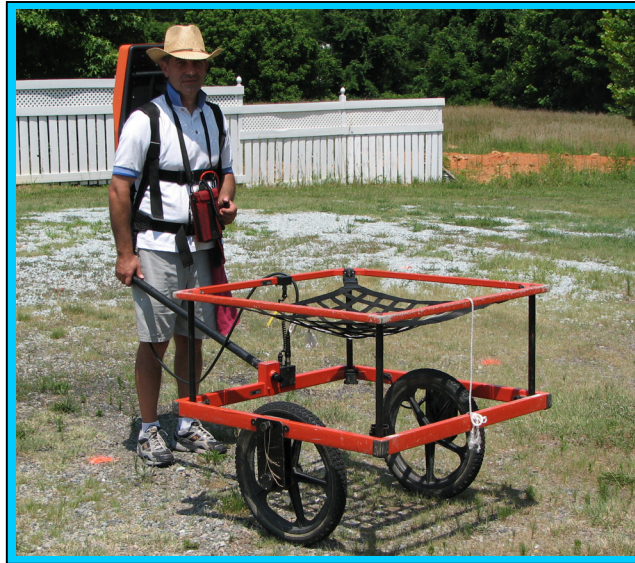
The photograph shows the Geonics EM61 metal detector that was used to conduct the metal detection survey across the southern portion of the Calvary Assembly of God of Spruce Pine property on February 7, 2012. Due to an absence of unexplained EM61 differential anomalies, ground penetrating radar scans were not performed at this site.

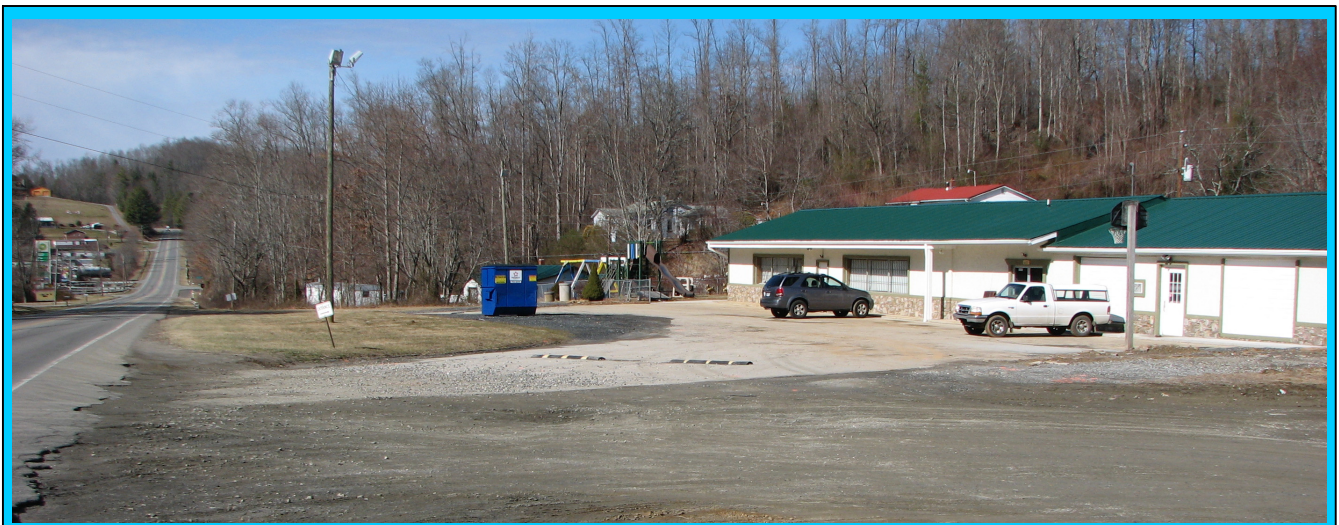
The photograph shows the southern portion (geophysical survey area) of the Calvary Assembly of God of Spruce Pine property (Parcel 27) located at 1637 US 19E in Mitchell County, North Carolina. The photograph is viewed in a westerly direction.

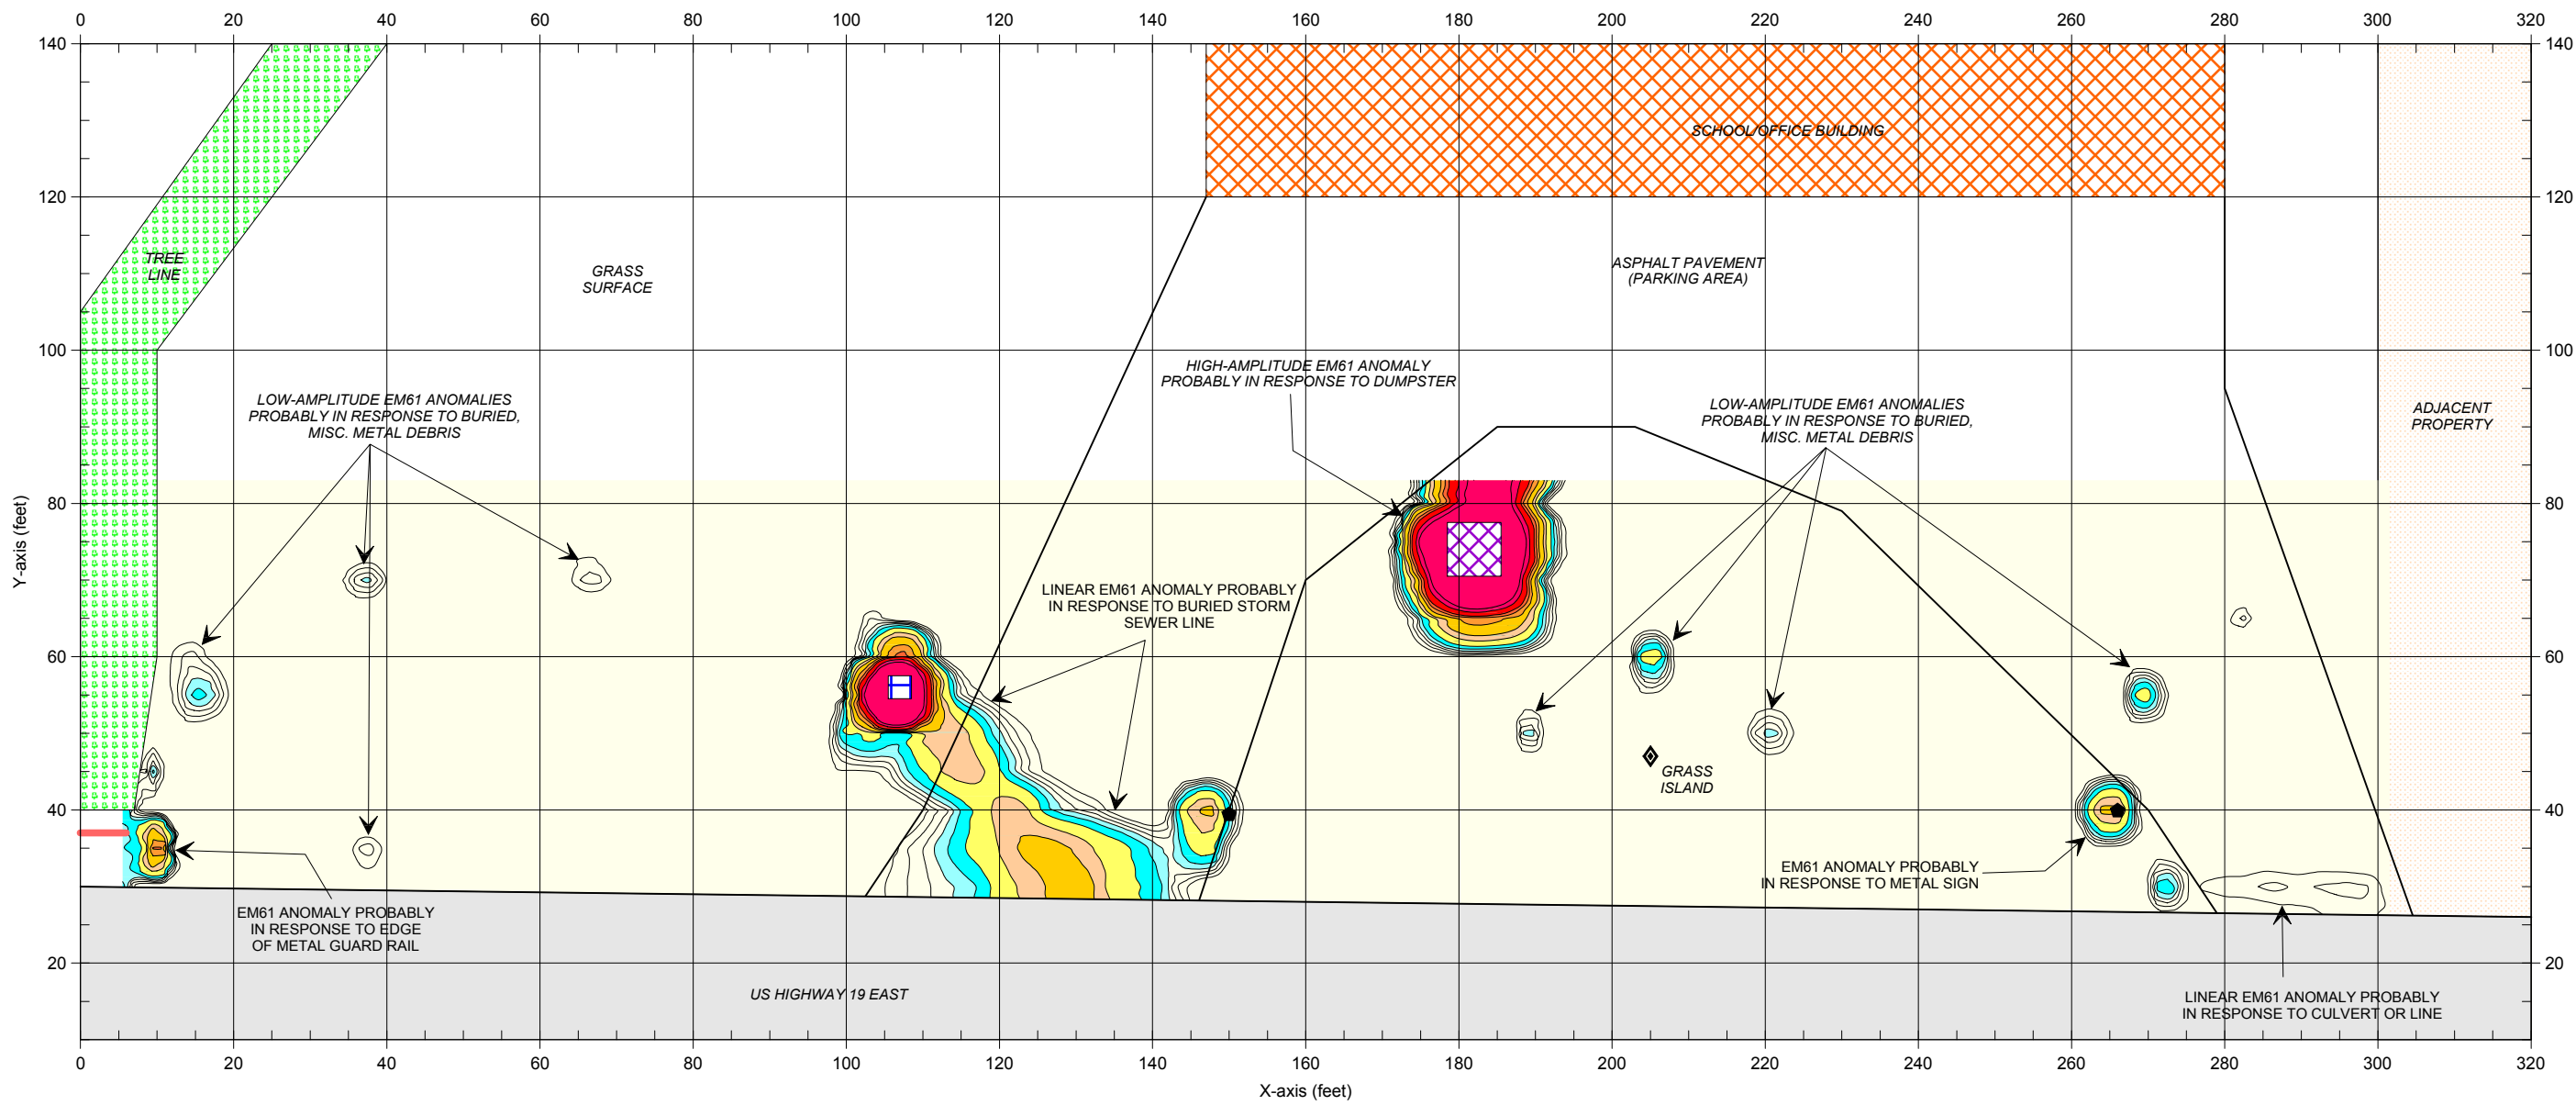
FIGURE 2

The contour plot shows the bottom coil (most sensitive) response of the EM61 instrument in millivolts (mV). The bottom coil response shows buried metallic objects regardless of size. The EM61 survey was conducted on February 7, 2012 using a Geonics EM61 instrument. Due to an absence of unexplained EM61 differential anomalies, ground penetrating radar (GPR) scans were not performed at this site.

The EM61 metal detection survey did not detect possible metallic USTs within the surveyed portions of the site.

**EM61 METAL DETECTION (BOTTOM COIL RESULTS)**

Contour plots of the EM61 bottom coil and differential results are presented in **Figures 2 and 3**, respectively. The bottom coil results represent the most sensitive component of the EM61 instrument and detect metal objects regardless of size. The bottom coil response can be used to delineate metal conduits or utility lines, small, isolated metal objects, and areas containing insignificant metal debris. The differential results are obtained from the difference between the top and bottom coils of the EM61 instrument. The differential results focus on the larger metal objects such as drum and UST-size objects and ignore the smaller insignificant metal objects.

The linear, EM61 anomaly intersecting grid coordinates X=120 Y=40 is probably in response to a storm sewer line. The high amplitude EM61 anomaly centered near grid coordinates X=182 Y=75 is probably in response to the metal dumpster. The small, randomly scattered, EM61 bottom coil anomalies centered near grid coordinates X=205 Y=50 and X=268 Y=40 are probably in response to buried, miscellaneous, metallic debris or known surface objects. The EM61 anomaly centered near grid coordinates X=10 Y=35 is probably in response to the end of the metal guard rail that runs along the north side of US Highway 19 East.
