Reference: Preliminary Site Assessment
Roger and Sheila Byrd Property (Parcel #82)
6971 US 19E
Burnsville, Yancey County, North Carolina
NCDOT Tip No. R-2519B
WBS Element 35609.1.1
AECOM Project No. 60241470

GEOPHYSICAL INVESTIGATION REPORT

ROGER & SHEILA BYRD PROPERTY - PARCEL 82

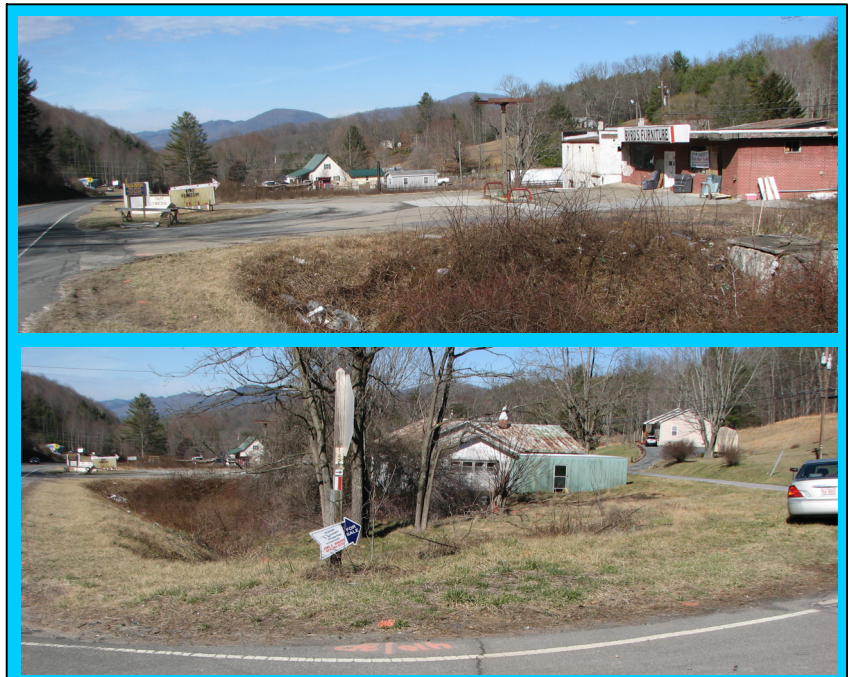
GEOPHYSICAL EQUIPMENT & SITE PHOTOGRAPHS

The photographs show the western portion (top) of the geophysical survey area and the eastern portion (bottom) of the geophysical survey area at the Byrd property located at 6971 US 19E in Yancey County, North Carolina. The photographs are viewed in a westerly direction.

AECOM Environment representative Mr. Michael Branson, PG identified the geophysical survey area to Pyramid Environmental personnel and provided site maps showing the boundaries of the proposed survey area prior to conducting the investigation. Photographs of the geophysical equipment used in this investigation and the eastern and western portions of the property are shown in **Figure 1**.
