Reference: Preliminary Site Assessment  
DEW Construction Co. Property (Parcel #150)  
1305 US 19E  
Spruce Pine, Mitchell County, North Carolina  
NCDOT Tip No. R-2519B  
WBS Element 35609.1.1  
AECOM Project No. 60241470

**GEOPHYSICAL INVESTIGATION REPORT**

**DEW CONSTRUCTION PROPERTY - PARCEL 150**

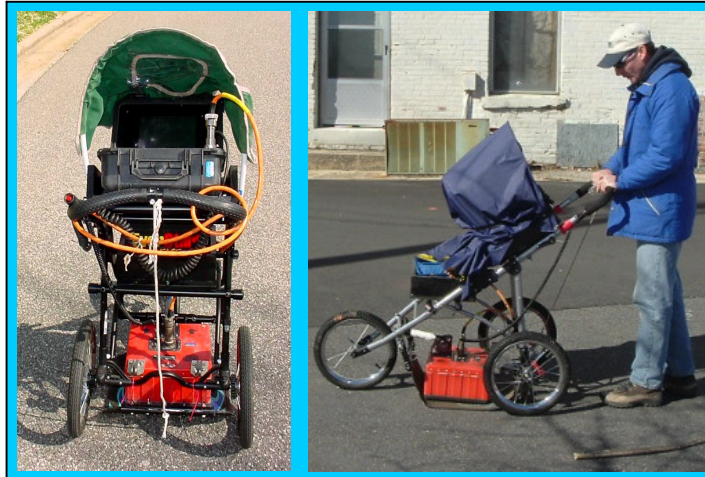
The photographs show the SIR-2000 GPR system equipped with a 400 MHz antenna that were used to conduct the ground penetrating radar investigation at the Dew property on February 15, 2012.

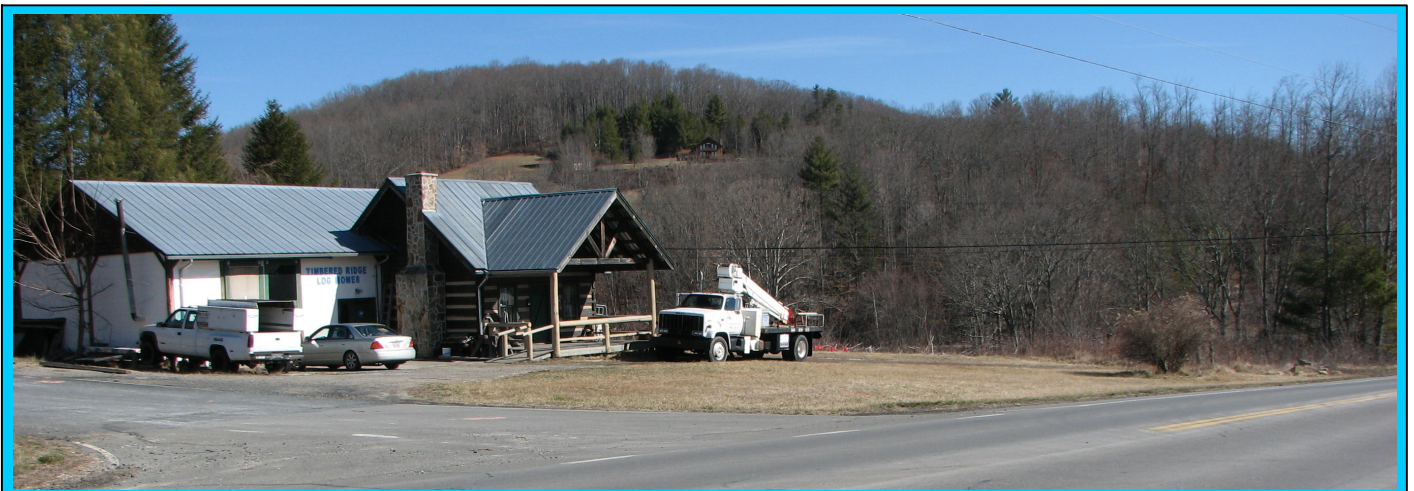
The photograph shows the southern portion (geophysical survey area) of the Dew Construction property (Parcel 150) located at 1305 US 19E in Mitchell County, North Carolina. The photograph is viewed in an easterly direction.
