Reference: Preliminary Site Assessment  
Brenda McNeil Property (Parcel #119)  
Windy Cove Lane  
Spruce Pine, Mitchell County, North Carolina  
NCDOT Tip No. R-2519B  
WBS Element 35609.1.1  
AECOM Project No. 60241470

**GEOPHYSICAL INVESTIGATION REPORT**

**BRENDA COX MCNEIL PROPERTY - PARCEL 119**

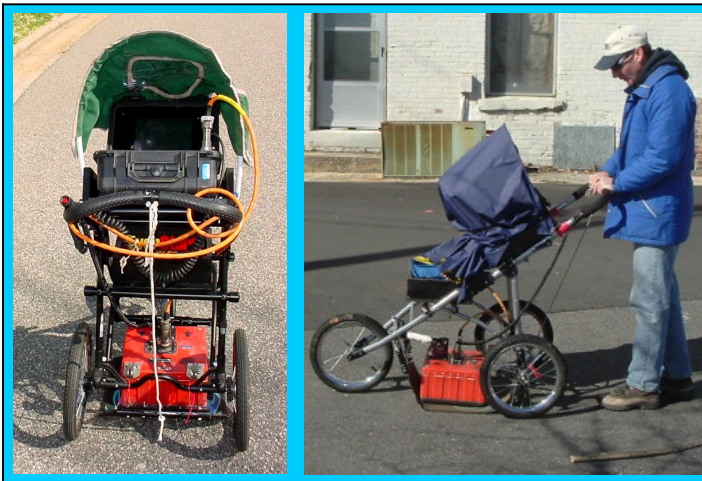
The photographs show the SIR-2000 GPR system equipped with a 400 MHz antenna that were used to conduct the ground penetrating radar investigation at the McNeil property on February 15, 2012.

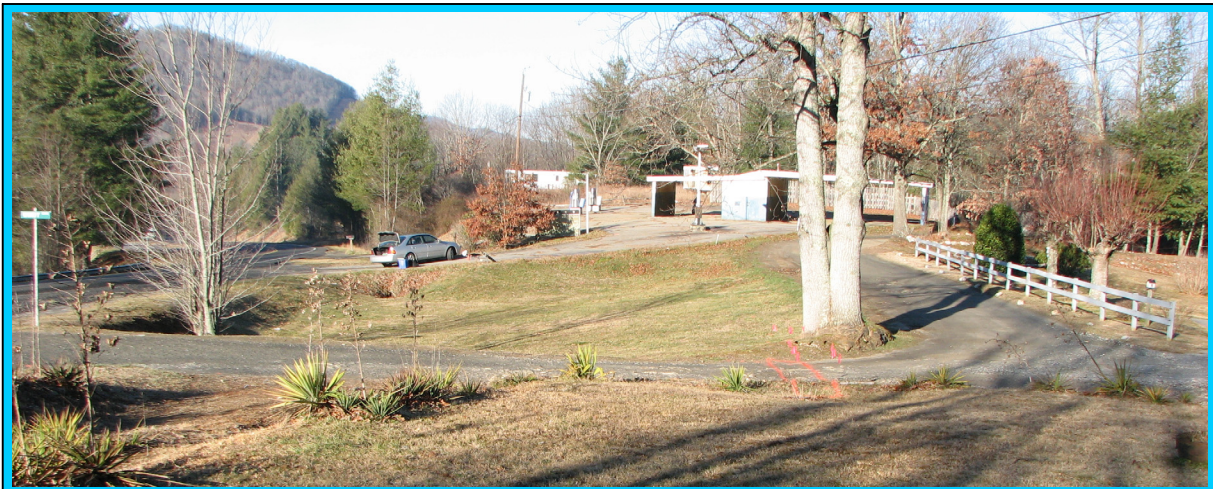
The photograph shows the Brenda Cox McNeil property (Parcel 119) located near the intersection of US Highway 19 East and Windy Cove Drive in Mitchell County, North Carolina. The photograph is viewed in a westerly direction.

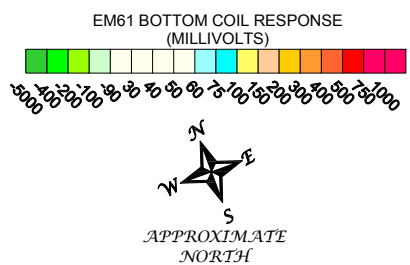
**EM61 METAL DETECTION (BOTTOM COIL RESULTS)**  
FIGURE 2

Contour plots of the EM61 bottom coil and differential results are presented in **Figures 2 and 3**, respectively. The bottom coil results represent the most sensitive component of the EM61 instrument and detect metal objects regardless of size. The bottom coil response can be used to delineate metal conduits or utility lines, small, isolated metal objects, and areas containing insignificant metal debris. The differential results are obtained from the difference between the top and bottom coils of the EM61 instrument. The differential results focus on the larger metal objects such as drum and UST-size objects and ignore the smaller insignificant metal objects.

The linear EM61 bottom coil anomalies intersecting grid coordinates X=180 Y=95 and X=310 Y=60 are probably in response to buried metallic lines or conduits. The probable line or conduit at X=180 Y=95 extends westward to the former pump island on the Barbara Huskins property and continues to the car wash building. The EM61 bottom coil anomalies centered near grid coordinates X=143 Y=127, X=155 Y=115, X=186 Y=82 are probably in response to the cable fence line or metal fence posts.

The contour plot shows the bottom coil (most sensitive) response of the EM61 instrument in millivolts (mV). The bottom coil response shows buried metallic objects regardless of size. The EM61 survey was conducted on February 8, 2012 using a Geonics EM61 instrument. Ground penetrating radar (GPR) data were acquired across selected EM61 anomalies on February 15, 2012 using a Geophysical Survey Systems SIR 2000 instrument with a 400 MHz antenna.

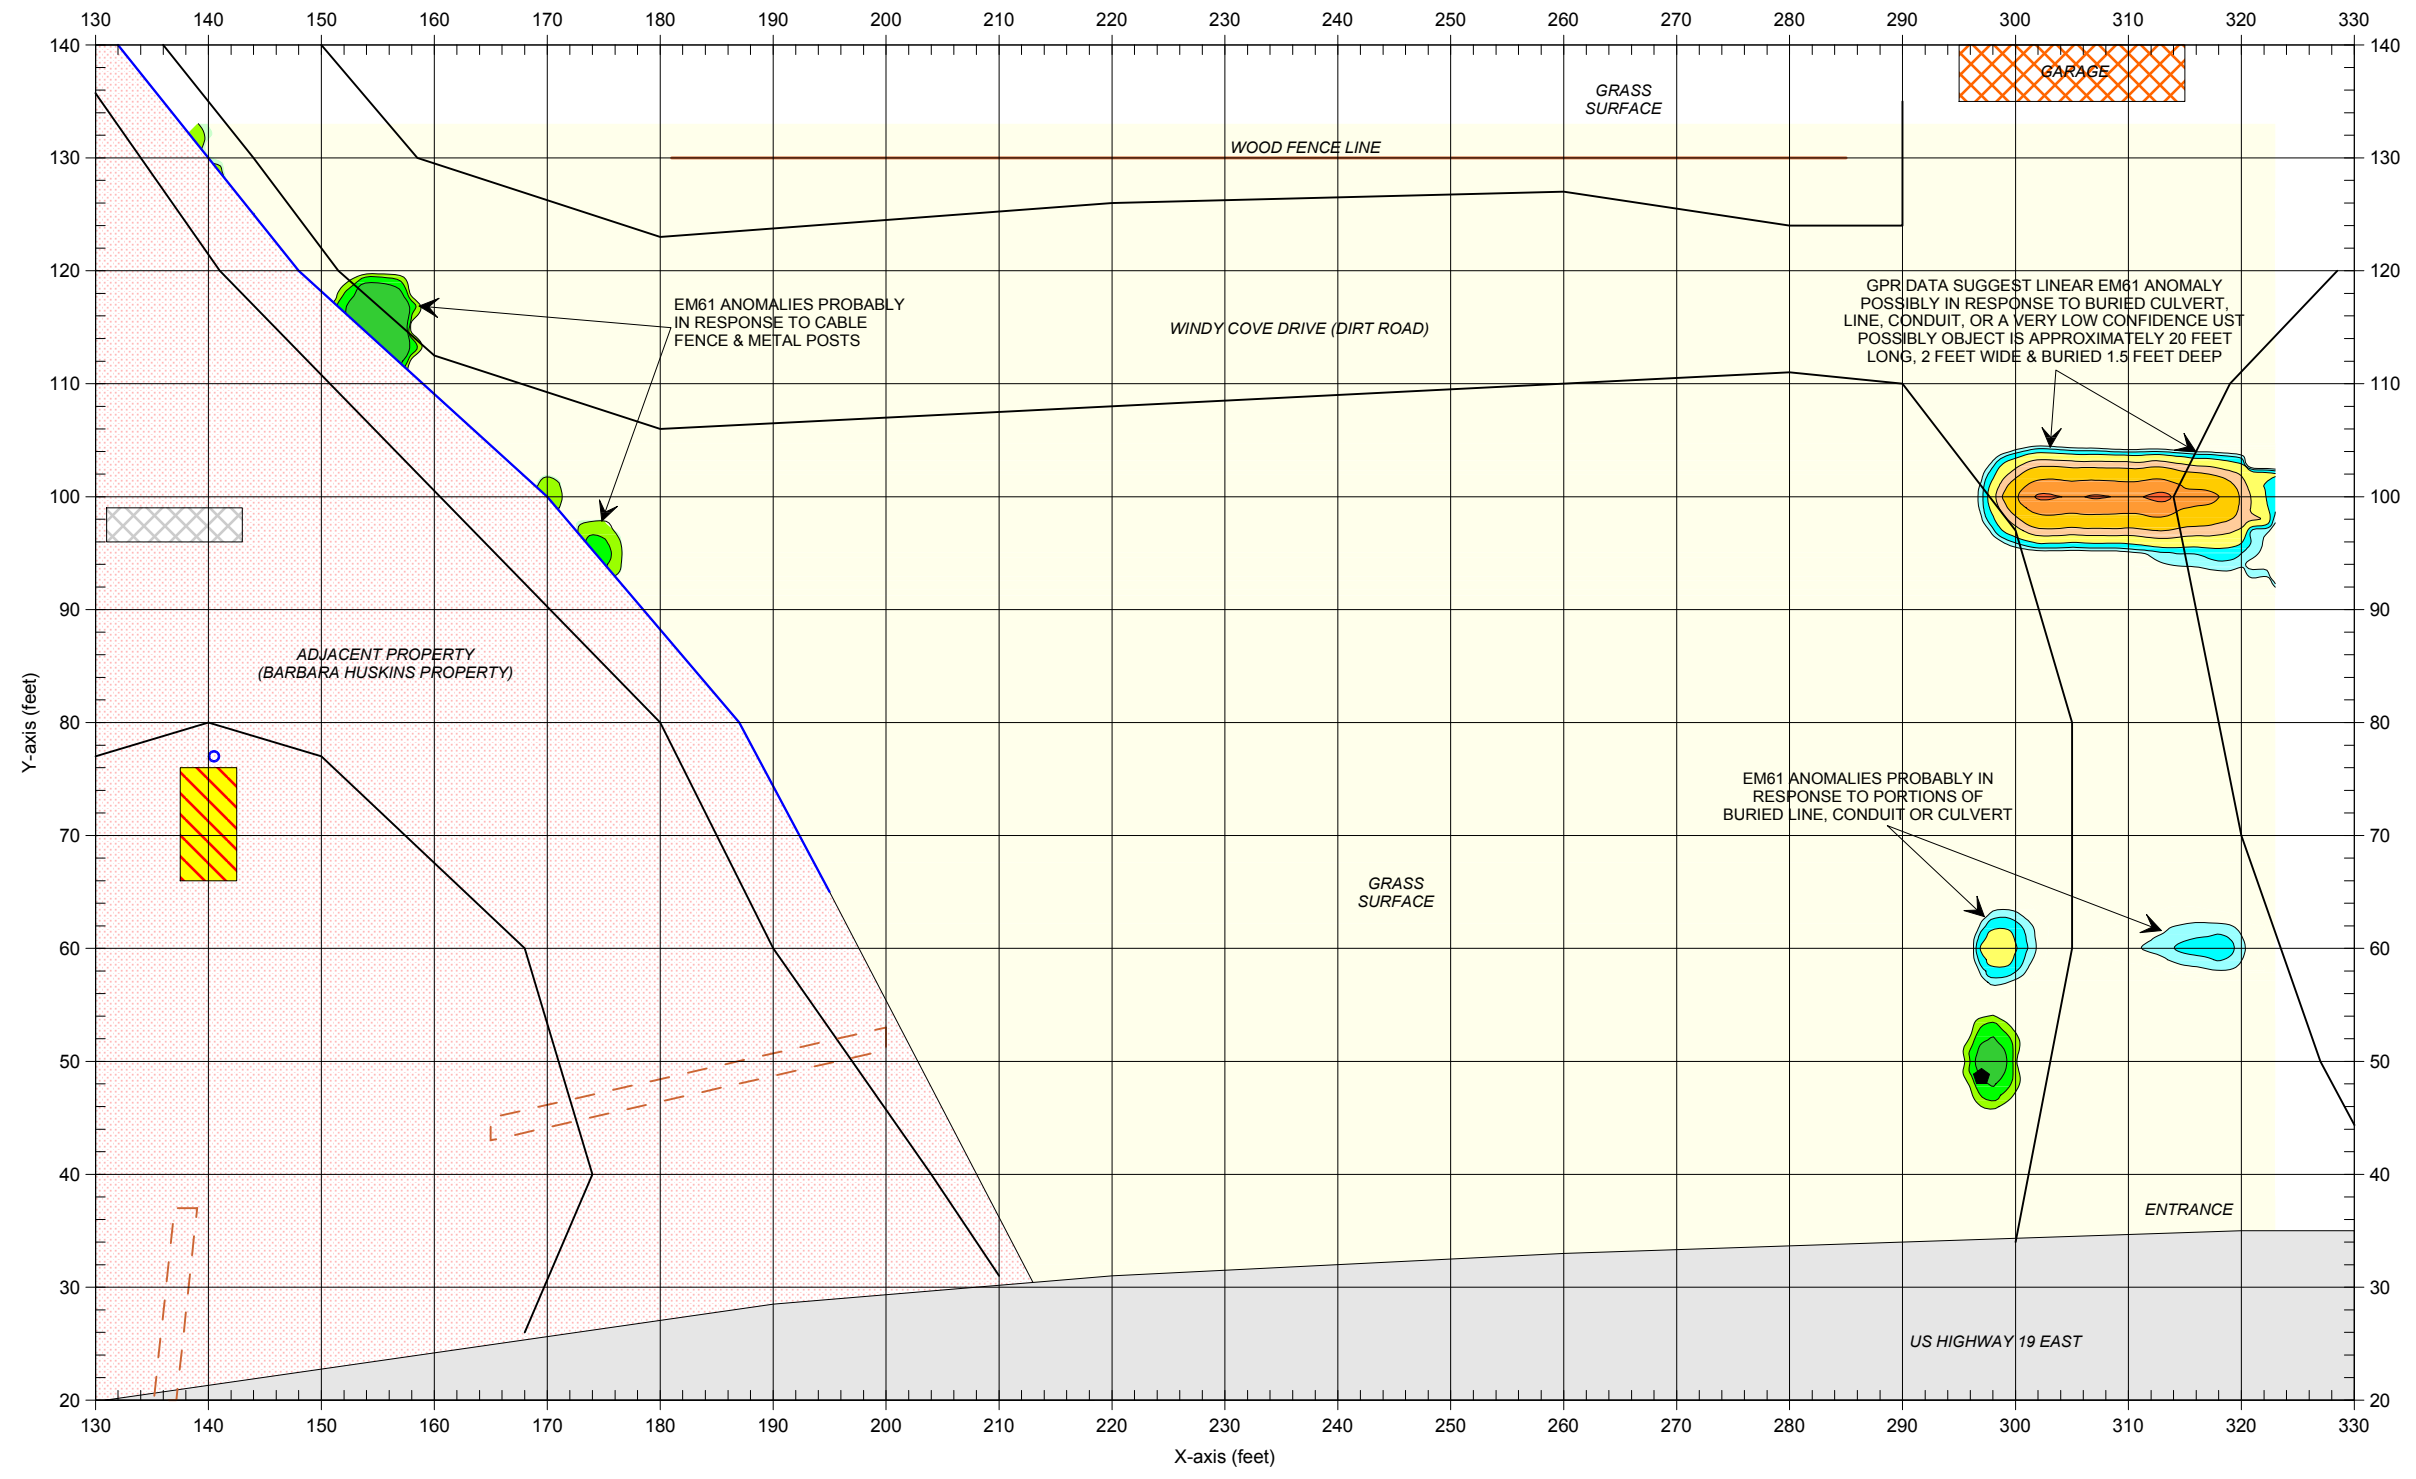
FIGURE 3

GPR scans performed across the EM61 differential anomaly centered near grid coordinates X=310 Y=100 detected a possible metallic culvert, line, conduit or a “very low confidence” UST buried approximately 1.5 feet below the grass surface. Based on the GPR data, the possible buried culvert, line or object is approximately 21 feet long and 2.0 feet wide. The GPR image obtained along a portion of survey line X=310, which crosses the possible line, object or UST and a photograph showing the location of the possible buried object are presented in **Figure 4**. The foot print of the possible buried line, object or UST was marked in the field using orange spray paint and pin flags.

Excluding the possible buried object or “very low confidence” UST located at grid coordinates X=310 Y=100, the geophysical investigation suggests that the remaining portion of the proposed ROW area does not contain metallic USTs.

The contour plot shows the bottom coil (most sensitive) response of the EM61 instrument in millivolts (mV). The bottom coil response shows buried metallic objects regardless of size. The EM61 survey was conducted on February 8, 2012 using a Geonics EM61 instrument. Ground penetrating radar (GPR) data were acquired across selected EM61 anomalies on February 15, 2012 using a Geophysical Survey Systems SIR 2000 instrument with a 400 MHz antenna.

The geophysical investigation suggests the surveyed portion of the site does not contain metallic USTs.

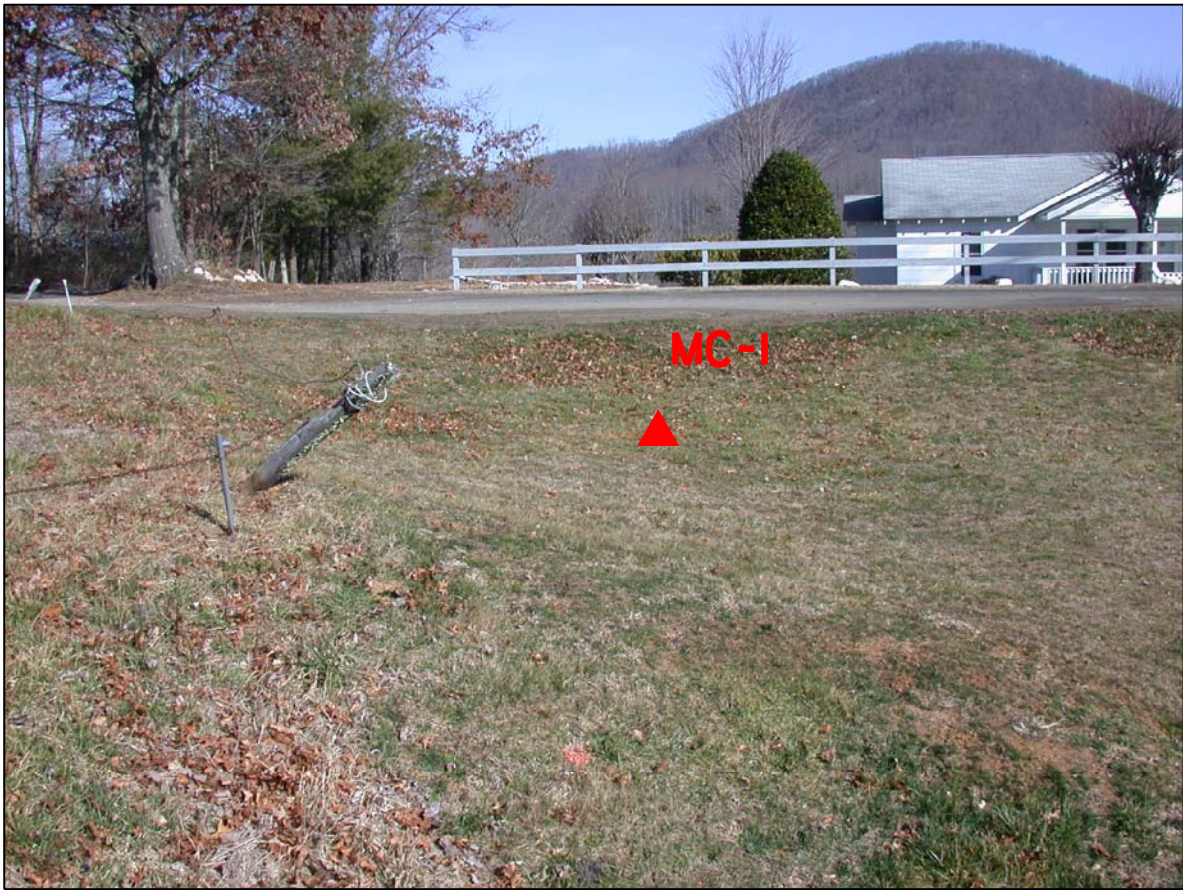
PHOTO 1 - BORING IN RIGHT-OF-WAY LOOKING NORTH

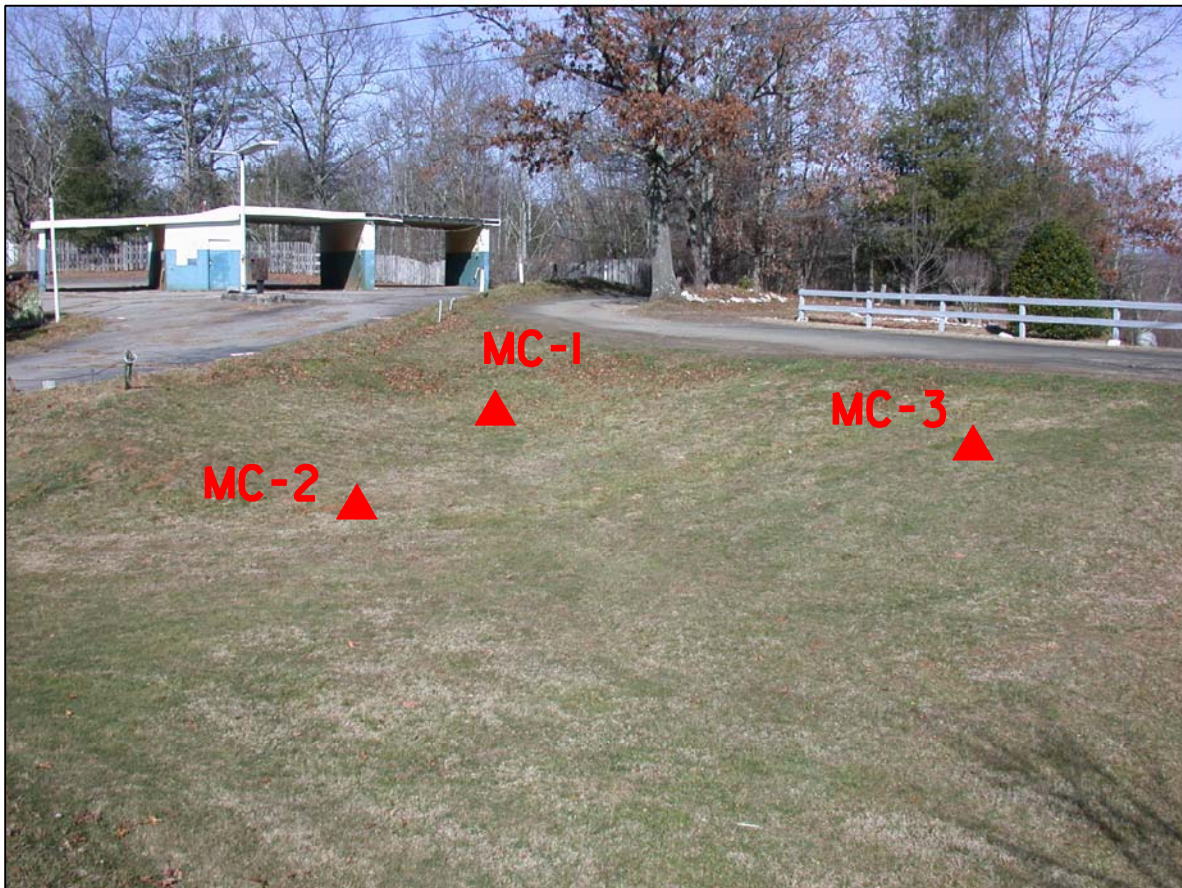
PHOTO 2 - BORINGS IN RIGHT-OF-WAY LOOKING WEST

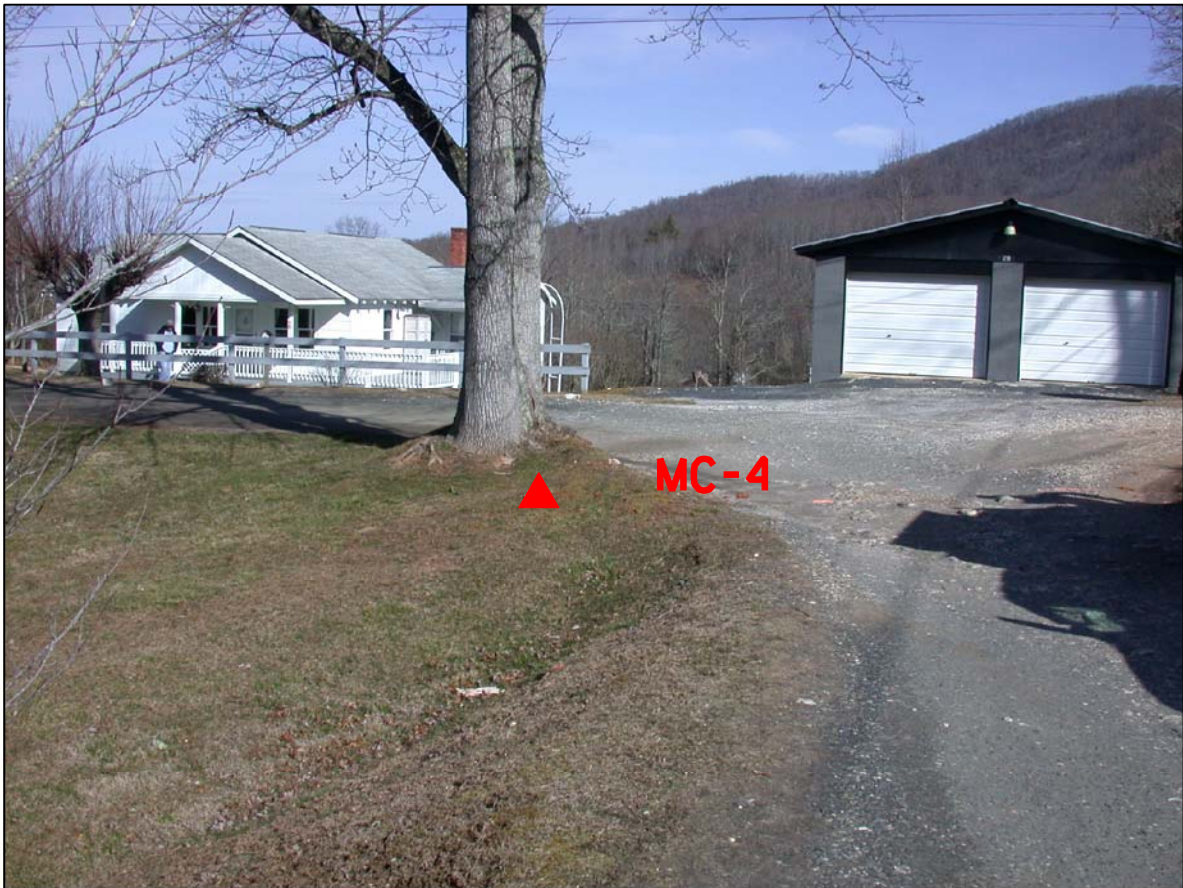
PHOTO 3 - BORING IN RIGHT-OF-WAY AT ANOMALY LOOKING NORTH
