Reference: Preliminary Site Assessment
Bill and Bobby Young Property (Parcel #112)
26 Mountain Music Drive
Spruce Pine, Mitchell County, North Carolina
NCDOT Tip No. R-2519B
WBS Element 35609.1.1
AECOM Project No. 60241470

TABLE 1
SOIL FIELD SCREENING AND ANALYTICAL RESULTS
BILL AND BOBBY YOUNG PROPERTY (PARCEL #112)
SPRUCE PINE, MITCHELL COUNTY, NORTH CAROLINA
NCDOT PROJECT NO. R-2519B
WBS ELEMENT 35609.1.1
AECOM PROJECT NO. 60241470

GEOPHYSICAL INVESTIGATION REPORT

BILL & BOBBY YOUNG PROPERTY - PARCEL 112

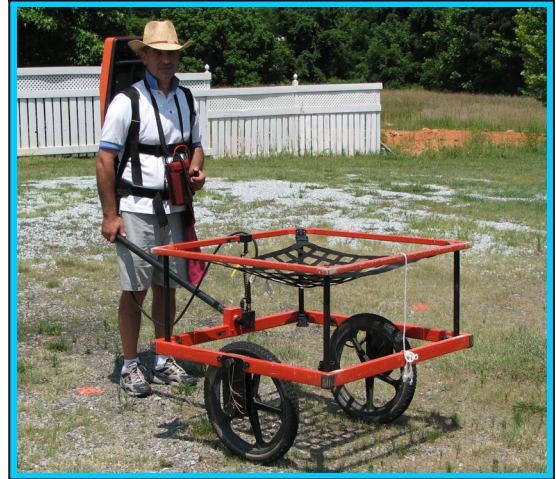
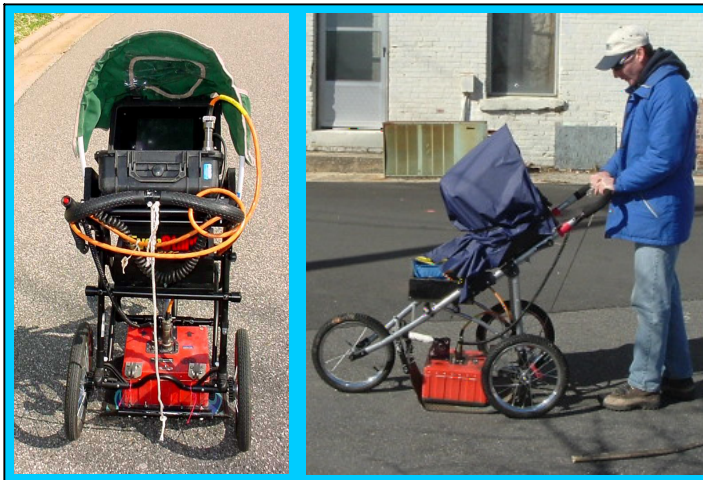
The photographs show the SIR-2000 GPR system equipped with a 400 MHz antenna that were used to conduct the ground penetrating radar investigation at the Young property on February 14, 2012.

GPR data were acquired on February 14, 2012 across selected EM61 differential anomalies using a GSSI SIR-2000 unit equipped with a 400 MHz antenna. GPR data were viewed in real time using a vertical scan of 512 samples, at a rate of 48 scans per second. A 70 MHz high pass filter and an 800 MHz low pass filter were used during data acquisition with the 400 MHz antenna. GPR data were viewed down to a maximum depth of approximately 5 feet, based on an estimated two-way travel time of 8 nanoseconds per foot.

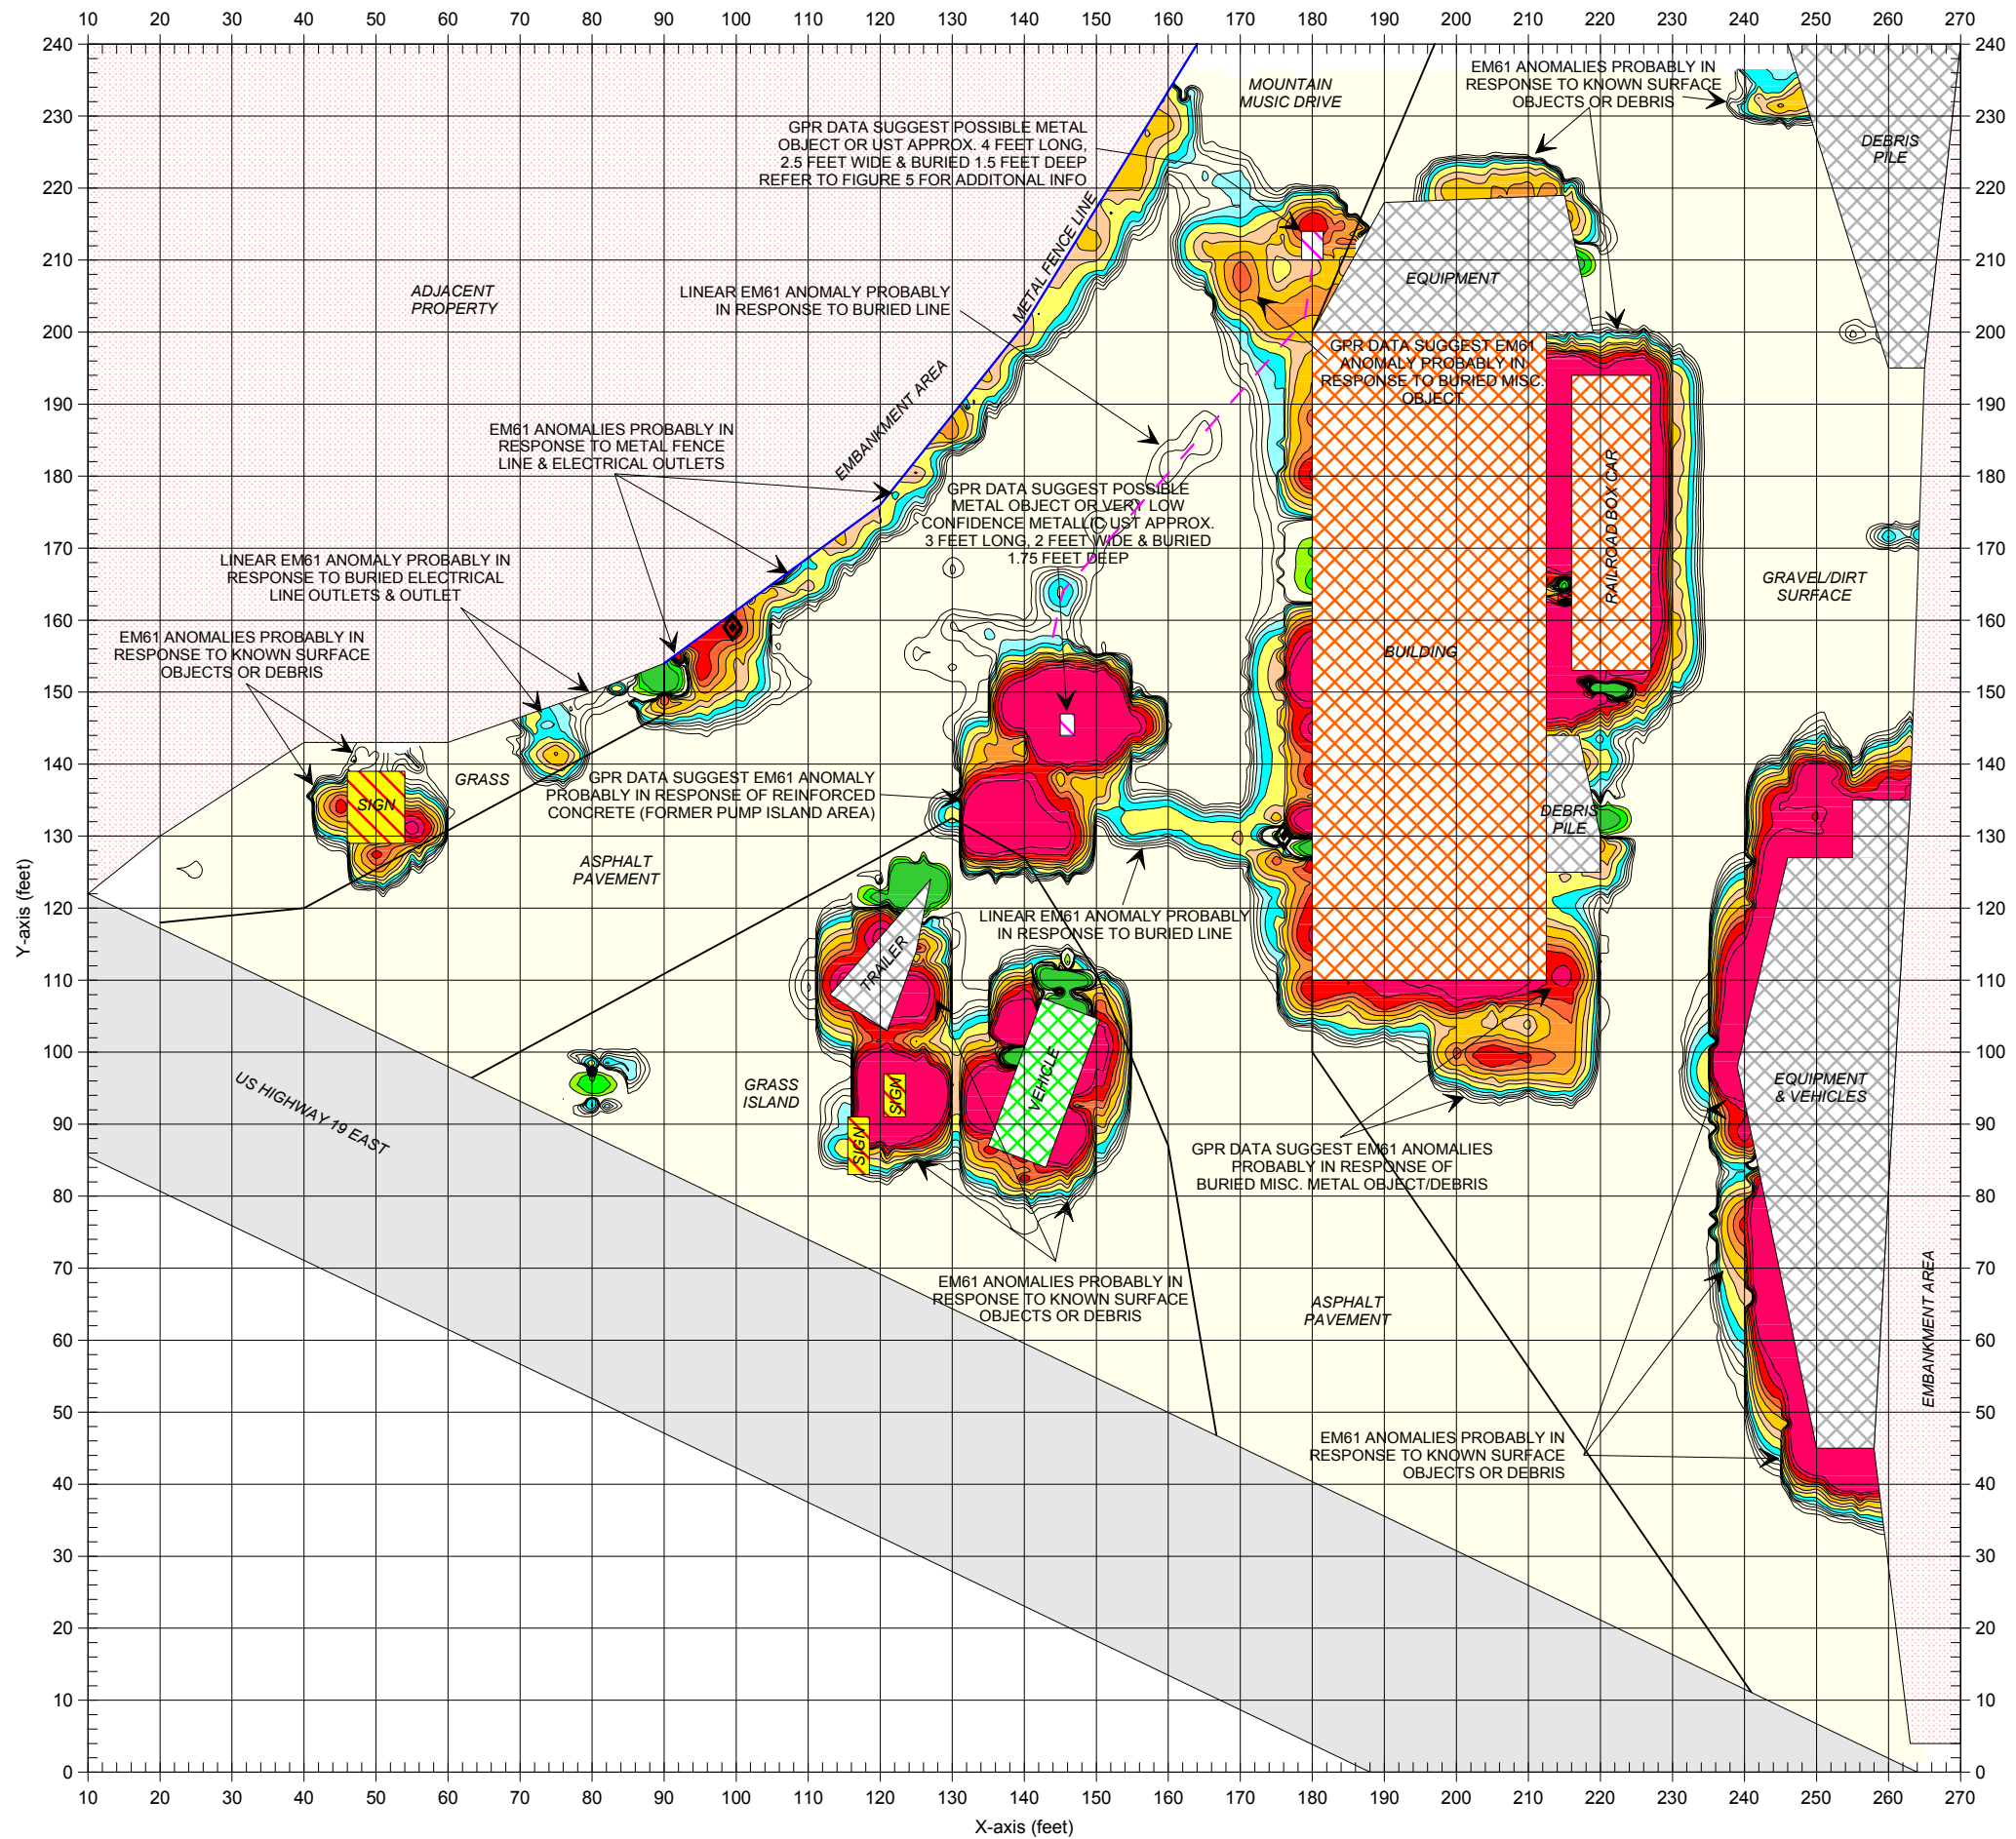
FIGURE 2

The contour plot shows the bottom coil (most sensitive) response of the EM61 instrument in millivolts (mV). The bottom coil response shows buried metallic objects regardless of size. The EM61 survey was conducted on February 10, 2012 using a Geonics EM61 instrument. Ground penetrating radar (GPR) data were acquired across selected EM61 anomalies on February 14, 2012 using a Geophysical Survey Systems SIR 2000 instrument with a 400 MHz antenna.

The geophysical investigation detected two possible buried, metal objects or USTs within the surveyed portion of the site.

EM61 METAL DETECTION (BOTTOM COIL RESULTS)

Contour plots of the EM61 bottom coil and differential results are presented in **Figures 2 and 3**, respectively. The bottom coil results represent the most sensitive component of the EM61 instrument and detect metal objects regardless of size. The bottom coil response can be used to delineate metal conduits or utility lines, small, isolated metal objects, and areas containing insignificant metal debris. The differential results are obtained from the difference between the top and bottom coils of the EM61 instrument. The differential results focus on the larger metal objects such as drum and UST-size objects and ignore the smaller insignificant metal objects.

The EM61 anomalies centered around grid coordinates X=130 Y=100, X=178 Y=140, X=220 Y=150, and X=240 Y=110 are probably in response to equipment, signs, vehicles, or the building. The EM61 anomalies centered near grid coordinates X=50 Y=130 and X=95 Y=155 are probably in response to a business sign, electrical outlets and the edge of metal fence line. The linear EM61 bottom coil anomaly intersecting grid coordinates X=130 Y=186 is probably in response to the metal fence line.

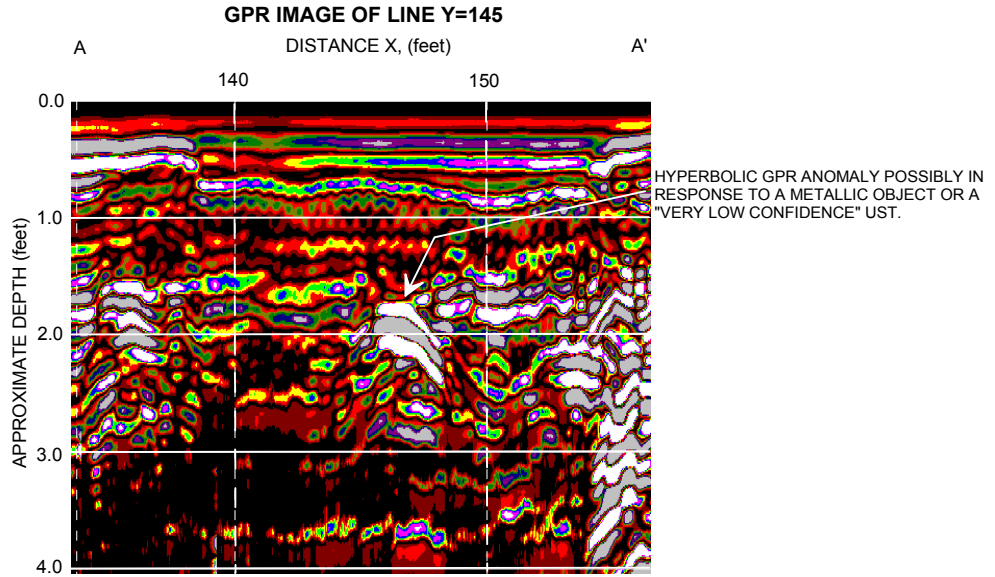
GPR IMAGE ACROSS
POSSIBLE BURIED OBJECT

The GPR image obtained along a portion of survey line Y=145 recorded a hyperbolic GPR anomaly across the EM61 metal detection anomaly centered near grid coordinates X=146 Y=145 that is possibly in response to a buried, metallic object or a "very low confidence" UST. The solid purple line labeled AA' in the photograph below shows the location of the GPR image.

The orange rectangle in the photograph represents the approximate perimeter of a possible, metallic object or a "very low confidence" UST, as suggested by the GPR data. Centered near grid coordinates X=146 Y=145, the possible metallic object is 2.75 feet long, 2.75 feet wide and buried 1.75 feet below present grade. The solid purple line in the photograph represents the approximate location of the GPR image shown above. The photograph is viewed in a northerly direction.

- GPR data acquired across the EM61 differential anomaly centered near grid coordinates X=146 Y=145 detected a possible metallic object or a small, “very low confidence” UST buried approximately 1.75 feet below the asphalt pavement. Based on the GPR data, the possible buried object or small UST is approximately 2.75 feet long and 2.75 feet wide.

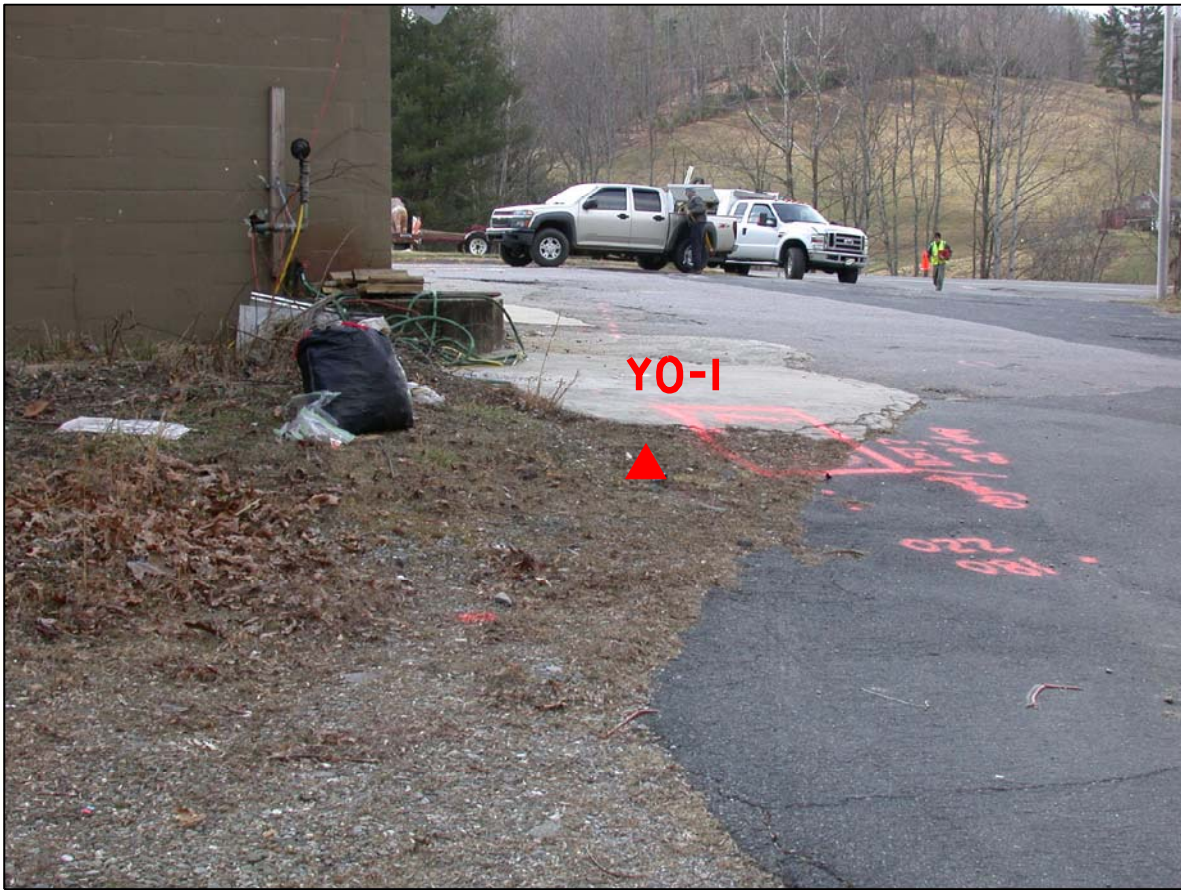
PHOTO 1 - BORING ON NORTH SIDE OF BUILDING AT ANOMALY LOOKING SOUTH
