LANDFILL SITE ASSESSMENT
Bladen County Landfill
NCD980502819
Bladen County
HURRICANE LANDFILL ASSESSMENT PROJECT
STATE OF NORTH CAROLINA
CONTRACT NO. N200016
S&ME PROJECT NO. 1040-00-335A
VOLUME I OF VII

October 25, 2002

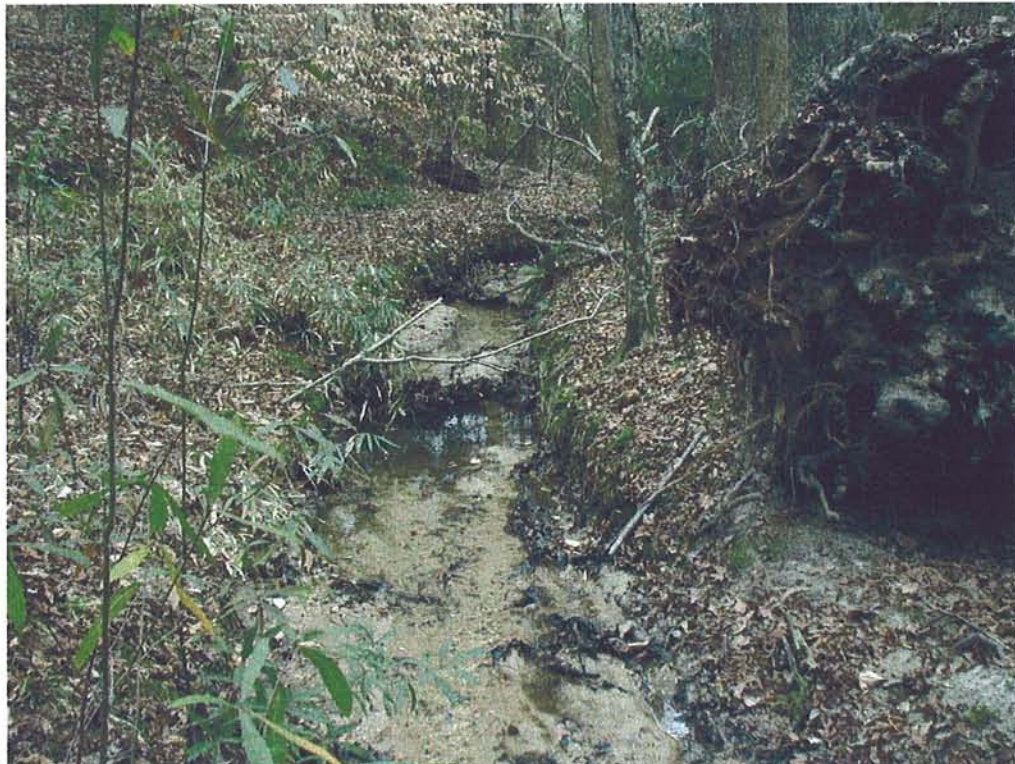
Photograph No. 2: Unnamed tributary of Brown's Creek that adjoins the site to the southwest.

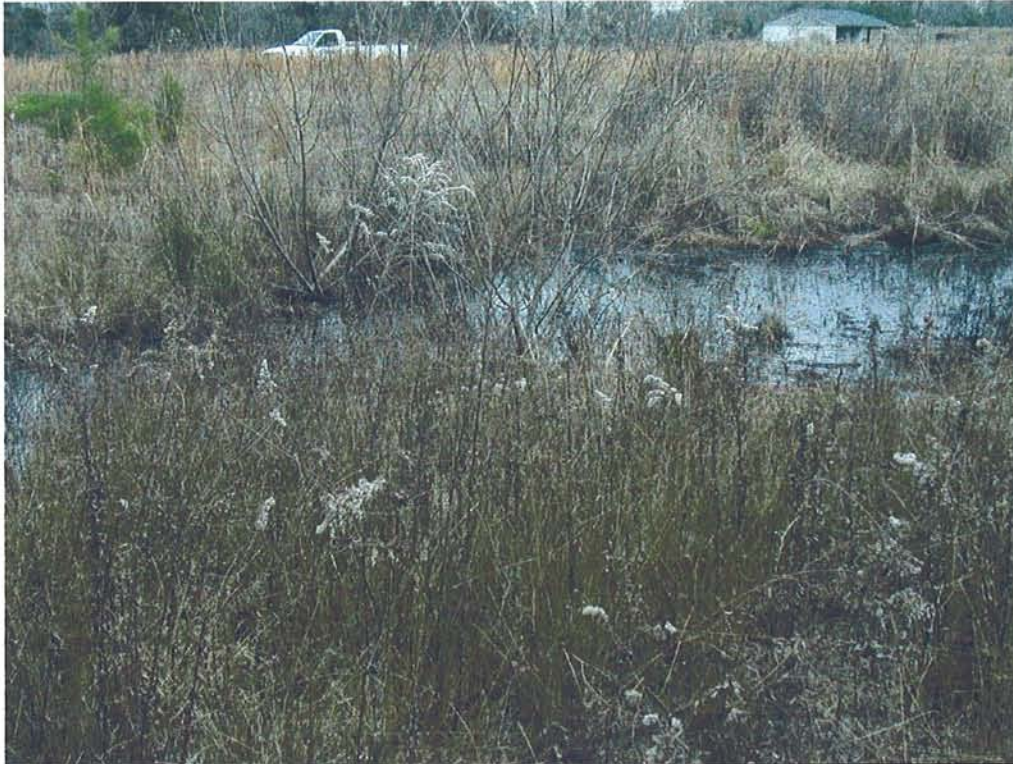
Photograph No. 3:	One of three areas of ponding on the landfill cap. This area is approximately 1/10 of an acre.
-------------------	--

All landfilled areas of the site are covered with vegetation. No significant areas of exposed waste or signs of significant erosion were observed throughout the site. Three small areas of

ponded water were observed at the edge of the western, eastern and south central fill areas. The coordinates for the limits of fill, as well as other site features, are summarized on Table 3.

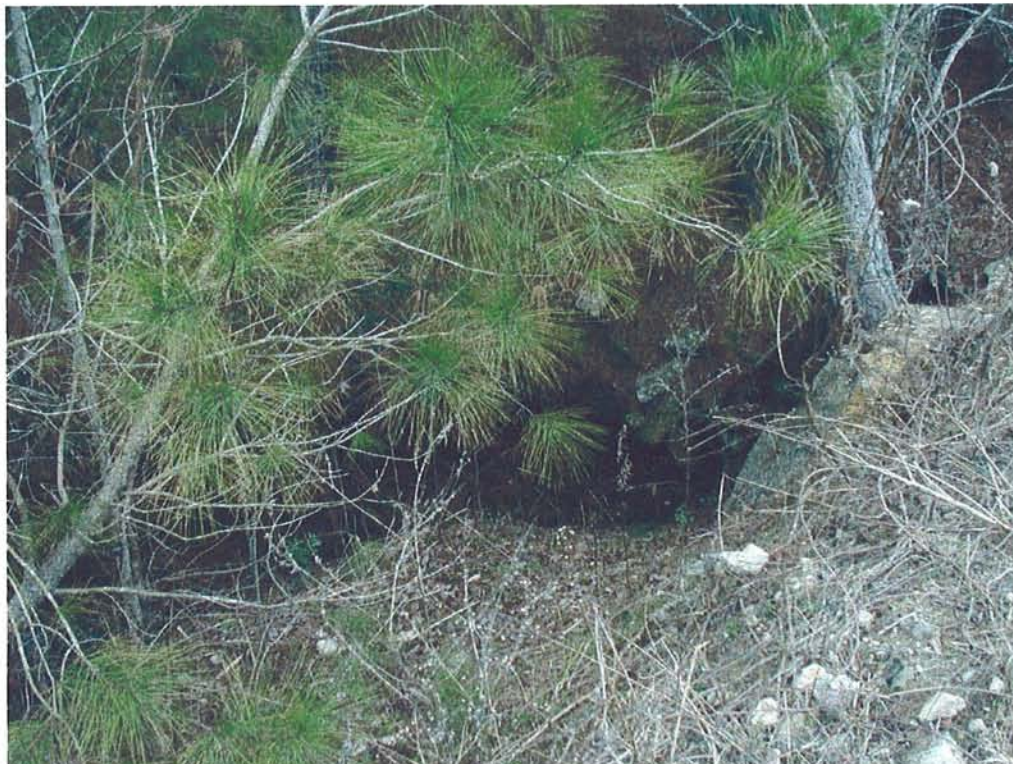
Photograph No. 4:	Drainage ditch that traverses the site. During the reconnaissance water was in the ditch.
-------------------	---

AOC Number	Northing Central Point Coordinate (NAD83 meters)	Easting Central Point Coordinate (NAD83 meters)	Description	Estimated Size
6	95026	645071	Drainage ditch traverses the site which is filled with water.	Approximately six to ten feet wide
7	95207	645075	Former garage where the landfill equipment was serviced is located on the site.	Undetermined
8	95207	645075	55-gallon drums are located within the garage, some are filled with waste oil.	Approximately 20 x 20 foot area
9	95214	645061	An empty AST is located north of the former garage. A small stained area is located on a concrete slab at the south end of the tank	Approximately 250-gallons

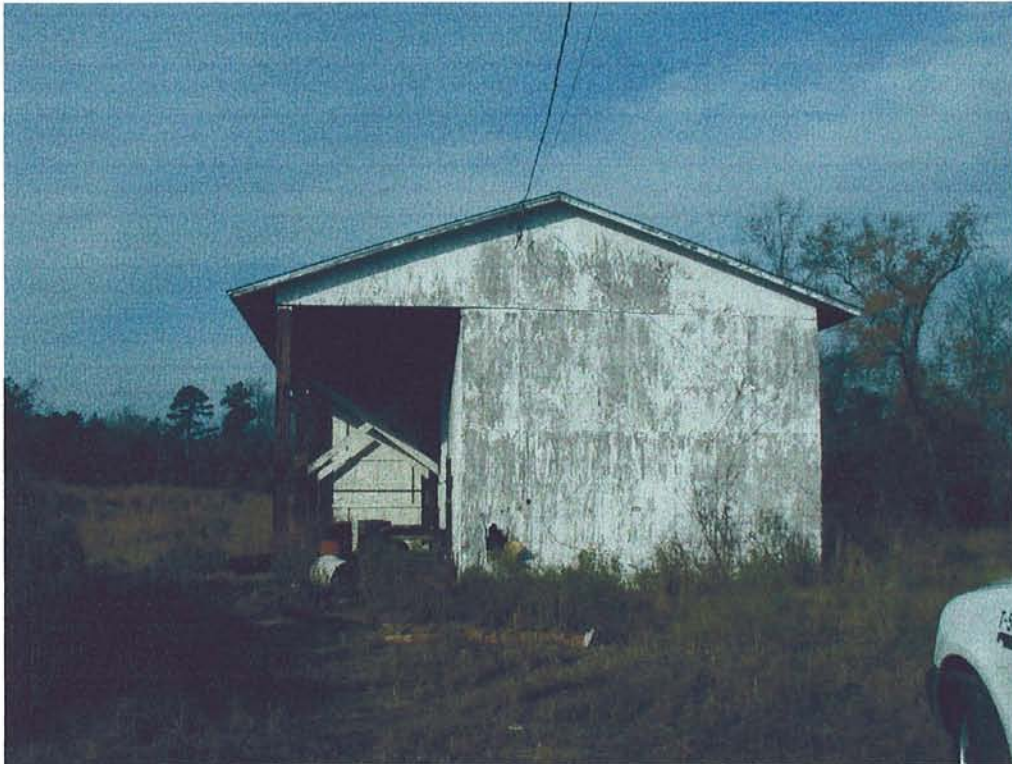
Photograph No. 5: Former garage where the equipment was serviced during the landfills operation.

A wooden building, which was a former garage for landfill equipment, is located at the end of the access road to the site. Another small wooden storage building is located near the former garage. Several 55-gallon steel drums are located within the former garage. Most of the drums were empty, however, some of the drums contained what appears to be waste oil. No visual signs of staining were noted around the drums. An above-ground storage tank, which appears to

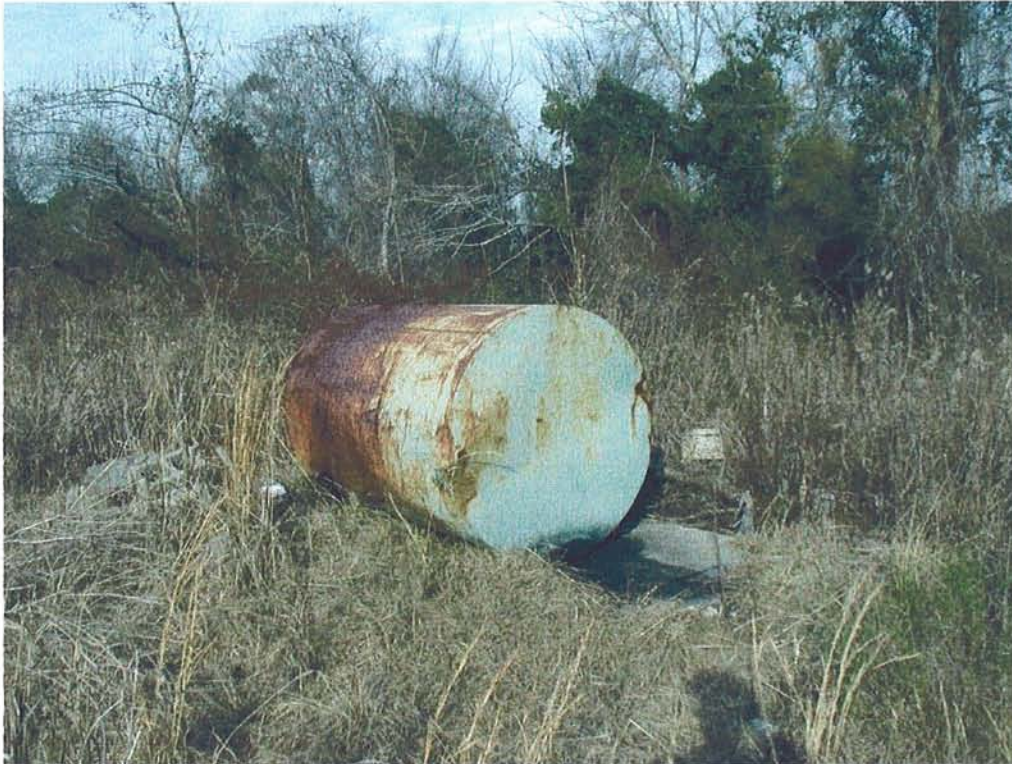
Photograph No. 7: Abandoned AST north of the garage. The concrete was stained with oil below the tank.

be empty, is located north of the garage. A small stained area is located on a concrete slab at the southern end of the tank.

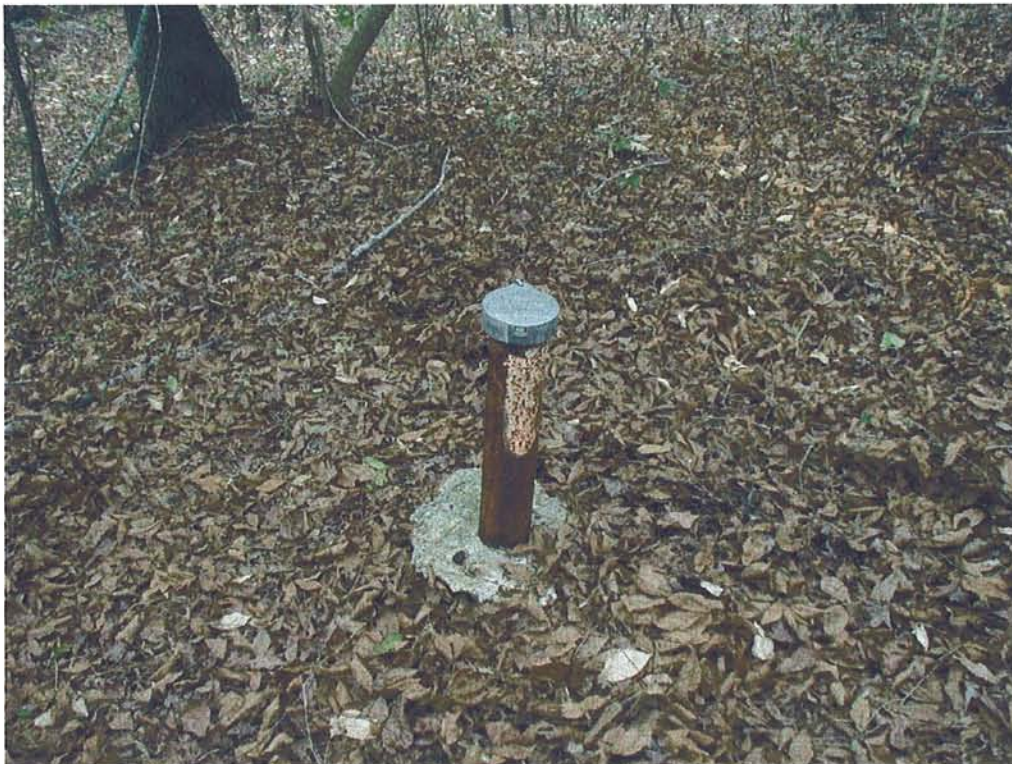
Photograph No. 8: One of nine monitoring wells that were installed along the perimeter of the site.
