PYRAMID ENVIRONMENTAL & ENGINEERING
(PROJECT 2013-149)

NCDOT PROJECT U-5305 (WBS 47025.1.1)

GEOPHYSICAL SURVEYS OF PARCEL 4 – UNDERGROUND STORAGE TANK INVESTIGATION

**GEOPHYSICAL INVESTIGATION REPORT
NCDOT ROW GEOPHYSICAL SURVEY
PARCEL 4 – MACK ROAD AND NC 49
Asheboro, Randolph County, North Carolina**

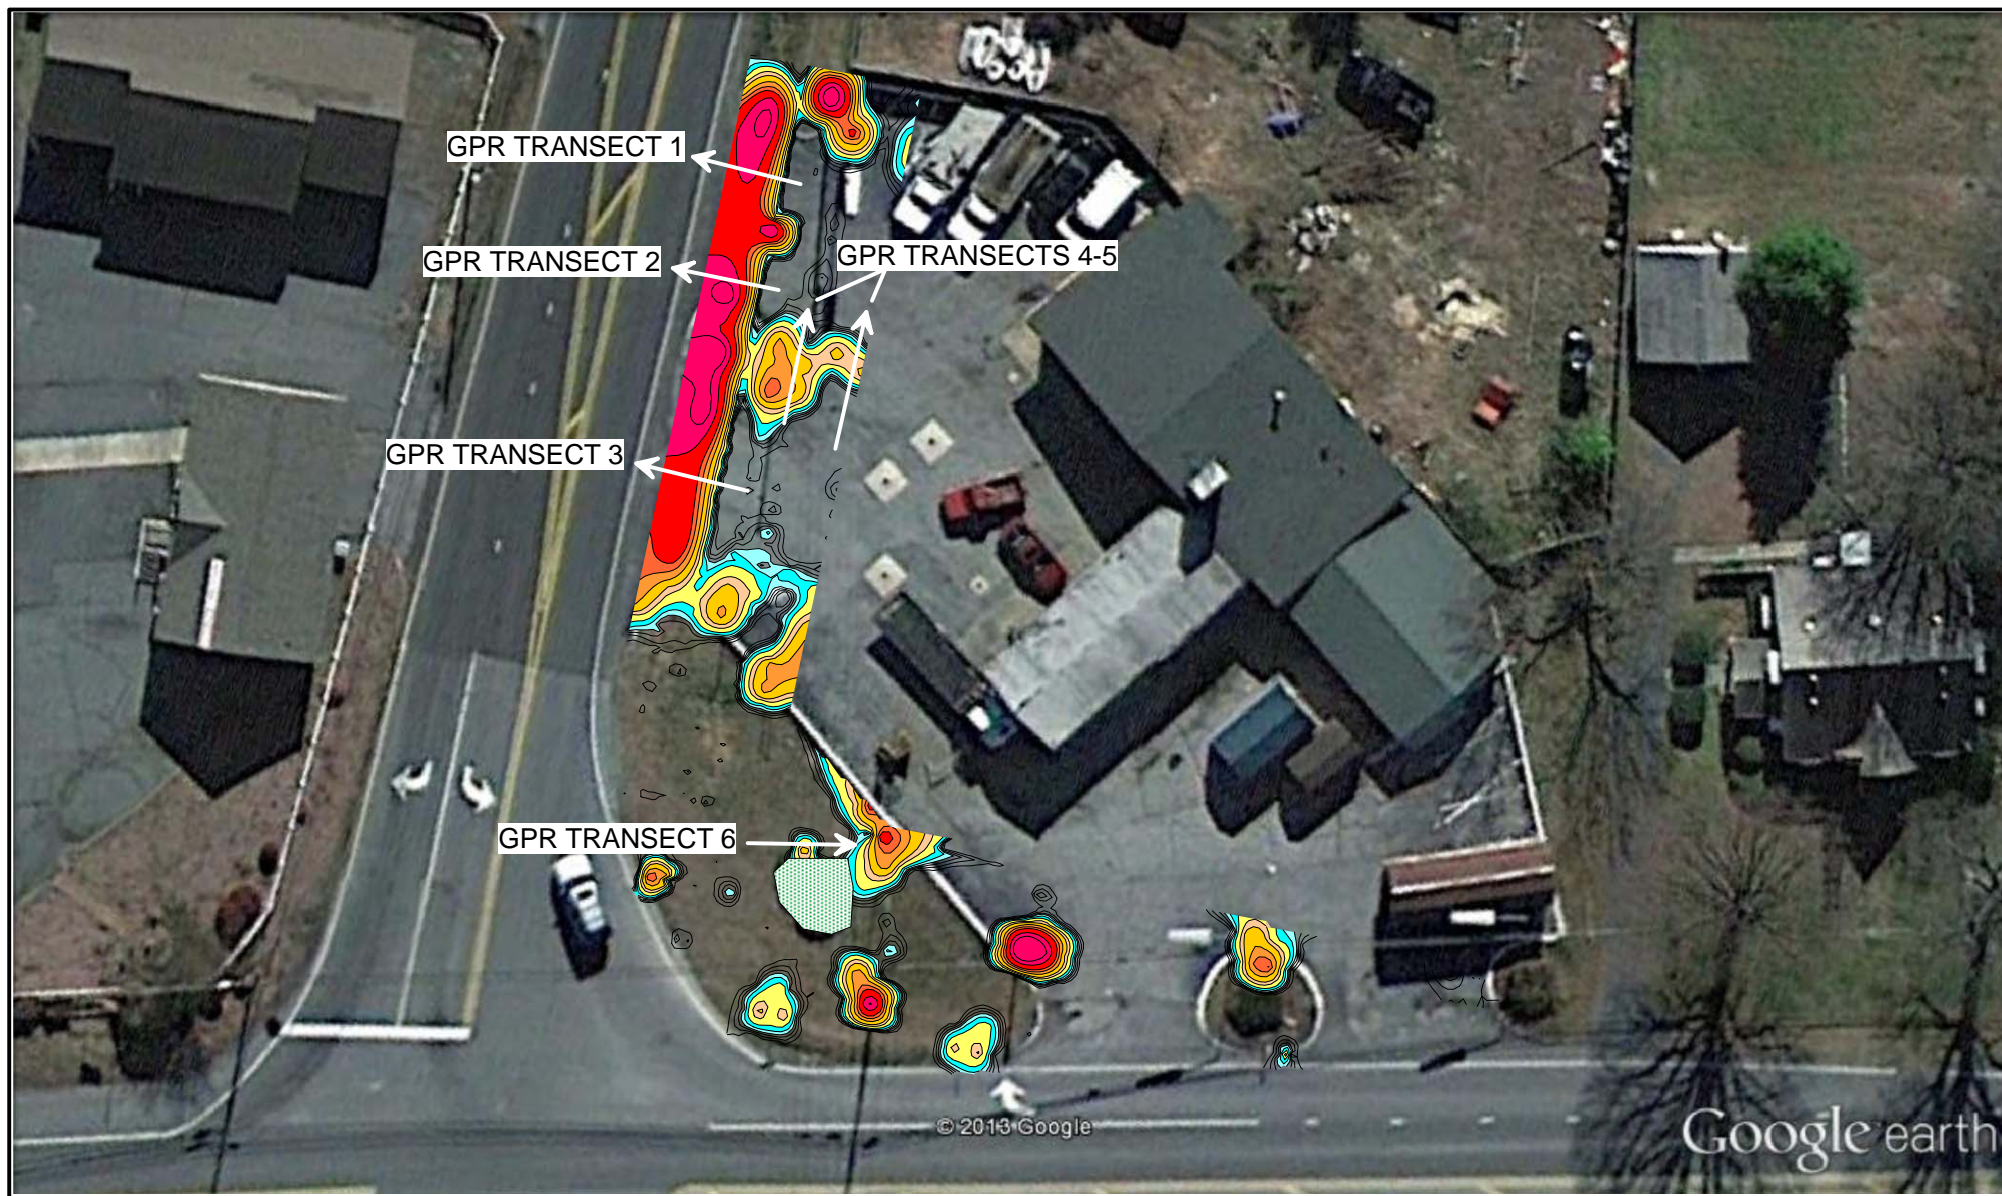
TITLE
**PARCEL 4 - GPR TRANSECT IMAGES
 ACROSS UNKNOWN ANOMALIES**

Anomalies that could not be directly attributed to visible objects at the ground surface were investigated further with the GPR. Specifically, the north/south feature at X=25 (suspected to be a storm drain pipe) was analyzed with the GPR. Additionally, anomalies at X=45, Y=145 and at X=58, Y=60 were investigated with GPR scans.

The GPR data were viewed in real time as the equipment was surveyed across the anomalies. Transects across EM anomalies were saved to the hard drive for post-processing in the office. **Figure 4** presents an aerial photograph showing the location of the GPR transects performed across the unexplained EM anomalies as well as the GPR images that were collected.

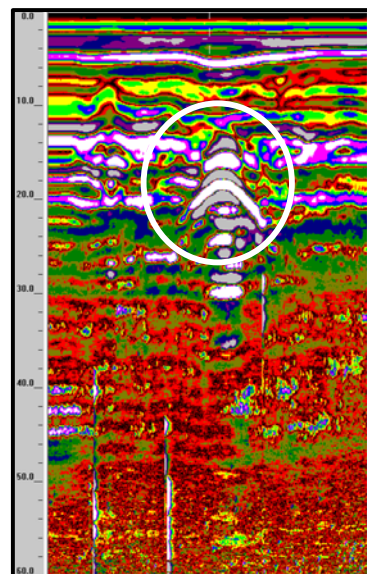
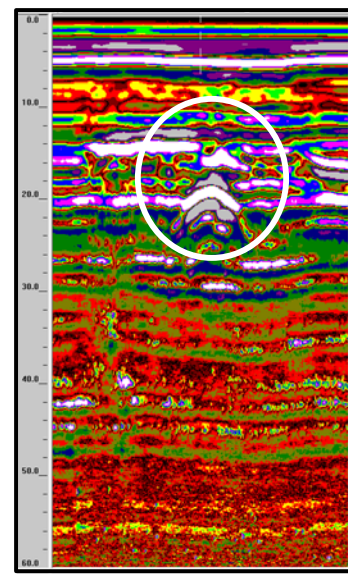
GPR Transects 1, 2 and 3 were performed from west to east across the suspected storm drain pipe at X=25. These scans confirmed the presence of an underground pipe across this area. GPR Transects 4 and 5 were performed from north to south across the anomaly centered at X=45, Y=145. These scans confirmed the presence of an unknown utility line extending across this area to the southwest. GPR Transect 6 was performed from east to west across the anomaly at X=58, Y=60, and recorded evidenced of possible buried metallic debris. No other significant features were recorded by the GPR within the formal survey grid that would be indicative of any large objects below the ground surface, such as metallic USTs.

Suspected Utility Line

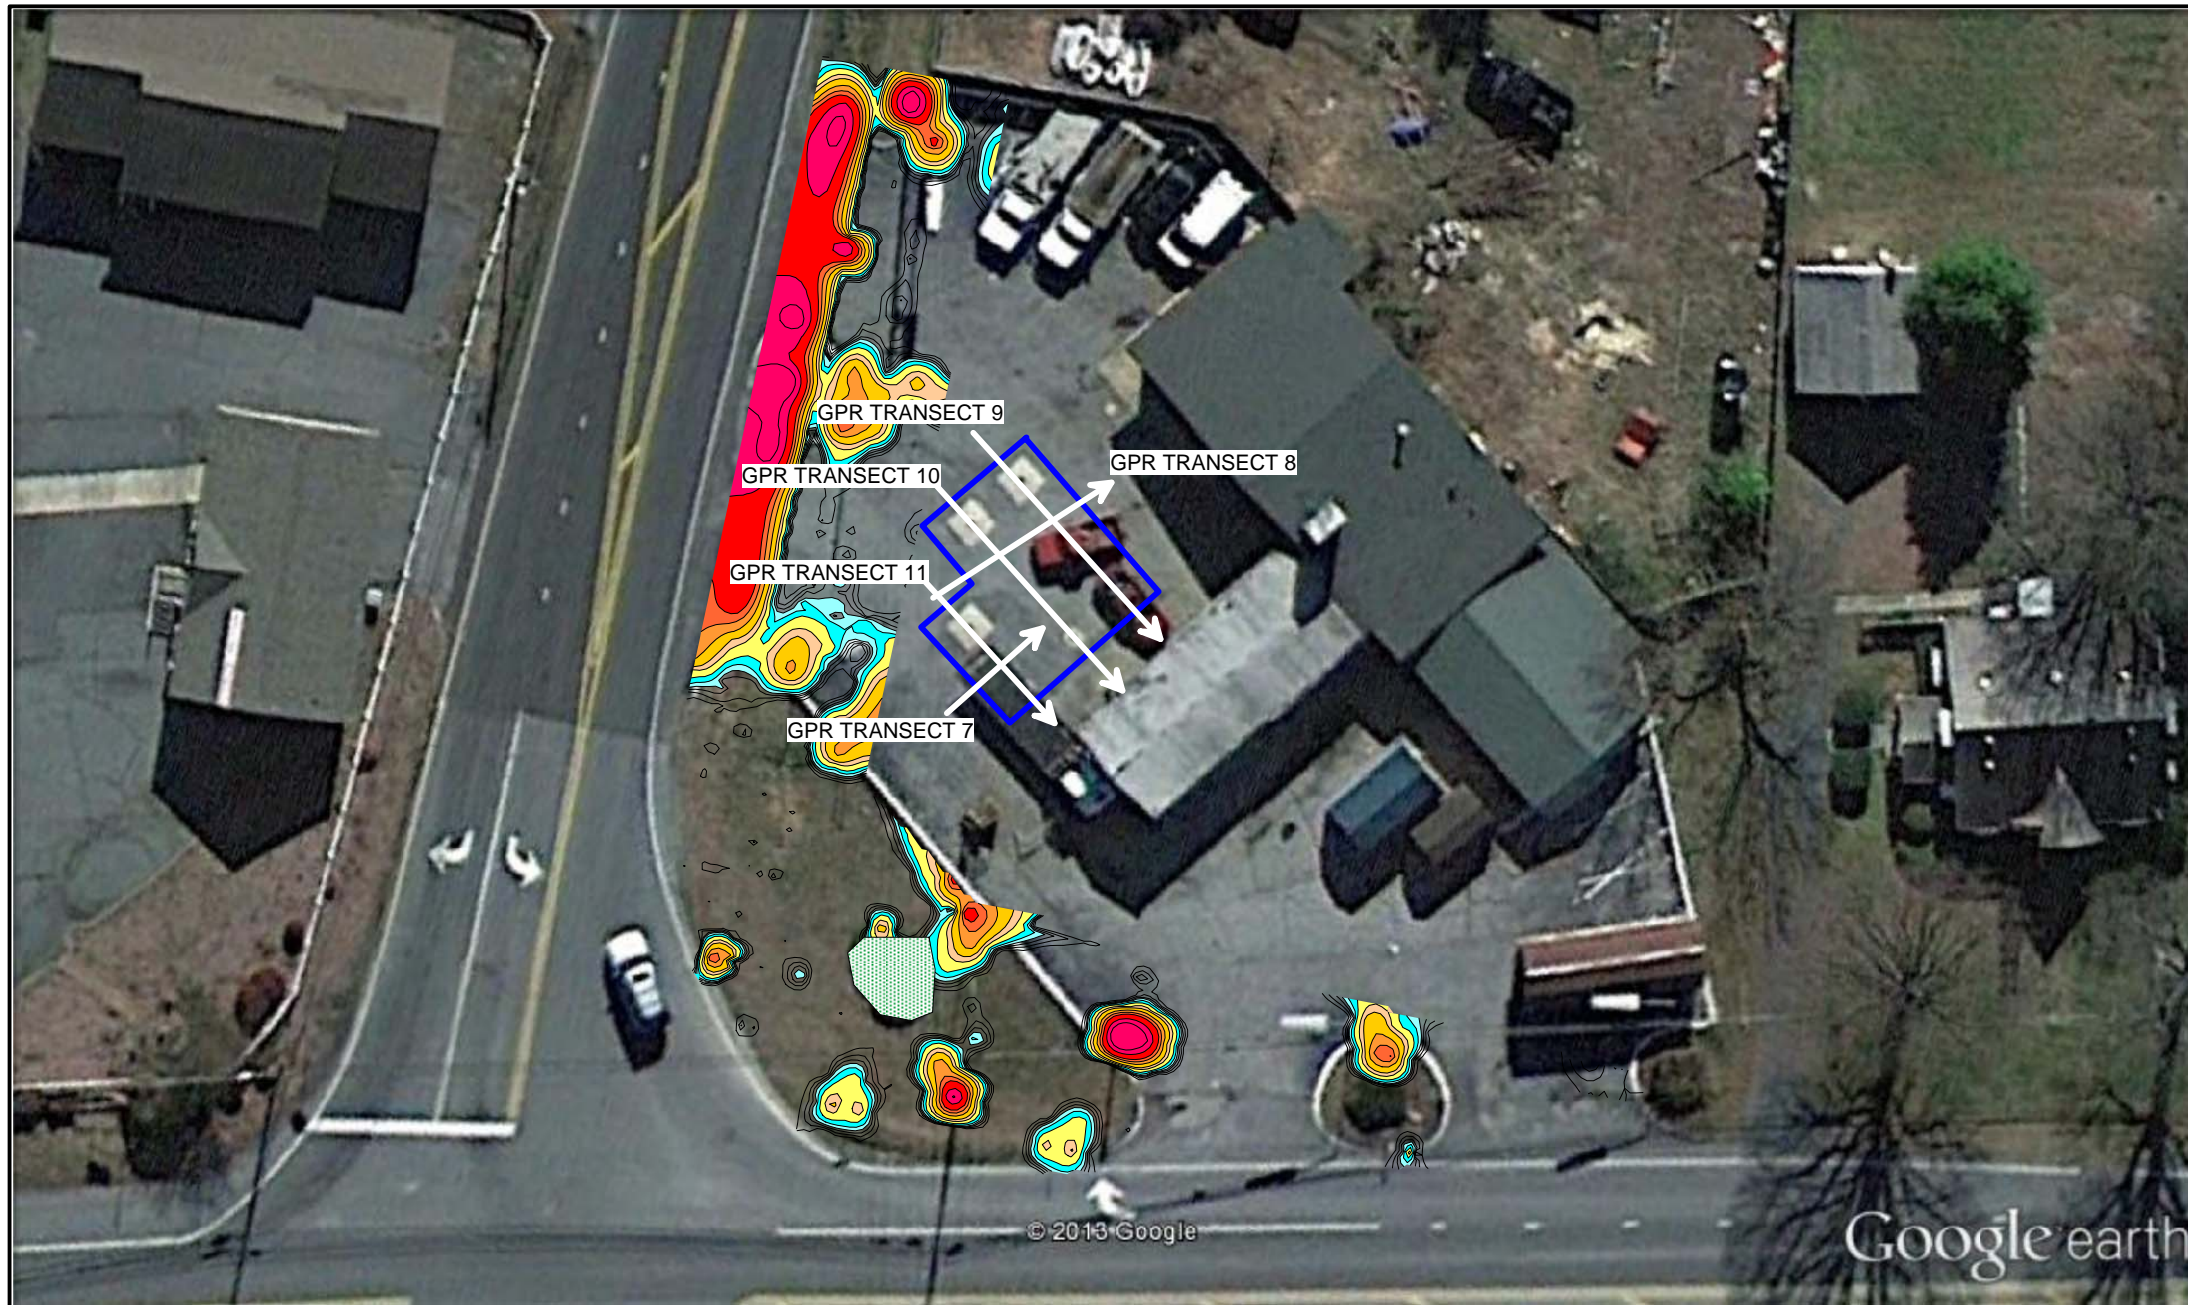
TITLE PARCEL 4 - GPR TRANSECT LOCATIONS AND TRANSECT IMAGES ACROSS USTs	
PROJECT NC DEPARTMENT OF TRANSPORTATION ROW IMPROVEMENT PROJECT ASHEBORO, RANDOLPH COUNTY, NC

Suspected UST Reconnaissance Survey: Reconnaissance GPR transects were performed across the area suspected of containing three USTs. The area was located to the southwest of the center of the survey grid. Three fill ports with concrete pads were observed in this area. According to the store owner, no USTs were actively being used at the shop. **Figure 5** presents the locations of the GPR Transects performed across the suspected UST field, as well as the transect images.

GPS points were taken at the center of each UST identified by the GPR survey. The GPS points were obtained using a Trimble AG-114 GPS unit coupled to an Allegro-CX field computer. Points were taken in the WGS84 datum and converted to North Carolina State Plane coordinates in the office. Table 1, presented below, presents the coordinates of the three tanks.

Approximate locations of known USTs

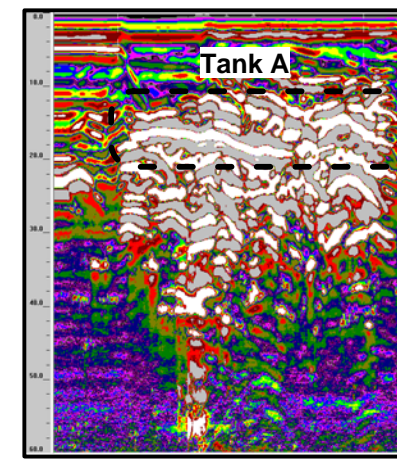
Three known USTs were confirmed by the reconnaissance GPR survey. GPR Transects 7 and 8 were performed approximately from north to south, perpendicular to the three tanks. GPR Transects 9, 10 and 11 were performed across the length of each tank from east to west. The GPR indicated that the two southern tanks were approximately 8 feet wide x 30 feet long, and that the northern tank was approximately 10 feet wide x 20 feet long. The two southern tanks were observed to be at a depth of approximately 3.5 to 4 feet below the ground surface (bgs), and the northern tank was observed to be at a depth of approximately 2.5-3 feet bgs.
