Preliminary Site Assessment

NCDOT Project U-5008

Charlotte - Sugar Creek Grade Separation

Parcel: Roy Carver Property

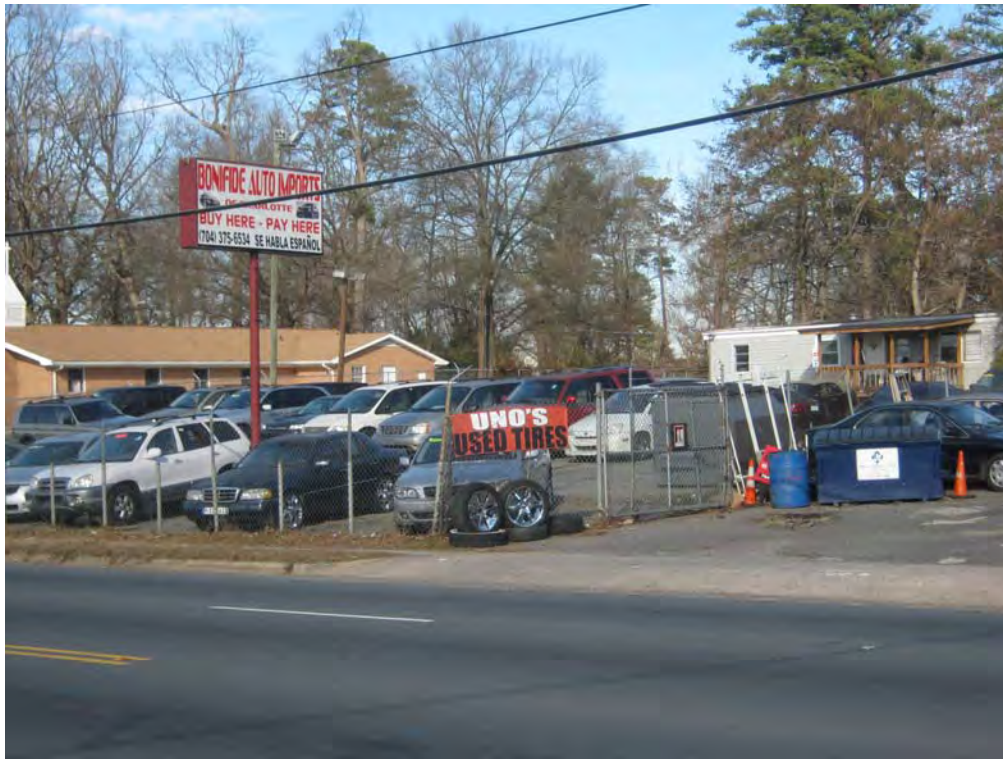
Photo 1 View of auto sales lot on northern portion of Carver property.

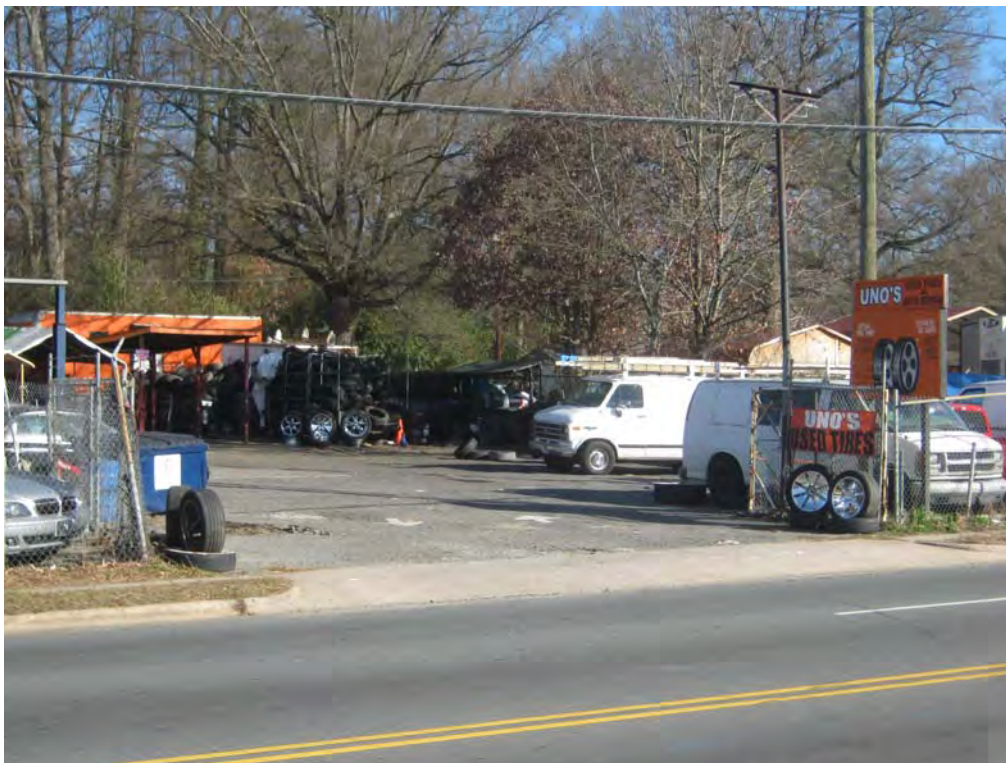
Photo 2 View of auto detailing and tire repair shop on southern portion of Carver property.

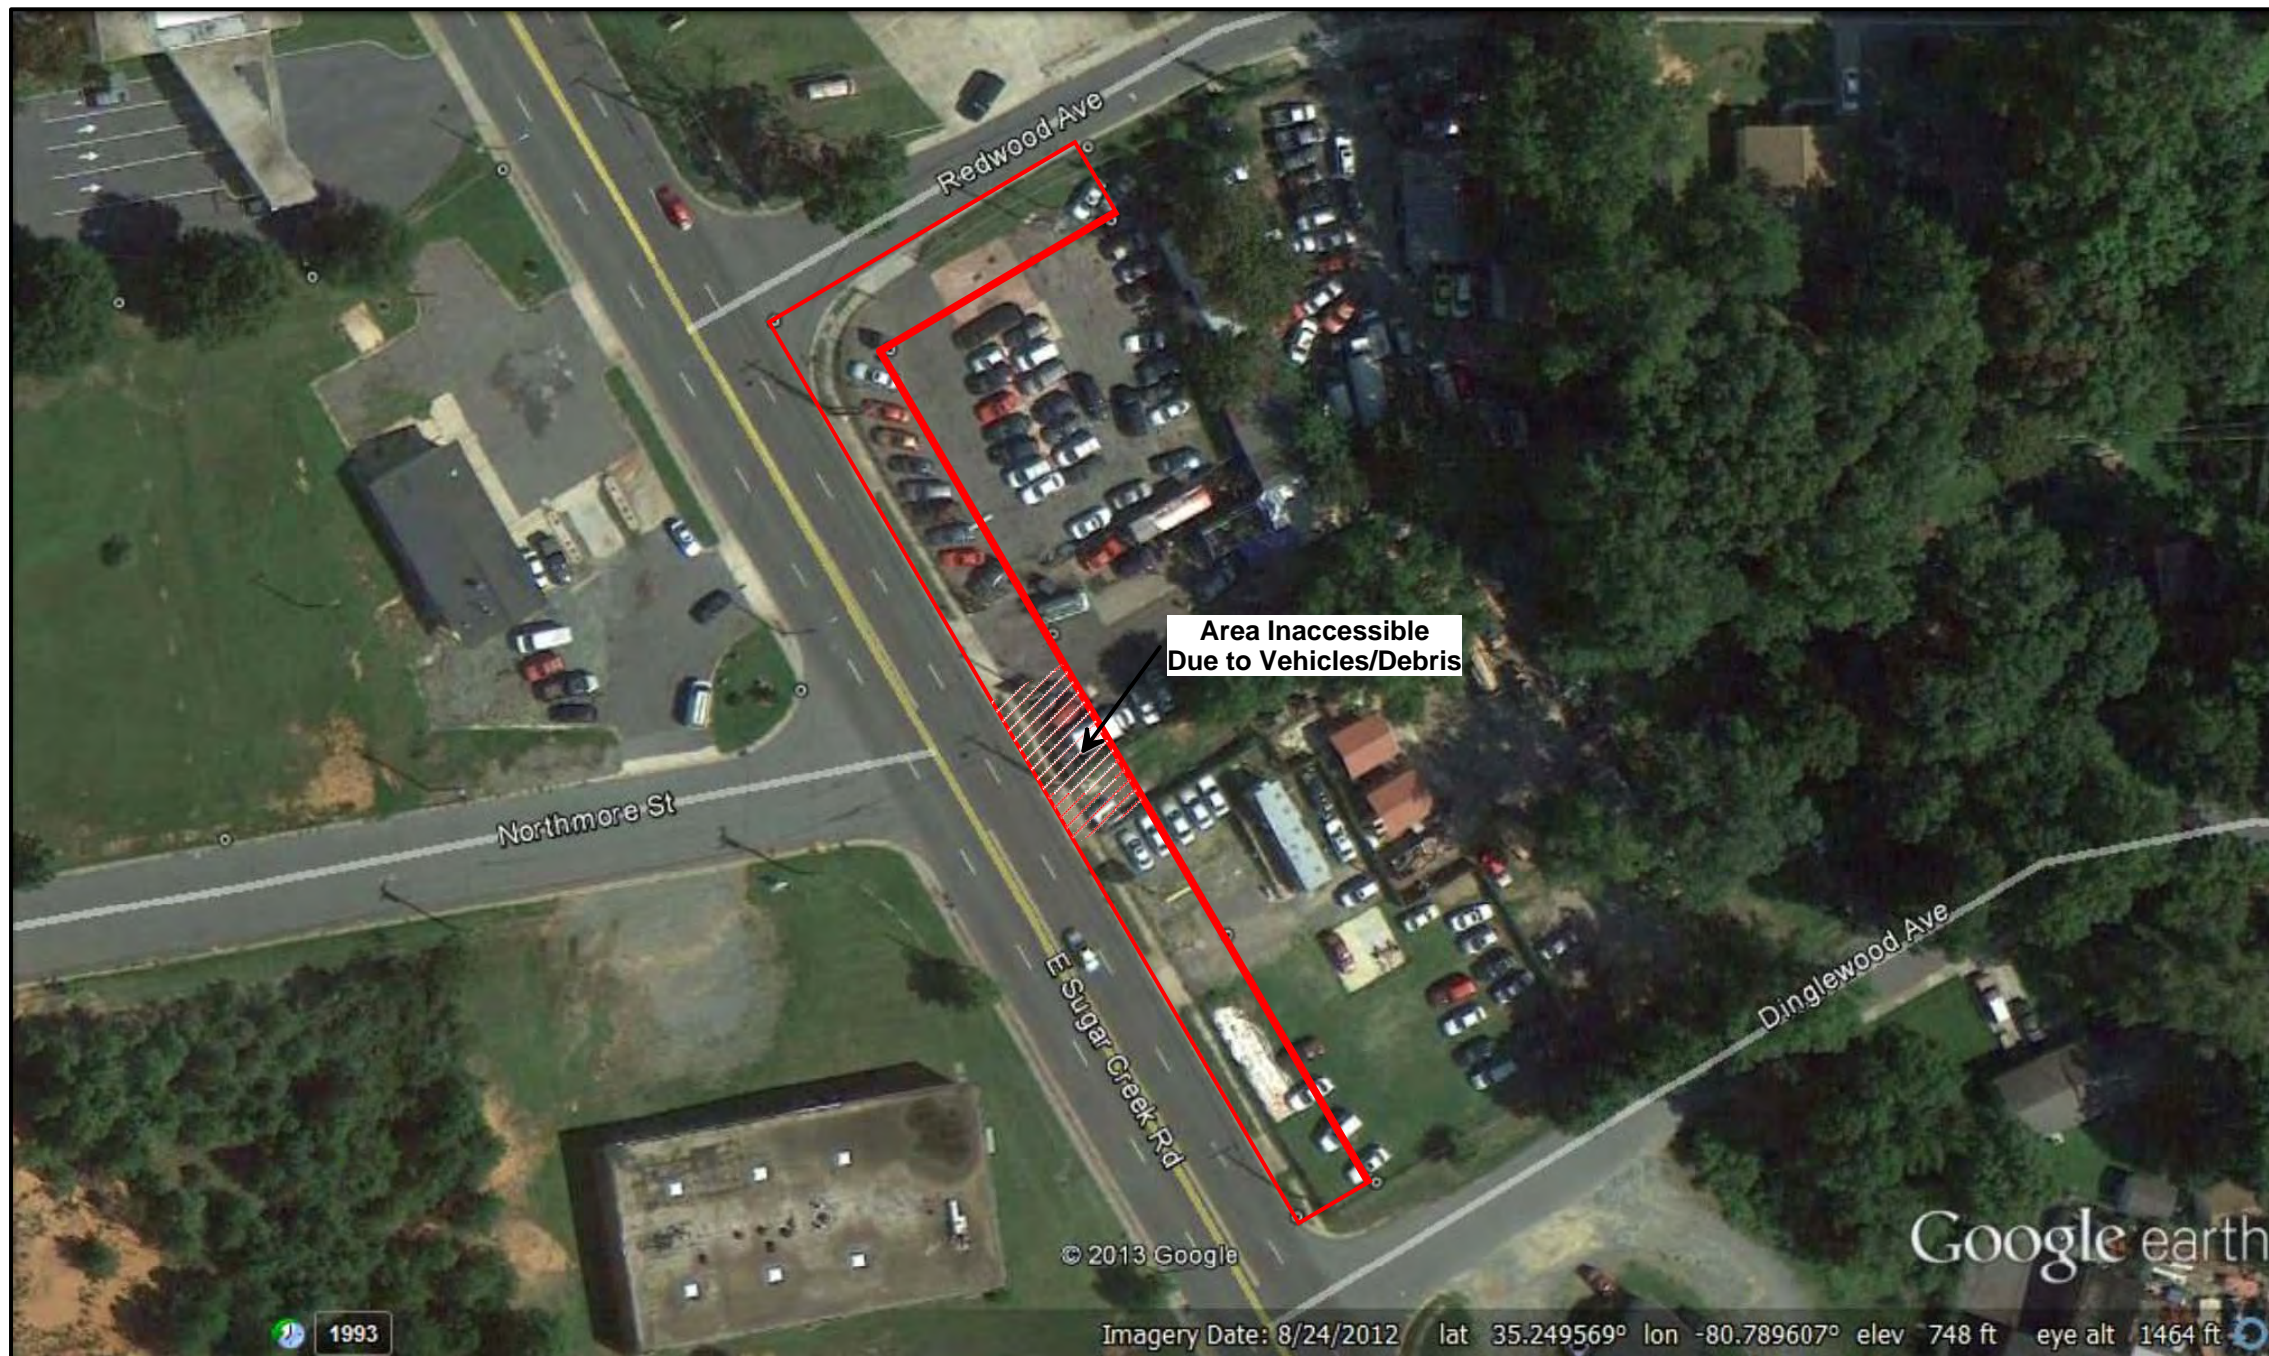
503 INDUSTRIAL AVENUE GREENSBORO, NC 27460 (336) 335-3174 (p) (336) 691-0648 (f) License # C1251 Eng. / License # C257 Geology	
DATE	11/6/2013	CLIENT	TERRACON
PYRAMID PROJECT #:	2013-259	FIGURE 1

The site had limited access, consisting of asphalt parking lot spaces and grassy areas with a large number of parked vehicles, equipment, and debris throughout the survey area. One section of the property was completely inaccessible due to vehicles and fences. Due to the widespread metal across the site (vehicles, fences, etc.), an EM61 survey was not performed because the level of interference would have been too great to make any significant observations regarding buried metal objects. For this reason, the geophysical survey at these properties consisted solely of a ground penetrating radar (GPR) survey. Aerial photographs showing the survey area boundaries and ground-level photographs are shown in **Figure 1**.

Approximate Boundaries of the Geophysical Survey Area

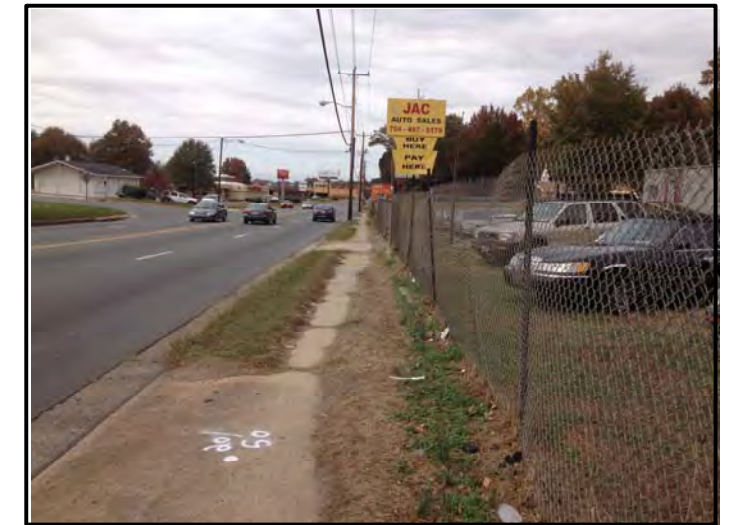
View of South & West Portion of Survey Area (Facing Approximately North)

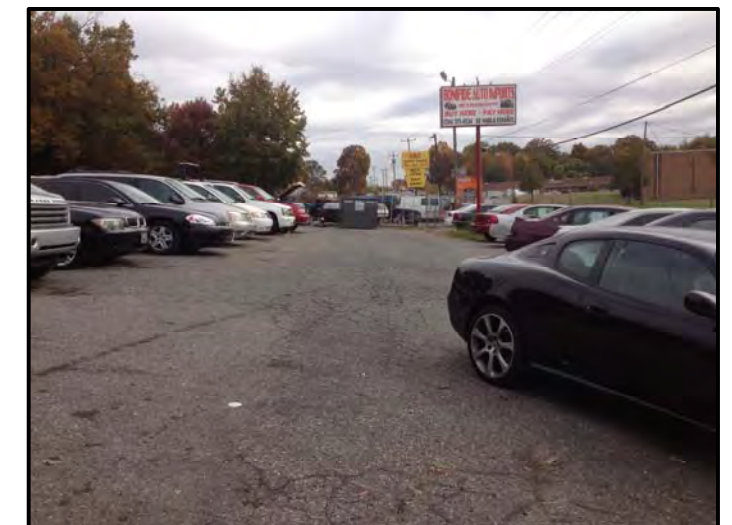
View of Northwest Portion of Survey Area (Facing Approximately South)

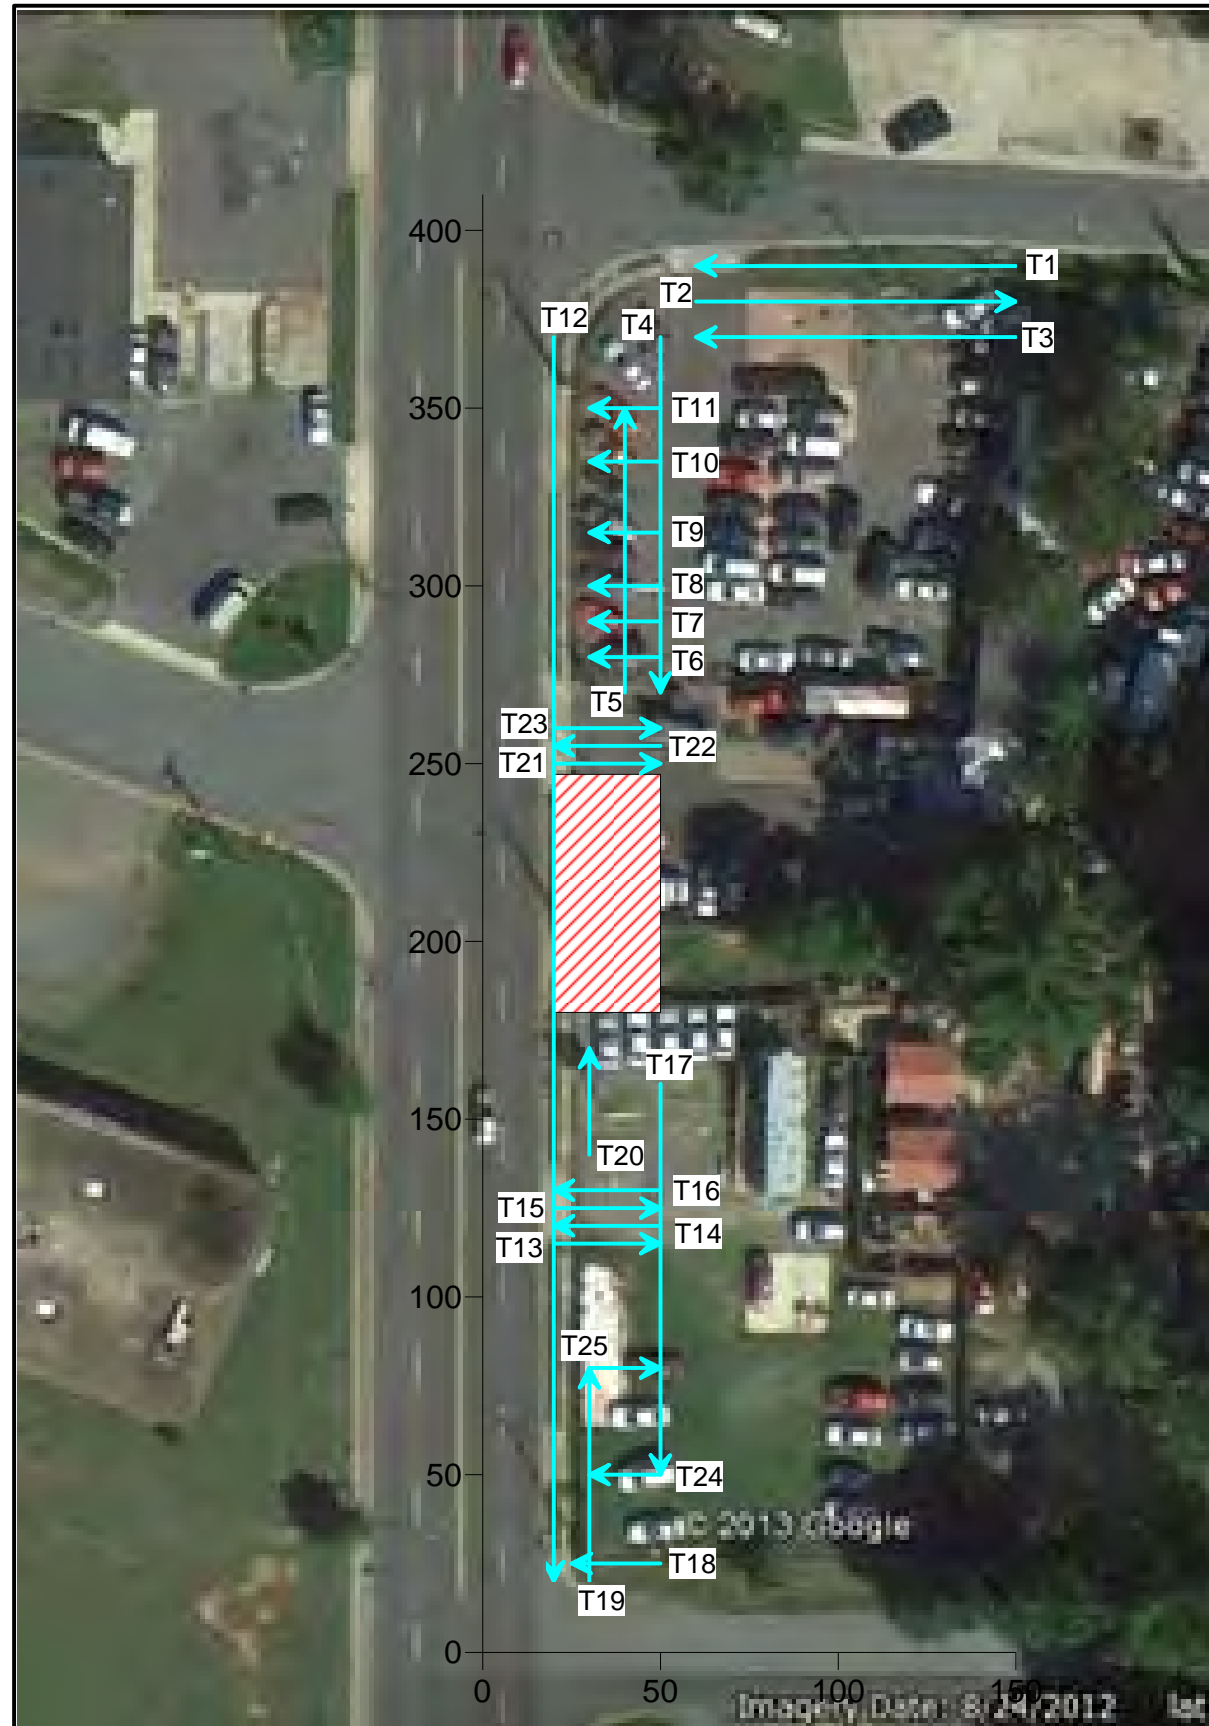
Locations of GPR Transects at Tzannis & Carver Properties

The locations of the GPR transect performed at the property, as well as images of select GPR transects, are presented in **Figure 2**. Images of all GPR transects are included in **Appendix A**. Transects were performed wherever possible in between parked vehicles, along the roadway, within median areas, and within open areas at the properties that fell within the NCDOT proposed ROW. It should be noted that the limited access prevented the property from being surveyed to the resolution and accuracy that our standard survey would provide under more normal site conditions. Additionally, one area of the property between Y=180 and Y=245 was completely inaccessible due to vehicles and fences.

The geophysical investigation did not record any evidence of USTs within the accessible portions of the proposed ROW and easement areas at the properties. However, it should be noted that an EM61 metal detection survey was not performed, and that the GPR survey was limited to the accessible portions of the site. Parked vehicles and other obstacles prevented significant portions of the site from being surveyed.
