Assessment Report Forms
for
North Carolina Dry-Cleaning Solvent Cleanup Act Program

Facility Name:	One Hour Martinizing 111 East Tenth Street Greenville, Pitt County, North Carolina
DSCA ID No.:	74-0007
Submittal Date:	8/19/2008
Prepared By:	Withers & Ravenel 1410 Commonwealth Drive, Unit 101 Wilmington, North Carolina 28403

Site Location Map
One Hour Martintizing
 111 East Tenth Street
 Greenville, North Carolina

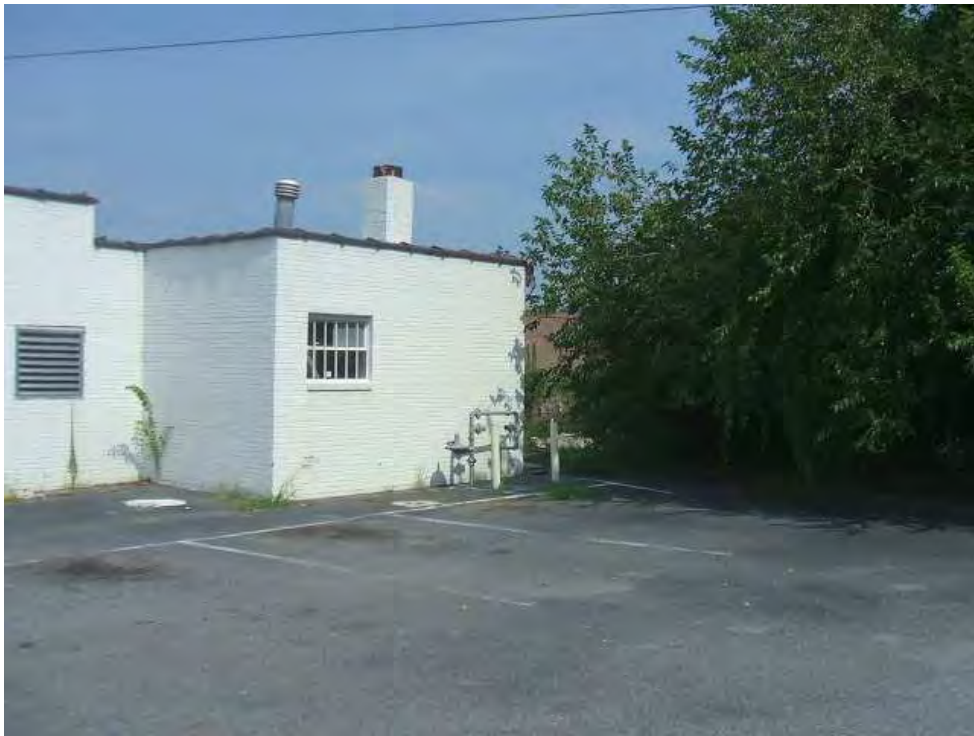
A view of the Northeast corner of the former dry cleaning facility. A monitoring well is located in the center of the picture, between the parking space and building.

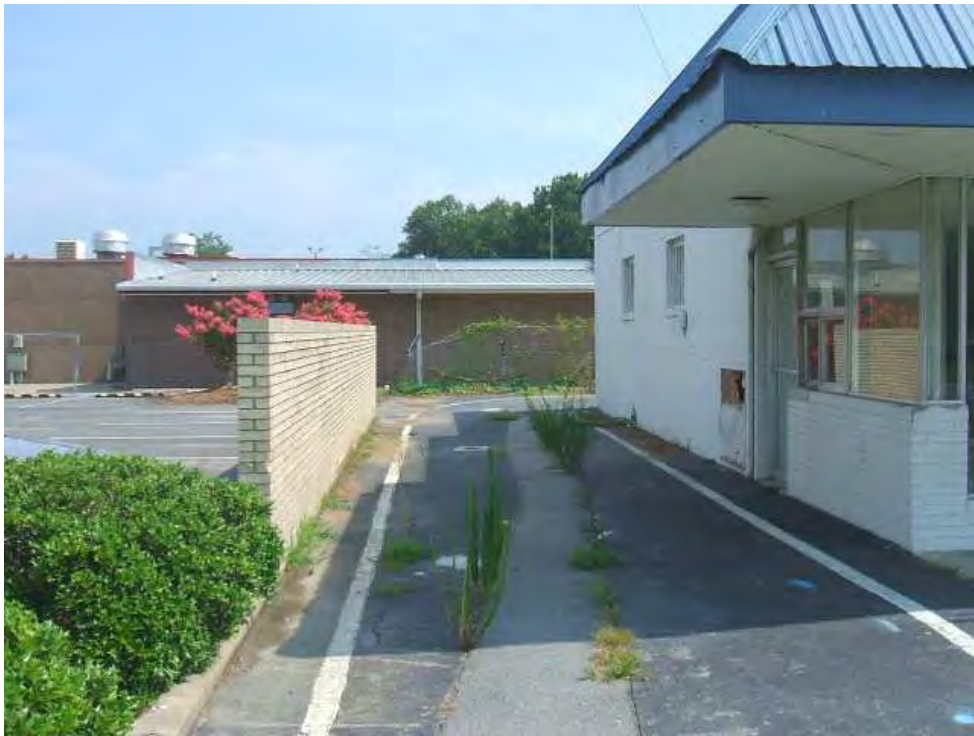
A view of the West side of the dry cleaning facility. A monitoring well is located in the center of the picture between the building and brick wall.

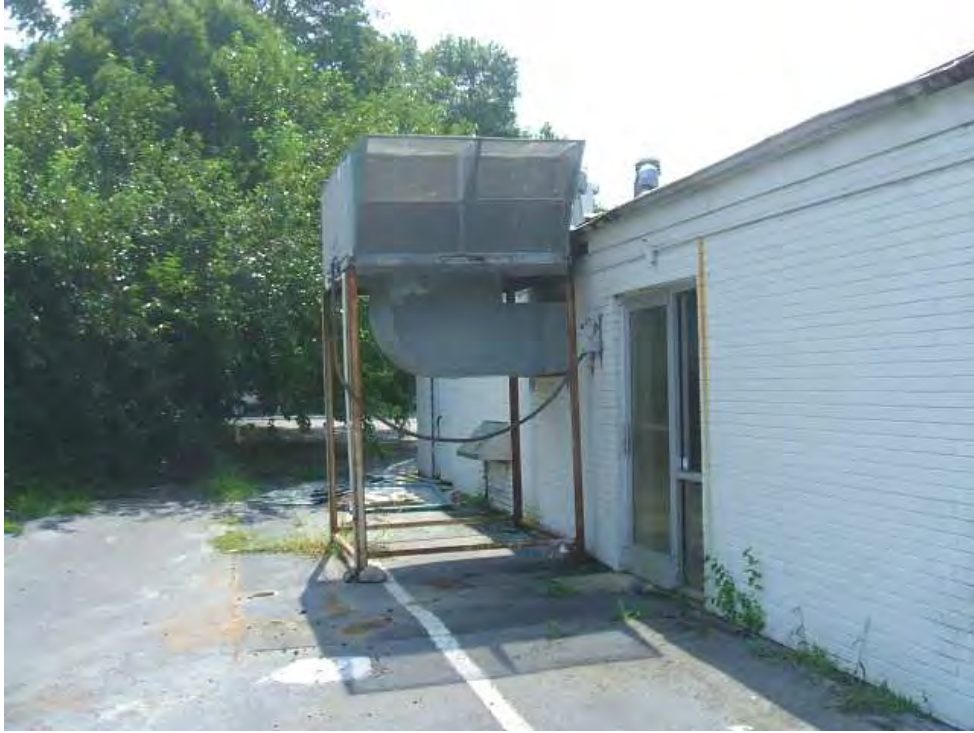
A monitoring well is located in the bottom portion of the picture. An old ventilation duct can be seen protruding from the rear of the building.

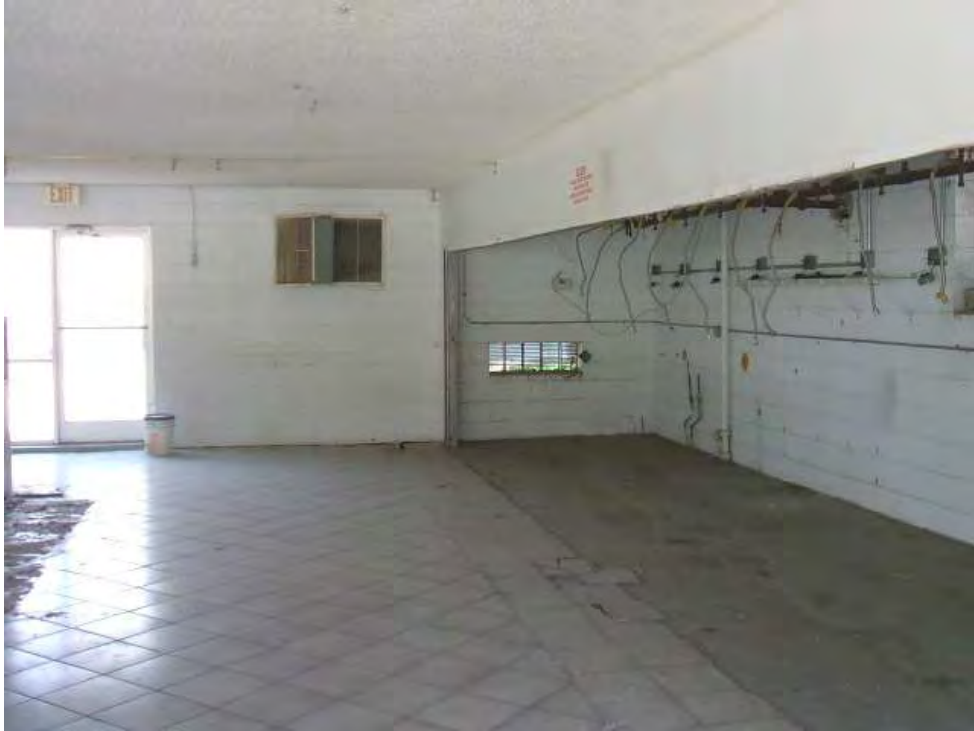
A view of the interior of the former dry cleaning facility. No direct evidence of the location of the former dry cleaning machine was apparent.

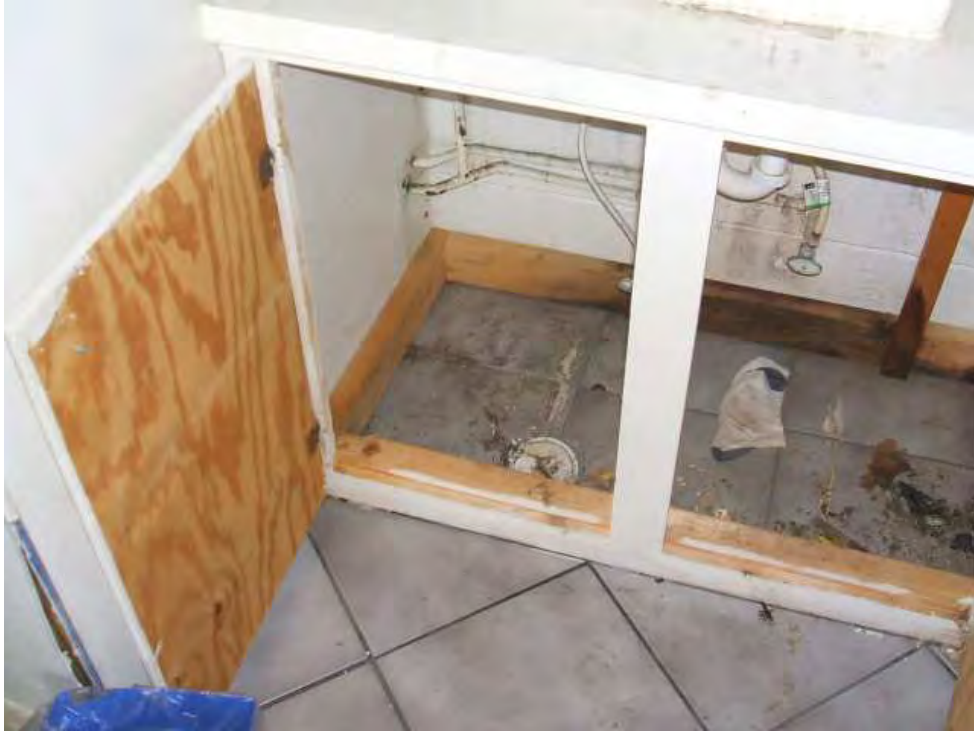
A photograph showing an old floor drain under the bathroom sink. The drain could be a possible location where spent solvent had been disposed of while the dry cleaning business was in operation.
